**WESTIN FRENCHMAN'S REEF INSPECTION**  
**PHOTO ALBUM**  
**September 25, 2024 CEI Facility Walkthrough**

PART A. Observations that revealed potential non-compliance with requirements and conditions of the Permit, as documented during the 2024 Inspection.

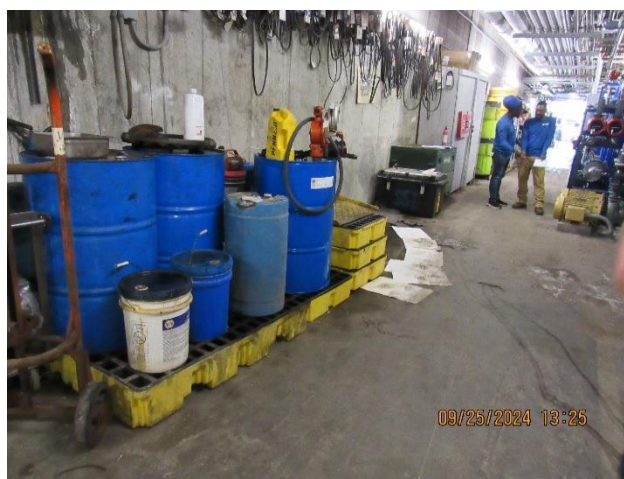
**IMG 1369**-Plant Operation Area of Facility, where dispensing of lubricants, chemicals, and storage of used oil are carried out. Evidence that materials spills had recently occurred in the area.

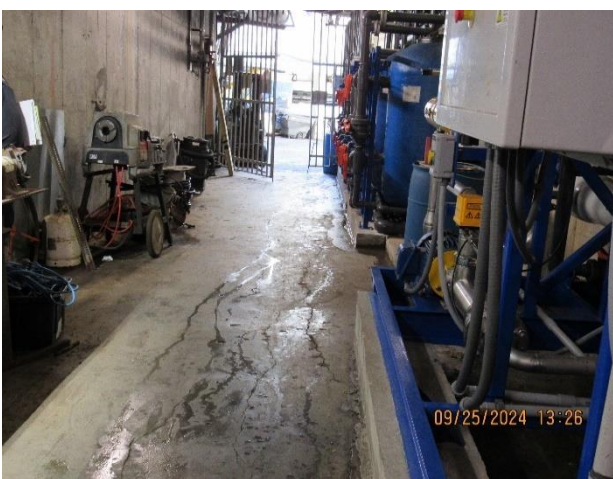
**IMG 1371**-Facility's Reverse Osmosis Plant (ROP) in the Plant Operations Area. The inclined paved floor allows drainage of spillages out of the section into an area exposed to stormwater runoff flow.

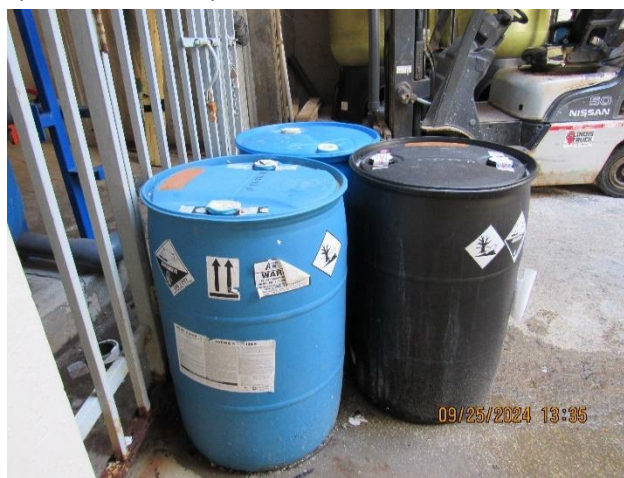
**IMG 1374**-Drums of chemical used in operations of Facility's ROP in a Loading/Unloading Bay (LUB)<sup>1</sup>.

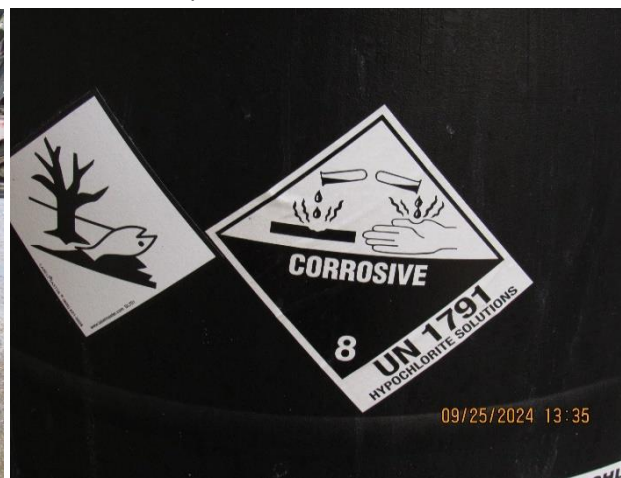
**IMG 1373**-Identification of the chemical reagent on labels affixed to the container.

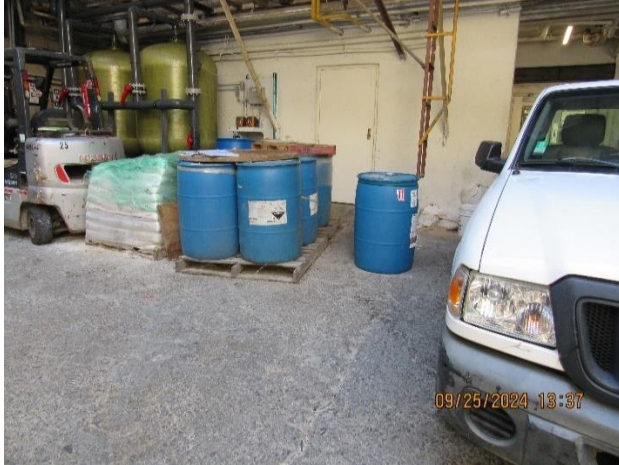
**IMG 1379**-Calcium carbonate and other chemicals improperly stored and unprotected from potential damage by operated vehicles in the LUB of Facility.

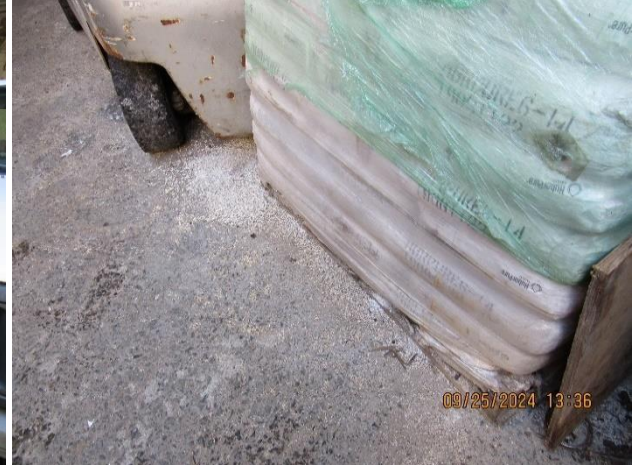
**IMG 1376**-Close-up of calcium carbonate spilled on pavement, exposed to rain and stormwater runoff and that will be readily washed-off.

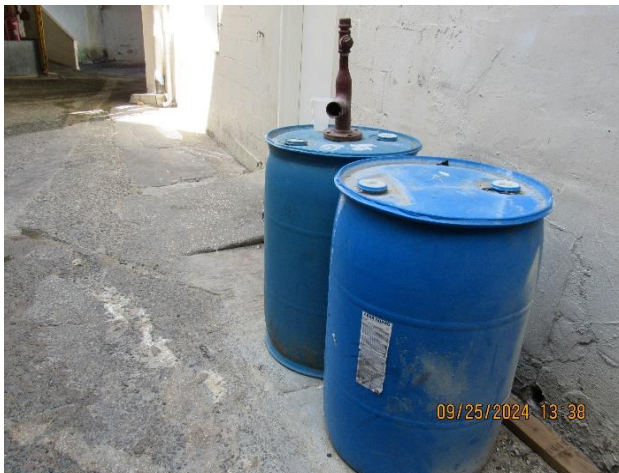
**IMG 1381**-55-gallons drums of aged chemicals in the LUB area unprotected from being damaged by operated vehicles.

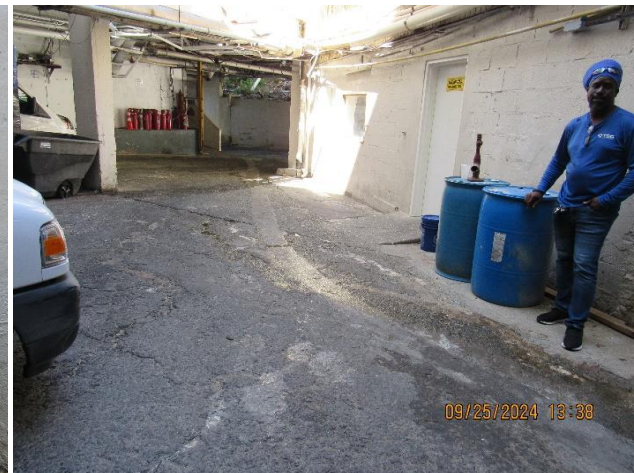
**IMG 1380**-Existing stormwater flow path in LUB area, that drains down gradient towards the Back-Of House (BOH)<sup>2</sup> area and into stormwater catch basins just downstream.

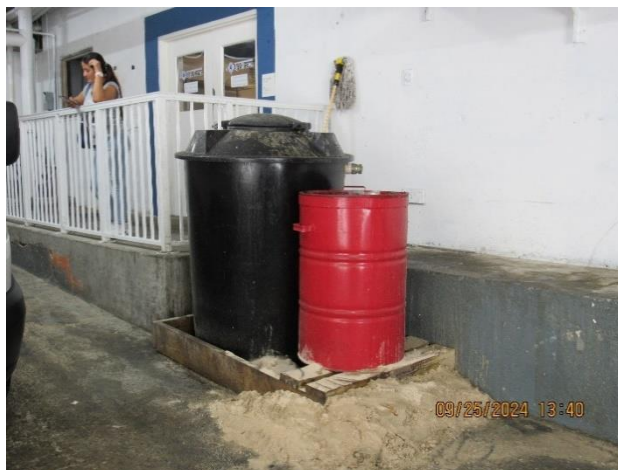
**IMG 1382**-A spent cooking oil collection station in the BOH. Evidence revealed sand saturated from spent cooking oil exposed to stormwater runoff.

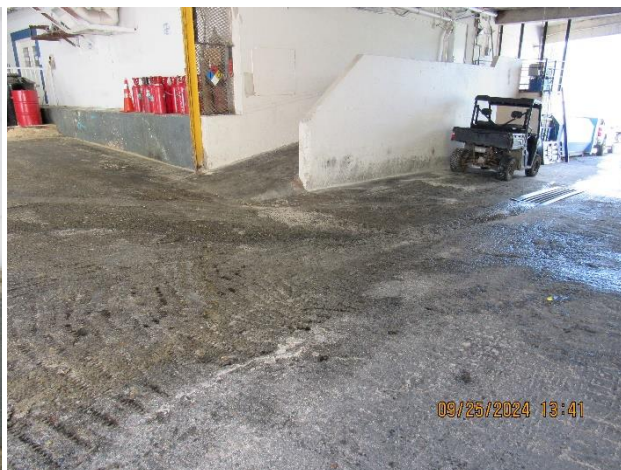
**IMG 1384**-Stormwater flow path down gradient drain into a stormwater catch basin that discharges into Outfall 002.

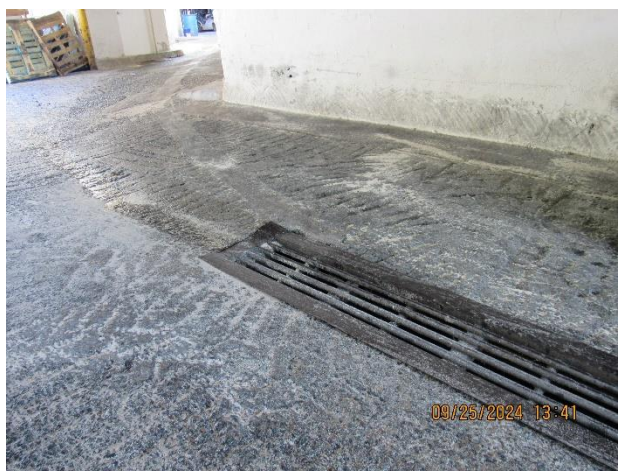
**IMG 1386**-Evidence of dry-weather flow from BOH transporting oil-saturated sand into the stormwater catch basin, which drains into Outfall 002.

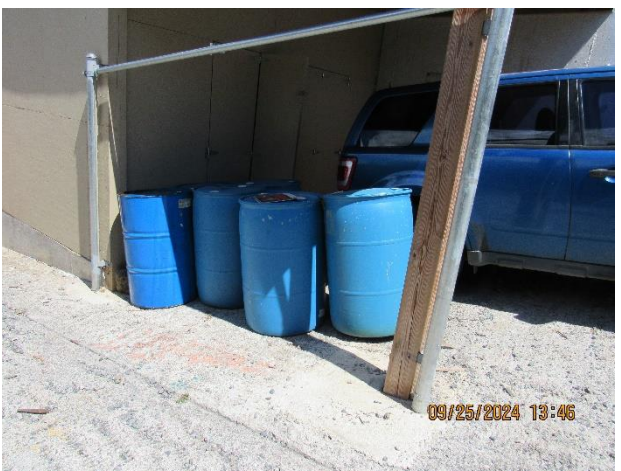
**IMG 1387**-Containers of material used by Dockside Water Sports (DWS)<sup>3</sup> on premises of Facility is not protected within an appropriate containment.

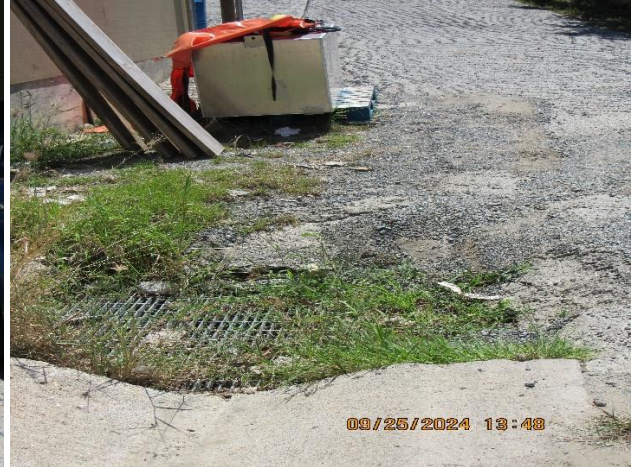
**IMG 1389**-Stormwater inlet to a Pacquereau Bay outfall is situated just upstream of the DWS setup.

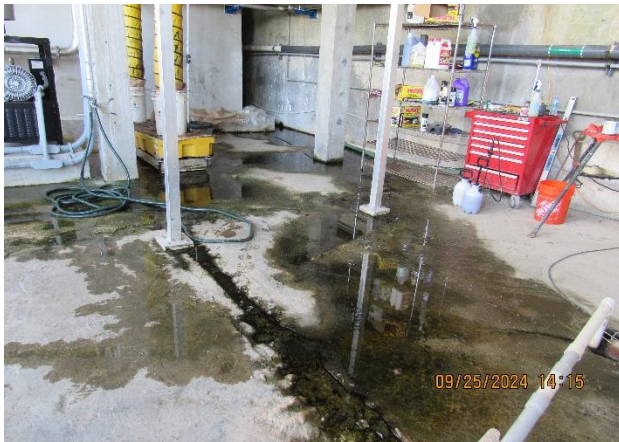
**IMG 1392**-Evidence of algal growth in water that appears to be sipping through a concrete wall and ponds on the lower paved floor of the WWTP. The water is pumped from a sump basin into nearby Pacquereau Bay.

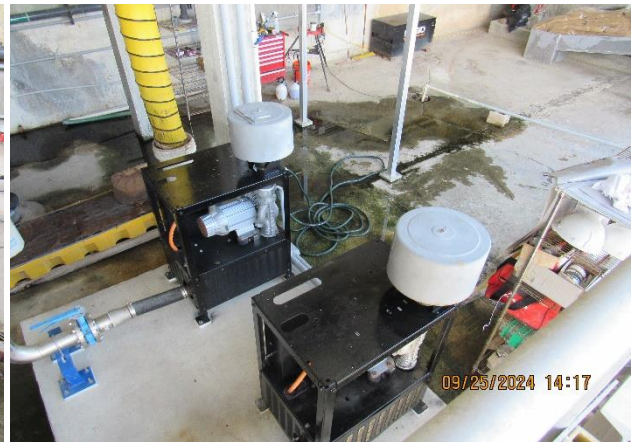
**IMG 1393**-Flexible shoots connected to the base of grit screen units staged on the upper floor of the WWTP. Screened grit from the units is transferred via the shoots into plastic buckets for disposal.

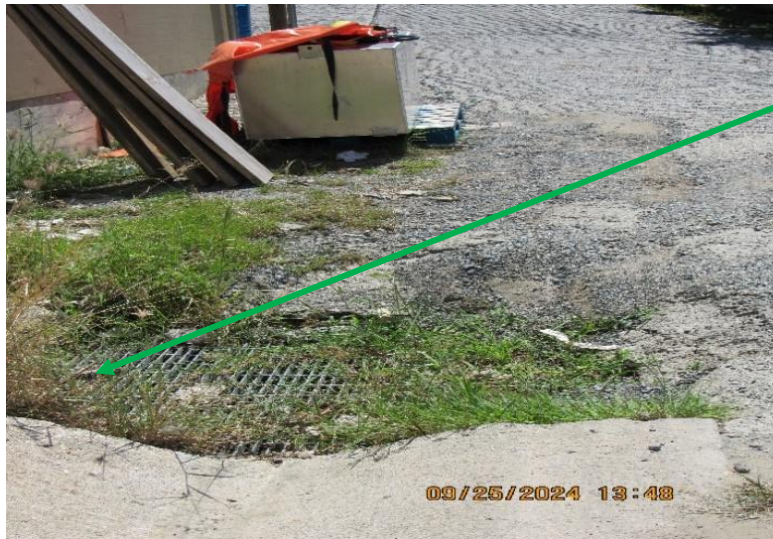
**SAMPLING  
POINT**

**IMG 1389-Outfall 001B** conveys wastewater from floor of WWTP into shoreline of Pacquereau Bay. No identification signage erected, and inlet of the associated catch basin was unprotected. Drainage of potentially contaminated wastewater from up-hill sources will readily enter the catch basin.

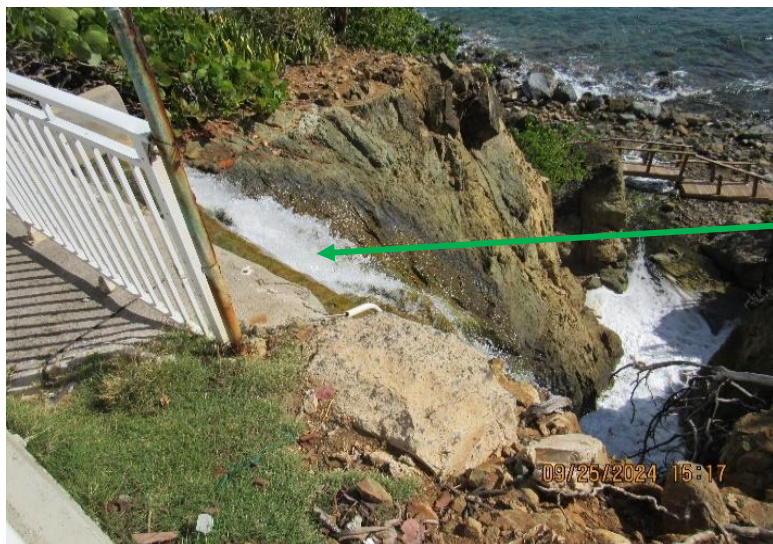
**OUTFALL 003**

**IMG 1403-Outfall 003.** Brine reject from the industrial operation of the ROP. The waste stream is discharged into Morning Star Bay from a designed waterfall along the northeastern side of the Facility.

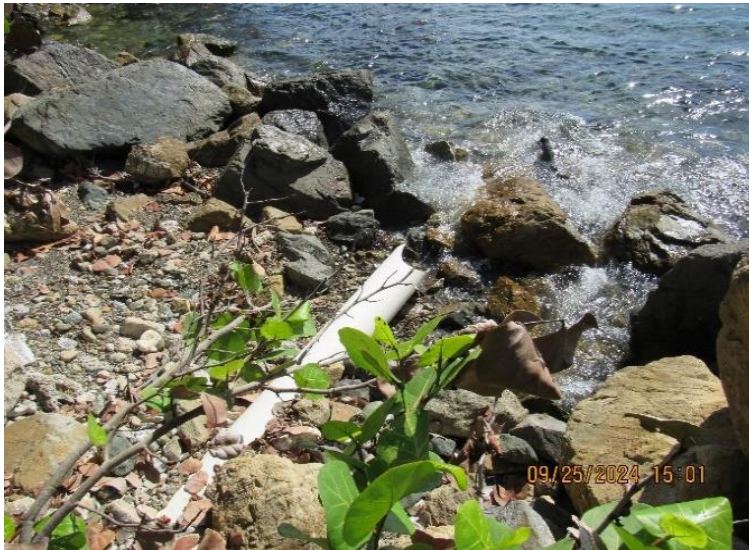
**IMG 1402-Outfall 002.** A 6-inch PVC pipe conveys stormwater runoff from uphill areas of Facility operations, including the LUB and BHA activities of the Facility. Discharges directly into Pacquereau bay.

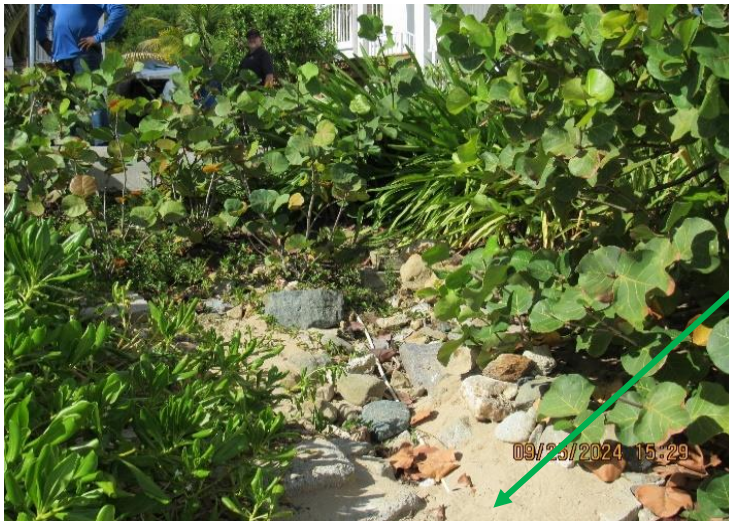
**OUTFALL A**

**IMG 1406-Outfall A.** Conveyance through which a combination of treated wastewater from the WWTP (applied as vegetation irrigation) and stormwater runoff during rain events are discharged into Morning Star Bay.

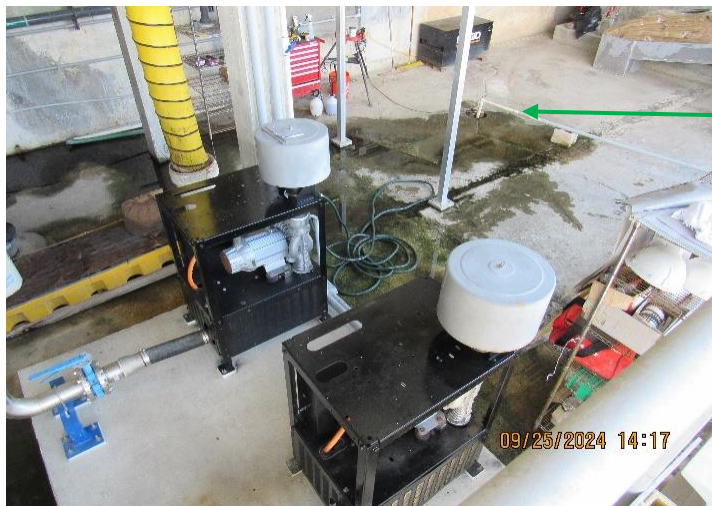
PVC PIPELINE FROM  
SUMP BASIN TO WALL.  
END OF PIPE DISCHARGE  
TO SWALE (BEYOND  
WALL)

**IMG 1393-*Outfall B***. PVC pipeline through which algae-laden water from floor in WWTP area is pumped into swale, that in turn drains into shoreline of nearby Pacquereau Bay.
