REPORT OF COMPLIANCE EVALUATION INSPECTION  
(INDUSTRIAL STORMWATER)

**Enterprise Precast Concrete**  
**13800 Giles Road, Omaha, Nebraska 68138**

BY  
U.S. ENVIRONMENTAL PROTECTION AGENCY  
REGION 7  
ENFORCEMENT AND COMPLIANCE ASSURANCE DIVISION (ECAD)  
WATER BRANCH/DRINKING WATER & INSPECTIONS SECTION (WB/DWIS)

ON  
October 4, 2023

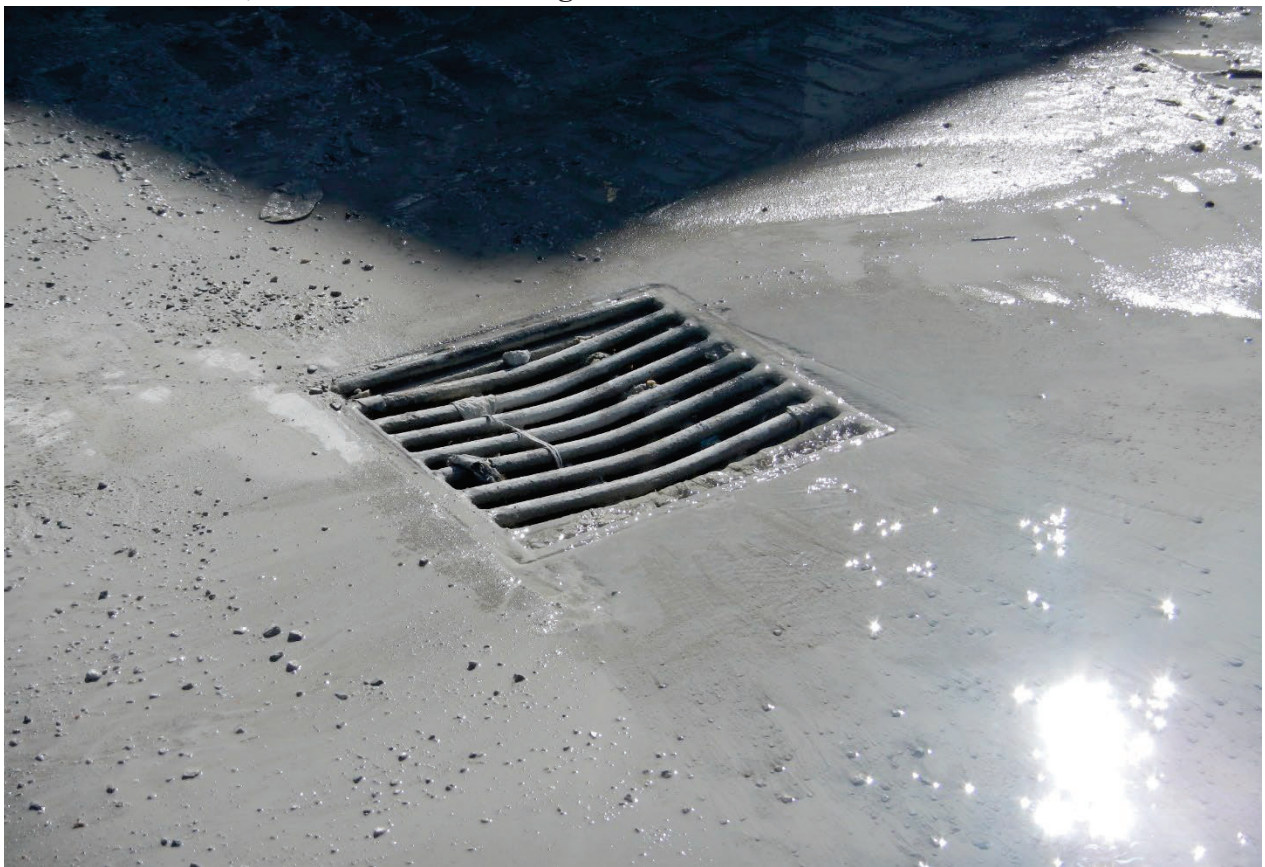
2. During the inspection I noticed that the Facility was discharging process water from the panel washing process through stormwater inlet #1 located at the northwest corner of the precast building that is piped to directly discharge to outfall 01 which discharges into the South Papillion Creek. The inlet was not protected (Photo 11).

**Photo 11, Process water entering a stormwater inlet that leads to Outfall 01.**

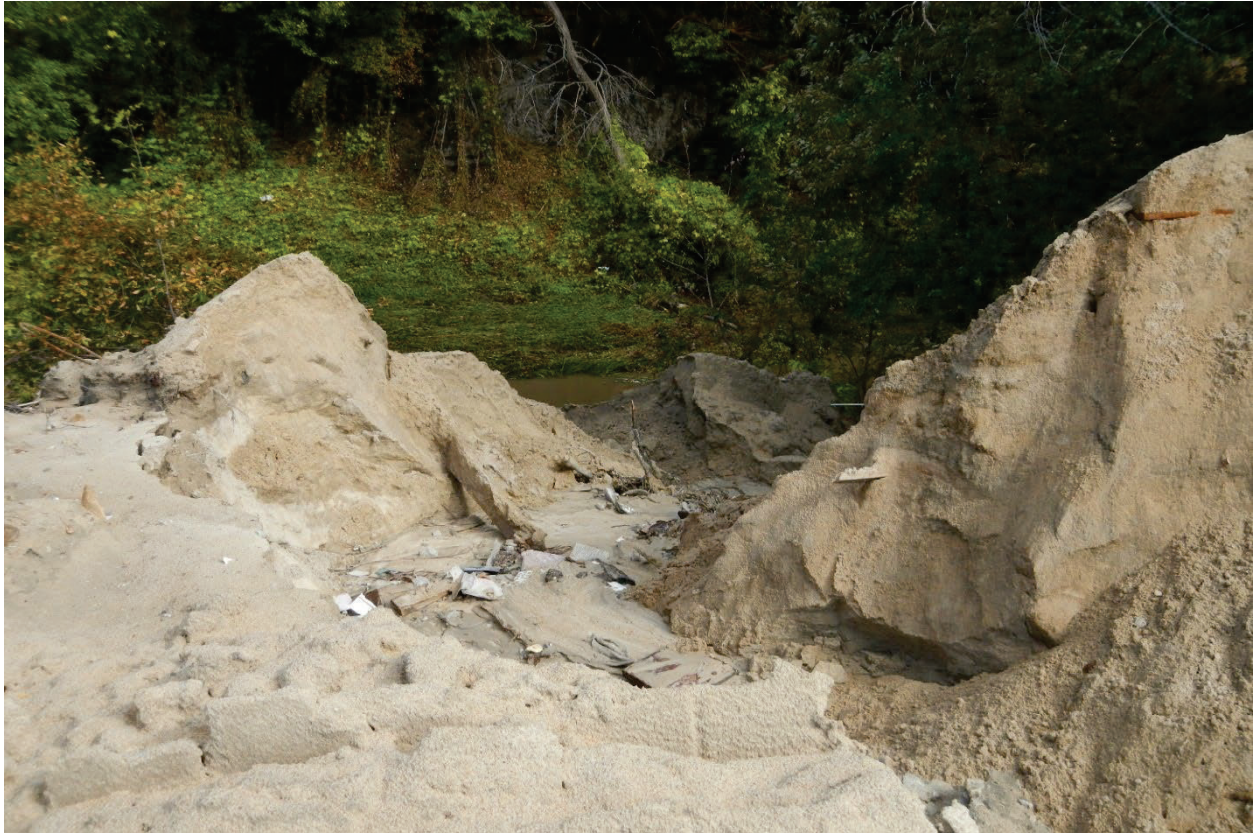
3. NOPF#2 was issued because the Facility placed a significant amount of process material, such as sand and gravel piles, at the edge of the north property line along the bank of the South Papillion Creek. This material spilled over onto the bank of the South Papillion Creek and into the Creek. Evidence of significant erosion caused by surface runoff indicates that the material has been there for an extended period of time without BMPs as illustrated in photo 17 below and photos 16, and 18 in attachment 5 of this report.

**Photo 17, significant erosion caused process material to enter the South Papillion Creek**
