**Well Inspection**  
**Osage DNR / Environmental Protection Agency**  
**1201 Elm Street, Suite 500**  
**Dallas, Texas 75270**

| | | <b>Lease Name</b> | Labadie | | |
| | | <b>Well ID</b> | 12 | | |

## Photograph Log

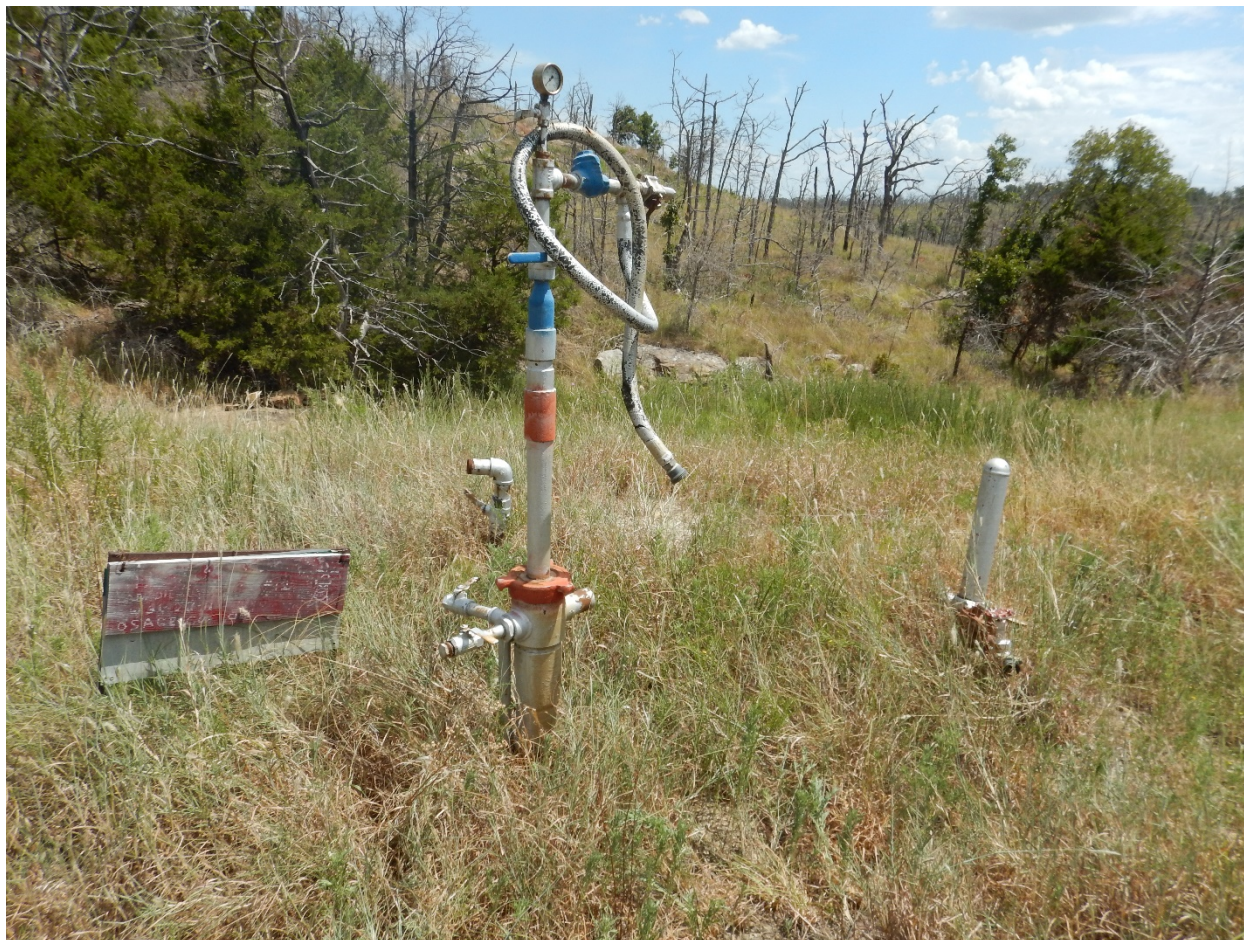
Photo No. 1

| <b>Inspection Comments</b> | At the time of the inspection, well OS5470023 (Labadie No. 12) was not connected or injecting. The valves and fittings on the well at the time of the inspection prevented observation of tubing and annulus pressures. At the time of the inspection, well fittings prevented observance of the tubing fluid level. The primary area of concern was the lack of accessible fittings to obtain well pressures and fluid level. The operator should equip the well with accessible fittings to accommodate measuring pressure on the tubing as well as the annulus. The well construction should also provide access to obtain fluid level measurements by use of an Echometer. The well sign should be updated. There were no other areas of concern at the time of the inspection. | | | | |

**Description:** This was well OS5470023 (Labadie No. 12). The tubing should be equipped with a valve and female fitting to allow pressure readings to be taken. At the time of the inspection, if the tubing valve was open, air/gas would vent through the hose into the atmosphere and prevent observance of pressure on the tubing.
