Clean Water Act Section 404: Site Visit/Case Development

Site Name	MW Mayagüez, LLC (hereinafter as "MW Mayagüez")	Start Date	January 24, 2023
		End Date	January 24, 2023
Inspection Purpose	Initial site visit		
Opening Conference			
<input checked="" type="checkbox"/> Presentation of Inspector Credentials			
Name and Title (Use N/A if owner/operator not available to join the inspection)			
Inspector, Seika Robinson, presented credentials to Virgilio Casiano Santiago, operator on behalf of MW Mayagüez.			
<input type="checkbox"/> Opening Conference			
Name of person authorizing access if applicable			
Mr. Virgilio Casiano Santiago, on behalf of MW Mayagüez, authorized in person access to property to conduct the inspection the day of the visit.			
Notes from Opening Conference			
After arriving to the site on January 24, 2023, EPA met with Mr. Virgilio Casiano Santiago. EPA-WPS explained the purpose of the inspection, EPA and the Corps role with regulating wetlands under the CWA, and what areas would be inspected.

Mini Warehouse Mayagüez

**Tax parcel number 207-015-554-33 in the Municipality
of Mayagüez, Puerto Rico**

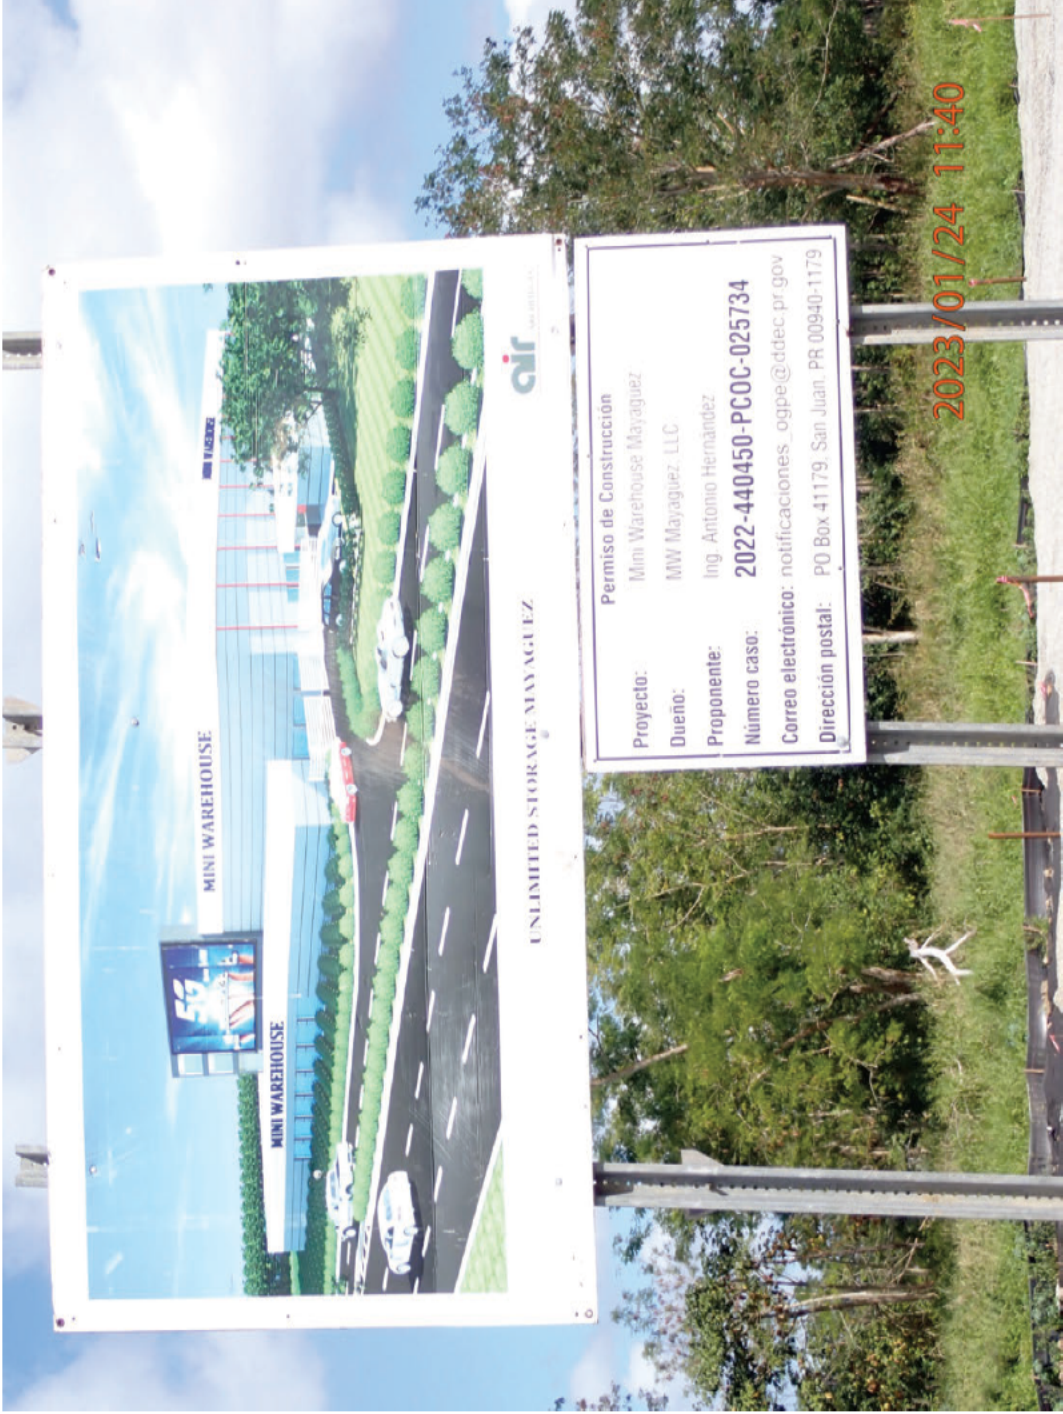
Photo ID: P1240328

Description: Construction permit sign at the entrance of the property.

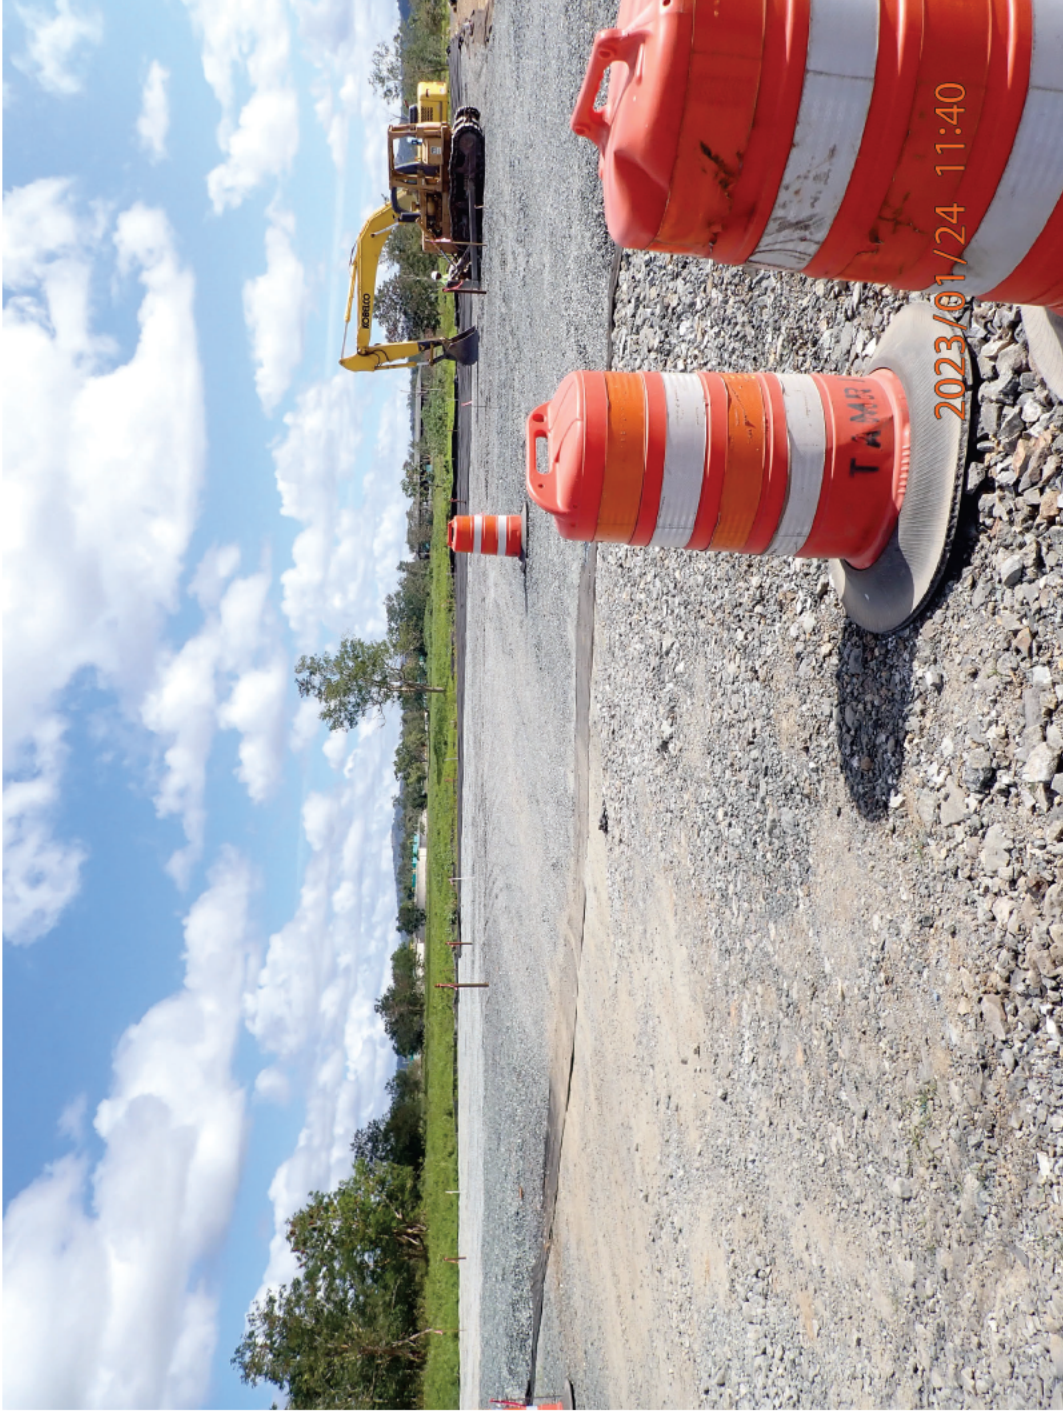
Photo ID: P1240328

Description: View of construction activities taking place at the property.

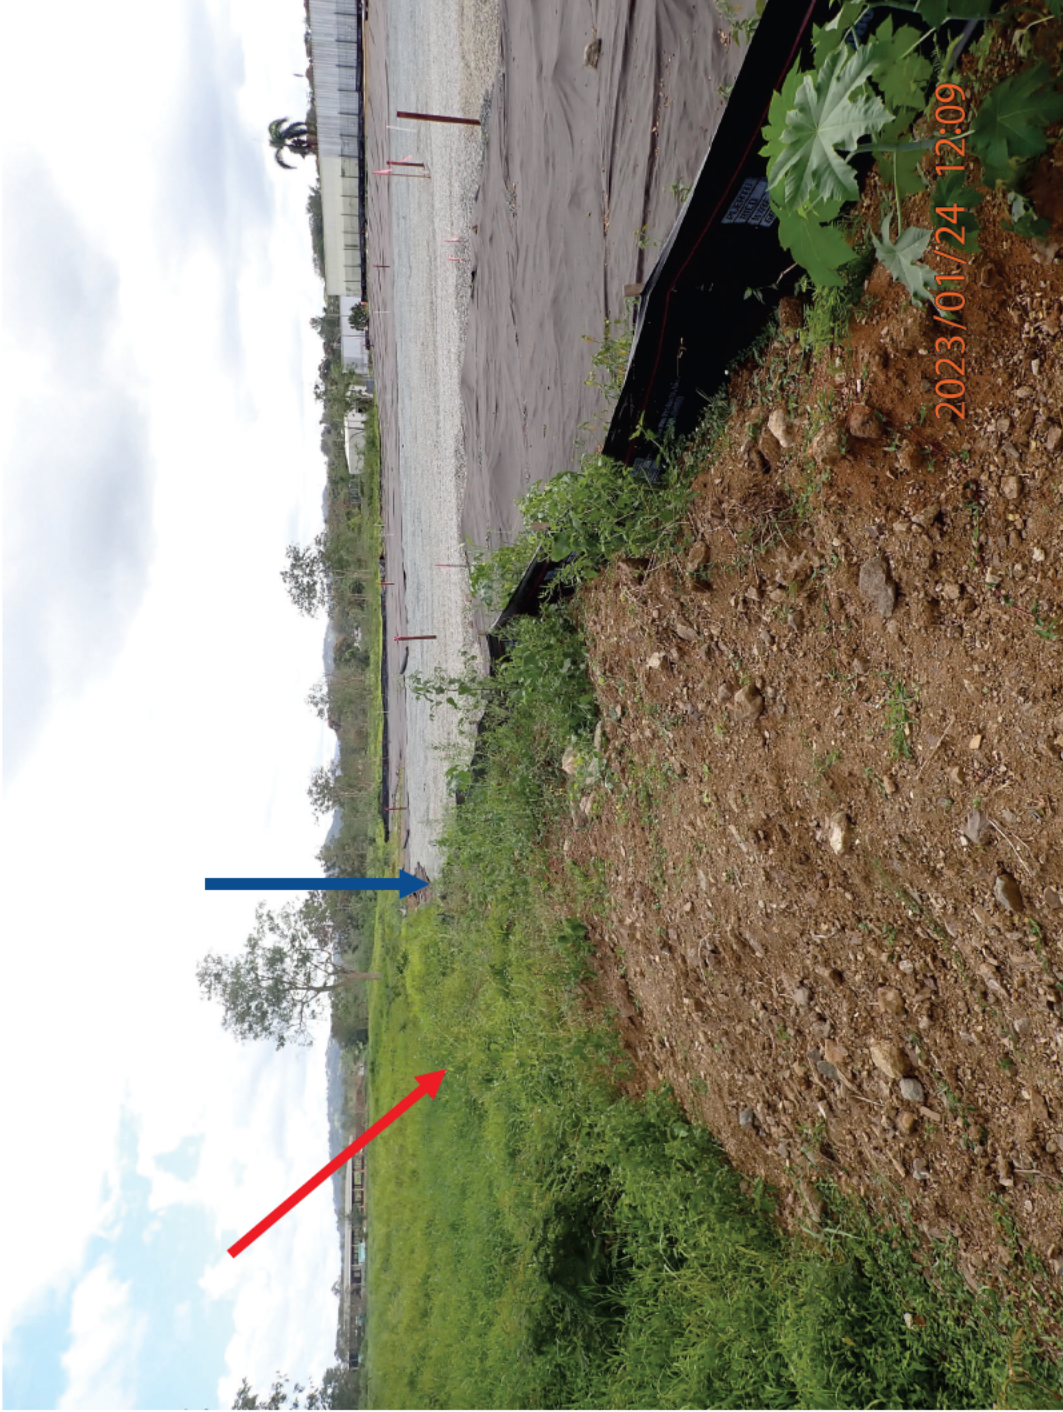
Photo ID: P1240331

Description: View from west to east on the northern work boundary.

Red arrow showing location of Caño Boquilla.

Blue arrow showing work boundary.

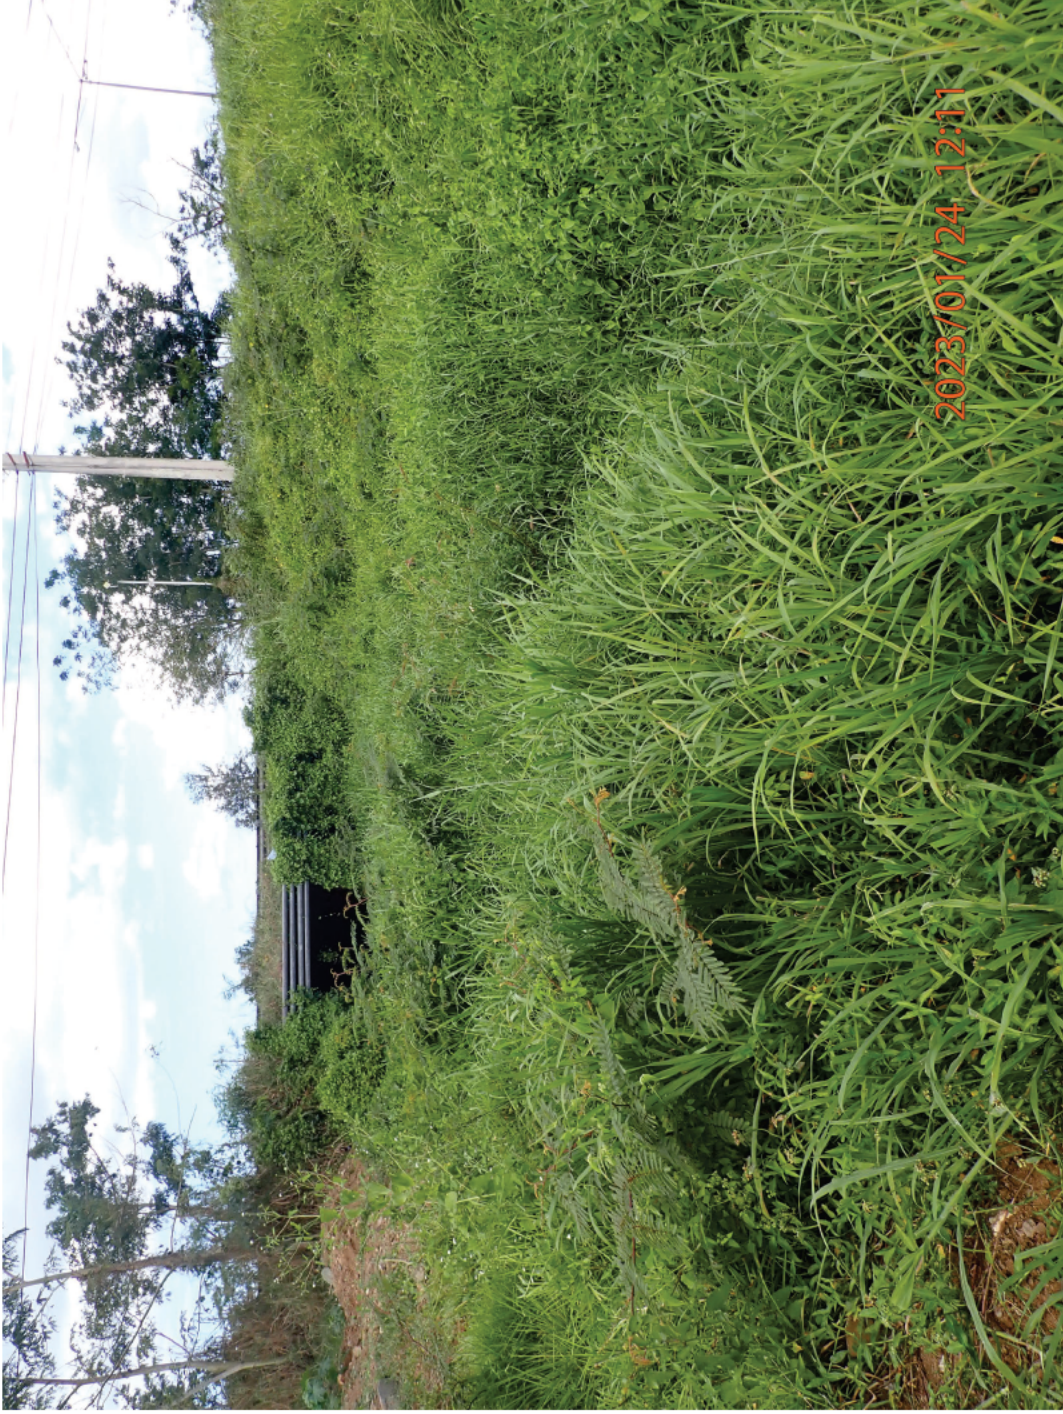
Photo ID: P1240333

Description: View of Caño Boquilla from the western property boundary. Picture depicts culvert at PR-2 N road.

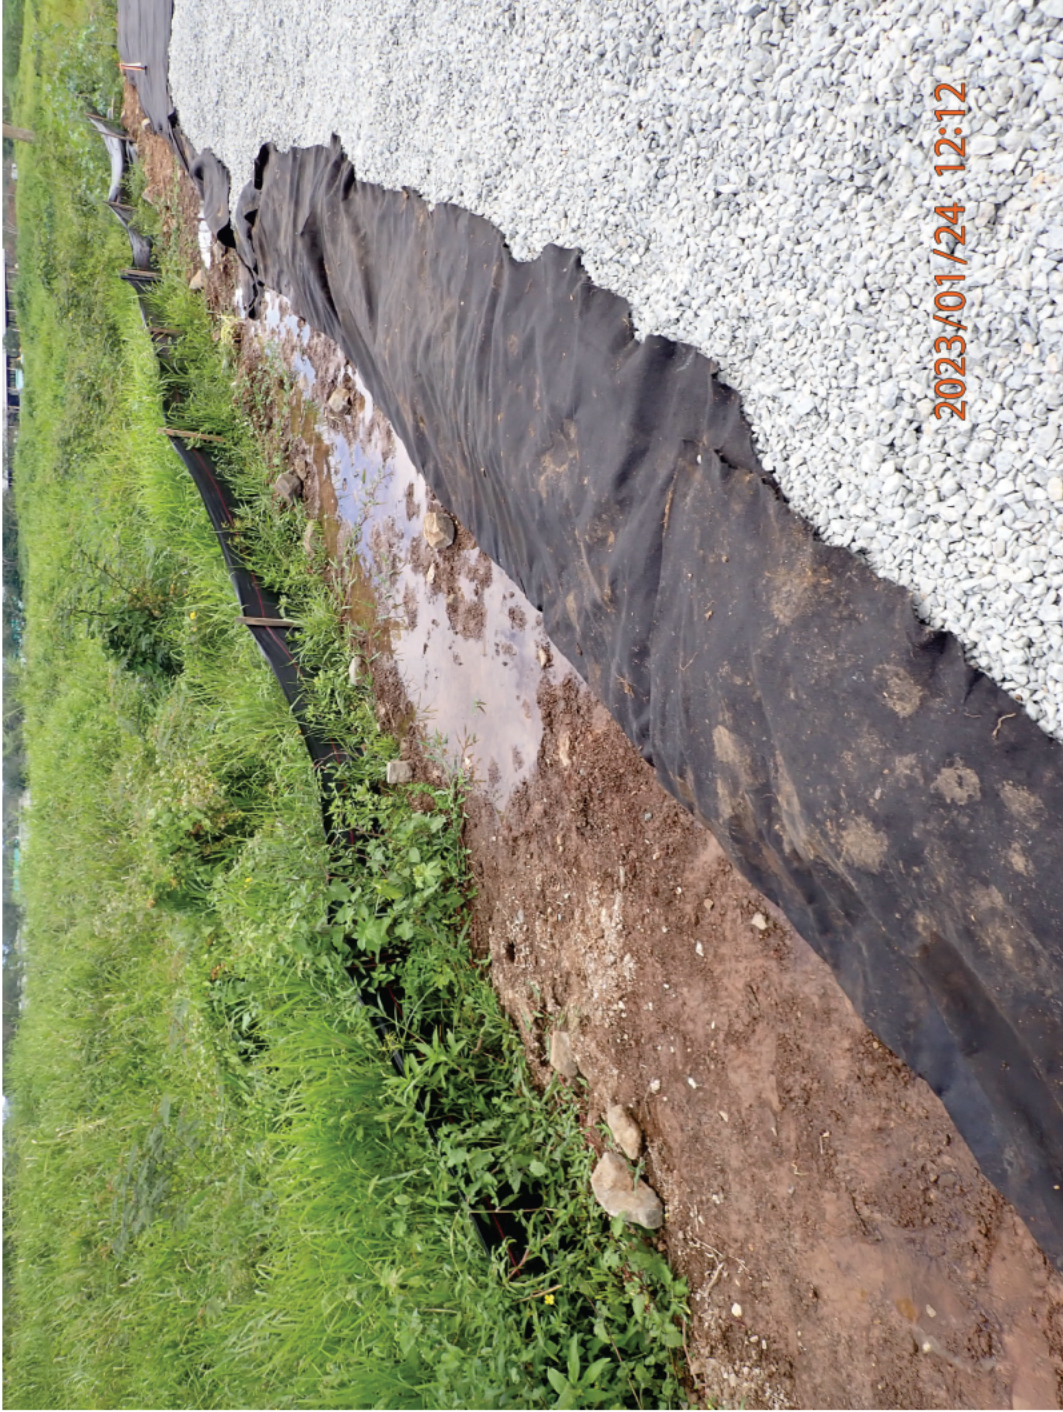
Photo ID: P1240337

Description: Construction lining and aggregate material at the northern boundary of the property. Ponding can be observed.

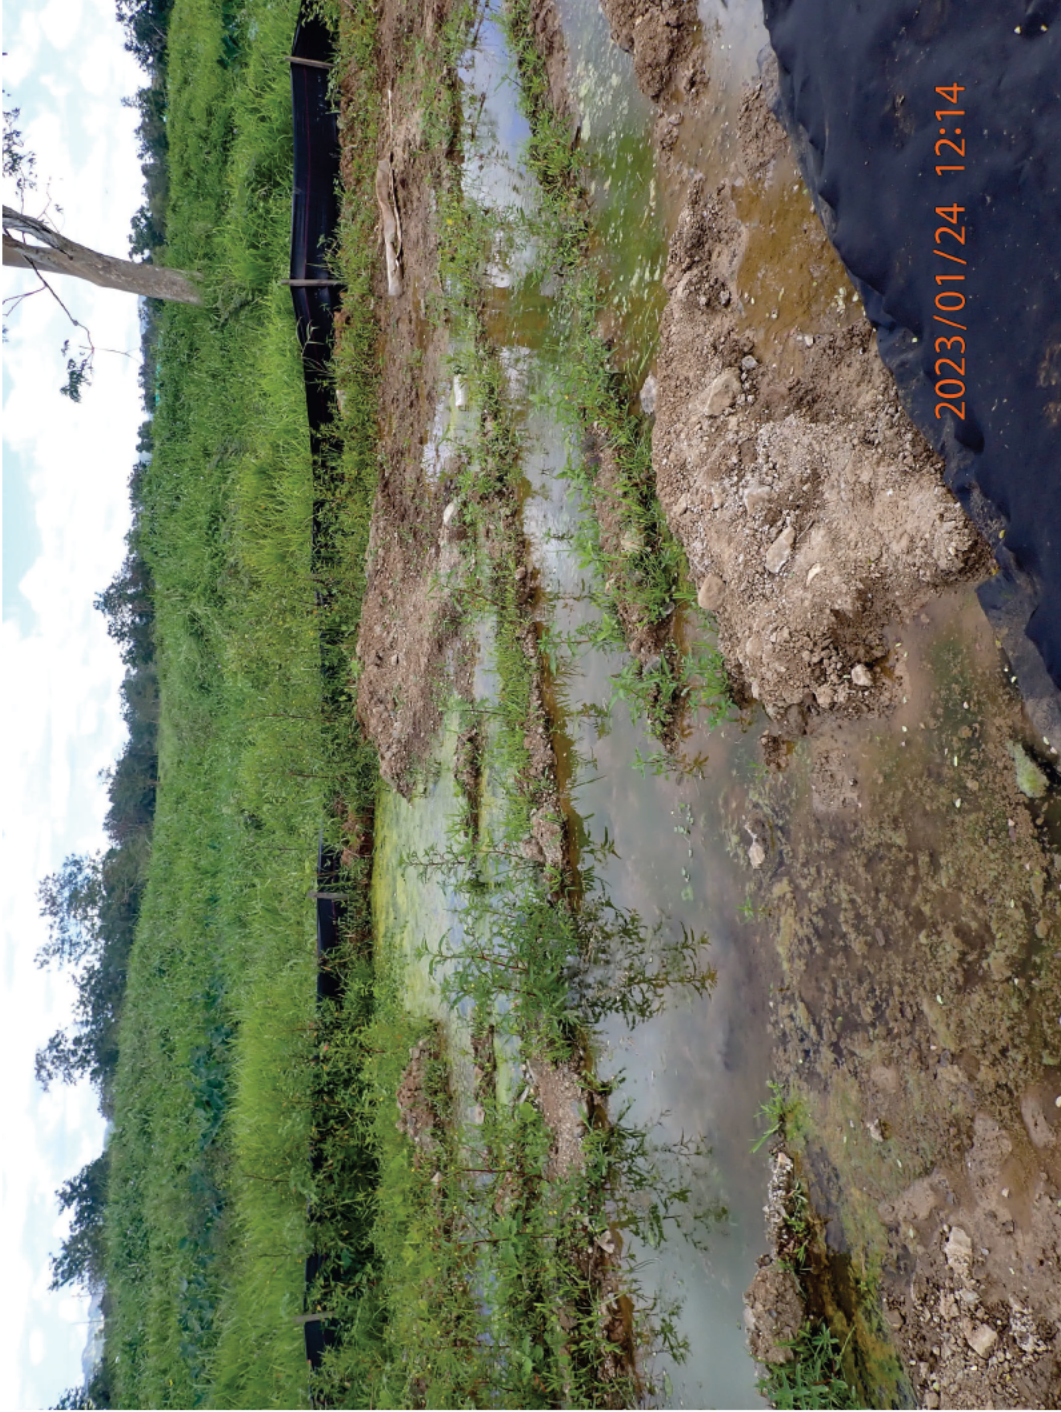
Photo ID: P1240340

Description: Inundated areas at the northern border of the property. Ponding and algal mats can be observed.

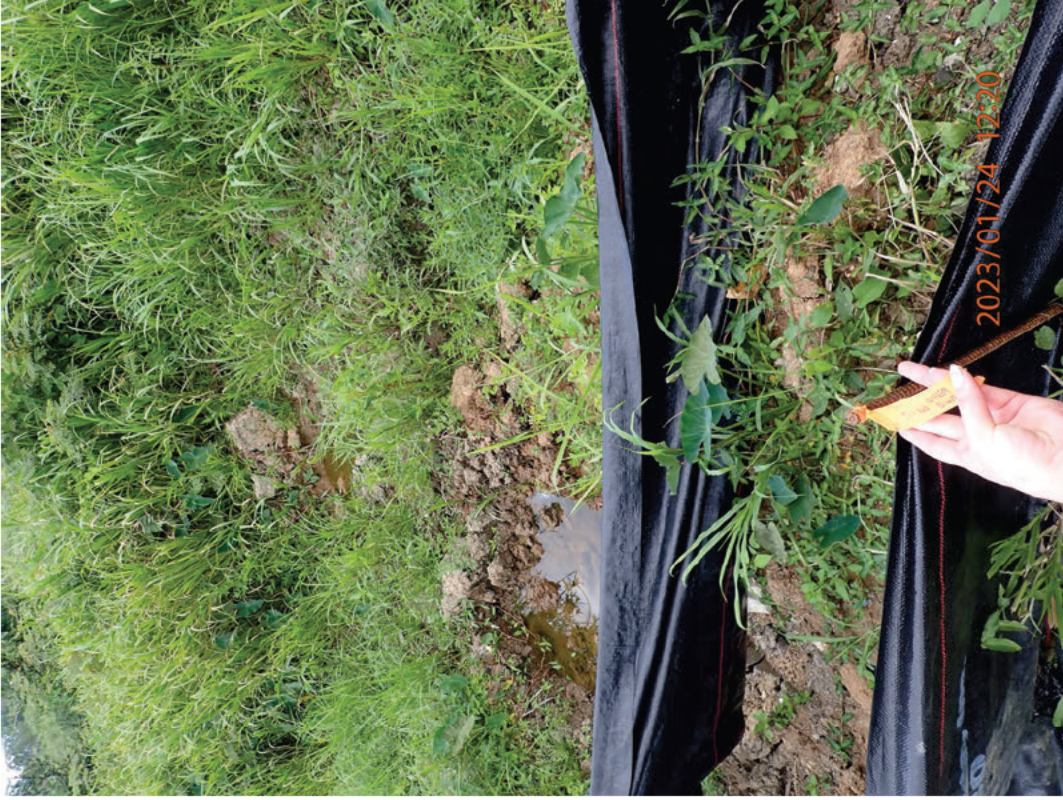
Photo ID: P1240346

Description: Silt fences and northeastern work boundary.

Iron rod with flagging of what appears to be a point marking a wetland delineation.

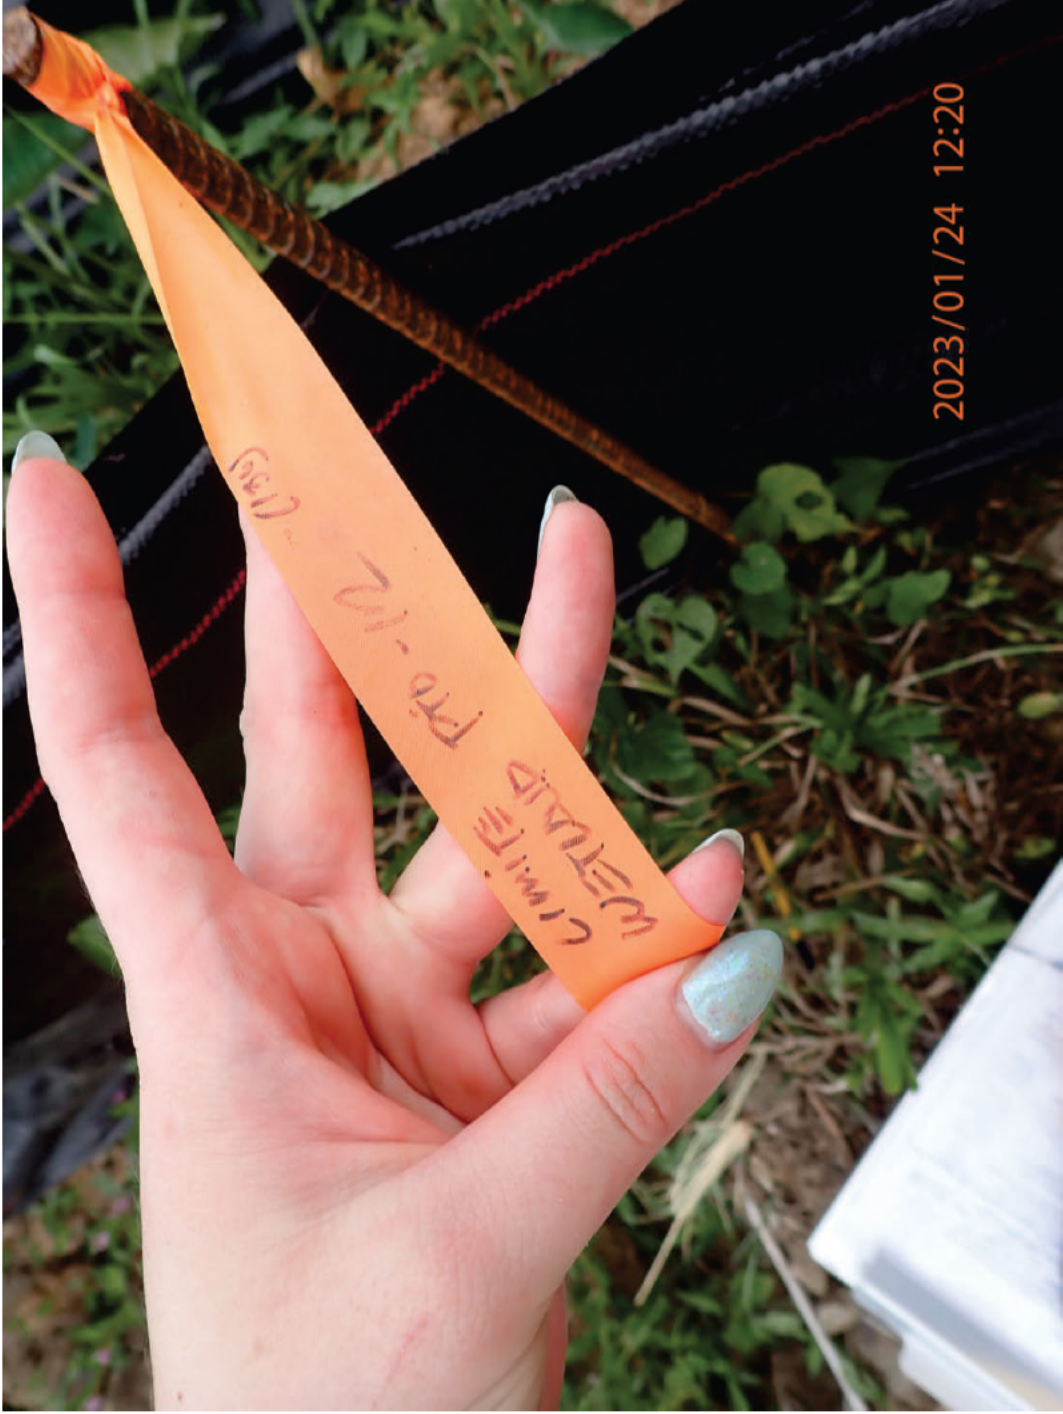
Photo ID: P1240347

Description: Close up of iron rod with flagging of what appears to me a point (#12) marking a wetland delineation.

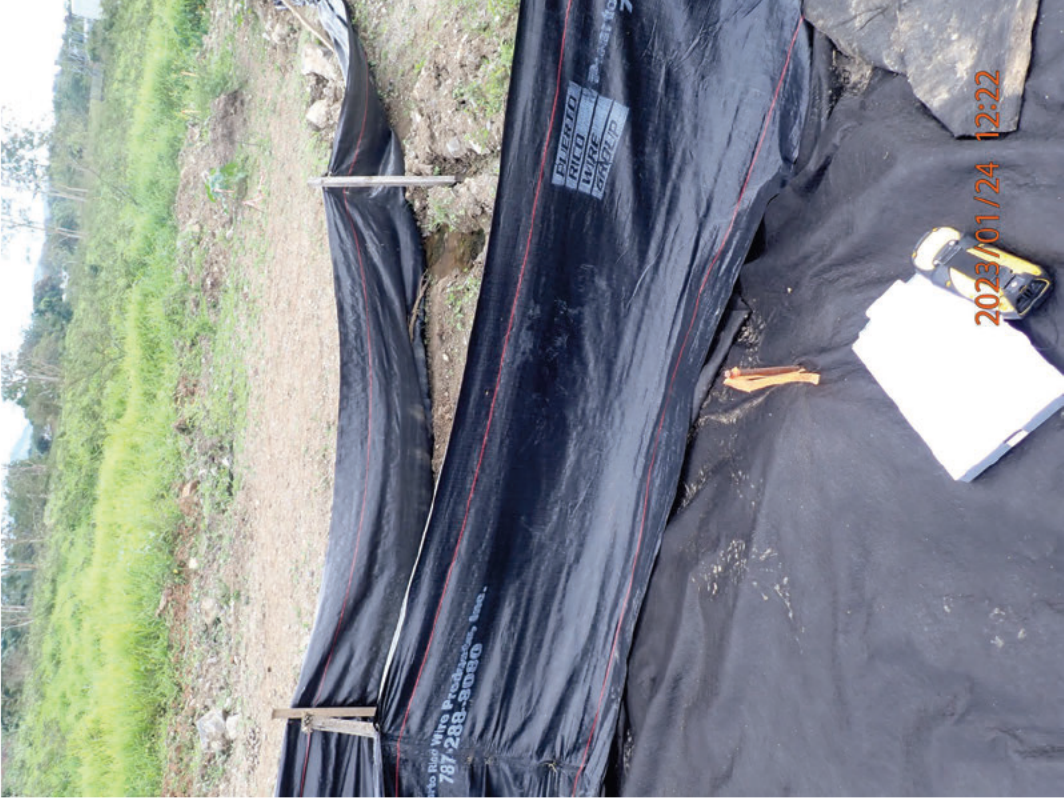
Description: Eastern work boundary.

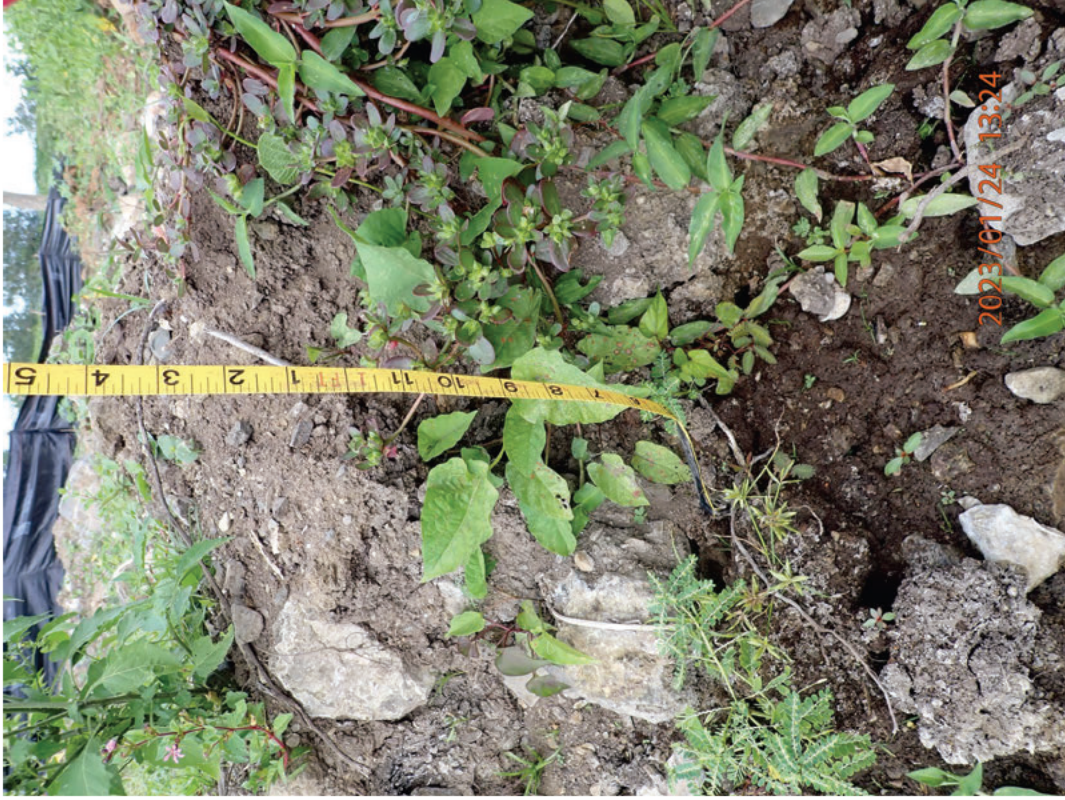
Photo ID: P1240354

Description: Fill material between silt fences at the eastern part of the property.

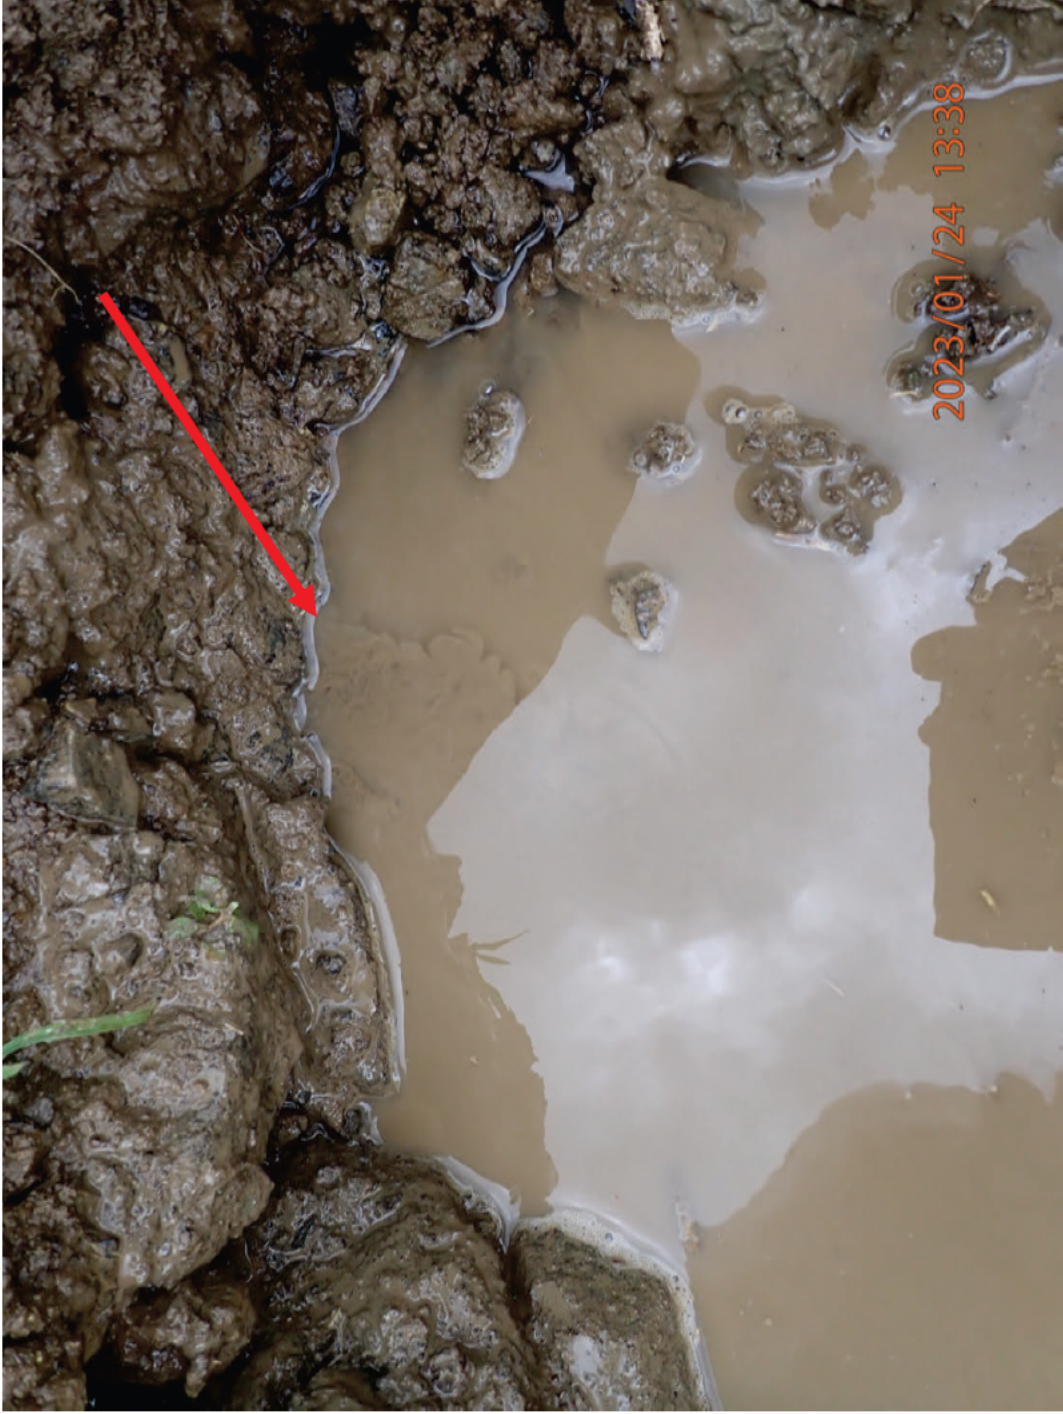
Photo ID: P1240358

Description: Soil Pit 1 water table and red arrow showing water continuously seeping into the pit.

Field Observations: Surface Water Present? Yes _____ No _____ Depth (inches): _____ Water Table Present? Yes <u>X</u> No _____ Depth (inches): <u>7</u> Saturation Present? Yes _____ No _____ Depth (inches): _____ (includes capillary fringe)	Wetland Hydrology Present? Yes <u>X</u> No _____
---	---

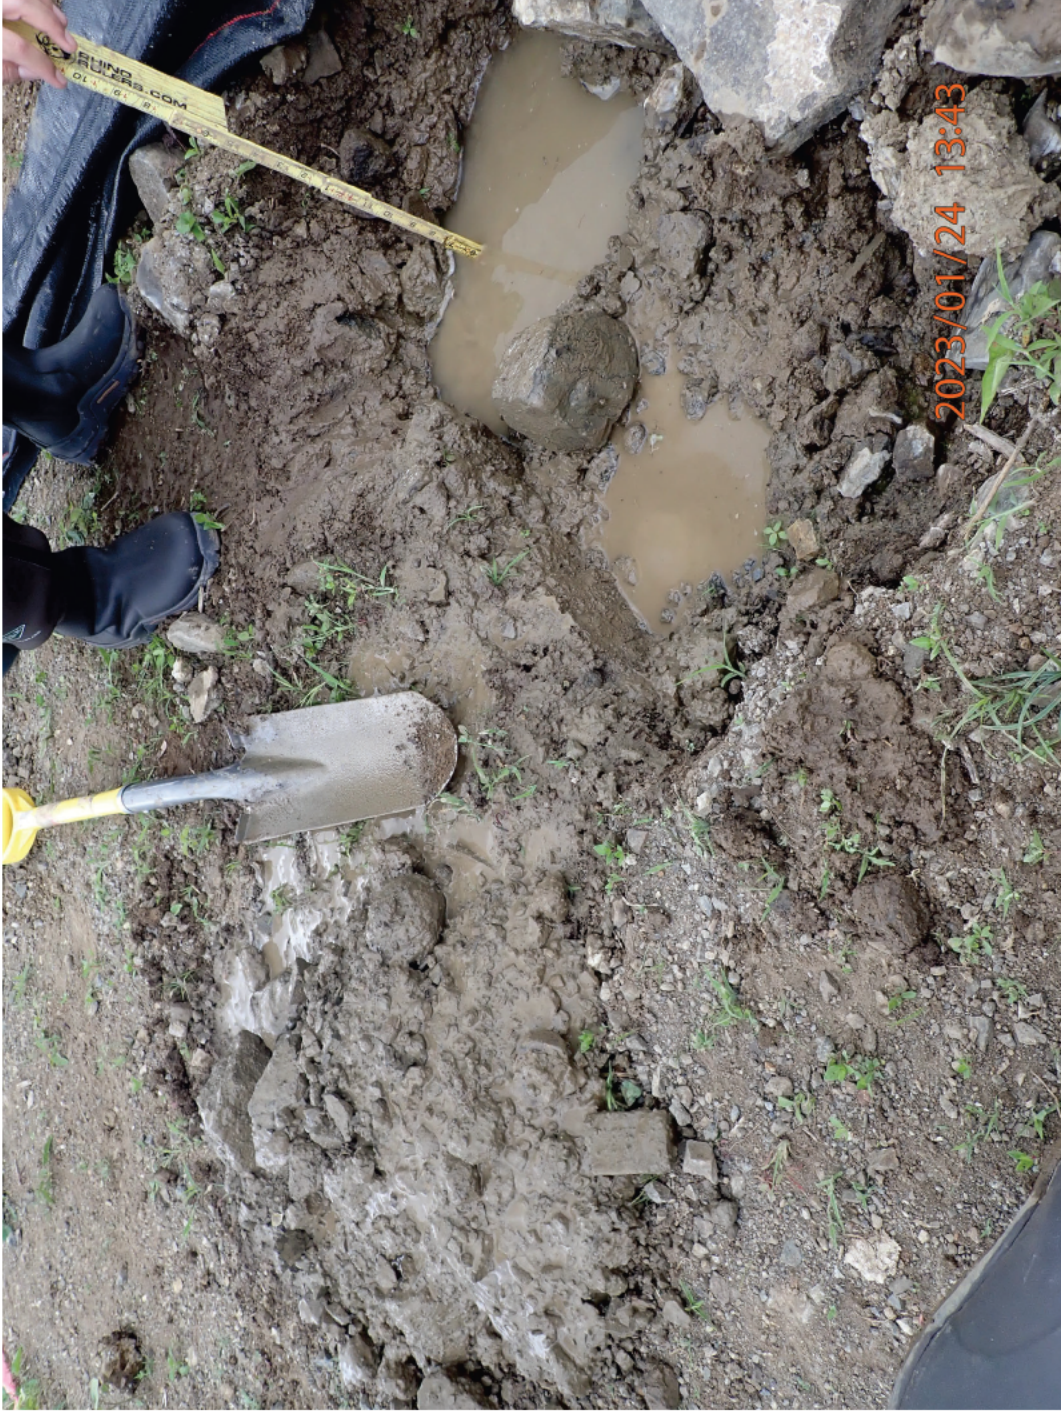
Photo ID: P1240360

Description: High water table can be observed at
Soil Pit 1

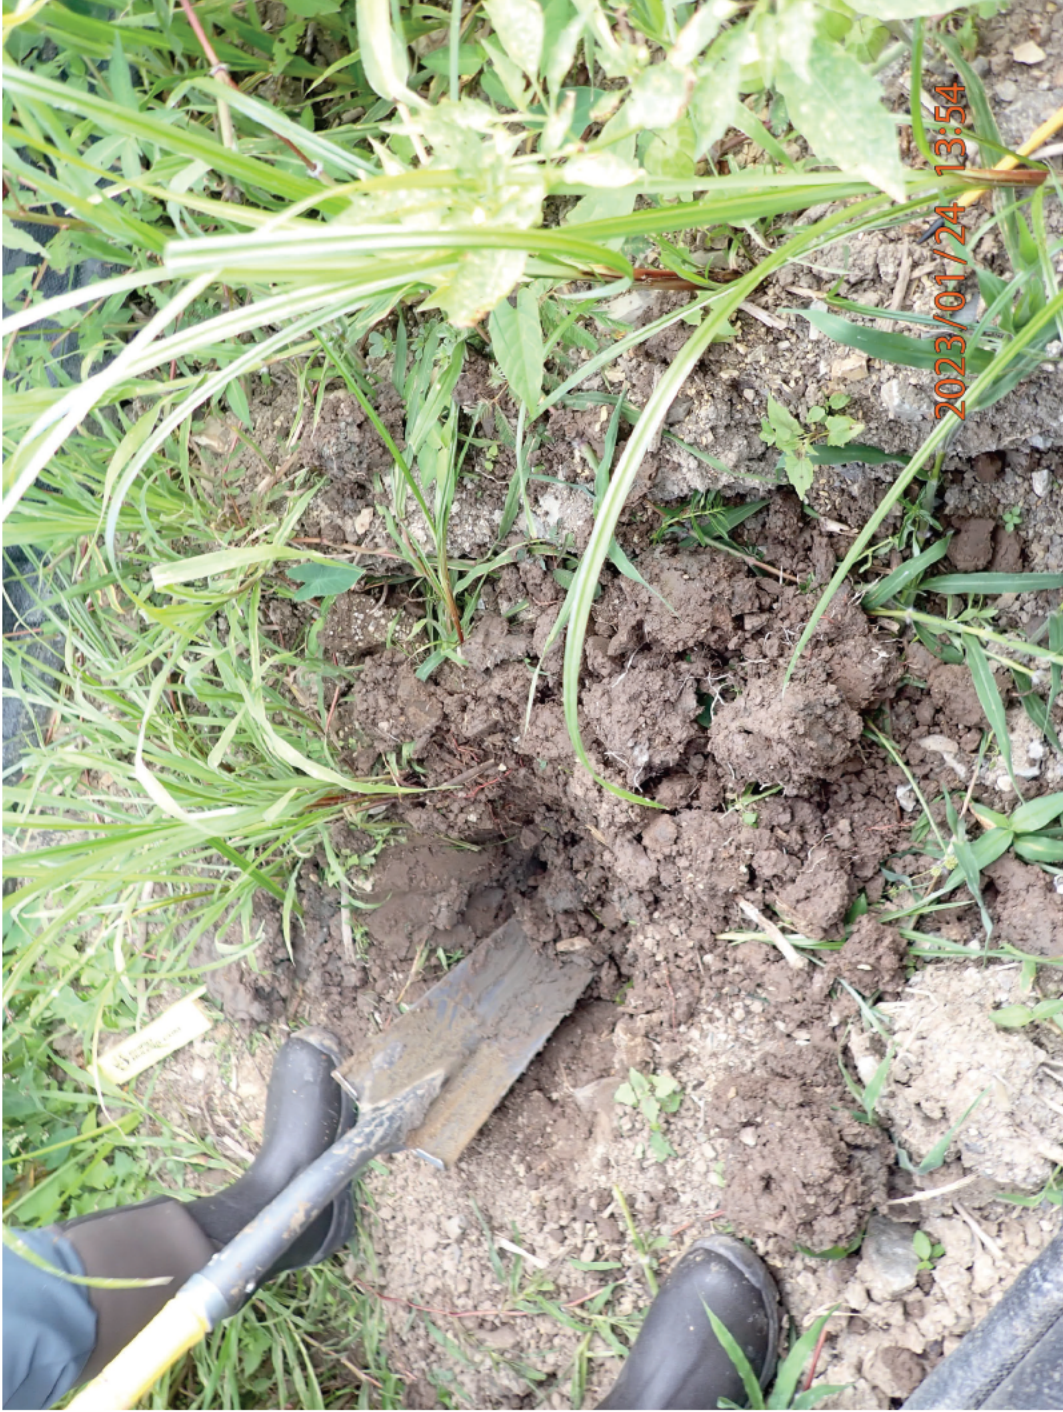
Date: 1/24/2023
Time: 1:54 PM
Photographer: Seika Robinson
Photo ID: P124364
Description: Soil Pit 2

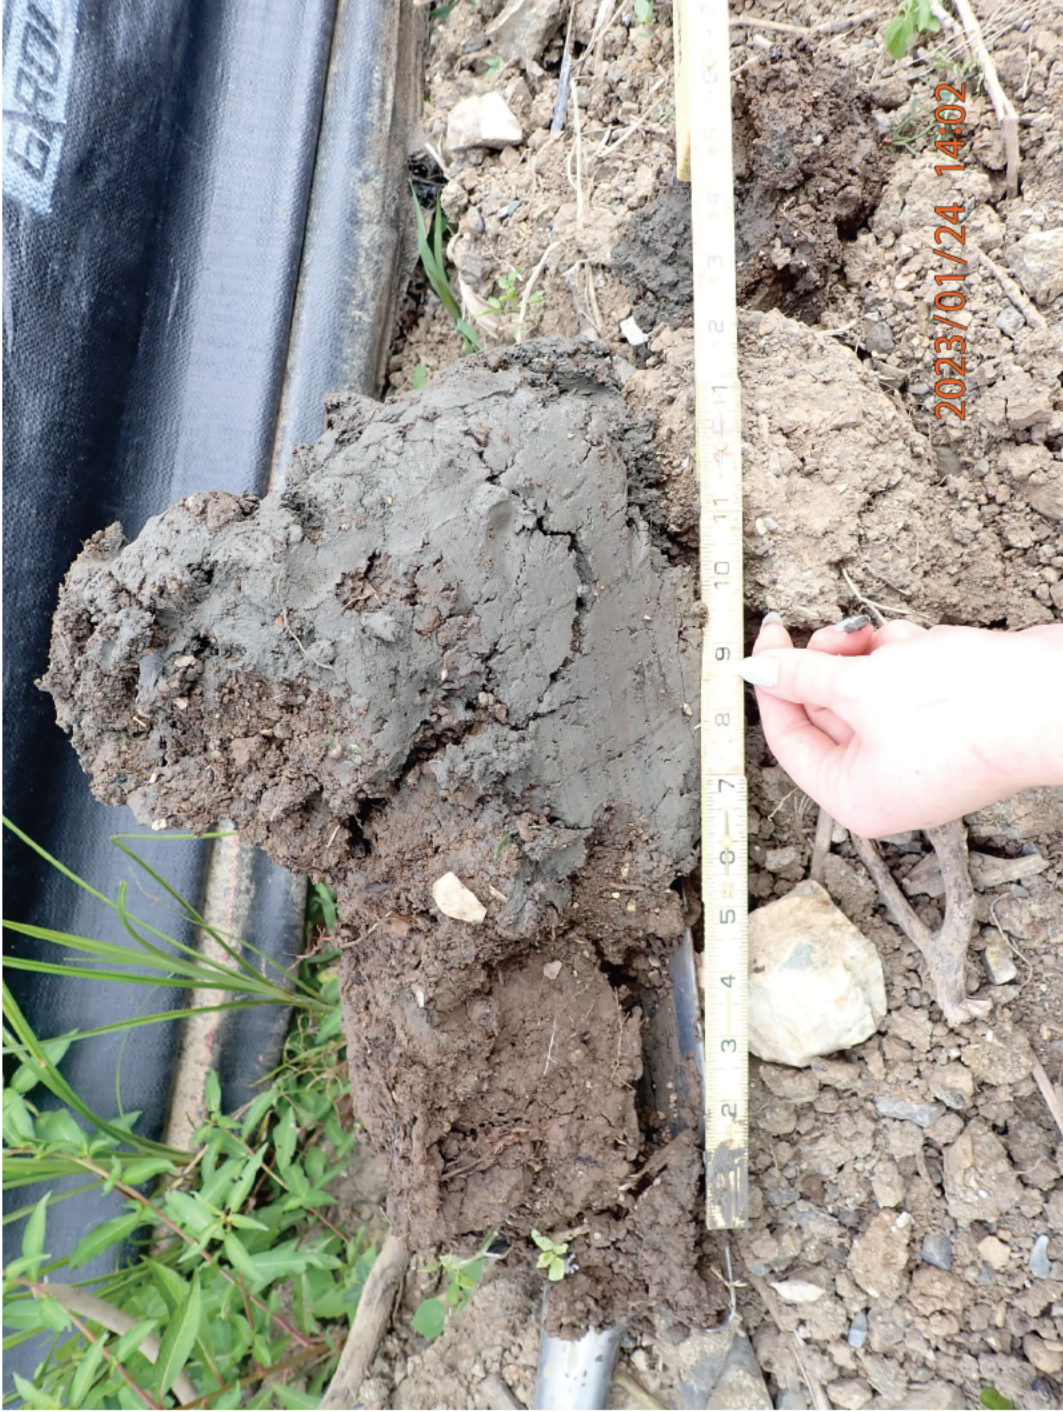
Date: 1/24/2023
Time: 2:02 PM
Photographer: Seika Robinson
Photo ID: P1240366
Description: Soil sample at Sol Pit 2.

Profile Description: (Describe to the depth needed to document the indicator or confirm the absence of indicators.)								
Depth (inches)	Matrix		Redox Features				Texture	Remarks
	Color (moist)	%	Color (moist)	%	Type ¹	Loc ²		
0-2	10YR 4/2	98	10YR 3/2	2	C	PL	Loamy/Clayey	Faint redox concentrations
2-6	5Y 3/1	80	10YR 4/2	20	C	PL/M	Loamy/Clayey	Distinct redox concentrations
6-14	10Y 4/1	100					Mucky Loam/Clay

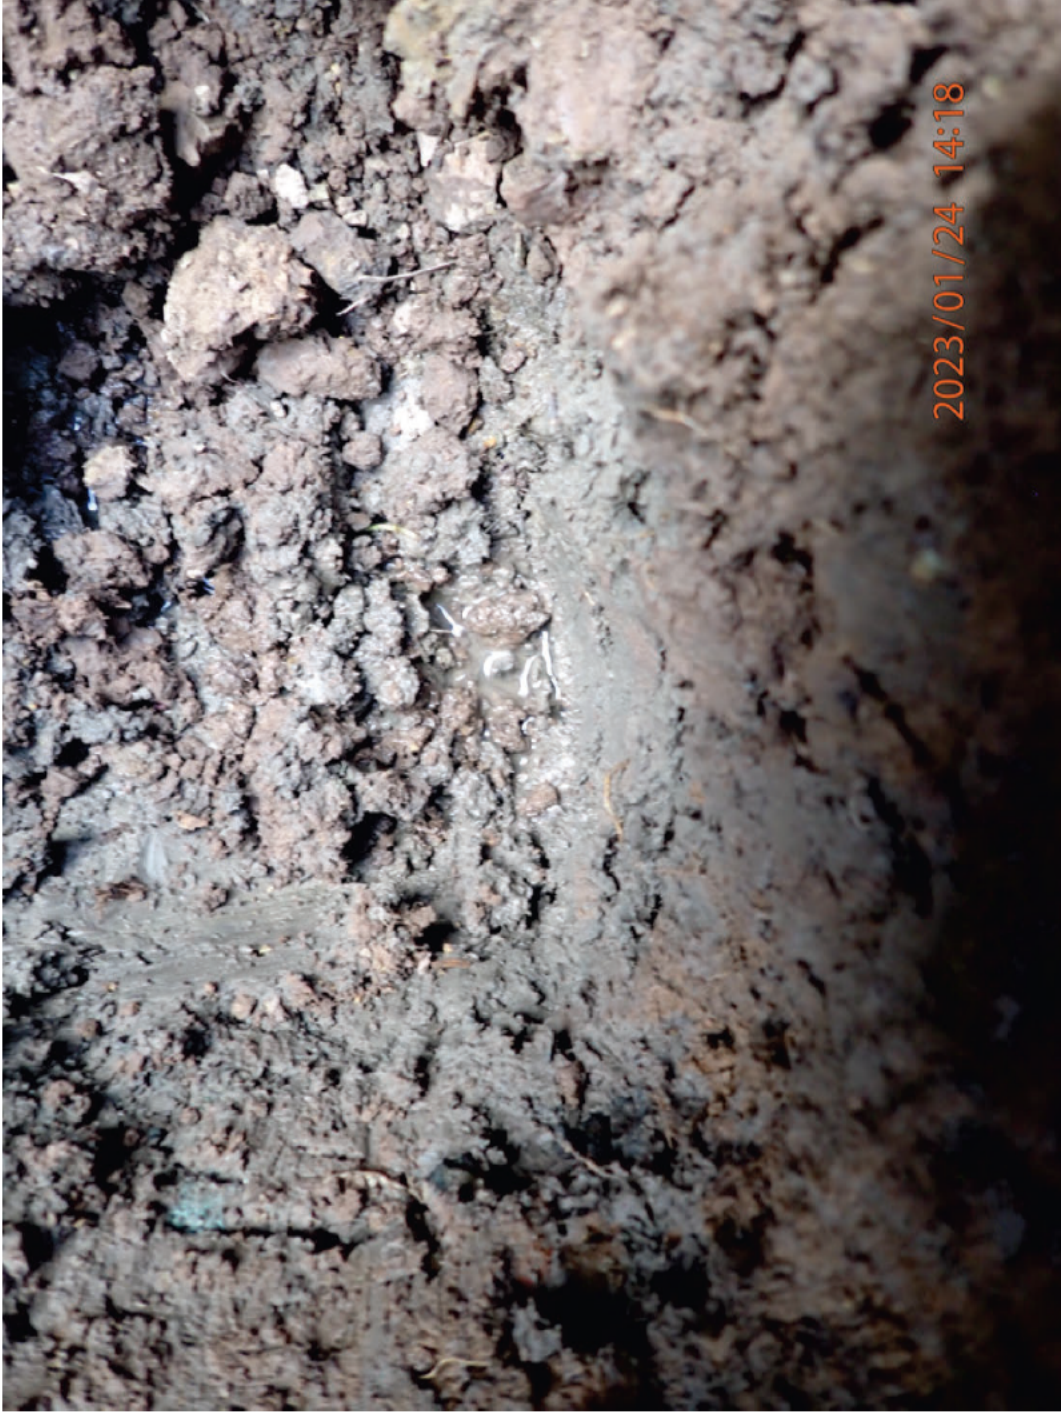
Photo ID: P1240370

Description: Saturation observed at the bottom of Soil Pit 2.

Field Observations: Surface Water Present? Yes <input type="checkbox"/> No <input type="checkbox"/> Depth (inches): _____ Water Table Present? Yes <input checked="" type="checkbox"/> No <input type="checkbox"/> Depth (inches): <u>15</u> Saturation Present? Yes <input type="checkbox"/> No <input type="checkbox"/> Depth (inches): _____ (includes capillary fringe)	Wetland Hydrology Present? Yes <input checked="" type="checkbox"/> No <input type="checkbox"/>
---	---
