| UNITED STATES ENVIRONMENTAL PROTECTION AGENCY, REGION 8 | | | |
| DRINKING WATER ENFORCEMENT INSPECTION (8ECA-W-S) | | | |
| <b>Public Water System (PWS)</b><br><b>Name:</b> Bridger Teton National Forest Hoback Campground | | <b>Location:</b><br>Jackson, Wyoming | <b>System Type:</b><br><input type="checkbox"/> Community<br><input checked="" type="checkbox"/> Transient Non-Community<br><input type="checkbox"/> Non-Transient Non-Community |

**Inspection Report Addendum  
Drinking Water Enforcement Photographic Log**

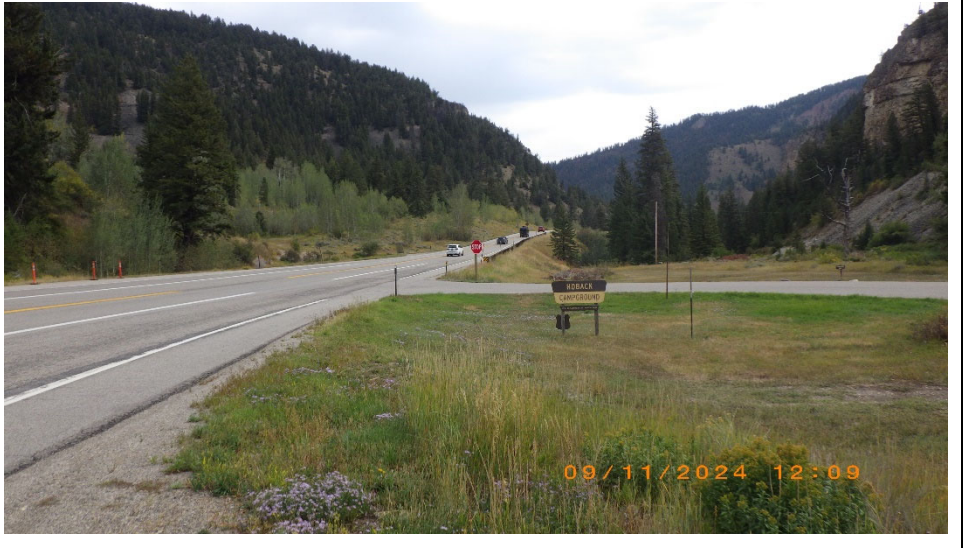
| <b>U.S. Environmental Protection Agency<br/>Region 8</b> | | | |
|---|---|---|---|
| <b>Photo No.</b><br>1 of 17 | <b>Time:</b><br>12:09 | | |

| <b>U.S. Environmental Protection Agency<br/>Region 8</b> | | | |
|---|---|---|---|
| <b>Photo Description:</b><br>Entrance to the campground (Rd 30492) viewed from the shoulder of eastbound Hwy 189. | | | |

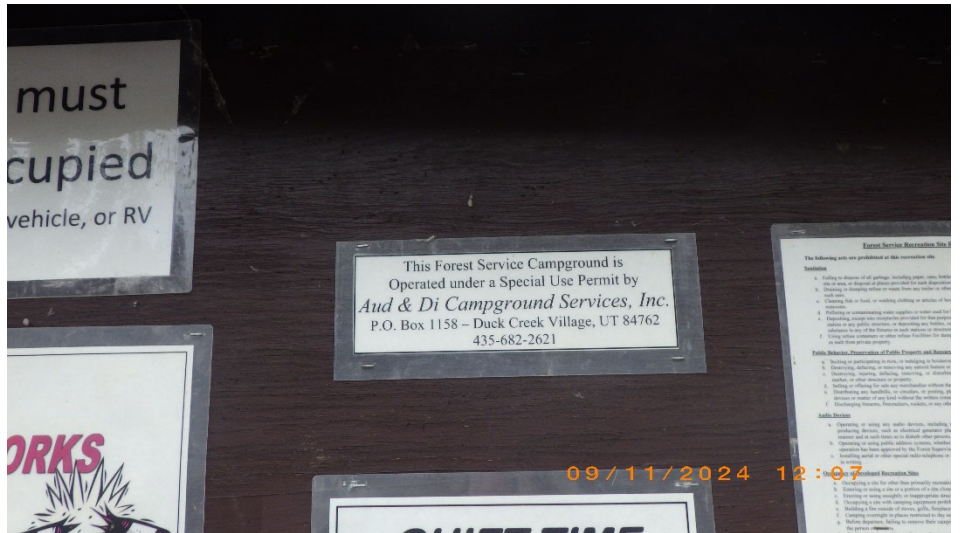
**Monthly coliform monitoring.** Interviews with the Forest Service representative indicates that the campground operator, AuDi Campground Services (see photo 2), collects the monthly coliform samples required for the public water system. The Forest Service and operator has more than six campground water systems that they sample. Missed samples are currently rare and the Forest Service is addressing these with the operator on a programmatic level.

| U.S. Environmental Protection Agency<br>Region 8 | | | |
|---|---|---|---|
| Photo Description:<br>Sign near campground entrance displaying contact info for the campground's concessionaire, "Aud & Di Campground Services, Inc.". Forest Service representative Philip Wong indicated that they are also involved in operation of the water system. | | | |

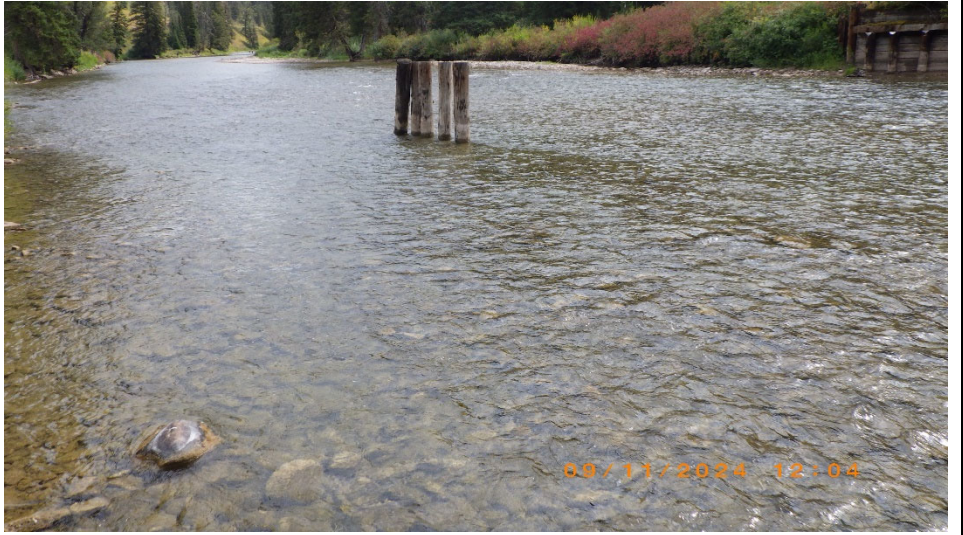
**Accessibility of Water Supply Well:** The campground's water supply well was previously accessible by a bridge over the Hoback River located at the entrance to the campground. Originally, there were campsites on both sides of the river. The bridge was reportedly destroyed in the 1980s by an ice jam. An historic aerial photo from 1983 shows the bridge, while another photo from 1989 does not show it (<http://maps.tetonconservation.org/>). The campground and its water supply have been operating without a bridge for at least 35 years. Photo 3 shows the pilings and south bulkhead for the former bridge.

| Photo Description:<br>Hoback River looking upstream from north bank at campground. Wooden piles from old bridge in center. River was wadable at time of inspection with several fly fishers in the water. | | | |

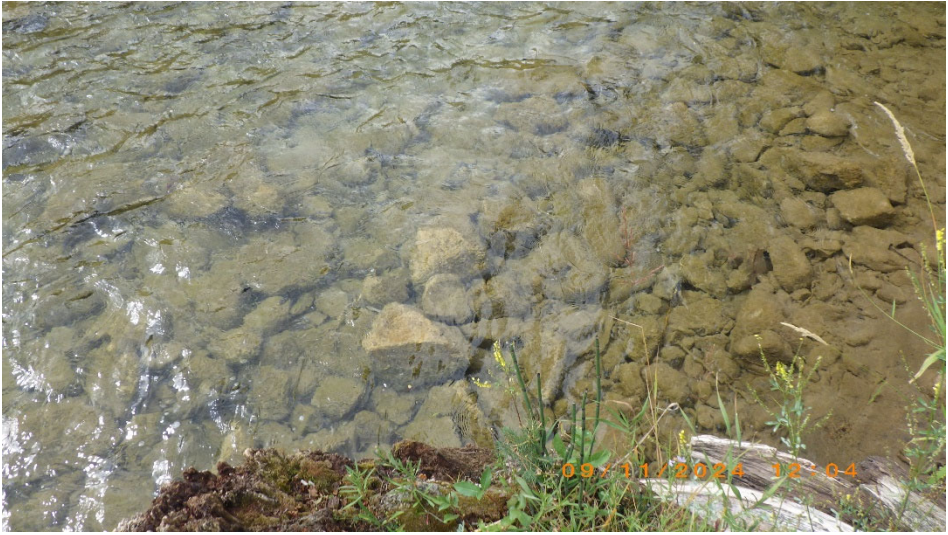
At the time of the inspection, the segment of the Hoback River separating the campground from the water supply well was approximately 120 feet wide. Inspectors did not attempt to wade the river, however it appeared to be no more than knee deep and with a cobble bottom (see photo 4). Several fly fishers were wading in the river at the time of the inspection. The Forest Service representative, Phil Wong, indicated that they can ford this section of the river during low water using all-terrain vehicles (ATVs).

| Photo Description:<br>Cobbles in bottom of Hoback River. This type of bed dominated the stretch of the Hoback River beside the campground. River was wadable at the time of inspection. | | | |

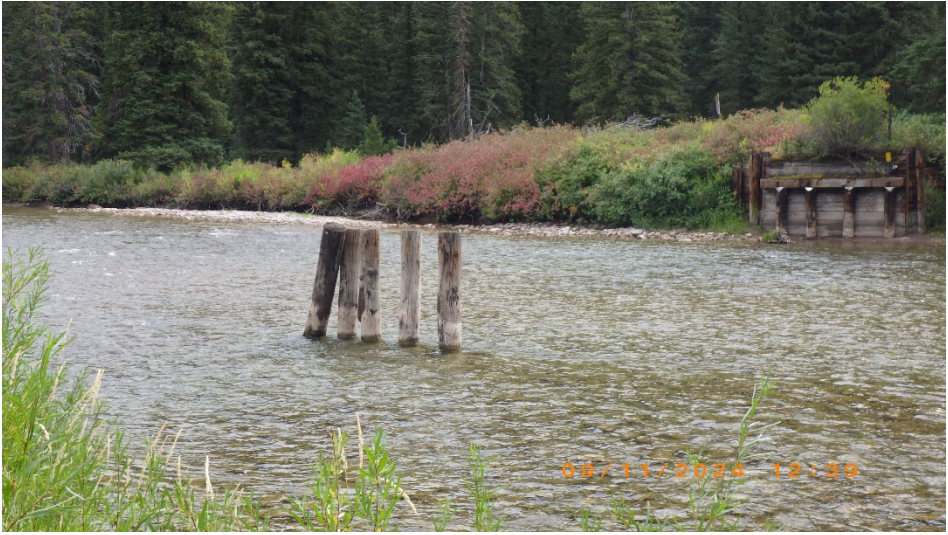
| Photo Description:<br>Hoback river viewed from north bank at campground. Wooden piles midstream and bulkhead on south bank are from old bridge. Structures display indications of ordinary high water for the river. | | | |

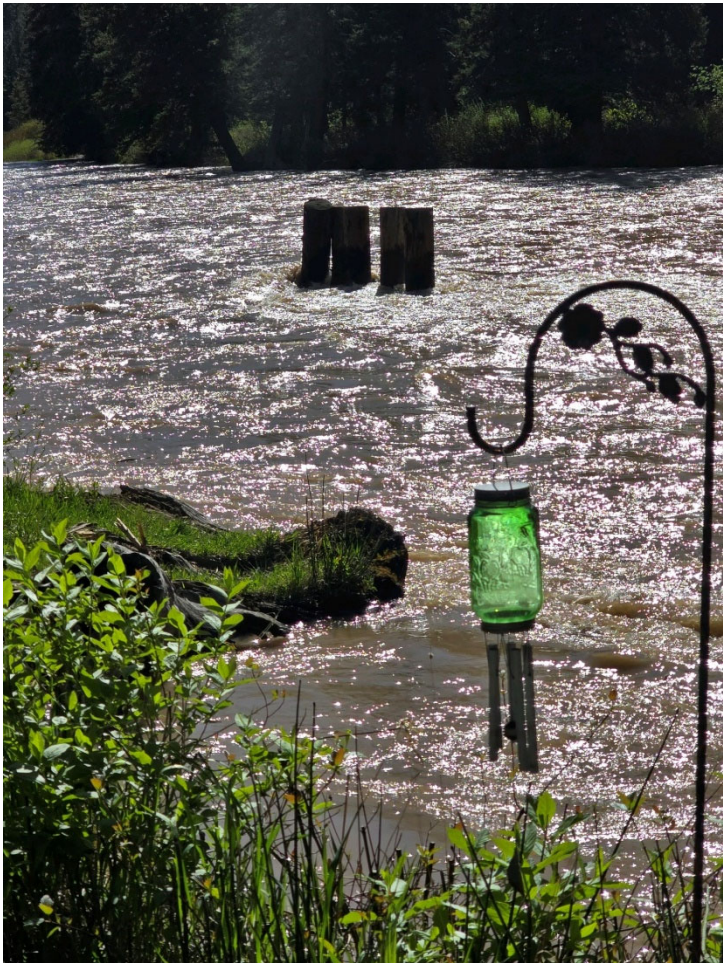
| U.S. Environmental Protection Agency<br>Region 8 | | | |
|---|---|---|---|
| Photo Description:<br>Undated photograph of Hoback River reportedly near seasonal high water during Spring runoff. Note river stage relative to the former bridge piling near the ordinary high water mark. Photo provided to EPA inspectors by campground host during the inspection. | | | |

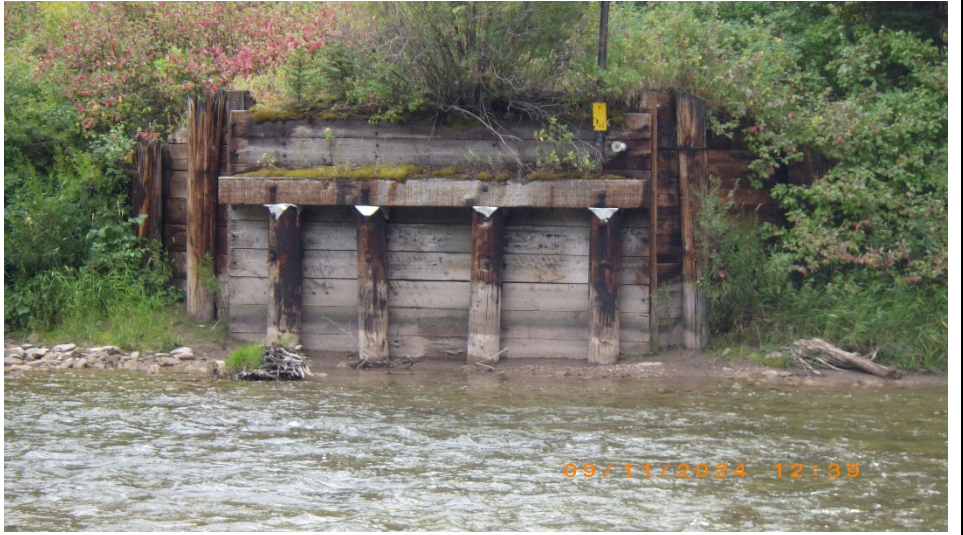
| Photo No.<br>7 of 17 | Time:<br>12:39 | | |

| Photo Description:<br>Old bridge bulkhead along south bank of Hoback River at the campground. Ordinary high water mark indicators on pilings. | | | |

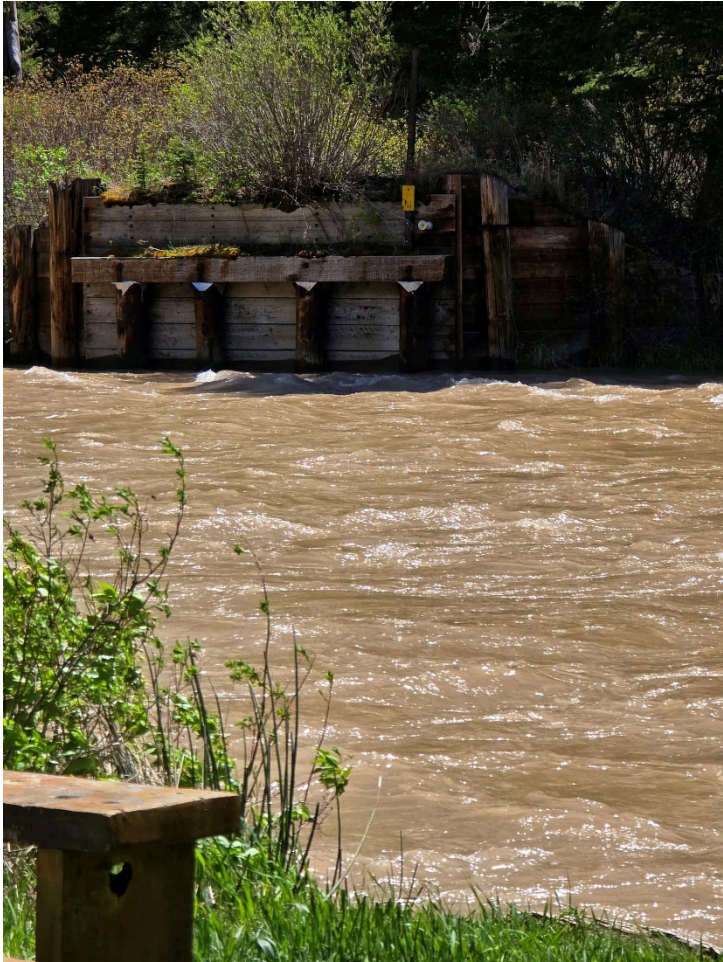
| U.S. Environmental Protection Agency<br>Region 8 | | | |
|---|---|---|---|
| Photo Description:<br>Undated photograph of Hoback River reportedly near seasonal high water during Spring runoff. Note river stage relative to the former bridge bulkhead at the ordinary high water mark. Photo provided to EPA inspectors by campground host during the inspection. | | | |

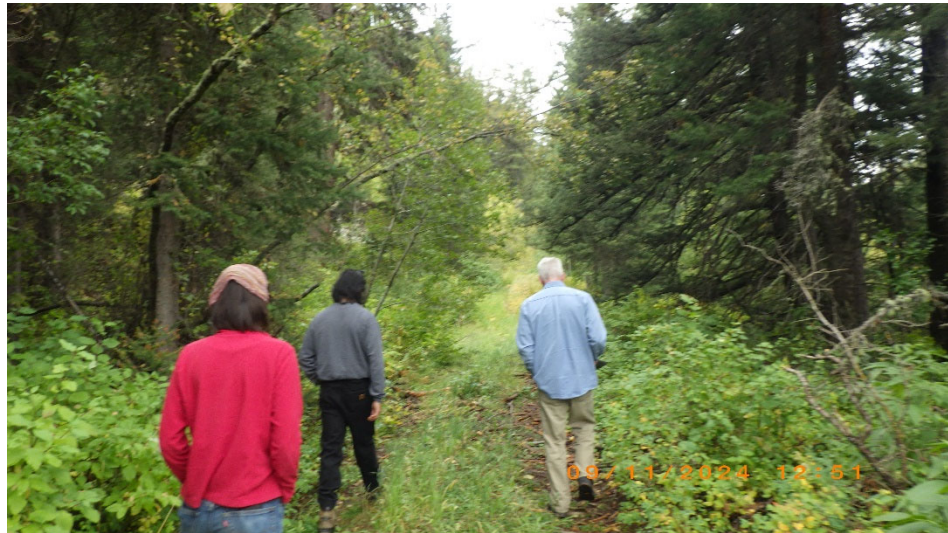
| U.S. Environmental Protection Agency<br>Region 8 | | | |
|---|---|---|---|
| Photo Description:<br>Former road on south side of the Hoback River used by EPA inspectors and Forest Service representative to access the campground's water supply well on foot. | | | |

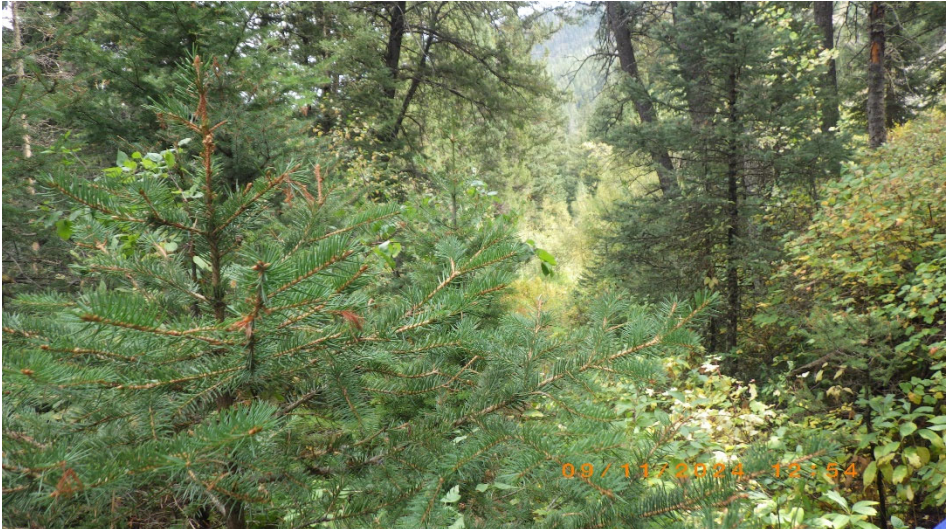
| Photo No.<br>10 of 17 | Time:<br>12:54 | | |

| Photo Description:<br>Vegetation regrowing on the former road used to access the campground water supply well. | | | |

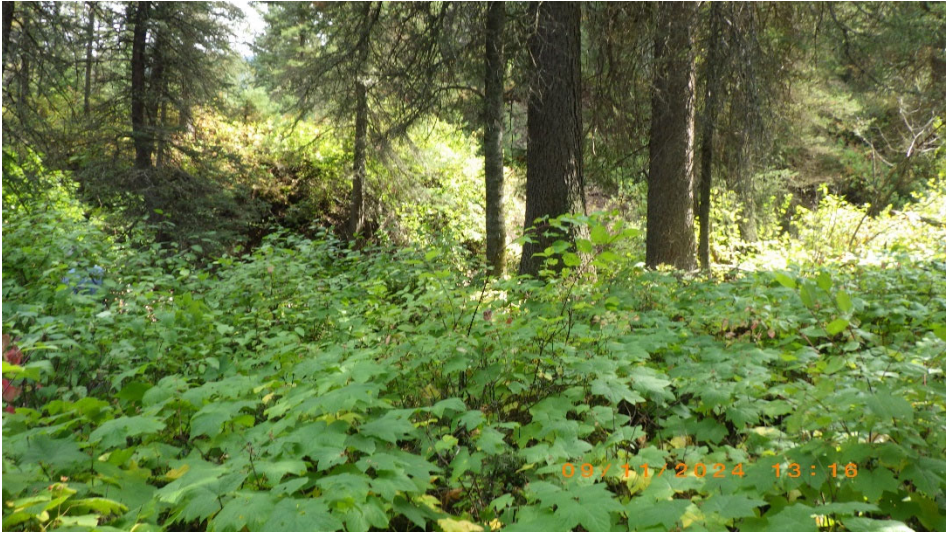
| Photo No.<br>11 of 17 | Time:<br>13:16 | | |

| Photo Description:<br>Forest understory regrowing in the former road. | | | |

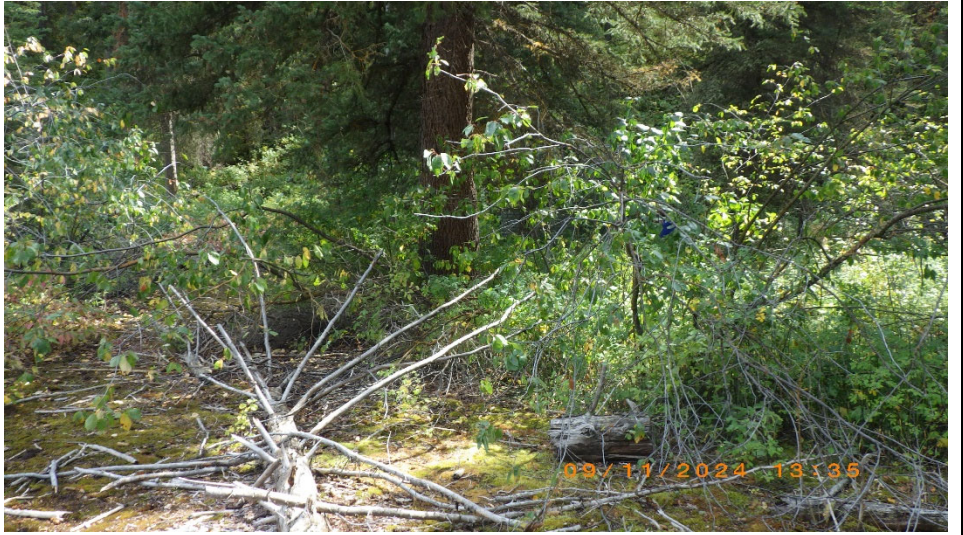
| Photo Description:<br>Regrowth in the old campsites on the south bank of the Hoback River. This area is adjacent to the campground's water supply well. Note moss-covered pavement from former campsite roads in foreground on left. | | | |

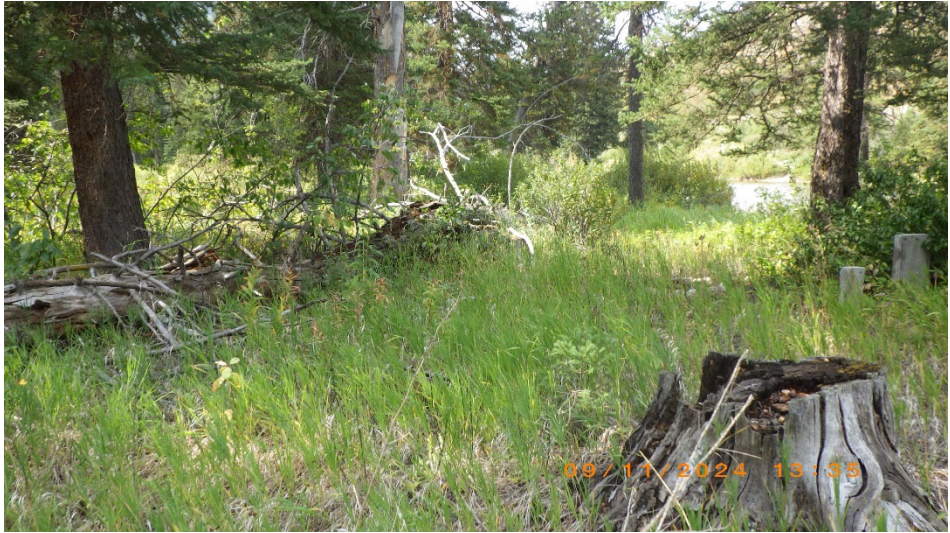
| Photo Description:<br>Regrowth in the old campsites on the south bank of the Hoback River. Old concrete supports for picnic tables visible on right edge of photo. Hoback River in background on right. | | | |

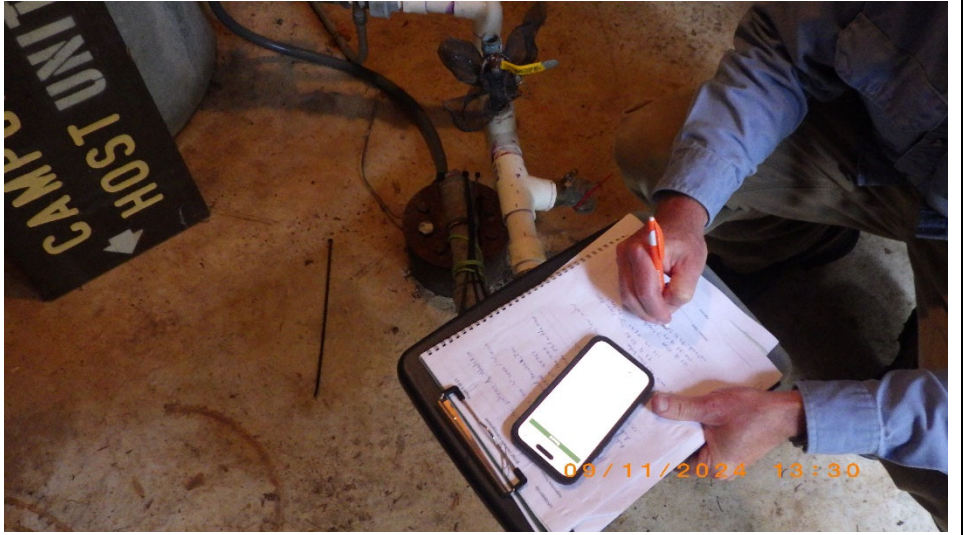
| U.S. Environmental Protection Agency<br>Region 8 | | | |
|---|---|---|---|
| Photo No.<br>15 of 17 | Time:<br>13:30 | | |

| U.S. Environmental Protection Agency<br>Region 8 | | | |
|---|---|---|---|
| Photo Description:<br>Campground water supply well and EPA inspector recording latitude/longitude as measured by GPS receiver on his phone. | | | |

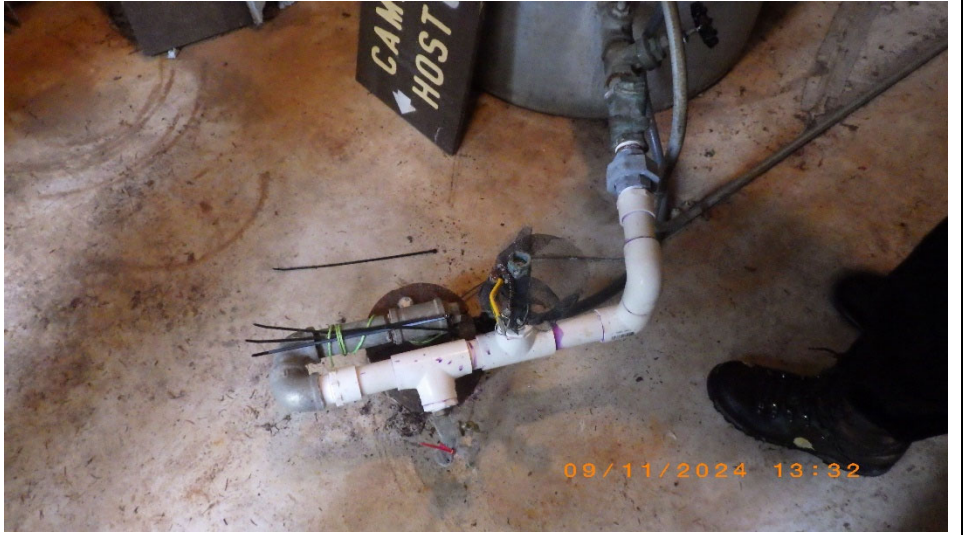
| Photo No.<br>16 of 17 | Time:<br>13:32 | | |

| Photo Description:<br>Wellhead for the Hoback Campground water supply well. | | | |

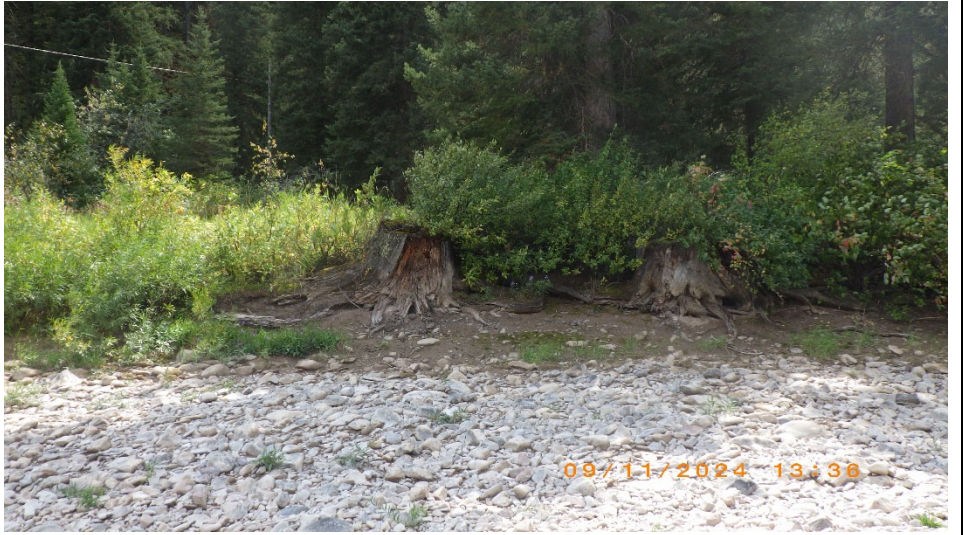
| Photo No.<br>17 of 17 | Time:<br>13:36 | | |

| Photo Description:<br>Gravel bar on south bank of the Hoback River.<br>Power line visible in top left of photo serves the campground's water supply well. | | | |
