## Region 6 Compliance Assurance and Enforcement Division INSPECTION REPORT

| Inspection Date(s): | 09/22/2015 | | |
| Regulatory Program(s) | CAFO | | |
| Facility Name: | Delta Downs Racetrack, Casino and Hotel | | |

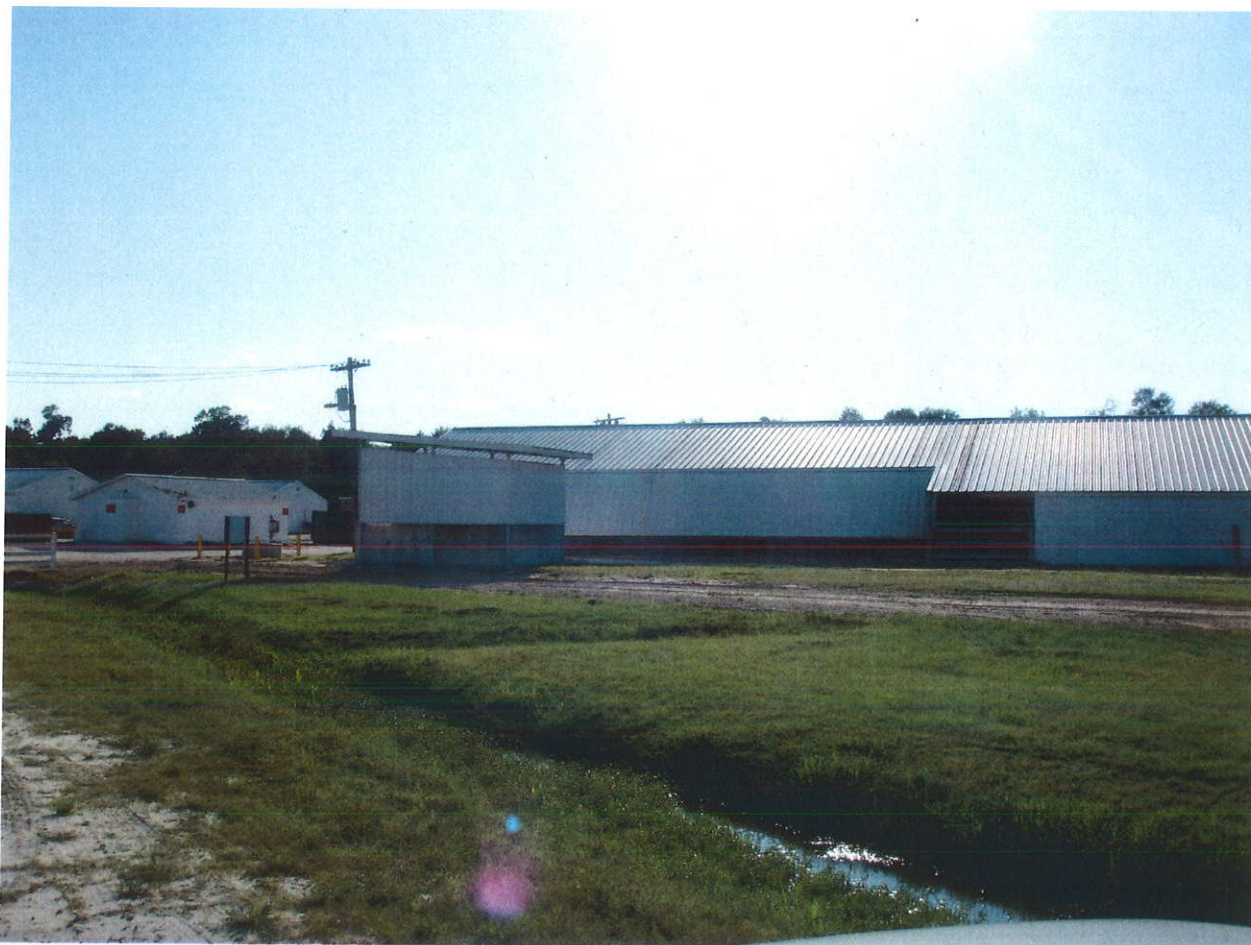
Photo No. 1

Description: Looking southwest at one of the improved manure bins located next to Barn 18. Note the tall roof that allows a tractor to clean-out the bin.

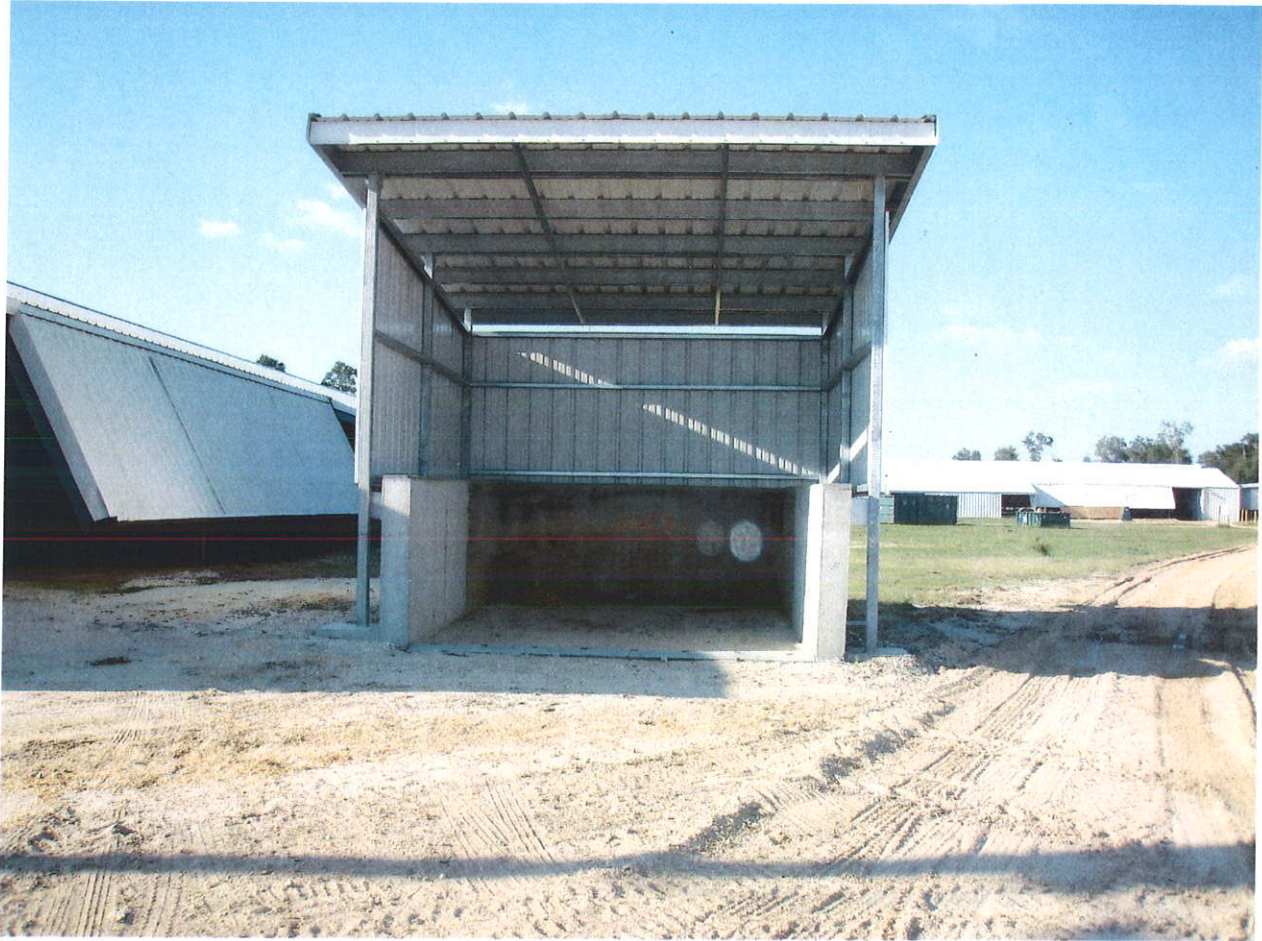
Photo No. 2

Description: Looking north, into the manure bin located next to Barn 18. Note the tall roof that allows a tractor to clean-out the bin, and the metal curbing at the bin entrance to prevent track-out.

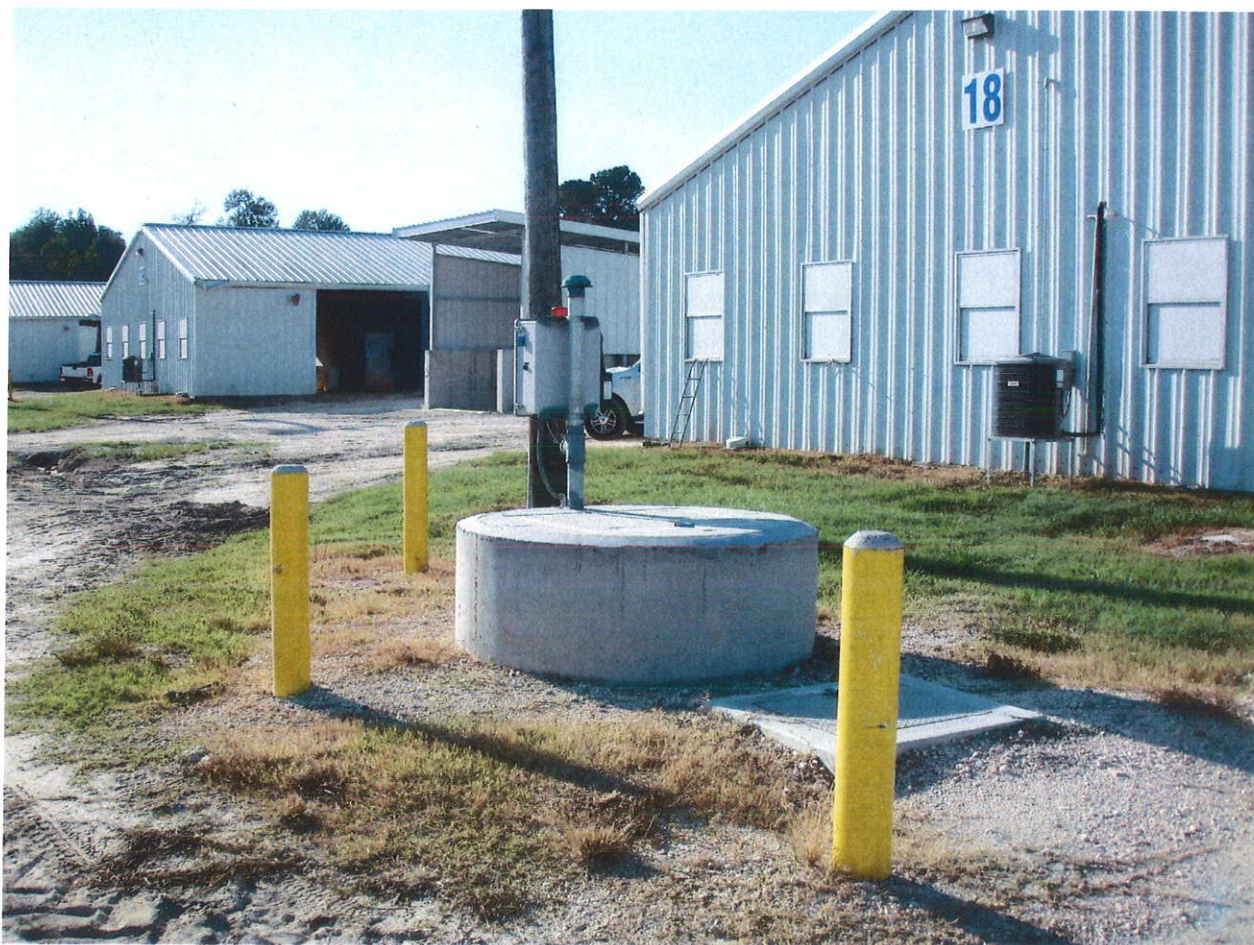
Photo No. 3

Description: Looking northwest at one of the seven lift stations. This one is located next to Barn 18. Each lift station is equipped with dual grinder pumps (for redundancy) and a red light alarm integrated with the lift station's float system.

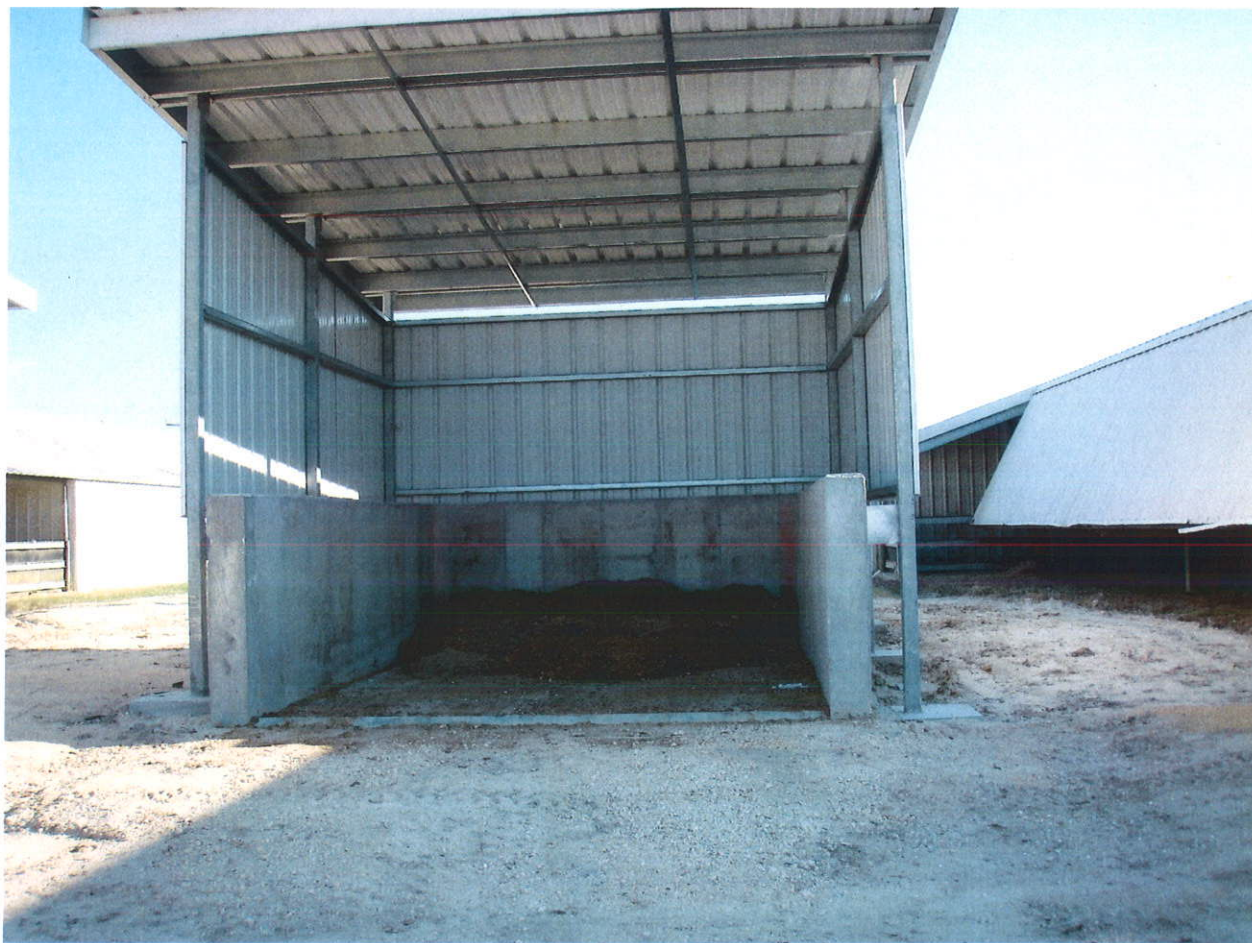
Photo No. 4

Description: Looking south at the manure bin located between Barns 13 and 14. The area in front of the manure bin has been kept clean and free of manure track-out. All of the manure bins were in this condition.

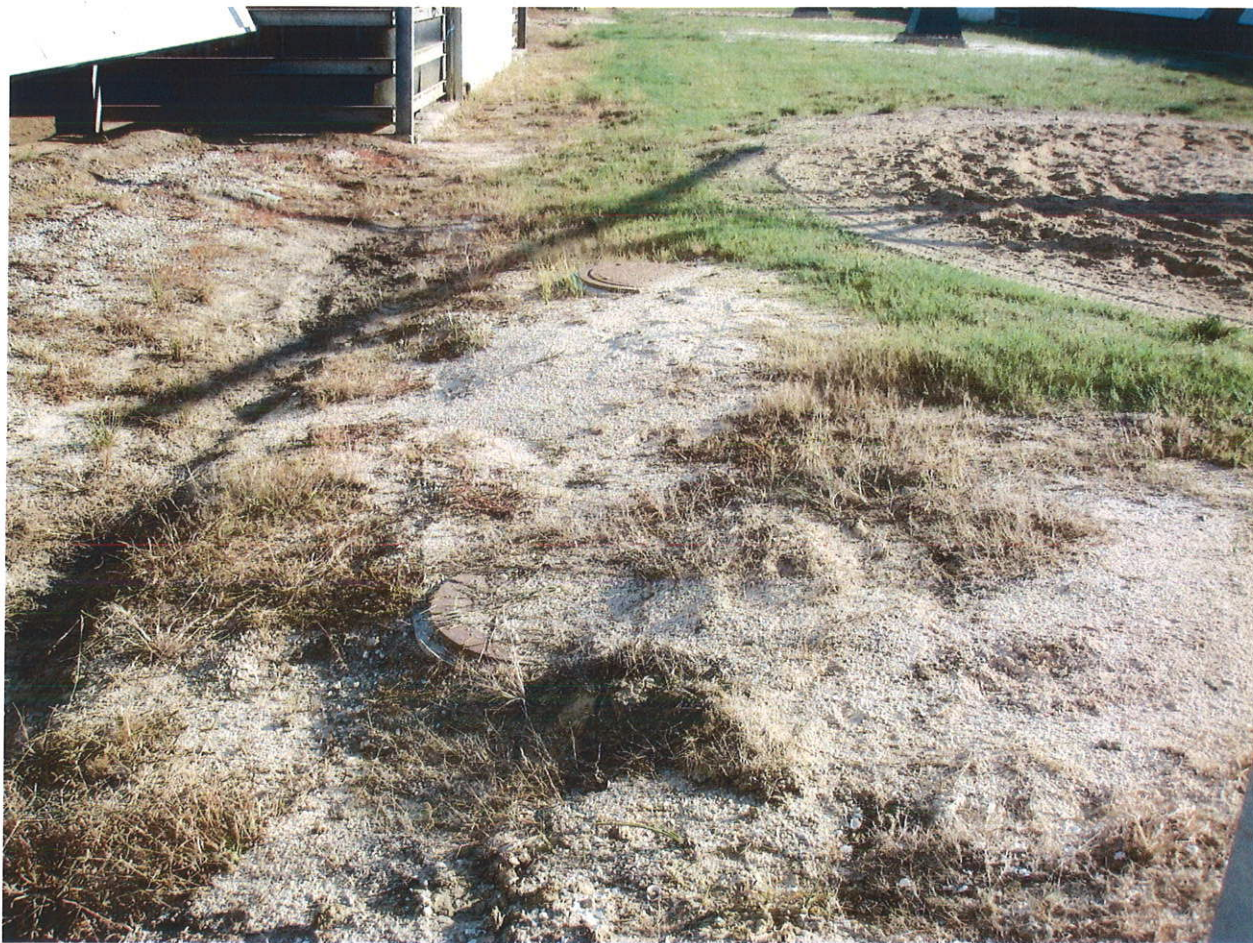
Photo No. 5

Description: Looking toward the south at the settling tank lids that are now located downstream of the covered horse wash racks (the corner of one is seen on the upper left with some black siding material around the fence).

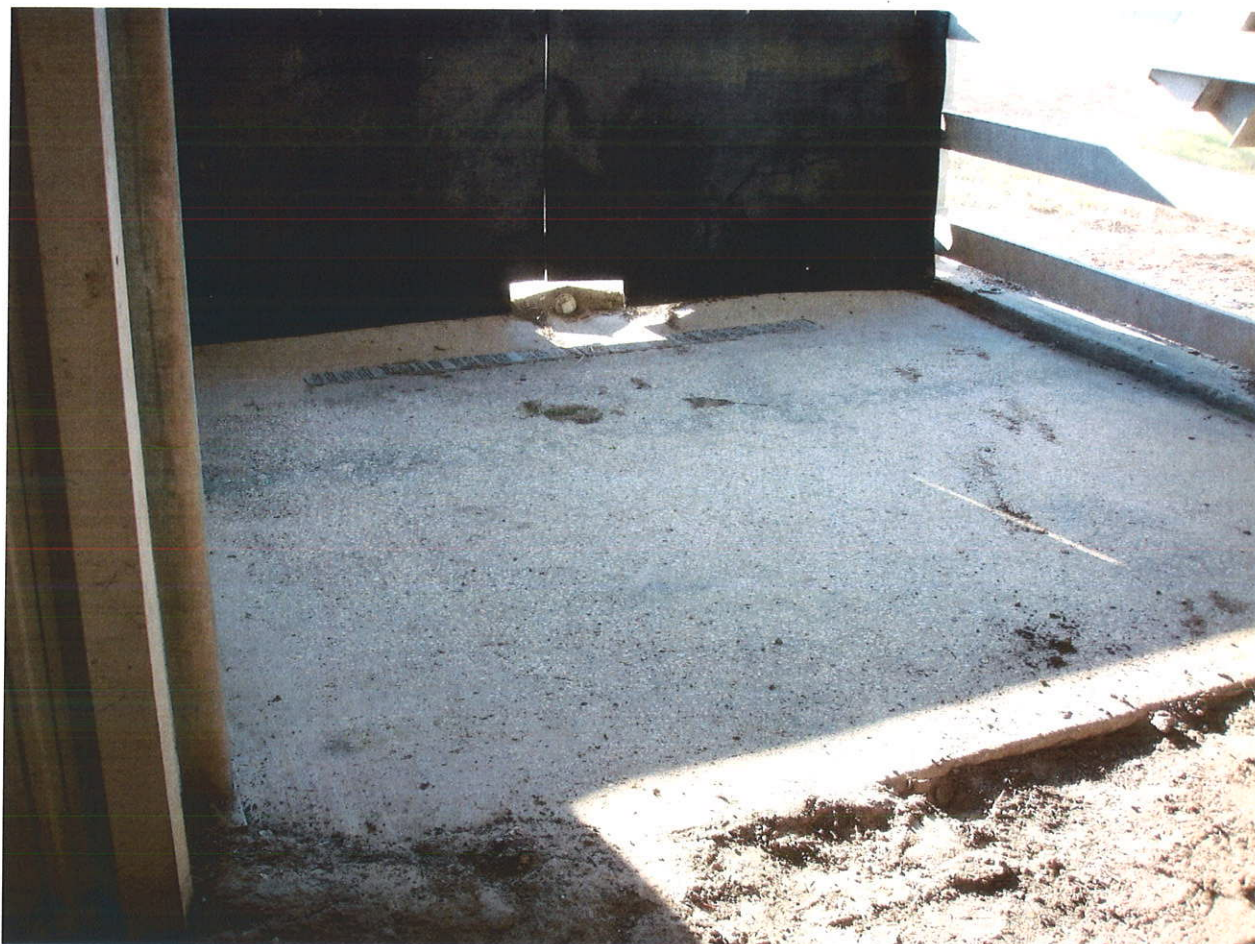
Photo No. 6

Description: Looking at one of the covered horse wash racks plumbed to the collection system. Note the new drain at the back of the wash rack, and the white cap at the former discharge route in the curbing.

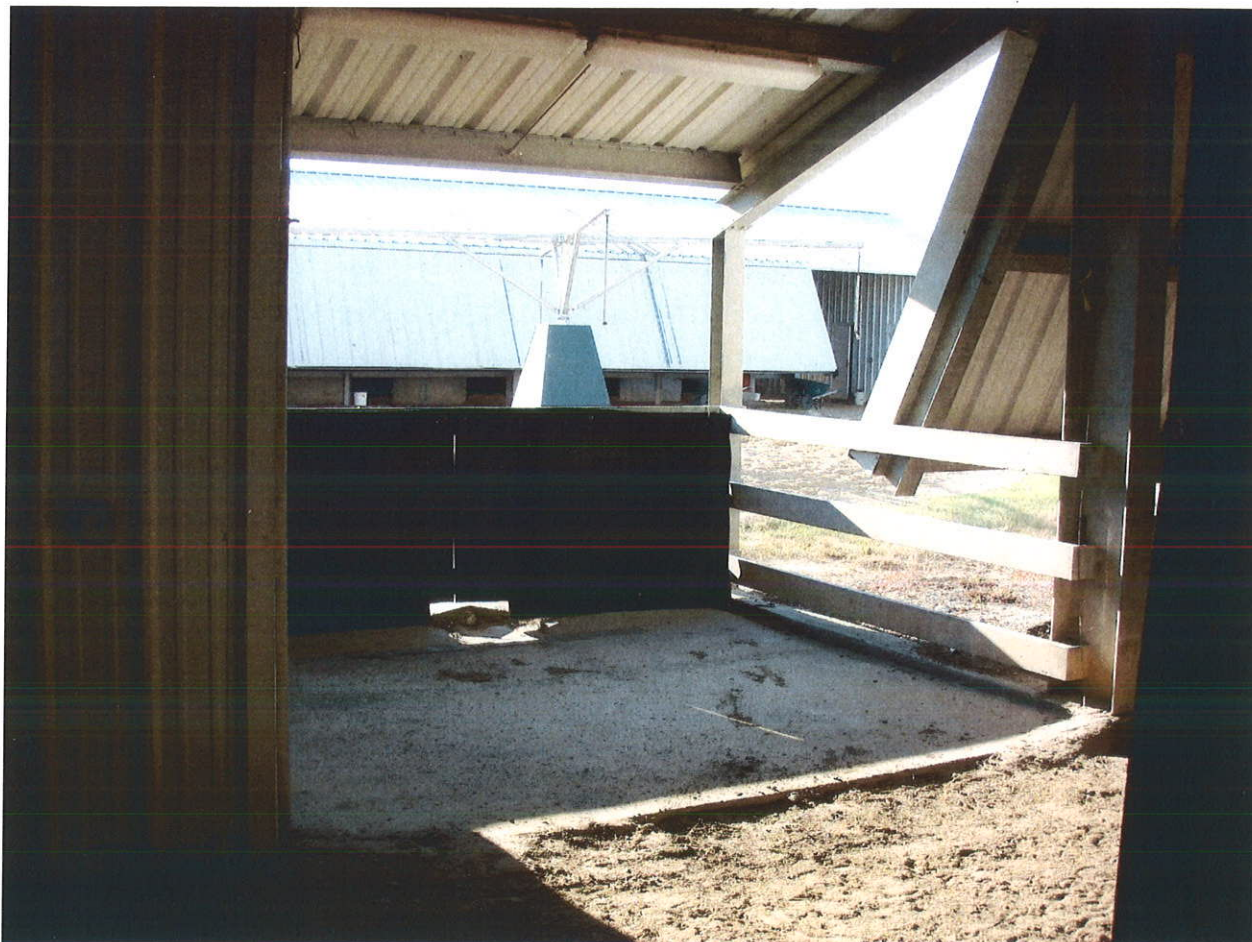
Photo No. 7

Description: A broader view of the same covered horse wash rack plumbed to the collection system.

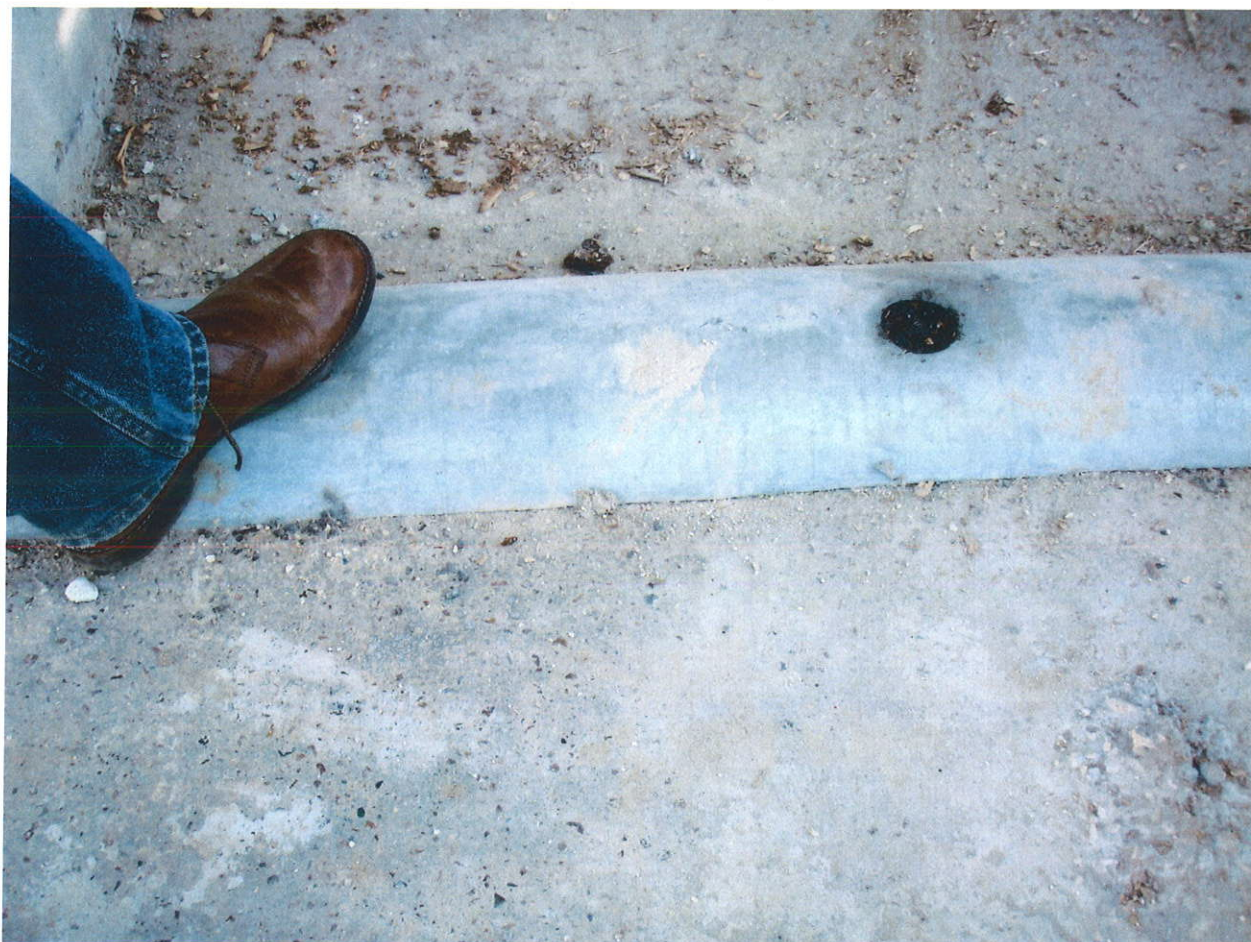
Photo No. 8

Description: A view of the metal curbing located at the entrance into each manure bin to prevent track-out.

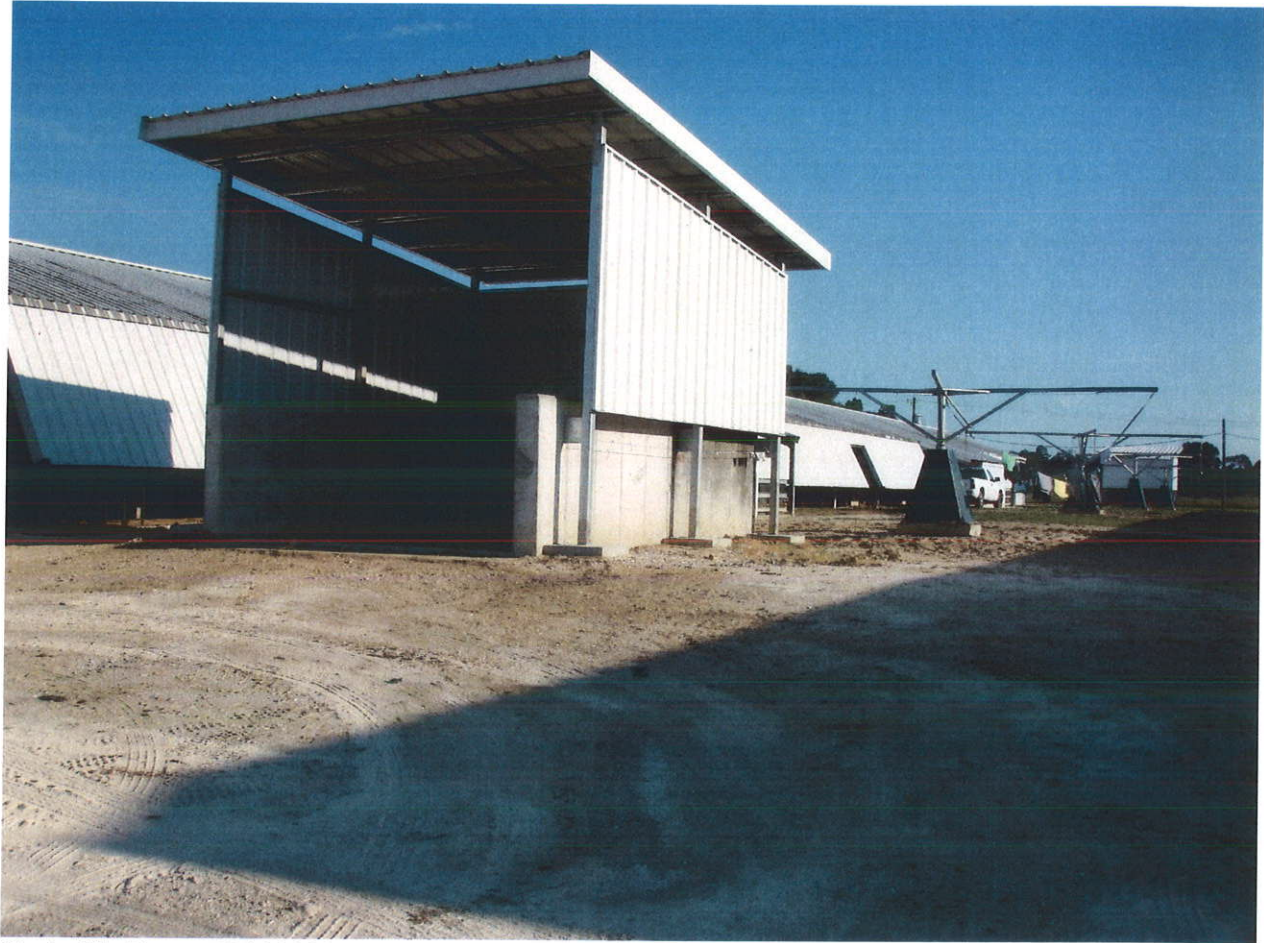
Photo No. 9

Description: Another manure bin located between Barns 11 and 12. Again, the area has been kept clean.

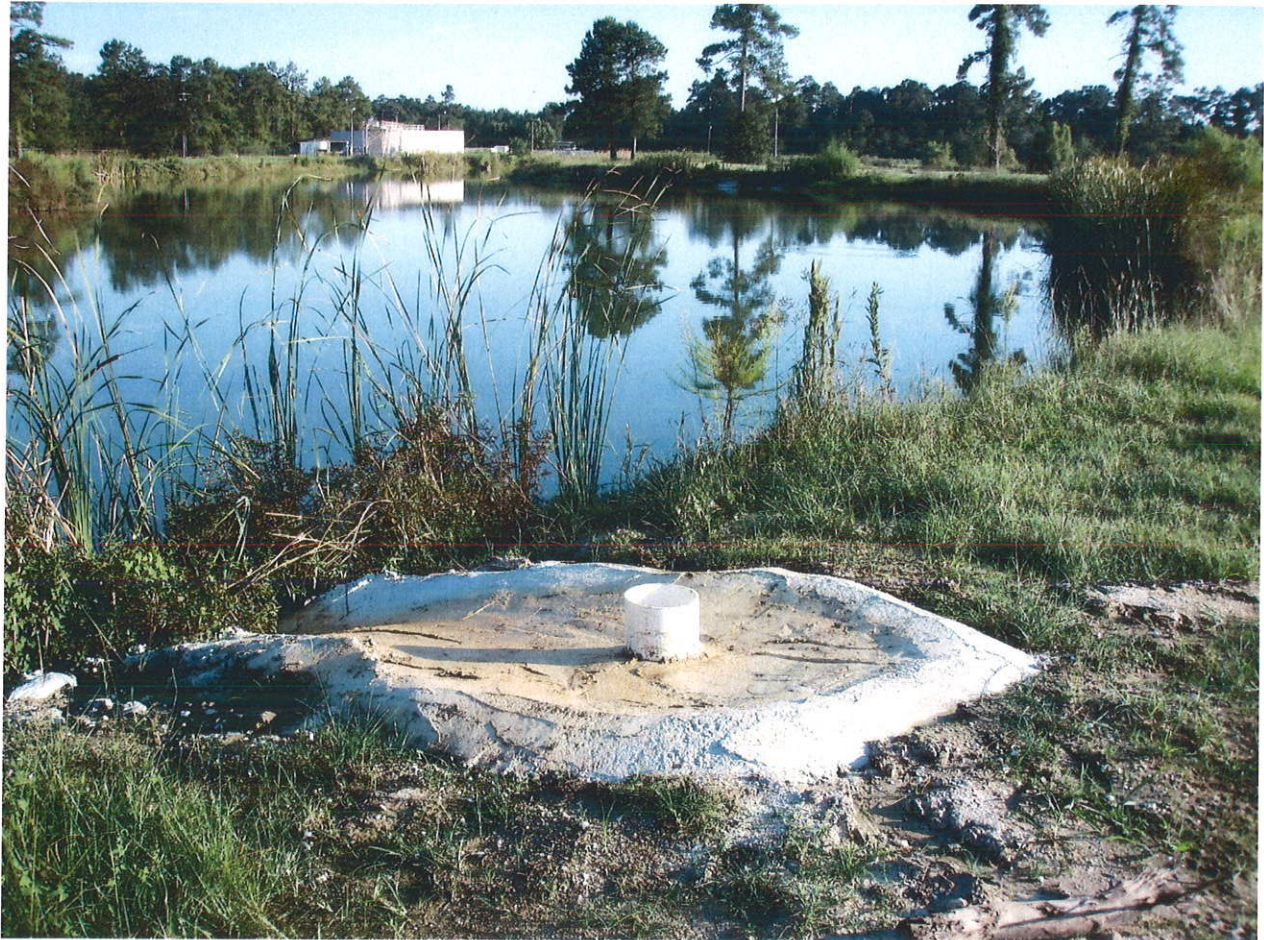
Photo No. 10

We observed some tall vegetation and shrubs on the embankment of the East Lagoon. This lagoon should be kept mowed to prevent embankment perforation by plant roots such as the brush seen in photos 10 and 13. As the plants grow and become trees, the roots compromise the embankments integrity. Additionally, the West Lagoon only had about 3" of freeboard. Although the facility is diverting influent flows from Barns 12-22 to the East Lagoon, operational management of lagoon levels must be balanced between both lagoons. Wash rack flows from Barns 1-11 go directly into the West Lagoon, while influent flows from Barns 12-22 can be diverted into either lagoon. Aside from improvements in operational management of the two lagoons, other lagoon management options mentioned by Mr. Willhite included the current use of the water truck to take water out of the West Lagoon and use it for dust control, and possible improvement of the West Lagoon embankment elevation.

Delta Downs has not adequately maintained the East Lagoon embankment to remove brush. Lagoon embankment maintenance is a standard maintenance condition for all CAFOs.

Description: Looking south at the East Lagoon, and the influent line (and concrete pad) from the lift stations.

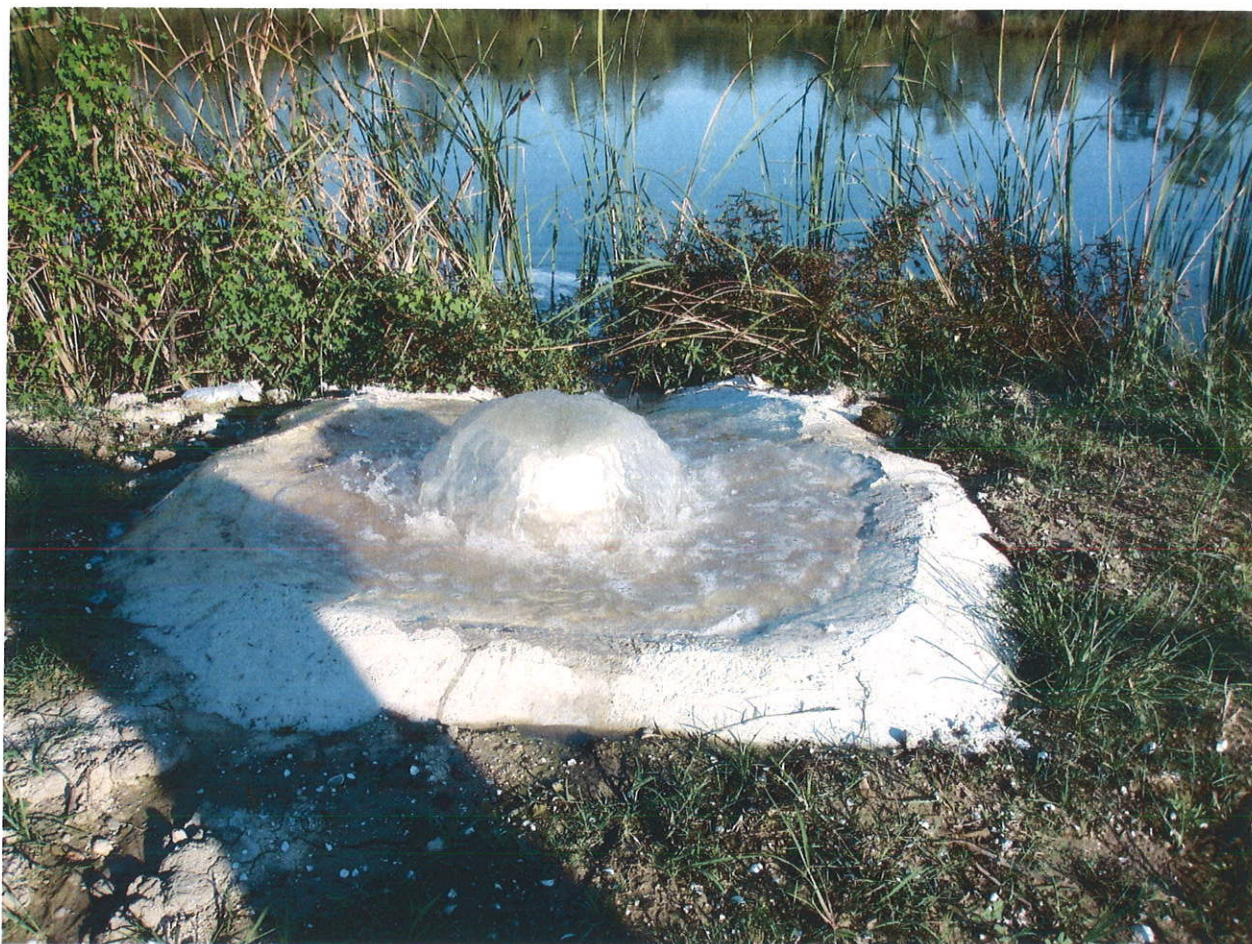
Photo No. 11

Description: During the inspection, the one of the lift stations began operating, and discharging into the East Lagoon.

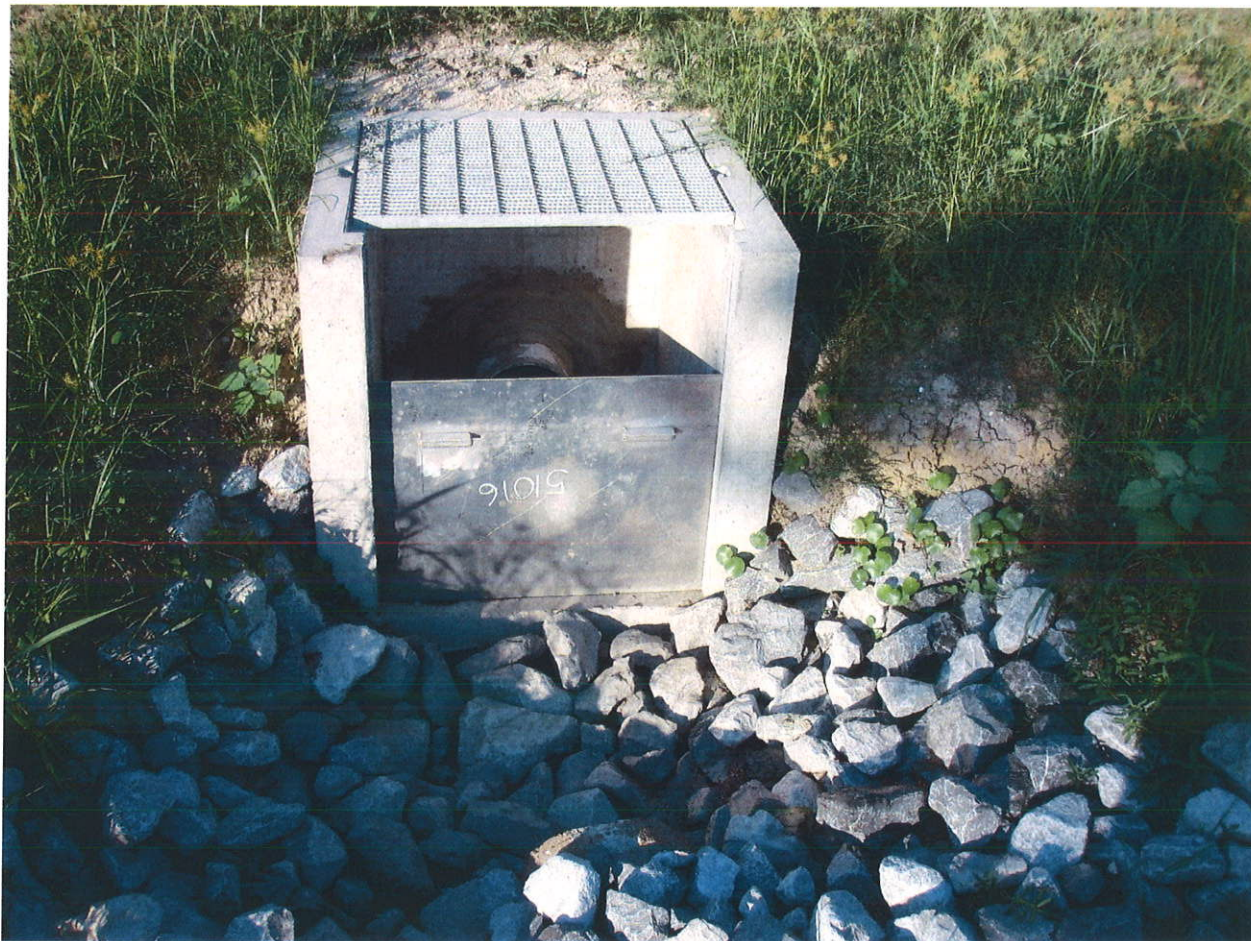
Photo No. 12

Description: The East Lagoon overflow gate. The lagoon had greater than 2' of freeboard at the time of the inspection.

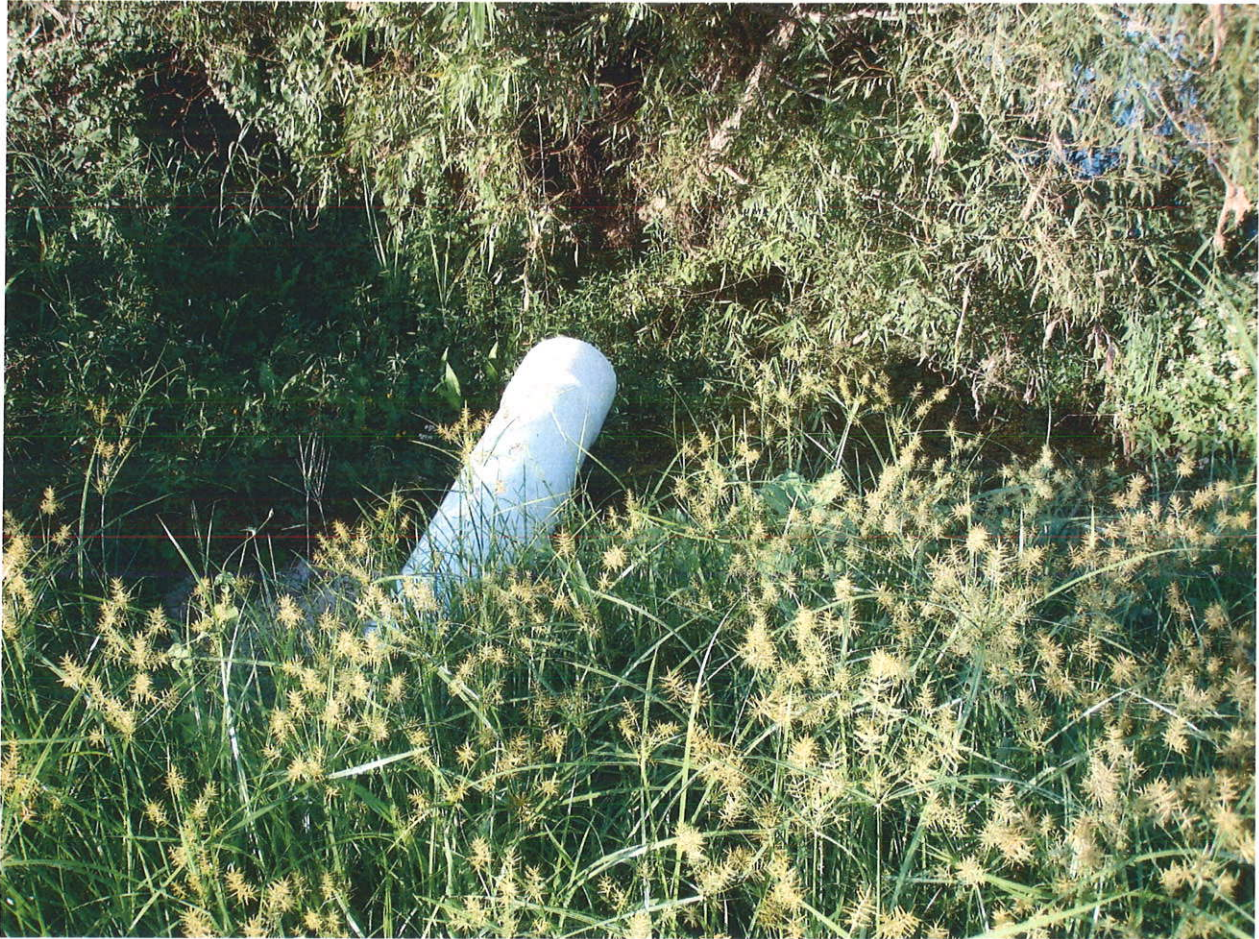
Photo No. 13

Description: The discharge line from the East Lagoon, leading to the gate shown in photo 12. The lagoon level is seen at the top right, thru the brush. This brush should be kept mowed to minimize root intrusion and perforation of the unit's embankments.

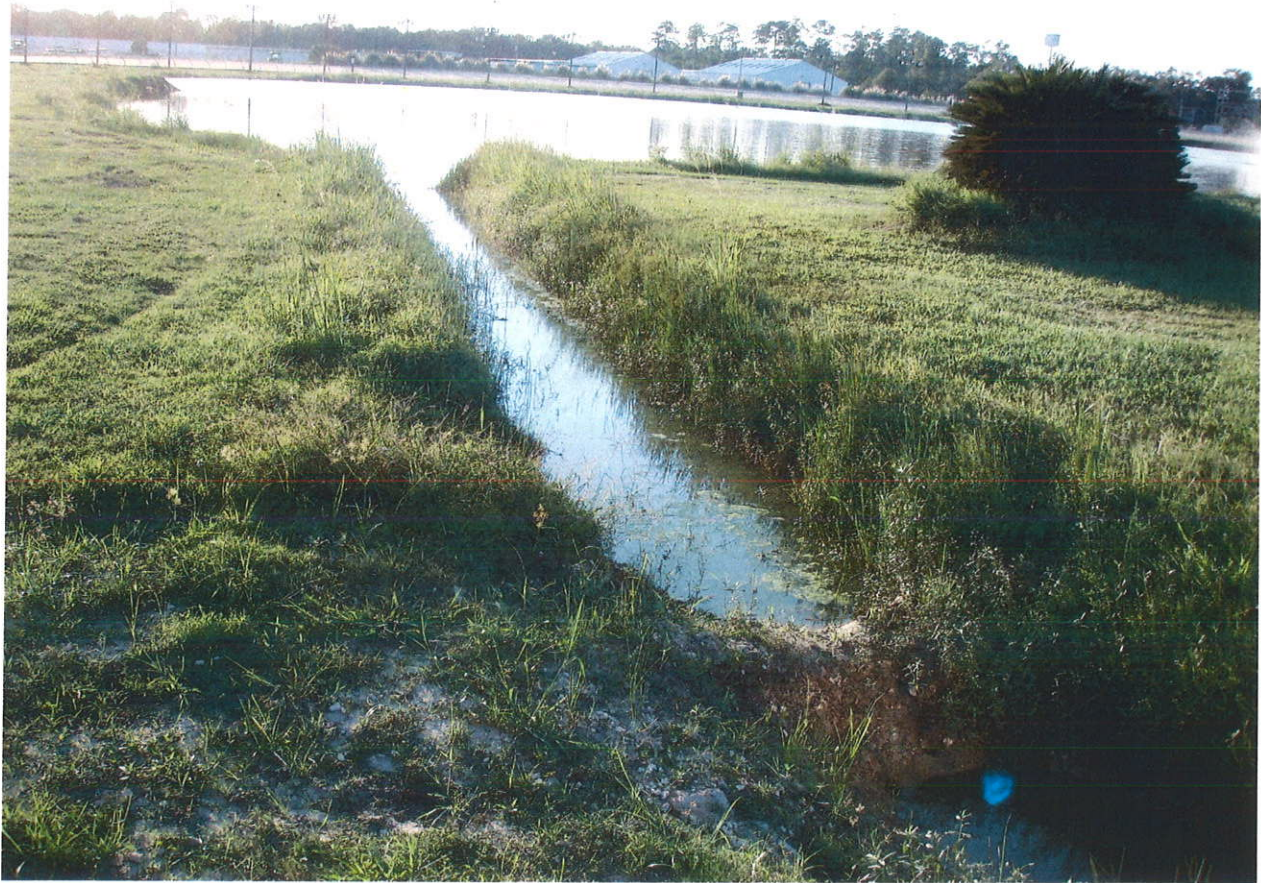
Photo No. 14

The West Lagoon has not provided for a minimum of 1' of freeboard, and preferably 2' of freeboard. At the time of the inspection, the West Lagoon had about 3" of freeboard. **Section IV – FOLLOW UP**

Description: Looking east-northeast at the West Lagoon. The unit has about 3" of freeboard, however, the facility has a collection system diversion gate that is directing wash rack water from Barns 12-22 to the East Lagoon which has sufficient freeboard capacity. Barns 1-11 go directly to the West Lagoon. The facility uses a water truck to dewater the West Lagoon. The unit must provide for a minimum of 1' of freeboard, and preferably 2' of freeboard.
