## INSPECTION REPORT

| Type of Inspection | Compliance Evaluation Inspection (CEI) | | |
| Facility or Site Name | Bradken Atlas | | |
| Type of Operation | Steel Foundry | | |

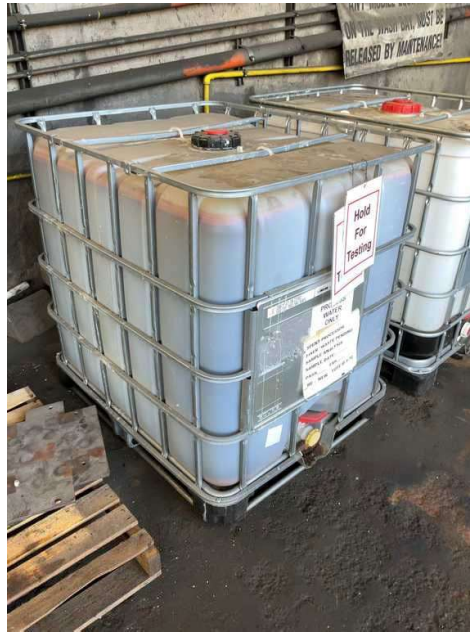
| [Title] | | | IMG-2023081709474547453224107.jpg |

While in the Wash Bay we saw a tote that held approximately 300 gallons of process water for testing. At the time of the inspection, the tote was labeled “Spent Processor Fixer - Waste Pending Analysis.” According to Ms. Wagner, the spent fixer wastewater does not designate as hazardous waste/dangerous waste but will occasionally not meet the City of Tacoma discharge limits. According to Ms. Wagner, the spent processor fixer wastewater was sampled by the City of Tacoma on 7/5/23.

| Tote labeled "Pending Analysis." | | | |

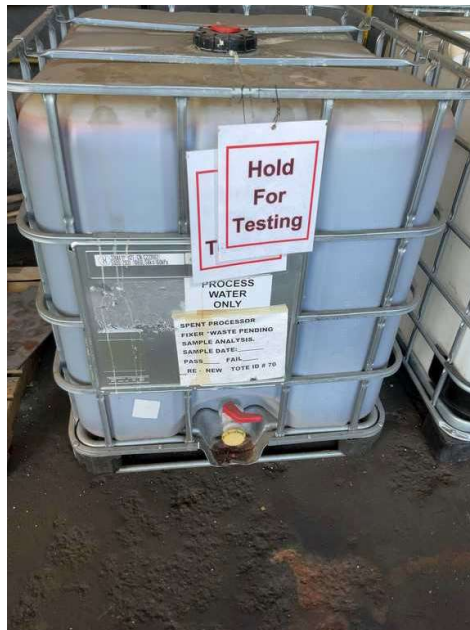
| [Title] | | | IMG-2023081709475247523074728.jpg |

| Close-up view of the same tote. | | | |

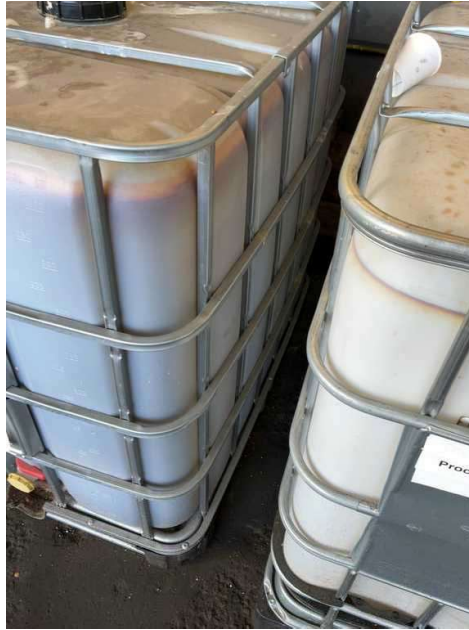
| [Title] | | | IMG-202308170948004802439689.jpg |

| Another view of the same tote. | | | |

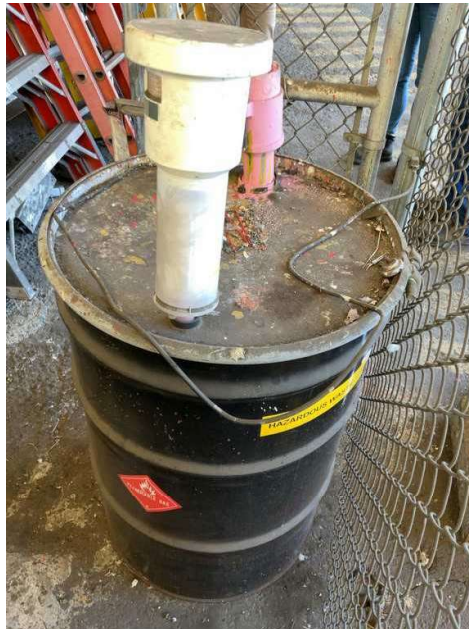
| [Title] | | | IMG-2023081709535153513801109.jpg |

While we were in the Maintenance area, I inspected a small, fenced area that the facility was using as a universal waste area. While in this fenced universal waste area, I saw that the facility had a 55-gallon closed-top container that was being used as a satellite accumulation area (SAA) container for aerosol can waste residue, generated from puncturing waste aerosol cans in a drum-top aerosol can popper. At the time of the inspection the lid on the can popper was open, and the SAA container was not closed.

| View of the SAA container holding waste aerosol residue. | | | |

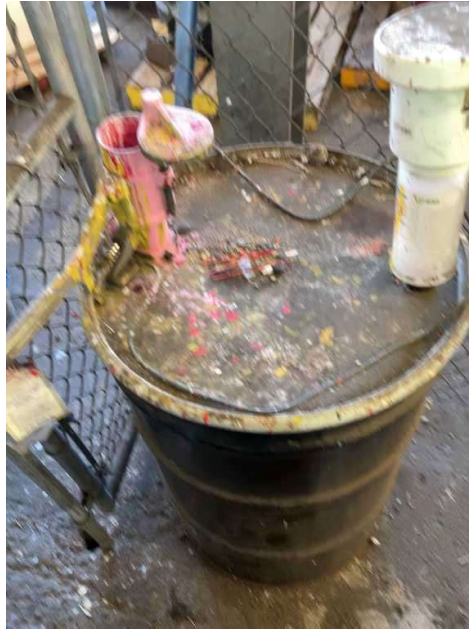
| [Title] | | | IMG-202308170954005402511532.jpg |

| <b>Building:</b> Maintenance | <b>Area:</b> Universal Waste Area | <b>Sub-area:</b> |
|---|---|---|
| At the time of the inspection, the lid on the aerosol can popper was open, and the SAA container of waste aerosol can residue was not closed.<br><br>The hazard/risk indicator on the SAA container of waste aerosol can residue was not accurate. | <b>Regulation:</b> | <b>Sections:</b> |

| Another view of the same waste aerosol residue SAA container, showing that it is not closed. | | | |

I also saw that there was a hazard/risk indicator on the SAA container that was inaccurate. At the time of the inspection, there was a DOT Class 2 flammable gas hazard/risk label on the SAA container. Mr. Spencer closed the aerosol residue SAA container during the inspection.

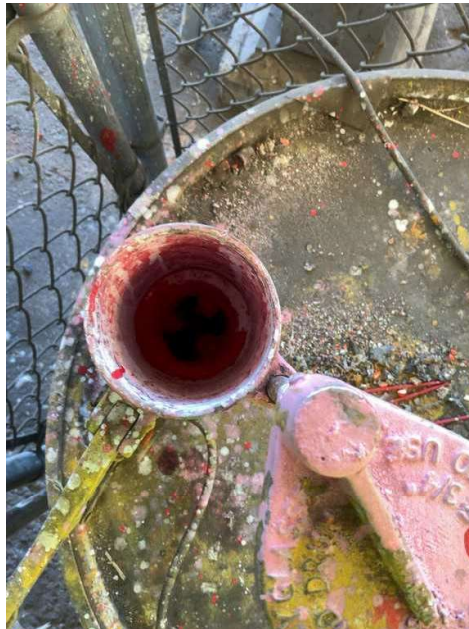
| [Title] | | | IMG-202308170954085482906240.jpg |

| Another view of the same waste aerosol residue SAA container, showing that it is not closed. | | | |

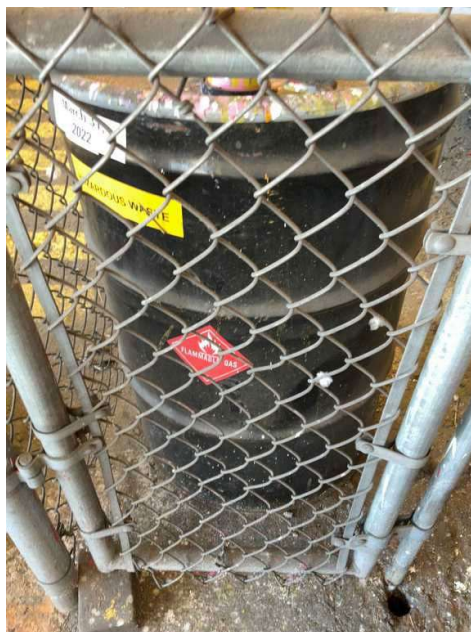
| [Title] | | | IMG-2023081709542454242950451.jpg |

| View of the SAA container with a hazard/risk indicator that is not accurate. | | | |

email from Mr. Spencer on 8/21/23 and that email included a photo of the 55-gallon waste aerosol residue SAA container after it had been labeled with a DOT Class 3 flammable liquid hazard/risk indicator.

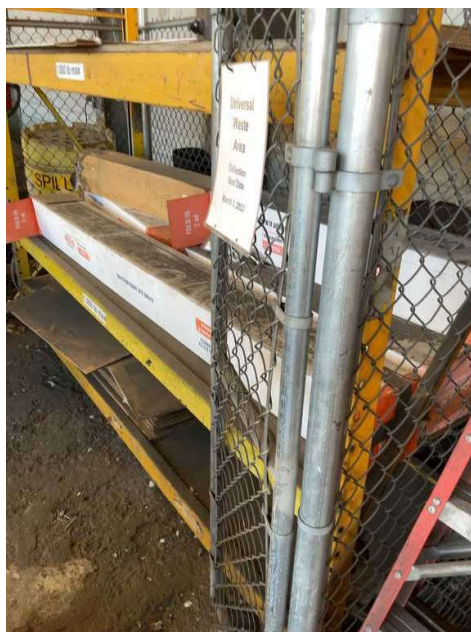
| [Title] | | | IMG-202308171002302303080216.jpg |

While in the universal waste area, we saw four cardboard boxes that held four-foot waste fluorescent lamps and one cardboard box that held eight-foot waste fluorescent lamps. At the time of the inspection, none of the five cardboard boxes of waste fluorescent lamps were labeled with either the phrase "Universal Waste-Lamps," "Used lamps," or "Waste Lamps." All five boxes were not closed. There were also three loose bulbs that were not packaged or labeled.

| View of the universal waste containers | | | |

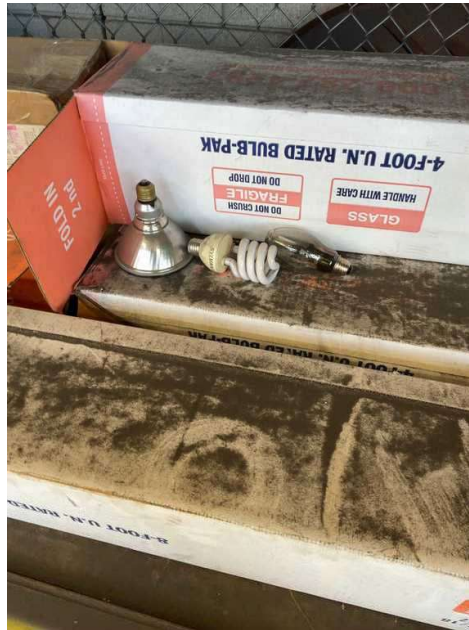
| [Title] | | | IMG-202308171002402403453810.jpg |

| There were also three loose bulbs that were not packaged or labeled. | | |

| View of waste bulbs that are not packaged. | | | |

Mr. Spencer had facility personnel package the loose bulbs, close the open boxes, and label each box with the words "Universal Waste-Lamps" during the inspection.

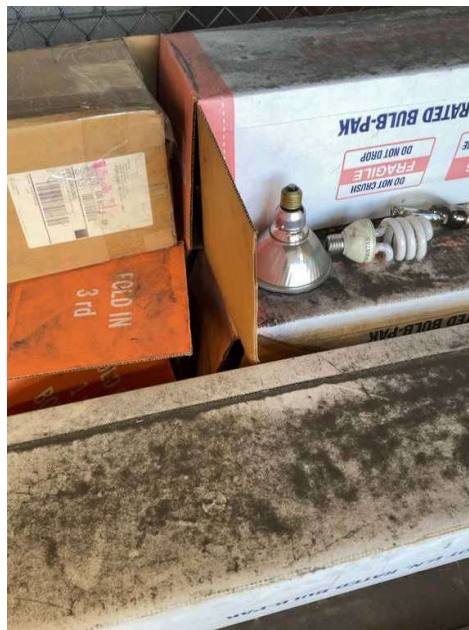
| [Title] | | | IMG-202308171002472473162521.jpg |

| <b>Building:</b> Maintenance | <b>Area:</b> Universal Waste Area | <b>Sub-area:</b> |
|---|---|---|
| Five cardboard boxes of waste fluorescent lamps were not labeled with either the phrase "Universal Waste-Lamps," "Used Lamps," or "Waste Lamps."<br><br>All five boxes of waste fluorescent lamps were not closed. | <b>Regulation:</b> | <b>Sections:</b> |

| View of the universal waste containers that are not closed. | | | |

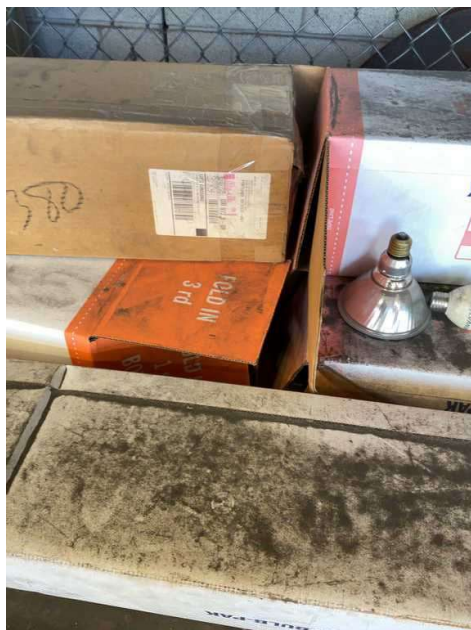
| [Title] | | | IMG-202308171002552553252590.jpg |

| Another view of the universal waste containers that are not closed. | | | |

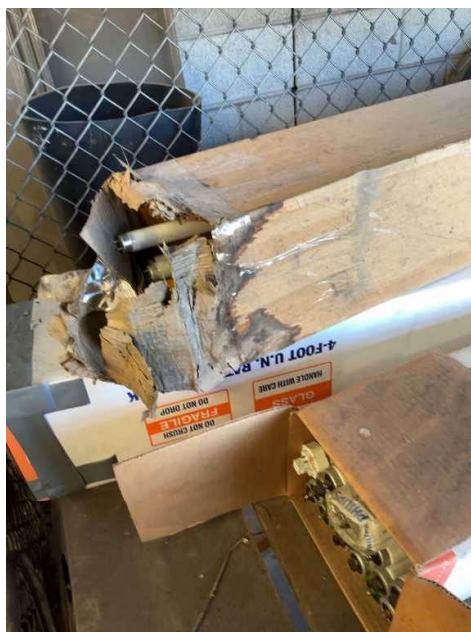
| [Title] | | | IMG-20230817100306362775253.jpg |

| Another view of the universal waste containers that are not closed. | | | |

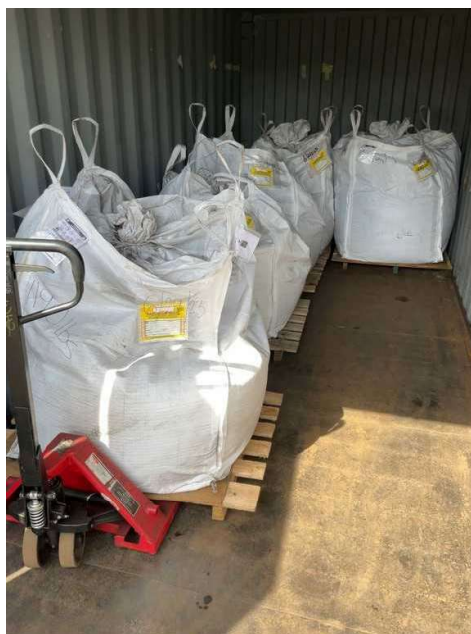
| [Title] | | | IMG-202308171018061863617465.jpg |

| Five, cubic yard super sacks that contained waste furnace dust with chromium (D007) were not marked with hazard/risk indicators. | <b>Regulation:</b> | <b>Sections:</b> |

| View of supersacks containing waste furnace dust in the CAA, showing that they are not marked with hazard/risk labels. | | | |

Mr. Spencer had facility personnel place stickers on each super sack, during the inspection, that contained the word "TOXIC."

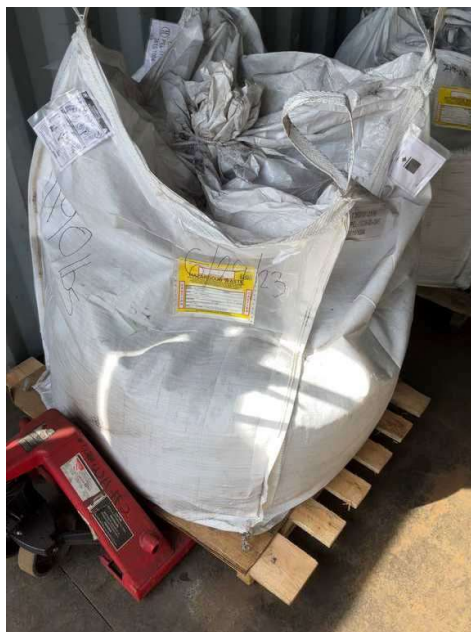
| [Title] | | | IMG-2023081710181418143778742.jpg |

| View of supersack containing waste furnace dust in the CAA, showing that it is not marked with a hazard/risk label. | | | |

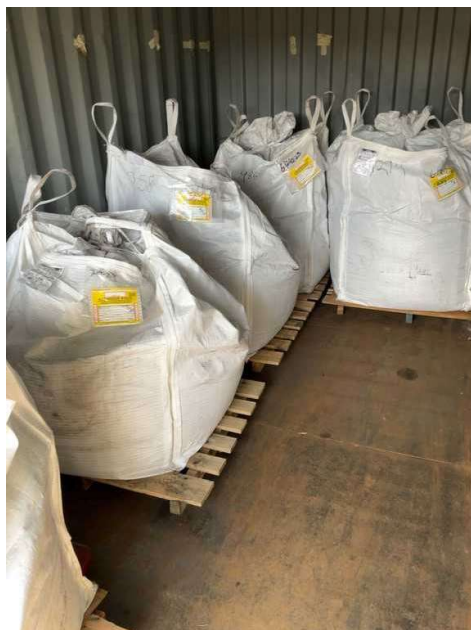
| [Title] | | | IMG-202308171019021922760351.jpg |

| Another view of supersacks containing waste furnace dust in the CAA, showing that they are not marked with hazard/risk labels. | | | |

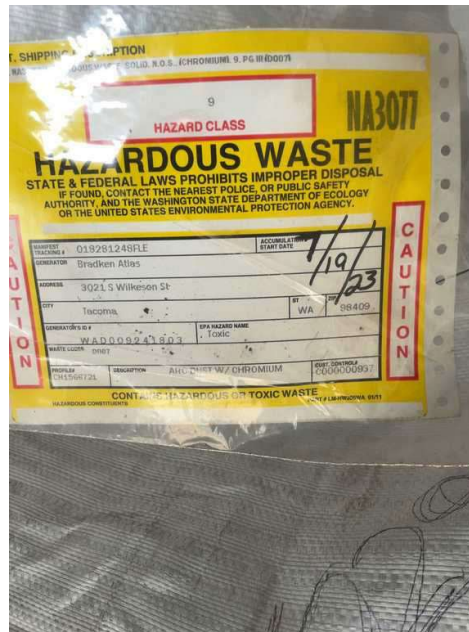
| [Title] | | | IMG-2023081710191619162934502.jpg |

were marked with hazardous waste labels and an accumulation start date (ASD), but none were marked with hazard/risk indicators. At the time of the inspection, all five waste super sacks had been in accumulation for less than 90 days. The words Class 9 N.O.S. were written on each of the hazardous waste labels and I explained to Ms. Wagner and Mr. Spencer that Class 9 N.O.S. was not specific to the hazard/risk.

| Close-up view of the label, showing that it is marked as Class 9 N.O.S. Class 9 is not specific to the hazard and cannot be used as a hazard/risk indicator. | | | |

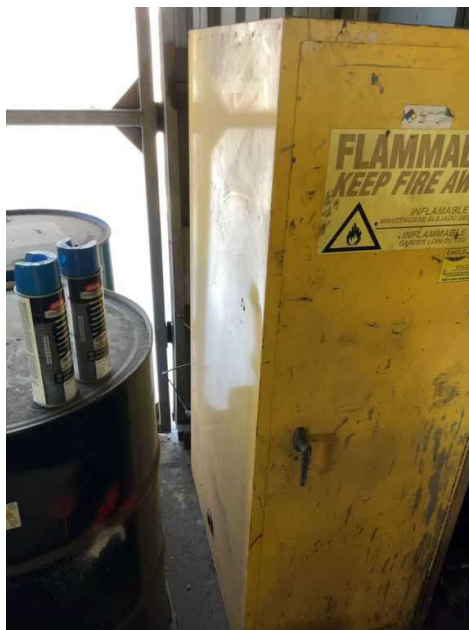
| [Title] | | | IMG-202308171100560562358569.jpg |

While inspecting the contents of a flammable storage cabinet in the Butler Building, I saw two aerosol cans that were waste aerosol cans. Mr. Spencer verified that the aerosol cans were a waste and should go to the SAA can popper.

| Two waste aerosol cans that were found inside of a flammable storage cabinet. The aerosol cans were not labeled with the words "Hazardous Waste." Mr. Spencer verified that the aerosol cans were a waste and should go to the SAA can popper. | <b>Regulation:</b> | <b>Sections:</b> |

| View of two waste aerosol cans, seen here on the left, that were found inside the yellow flammable storage cabinet, seen here on the right. | | | |

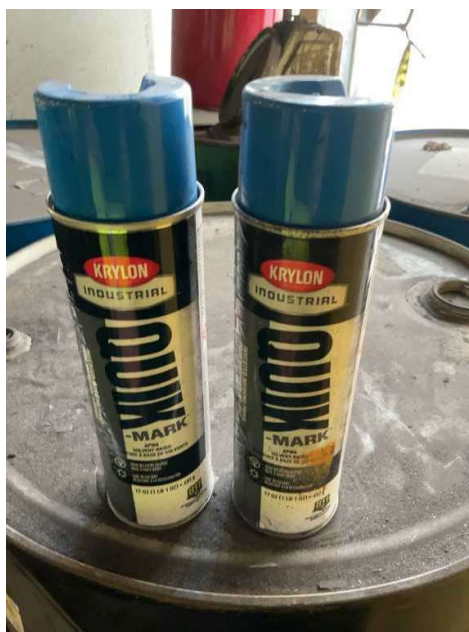
| [Title] | | | IMG-20230817110103132142280.jpg |

| Close-up view of the waste aerosol cans. | | | |

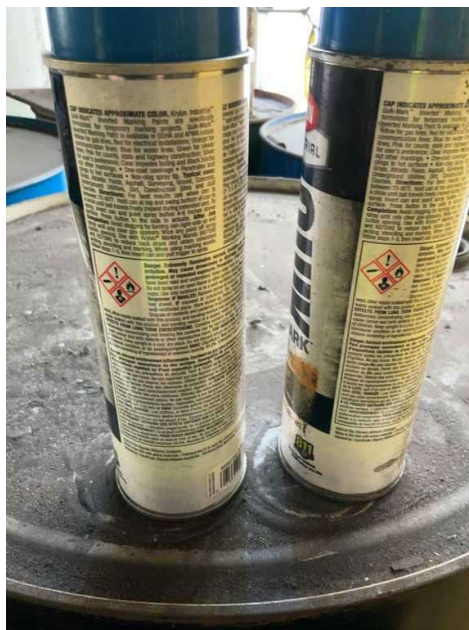
| [Title] | | | IMG-202308171101241242702261.jpg |

| Another close-up view of the waste aerosol cans. | | | |

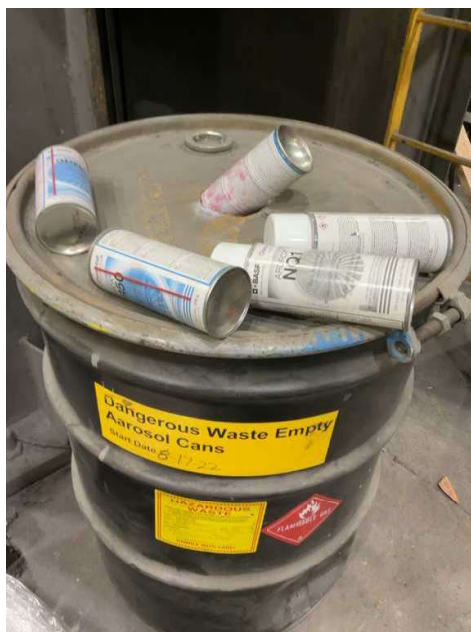
| [Title] | | | IMG-20230817111472147212300436.jpg |

While in Cleaning Room 1, we saw a 55-gallon SAA container that was being used for the accumulation of waste aerosol cans. At the time of the inspection the container was not closed. There was a round hole in the container lid with a waste aerosol can protruding from the hole and four additional waste aerosol cans were on the top of the container.

| <p>A 55-gallon waste aerosol can SAA container was not closed, and four waste aerosol cans were accumulating on the top of the container.</p> <p>The four waste aerosol cans on top of the SAA container were not labeled with the words, "Hazardous Waste."</p> | <b>Regulation:</b> | <b>Sections:</b> |

| View of the waste aerosol SAA container showing that it is not closed with additional waste aerosol cans seen on top of the container. | | | |
