**SUBJECT:** CLEAN AIR ACT INSPECTION REPORT  
WM Autumn Hills RDF Landfill, Zeeland, MI

**Facility Name:** WM Autumn Hills RDF Landfill, Zeeland, MI

**Date of Inspection:** September 13, 2024

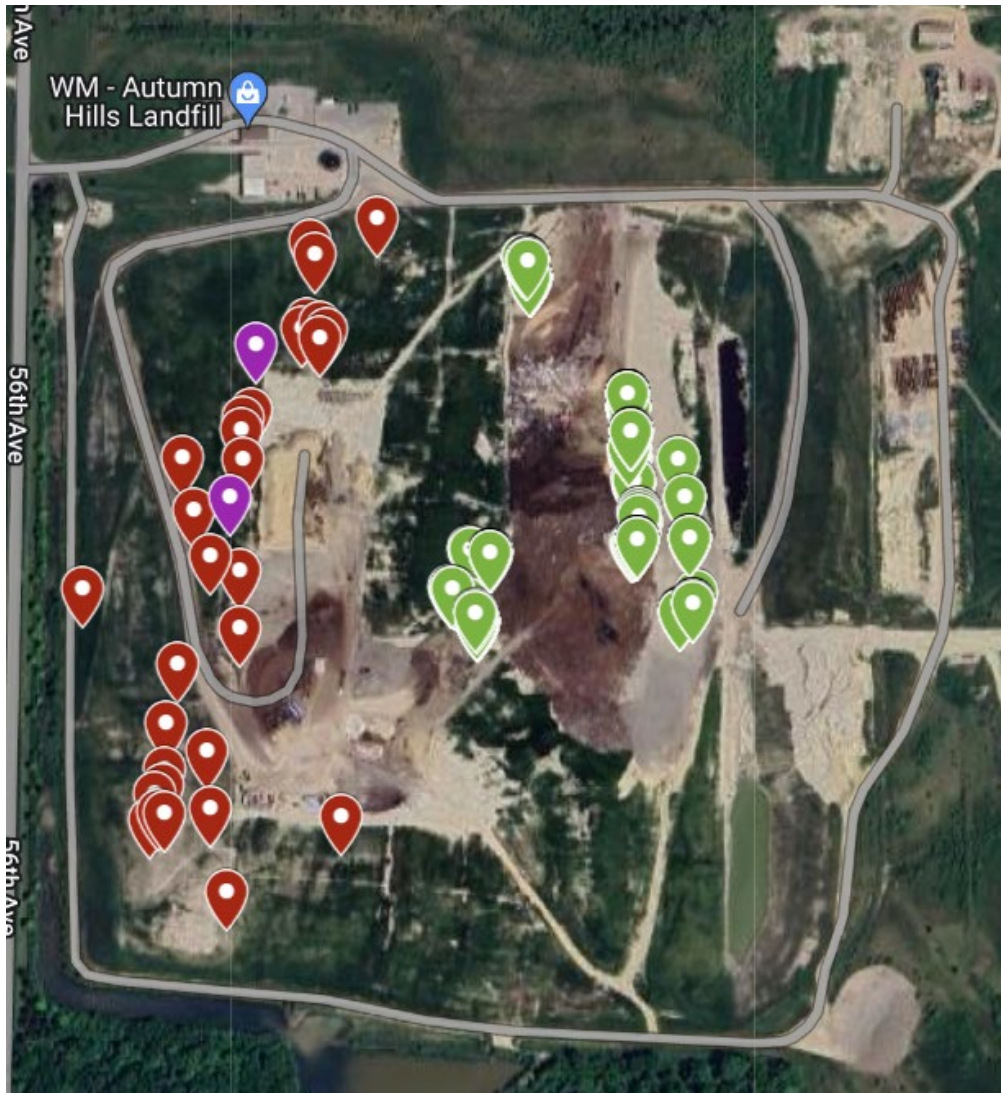
Map of EPA and EGLE SEM Exceedances and Leaking Marker Pipes

In summary, EPA logged 29 separate exceedances, many of which represented multiple penetrations or broader areas of exceedance. Six exceedances were located at wellhead penetrations, while the remaining 23 exceedances were located in areas where poor cover had lead to elevated emissions, including areas with distressed to no vegetation, cracks or erosion gullies. A majority of exceedances were more than double the surface methane standard, and 11 exceedances were at least 4 times the surface methane standard. Additionally, EPA identified two marker pipes protruding from the landfill's cover that were releasing LFG containing 8,000 and 10,000 ppm of methane (Images #38 and #45).

Jeff Benya from Michigan EGLE performed a separate concurrent SEM survey on the eastern part of the landfill, finding 15 exceedances above 500 ppm methane. Jeff Benya used a LandTec SEM5000 device to perform SEM.
