# NPDES Stormwater Industrial and Construction Inspection Report

| National Database Information | |
|---|---|
| NPDES ID Number: <b>COR05I301</b> | Inspection ID: <b>202503_COR05I301</b> |
| Facility Type: <b>Gas Processing Plant</b> | Inspection Type: <b>Stormwater Industrial</b> |

| Facility Location Information | |
|---|---|
| Site/Facility and Location:<br><br><b>Ignacio Gas Plant<br/>3746 Country Road 307<br/>Durango, Colorado 81303<br/>La Plata County</b> | Mailing address:<br><br><b>Harvest Four Corners, LLC<br/>1755 Arroyo Dr,<br/>Bloomfield, New Mexico 87413</b> |

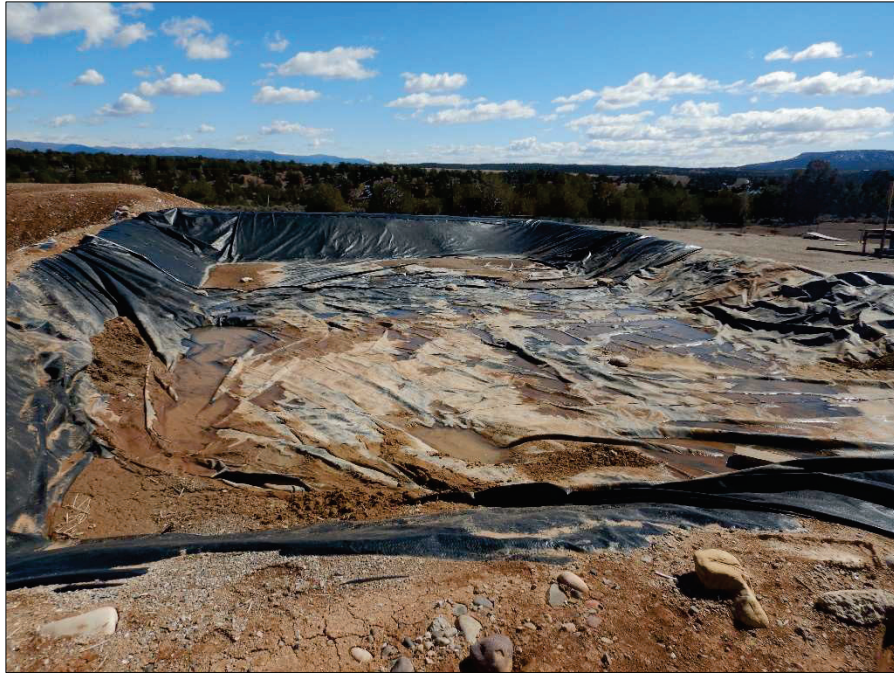
Photograph 1. View, facing Southeast, of a lined basin in the Soil Drying Containment Area in the Northeast area of the Facility.

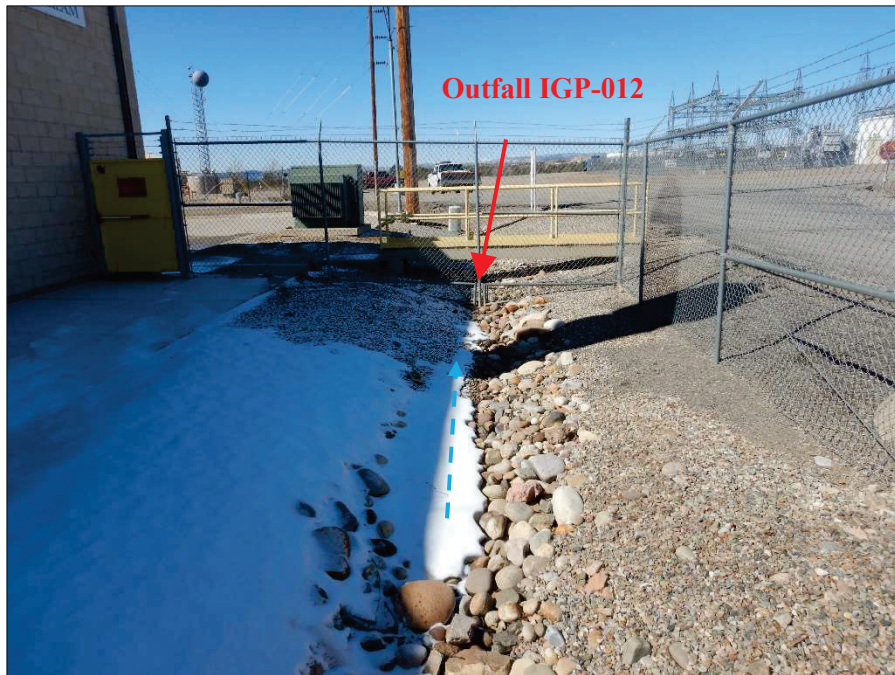
Photograph 7. View, facing North, of Outfall IGP-012.

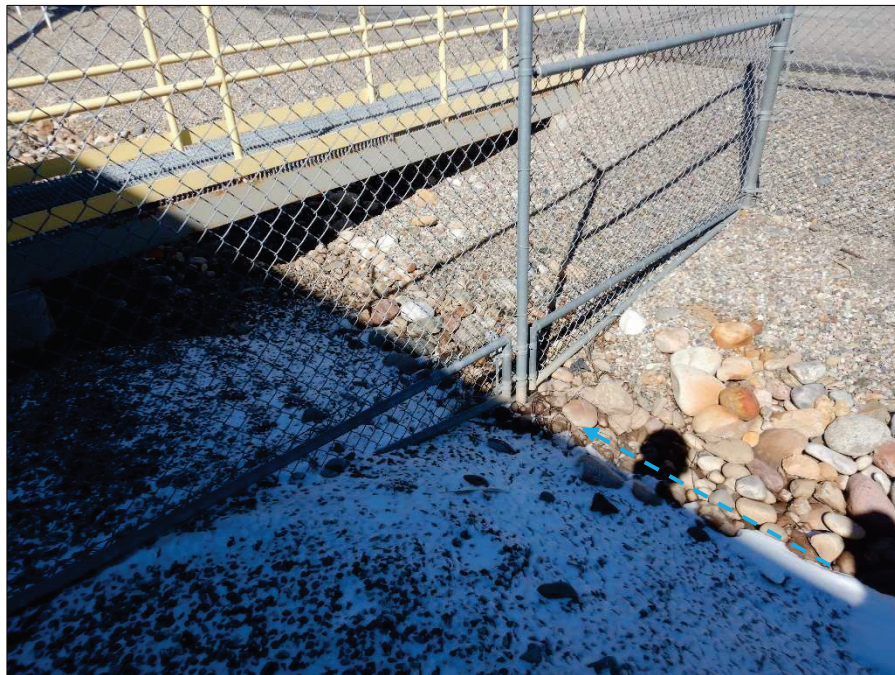
Photograph 8. Close-up view of Outfall IGP-012, as shown in Photograph 7.

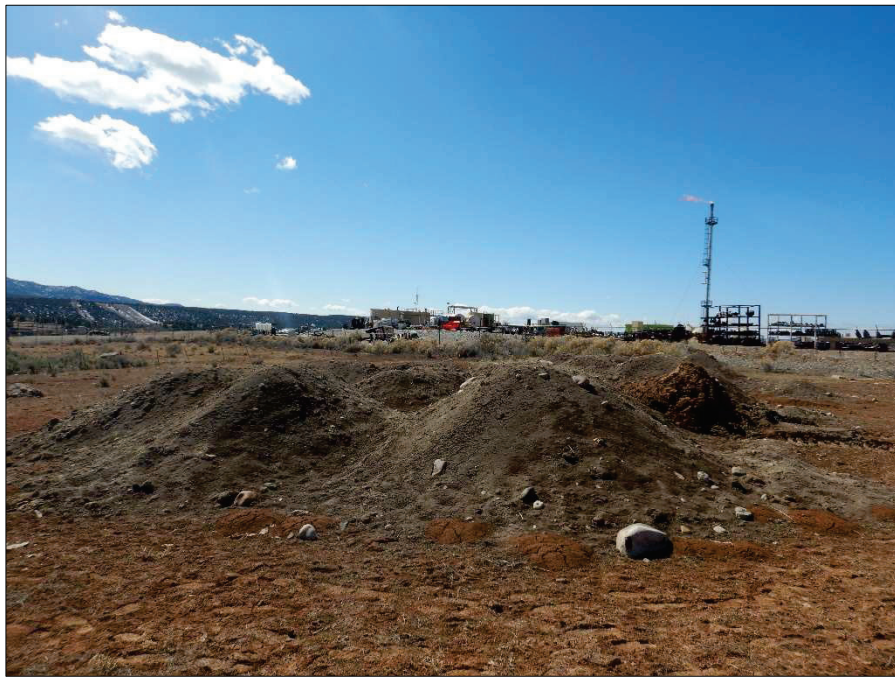
Photograph 10. Additional view, facing West, of dredged material outside of the fence line Drainage Area 15, as referenced in Photograph 9. Note piles are uncovered and uncontained.

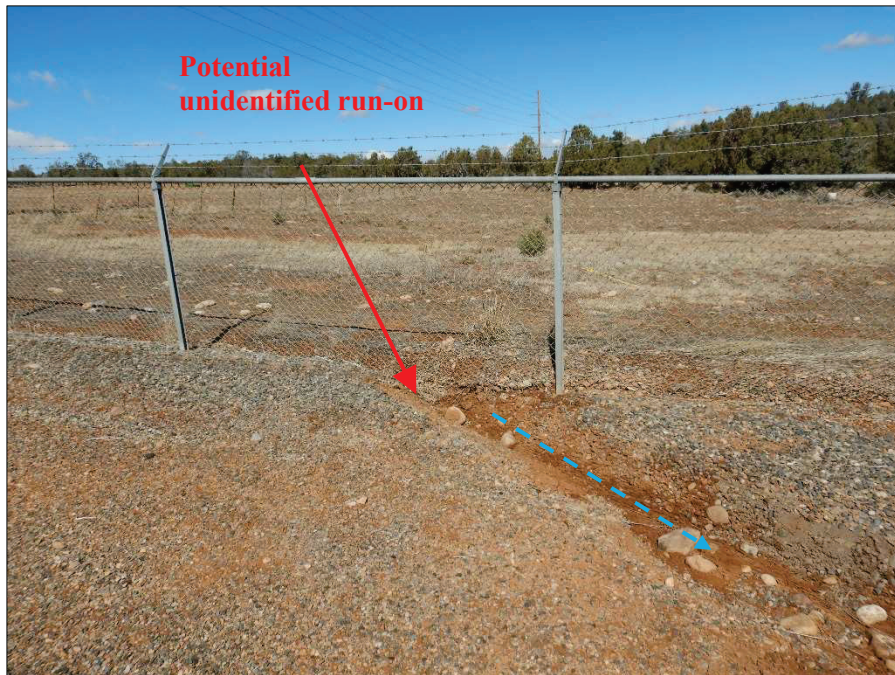
- c. Stormwater monitoring points (refer to Appendix B, Exhibit 1).
- d. Locations of stormwater run-on to the Facility from neighboring properties (refer to Appendix B, Exhibit 1). The Inspection Team observed one location along the Facility's northeast perimeter (Drainage Area 15) where stormwater appeared to flow onto the Facility from the neighboring undeveloped property (refer to Appendix A, Photographs 11 and 12).

Photograph 11. View, facing North, of potential unidentified run-on in Drainage Area 15.

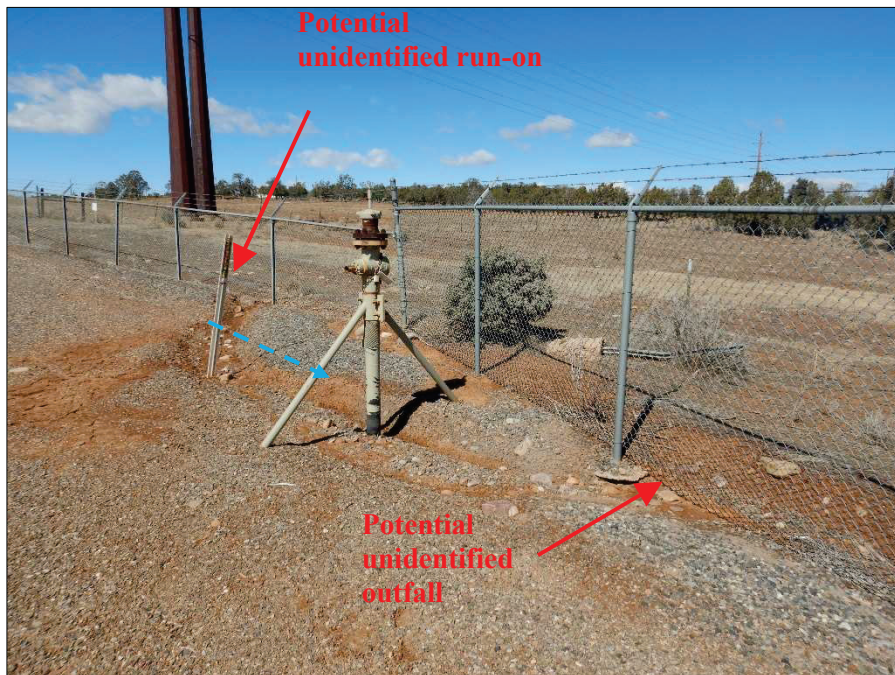
- Drainage Area 15 contains three outfalls on the site map; however the Inspection Team observed an additional three potential outfalls (refer to Appendix A, Photographs 12 through 14, 17, 18 and 25).

Photograph 12. View, facing Northwest, of potential unidentified run-on and outfall in Drainage Area 15, as referenced in Photograph 11.

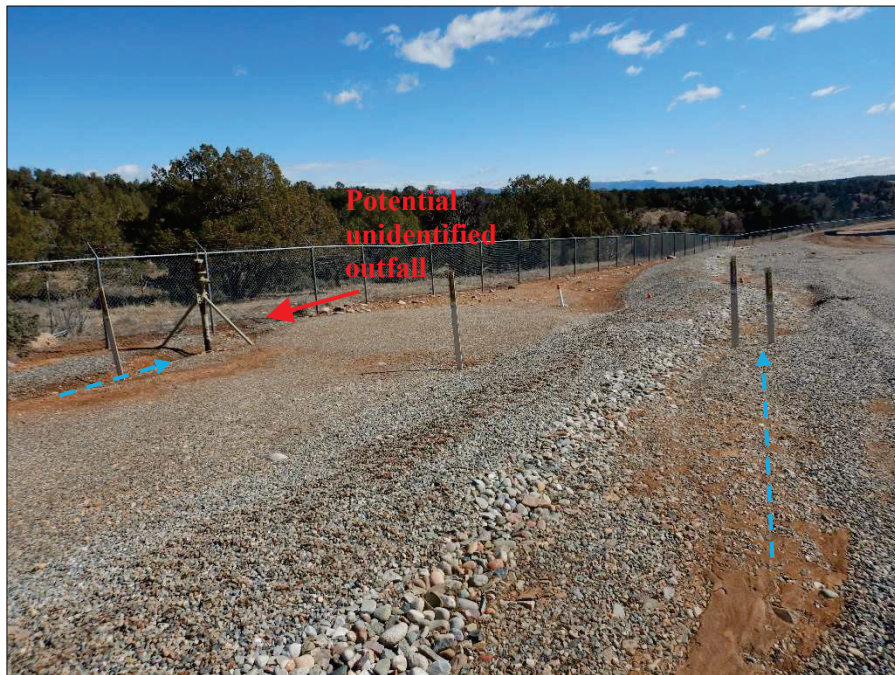
Photograph 14. Additional view, facing Northwest, of potential unidentified outfall in Drainage Area 15, as referenced in Photographs 12 and 13.

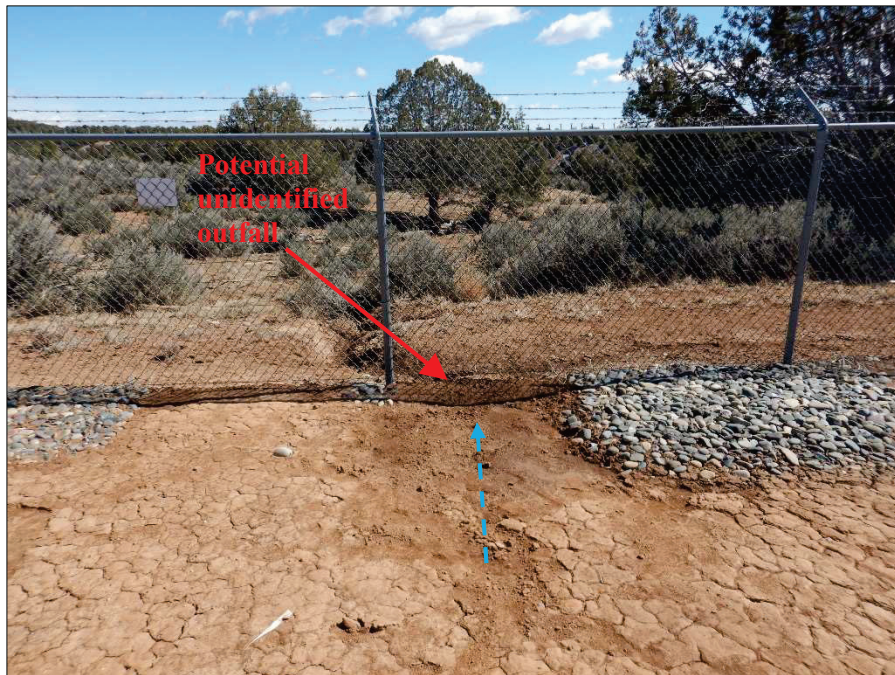
Photograph 17. View, facing East, of a potential unidentified outfall point in Drainage Area 15, near the Soil Drying Containment Area.

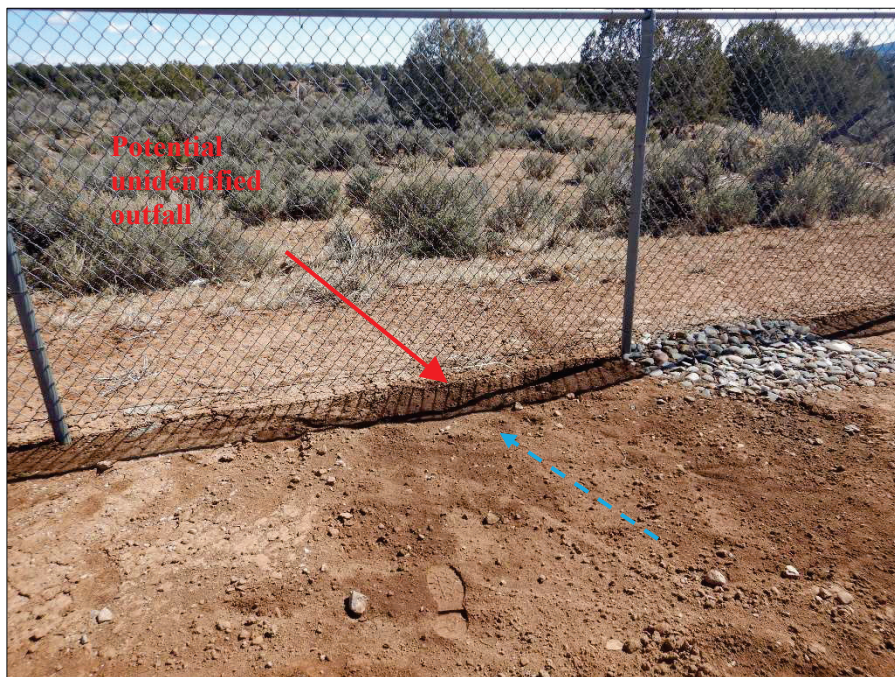
Photograph 18. Close-up view, facing East, of a potential unidentified outfall point in Drainage Area 15, near the Soil Drying Containment Area, as referenced in Photograph 17.

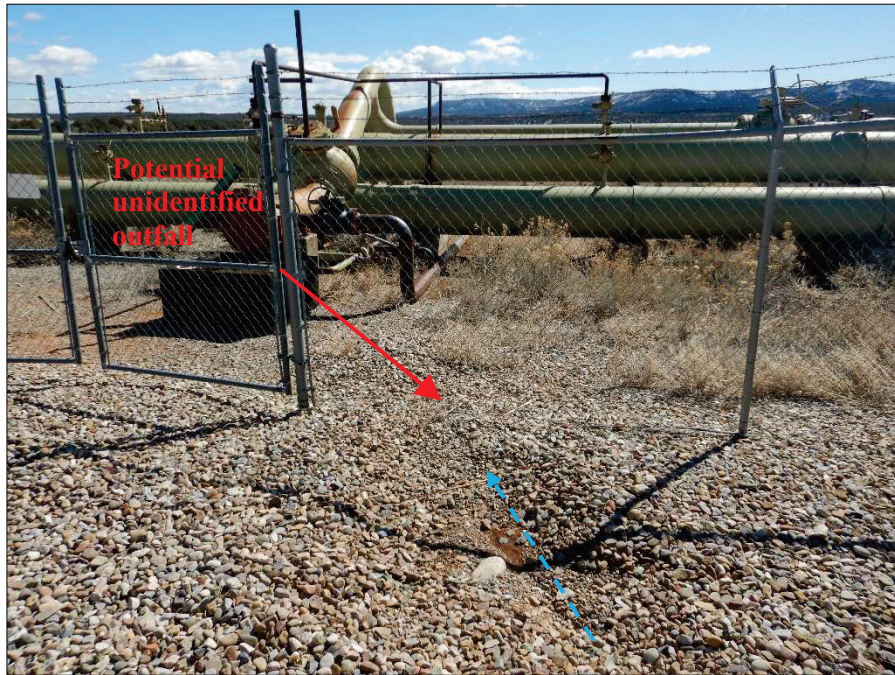
Photograph 20. Close-up view, facing South, of a potential unidentified outfall point in Drainage Area 11, as referenced in Photograph 19.

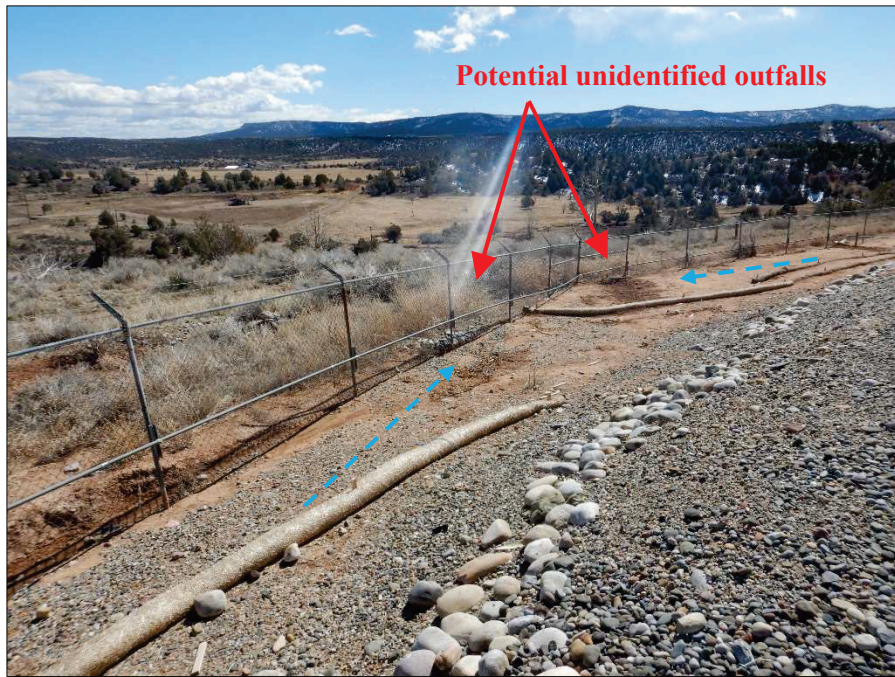
Photograph 23. View, facing South, of potential unidentified outfall points in Drainage Area 14.

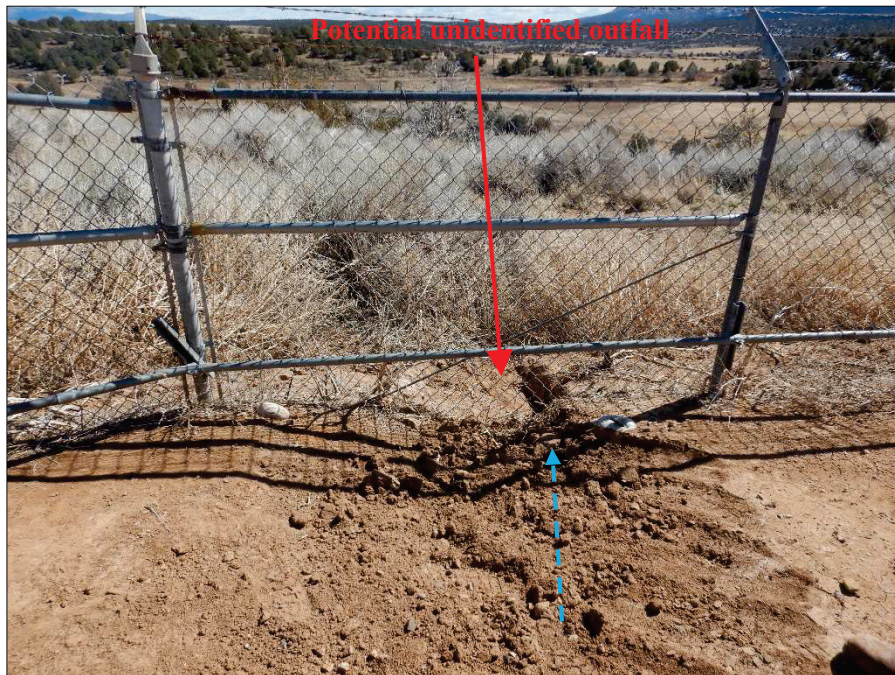
Photograph 24. Close-up view, facing Southeast, of one of the potential unidentified outfall points in Drainage Area 14, as referenced in Photograph 23.

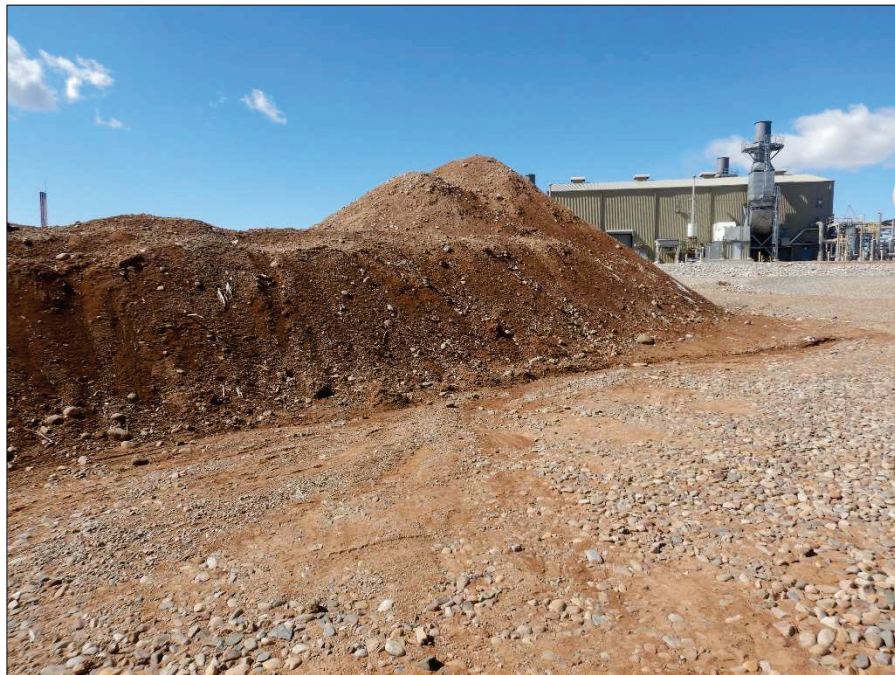
Photograph 26. View, facing Southwest, of dredged material stored in Drainage Area 15, upgradient from Outfall IGP-004. Note piles are uncovered and uncontained.

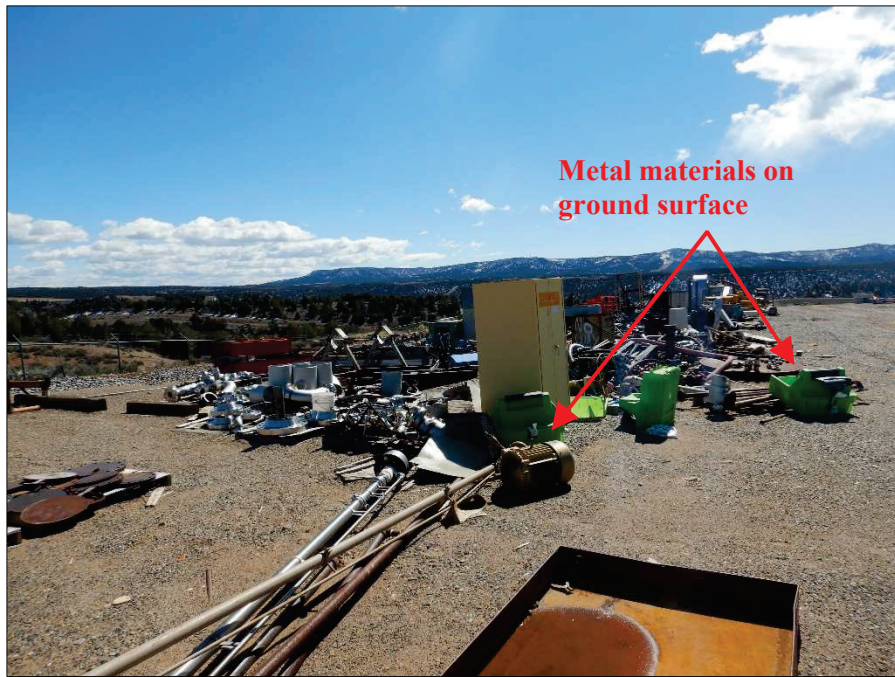
Photograph 31. Additional view, facing South, of boneyard, as referenced in Photographs 28 through 30. Note materials are uncovered and sitting on the ground.

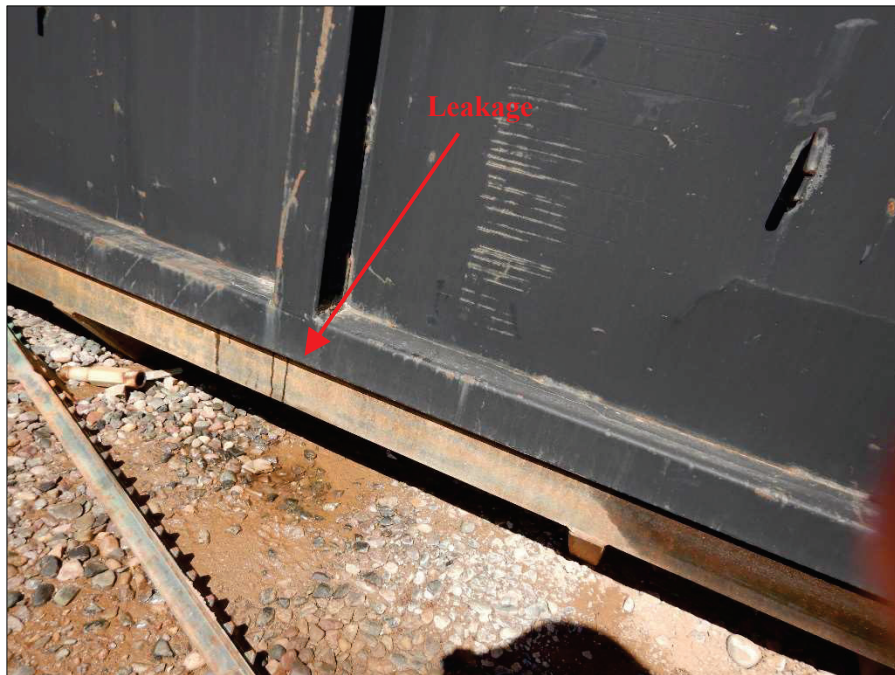
- d. An uncovered scrap metal dumpster in the boneyard (refer to Appendix A, Photographs 35 and 36). The Inspection Team observed liquid leaking from the dumpster (refer to Appendix A, Photograph 37).

Photograph 37. Additional view of dumpster in boneyard, as referenced in Photographs 35 and 36. Note leakage from dumpster.

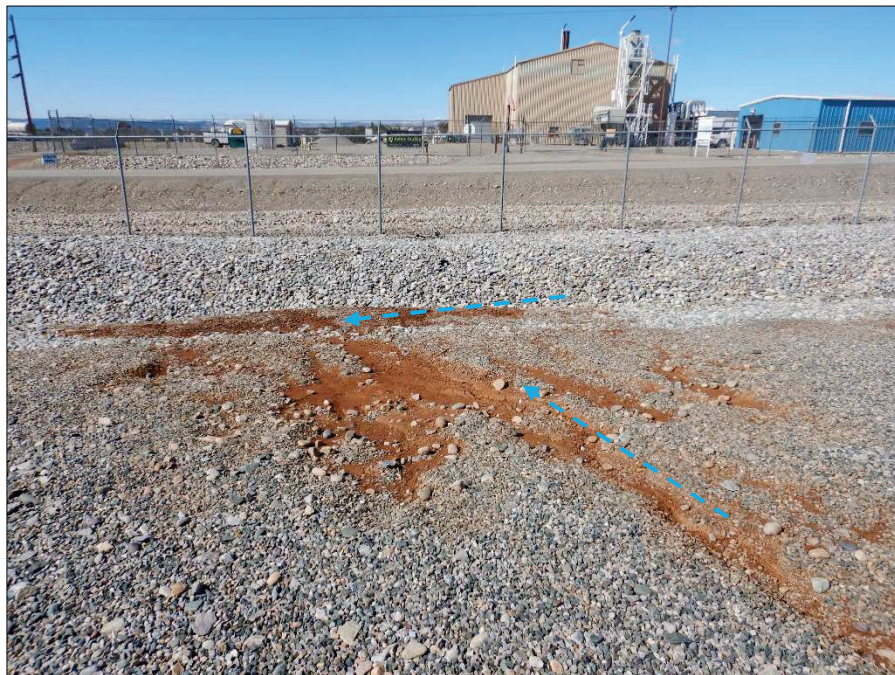
Photograph 38. View, facing West, of the bank of the ditch that drains into Gosney Pond. Note the rilling on the bank.

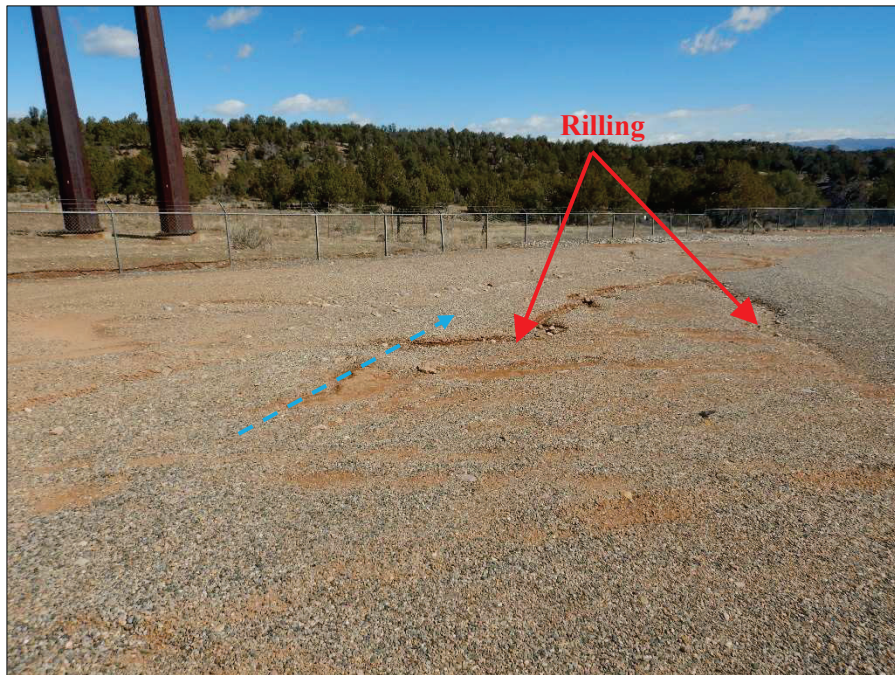
Photograph 39. View, facing East, of rilling in a stormwater drainage pathway along the fence line in the Northeastern corner of Drainage Area 5.

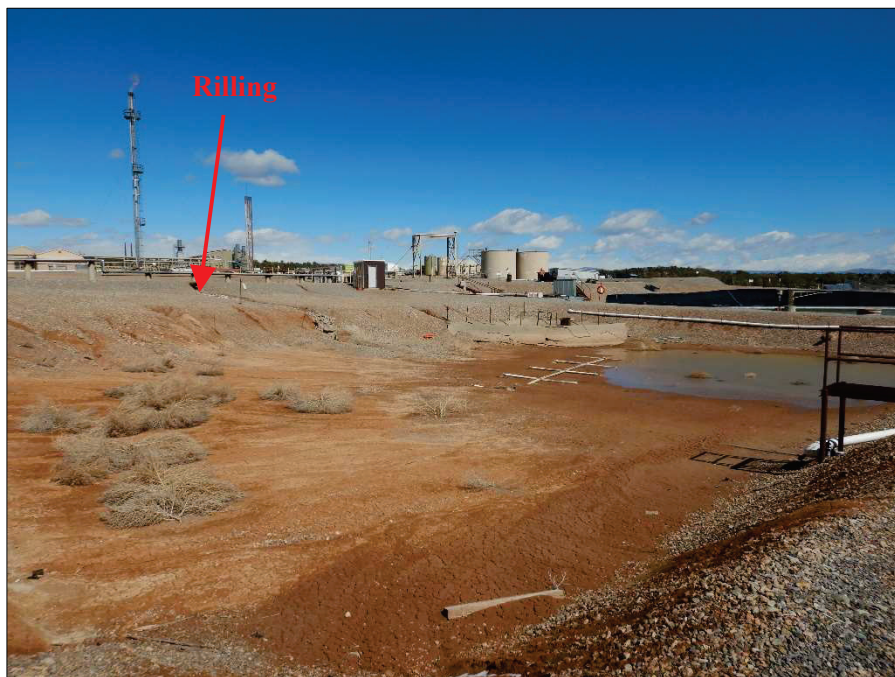
Photograph 40. View, facing North, of West Excess Pond. Note rilling on the pond bank.

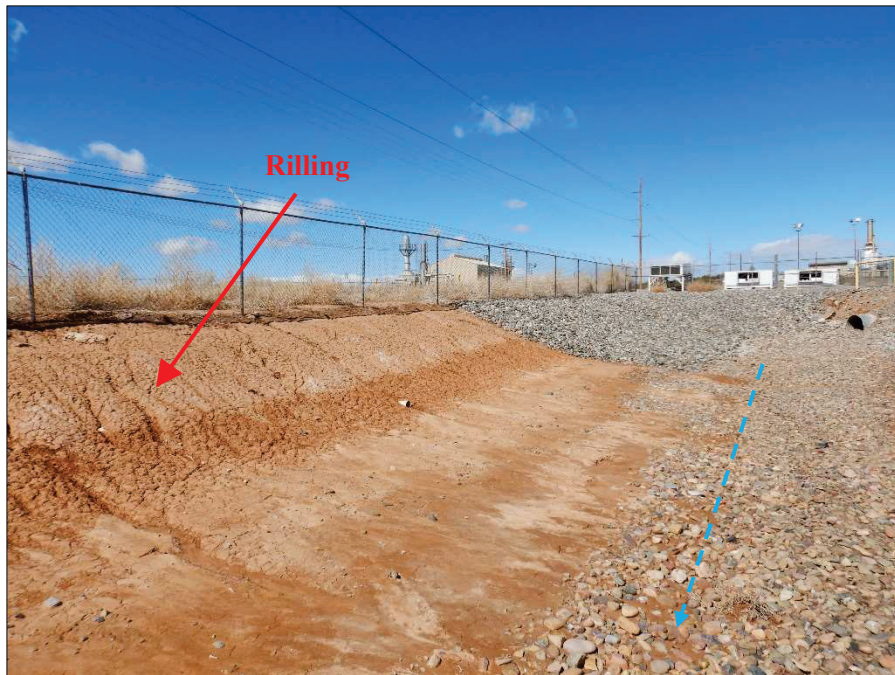
Photograph 43. View, facing North, of bank of the ditch leading to Outfall IGP-011. Note rilling on the unstabilized bank.

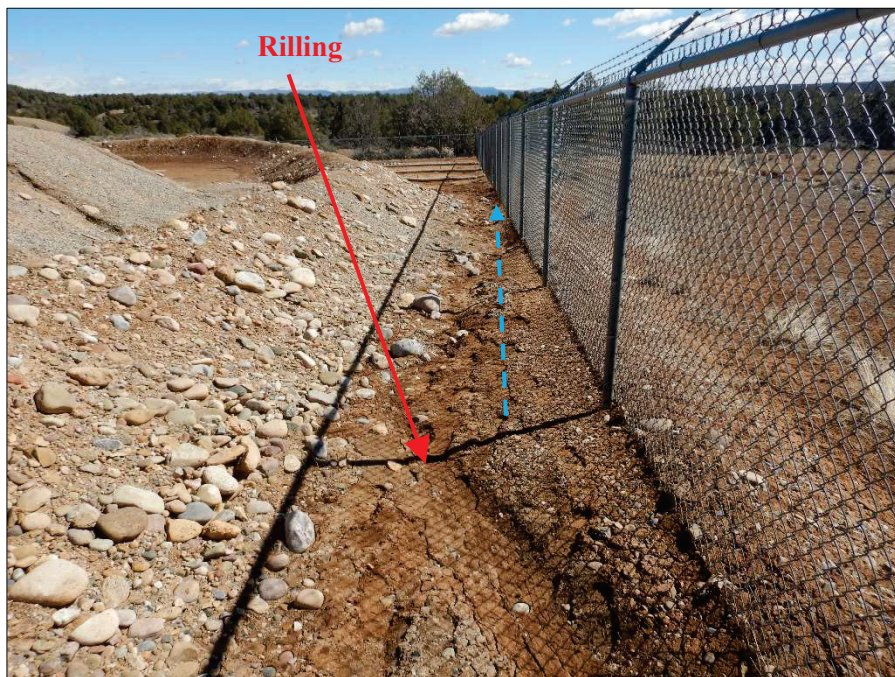
Photograph 44. View, facing East, of rilling along the fence line in Drainage Area 15, South of the Soil Drying Containment Area. Note erosion and sediment accumulation.

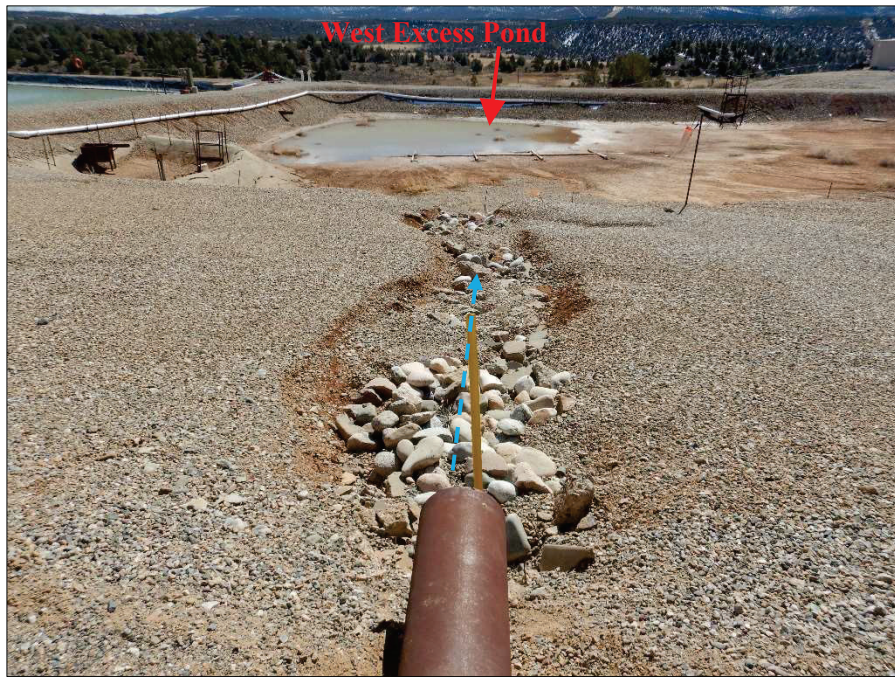
Photograph 45. View, facing South, of outlet of culvert leading to West Excess Pond. Note evidence of erosion.

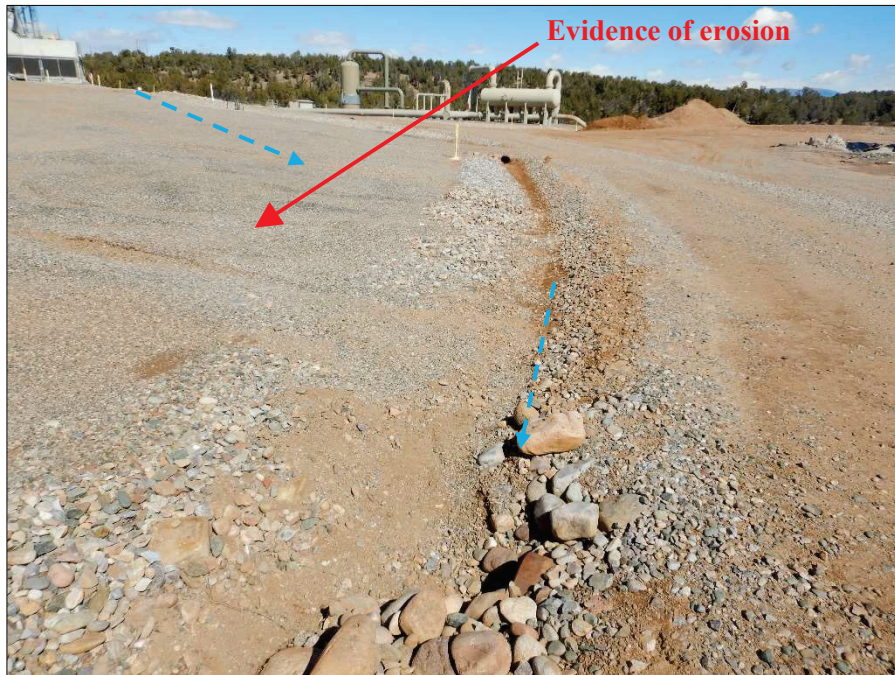
Photograph 46. View, facing Northeast, of a stormwater drainage path in Drainage Area 15 which leads to Outfall IGP-006. Note the evidence of erosion on the upgradient slope.

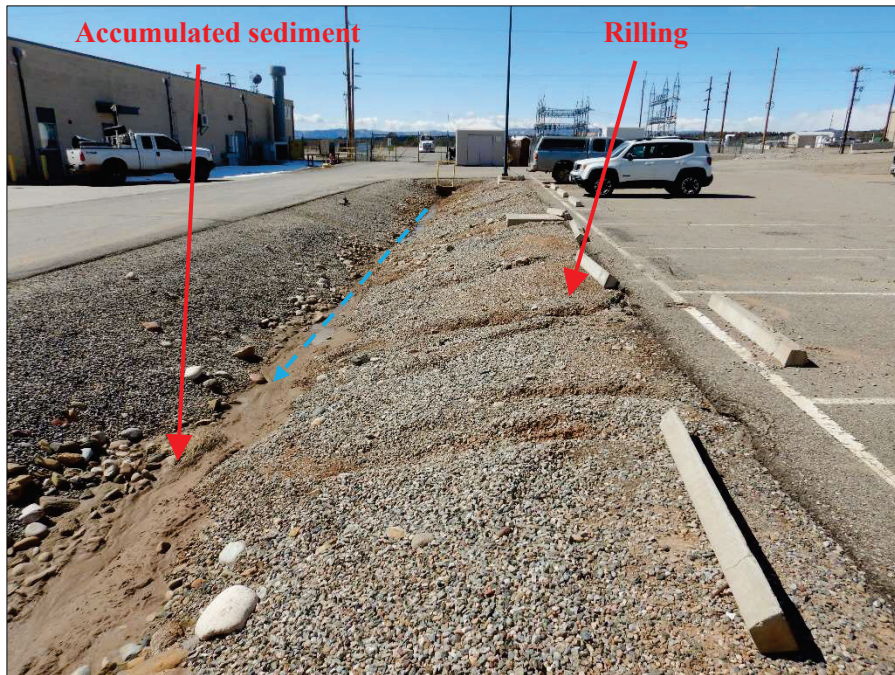
Photograph 47. View, facing West, of a ditch adjacent to parking lot that drains to North Evaporation Stormwater Holding Pond. Note rilling on the bank and accumulated sediment in the ditch.

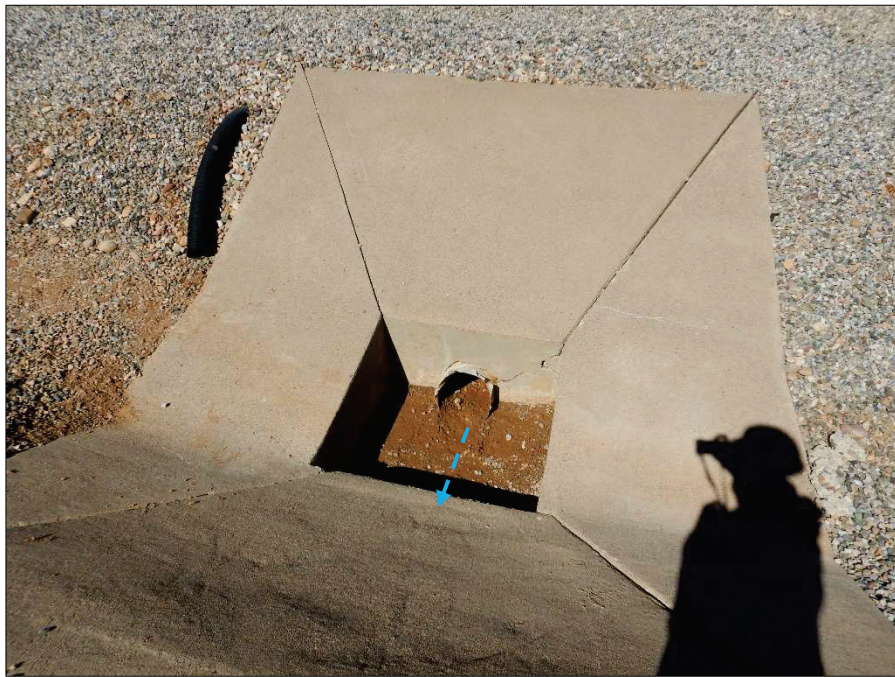
Photograph 48. View, facing North, of a drainage inlet flowing from Drainage Area 3 to the North Evaporation Stormwater Holding Pond. Note sediment accumulation.

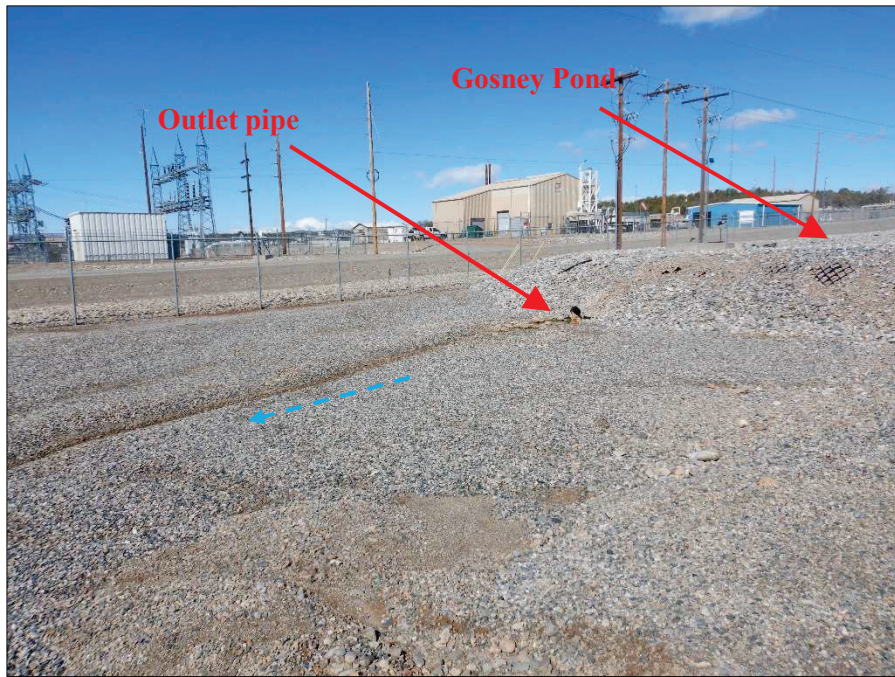
Photograph 67. View, facing Northwest, of the outlet pipe and ditch that flow away from Gosney Pond.

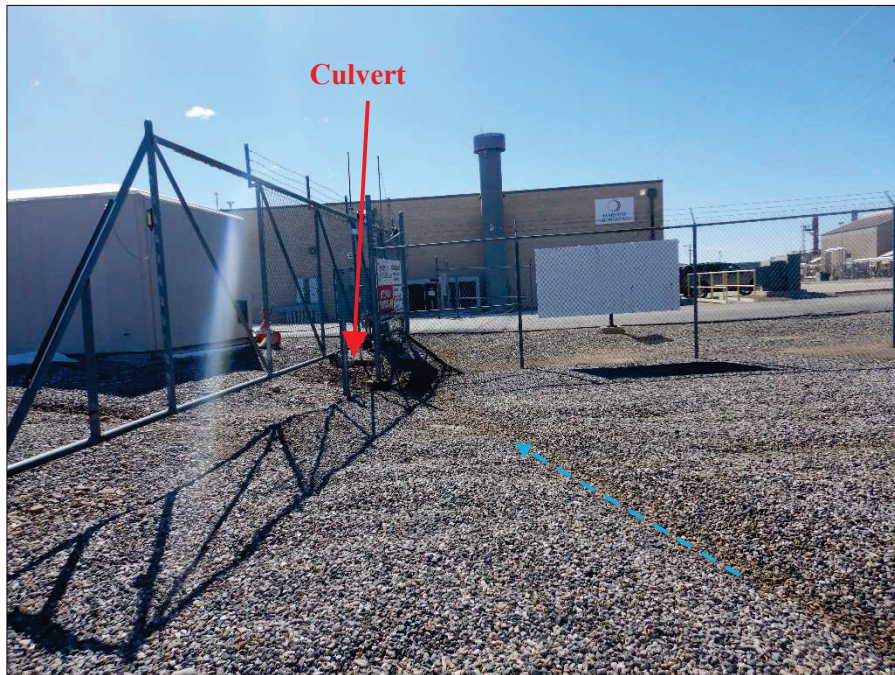
Photograph 68. View, facing South, of ditch and culvert beneath main entrance road, connecting Gosney Pond to Drainage Area 8.

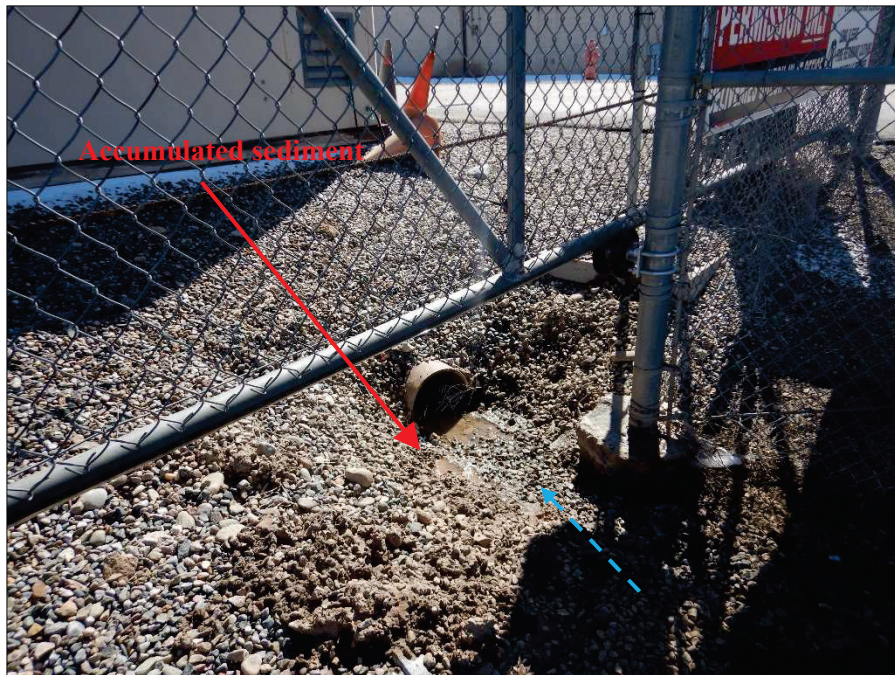
Photograph 69. Close-up view, facing Southeast, of culvert beneath main entrance road, connecting Gosney Pond to Drainage Area 8, as referenced in Photograph 68. Note sediment accumulation at the mouth of the pipe.

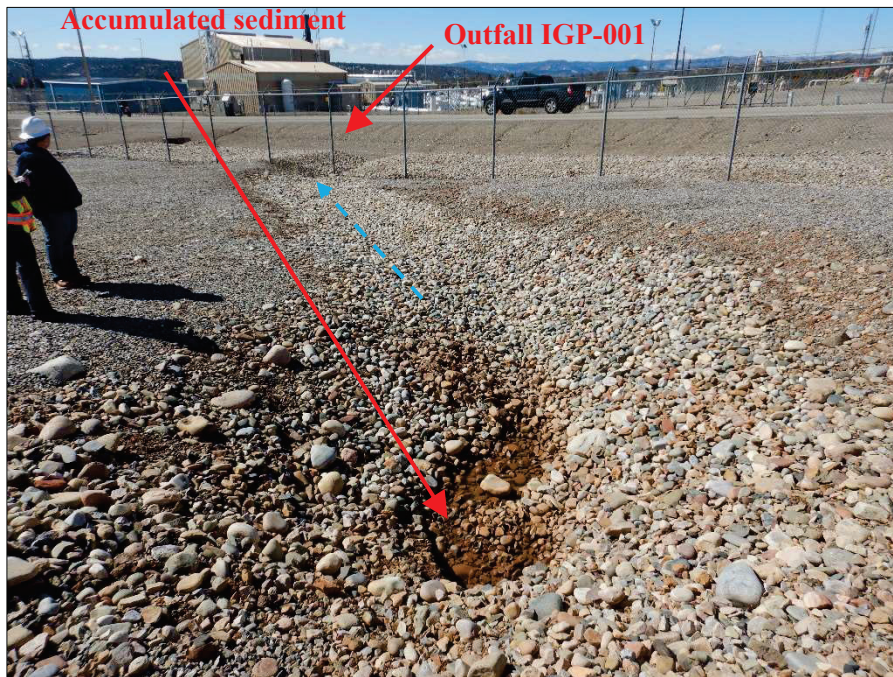
Photograph 72. View, facing Southwest, of Outfall IGP-001. Note accumulated sediment upgradient from the outfall.

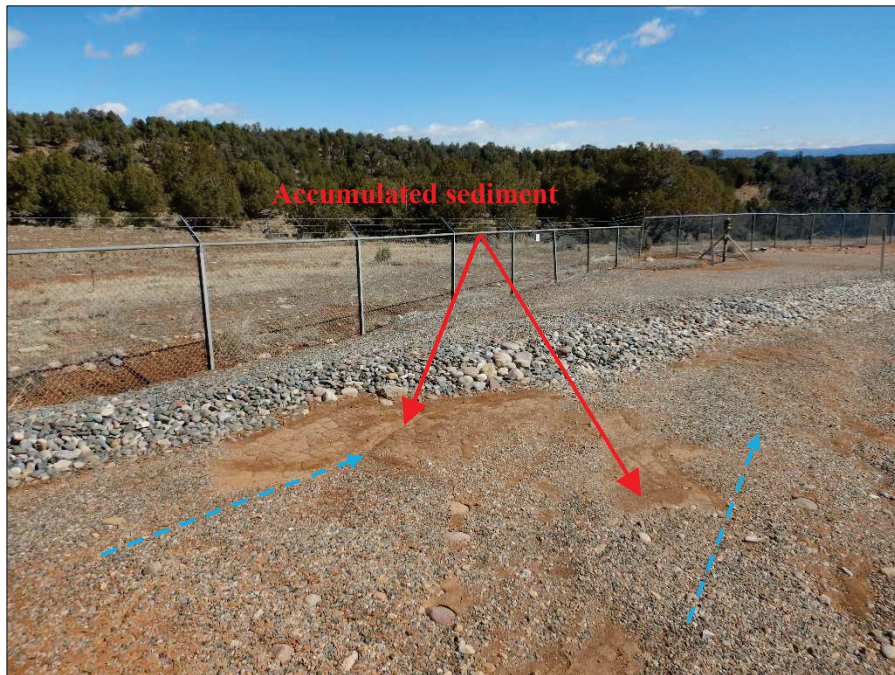
Photograph 73. View, facing East, of accumulated sediment in a drainage ditch in the Northwestern corner of Drainage Area 15.

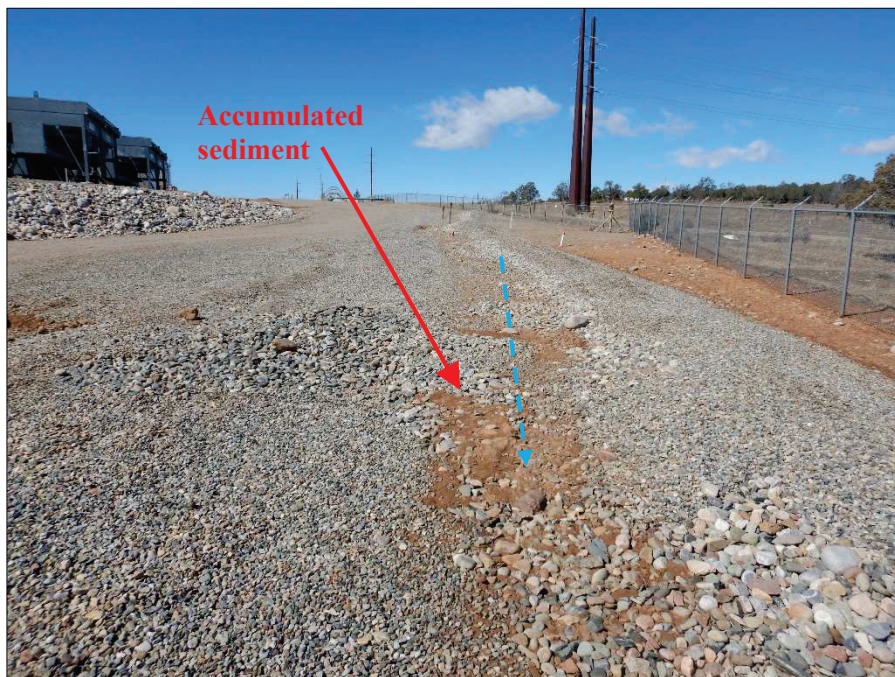
Photograph 74. Additional view, facing Northwest, of the ditch along Northeastern fence line in Drainage Area 15, as referenced in Photograph 73. Note accumulated sediment in the ditch.

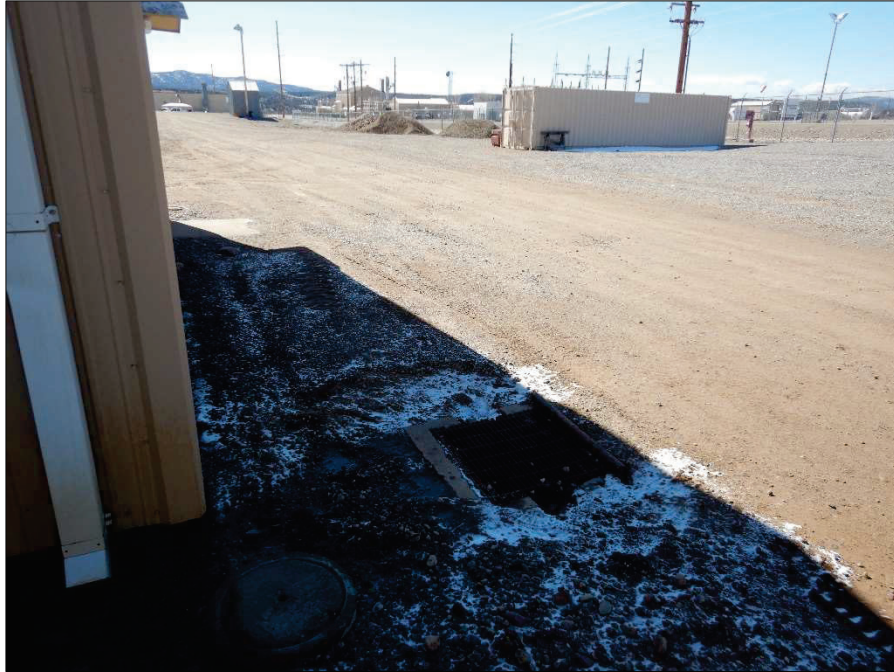
- a. Catch basins containing sediment and rocks above outlet pipes (refer to Appendix A, Photographs 75 through 82). No control measures were implemented to minimize material entering the catch basin inlets.
- b. Straw wattles that were deteriorated and/or had sediment accumulated against them (refer to Appendix A, Photographs 105 and 106). Additionally, wattles installed around the Soil Drying Containment area in the northwest area of the Facility appeared to have been recently installed, but there were gaps between some consecutive segments creating potential for sediment to leave the site (refer to Appendix A, Photographs 107, 108, and 109).
- c. Sediment accumulated against a straw wattle that had been installed along the southeastern fence line of Drainage Area 14, next to the South Evaporation Pond (refer to Appendix A, Photographs 110 and 111).

Photograph 75. View, facing Southwest, of an unprotected catch basin in Drainage Area 1. Note loose gravel and sediment near catch basin grate.

In accordance with Part 2.1.2.3.a of the permit, ensure that all stormwater control measure maintenance needs are identified through inspections and maintenance is conducted as needed to keep control measures in effective operating condition. Provide the EPA with a written narrative description and photographs of the corrective actions to address this finding.

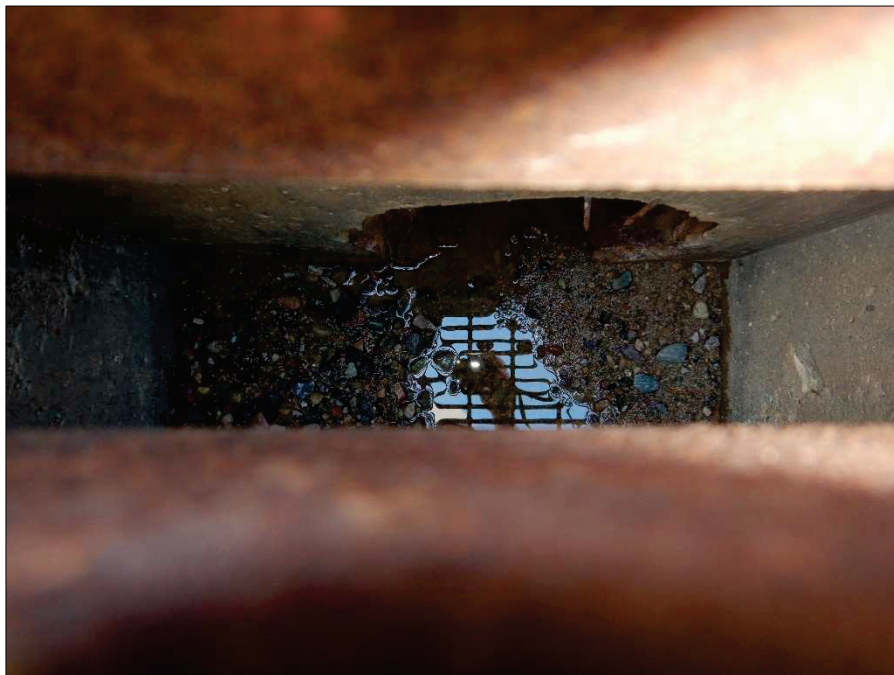
Photograph 76. Close-up view inside of catch basin in Drainage Area 1, as referenced in Photograph 75. Note accumulation of gravel and sediment.

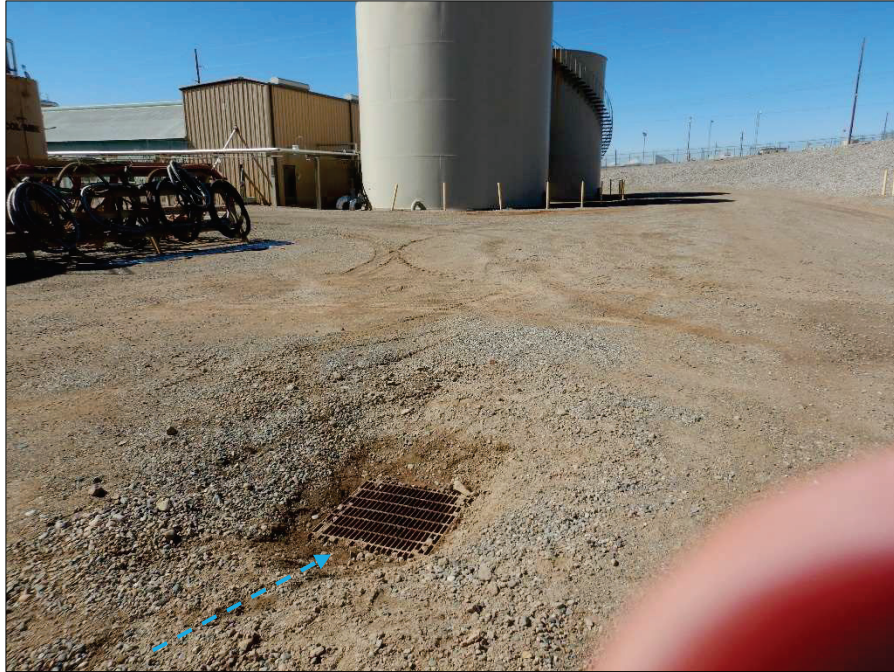
Photograph 77. View, facing West, of an unprotected catch basin in Drainage Area 2. Note loose gravel and sediment near entrance of catch basin.

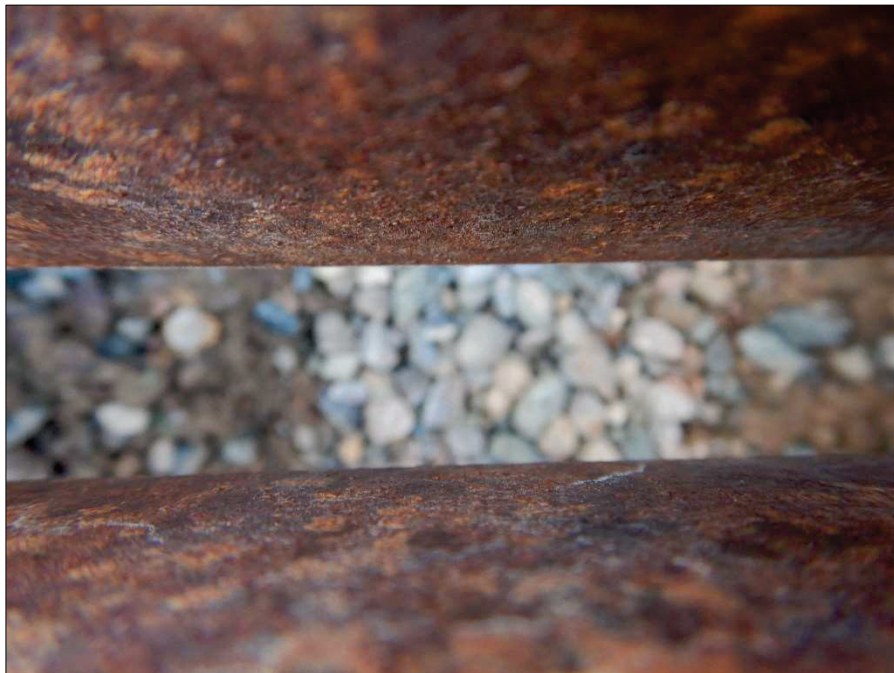
Photograph 78. Close-up view into catch basin in Drainage Area 2, as shown in Photograph 77. Note accumulated sediment and gravel.
