# NPDES Stormwater Industrial and Construction Inspection Report

| National Database Information | |
|---|---|
| NPDES ID Number: <b>COR05I301</b> | Inspection ID: <b>202503_COR05I301</b> |
| Facility Type: <b>Gas Processing Plant</b> | Inspection Type: <b>Stormwater Industrial</b> |

| Facility Location Information | |
|---|---|
| Site/Facility and Location:<br><br><b>Ignacio Gas Plant<br/>3746 Country Road 307<br/>Durango, Colorado 81303<br/>La Plata County</b> | Mailing address:<br><br><b>Harvest Four Corners, LLC<br/>1755 Arroyo Dr,<br/>Bloomfield, New Mexico 87413</b> |

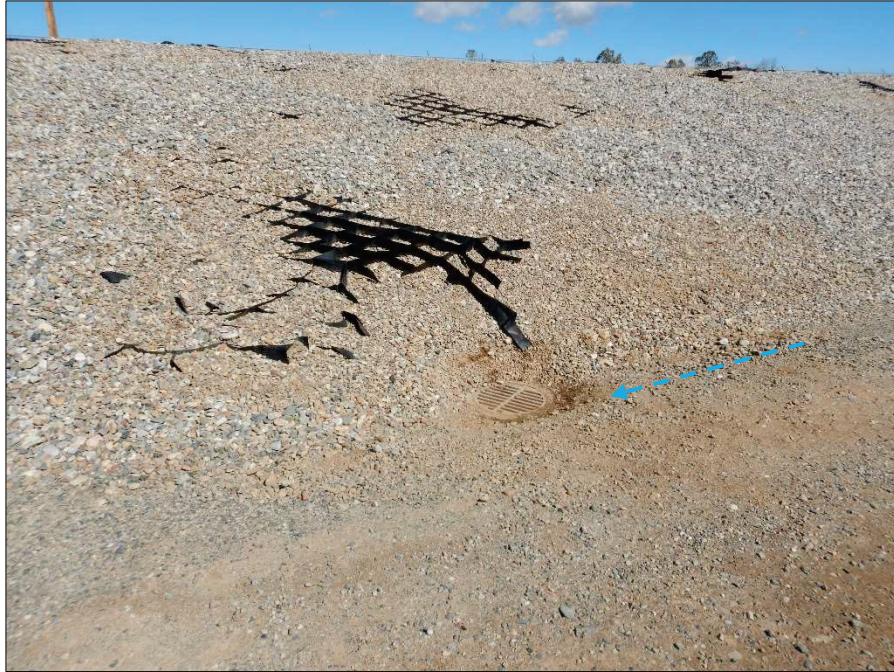
- a. Catch basins containing sediment and rocks above outlet pipes (refer to Appendix A, Photographs 75 through 82). No control measures were implemented to minimize material entering the catch basin inlets.
- b. Straw wattles that were deteriorated and/or had sediment accumulated against them (refer to Appendix A, Photographs 105 and 106). Additionally, wattles installed around the Soil Drying Containment area in the northwest area of the Facility appeared to have been recently installed, but there were gaps between some consecutive segments creating potential for sediment to leave the site (refer to Appendix A, Photographs 107, 108, and 109).
- c. Sediment accumulated against a straw wattle that had been installed along the southeastern fence line of Drainage Area 14, next to the South Evaporation Pond (refer to Appendix A, Photographs 110 and 111).

Photograph 79. View, facing Northeast, of an unprotected catch basin in Drainage Area 1. Note loose gravel and sediment near entrance of catch basin.

In accordance with Part 2.1.2.3.a of the permit, ensure that all stormwater control measure maintenance needs are identified through inspections and maintenance is conducted as needed to keep control measures in effective operating condition. Provide the EPA with a written narrative description and photographs of the corrective actions to address this finding.

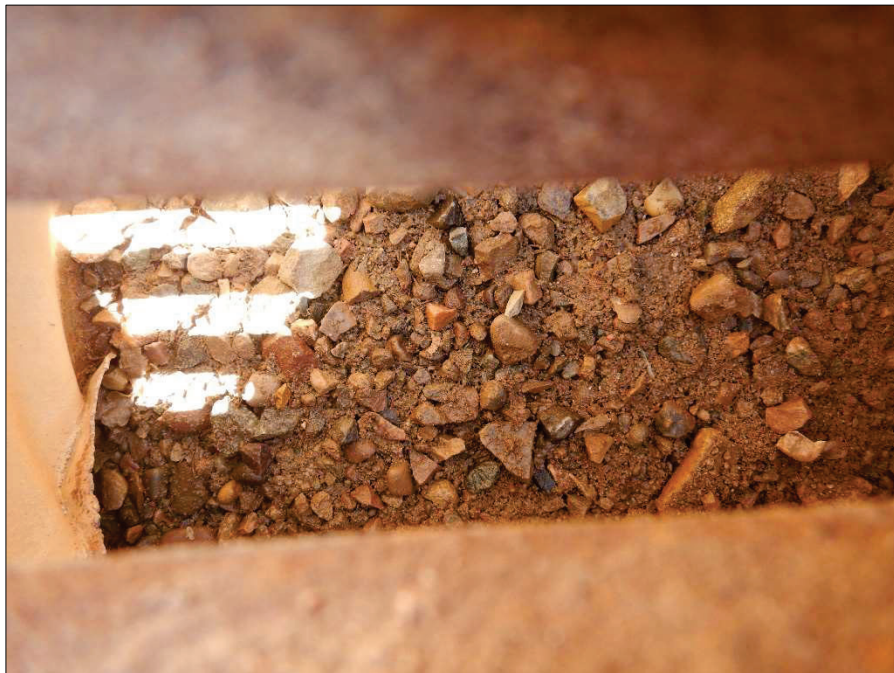
Photograph 80. Close-up view into catch basin in Drainage Area 1, as shown in Photograph 79. Note accumulated sediment and gravel.

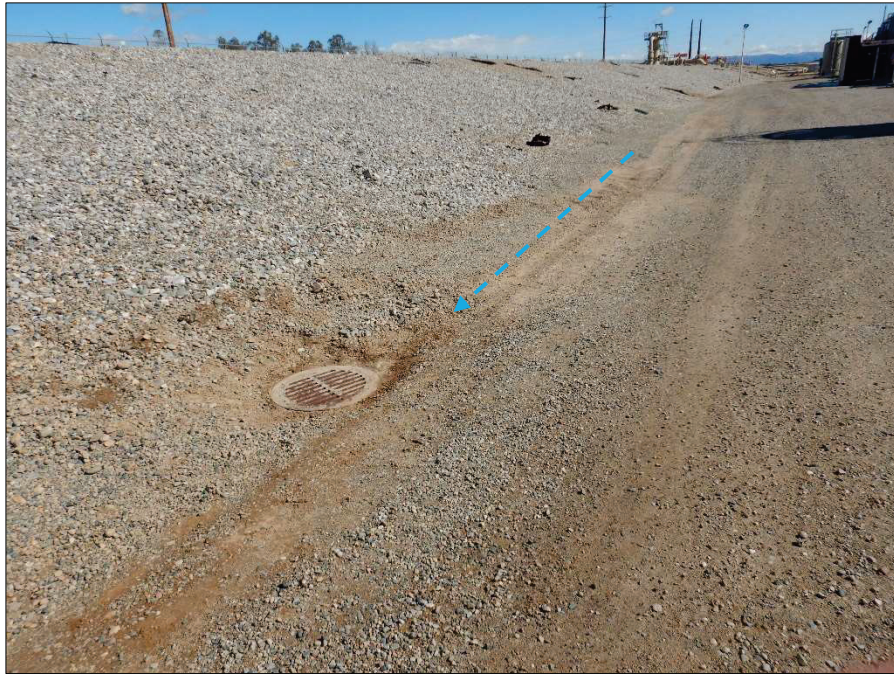
Photograph 81. View, facing East, of catch basin in Drainage Area 1. Note loose gravel and sediment near entrance of catch basin.

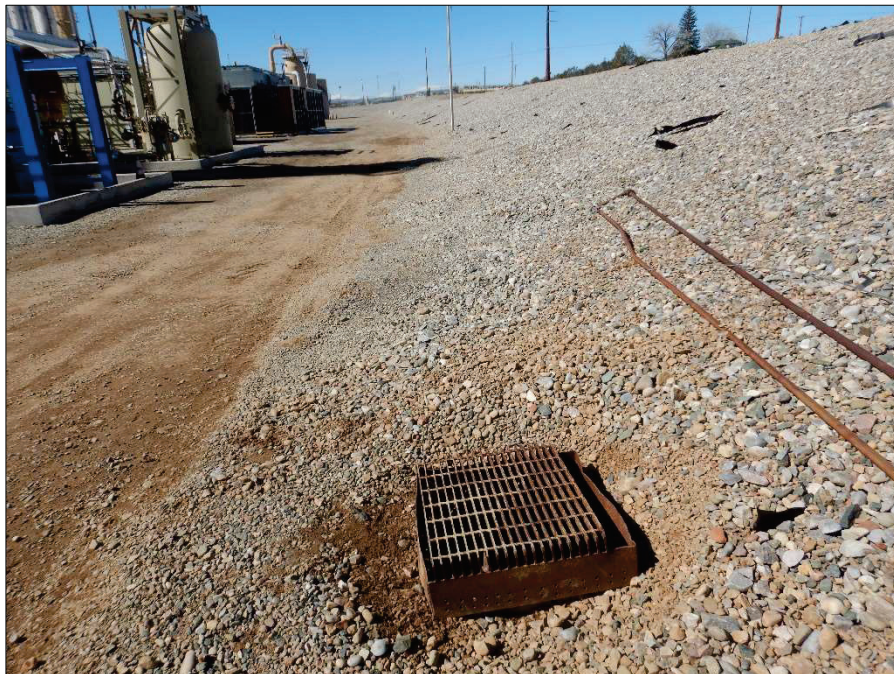
Photograph 82. View, facing West, of catch basin in Drainage Area 1. Note structure is not seated in ground and loose gravel and sediment near entrance of catch basin.

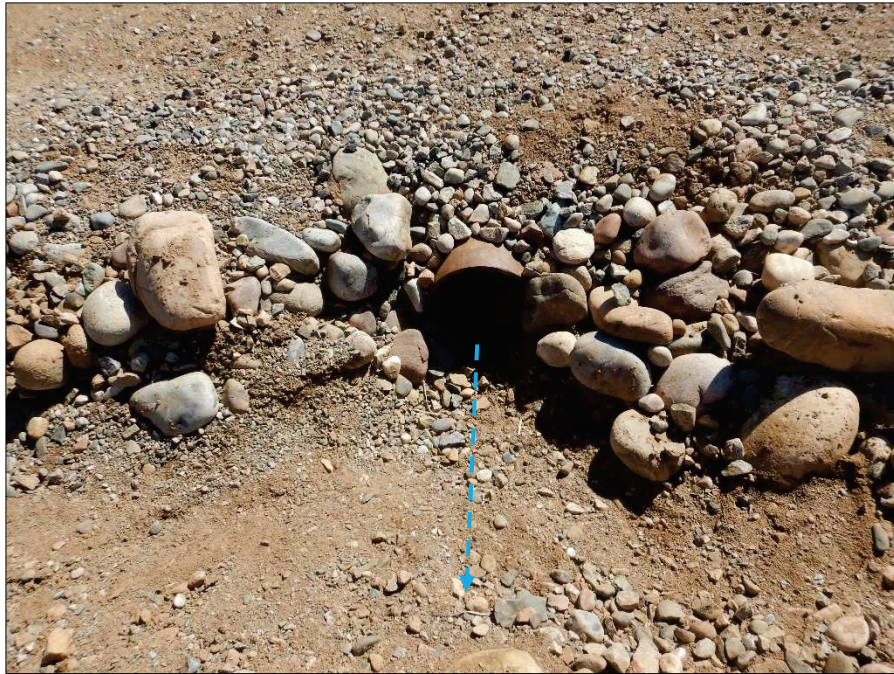
Photograph 83. View, facing south, of culvert in Drainage Area 15 that ultimately drains to Outfall IGP-003. Note accumulated sediment and gravel at the mouth of the pipe.

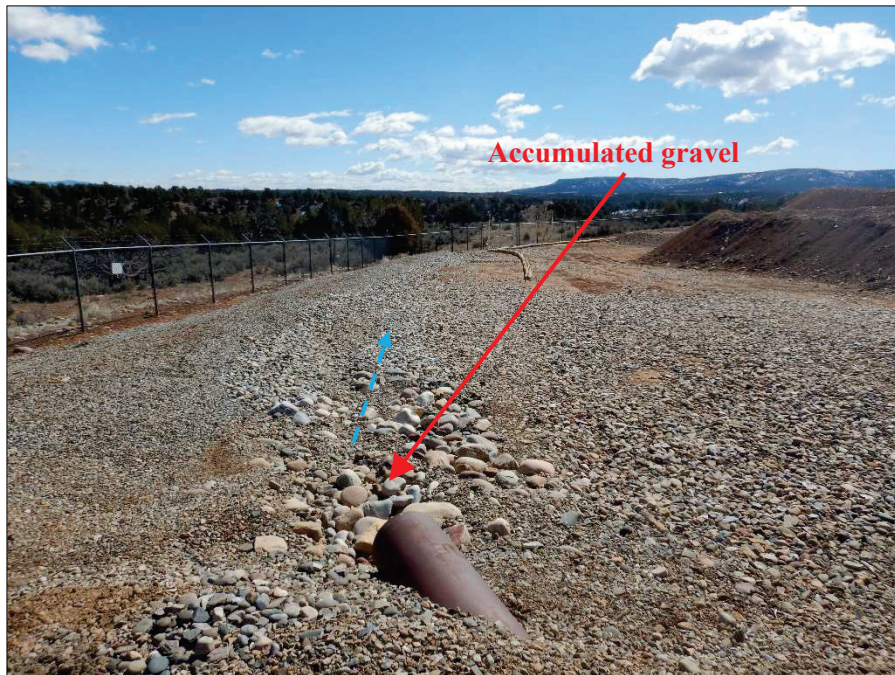
Photograph 85. Additional view, facing Southeast, of outlet to culvert beneath road in Drainage Area 15, as referenced in Photograph 84. Note accumulated gravel downgradient from the outlet pipe.

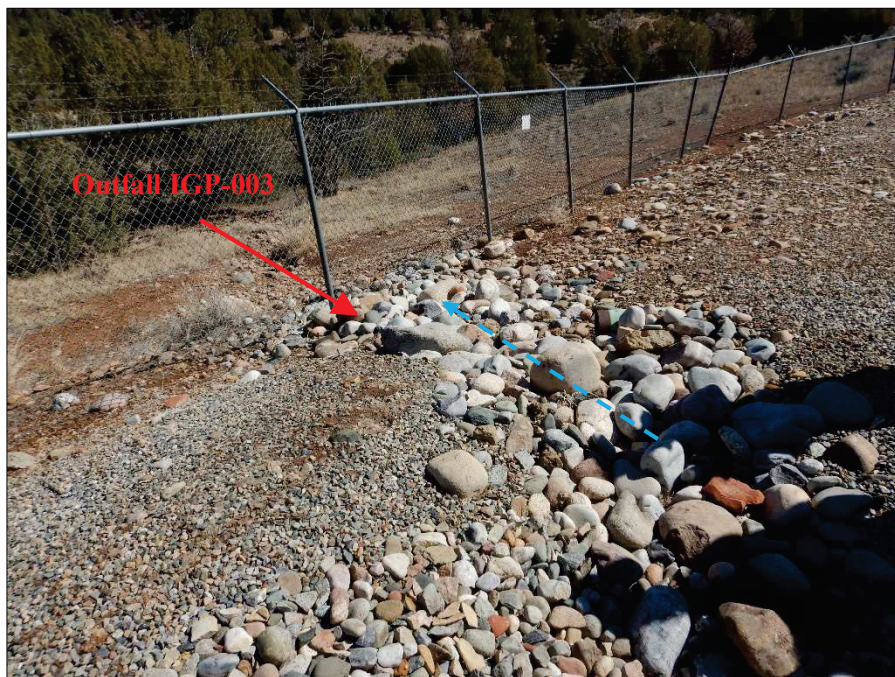
Photograph 86. View, facing Northeast, of Outfall IGP-003.

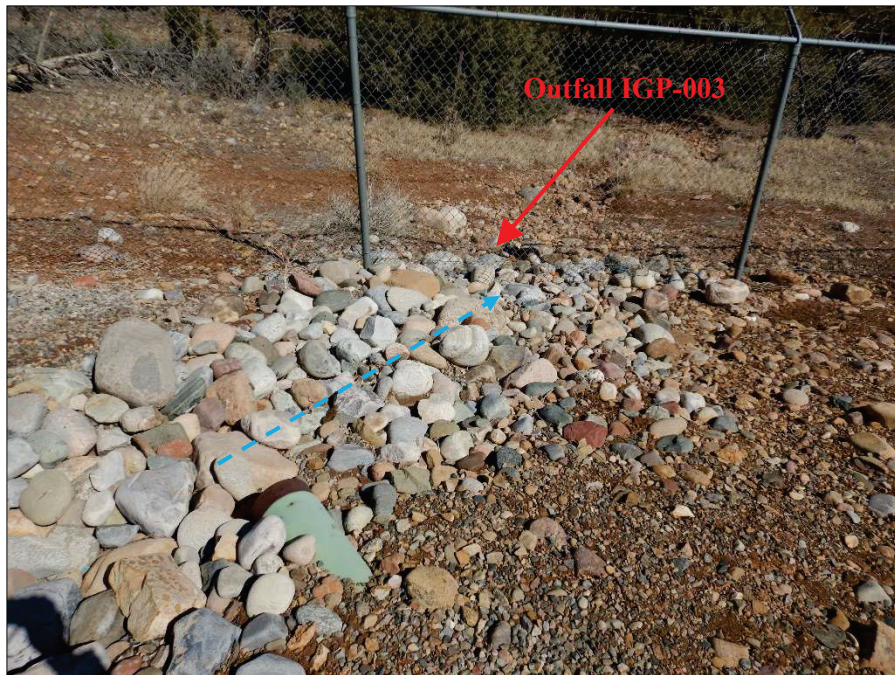
Photograph 87. Additional view, facing Northeast, of Outfall IGP-003, as referenced in Photograph 86.

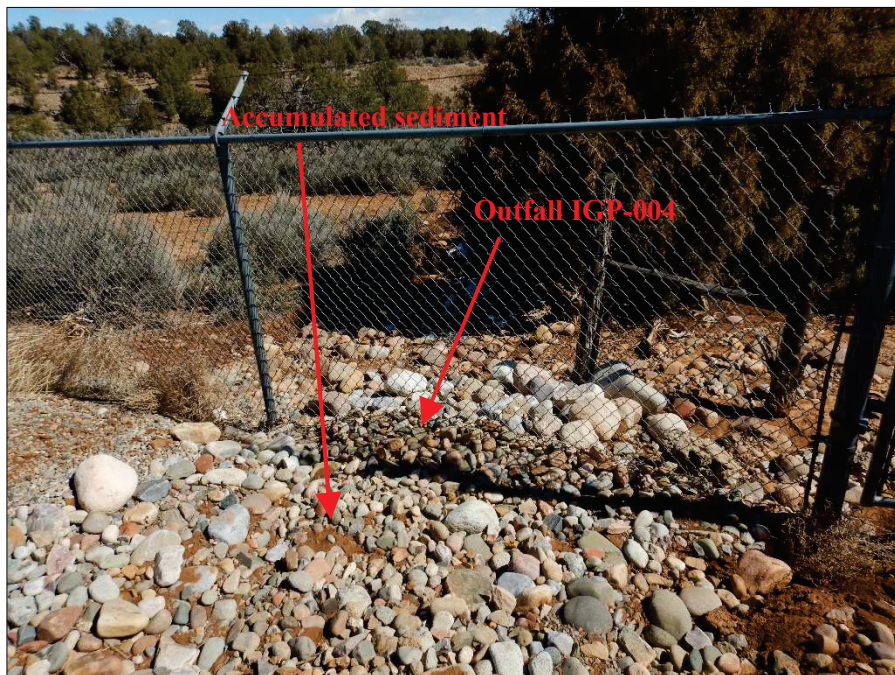
Photograph 88. View, facing East, of Outfall IGP-004. Note sediment accumulated upgradient from the outfall.

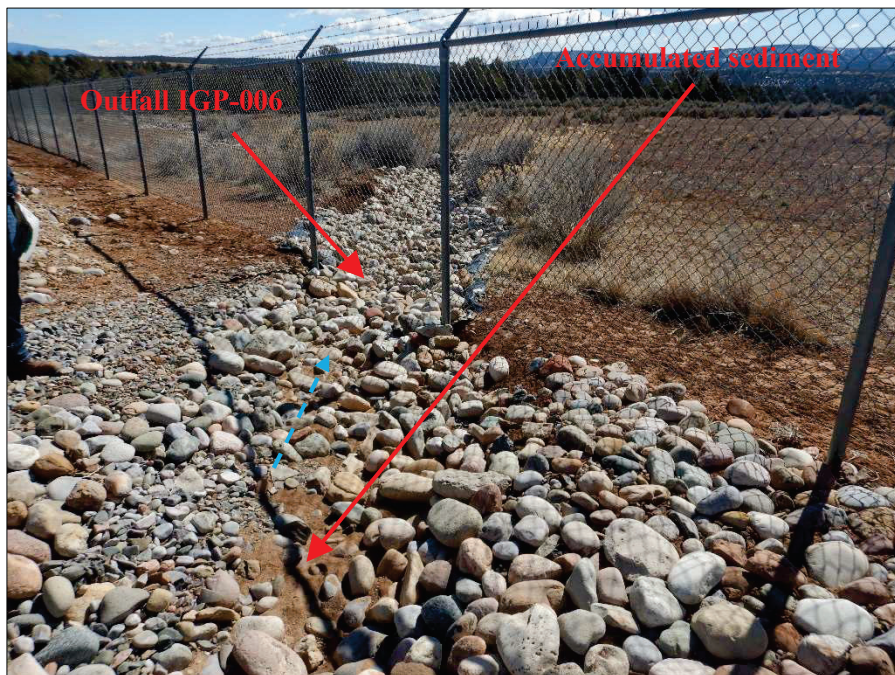
Photograph 94. View, facing Southeast, of Outfall IGP-006. Note accumulated sediment upgradient from the outfall.

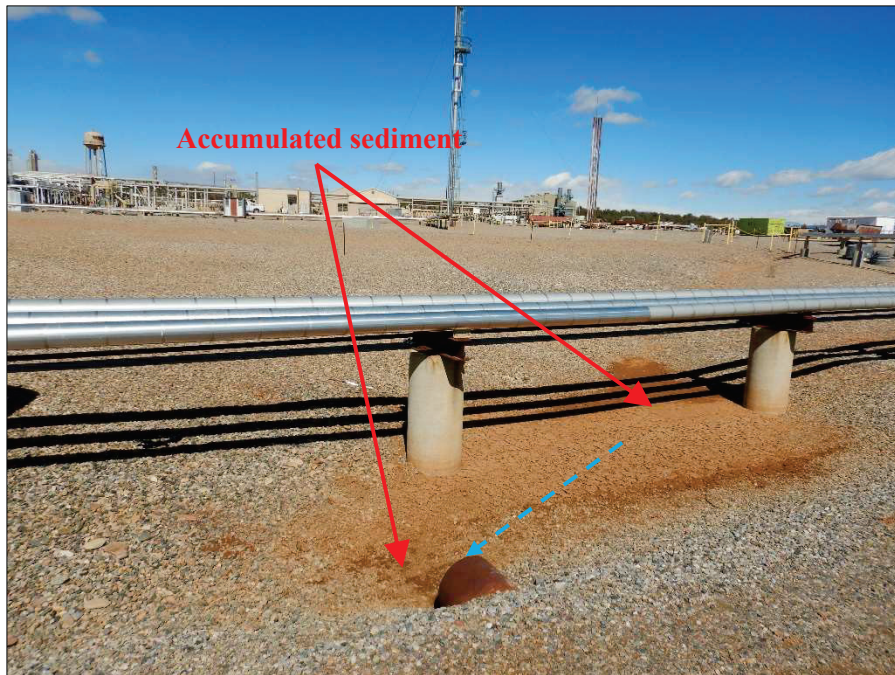
Photograph 95. View, facing Northeast, of inlet of culvert in Drainage Area 9, near West Excess Pond. Note sediment accumulation.

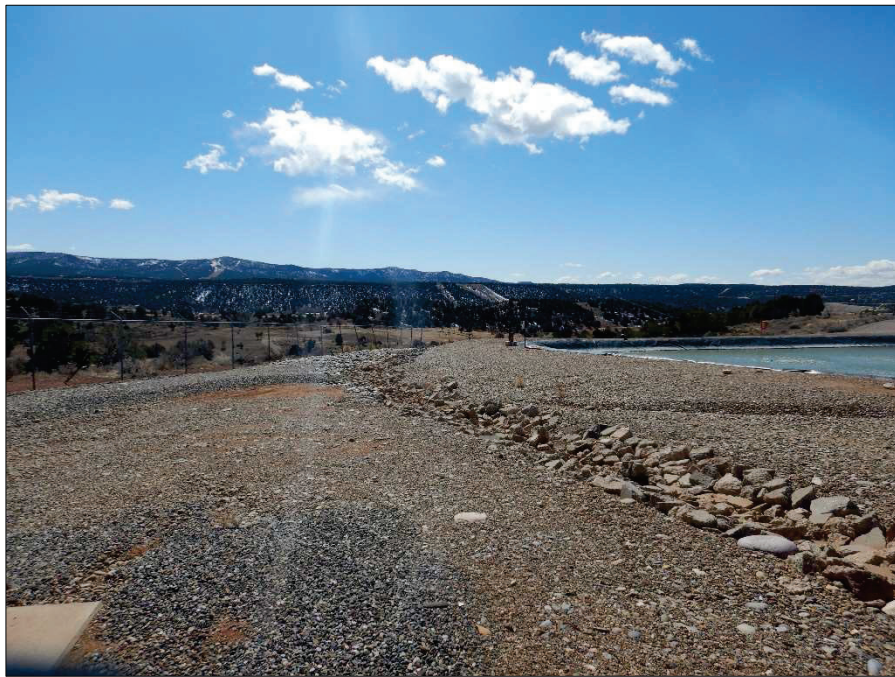
Photograph 96. View, facing South, of a ditch near East Excess Pond which drains to Outfall IGP-009, downstream from the culvert shown in Photograph 95.

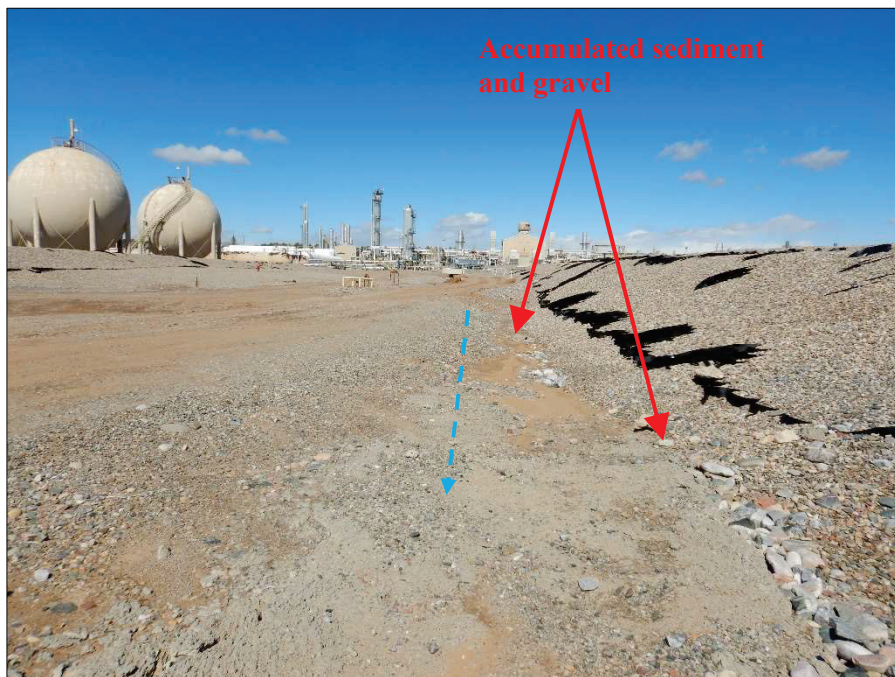
Photograph 100. View, facing North, of ditch along west berm of Clearwater Pond. Note accumulated sediment and gravel.

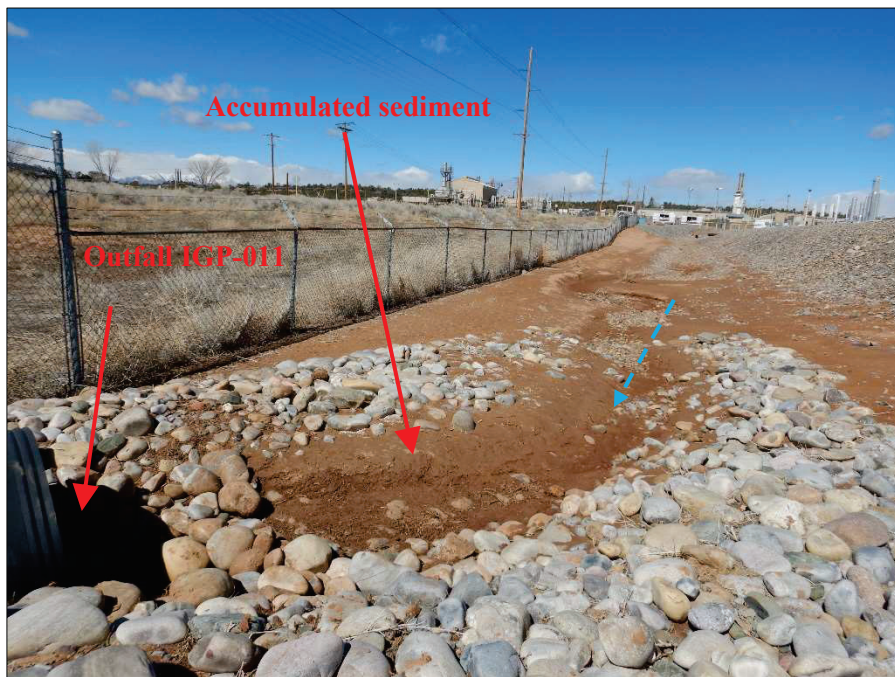
Photograph 102. View, facing North, of Outfall IGP-011. Note sediment accumulation.

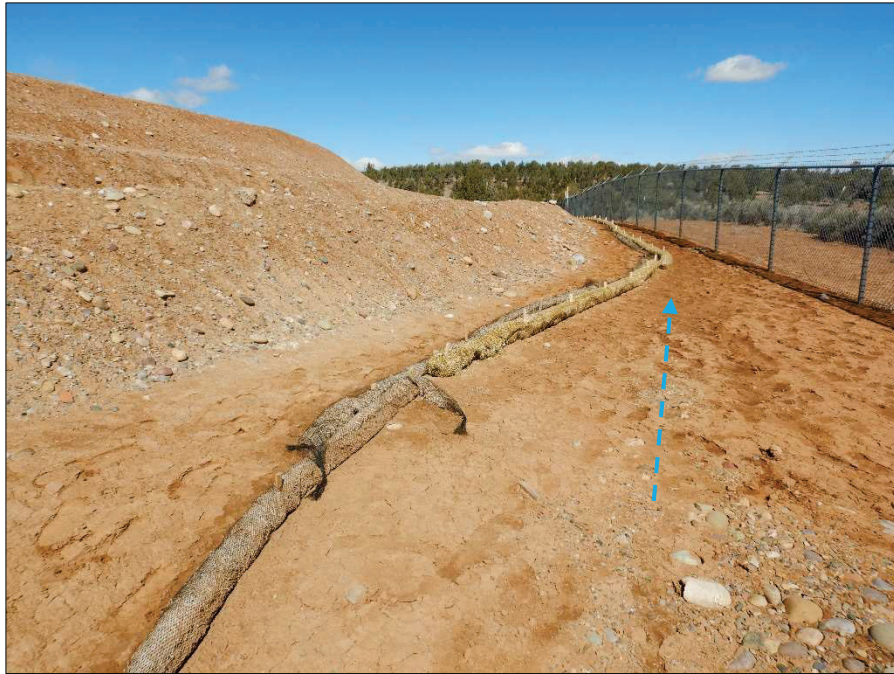
Photograph 105. View, facing North, of straw wattle along fence line in Drainage Area 15, downgradient from an unstabilized bank around the Soil Drying Containment Area. Note deterioration of the straw wattle and sediment accumulation against wattle barriers.

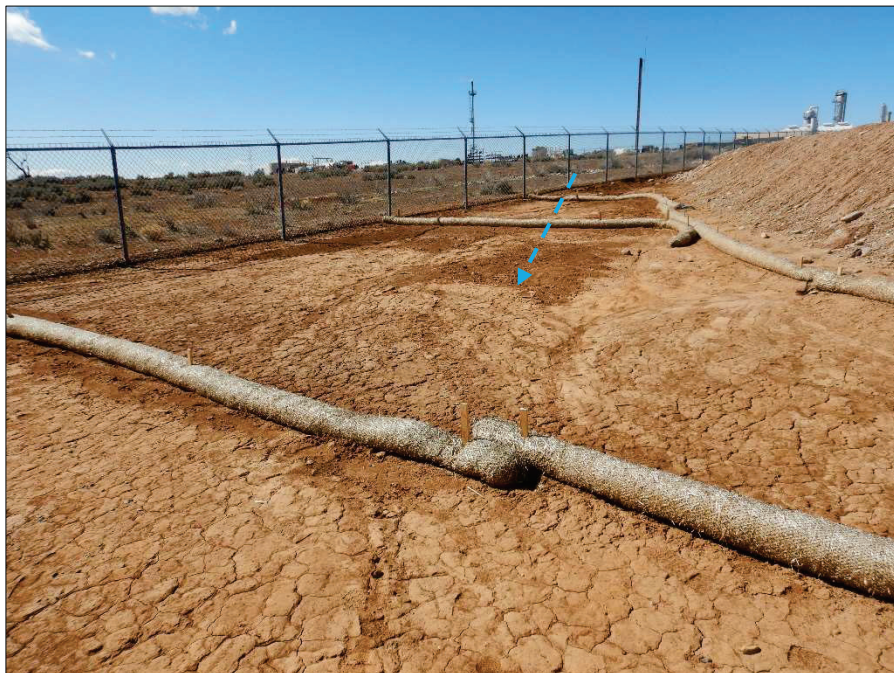
Photograph 106. Additional view, facing Southwest, of straw wattles along fence line in Drainage Area 15, near the Soil Drying Containment Area, downgradient from the area shown in Photograph 105. Note sediment accumulation against the wattles.

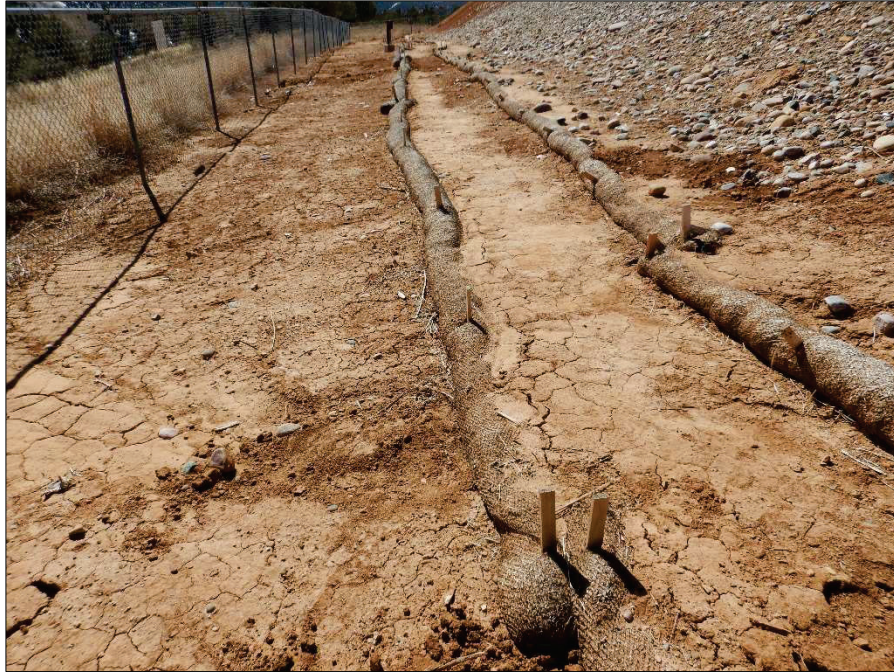
Photograph 111. Close-up view, facing Southwest, of straw wattles along southeastern side of South Evaporation Pond, as referenced in Photograph 110. Note deterioration of straw wattles and sediment accumulation against the wattles.

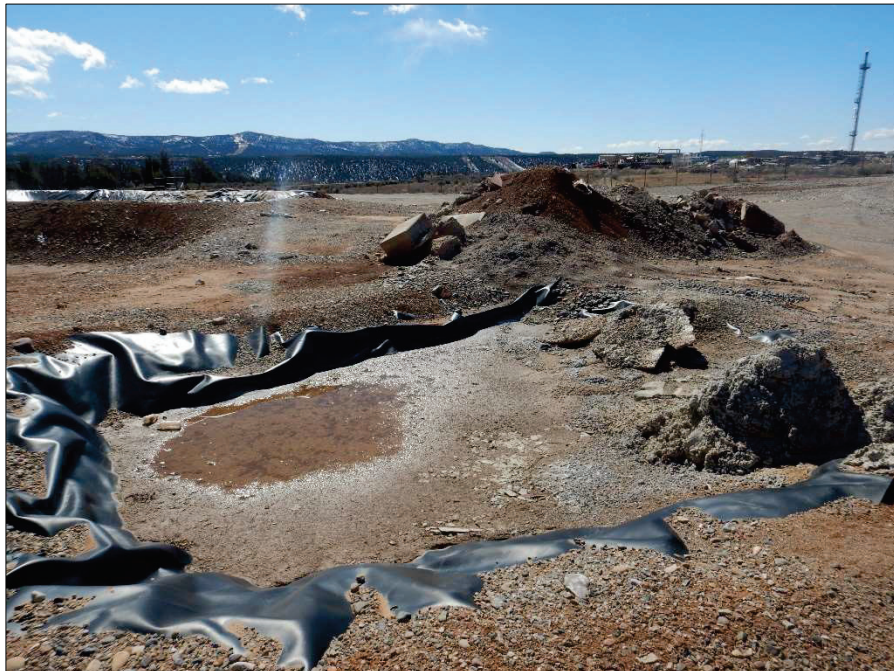
Photograph 112. View, facing Southwest, of a concrete washout area located in Drainage Area 15. The concrete wash out area was more than half full at the time of the inspection.
