## INSPECTION REPORT

| <b>Type of Inspection</b> | Compliance Evaluation Inspection | | |
| <b>Permittee Name</b> | Lurre Construction | | |
| <b>Site Name</b> | Kuna Mora Pit aka Blacks Creek Pit | | |

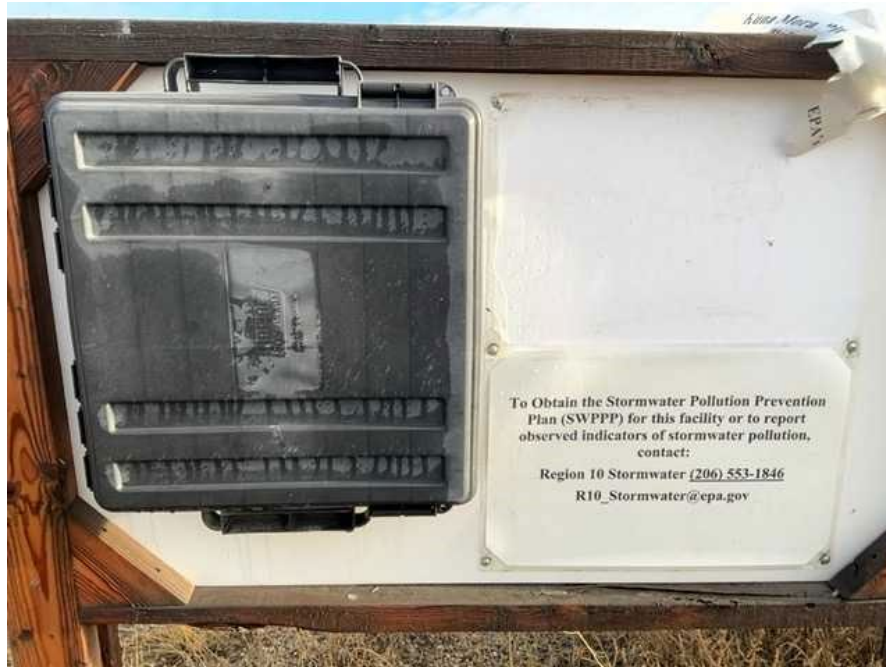
| Site Entrance Sign with SWPPP, Photo 1 | | | |

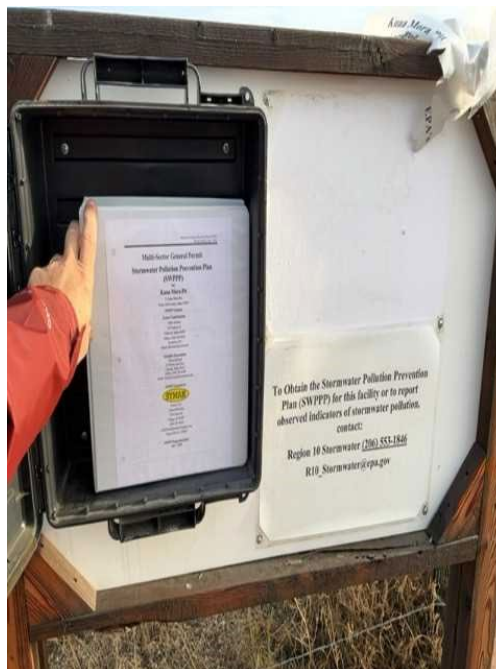
| Site Entrance Sign with SWPPP, Photo 2 | | | |

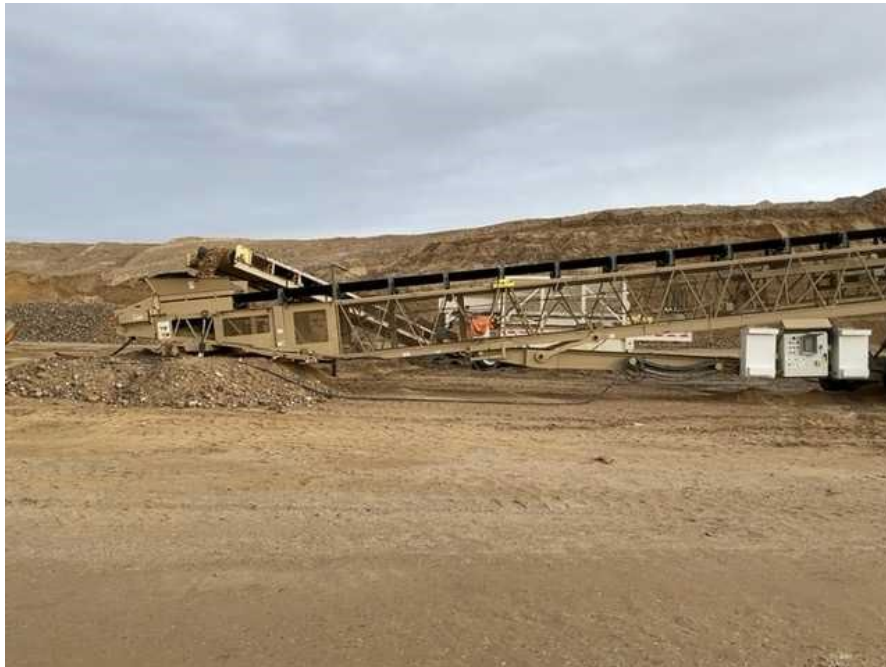
| Conveyor, photo 1 | | | |

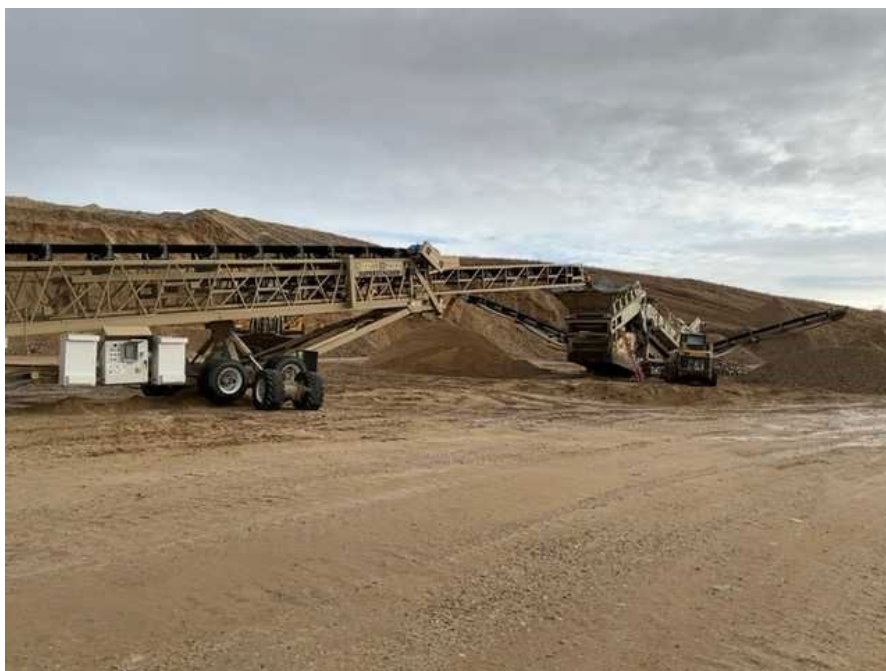
| Conveyor, photo 2 | | | |

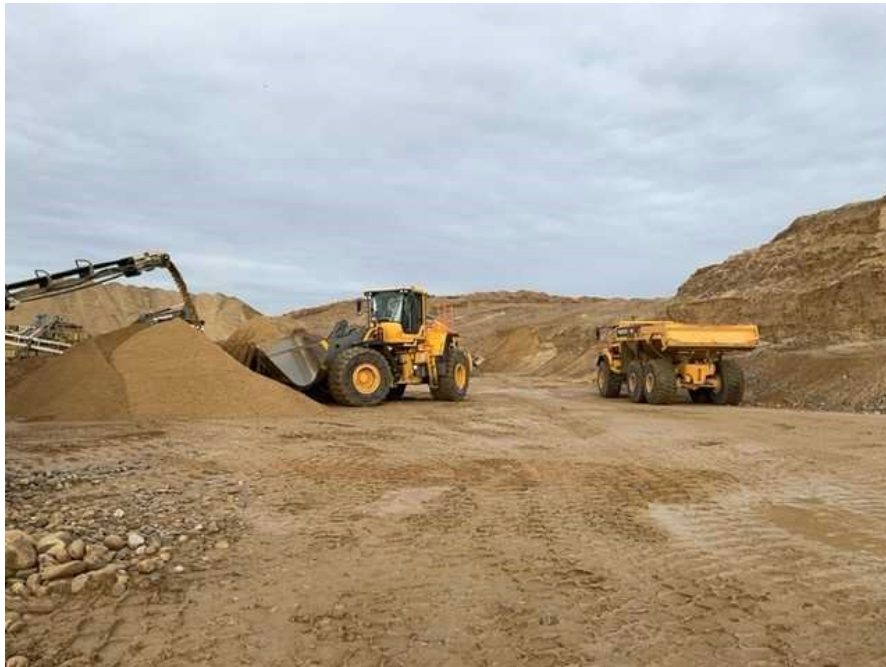
| End of Conveyor on left side of photo with bucket loader and dump truck | | | |

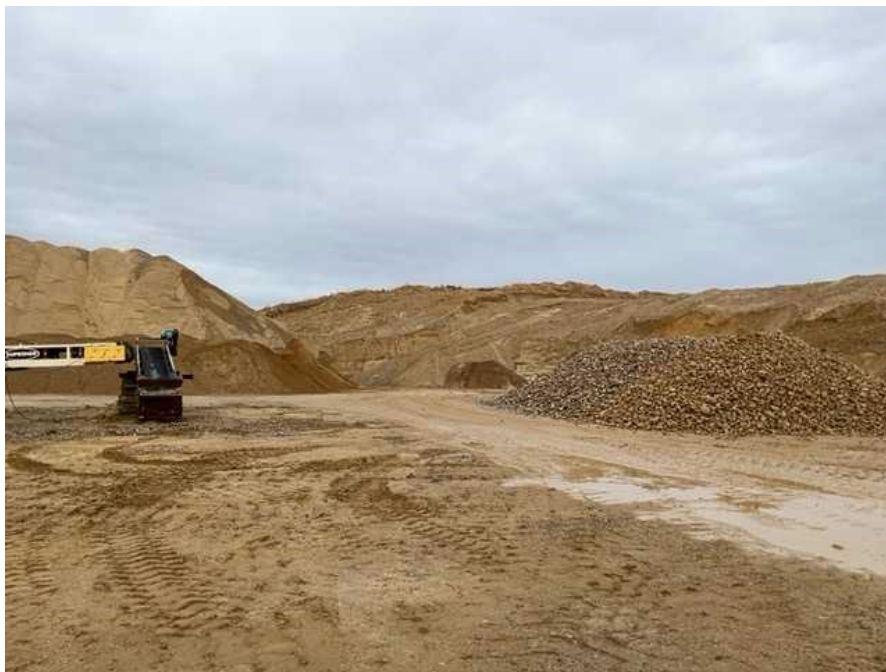
| General site photo | | | |

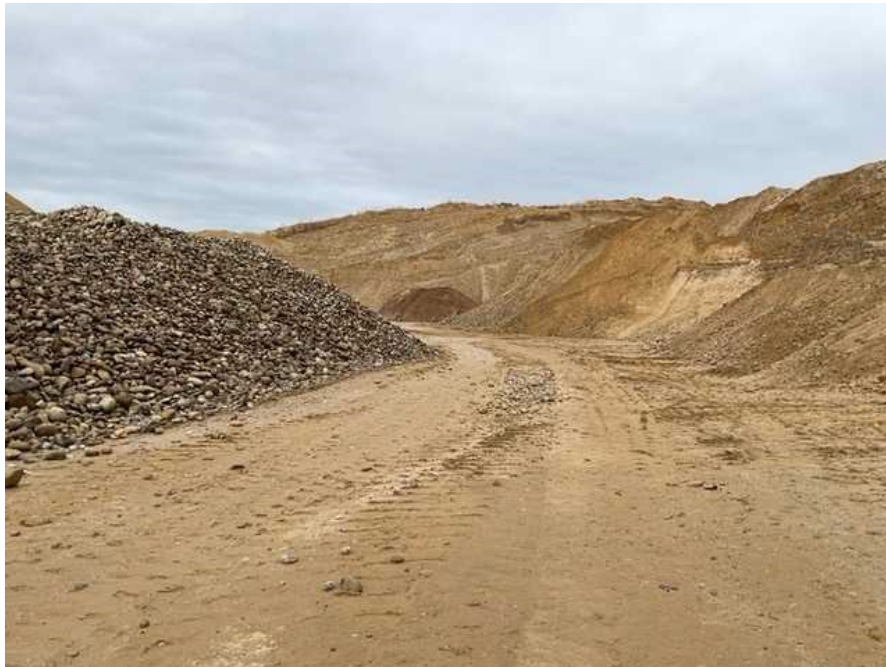
| Access Road with working rock pile on the left | | | |

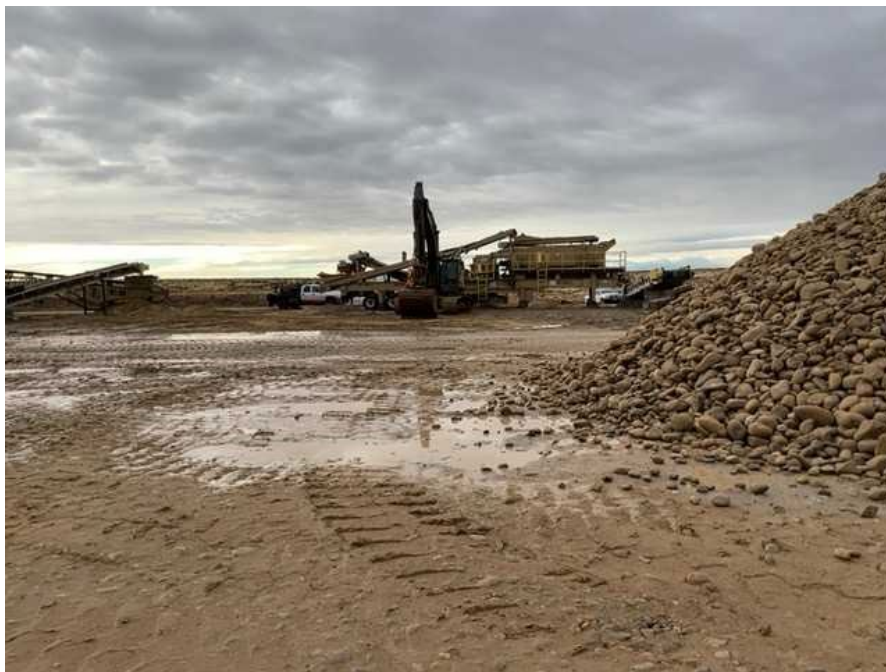
| Rock Crusher with piled rock in foreground | | | |

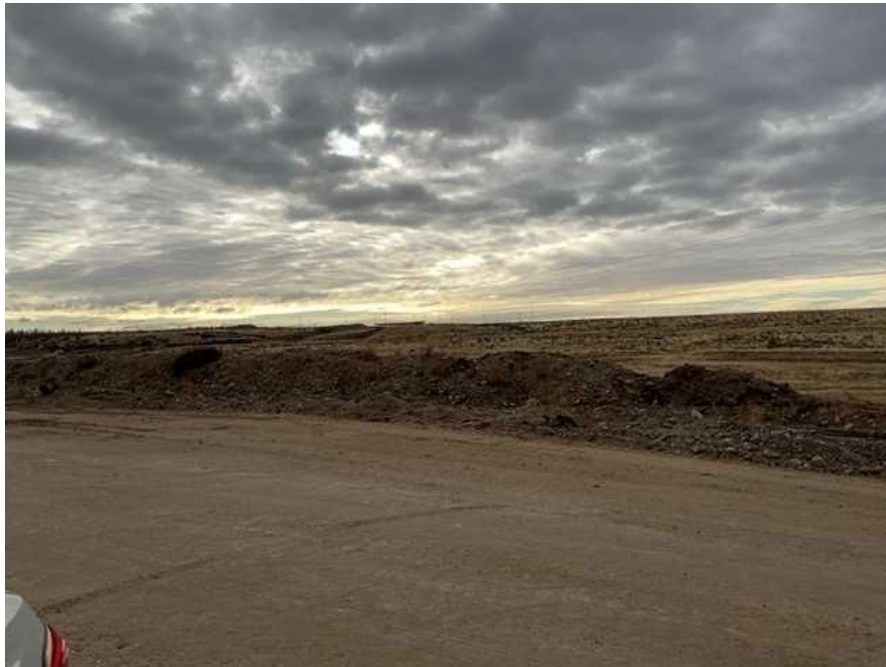
| Access road with active site perimeter berm, photo 1 | | | |

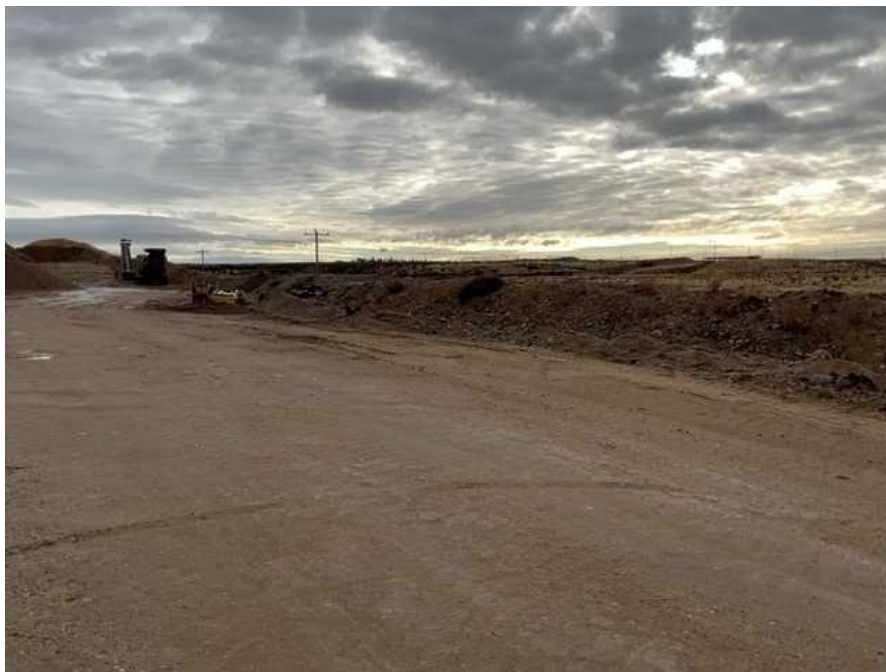
| Access road with active site perimeter berm, photo 2 | | | |
