**Region 6 Compliance Assurance and Enforcement Division  
INSPECTION REPORT**

| Inspection Date(s): | 1/19/2018 | | |
| Facility Name: | Rio de Arenas Wastewater Treatment Plant | | |
| Identification/Permit Number: | NM0027375 | | |

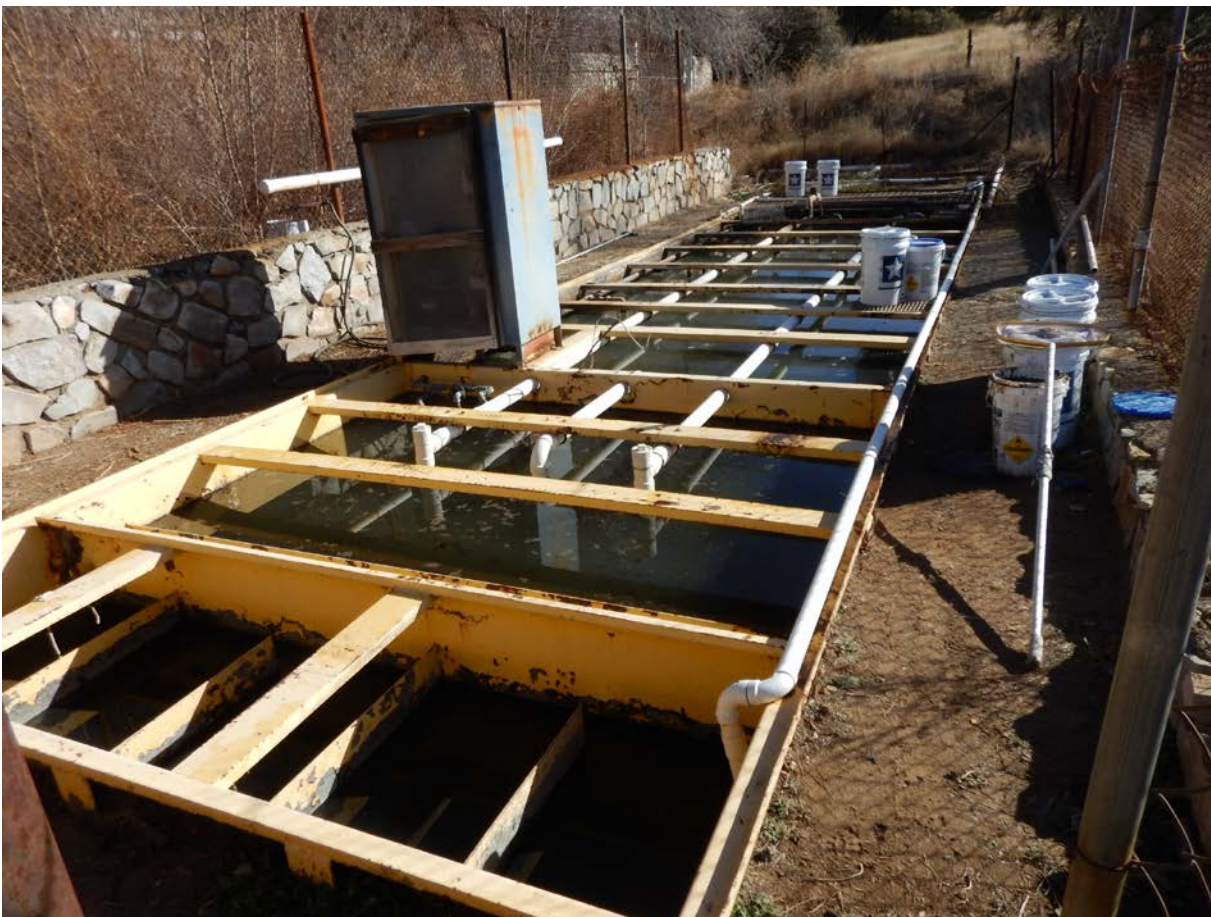
Photo No. 1

Description: View of the wastewater treatment plant, with the chlorine contact chamber at the bottom of the photo.

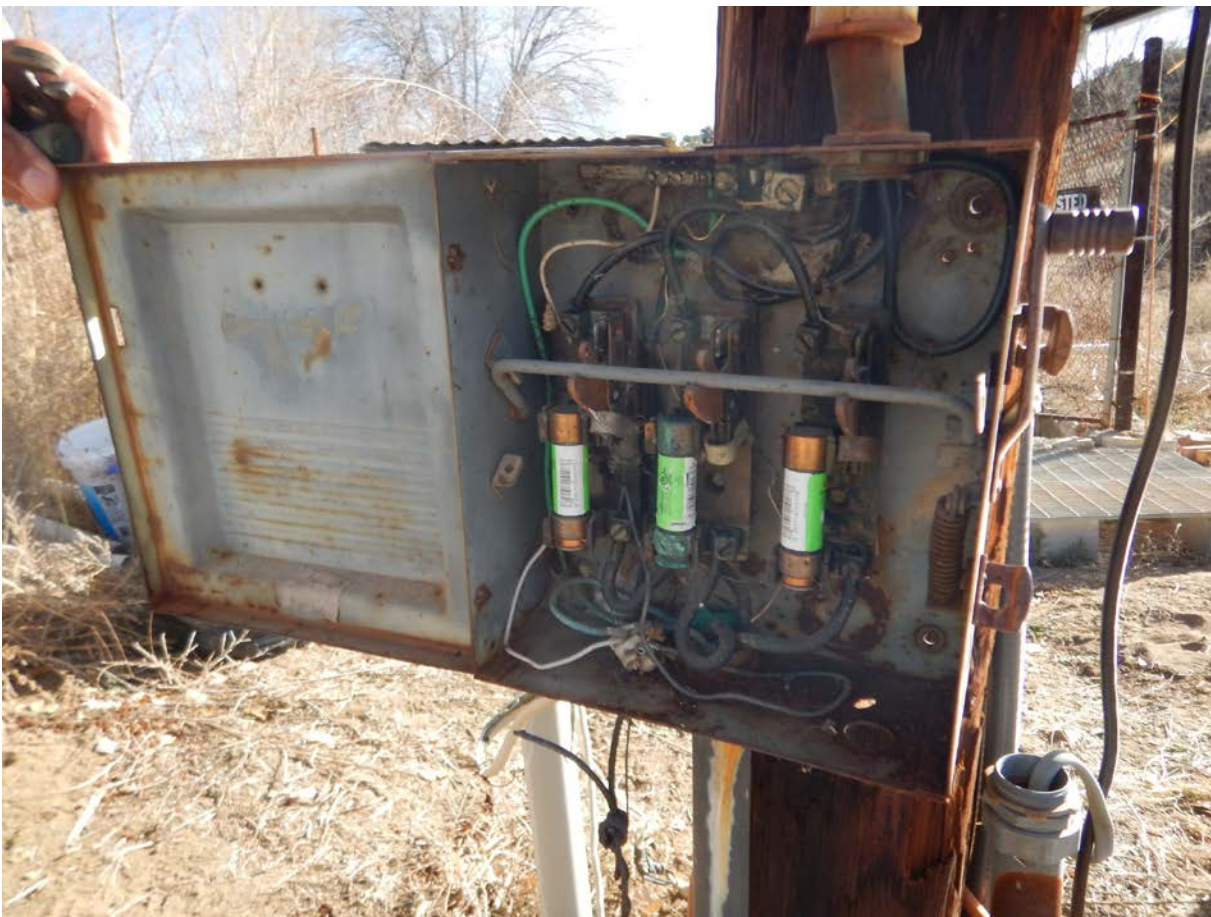
Photo No. 2

Upon arrival at the facility, the wastewater treatment plant was non-operational because the power had gone out. Mr. Orosco was replacing the fuses in the fuse box (see Photos 2-4 in Appendix 1). He stated that he didn't know how long the power had been out but that was not the first time the power had gone out and the "classic" fuses are difficult to find in stores and hazardous to replace.

Description: Inside of the electrical control panel, showing the "classic" fuses.

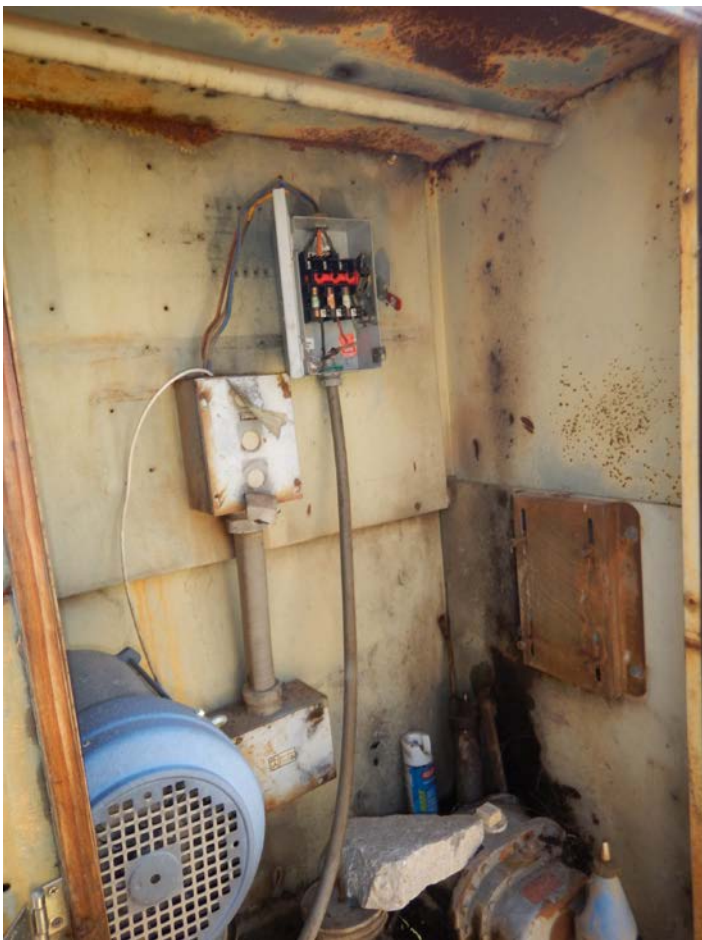
Photo No. 3

Description: Closeup view of a second electrical control panel with similar "classic" fuses.

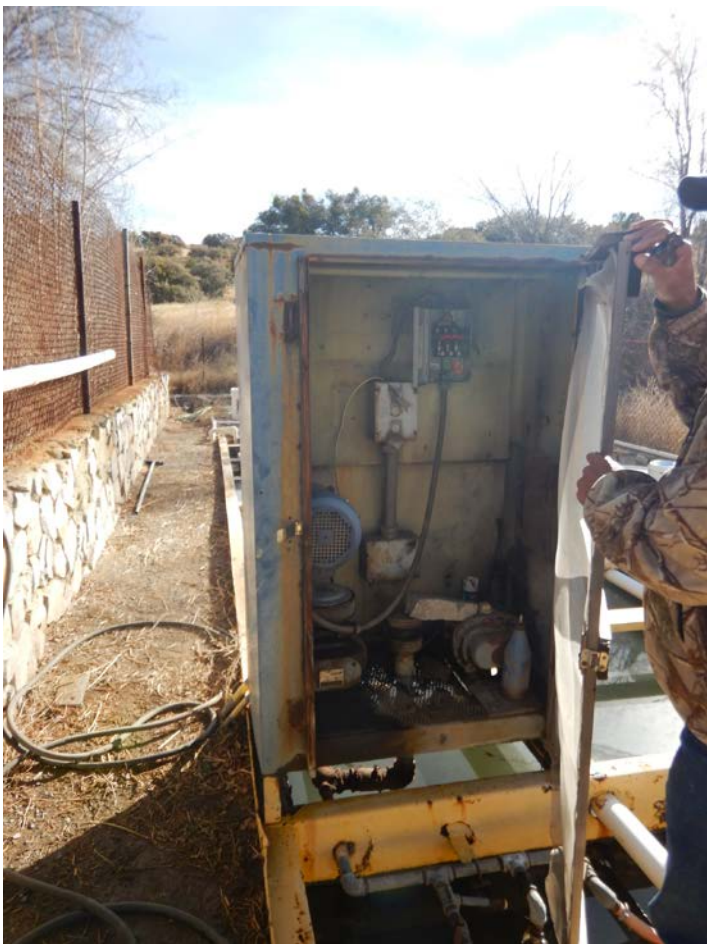
Photo No. 4

Description: View of the second electrical control panel, inside of a maintenance closet.

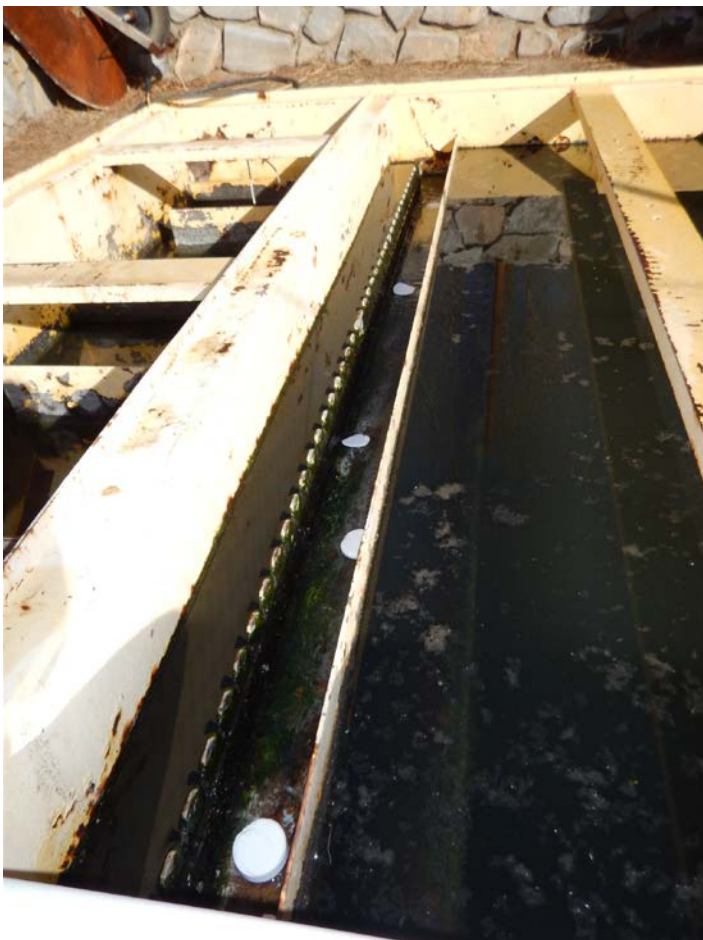
Photo No. 5

There were solids floating in the clarifier (see Photo 5 in Appendix 1). It was unclear if this was a result of short circuiting in the system due to the aforementioned power failure, or a more serious problem with the operation of the plant itself.

Description: View of the clarifier with solids present.

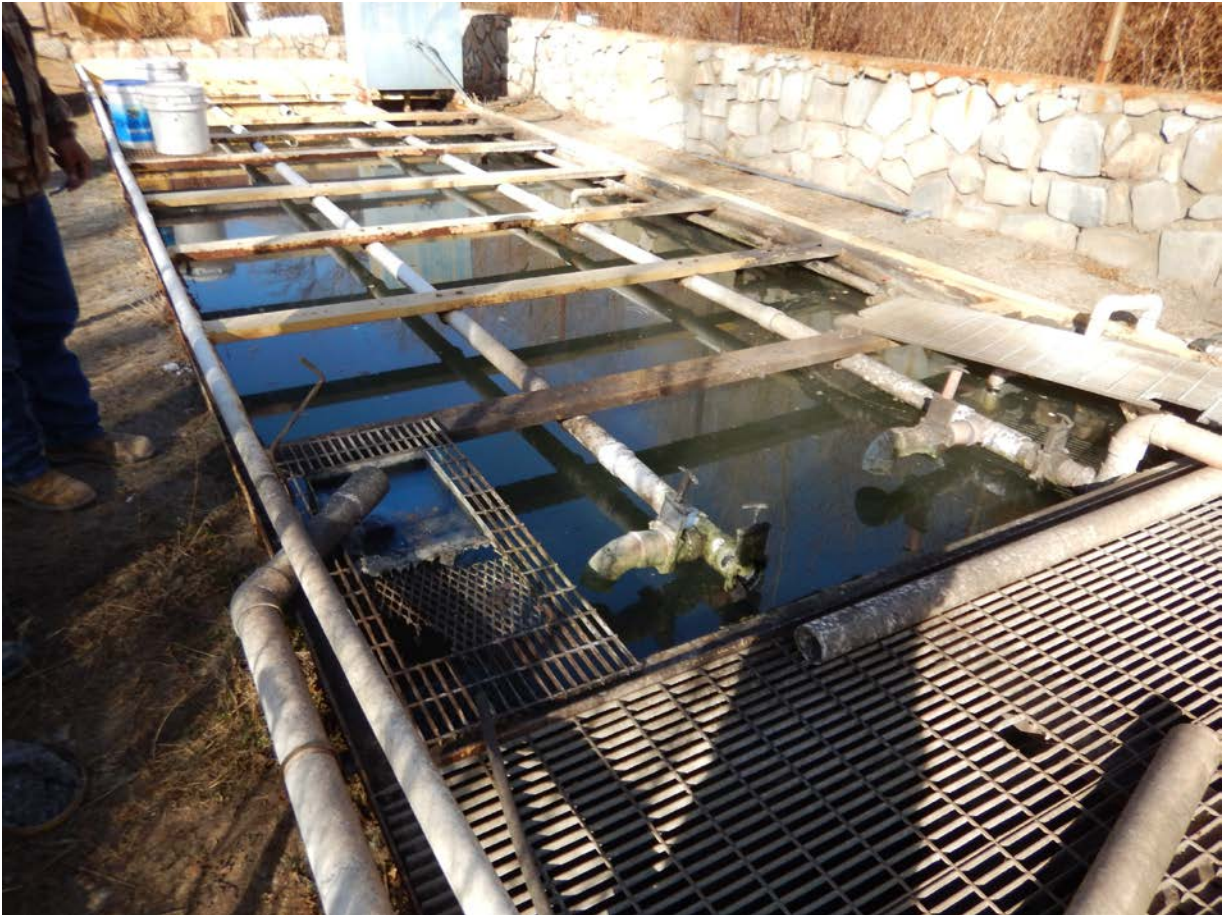
Photo No. 6

Piping at the facility had been used to prop up other piping (see Photo 6 in Appendix 1), rather than using appropriate strapping. Mr. Orosco stated that there was a lack of funding for the items needed to do the maintenance properly.

Description: View of piping propped up with other piping.
