### INSPECTION REPORT

| Inspection Date(s): | 05/29/2025 | |
| Company Name: | <b>R&amp;D Resources</b> | |
| Facility Name: | <b>Stoney #1</b> | |

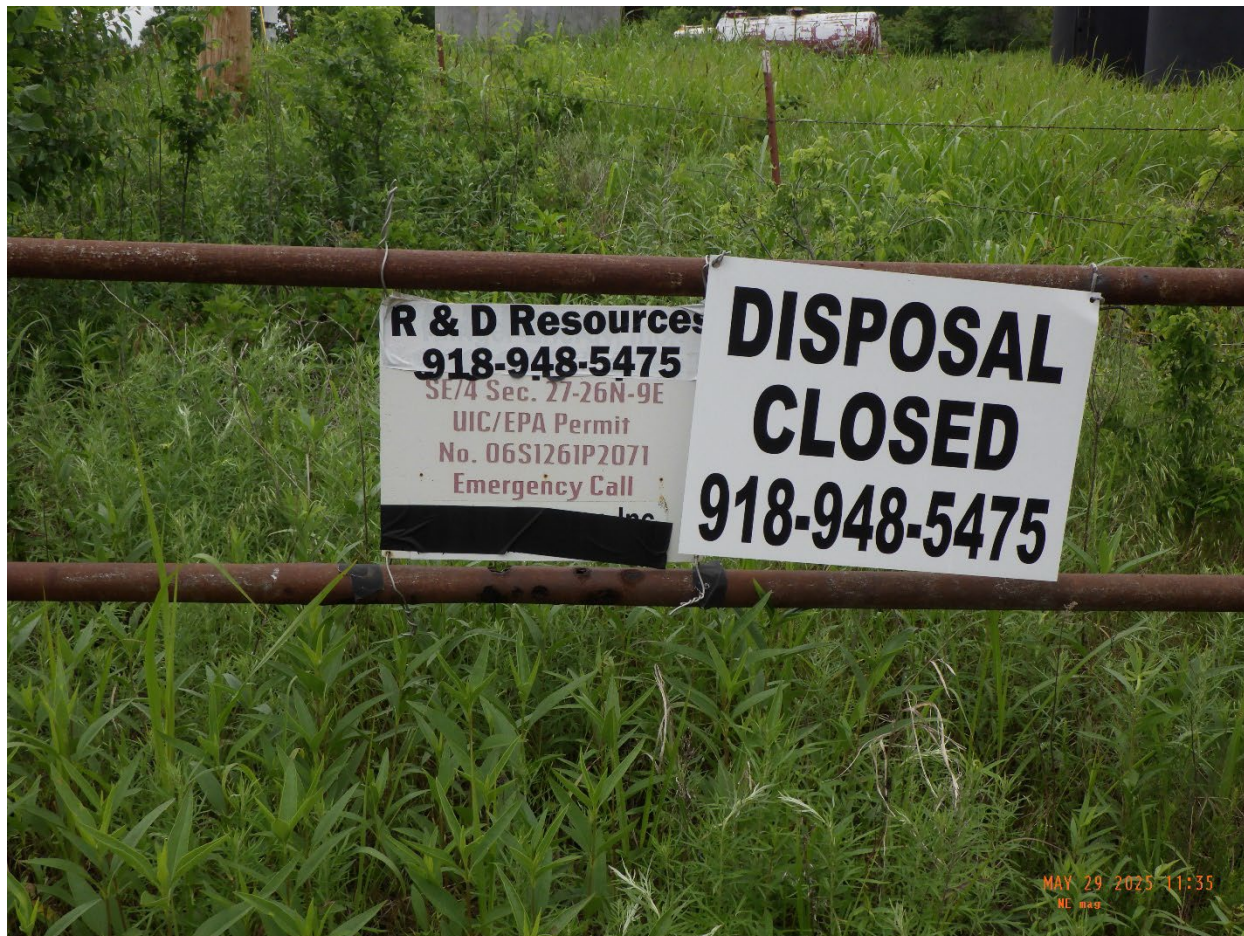
Photo No. 1

I observed the facility sign for the R&D Resources, Stoney #1 lease, see Photo No. 1. For additional GPS location information and photo metadata, please see Appendix 1 (photo log) attached to this report.

Description: Looking NE, this was the facility sign for the R&D Resources, Stoney #1 Lease.

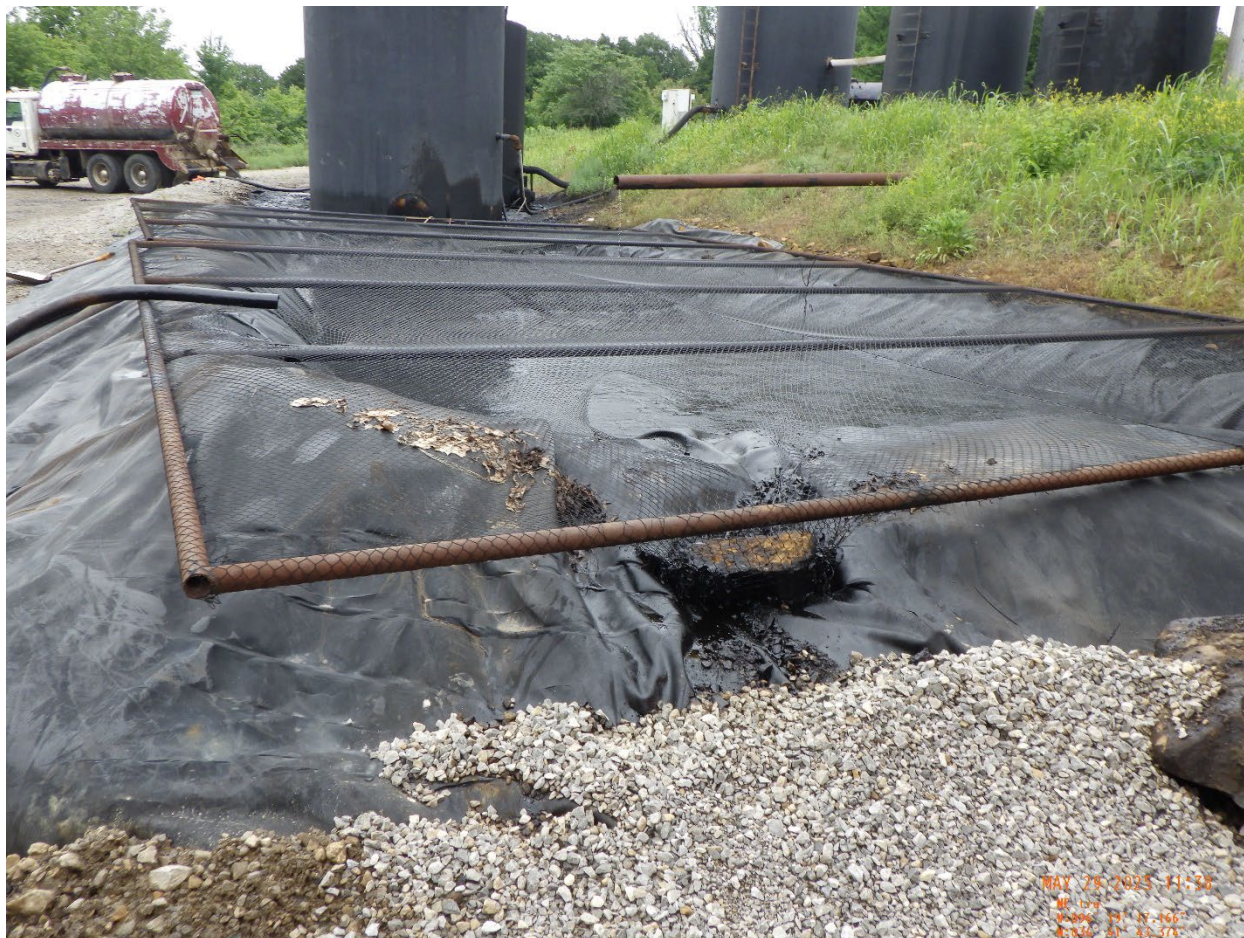
Photo No. 2

I observed the release point of the spill. The spill overtopped the facility's secondary containment near the southwest corner, releasing a company-estimated 1.5 barrels of oil, see Photo No. 2.

An additional area of concern was the possibility of the same type of release recurring due to improper drainage systems at the responsible facility, which allowed excess stormwater runoff to enter the facility and overwhelm the secondary containment.

**Description:** Looking NE, this was the release point of the spill, the low point in the secondary containment where oil and diluted saltwater overtopped the lined pit area.

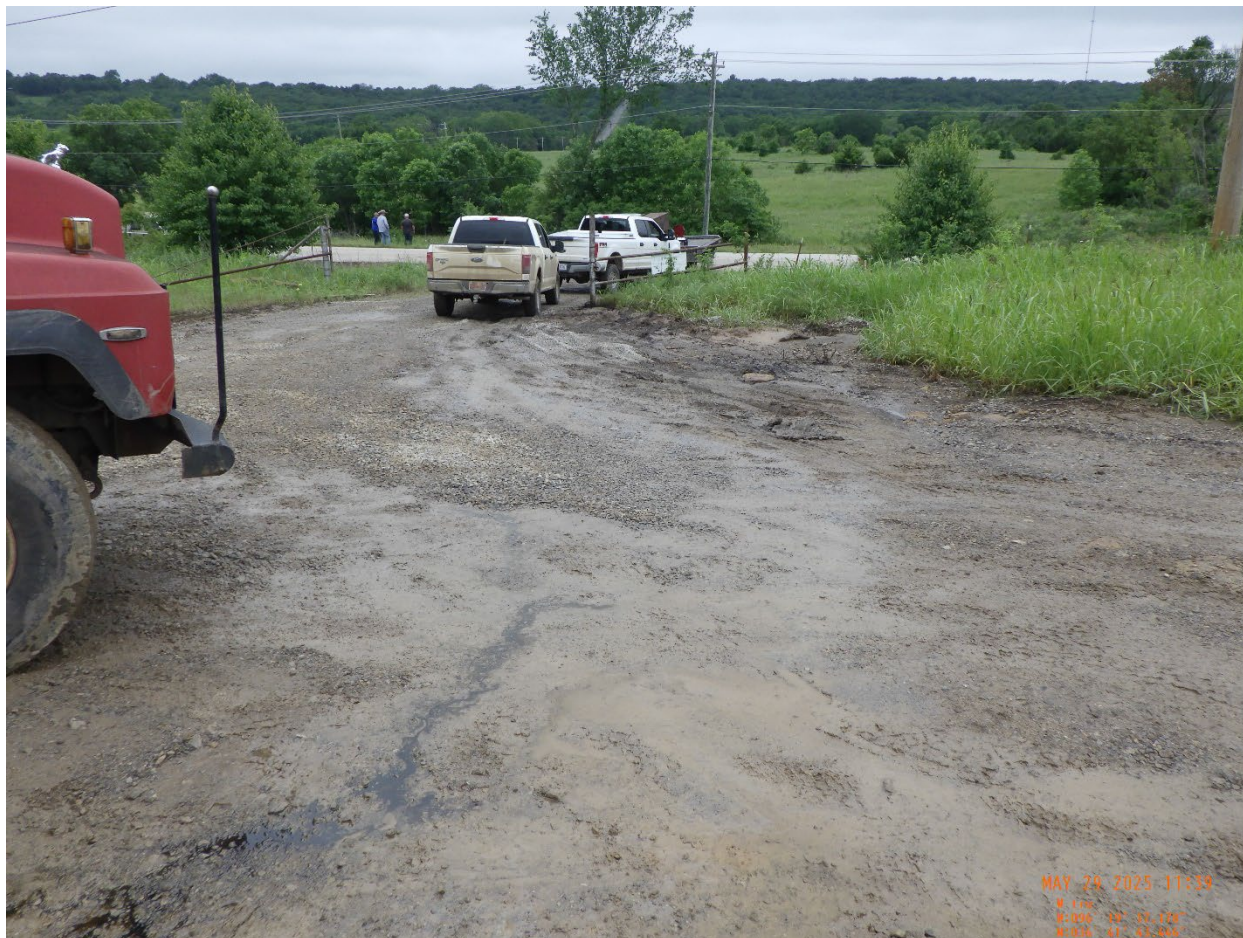
Photo No. 3

From the release point, I observed the overland flowpath of the release as spill impacts migrated toward the southwest. The flowpath primarily consisted of the gravel road ingress/egress associated with the facility, see Photo No. 3.

**Description:** Looking W, this was the overland flowpath from the release point toward the west.

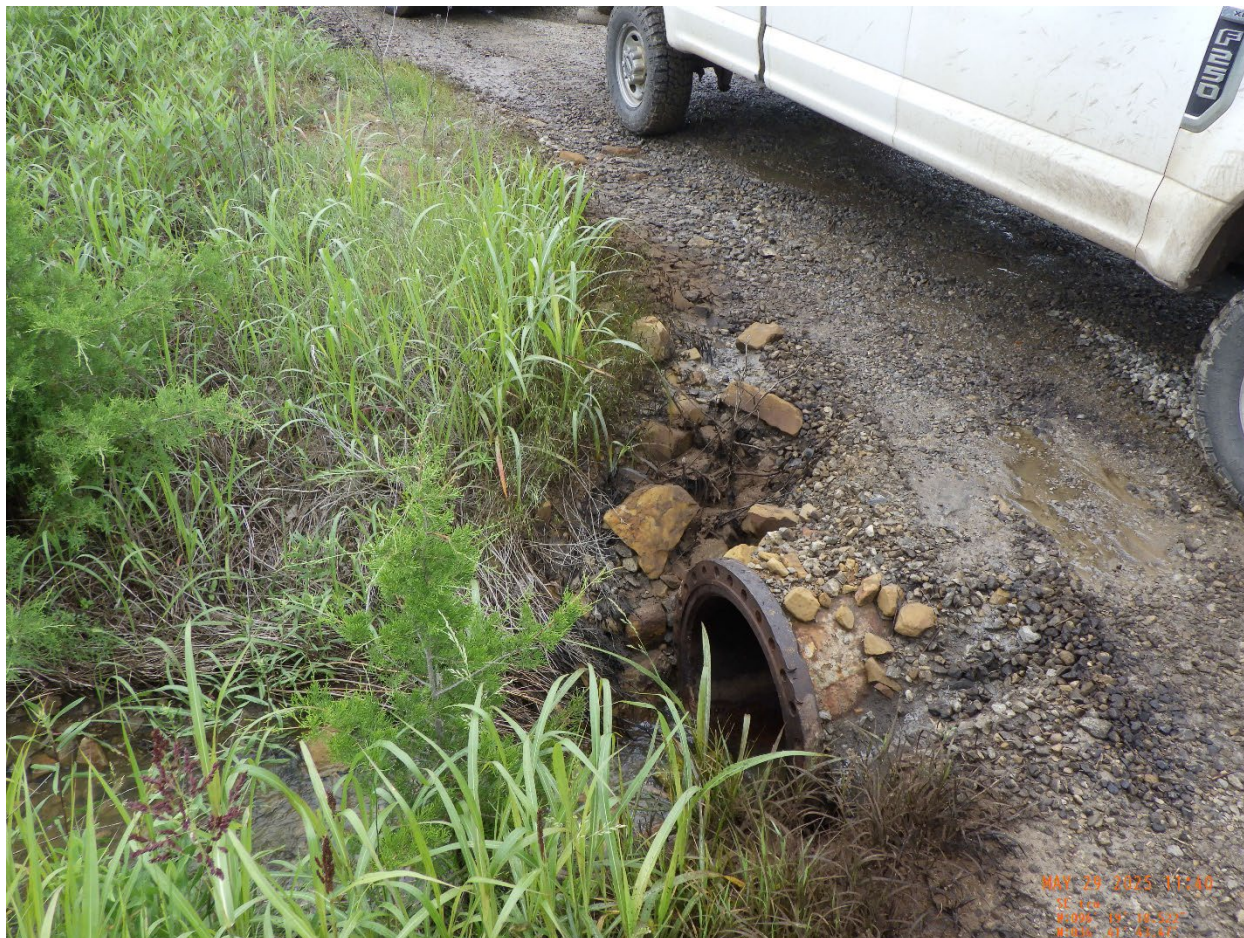
Photo No. 4

I observed the point of entry (POE) of spill impacts into the conveyance (ditch) along Lynn Avenue, which ran along the west side of the facility, see Photo No. 4.

**Description:** Looking SE, this was the point of entry (POE) into a conveyance (ditch) along Lynn Avenue.

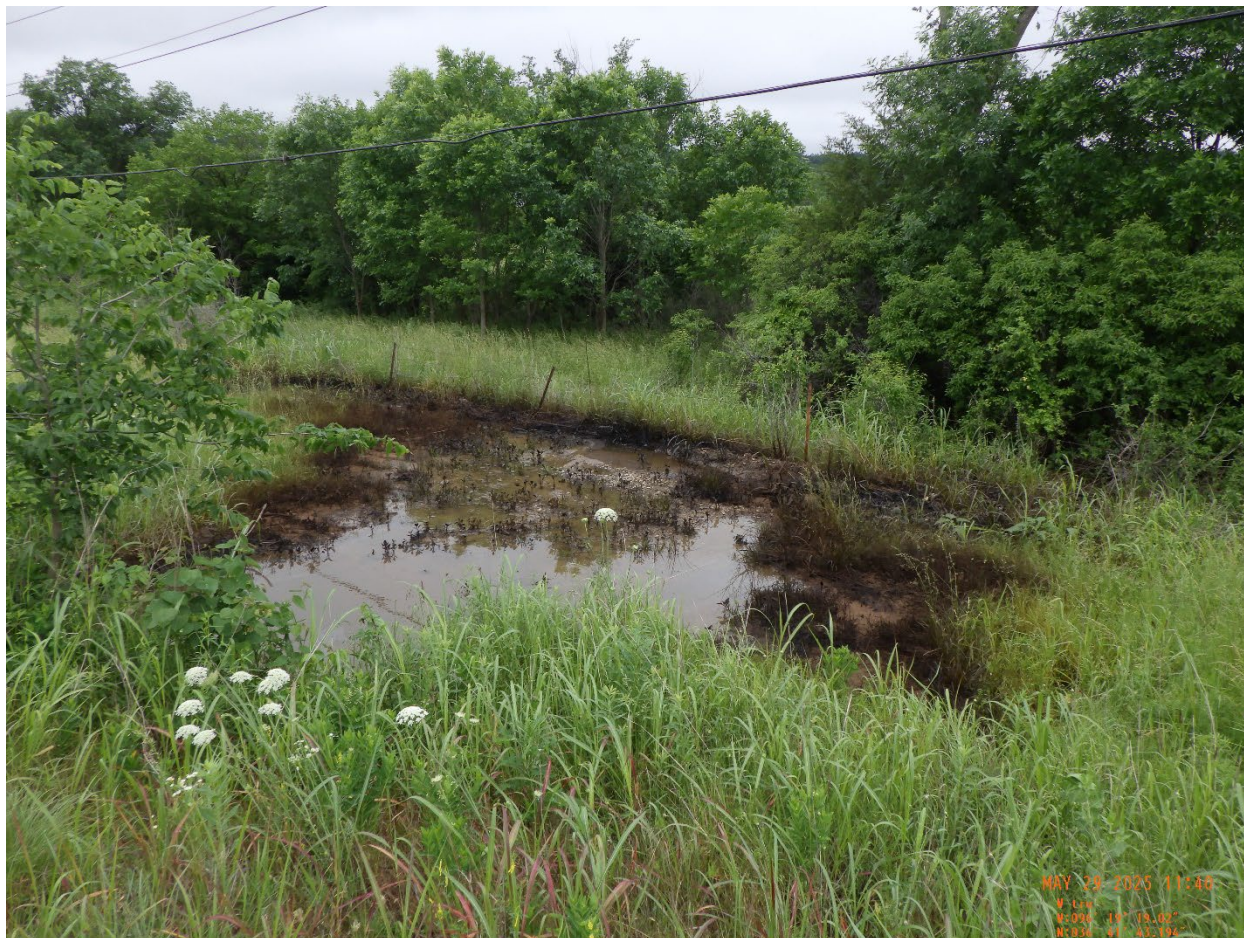
Photo No. 5

On the west side of Lynn Avenue (across the road from the facility), I observed a significant area of oil-stained soil and vegetation along the conveyance. At this same location, I observed a TDS field reading of **165.3 mg/L**, see Photos No. 5 and 6.

The primary area of concern was the oil-stained soil and vegetation along the roadside conveyance on the east and west sides of Lynn Avenue and the overland flowpath that was impacted by oil.

**Description:** Looking W, this was an area of oil-stained soil and grass in the conveyance along the west side of Lynn Avenue immediately downstream from the POE into the conveyance.

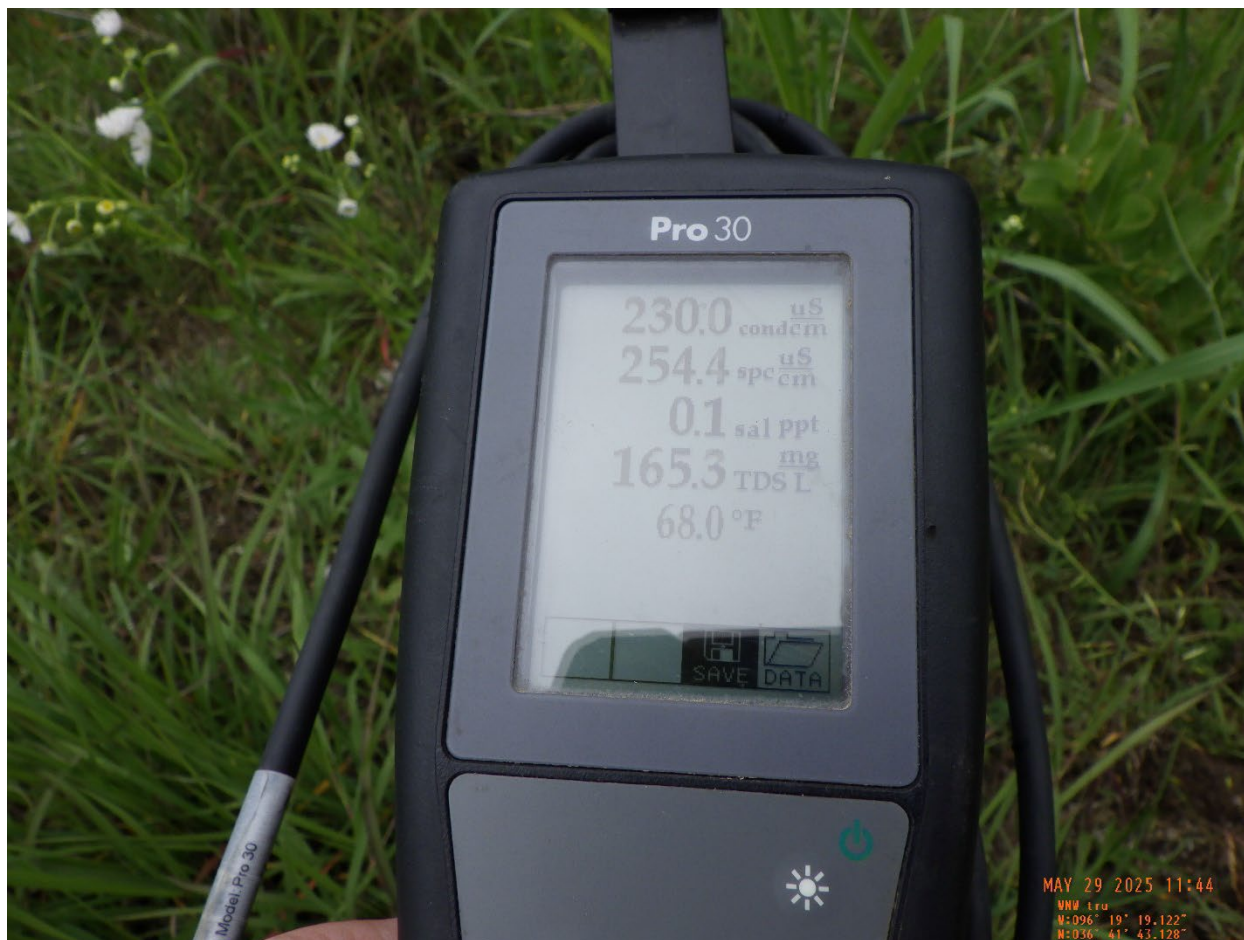
Photo No. 6

**Description:** This was a TDS field reading of **165.3 mg/L** taken in the first pool of water along the impacted conveyance.

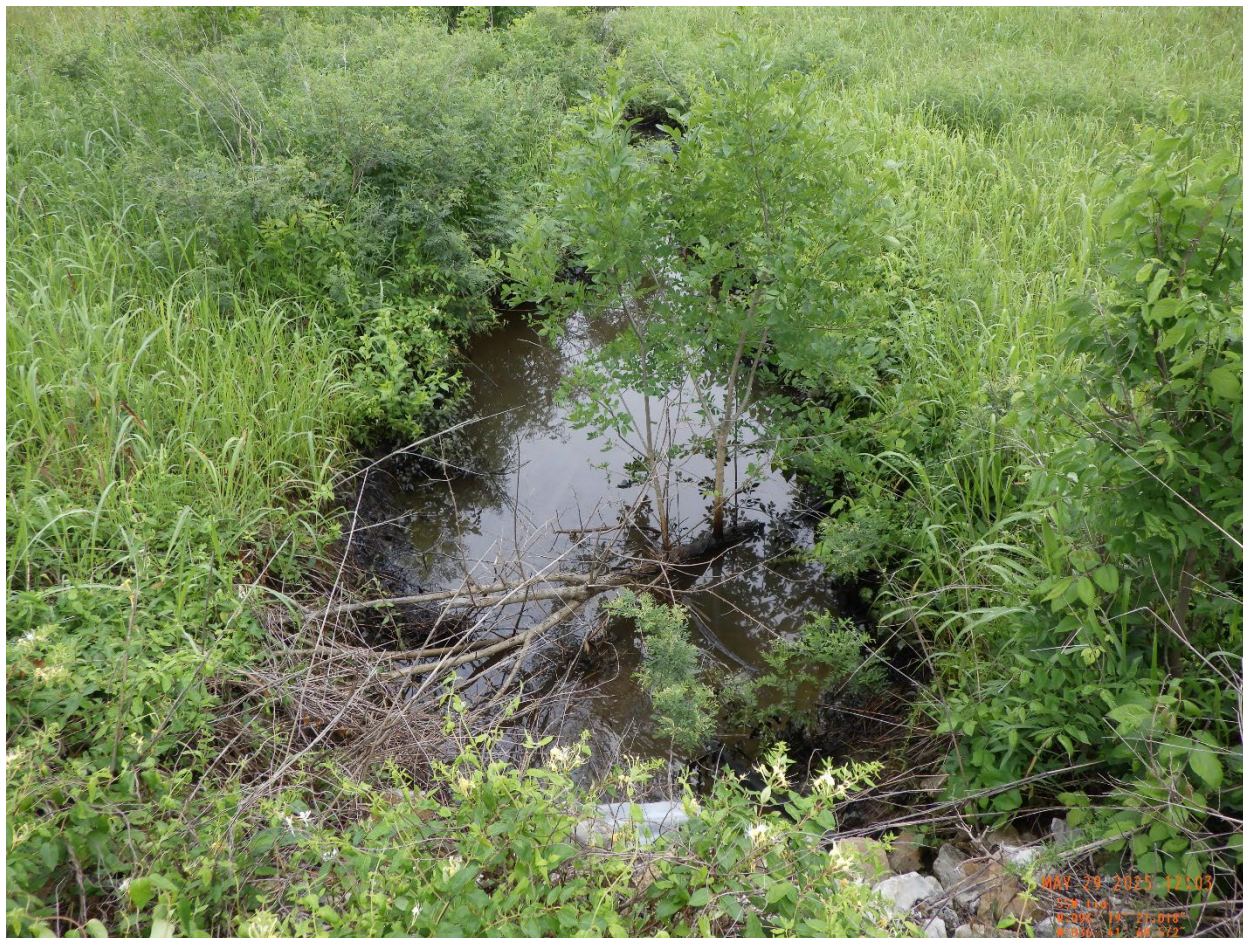
Photo No. 7

On the south side of the intersection of Lynn Avenue and CR4070, I observed oil-stained vegetation in the conveyance, see Photo No. 7.

**Description:** Looking SSW, this was a photo of oil-stained vegetation along the conveyance at the intersection of Lynn Avenue and CR4070.

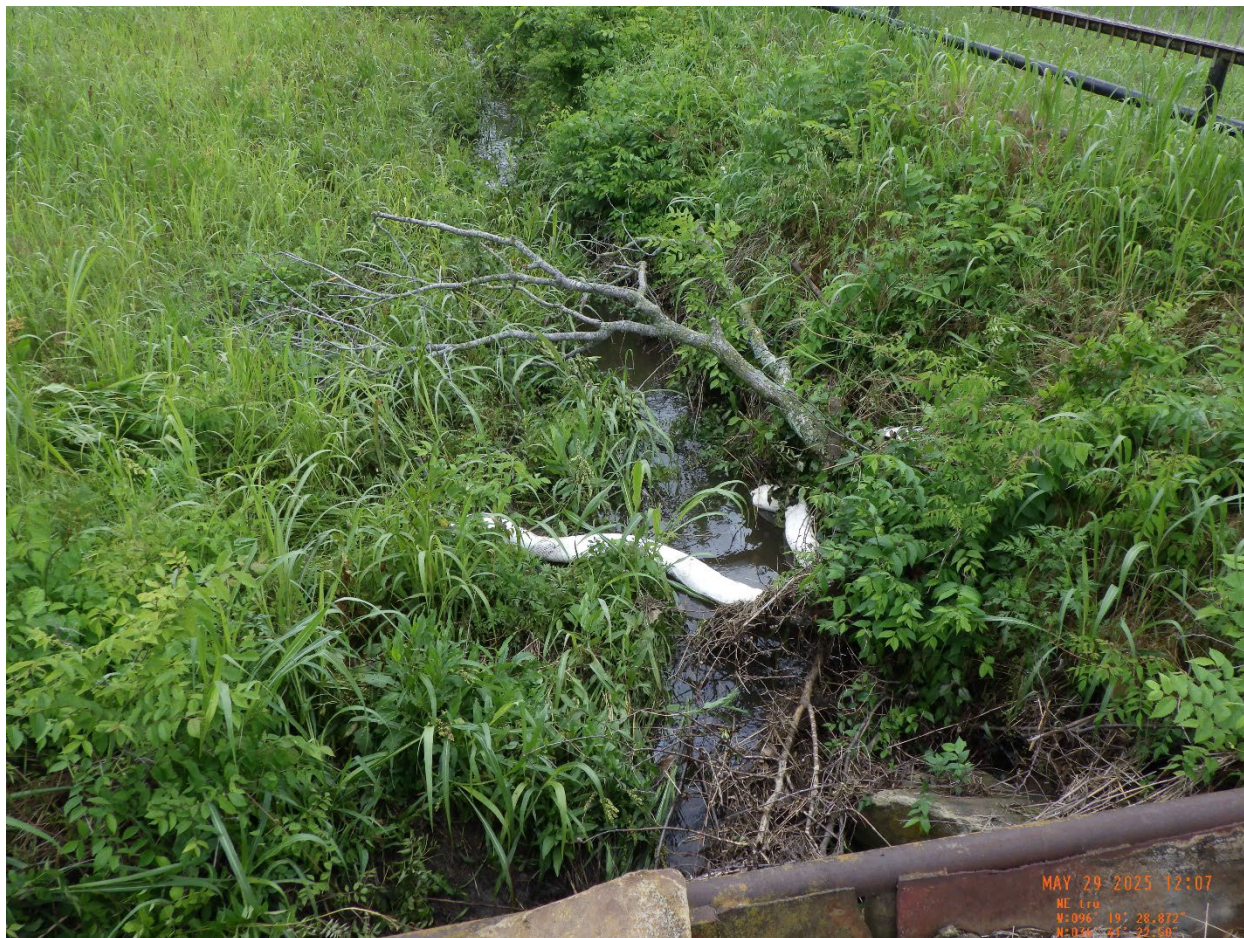
Photo No. 8

I observed the end of spill impacts. The operator had placed an oil absorbent boom to prevent downstream migration of spill impacts. The boom was properly placed; and at the time of the inspection, the containment boom was effectively preventing downstream migration of spill impacts. At this same location, I observed a TDS field reading of **180.1 mg/L**, see Photos No. 8 and 9.

**Description:** Looking NE, this was an oil absorbent boom placed in the conveyance by the operator to prevent downstream migration of oil. This boom location was approximately 60 yards upstream from Soldier Creek. Soldier Creek was not impacted by the spill.

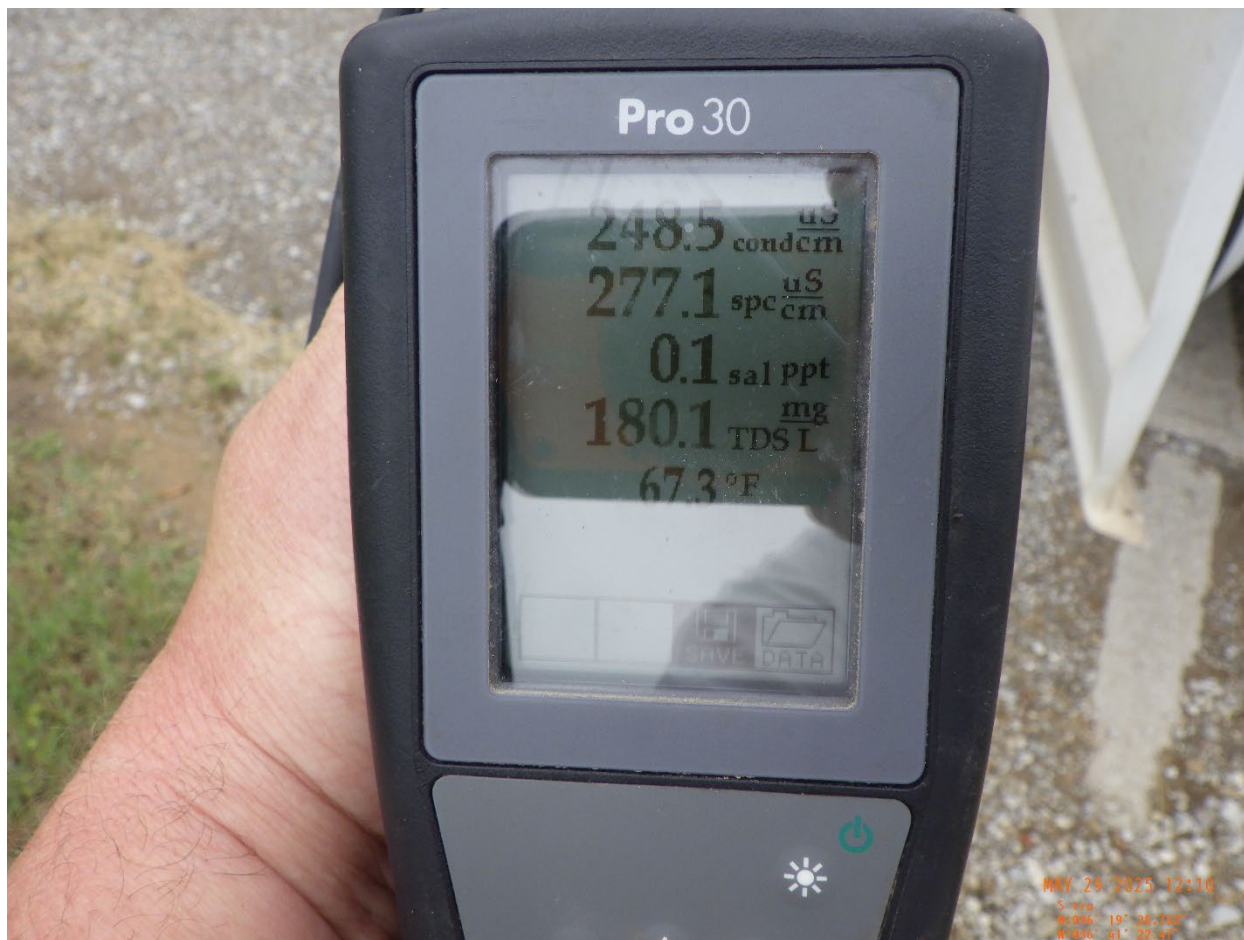
Photo No. 9

**Description:** This was a TDS field reading of **180.1 mg/L** taken at the lower boom location.
