**Inspection Report**  
**Mechanical Integrity Test**  
**Osage DNR / Environmental Protection Agency**  
**1201 Elm Street, Suite 500**  
**Dallas TX 75270**

| | | | <b>Lease Name</b> Howell | | |
| | | | <b>Well ID</b> 11-8W | | |
| <b>Type of MIT</b> Casing - Tubing Annulus Pressure | | | <b>Test Reason</b> Routine | | |

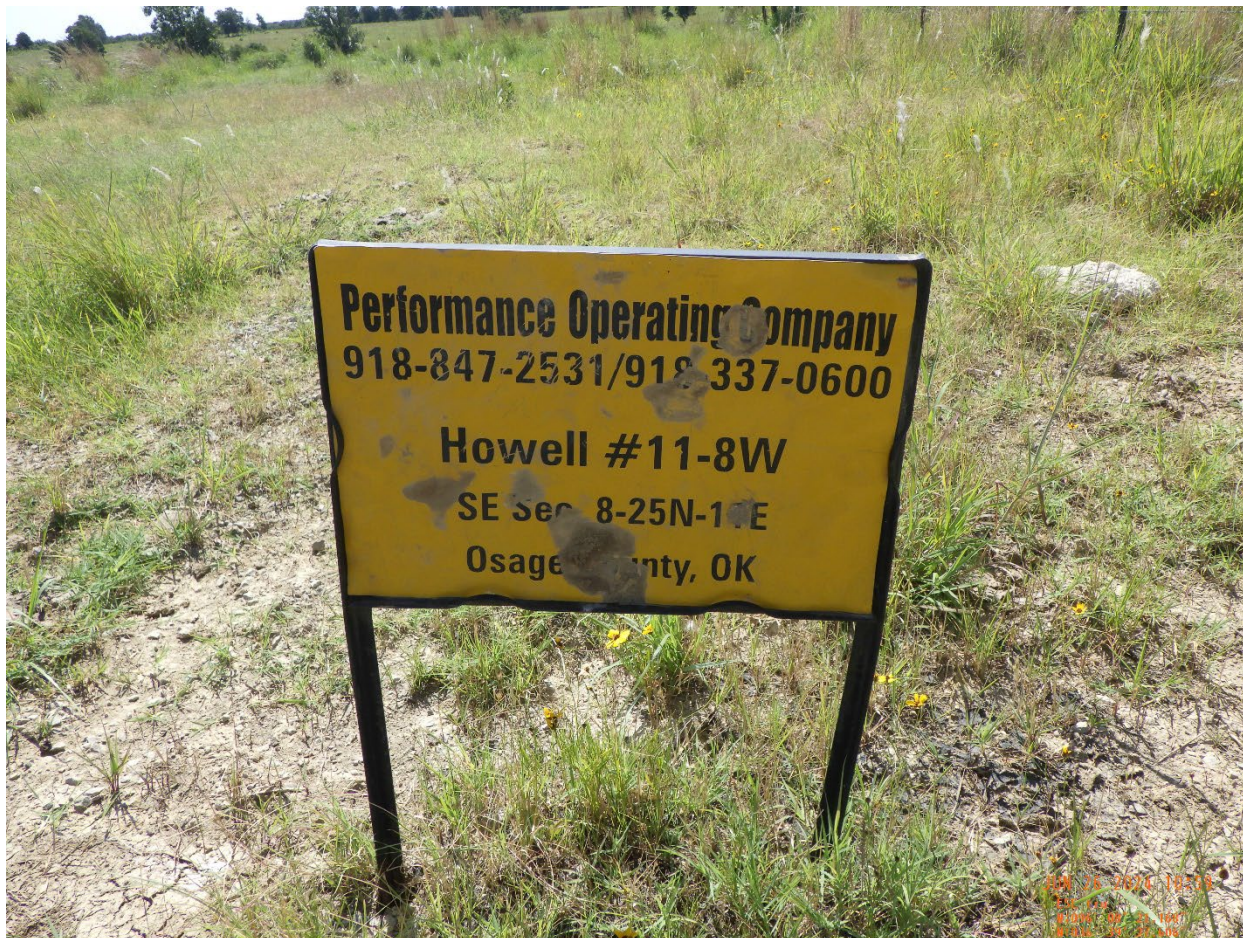
Photo No. 1

**Description:** This was the well sign for well OS6337000.

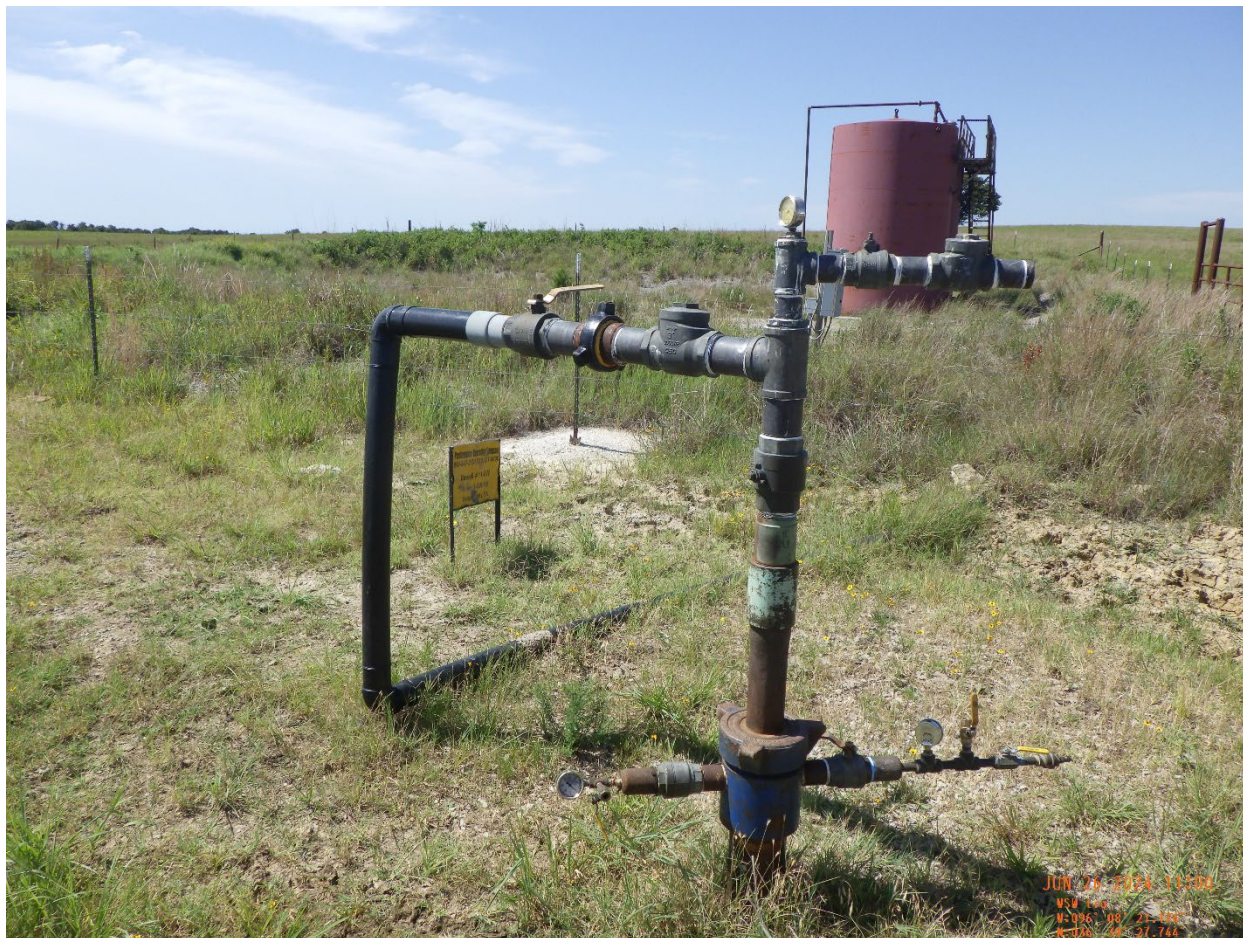
Photo No. 2

**Description:** This was well OS6337000 at the time of the inspection. The well was connected but not injecting.
