Clean Water Act (CWA) Inspection Report

| Inspection Entry Date/Time | 09/18/2024 10:00 AM (PST) | Announced: No | | |
|---|---|---|---|---|
| Type of Inspection | CEI - Compliance Evaluation Inspection | | | |
| Facility Name | Lamb Weston, Inc. – Twin Falls | | | |
| EPA/IDEQ Permit Tracking # | IDR053145 | | | |

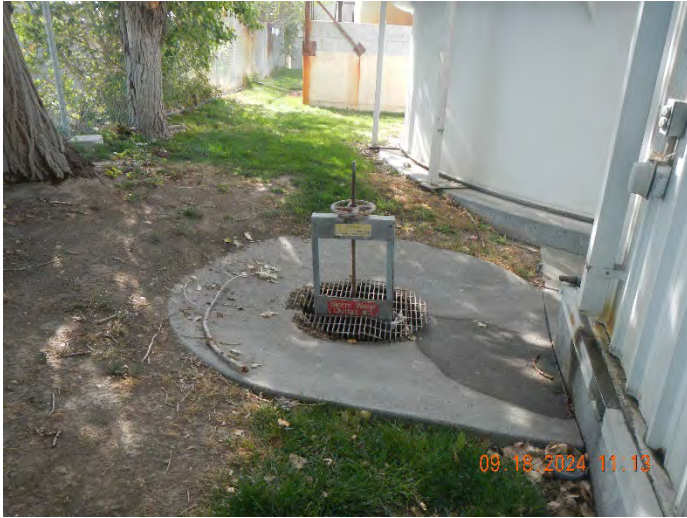
We observed the previous collection point for Outfall 002 (**Photo 1**), which now connects to the main line and collection pond/system. North of the area, we observed the discharge area for Outfall 001 (**Photo 2**), no discharge was observed. Outfall 001 discharges to a vegetated area along the top of Rock Creek Canyon, Rock Creek is located at the base of the canyon. According to Mr. Kennedy he was not aware of discharge/overflow since the 2013/2014 upgrade. We continued north/northwest and observed catch basins located within the areas around the main facility, south of the railroad track (**Photo 3, Photo 4**).

Photo #:01 (DSCN3908)  
Description: Facing south, photo of the decommissioned Outfall 002. The collection area is now routed to the main stormwater line, discharging to the collection pond.

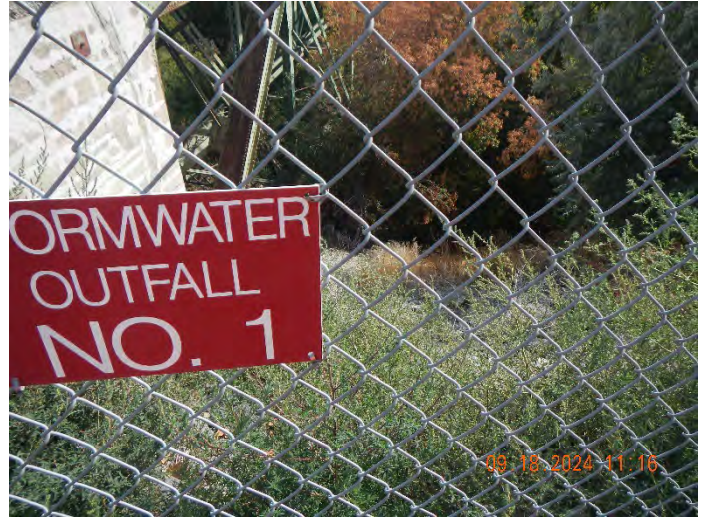
Photo #:02 (DSCN3909)  
Description: Facing east, photo of the approximate location of the Outfall 001 discharge area within Rock Creek/Rock Creek Canyon.

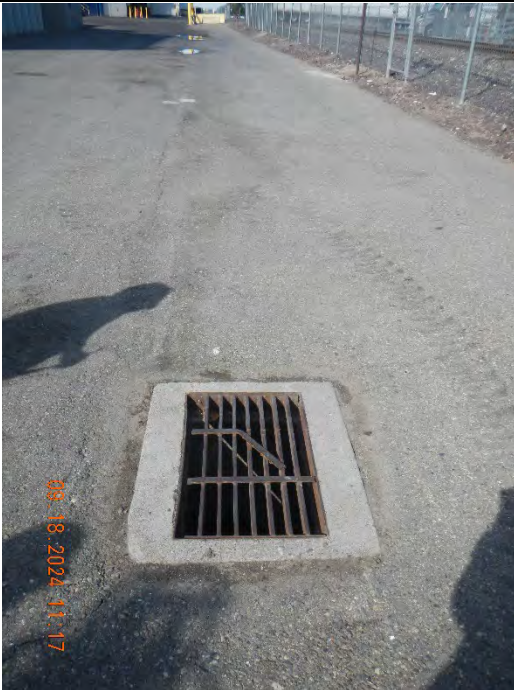
Photo #:03 (DSCN3910)  
Description: Facing west, photo of catch basin located south of the railroad.

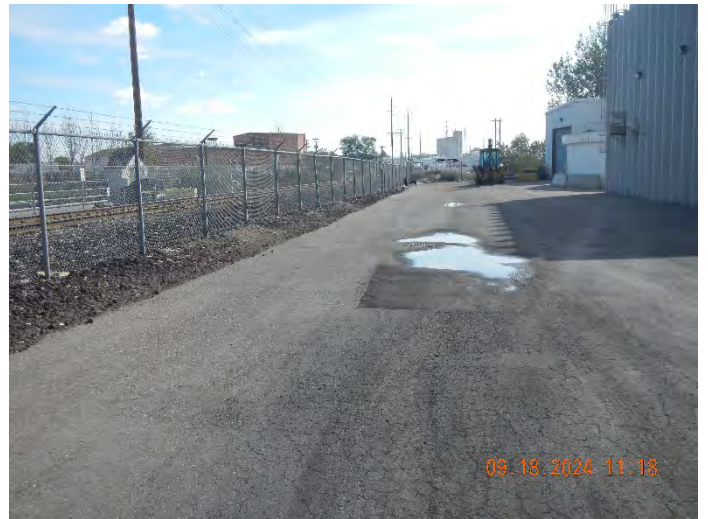
Photo #:04 (DSCN3911)  
Description: Facing east, photo of drainage area south of the railroad.

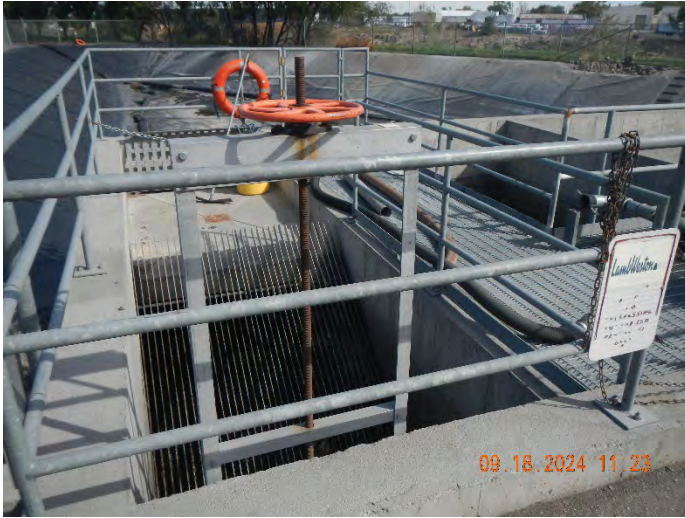
Photo #:05 (DSCN3912)

Description: Facing north, photo of the initial screen within the stormwater collection/retention basin.

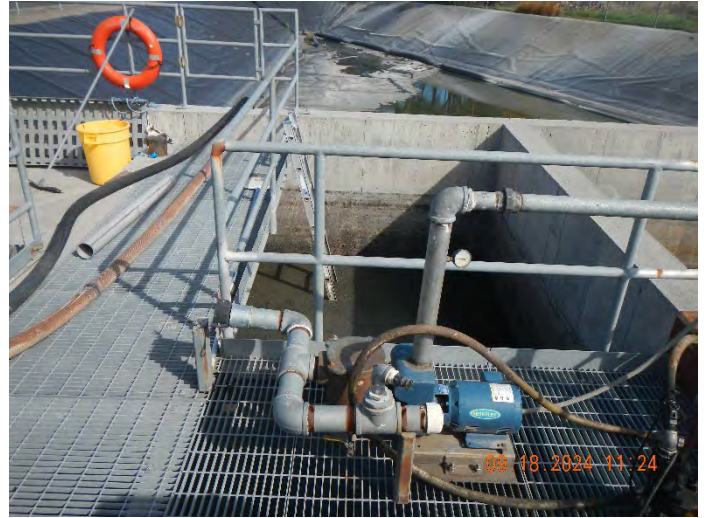
Photo #:06 (DSCN3913)

Description: Facing north, photo of grit chamber within the stormwater collection/retention basin.

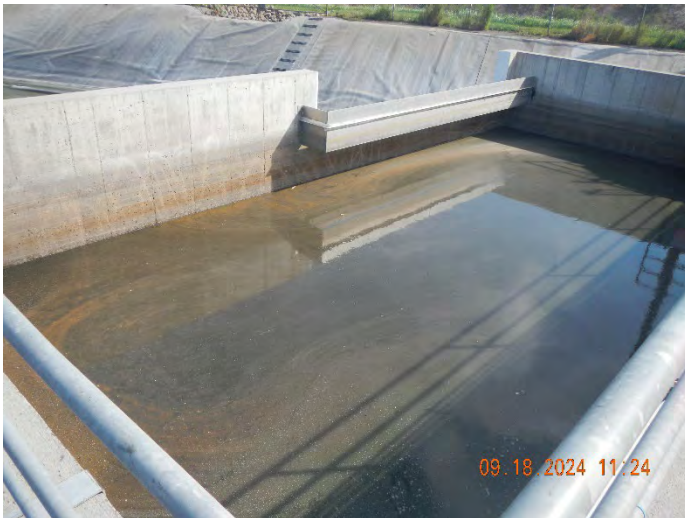
Photo #:07 (DSCN3914)

Description: Facing northeast, photo of stormwater basin within the stormwater pond.

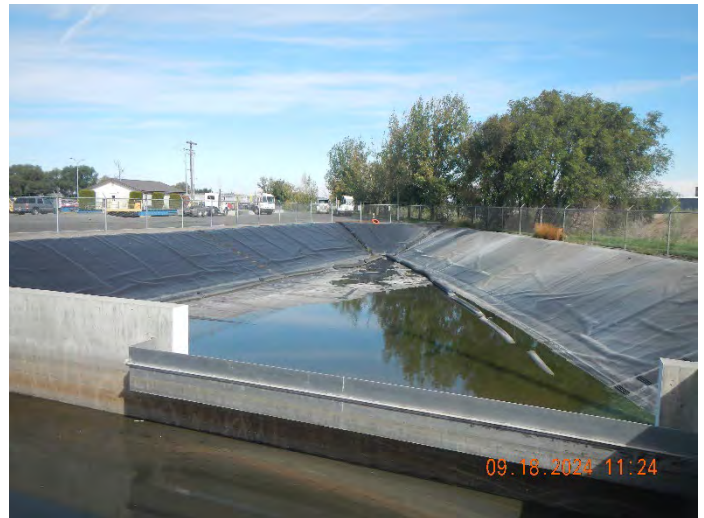
Photo #:08 (DSCN3915)

Description: Facing north, photo of the stormwater pond.

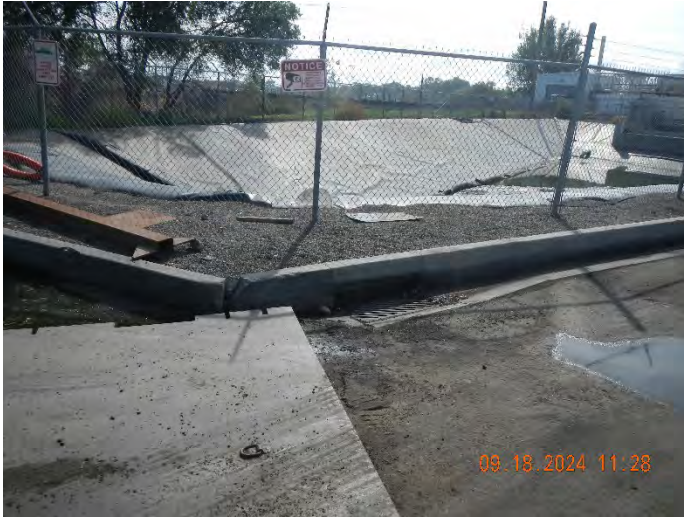
Photo #:09 (DSCN3916)  
Description: Facing east, photo of northwest inlet to the stormwater collection system/pond.

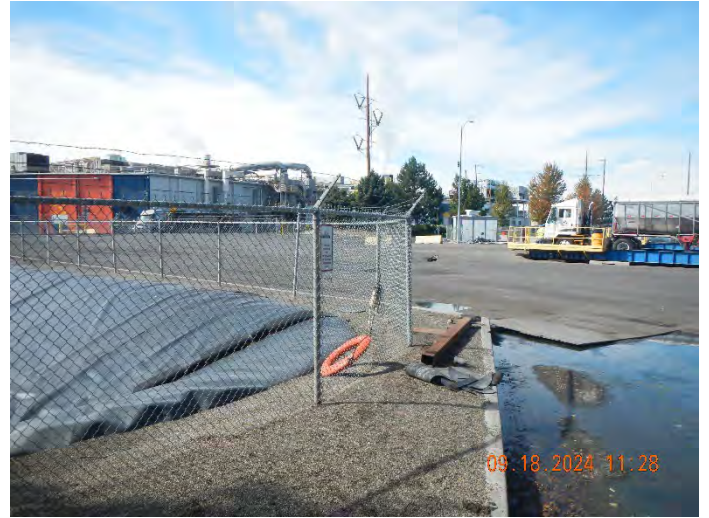
Photo #:10 (DSCN3917)  
Description: Facing southwest, photo of the north end of the stormwater system/pond.

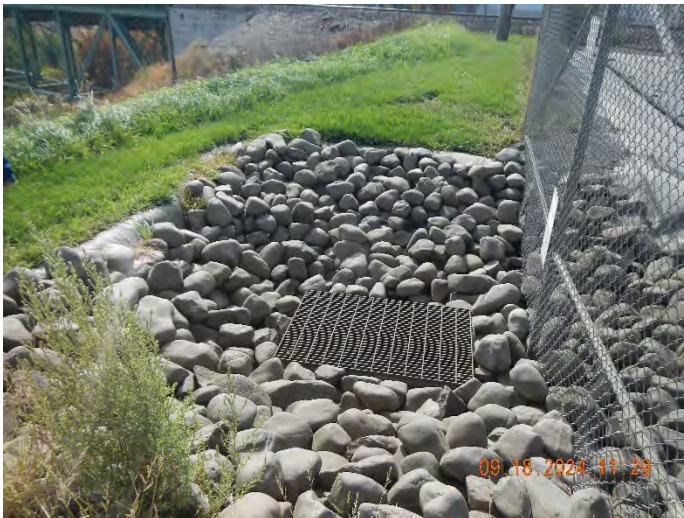
area/scale. We observed one stormwater catch basin/inlet to the northeast corner of the pond within the receiving area access road (**Photo 9, Photo 10**). Along the west end of the stormwater pond, we observed the pond's overflow within a rip-rap area identified as Outfall 003 (**Photo 11**). No discharge was observed, Rock Creek is located downslope of Outfall 003 to the east, at the bottom of the canyon (**Photo 12, Photo 13**). According to Mr. Kennedy he was not aware of discharge/overflow since the 2013/2014 upgrade.

Photo #:11 (DSCN3918)  
Description: Facing south, photo of stormwater Outfall 003. Overflow of the stormwater collection system/pond.

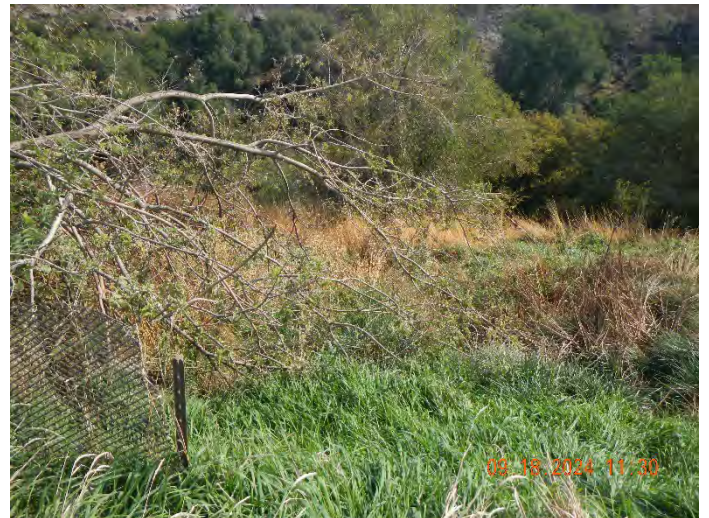
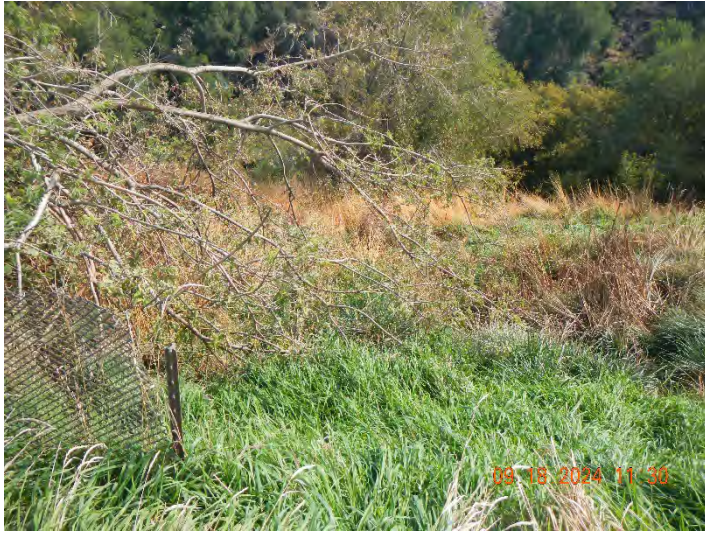
Photo #:12 (DSCN3919)  
Description: Facing northeast, photo of Outfall 003 discharge area within Rock Creek/Rock Creek Canyon.

Description: Facing northeast, photo of Outfall 003 discharge area within Rock Creek/Rock Creek Canyon (duplicate photo to DSCN3919).

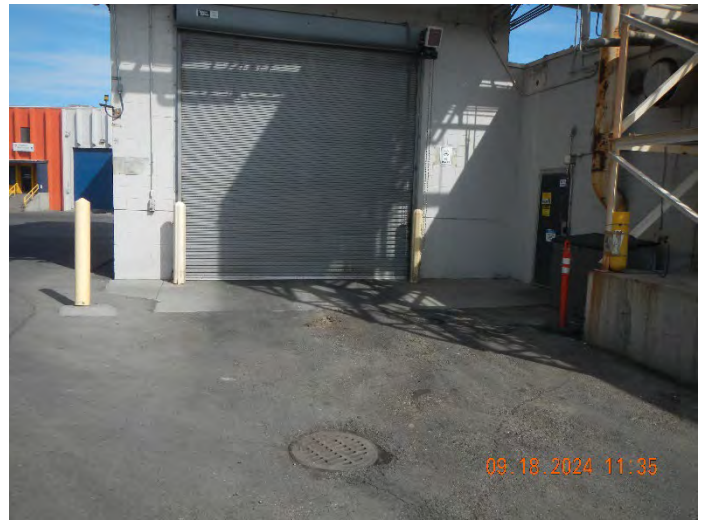
Photo #:14 (DSCN3921)

Description: Facing north, photo of catch basin within the receiving area.

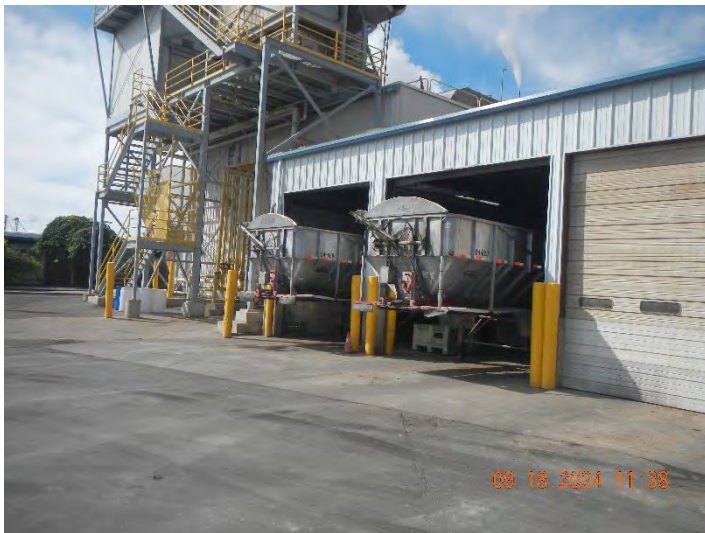
Photo #:15 (DSCN3922)

Description: Photo of truck receiving area.

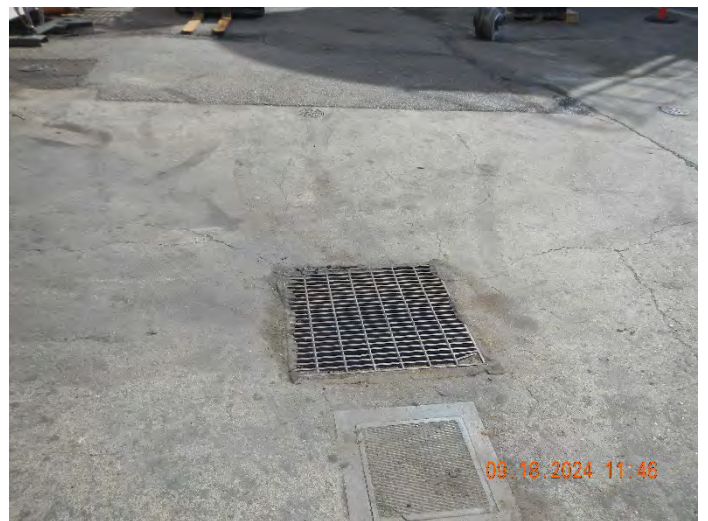
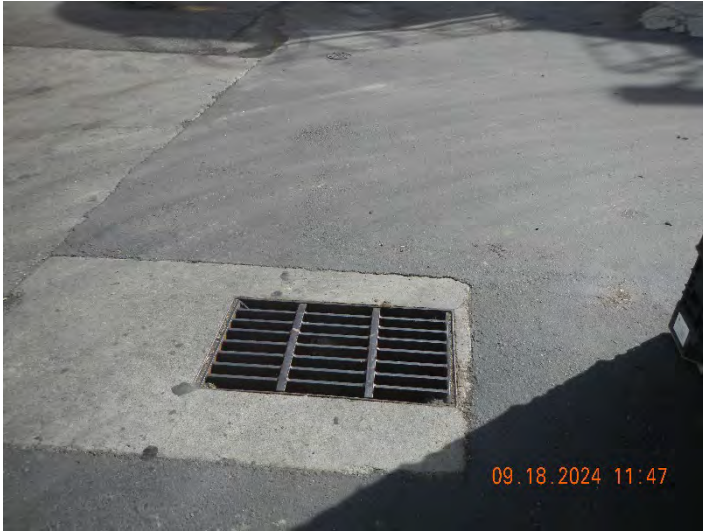
We continued north to the "pipe and metal storage area;" a roof overhang partially covers the storage area. We also observed the forklift "Hyster" maintenance shop, where work is conducted indoors. The area was generally clean and free of staining/debris. We observed catch basins in the surrounding area, described as catch basins #9 and #10 (**Photo 16, Photo 17**). It was discussed that the catch basins were recently cleaned with the recommendation of needing a high pressure washed. The recent cleaning occurred two days prior to the inspection, on September 16, 2024.

Description: Photo of catch basin near the Hyster (forklift) maintenance shop.

Photo #:17 (DSCN3924)  
Description: Photo of catch basin near the Hyster (forklift) maintenance shop.

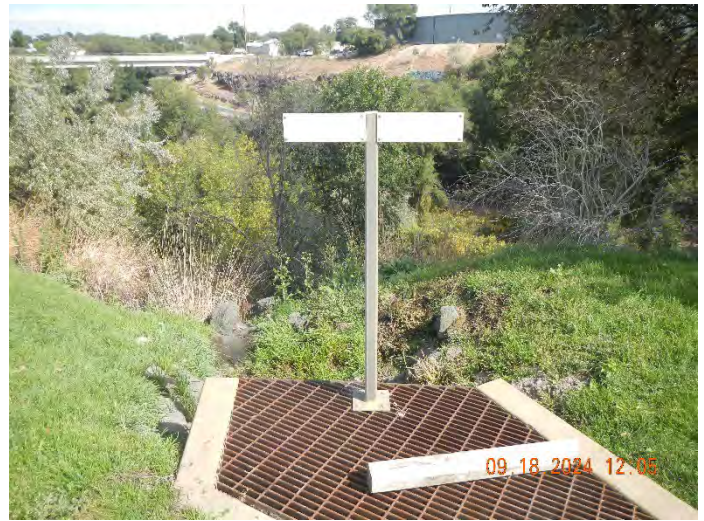
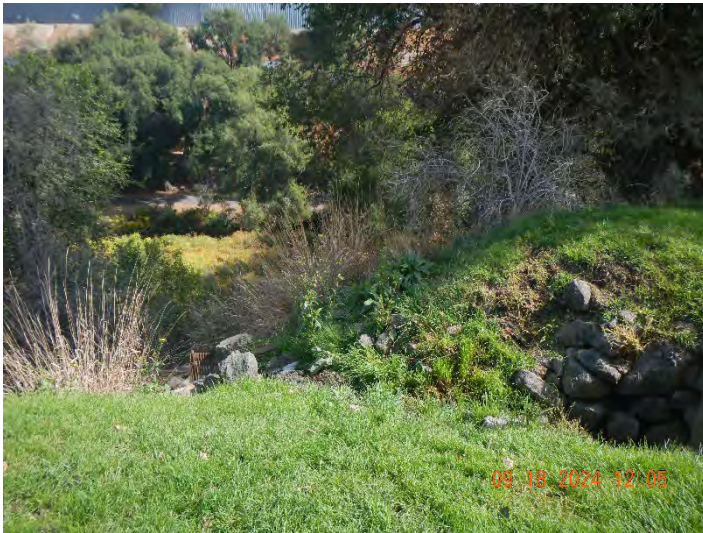
We observed the combined discharge location for Outfall 005 and 008 (**Photo 18, Photo 19**). The discharge location had two effluent pipes (Outfall 005 & Outfall 008); no discharge was observed at the time of inspection. The two pipes discharge to a vegetated area along the top of Rock Creek Canyon, Rock Creek is located at the base canyon.

The review noted only one discharge/sampling event, which occurred on October 25, 2021, from Outfall 005. As discussed earlier in this report, Outfall 005 is the overflow from the northern oil/grit chamber. Under normal conditions, the oil/grit chamber is designed to discharge to the stormwater pond and would only discharge to Outfall 005 when the water level in the stormwater pond will no longer allow drainage from the oil/grit chamber due to the hydraulic gradient.

Samples from the October 25, 2021, discharge event were collected in-house, under the direction of the previous Environmental Manager and analyzed by Magic Valley Labs, located in Twin Falls, Idaho. The discharge resulted in reported benchmark exceedances for TSS, TP, and E. Coli (summarized below).

Photo #:18 (DSCN3925)  
Description: Facing east, photo of the Outfall 008 discharge location and grit chamber overflow discharge location Outfall 005.

Photo #:19 (DSCN3926)  
Description: Photo of the Outfall 008 discharge location and grit chamber overflow discharge location Outfall 005. Both discharging to Rock Creek/Rock Creek Canyon.

According to Mr. Kennedy, an Additional Implementation Measure (AIM) Level 1 corrective action response was performed to address the exceedances. Actions included a contracted clean-out/vacuuming of the oil/grit chamber and stormwater system and contracted pest management for the live trapping of "Rock Chuck," within the outfall area.

Post-inspection, Mr. Kennedy discussed that Outfall 005 piping has since been equipped with a plug, preventing future discharges.

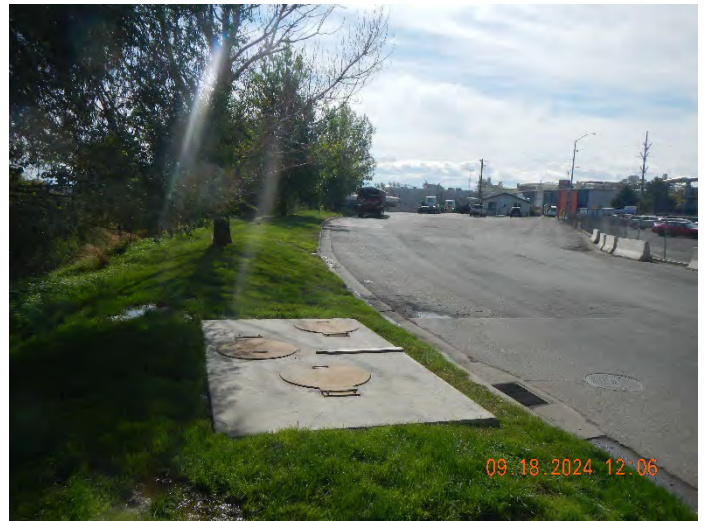
Outfall 005 serves as the overflow for the oil/grit chamber, installed along the eastern portion of the access road (**Photo 20**). A single catch basin along the southern half of the primary access/receiving road is the single influent source to the oil/grit chamber. The northern half/portion of the access road is served by a northern catch basin (**Photo 21**), discharging exclusively as Outfall 008.

Photo #:20 (DSCN3927)  
Description: Photo of the oil/grit chamber/seperator associated with Outfall 005.

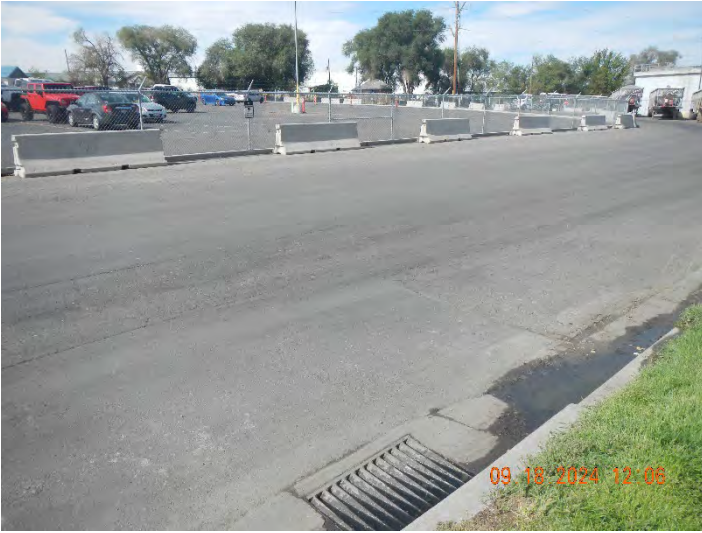
Photo #:21 (DSCN3928)

Description: Facing northwest, photo of the collection area and catch basin for Outfall 008.
