DOCUMENT DESCRIPTION: Reports and Letters RE Air Quality Reports - Bendix Windsor Plant - Ontario Ministry of Labor

AIR QUALITY ASSESSMENT REPORT

Plant: Bendix Automotive of Canada Ltd.

Date of Visit: May 2, 1979

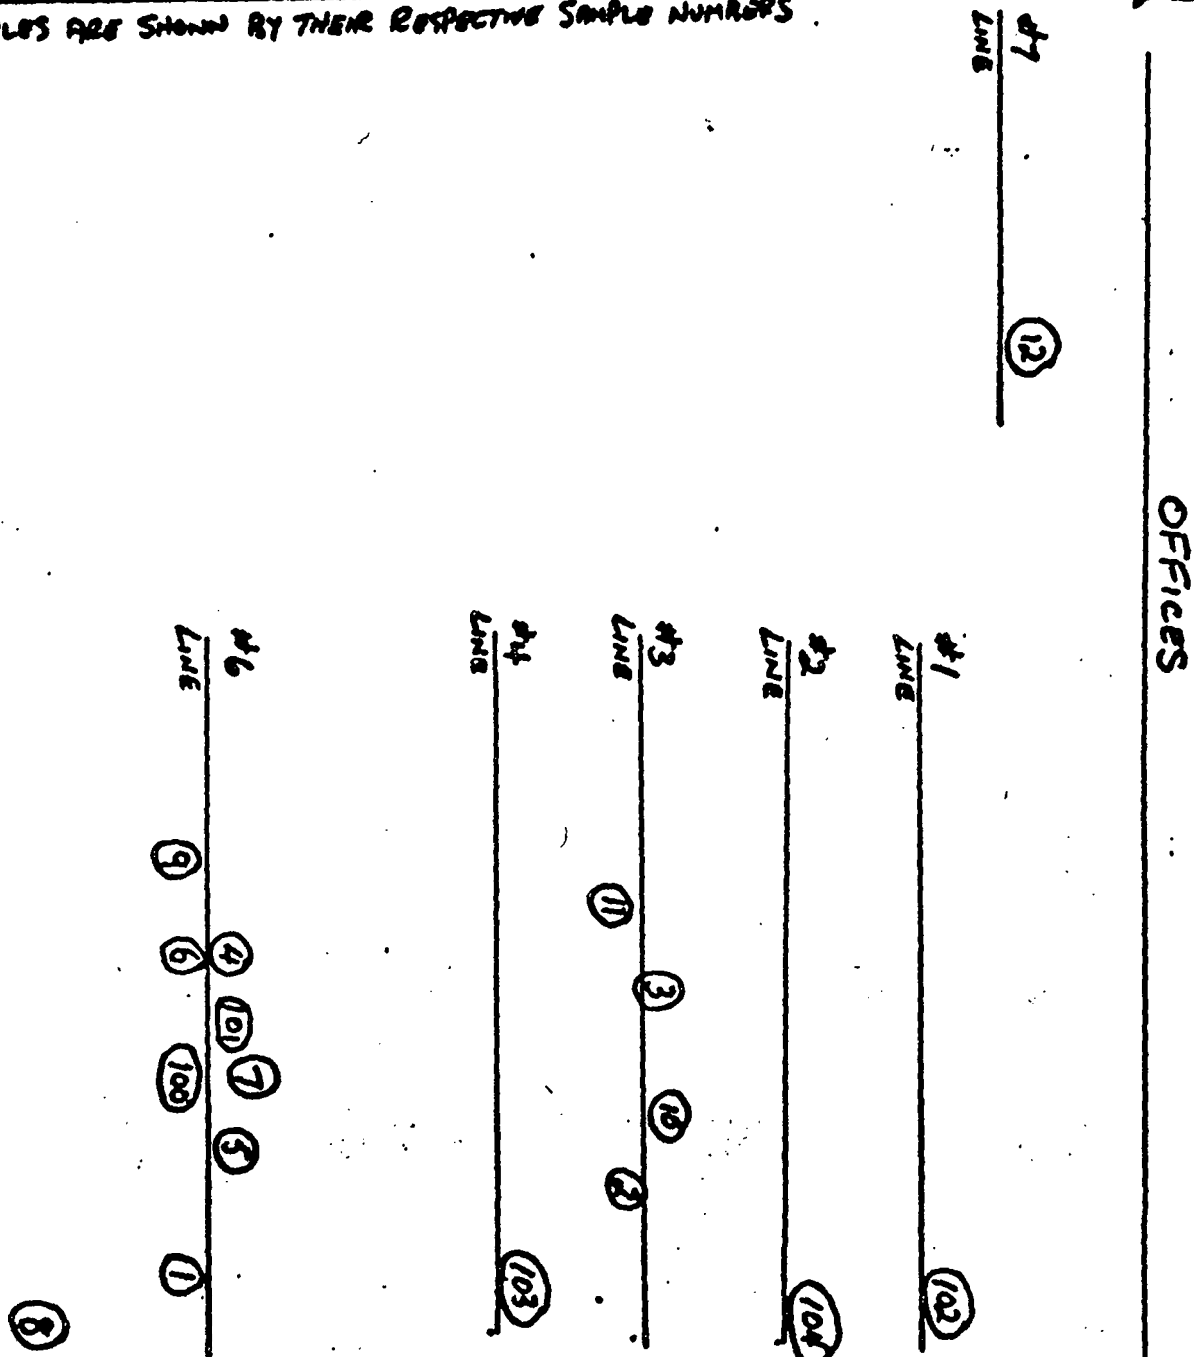
DIAGRAM OF AIR SAMPLING LOCATIONS (NOT TO SCALE)

AIR SAMPLES ARE SHOWN BY THEIR RESPECTIVE SAMPLE NUMBERS
