# NPDES Compliance Inspection Report

## Ketchikan Pulp Leachate Facility Ketchikan, AK

NPDES Permit Tracking Number  
# AK0053392

Inspection Date: September 25, 2024

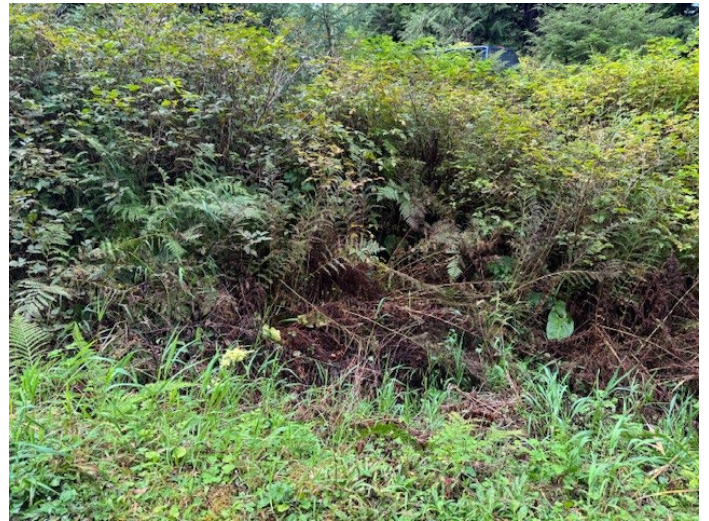
I began the facility walkthrough with Ms. Hogarty at 11:30 am starting with storm water outfall SWL6B located at the northern portion of the property. Storm water from SWL6B flows to the northwest into Refuge Cove (**Photos 6, 7, and 8**). Next, we drove to the treatment facility, and I observed the backup generator (**Photo 9**). Ms. Hogarty stated that the generator is serviced as needed and it has not been used since there have been no issues with power outages. A copy of the permit was observed in the generator room (**Photo 10**).

Photo #:06 (015)  
Description: Storm water outfall SWL6B

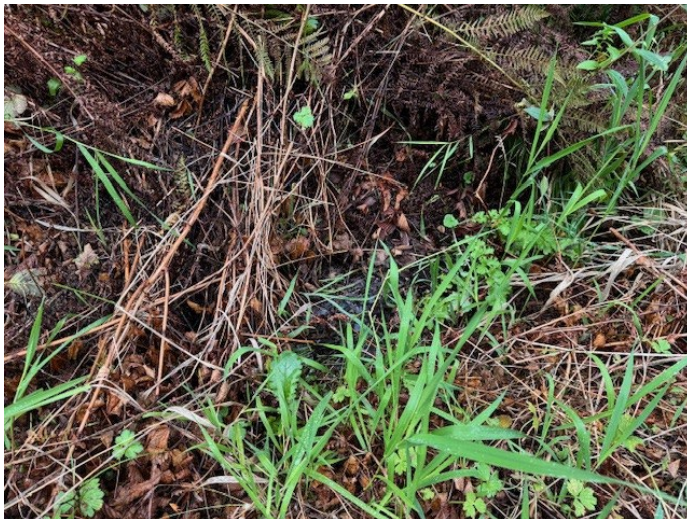
Photo #:07 (016)  
Description: Storm water outfall SWL6B sampling location.

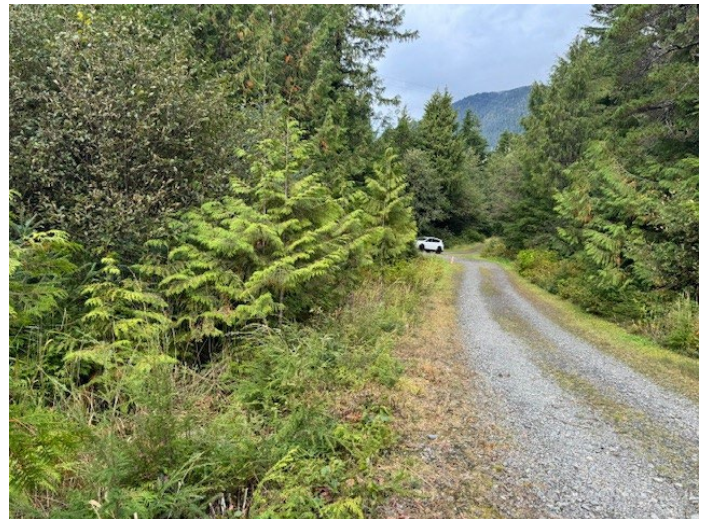
Photo #:08 (017)  
Description: Storm water outfall SWL6B flow direction to the northwest.

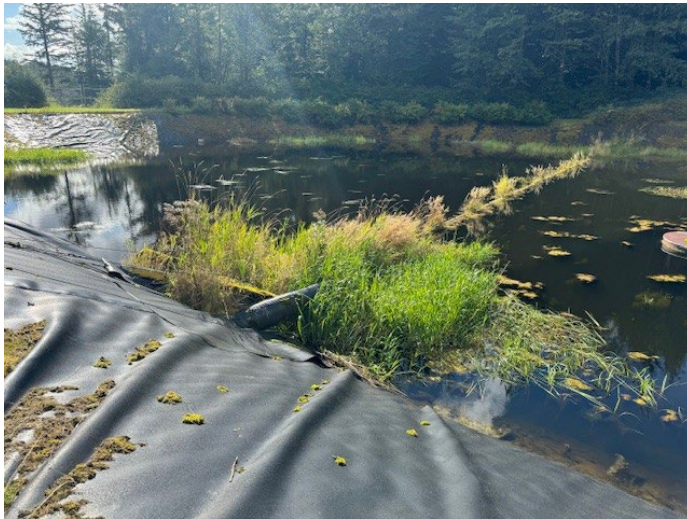
Photo #:11 (026)

Description: Leachate and groundwater influent pipe.

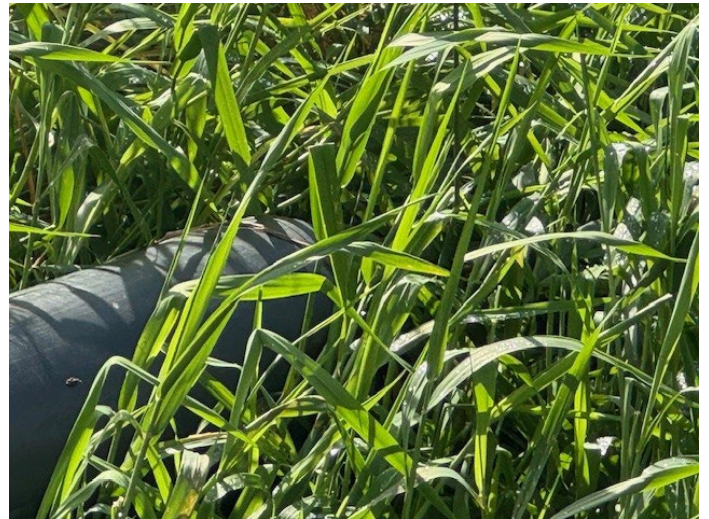
Photo #:12 (027)

Description: Leachate and groundwater influent pipe.

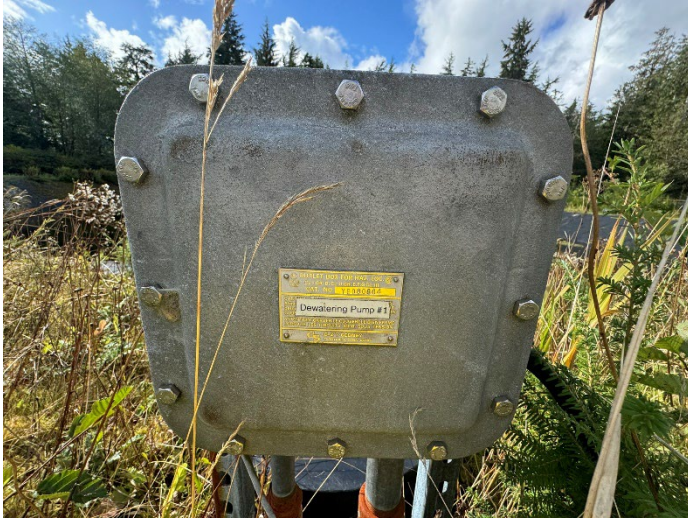
Photo #:13 (08463)  
Description: Groundwater dewatering pump #1.

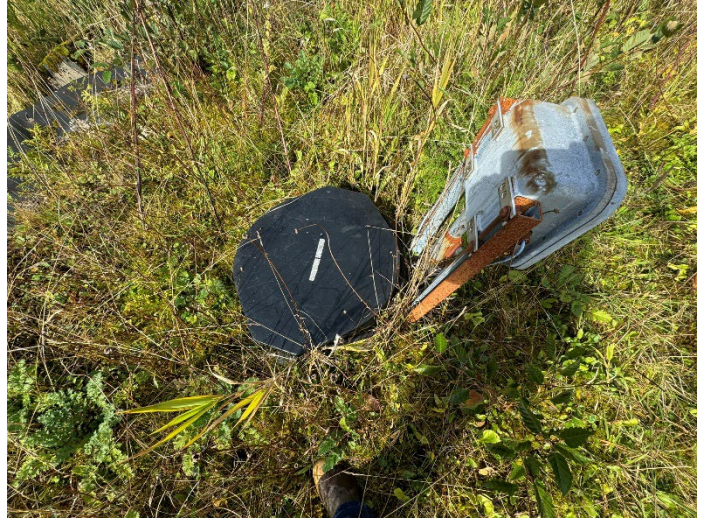
Photo #:14 (08464)  
Description: Groundwater dewatering pump #1

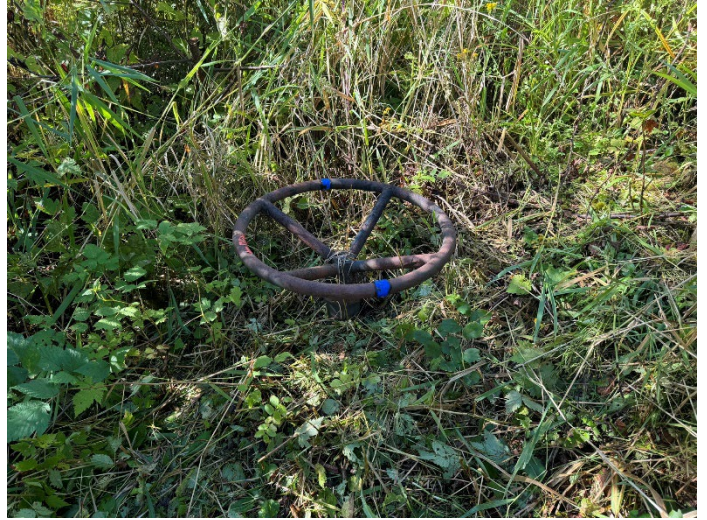
Photo #:22 (8479)  
Description: Pinch valve to shutoff flow to wetlands.

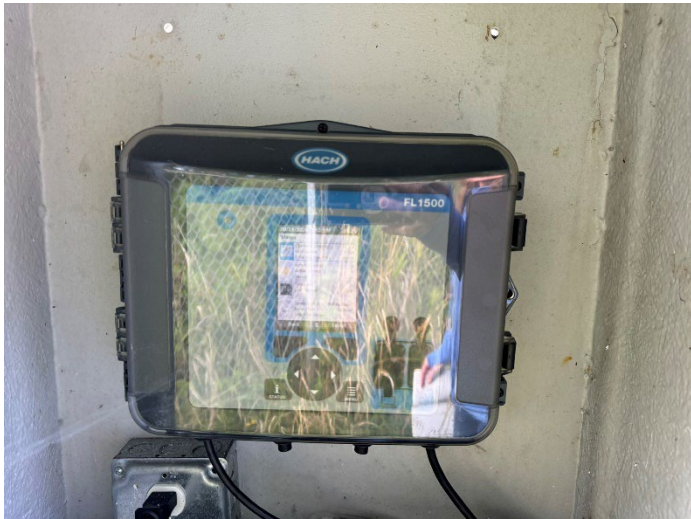
Photo #:23 (8481)  
Description: Flow meter.

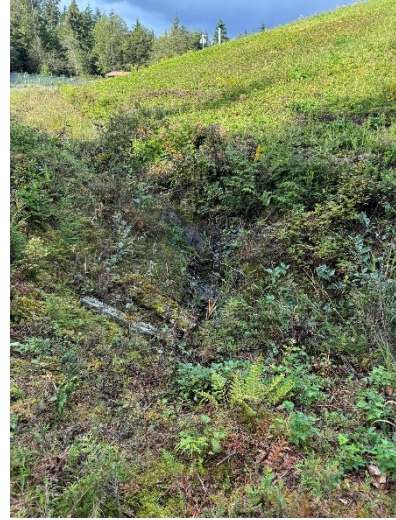
Photo #:30 (8496)

Description: Limestone lined ditches to help with pH neutralization.

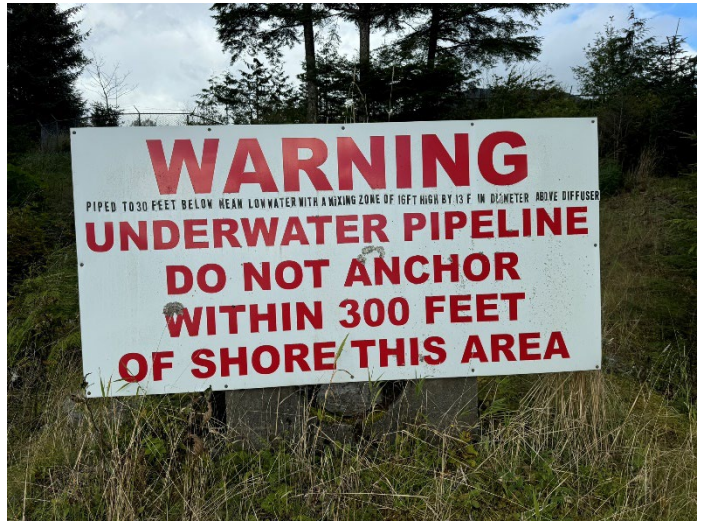
**C.** Missing information on the identification sign. The phone number, the discharge of leachate, and name of the discharger is omitted from the identification sign.

Part 3.3 of the permit states, “At least one sign must be posted on the shoreline near Outfall 001A during discharge. Signs must inform the public that treated landfill leachate is being discharged, state that there is a mixing zone and describe it and provide the phone number and identify of the discharger.”

Photo #:34 (8508)  
Description: Discharge location ID sign.

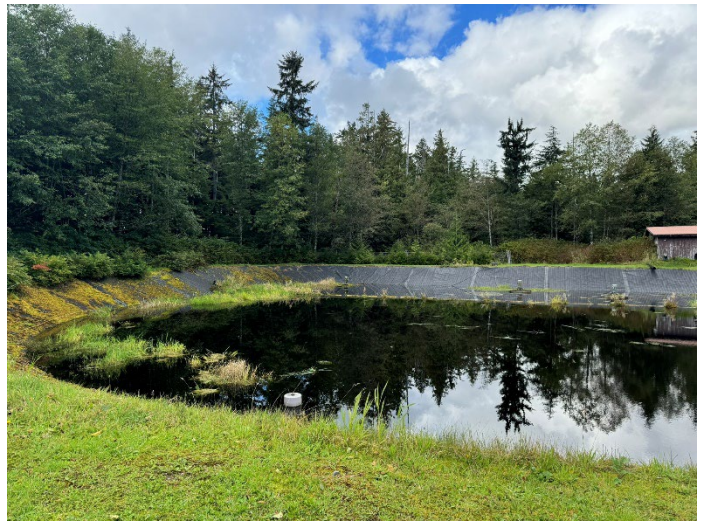
- G.** There is vegetation growing in the lagoon.

Part Appendix A 1.6.1 of the permit states, “A permittee shall at all times properly operate and maintain all facilities and systems of treatment and control and related appurtenances that the permittee installs or uses to achieve compliance with the conditions of the permit. The permittee’s duty to operate and maintain properly includes using adequate laboratory controls and appropriate quality assurance procedures. However, a permittee is not required to operate back-up or auxiliary facilities or similar systems that a permittee installs unless operation of those facilities is necessary to achieve compliance with the conditions of the permit.”

Photo #36 (8512)  
Description: Wastewater lagoon with vegetative growth.

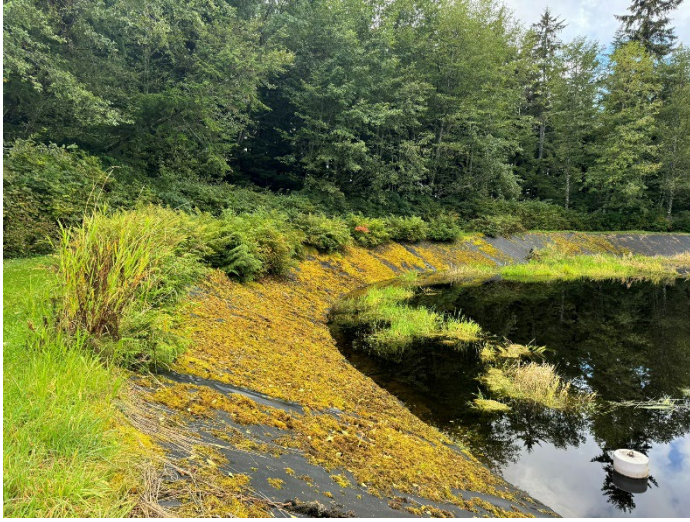
Photo #:37 (8513)  
Description: Wastewater lagoon with vegetative growth.

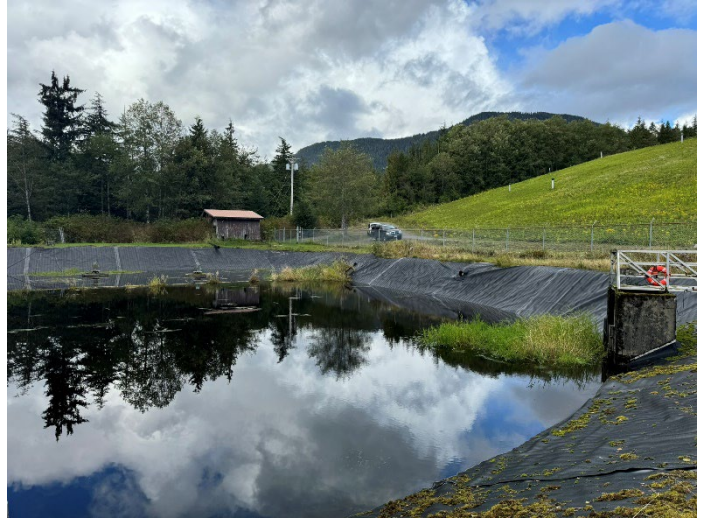
Photo #:38 (8514)  
Description: Wastewater lagoon with vegetative growth.

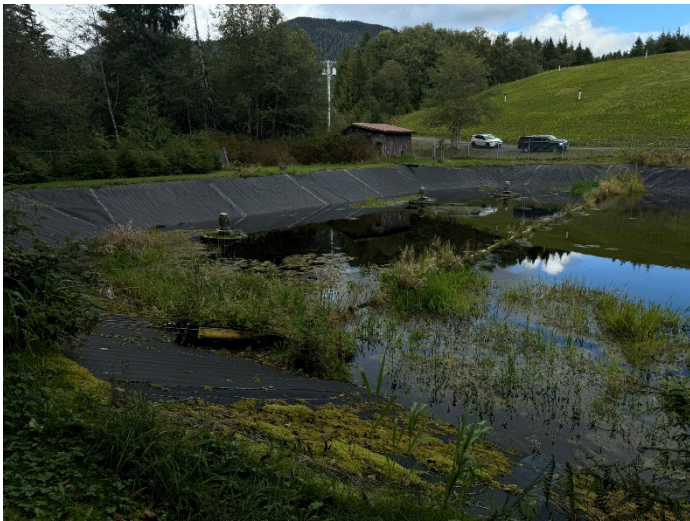
Photo #:39 (8515)  
Description: Wastewater lagoon with vegetative growth.

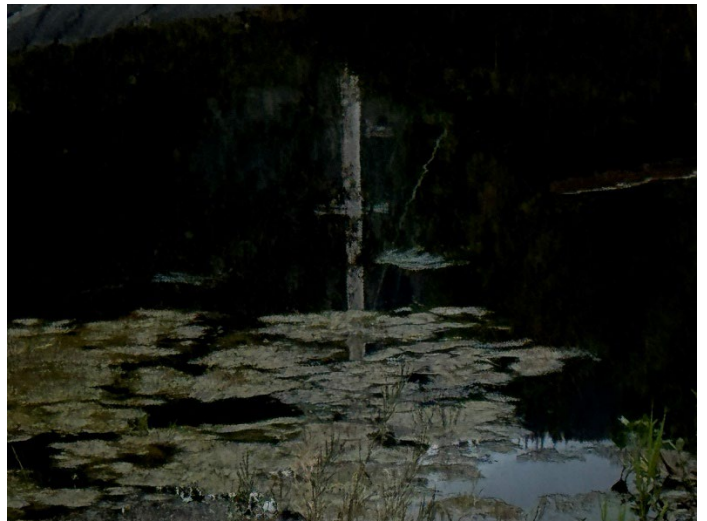
Photo #40 (8516)  
Description: Wastewater lagoon with vegetative growth.

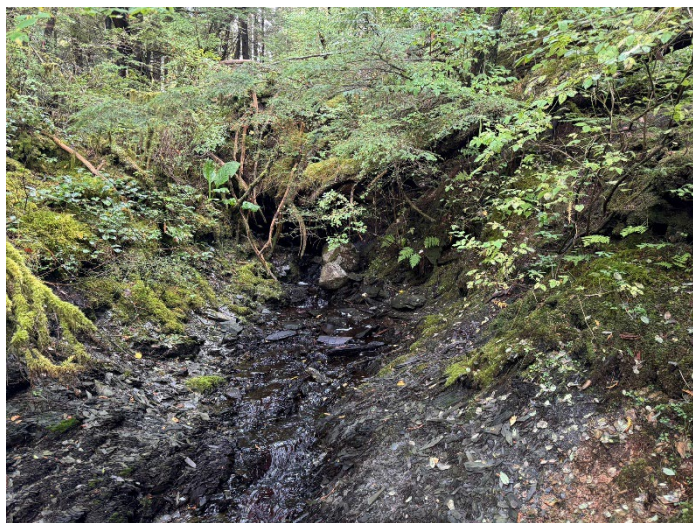
Next, we walked to the storm water outfall SW11 located at the south portion of the property and observed the sample location. No sheen or odor was observed, and the limestone ditch was visible (**Photos 27, 28, 29, and 30**). Next, we walked to the storm water outfall SW12 located at the southeast portion of the property. (**Photos 31 and 32**). Next, we walked to the beach to observe the outfall sign and the outfall pipe (**Photos 34 and 35**). The outfall pipe has riprap over it and is not visible. The outfall sign is missing information such as the phone number, the discharge of leachate, and name of the discharger. Finally, we walked through the woods to storm water outfall SWL4 located on the east portion of the property. No sheens or odors were observed (**Photos 41 and 42**).

Photo #:41 (8521)  
Description: Storm water outfall SWLL4 sample location.

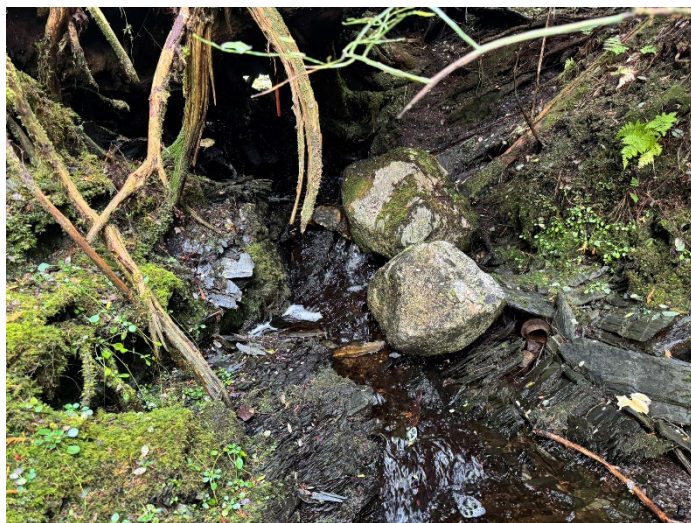
Photo #:42 (8522)  
Description: Storm water outfall SWLL4 sample location.
