**Region 6 - Enforcement & Compliance Assurance Division**  
**INSPECTION REPORT**

| Inspection Date(s): | 06/26/2023 | |
| Regulatory Program(s) | AWIA/SDWA | |
| Facility Name: | <b>Liberty Utilities Company (Pine Bluff)</b> | |

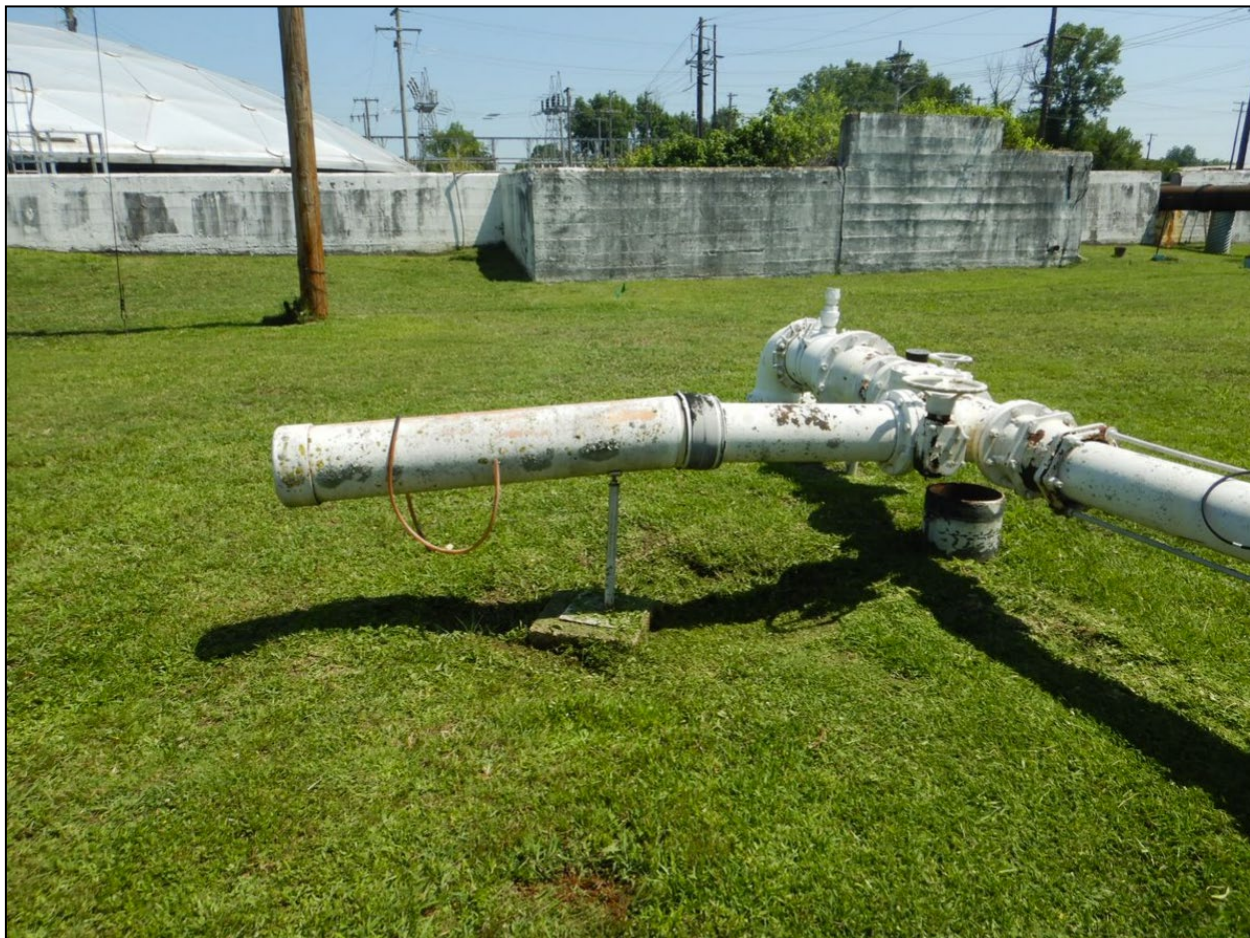
**Photograph 1. Well No. 20** View of Well No. 20 that was inside fence line at the WTP #1 property. The well was functional at the time of the inspection and sending water to WTP#1 for treatment.

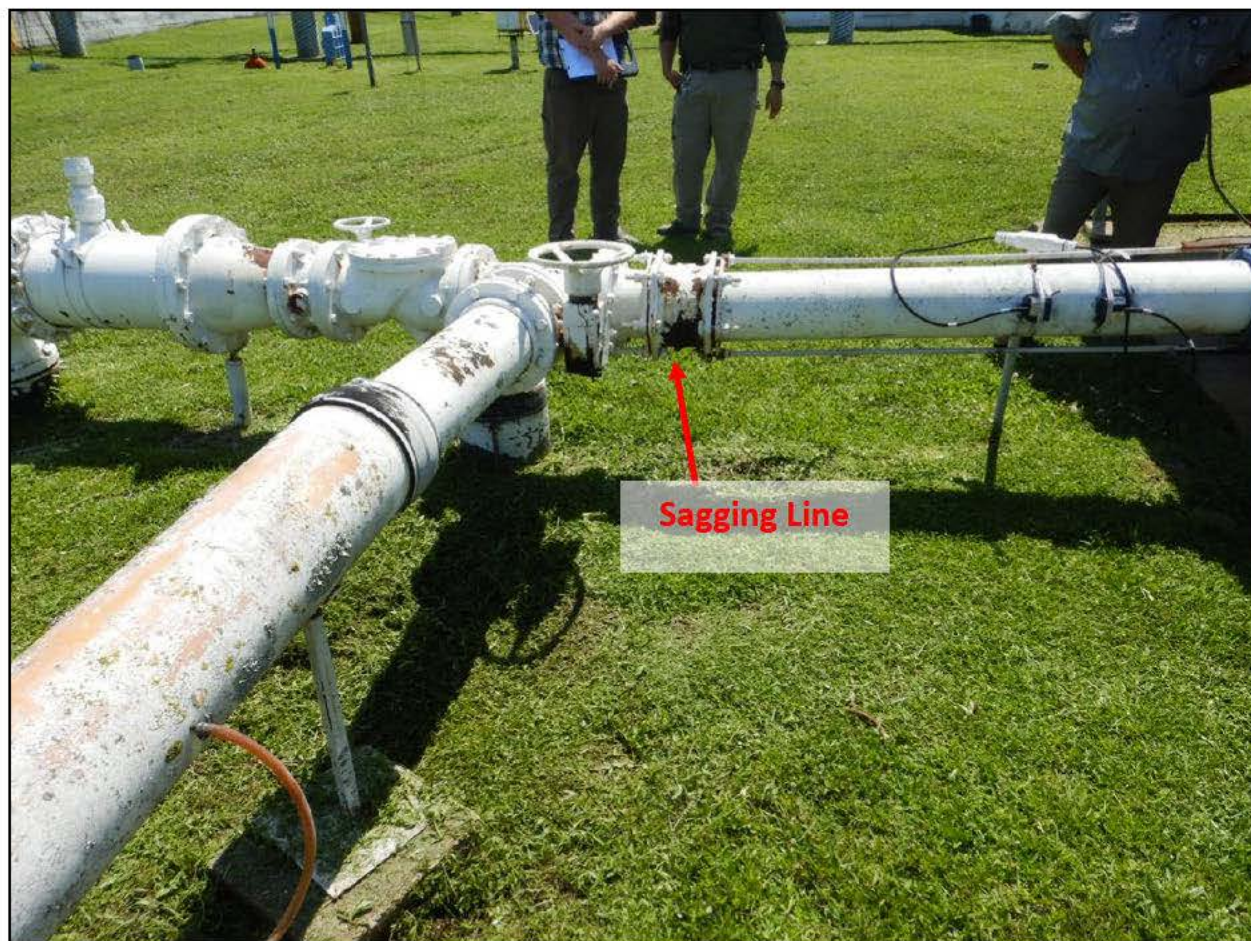
- The line extending from the pump was sagging toward the ground at the point where it met the pipe that extended below ground (refer to [Appendix 2, Photograph 2](#)). It appeared that a support stand was missing from beneath the line.

**Photograph 2. Well No. 20** View of the pump line of Well No. 20. The line was sagging, and it appeared that a support stand was missing under the line.

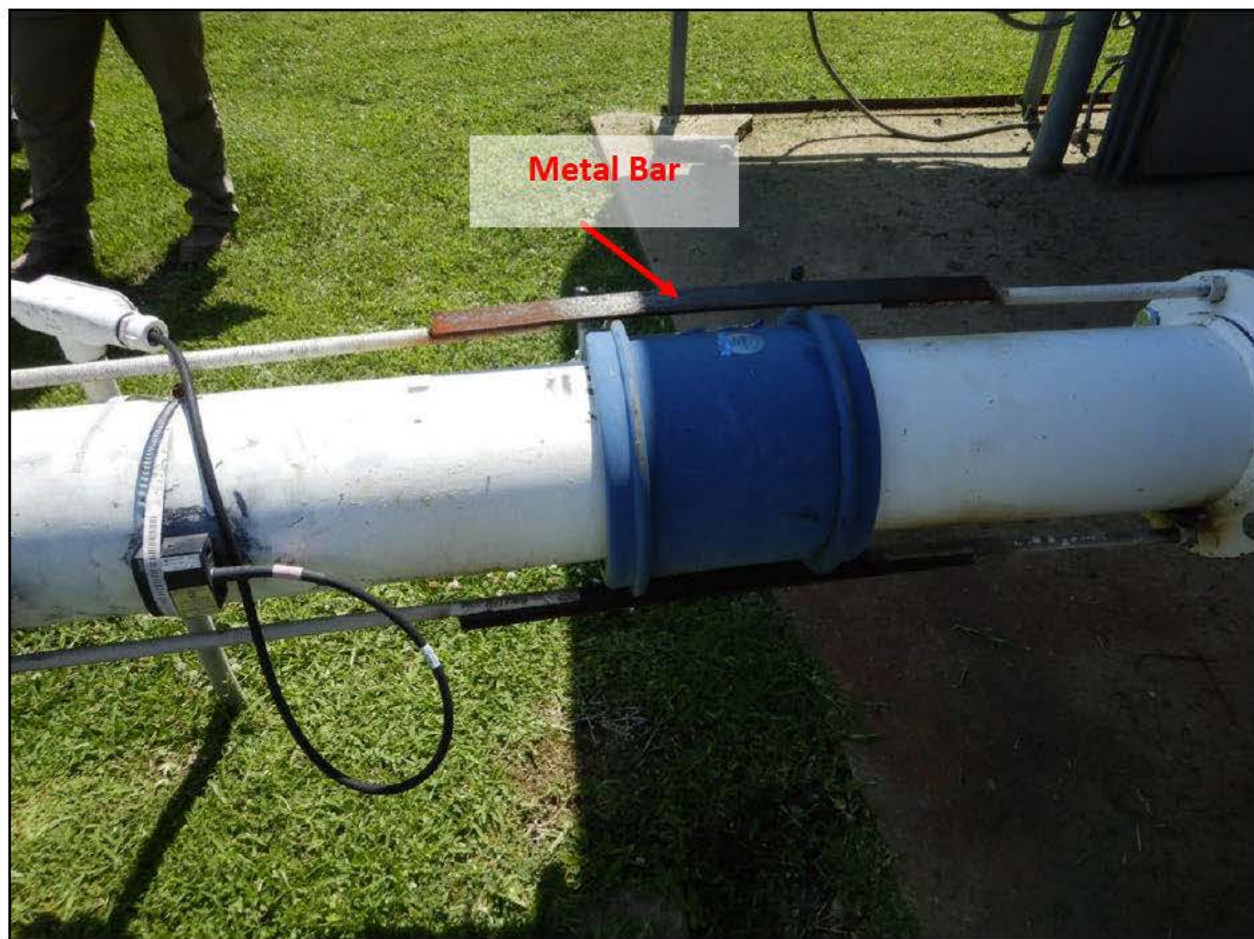
**Photograph 3. Well No. 20** View of the pump line at Well No. 20. Metal bars had been welded to the support rebar. System representatives stated that the metal bars had been used because the rebar was not long enough.

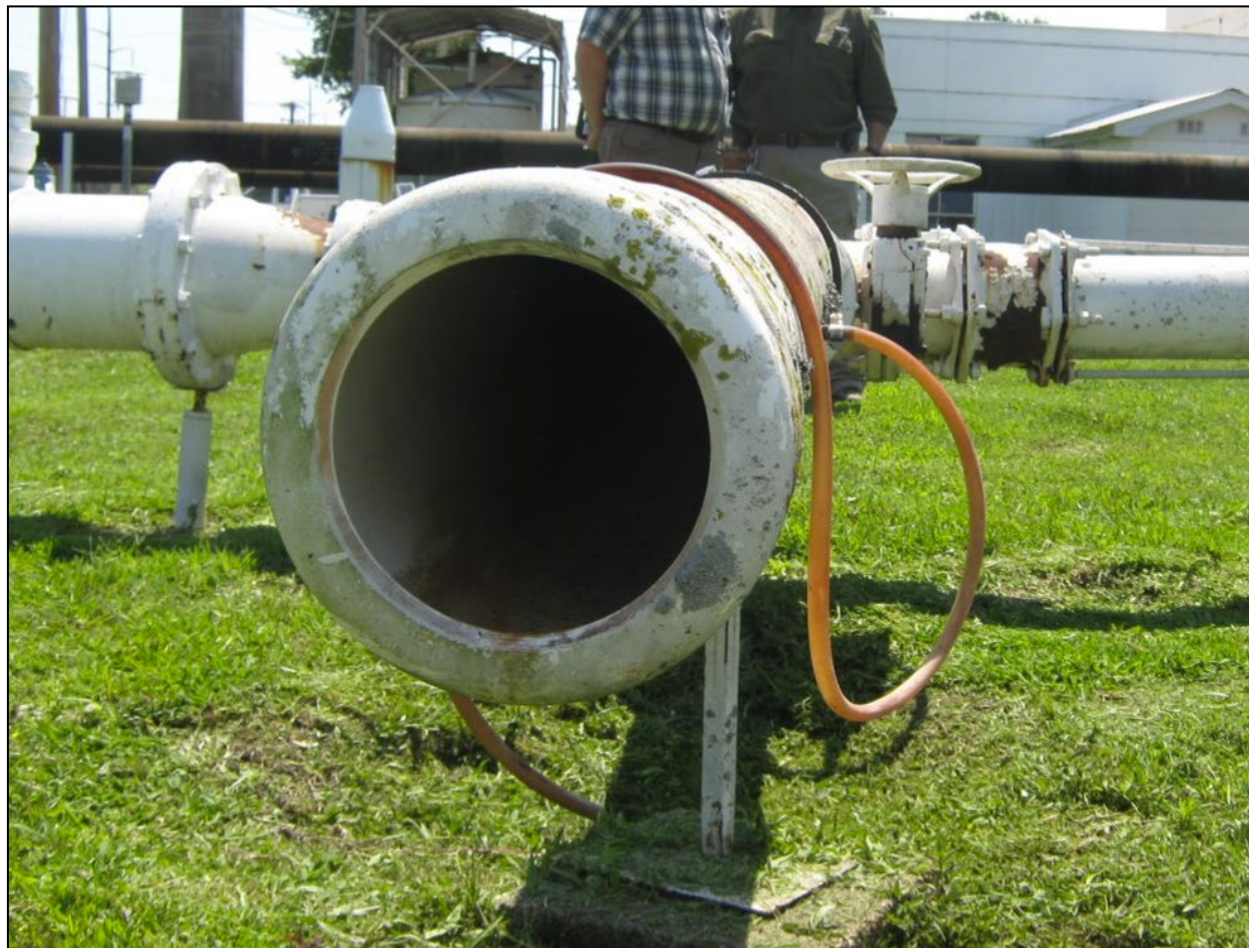
**Photograph 4. Well No. 20** View of the pump to waste line at Well No. 20. The line was valved off from the line into the treatment system, but the end of the line was uncovered.

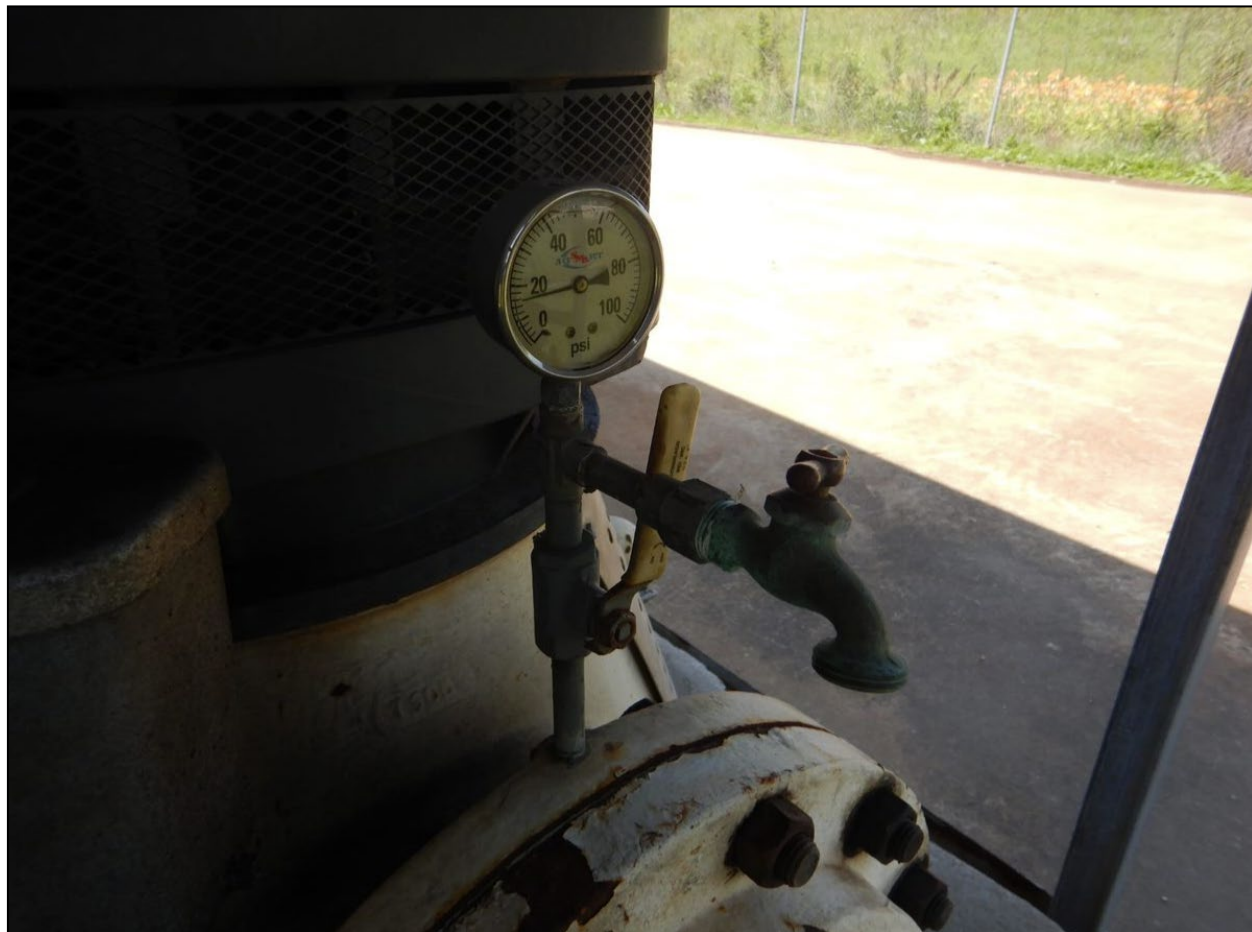
**Photograph 5. Well No. 20** View of a threaded hose tap and pressure gauge extending off of the Well No. 20 pump line. The hose tap did not have backflow prevention.

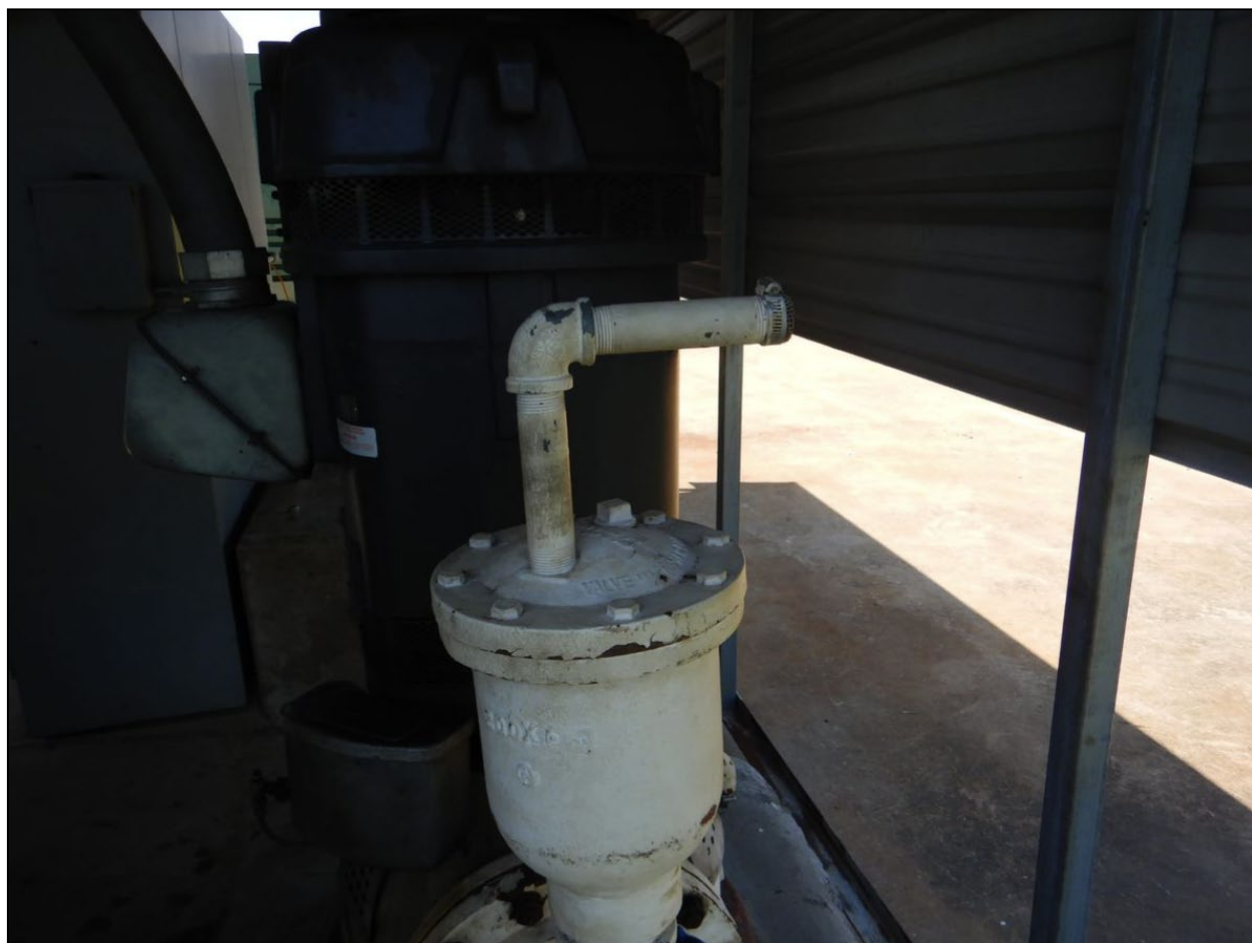
**Photograph 6. Well No. 20** View of an air relief valve extending off of the pump line at Well No. 20. The opening was screened but the valve was not downturned.

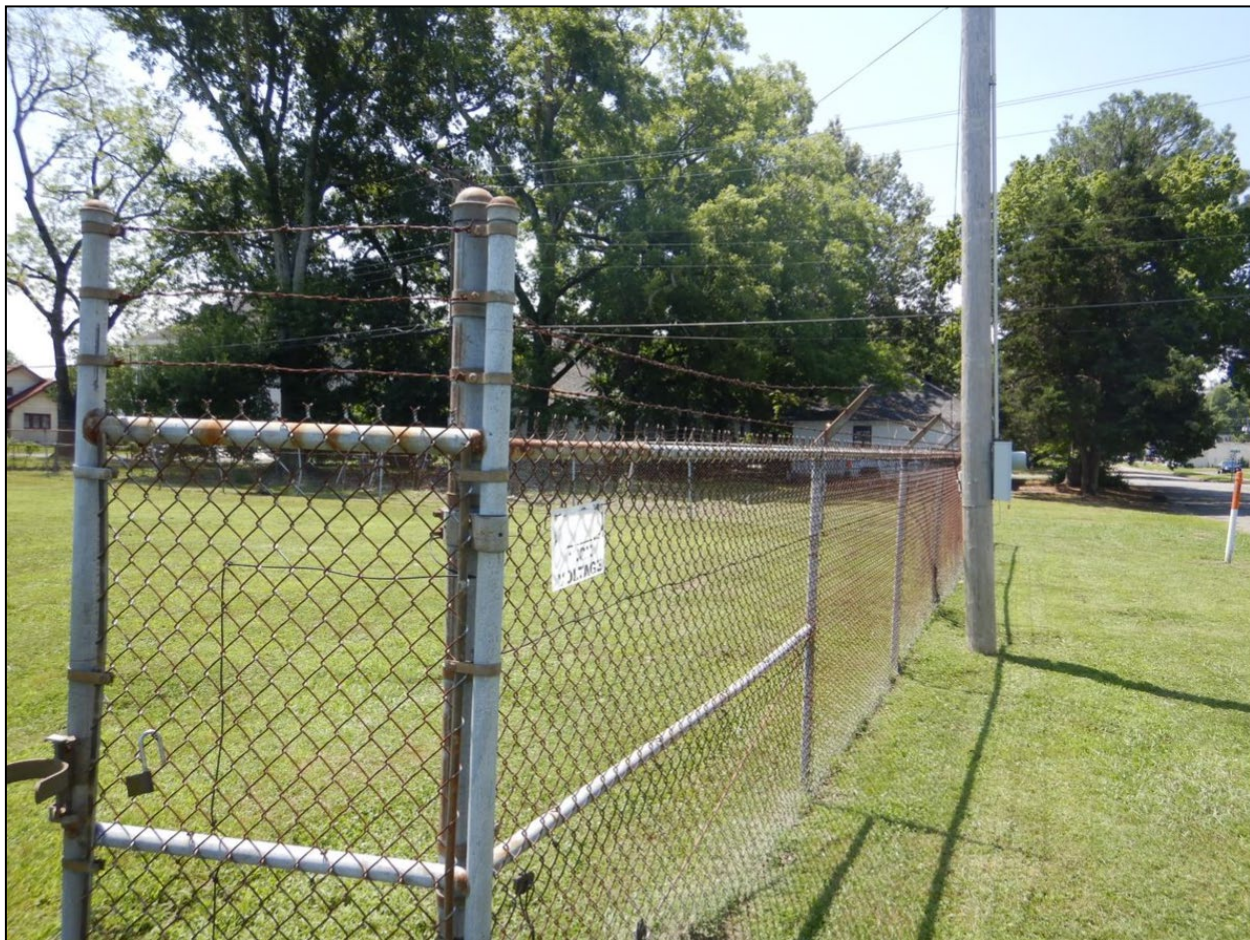
**Photograph 7. Perimeter Fence, Well No. 18** View of the perimeter fence that surrounded Well No. 18. The fence was locked when the EPA Inspection Team arrived, and there was barbed wire.

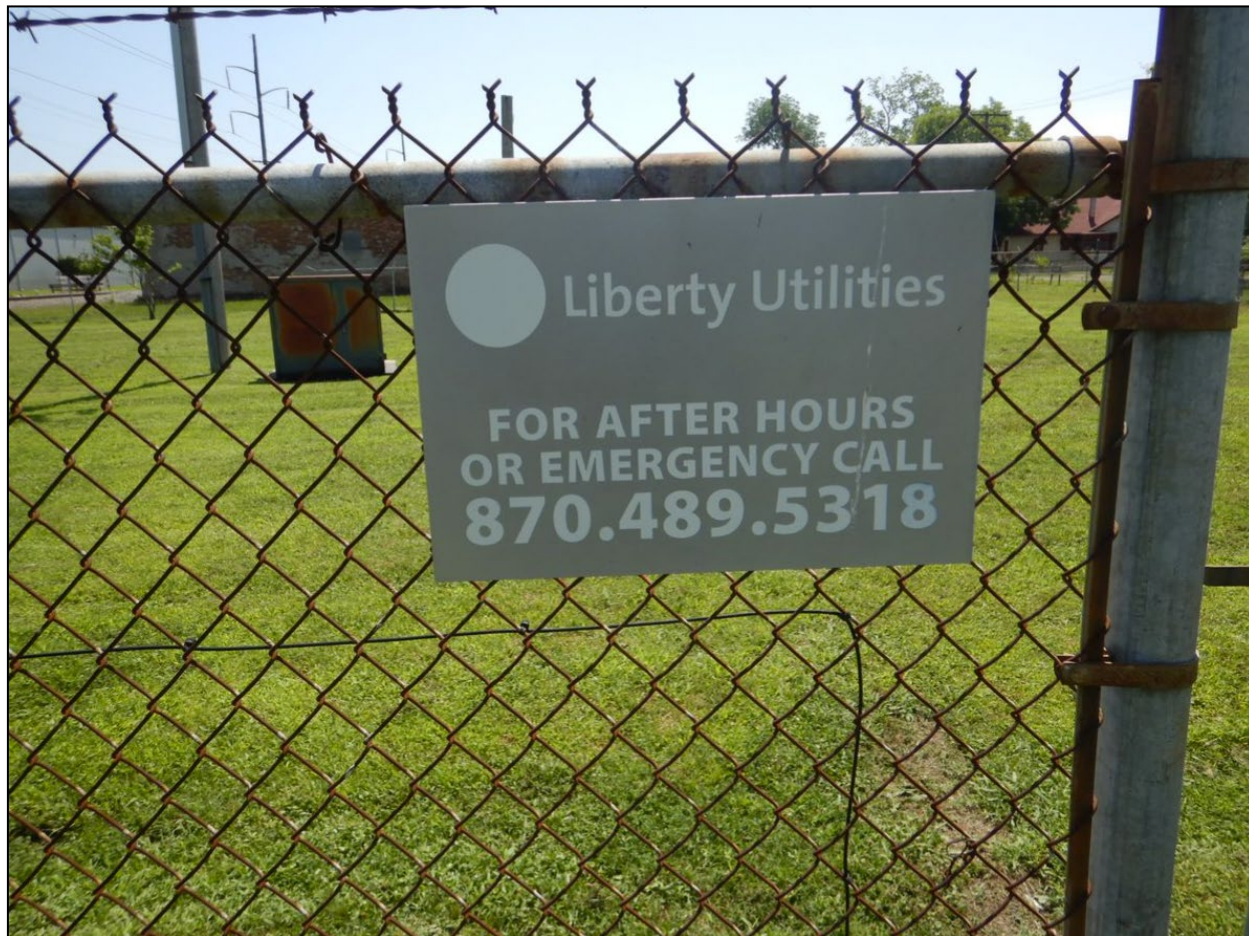
**Photograph 8. Perimeter Fence, Well No. 18** View of a sign posted on the perimeter fence of Well No. 18 containing critical information about the System, including the System name and a number to call in case of an emergency.

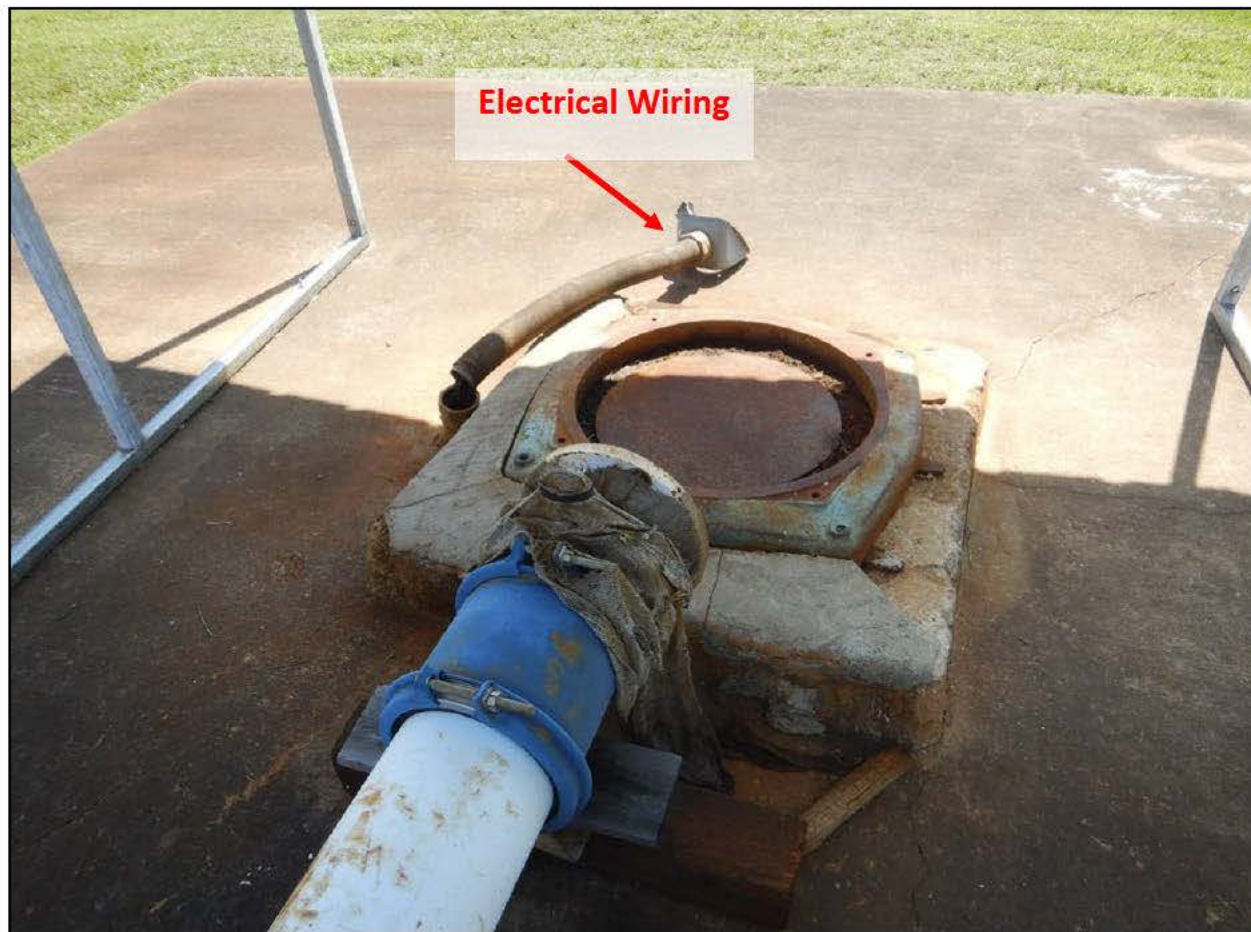
**Photograph 9. Well No. 18** View of the pad at Well No. 18 where the pump had sat prior to the well being taken offline. The well had not been formally decommissioned but had been offline for approximately a year because it was pumping sand into the treatment system. The unattached electrical wiring for the pump was laying, uncovered, next to the pump pad.

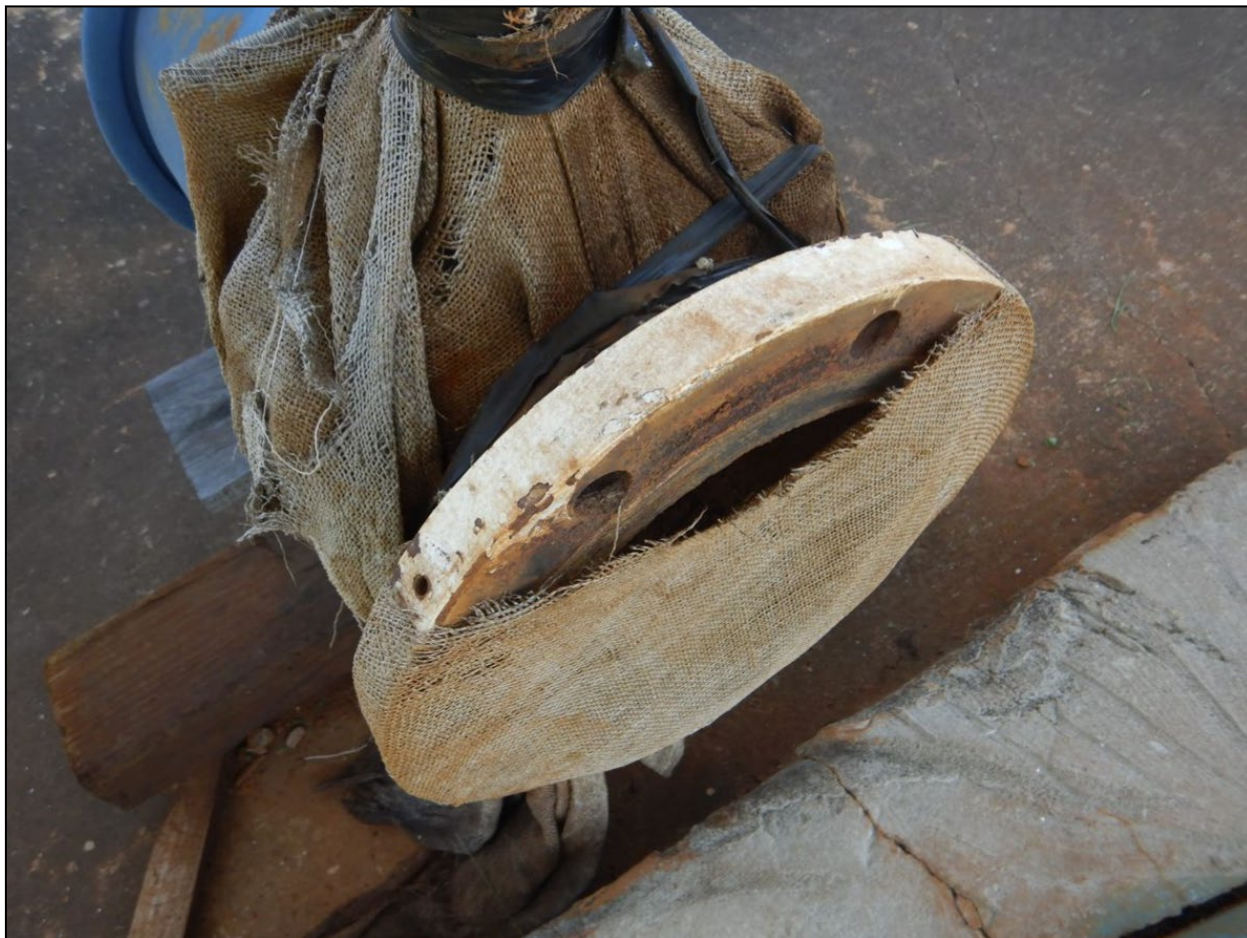
- System representatives stated that Well No. 18 was not in use because a hole in the pump line below grade had caused sand to be pumped into the treatment system. The well had been taken offline approximately a year prior to the inspection, but it was not formally decommissioned. System representatives stated that they were in the process of conducting a financial assessment to see if it would be more cost effective to repair the well and bring it back online or formally decommission it.
- The unattached electrical wiring that was originally connected to the pump at Well No. 18 was sitting on the ground, uncovered, at the time of the inspection (refer to [Appendix 2, Photograph 9](#)).
- A burlap sack had been placed over the end of the pump line where the pump used to be attached (refer to [Appendix 2, Photograph 10](#)). The sack had holes,

**Photograph 10. Well No. 18** View of the end of the pump line that was attached to the pump at Well No. 18 prior to its removal. The end of the line was covered with a burlap sack. The sack was ripped in multiple places creating openings to the pump line.

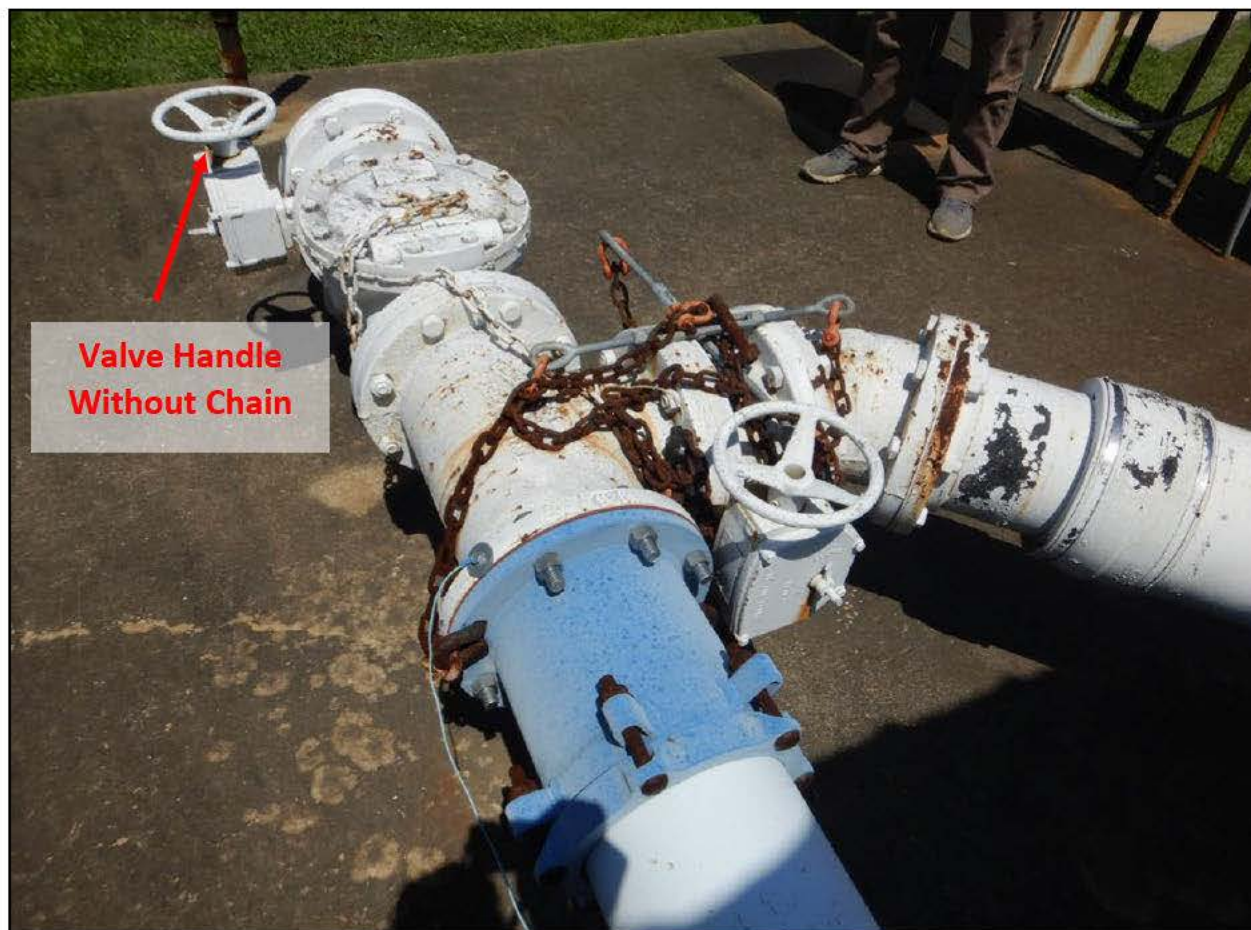
**Photograph 11. Well No. 18** View of the pump line and valves at Well No. 18. There was a chain sitting next to the valve handle that closed off flow to the treatment system. An operator stated that the chain was supposed to be threaded through the valve handle to prevent it from accidentally being opened.

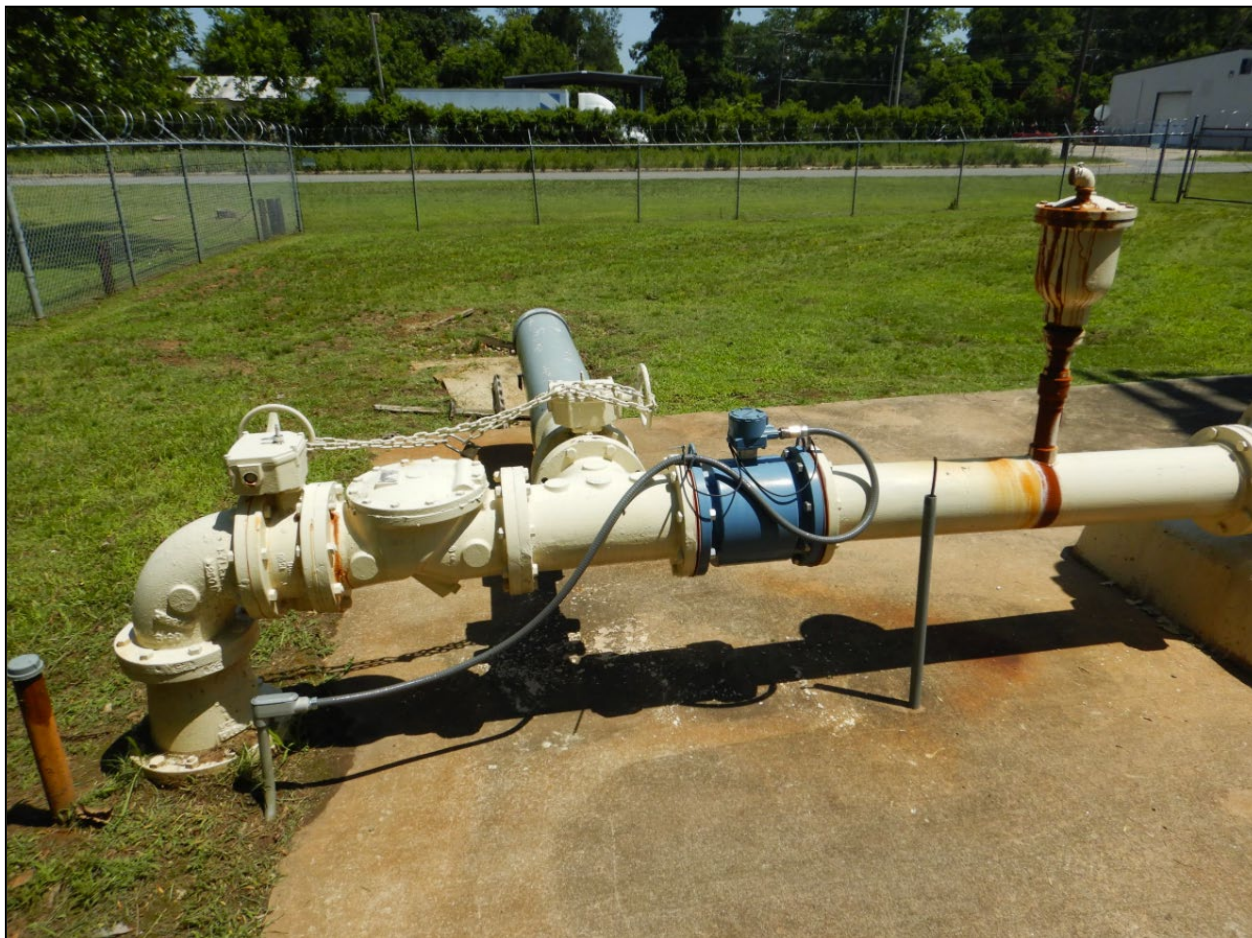
**Photograph 12. Well No. 17** View of Well No. 17. The well was fully functional. The well is used to pump raw water to WTP #1.

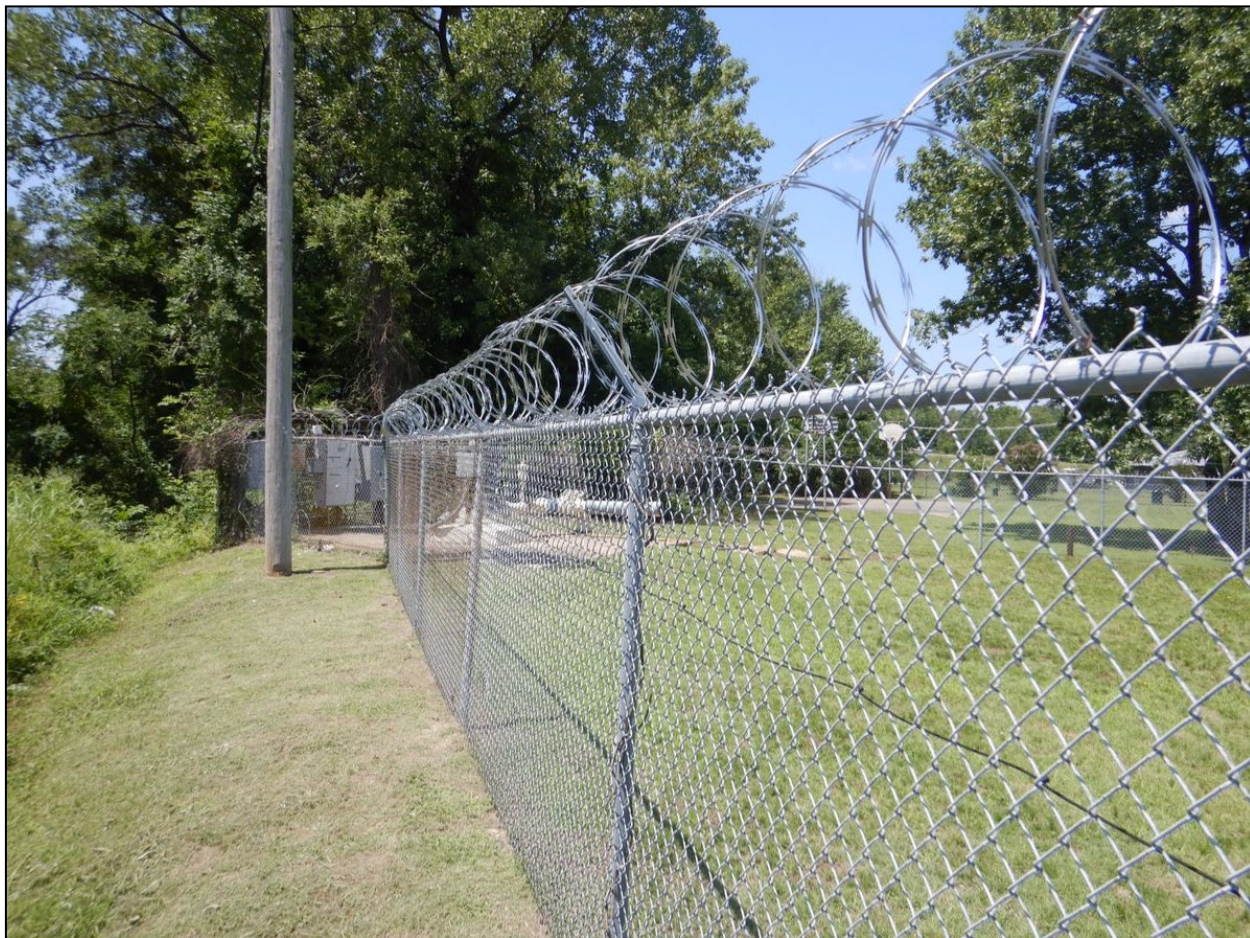
**Photograph 13. Perimeter Fence, Well No. 17** View of the perimeter fence surrounding Well No. 17. The fence was locked and had razor wire.

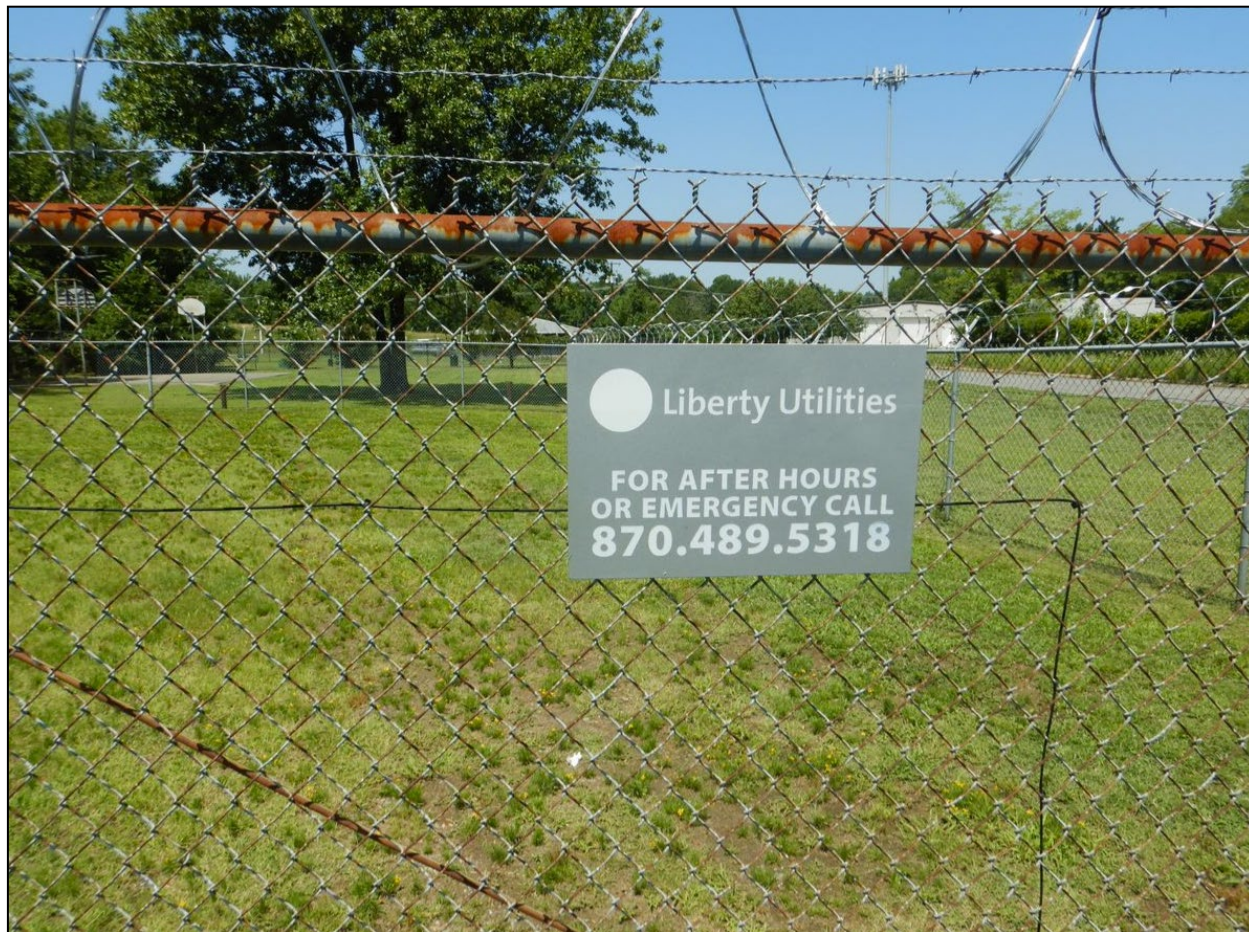
**Photograph 14. Perimeter Fence, Well No. 17** View of a sign posted on the perimeter fence of Well No. 17 containing critical information about the System, including the System name and a number to call in case of an emergency.

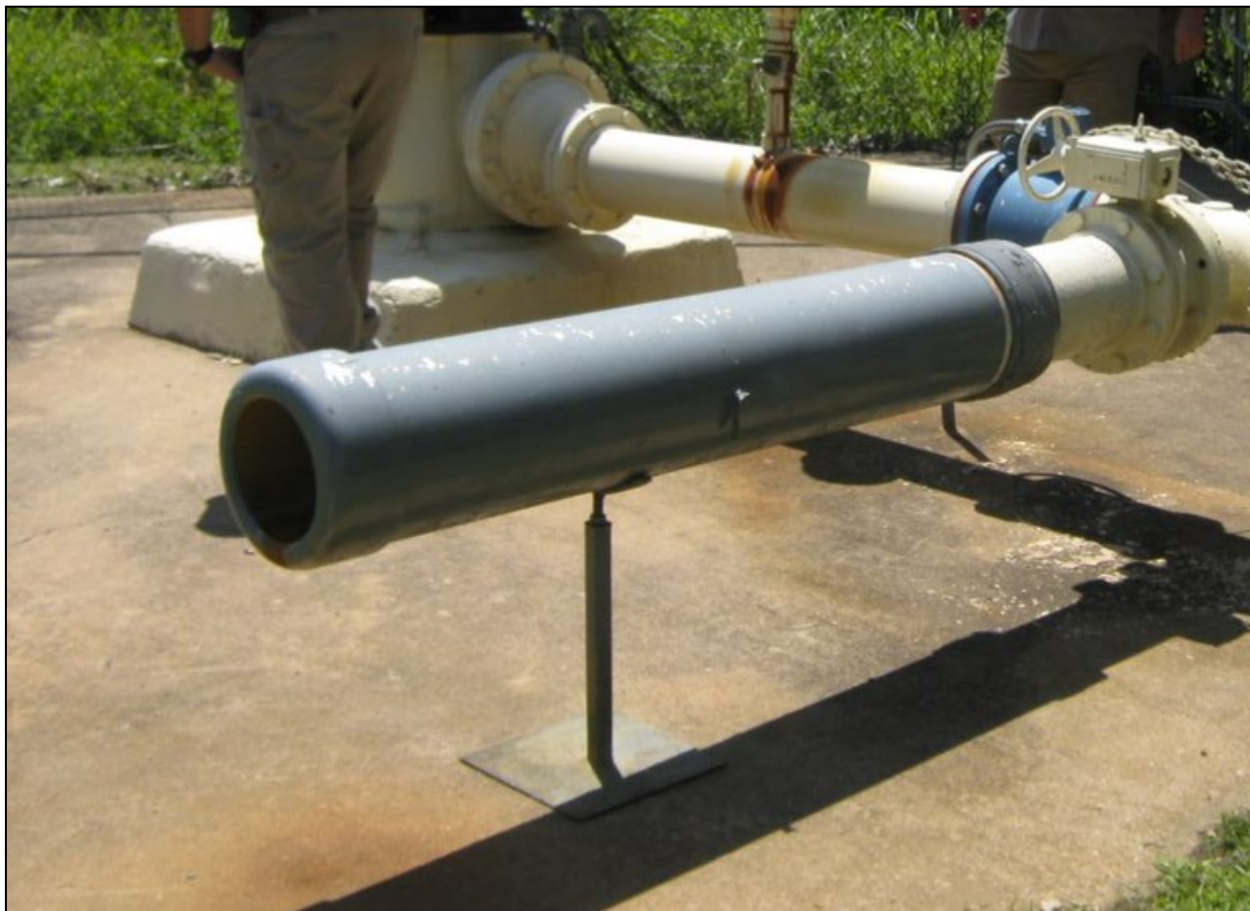
**Photograph 16. Well No. 17** View of the pump to waste line at Well No. 17. The line was valved off from the line into the treatment system, but the end of the line was uncovered.

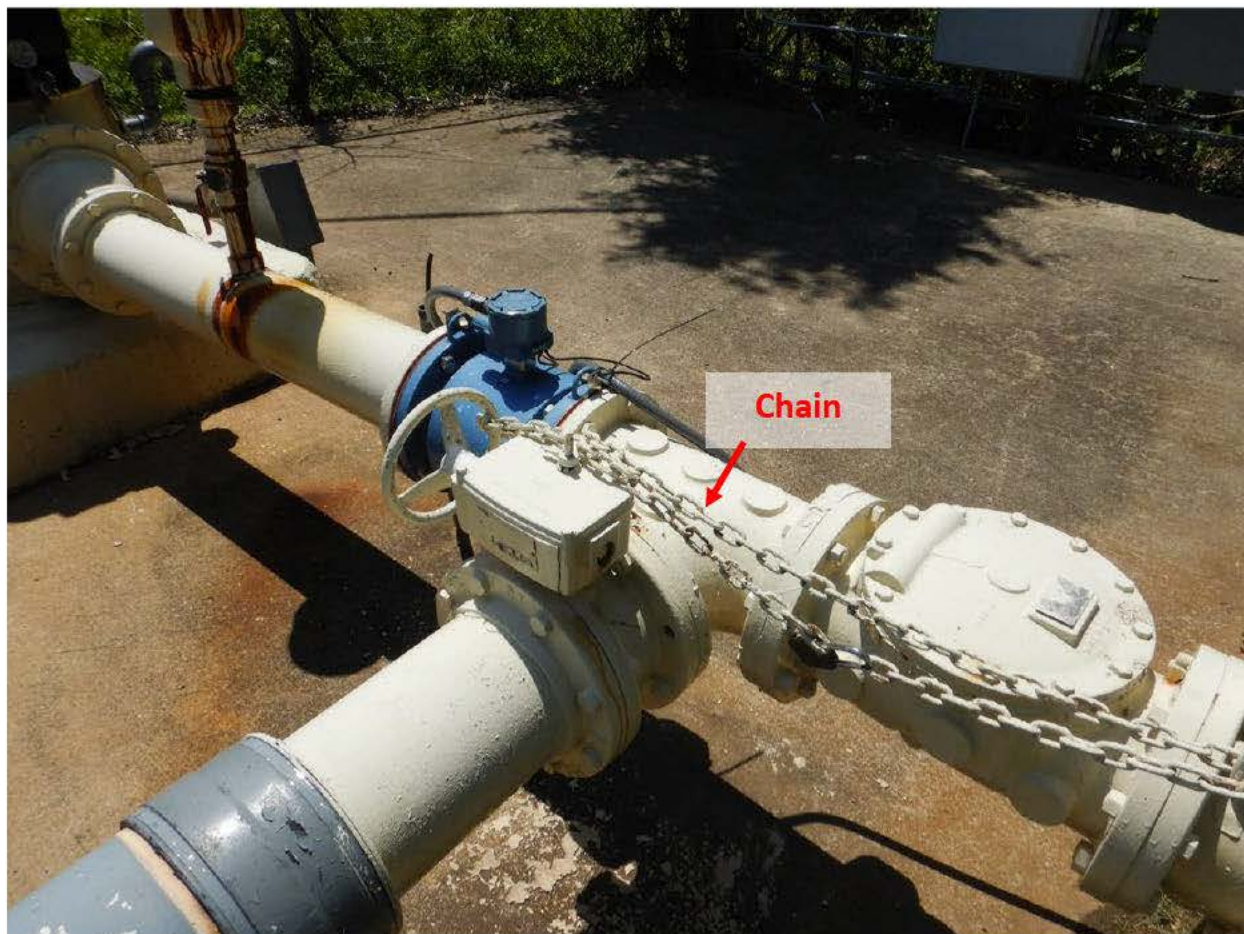
**Photograph 17. Well No. 17** View of a chain that was threaded through the valve handle that was used to close the valve leading to the treatment system, as well as the handle to close the pump to waste line valve. The chain was in place to make sure the pump to waste valve did not get opened by mistake.

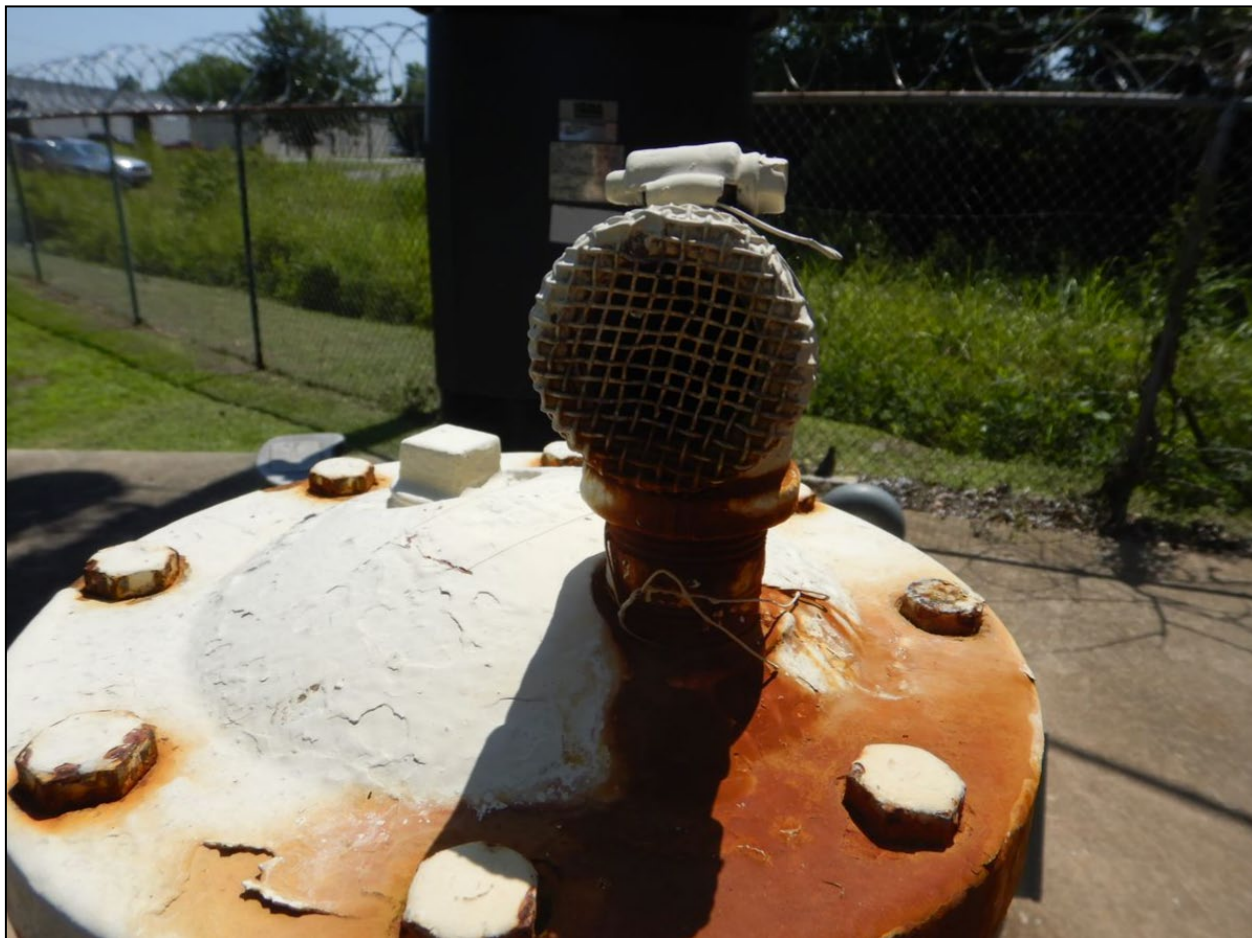
**Photograph 18. Well No. 17** View of an air relief valve that extended off of the Well No. 17 pump line. The valve opening was screened but not downturned.

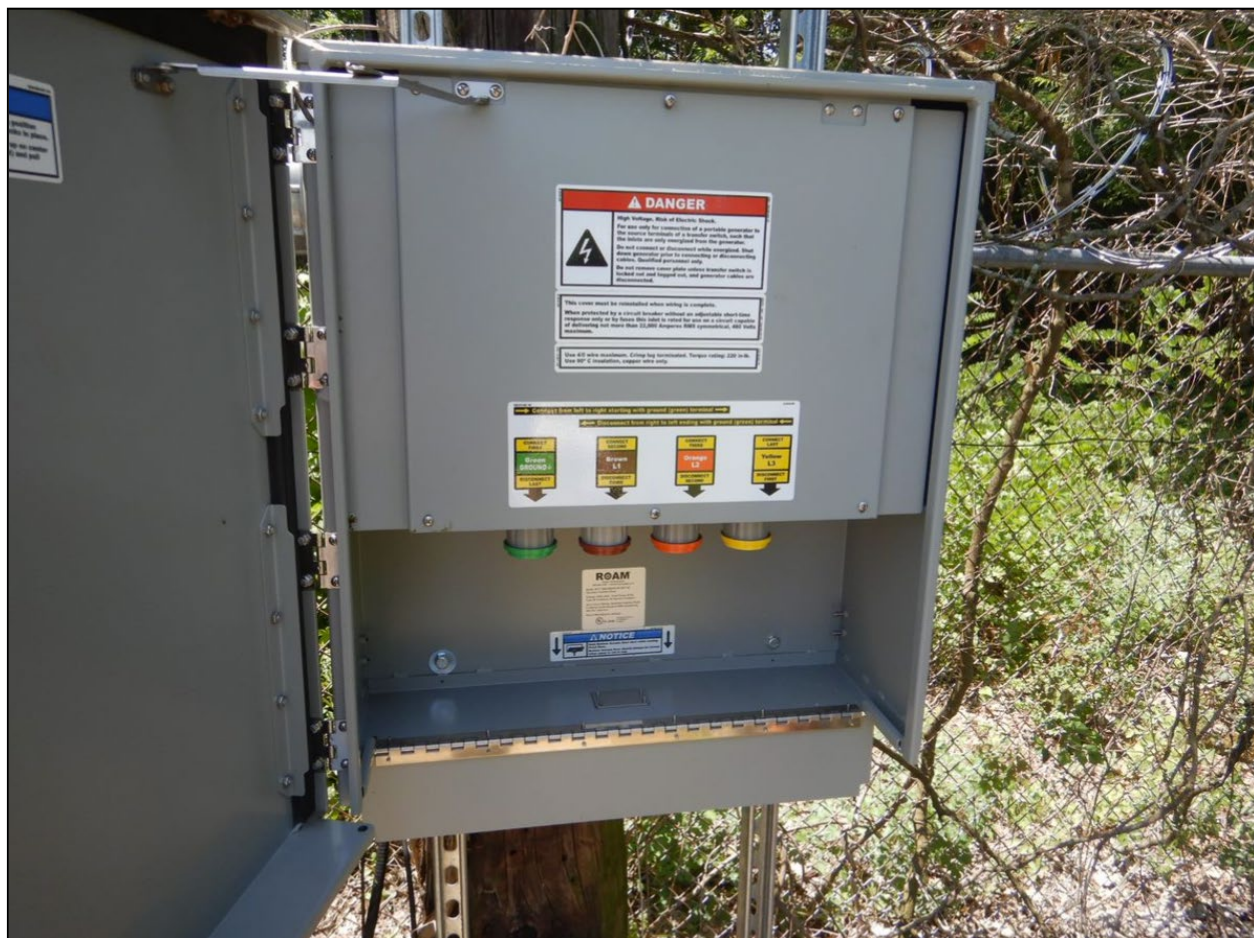
**Photograph 19. Generator Connection, Well No. 17** View of the generator connection box at Well No. 17. The Operations Manager stated that this box enabled easy connection to the portable generators.
