**Region 6 - Enforcement & Compliance Assurance Division**  
**INSPECTION REPORT**

| Inspection Date(s): | 06/26/2023 | |
| Regulatory Program(s) | AWIA/SDWA | |
| Facility Name: | <b>Liberty Utilities Company (Pine Bluff)</b> | |

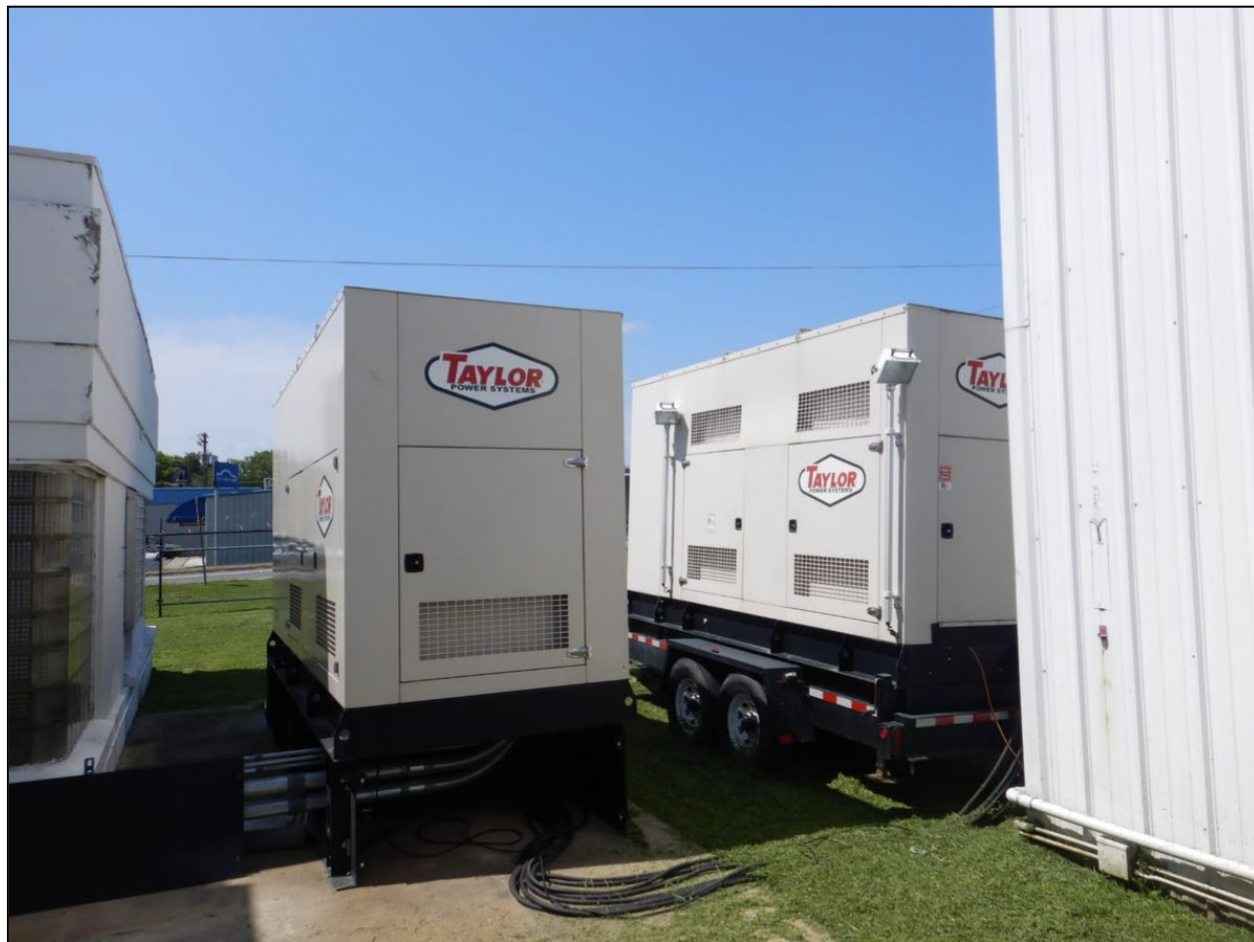
**Photograph 20. Generators, WTP #1** View of the mounted backup generator and portable backup generator that were positioned at WTP #1. The mounted generator was out of service, so the portable generator had been brought in and wired through the mounted generator's switch gear. The trailer generator had turned on automatically and ran the treatment plant on the night prior to the inspection.

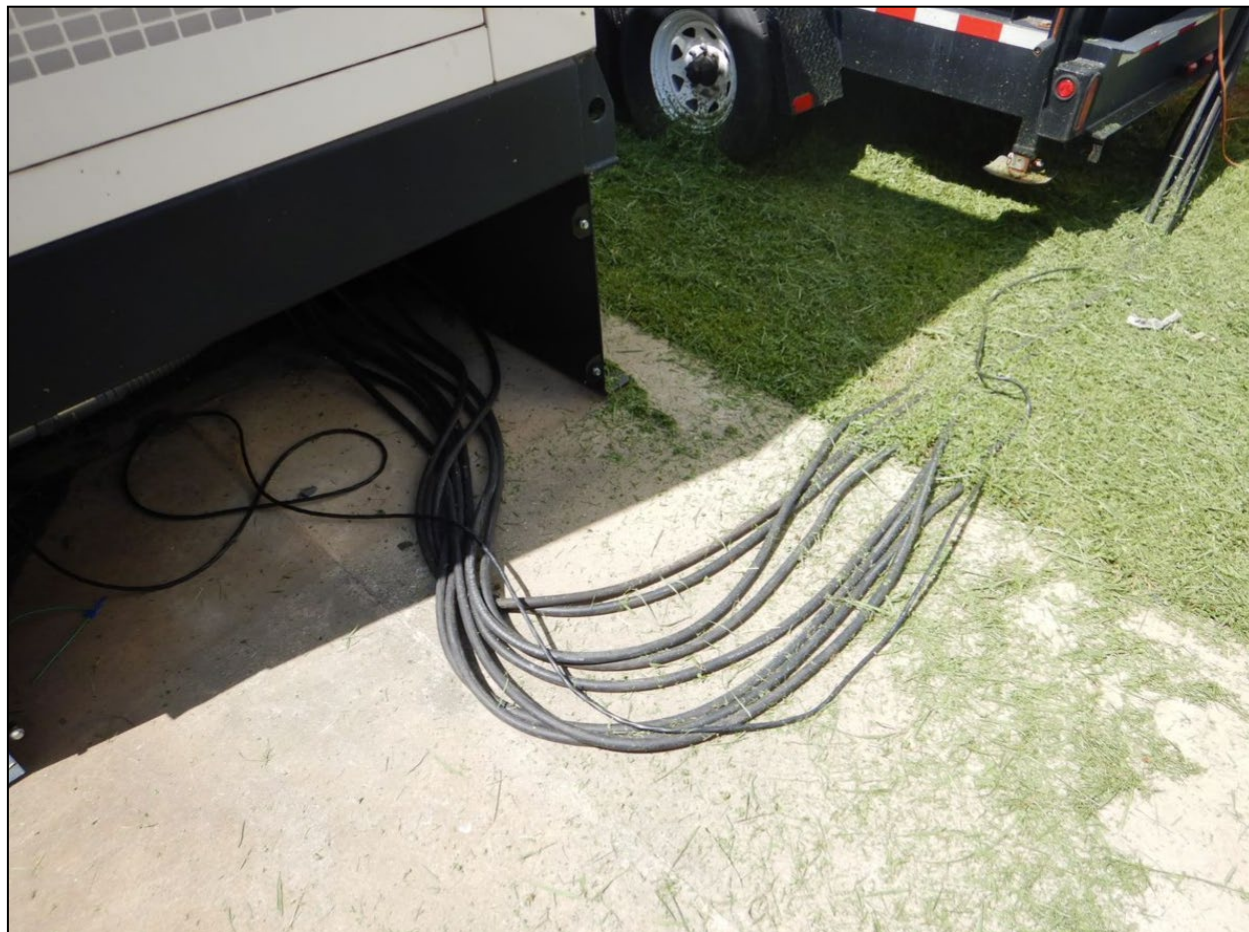
**Photograph 21. Generators, WTP #1** View of the wiring between the trailer backup generator and the mounted generator at WTP #1. The trailer generator was wired through the mounted generator's switch gear so that it would turn on automatically in the event of a power outage.

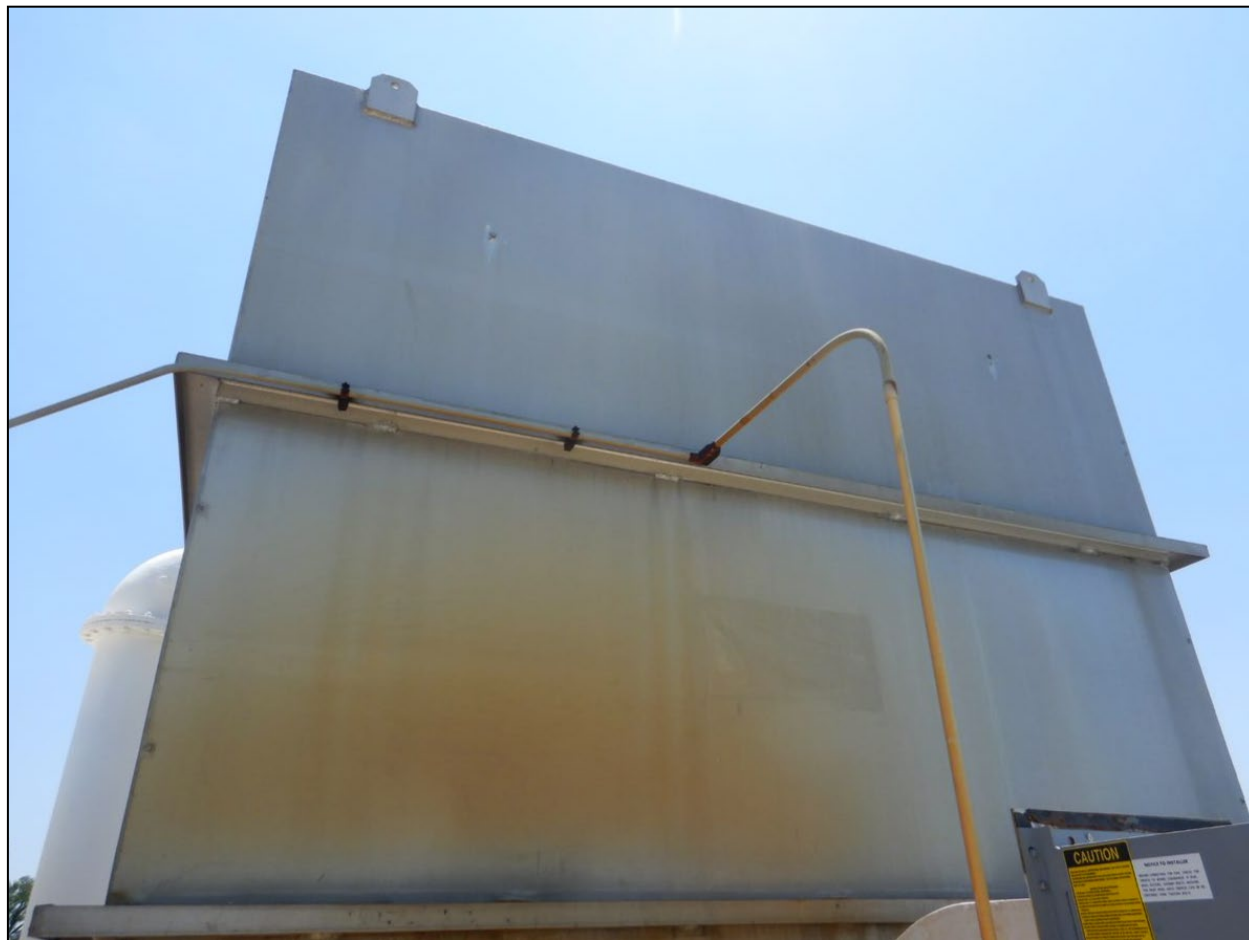
**Photograph 22. Aerator No. 2, WTP #1** View of the aerator that was associated with Filter No. 2 at WTP #1. Raw water is pumped into the plant, and it cascades through the aerators prior to being filtered.

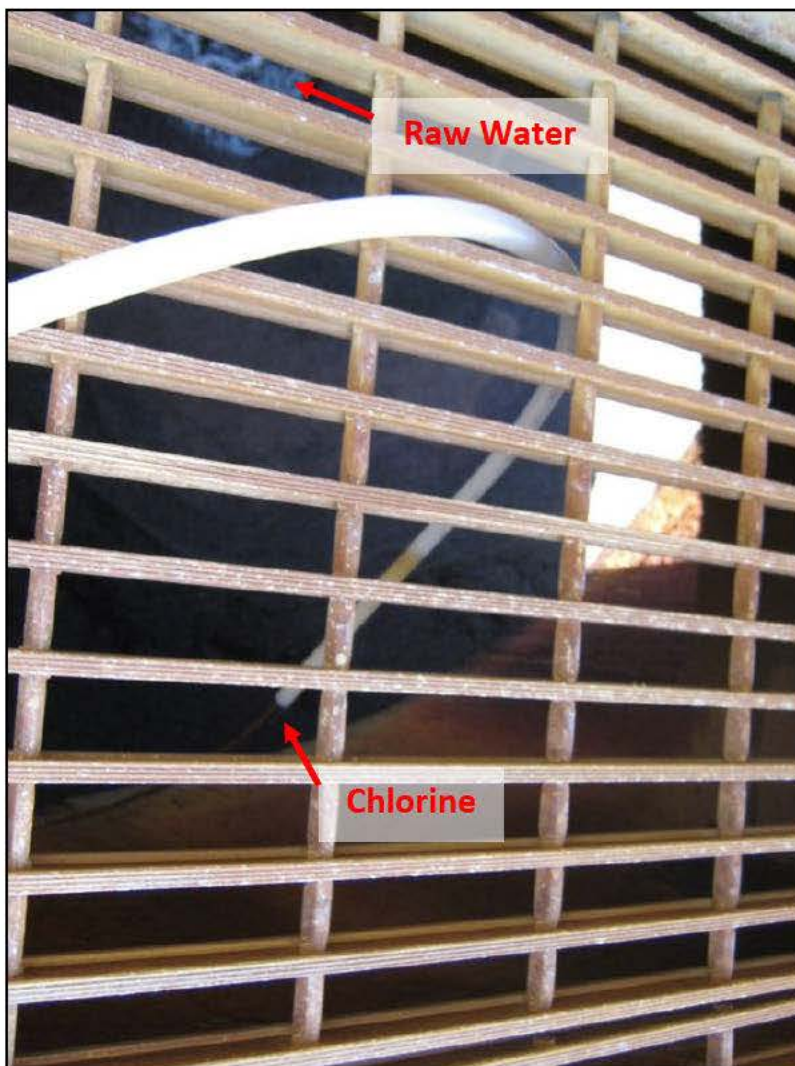
- The actuators on the valves sending raw water to the aerators and Filter Nos. 1 and 2 had failed and were not communicating with SCADA during the inspection. Ordinarily the actuators open and close the valves automatically to regulate flow coming into the plant. Since the actuators were online, the operator stated that the valves had been manually opened to 30 percent to ensure that the filter basins did not overflow. Due to the fact that the valves were only opened to 30 percent, during periods of low flow the water going through Filter No. 2 was short circuiting the filter. The water level was below the filter media. As a result of the short circuiting, the chlorine that was being injected was not mixing with the raw water prior to filtration (refer to [Appendix 2, Photograph 23](#)). It was unclear if the chlorine was mixing with the raw water at all.

**Photograph 23. Filter No. 2 Chlorine Injection Tube, WTP #1** View of the chlorine injection tube that was sending chlorine against the wall of the Filter No. 2 basin. Since the water was below the filter media in the basin, the chlorine was not mixing with the raw water prior to filtration.

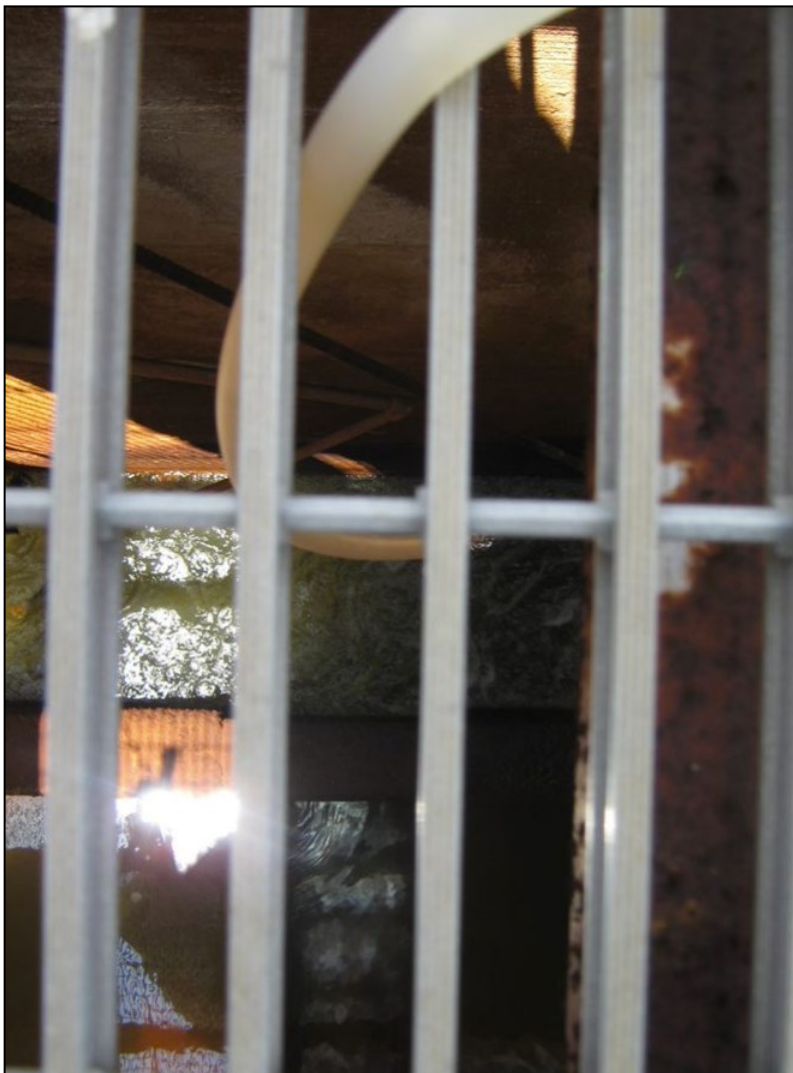
**Photograph 24. Filter No. 4 Chlorine Injection Tube, WTP #1** View of the chlorine injection tube that was sending chlorine into the raw water at Filter No. 4 to mix prior to being filtered.

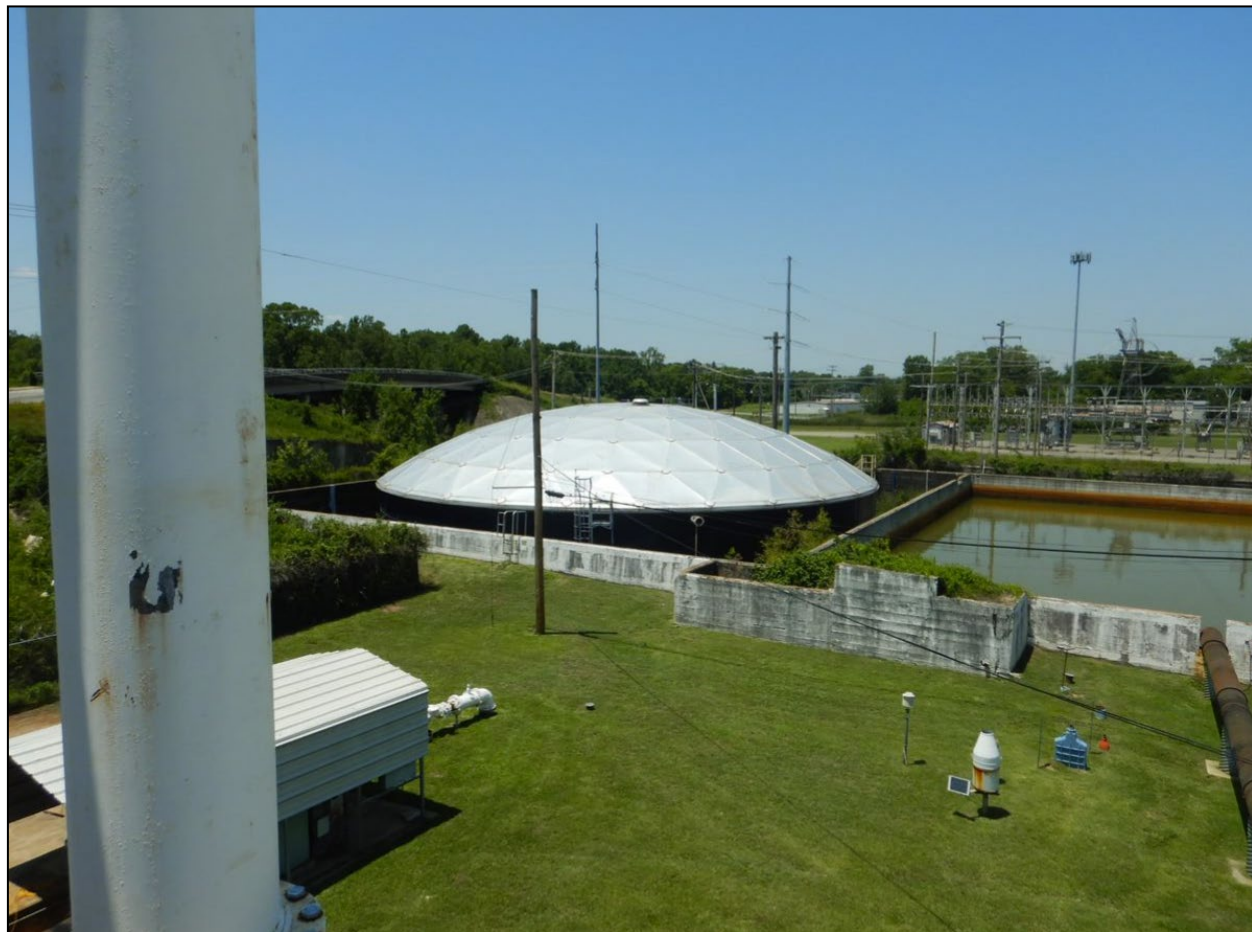
**Photograph 25. Clearwell, WTP #1** View of one of the two, 1.5 million gallon onsite clear wells at WTP #1 where treated water is sent prior to being pumped into the distribution system.

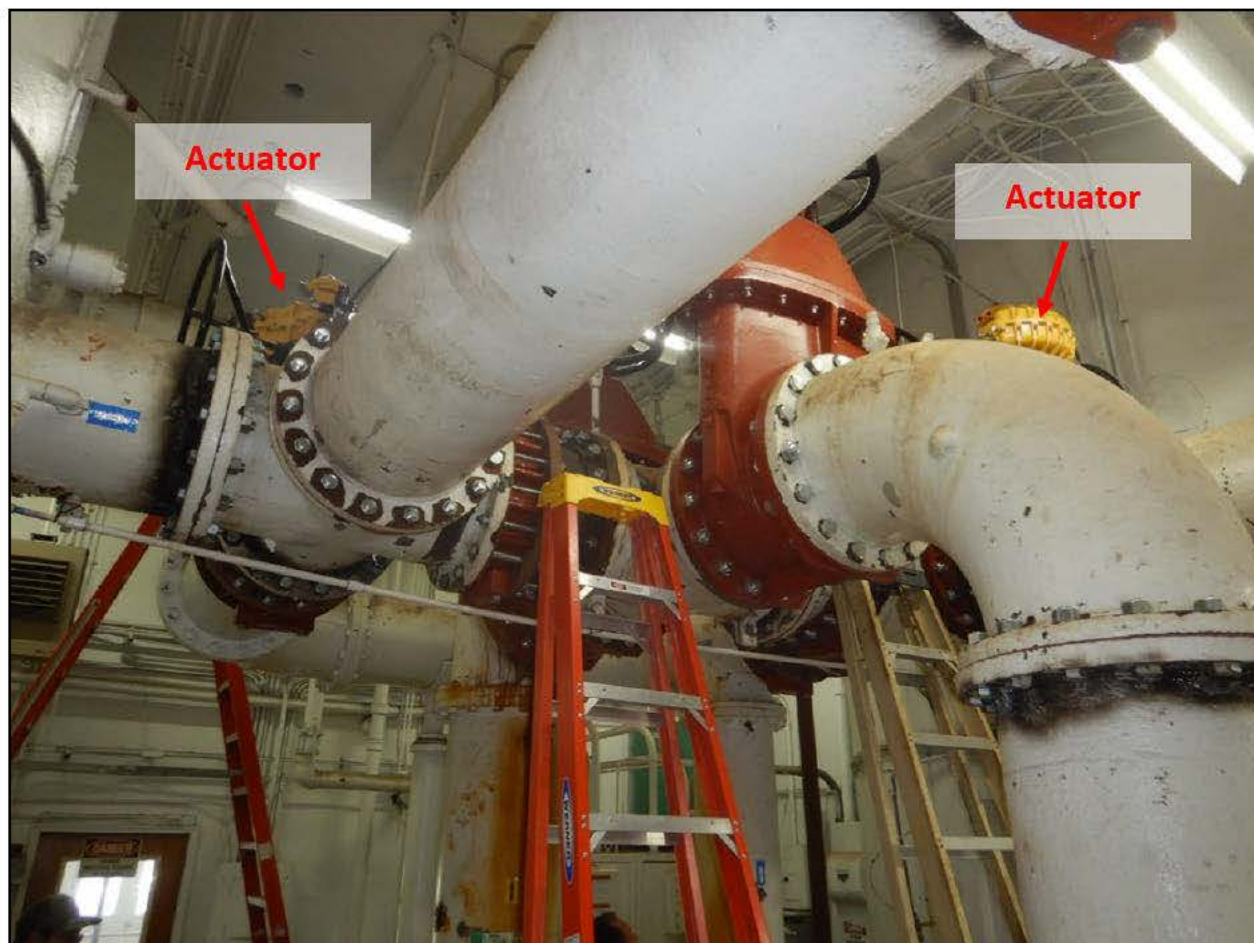
The pipe gallery at WTP #1 was observed. System representatives explained how raw water entered the aeration tanks and showed where filtered and chlorinated water flowed following treatment (refer to [Appendix 2, Photograph 26](#)). The Operations Manager stated that there were actuators on the valves used to regulate the amount of raw water flowing through Aeration Tank Nos. 1 and 2. He stated that the SCADA system could be used to regulate the amount of raw water sent into the treatment system,

but that the communication had failed. Therefore, the operators had manually opened the valves to 30 percent. During low flow conditions (as was occurring during the inspection), not enough water is able to flow through the aerators and filters to ensure that the water level is higher than the filter media. It was unknown when the communication failure would be repaired to allow the valves to open and close automatically again.

**Photograph 26. Pipe Gallery, WTP #1** View of the pipe gallery beneath the filter basins for Filter Nos. 1 and 2 at WTP #1. The actuators on the raw water lines leading to the aerators and filters were not communicating with SCADA and therefore were unable to automatically regulate the flow coming into the filters.

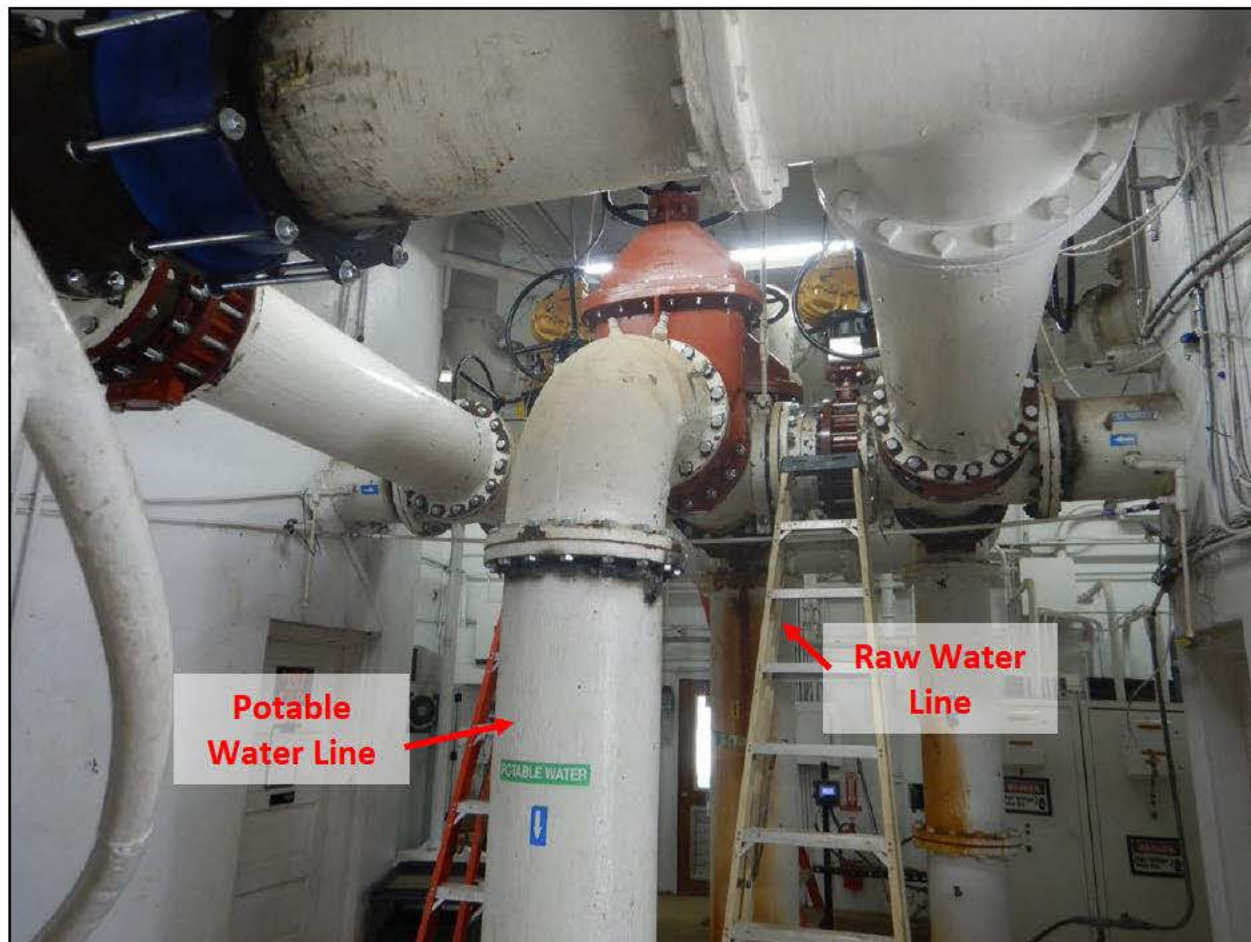
**Photograph 27. Pipe Gallery, WTP #1** Alternate view of the pipe gallery beneath the filter basins for Filter Nos. 1 and 2 at WTP #1. Visible in this image is the potable water line which sends treated water to the distribution system, as well as the raw water line that sends water to the filters. The lines are separated by one closed valve.

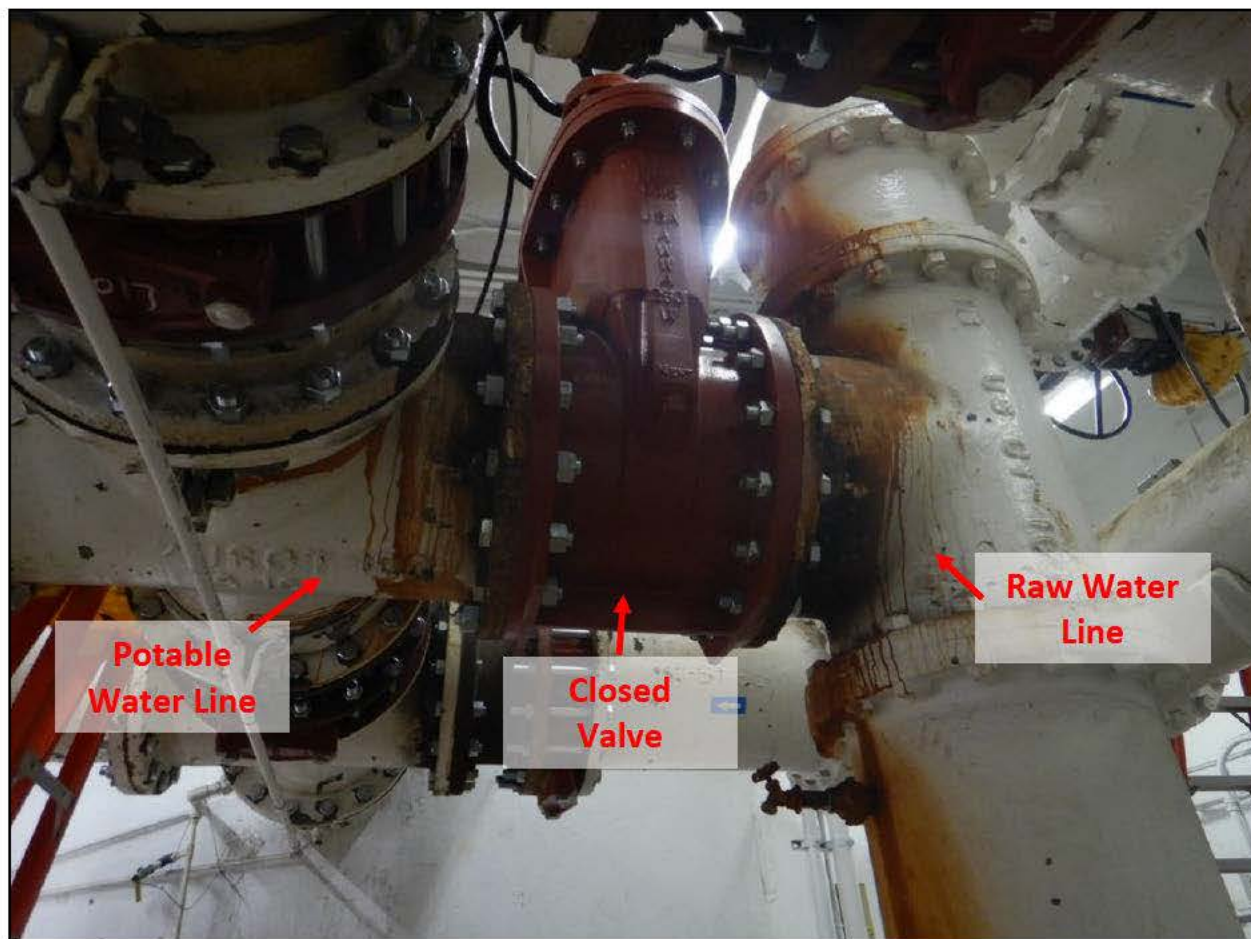
**Photograph 28. Pipe Gallery, WTP #1** View of the one closed valve separating the influent raw water and the potable water line that sends finished water to the distribution system. The valve was not locked or marked to prevent it from being accidentally opened.

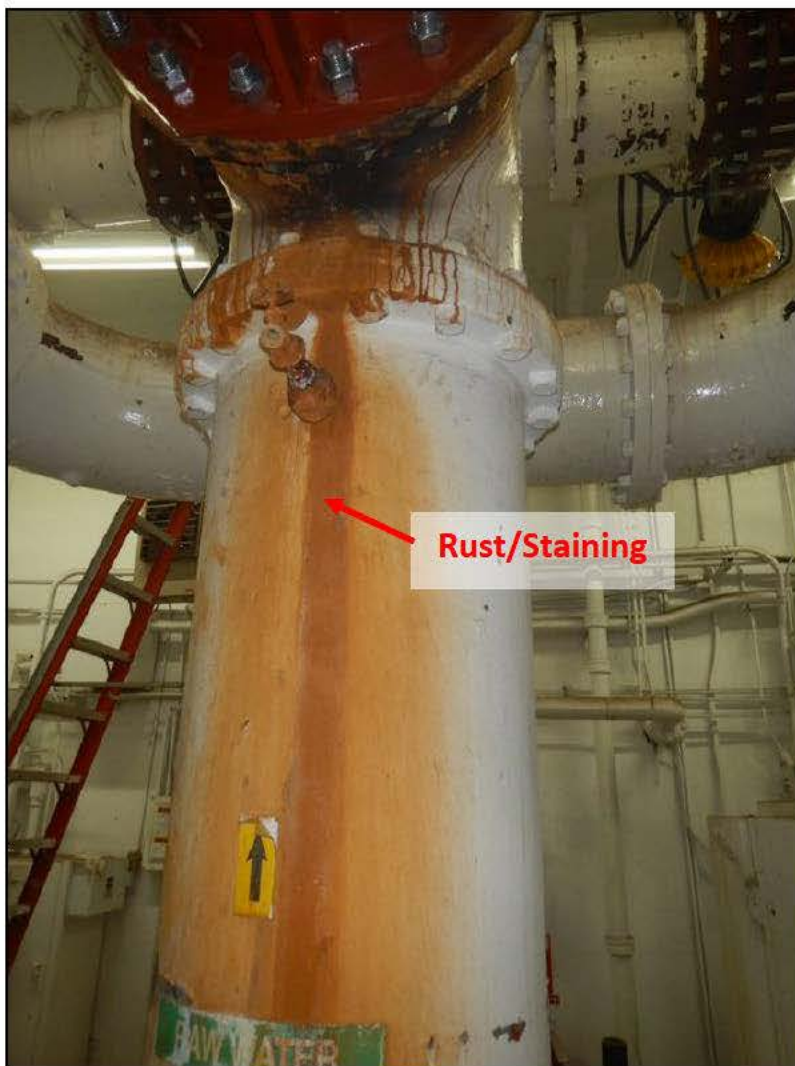
**Photograph 29. Raw Water Line, WTP #1** View the influent raw water line in the pipe gallery at WTP #1. There was rust/staining on the line, and it appeared that the rust had come from a valve leak. The leaking valve was the only valve separating raw influent water from being sent into the distribution system.

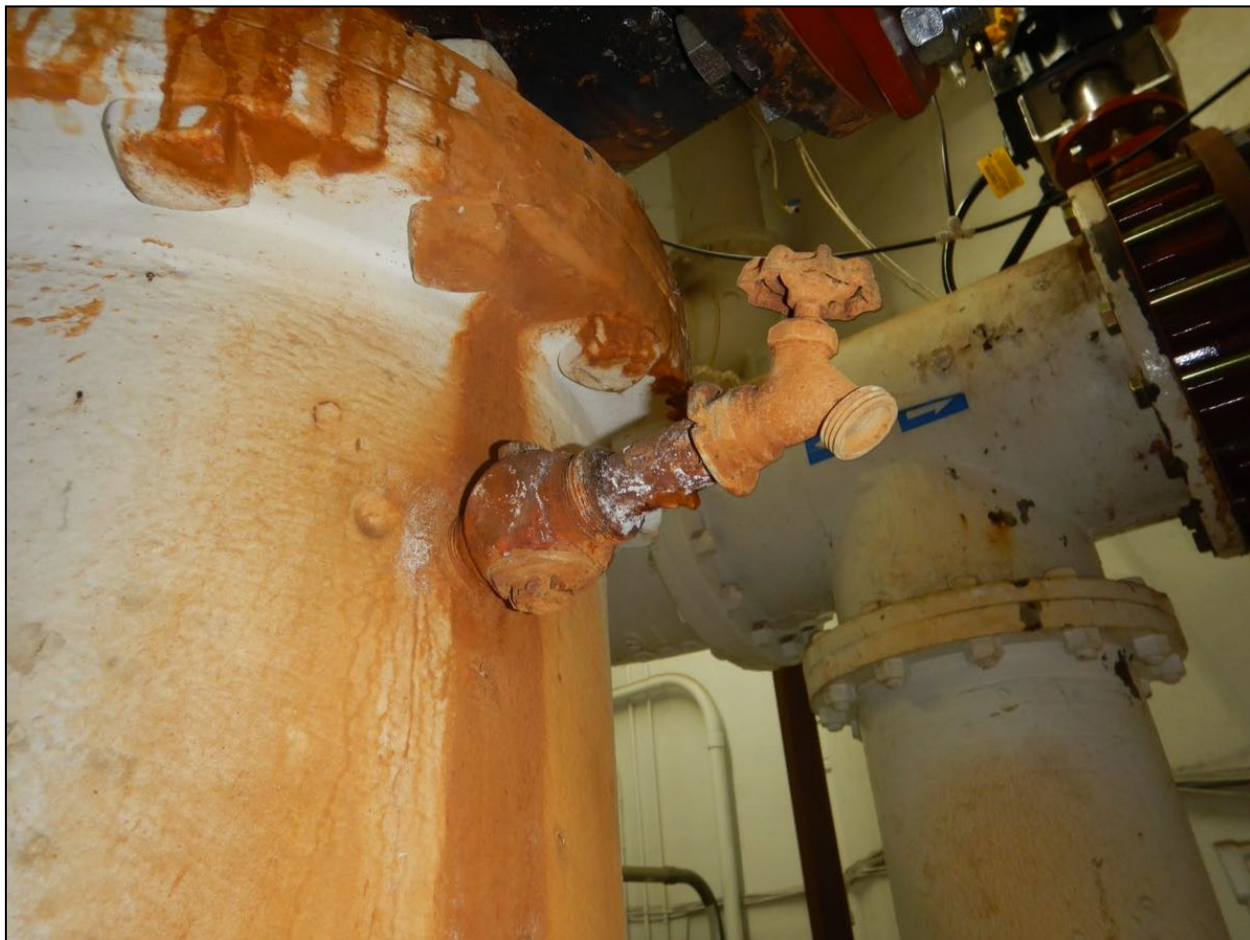
**Photograph 30. Raw Water Line, WTP #1** View of a threaded hose tap that extended off of the raw water line at WTP #1. The hose tap did not have backflow prevention.

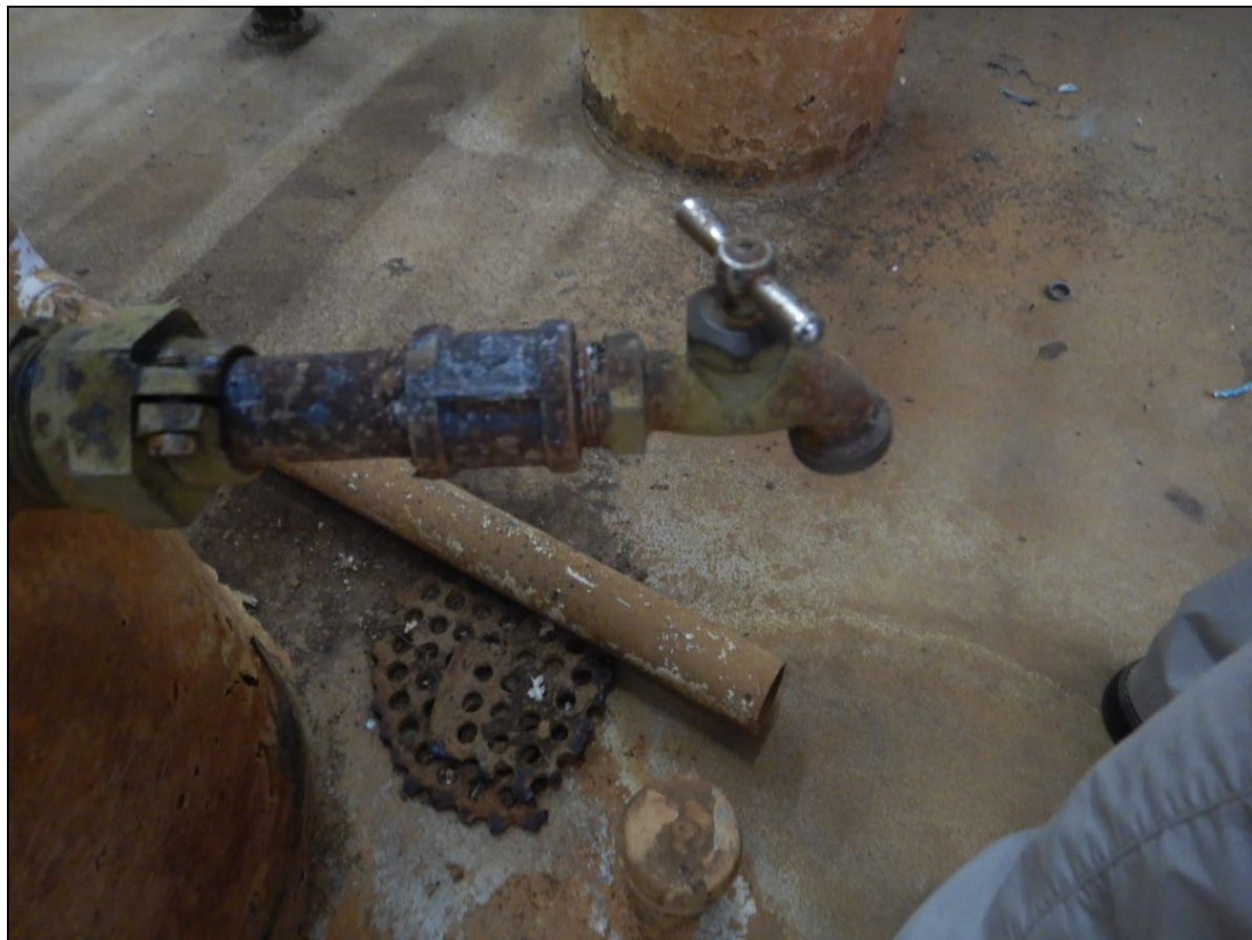
**Photograph 31. Raw Water Line, WTP #1** View of a second threaded hose tap that extended off of the raw water line at WTP #1. The hose tap did not have backflow prevention.

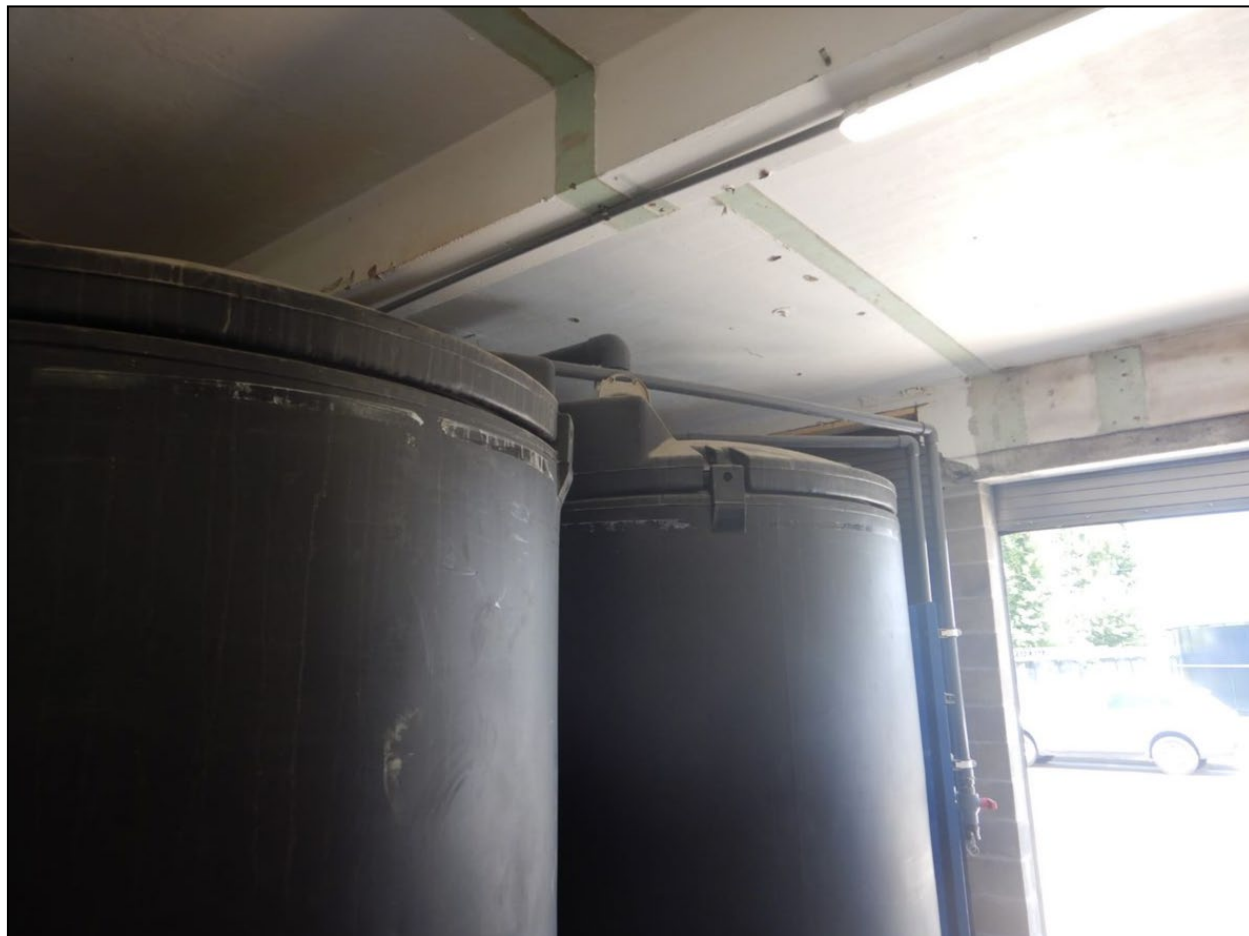
**Photograph 32. Chemical Storage/Injection Room, WTP #1** View of the two sodium hypochlorite bulk storage tanks inside of the chemical storage room at WTP #1. The tanks were not labeled.

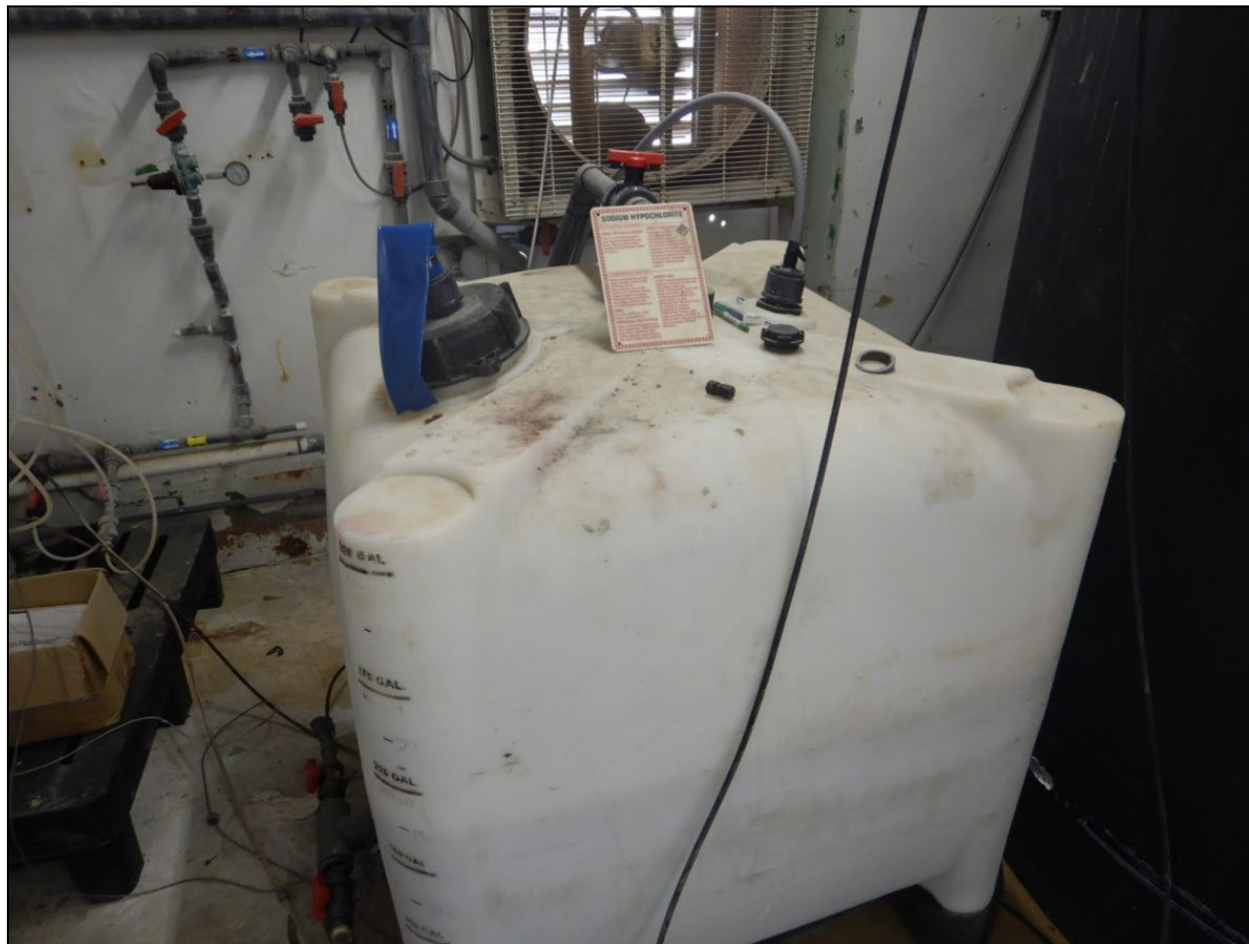
**Photograph 33. Chemical Storage/Injection Room, WTP #1** View of the sodium hypochlorite day tank inside the chlorine storage room at WTP #1. The tank had a label sitting on top of it.

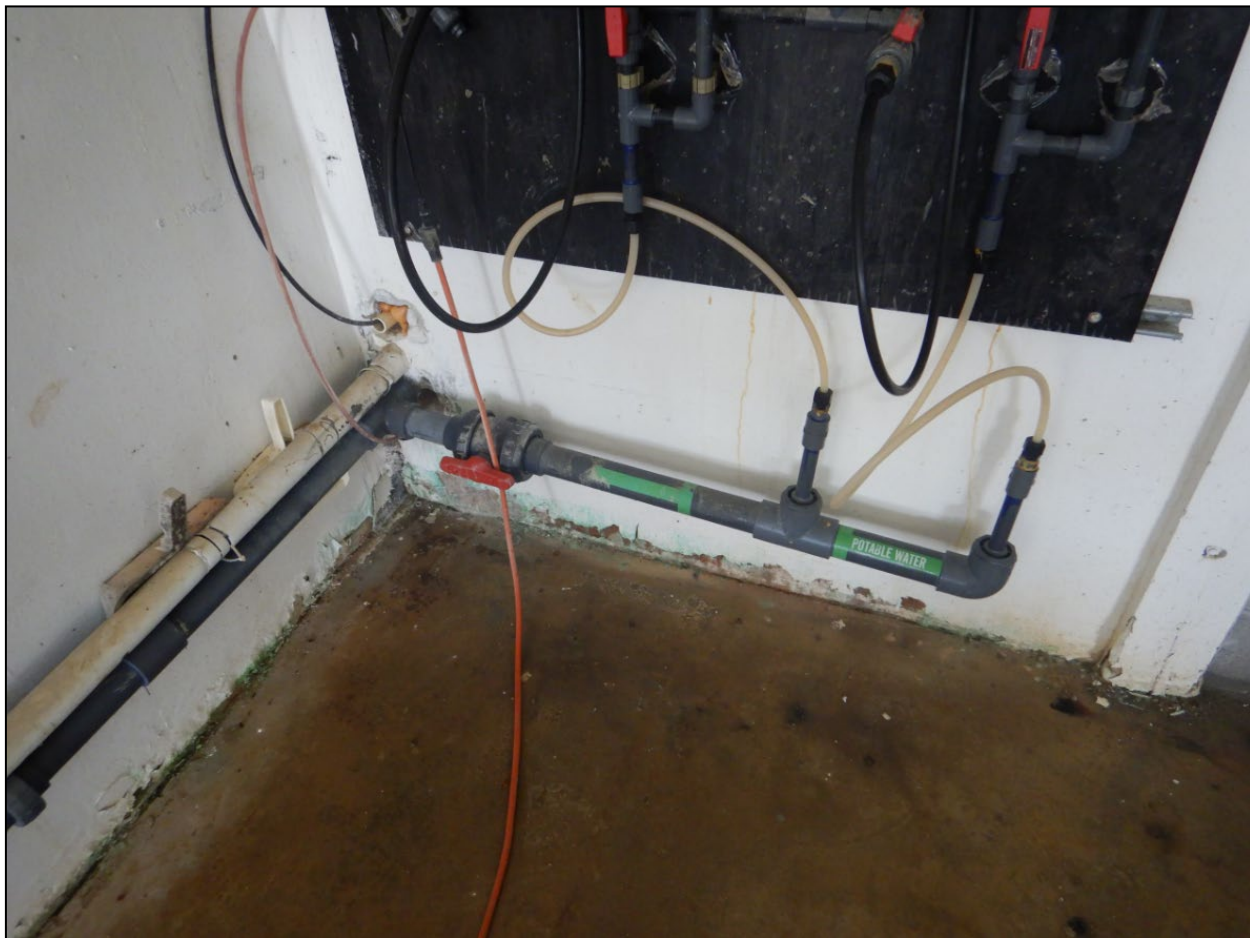
**Photograph 34. Carry Water Injection Point, WTP #1** View of the point where carry water is injected to facilitate sodium hypochlorite injection. There was no backflow prevention on the carry water line.

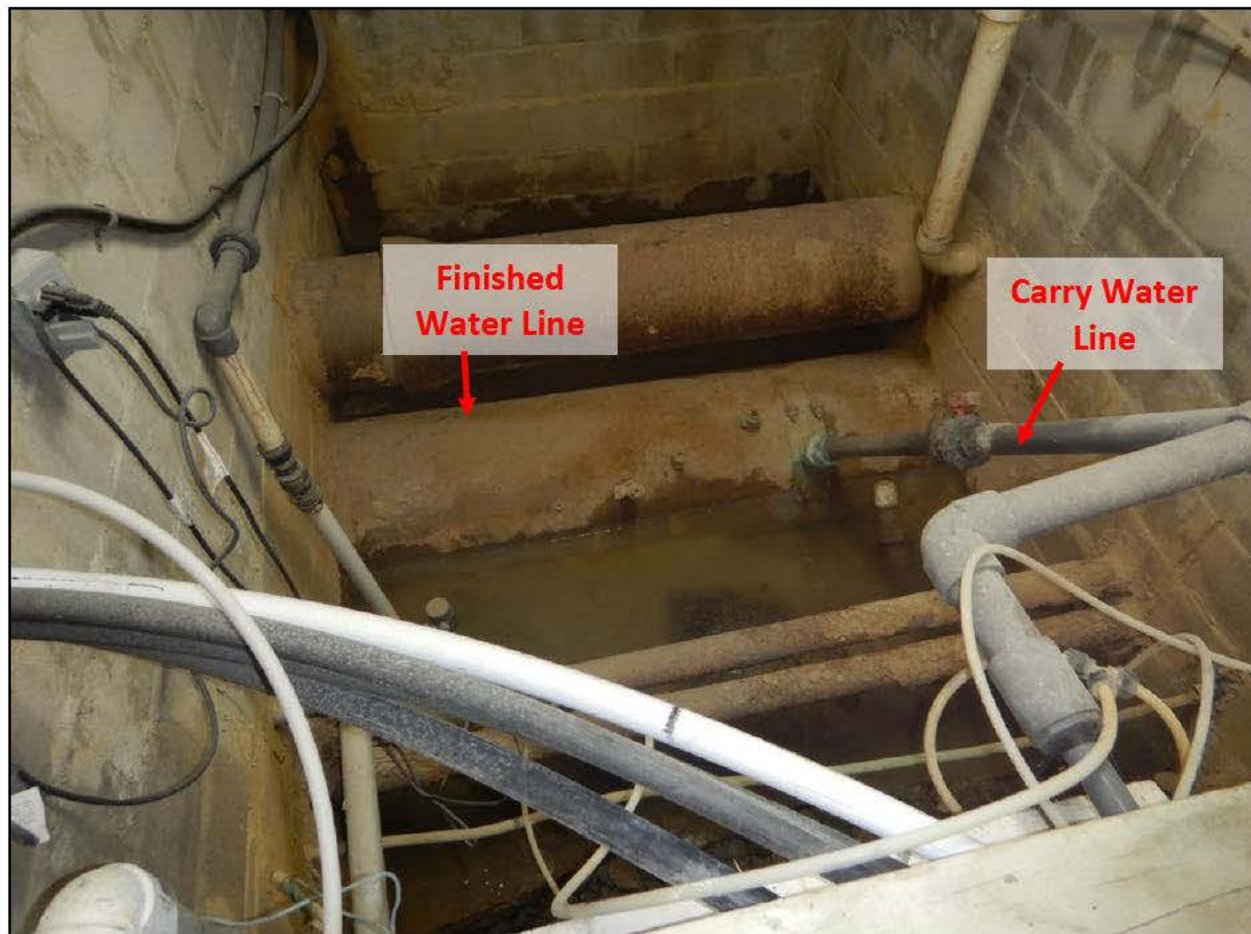
**Photograph 35. Carry Water Line, WTP #1** View of the carry water line that extended off of the finished water line. There was no backflow prevention on the line.

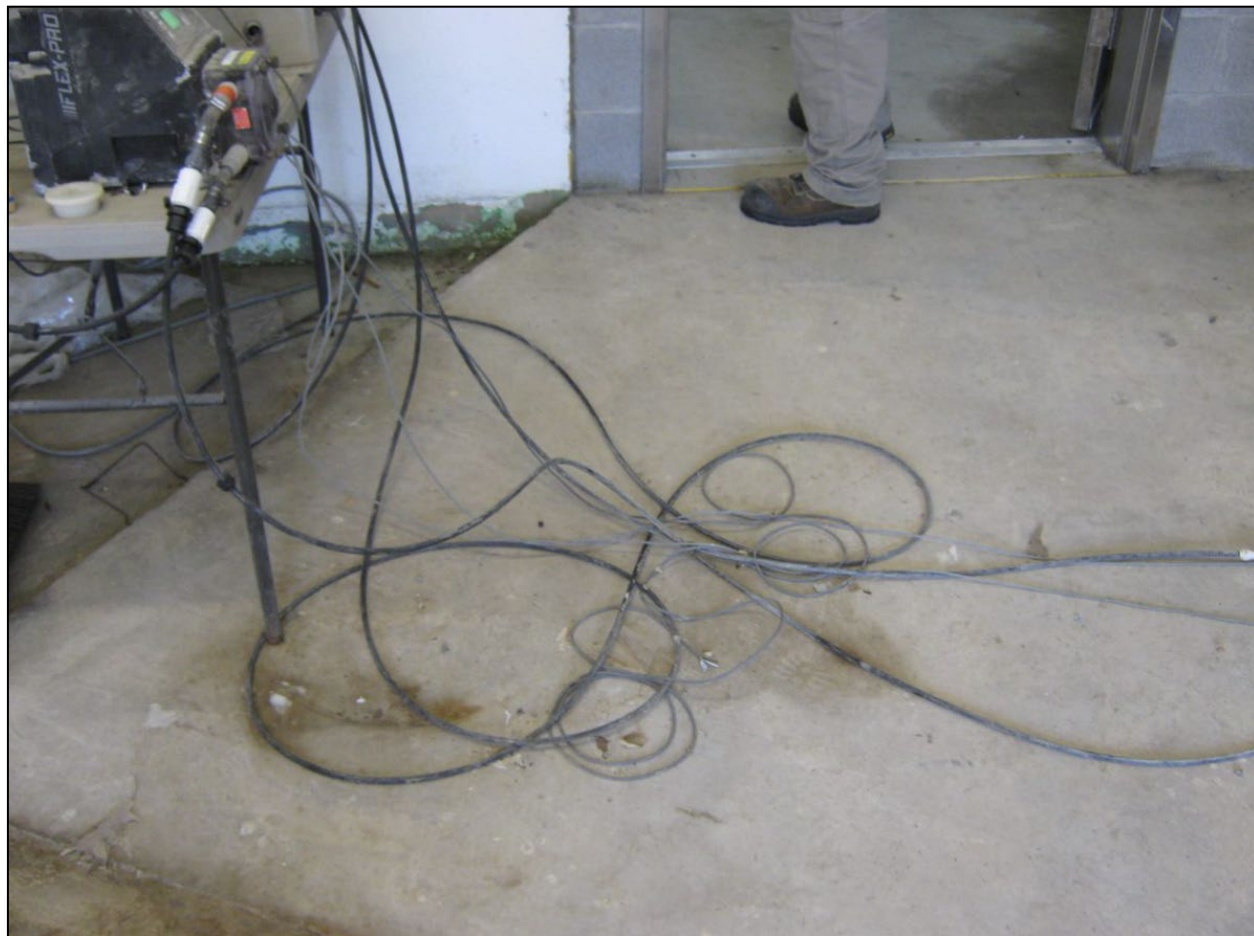
**Photograph 36. Chlorine Lines, WTP #1** View of the chlorine pump lines on the floor in the chemical injection room at WTP #1. The lines presented a tripping hazard.

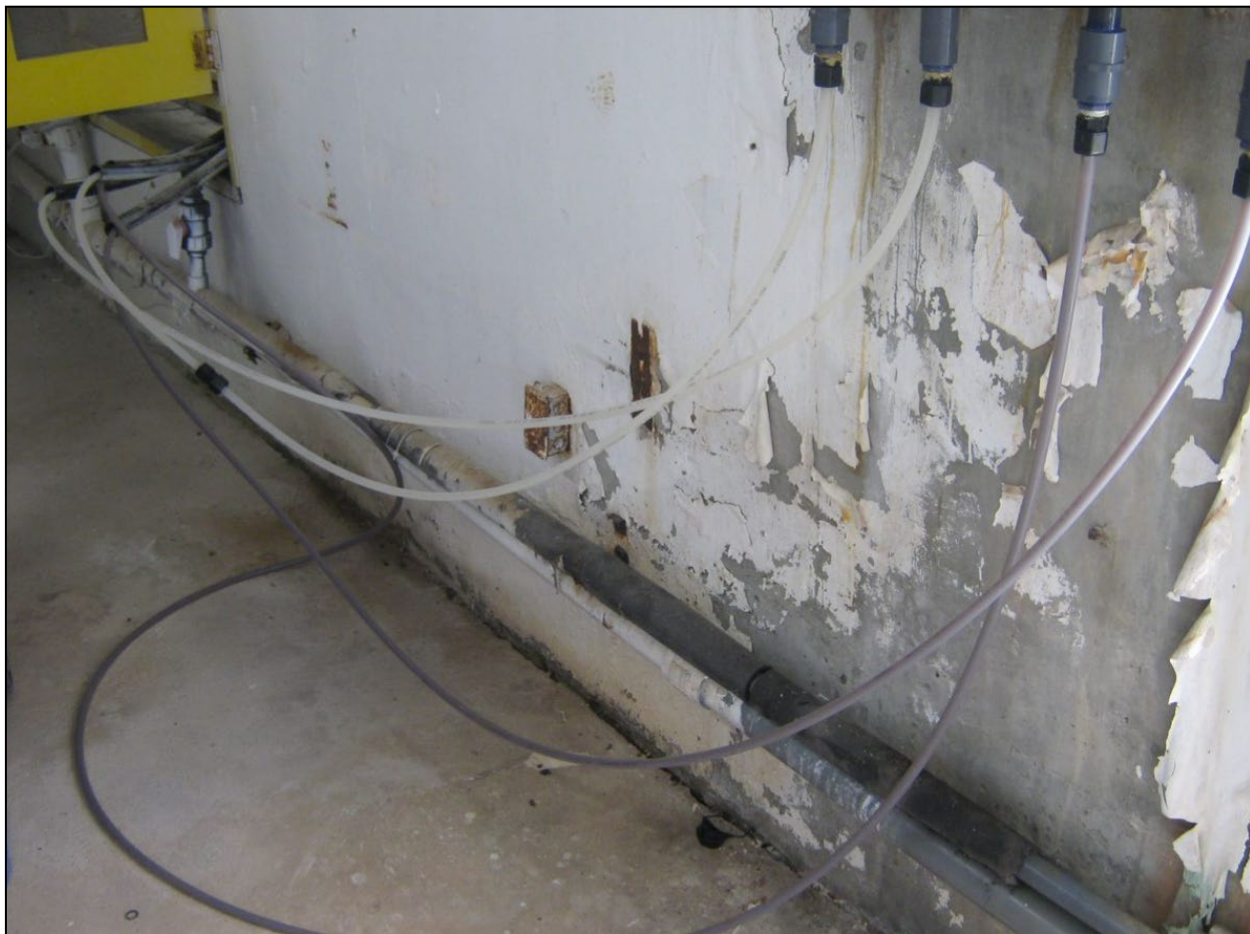
**Photograph 37. Chlorine Lines, WTP #1** Alternate view of the chlorine pump lines on the floor in the chemical injection room at WTP #1. The lines presented a tripping hazard.

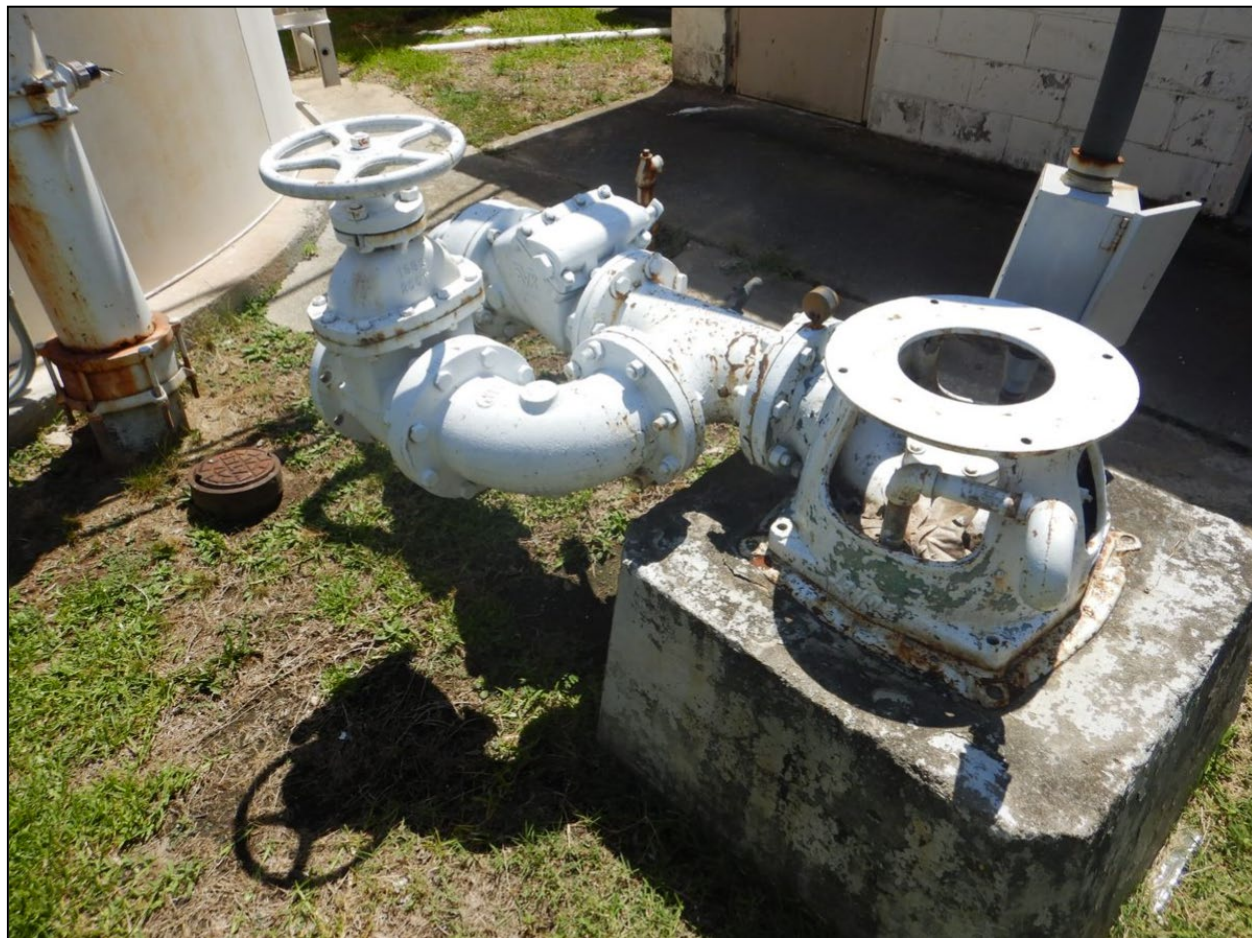
**Photograph 39. Well No. 28** View of Well No. 28 at the White Hall property. System representatives stated that the well had been out of service for several years due to its proximity to a bathroom. If the well was in service, it would pump raw water to White Hall WTP #4.
