**Region 6 - Enforcement & Compliance Assurance Division**  
**INSPECTION REPORT**

| Inspection Date(s): | 06/26/2023 | |
| Regulatory Program(s) | AWIA/SDWA | |
| Facility Name: | <b>Liberty Utilities Company (Pine Bluff)</b> | |

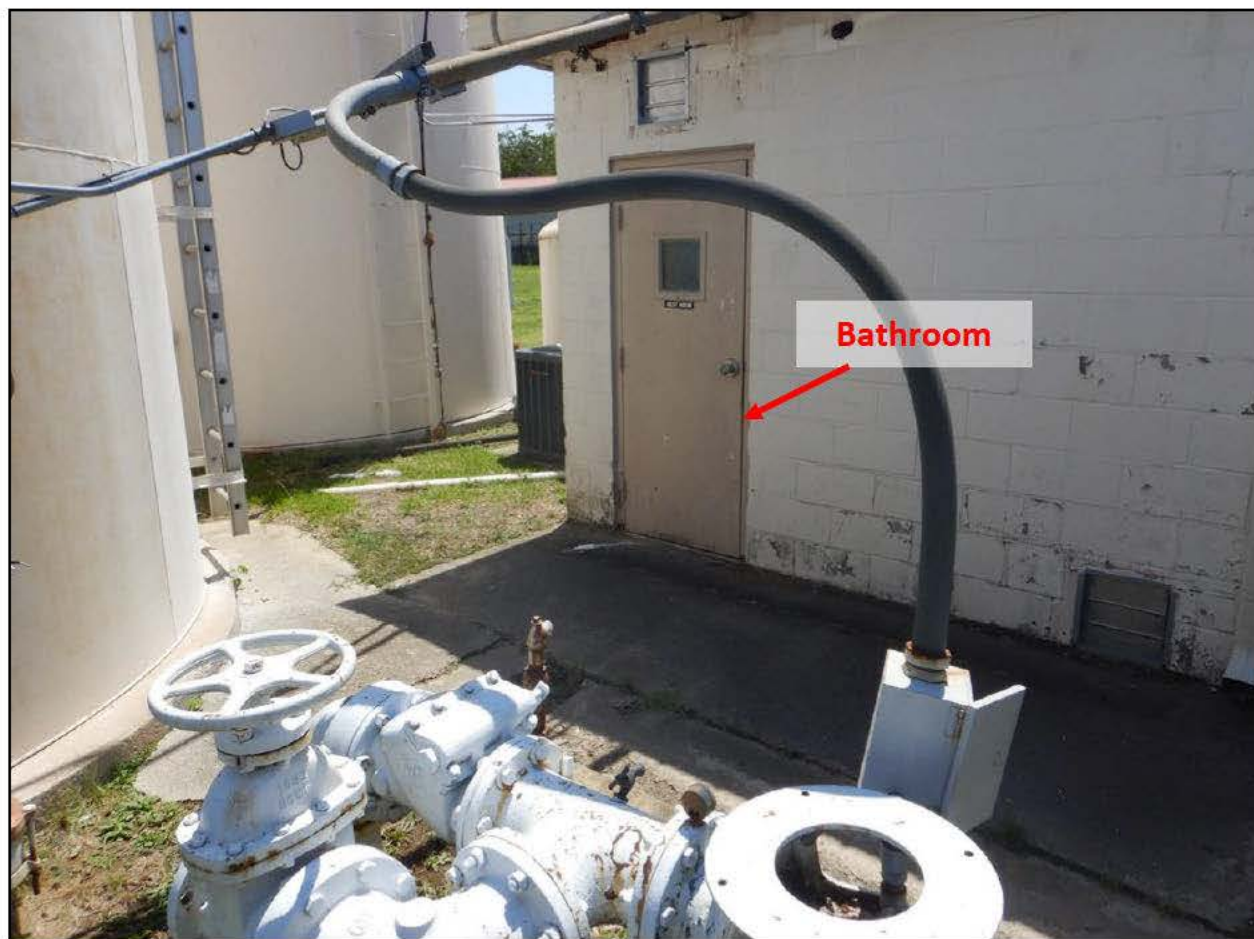
**Photograph 40. Well No. 28** View of Well No. 28 and its proximity to a bathroom at White Hall WTP #4.

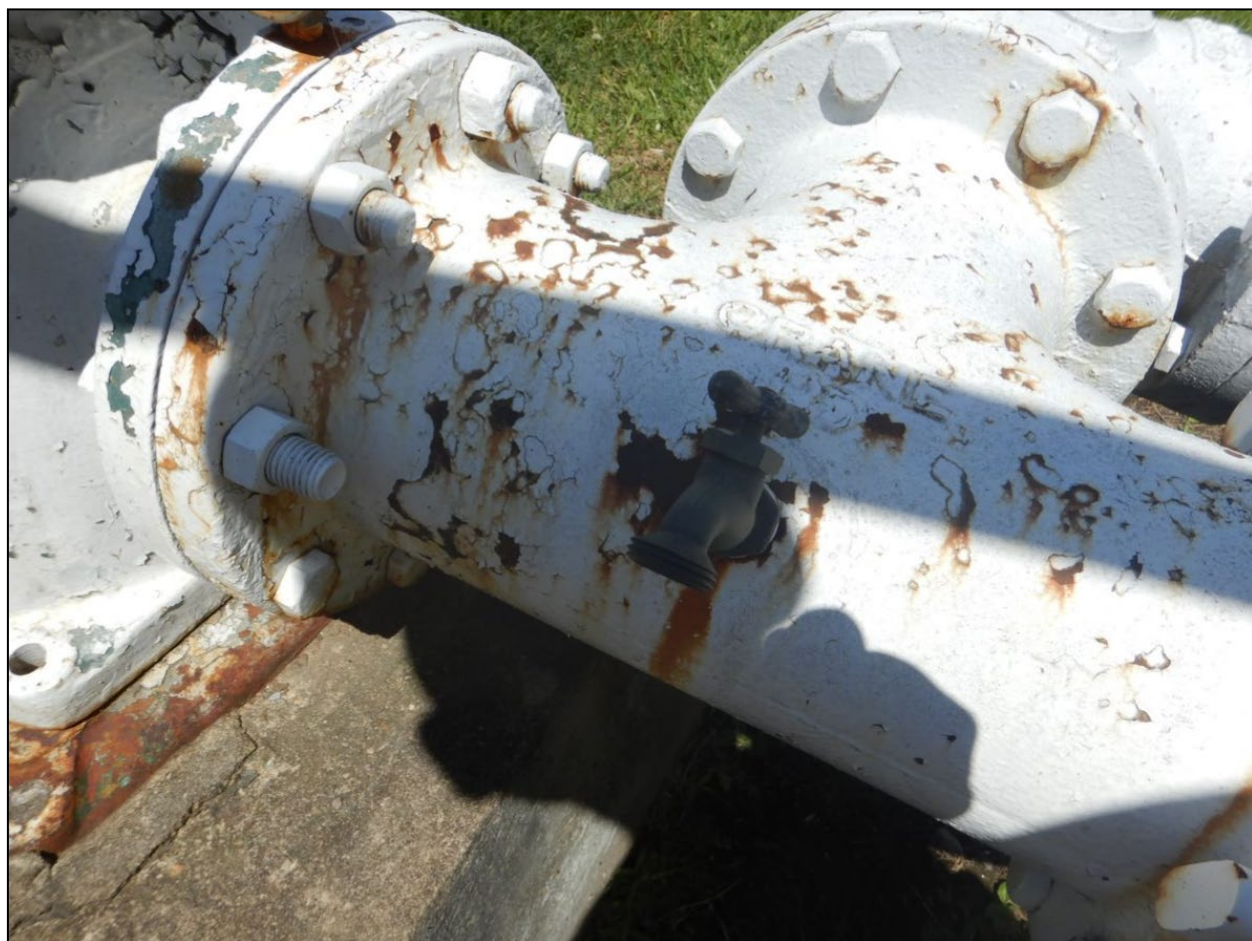
**Photograph 41. Well No. 28** View of a threaded hose tap without backflow prevention that extended off of the pump line at Well No. 28.

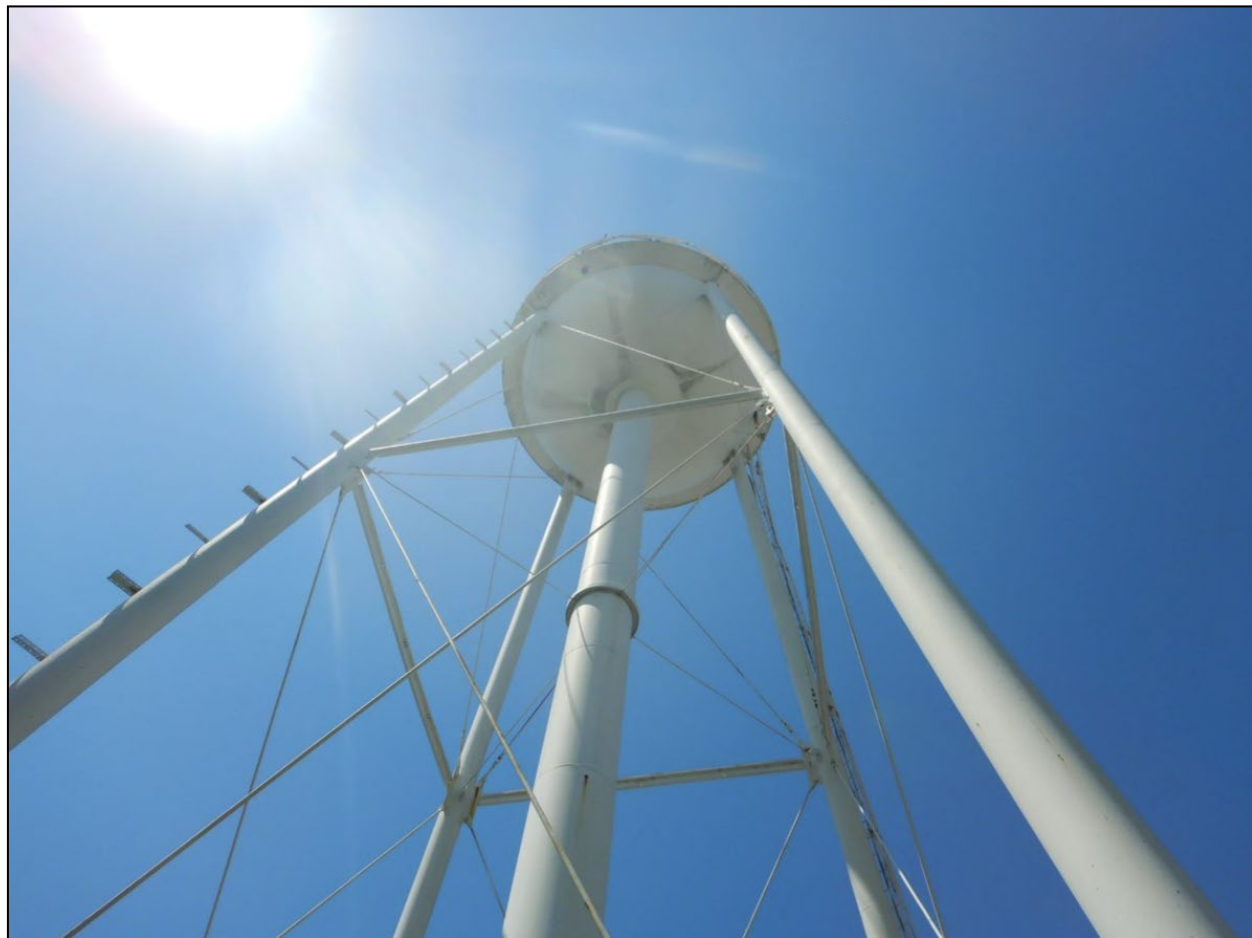
**Photograph 42. White Hall Tank #1** View of the formally decommissioned, 50,000 gallon elevated White Hall Water Tank #1.

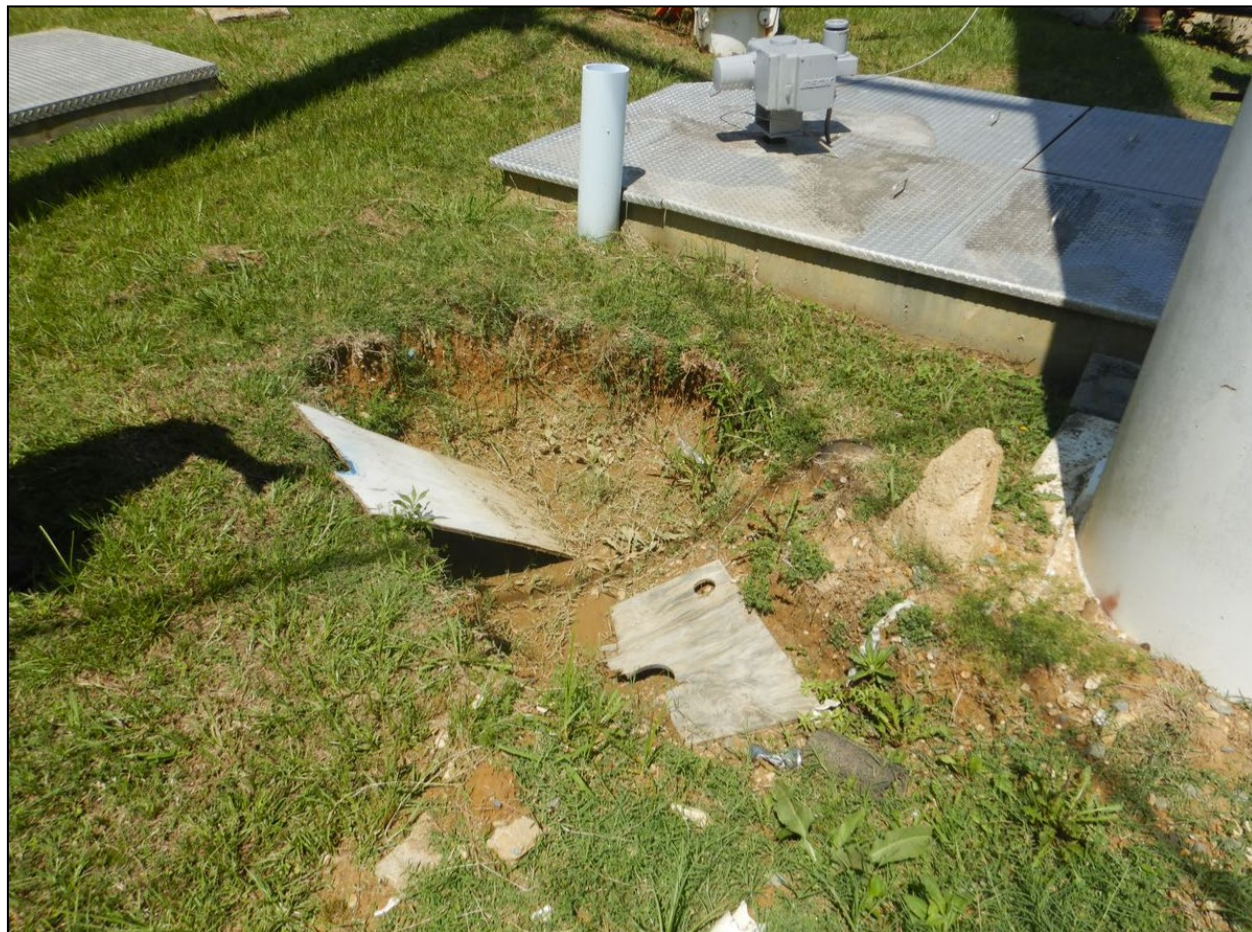
**Photograph 43. Trench, White Hall Tank #1** View of the trench that was dug to formally cut and cap White Hall Tank #1 when it was formally decommissioned. The capped line was not visible.

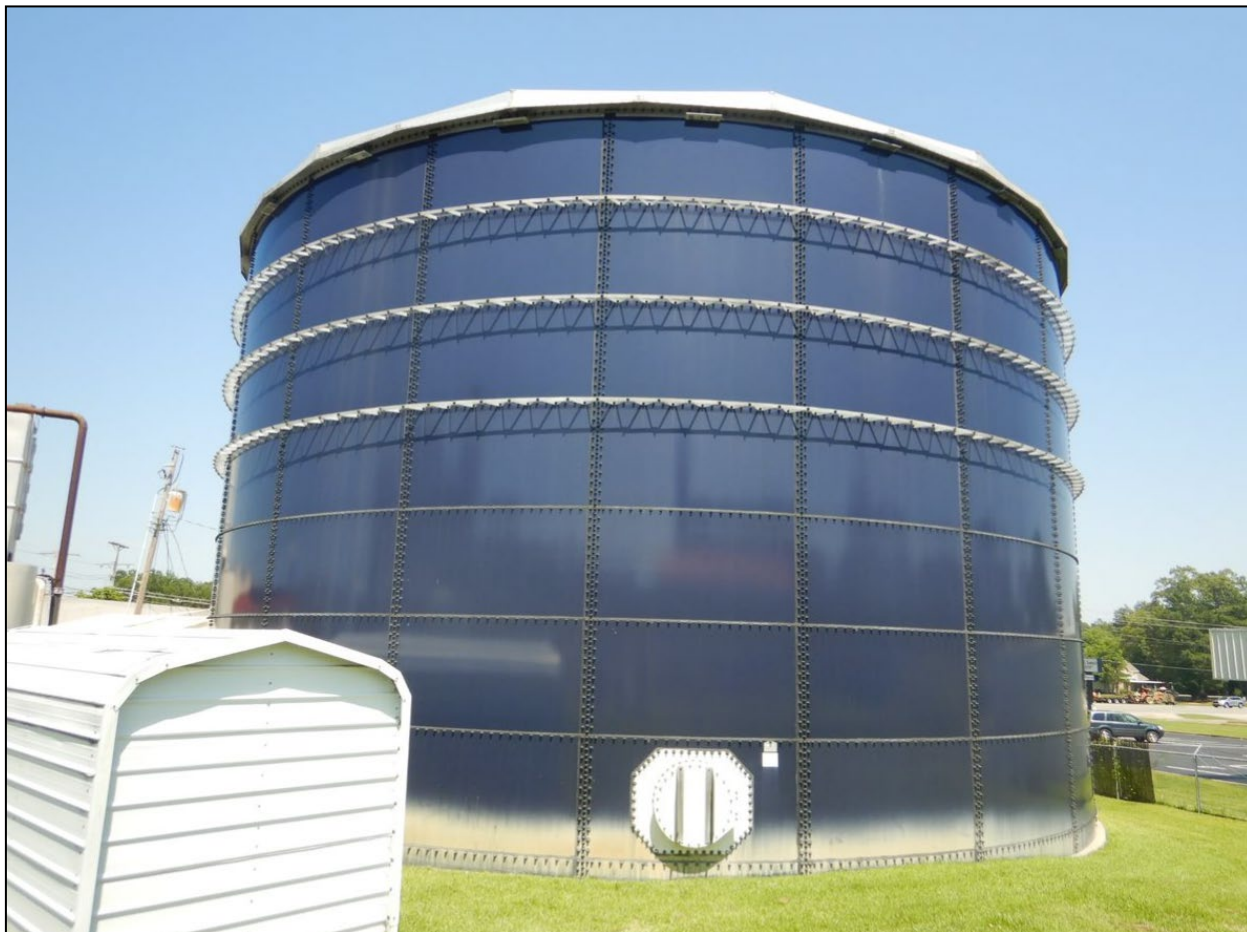
**Photograph 47. White Hall Water Tank #3** View of the 750,000 gallon White Hall Water Tank. The tank was in use at the time of the inspection.

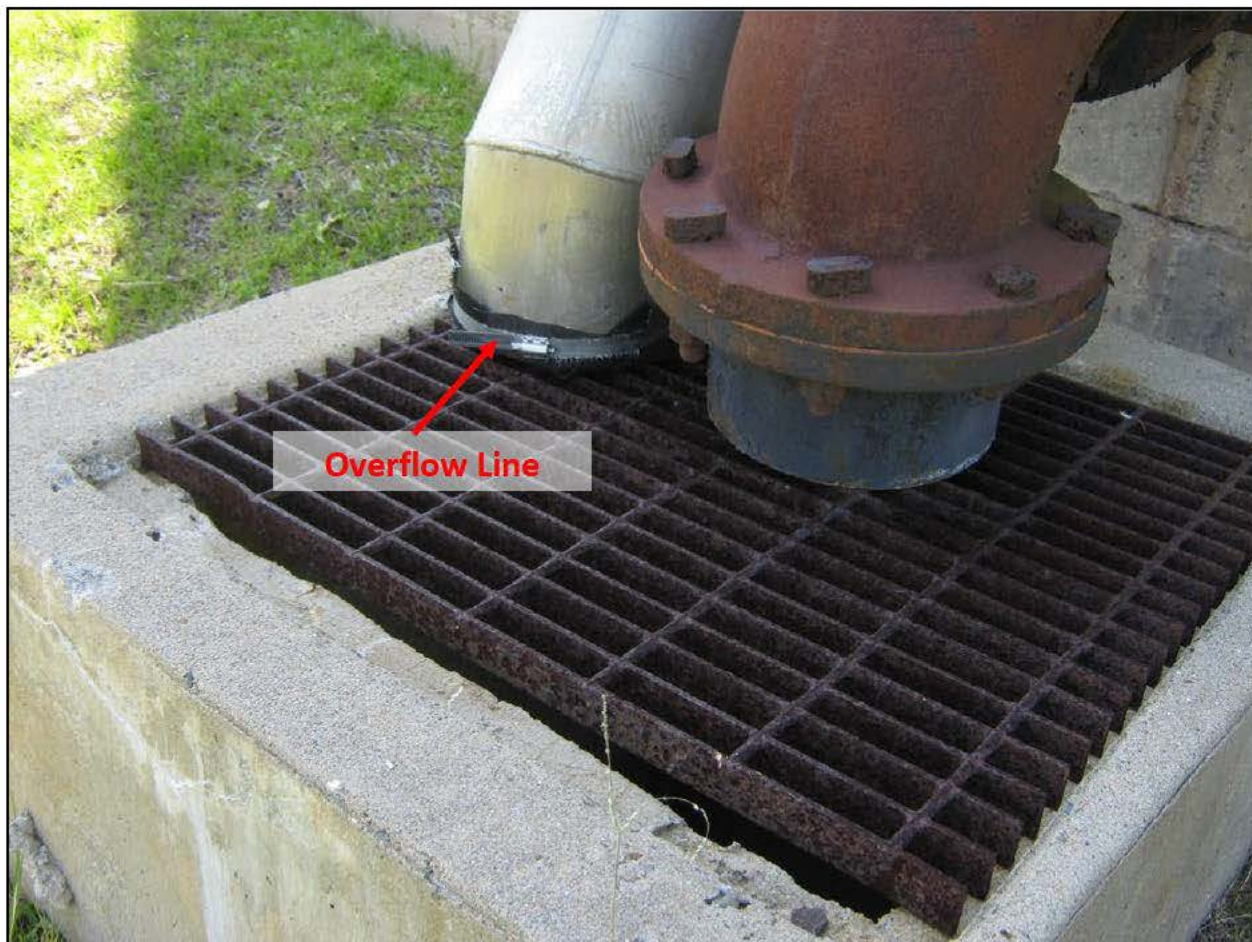
**Photograph 48. Overflow Pipe, White Hall Tank #3** View of the terminus of the White Hall Tank #3 overflow pipe. The pipe was downturned, screened, and it terminated above a rectangular grate. Also visible in this image is a valved line that can be used to empty the tank.
