INSPECTION REPORT

Inspection Date:	July 28, 2022	Inspection Announced: No
Time:	Entry: 8:30 AM	Exit: 10:00 AM
Media:	Stormwater	
Statute (s)/Program(s):	Clean Water Act, NPDES, Industrial Stormwater, Indirect Discharger	
Type of inspection:	CEI - Compliance Evaluation Inspection	
Access:	Granted	
<hr/>		
Permittee Name:	Republic Services	
Facility or Site Name:	Republic Services	
Facility/Site Physical Address:	3950 Mississippi Avenue	
(City, State, Zip Code)	Cahokia Heights, Illinois 62206	
County/Parish:	St. Clair County	
<hr/>		
Permit and Application Number:	ILR006145	
SIC or NAICS:	4212

**Republic Services
EPA Inspection July 28, 2022
All photos taken by Ted Flatebo, Environmental Engineer, U.S. EPA
Camera: Ricoh WG-4**

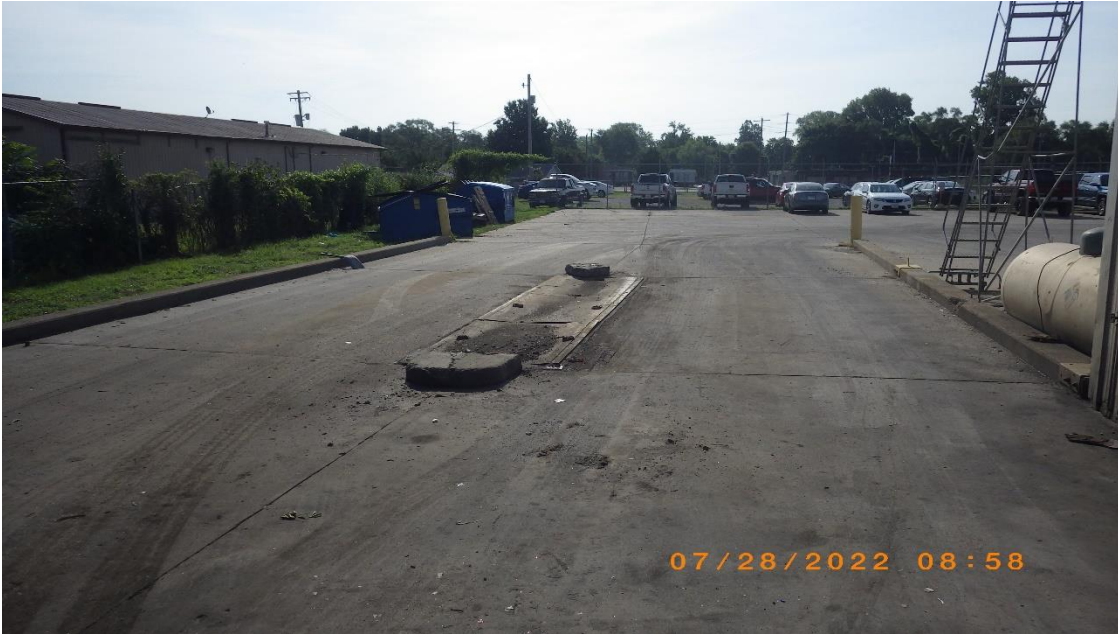
1: RIMG0070

Description: Truck washing area. Oil-water separator located underground, covered by gray covers in center of photo.

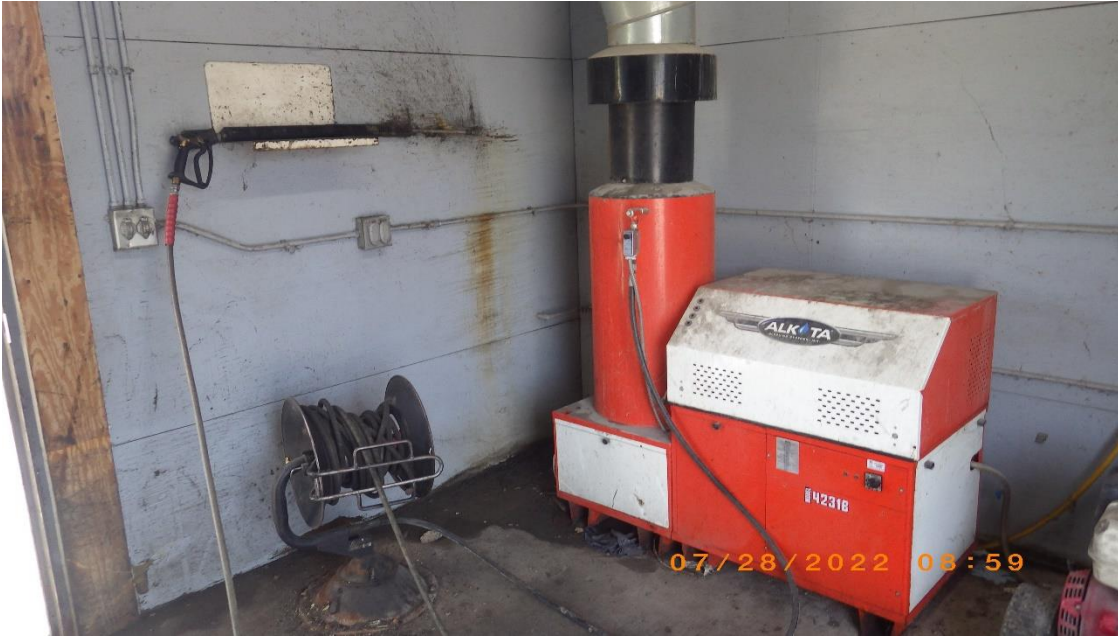
2: RIMG0071

Description: Pressure washer used for truck washing.

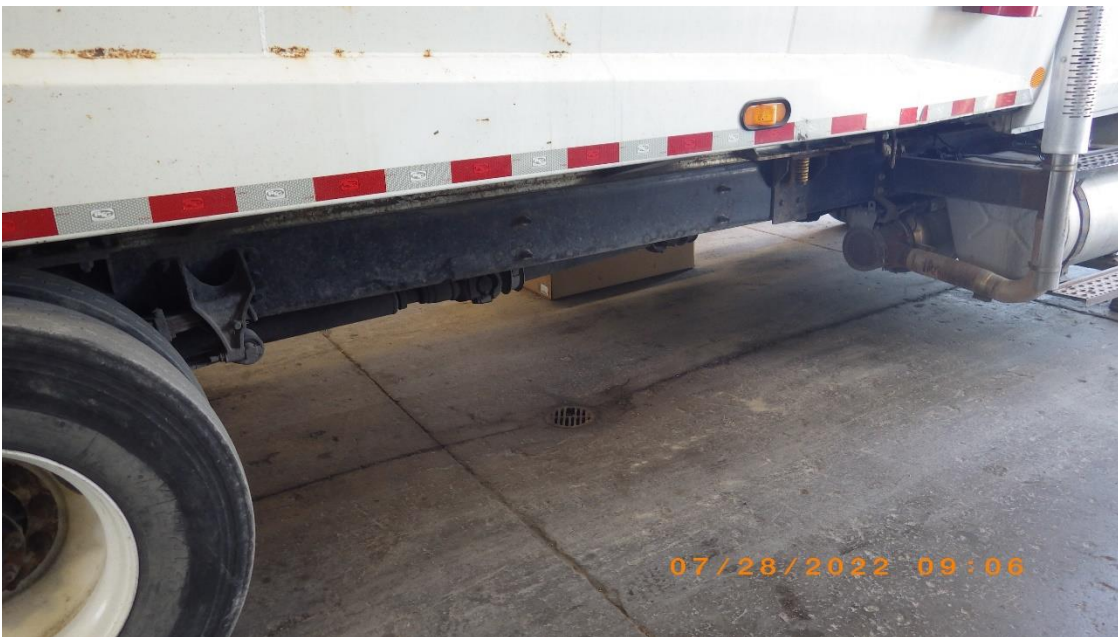
3: RIMG0072

Description: Floor drain in maintenance building. Drains to oil-water separator.

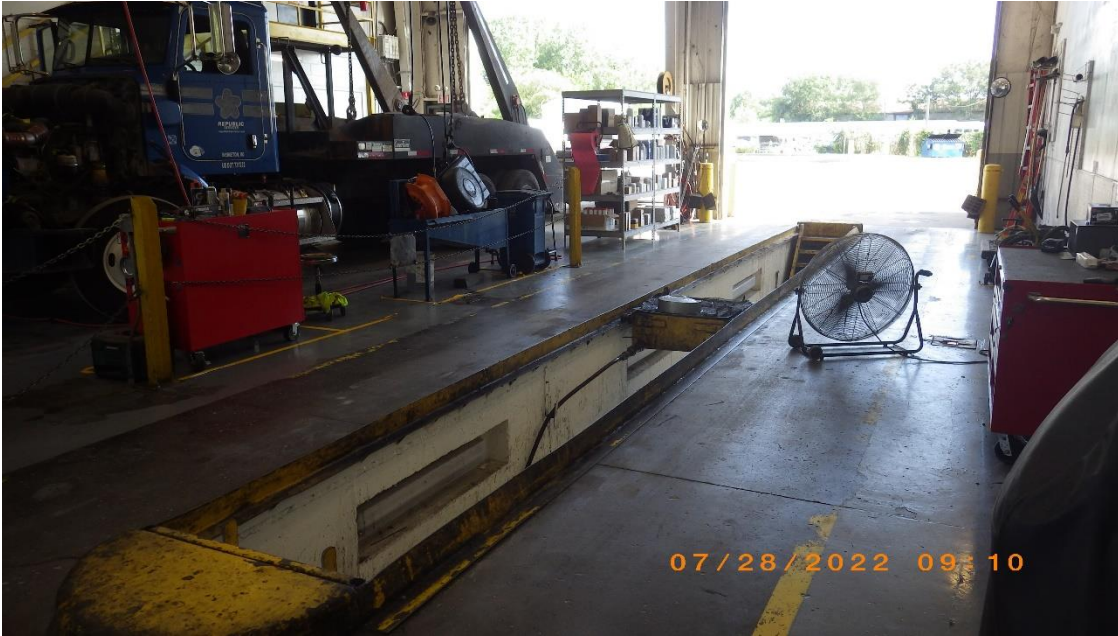
4: RIMG0073

Description: Engine fluid collection system and maintenance pit.

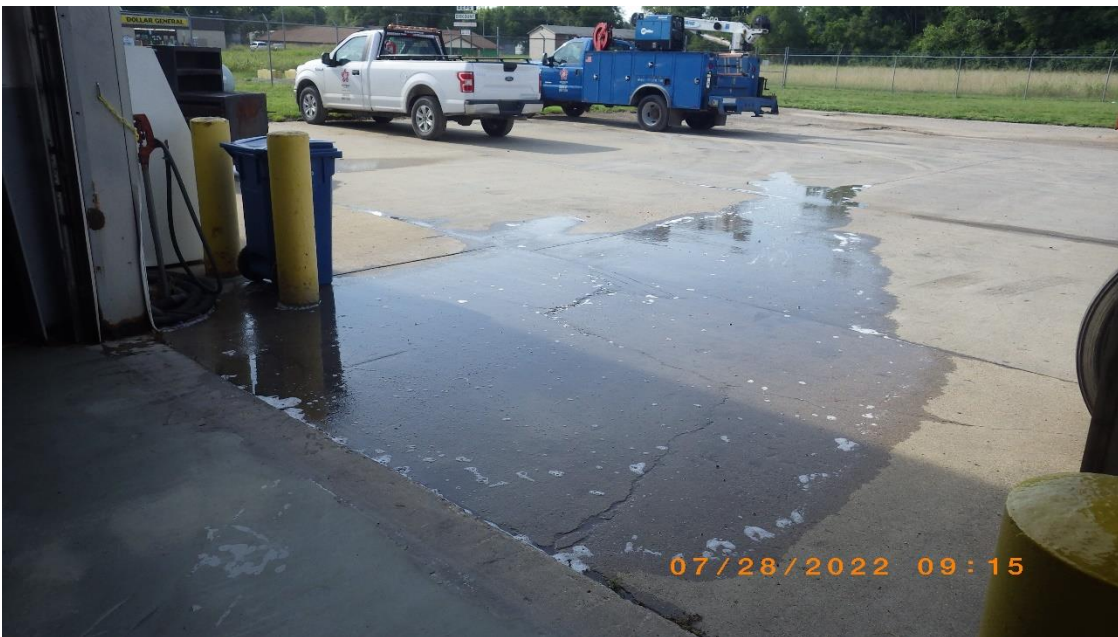
5: RIMG0074

EPA inspectors observed a Facility employee dispose of dirty mop water on the ground in the parking lot. Inspectors discussed with Facility staff the best management practices for disposing of oily mop water.

Description: Facility employee disposed of mop water outside.

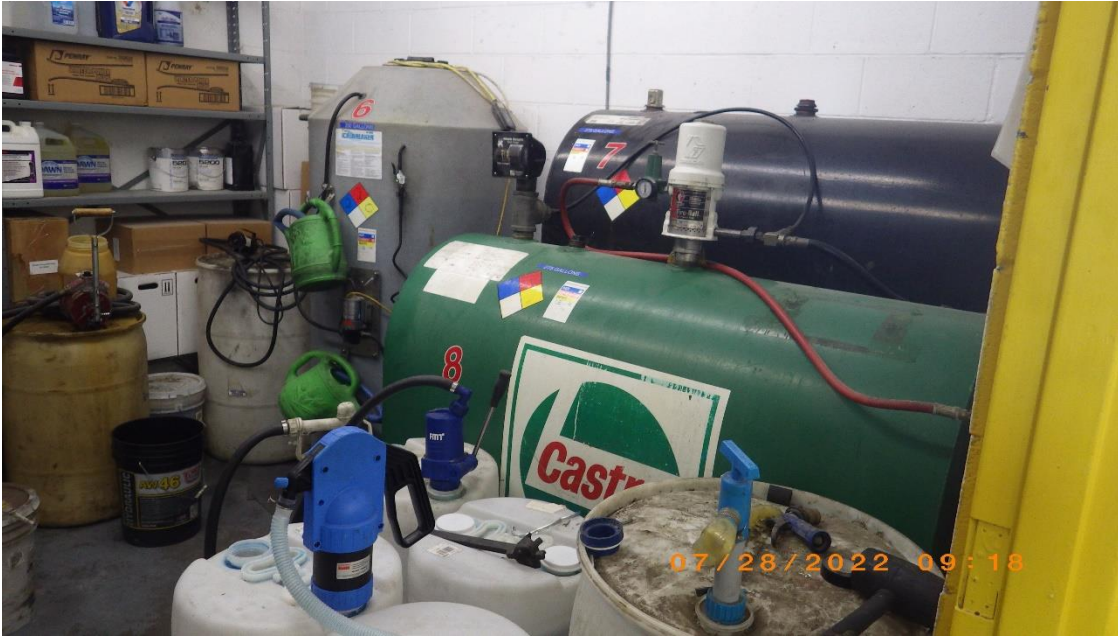
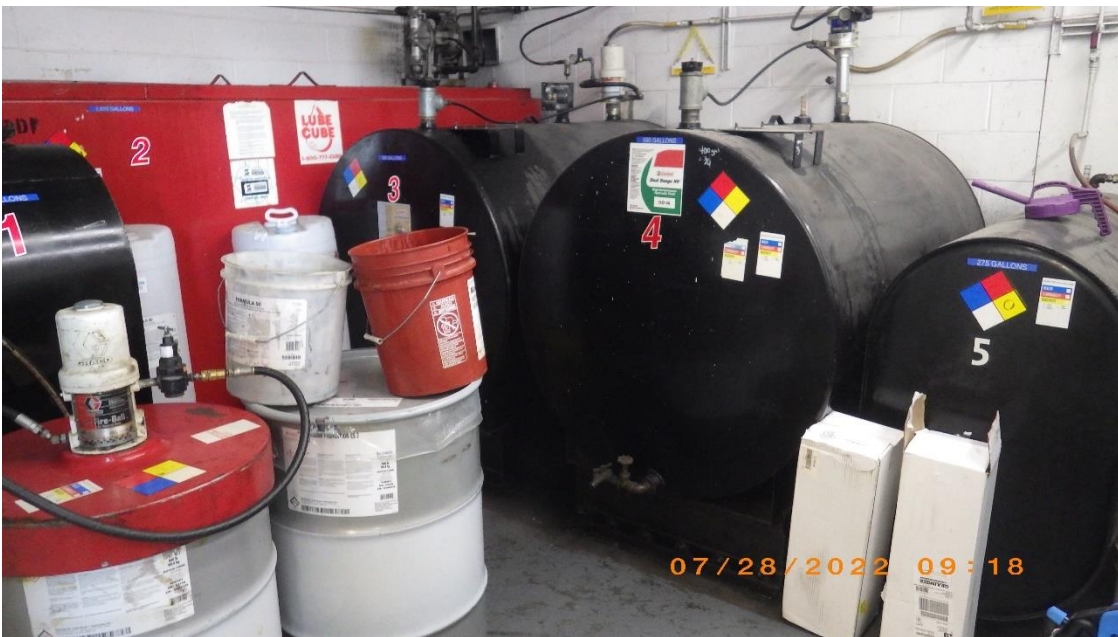
Description: Overview of fluids storage area.

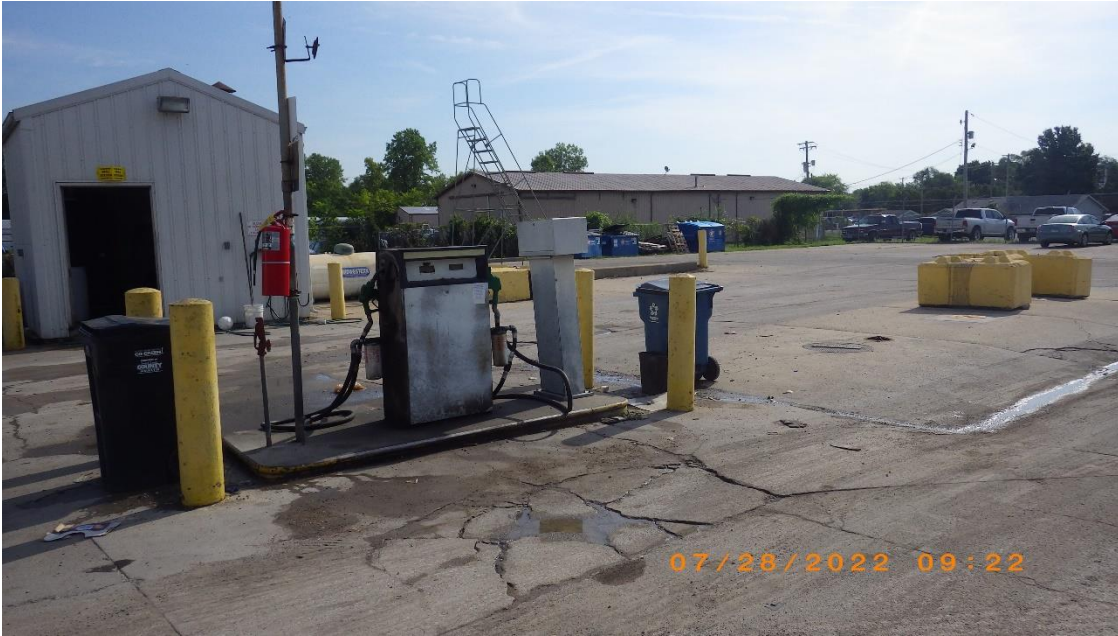
8: RIMG0077

Description: Overview of diesel pumping area.

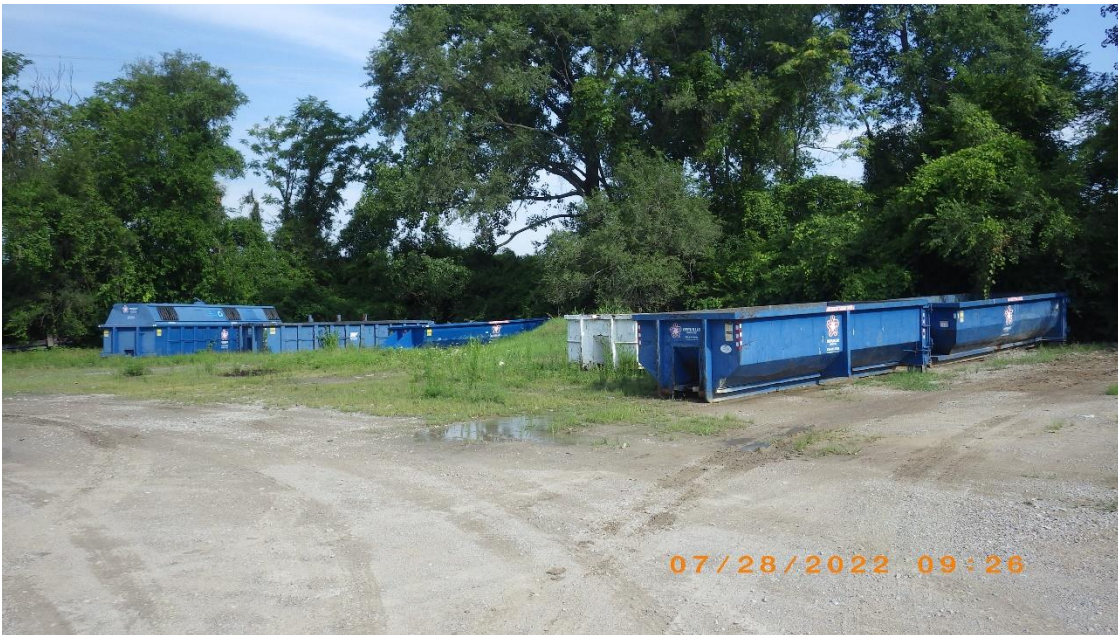
9: RIMG0078

Description: Roll off storage area. Note some containers are not covered.

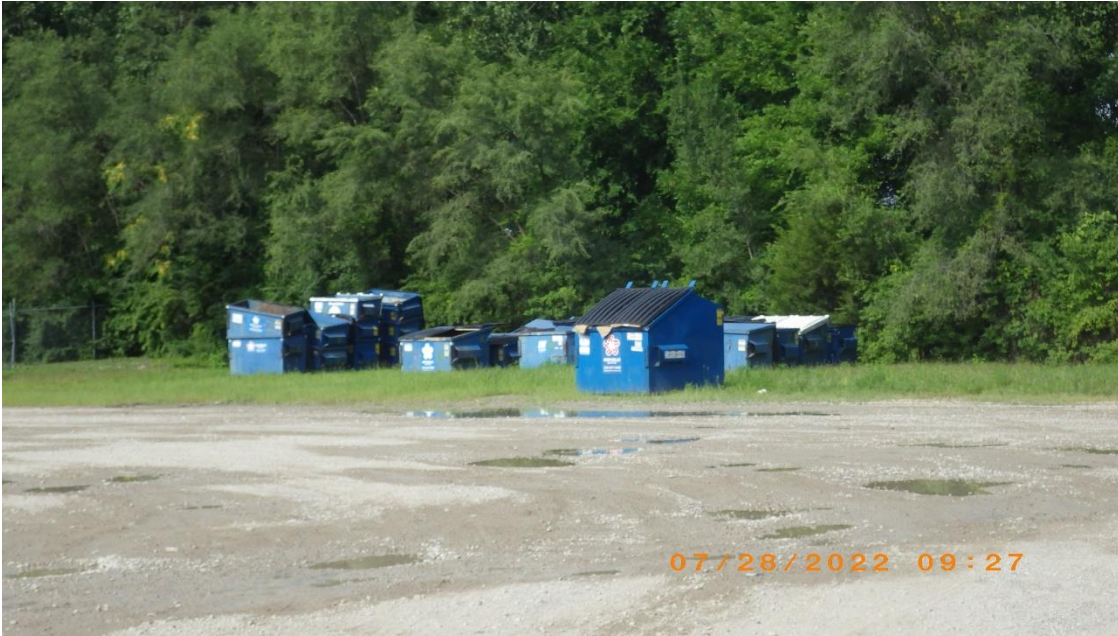
10: RIMG0079

Description: Dumpster storage area. Note some containers are not covered.

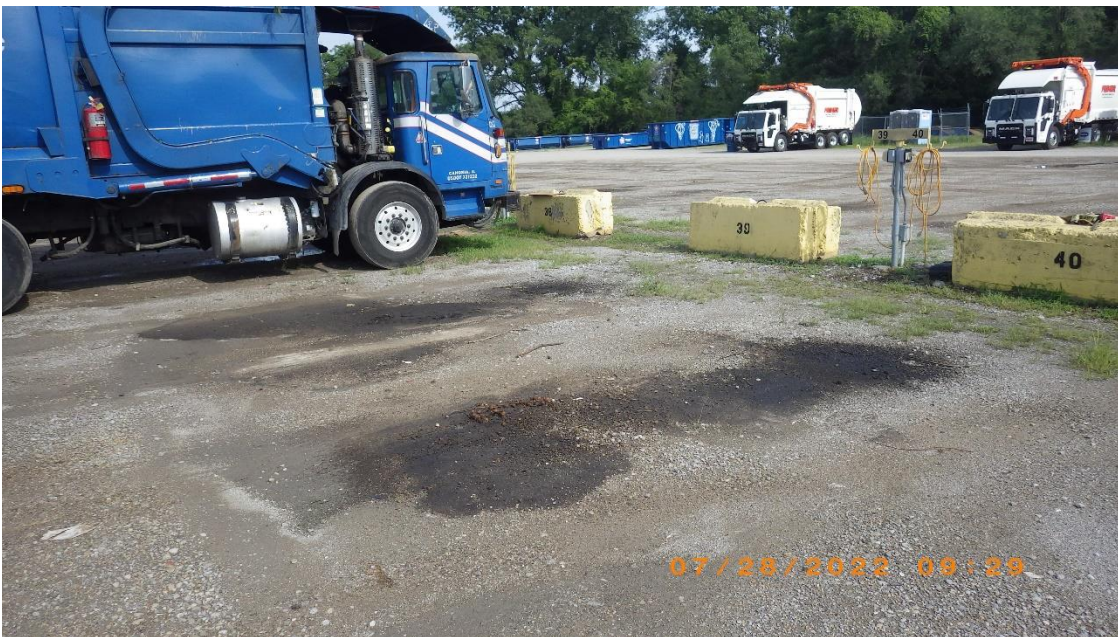
11: RIMG0080

TF-RR-011	Inspectors observed soil staining in the truck parking area. There was no documentation in the SWPPP regarding a corrective action to clean up stained soil and to prevent future contamination.	Yes
TF-RR-012	The April 2022 SWPPP states that all trash containers stored outdoors should be covered. Inspectors observed containers that were not covered.	Yes
TF-RR-013	The April 2022 SWPPP does not contain information regarding the frequency, volume, or destination of truck wash water disposal.	Yes
TF-RR-014	The Facility has a wastewater aeration system that treats sanitary wastewater and discharges it to a channel southeast of the maintenance building.	Yes

Description: Soil staining.
