**Well Inspection**  
**Osage DNR / Environmental Protection Agency**  
**1201 Elm Street, Suite 500**  
**Dallas, Texas 75270**

| <b>Operator Info</b> | CapturePoint, LLC (formerly Perdure Petroleum, LLC)<br>1101 Central Expwy S., Suite 150<br>Allen, TX 75013<br>Phone: 832-300-8221 | <b>Inventory ID</b> | OS0643000 | | |
| | | <b>Well ID</b> | 122-W7 | | |
| <b>Inspection Reason</b> | MIT | <b>Responsible Company at Time of Inspection</b> | CapturePoint, LLC | | |

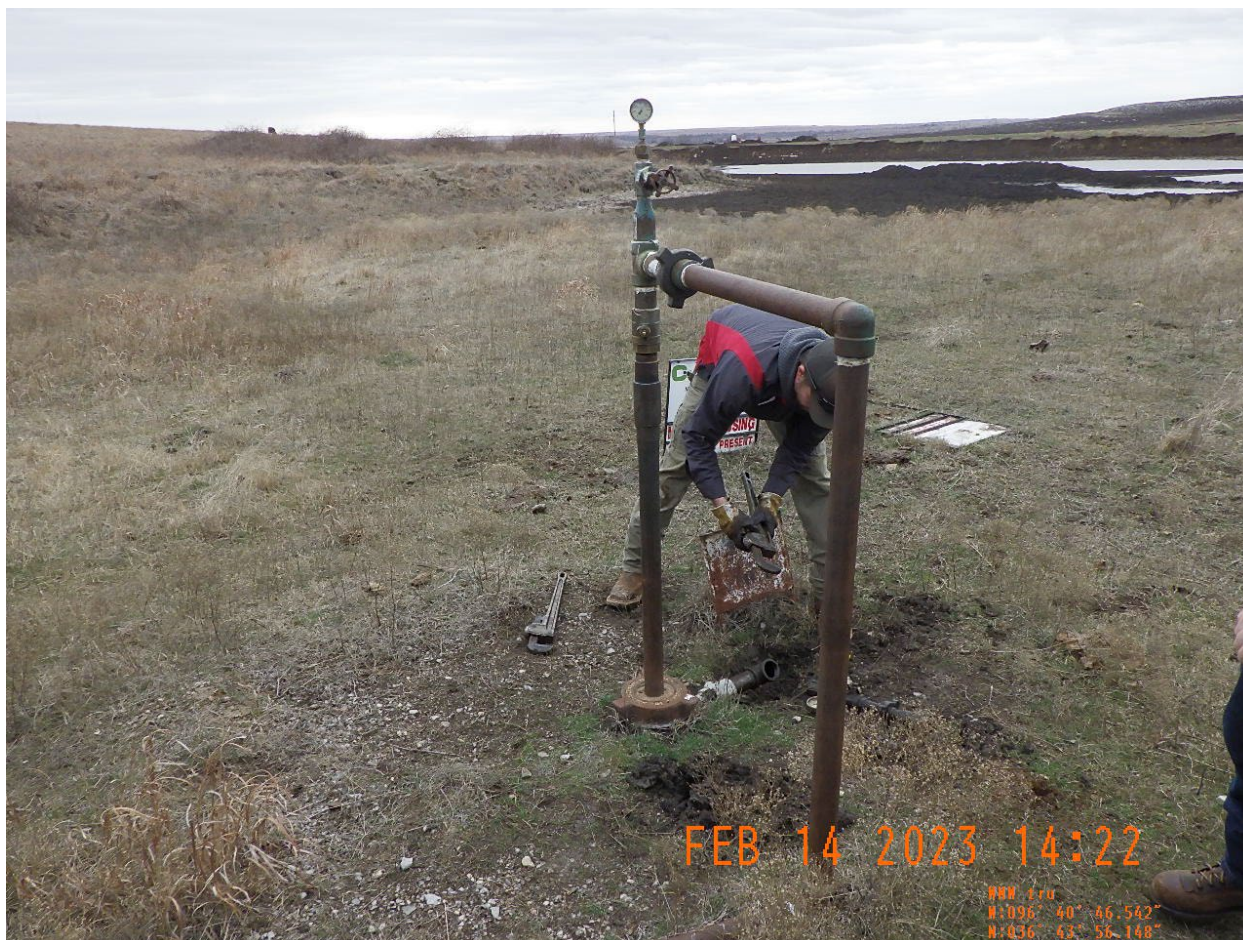
Photo No. 1

**Description:** This was well OS0643000 at the time of the inspection.
