**Region 6 - Enforcement & Compliance Assurance Division**  
**INSPECTION REPORT**

| Inspection Date(s): | 06/08/2023 | |
| Facility Name: | Oshara Village Water Reclamation Facility | |
| Identification/Permit Number: | NM0030813 | |

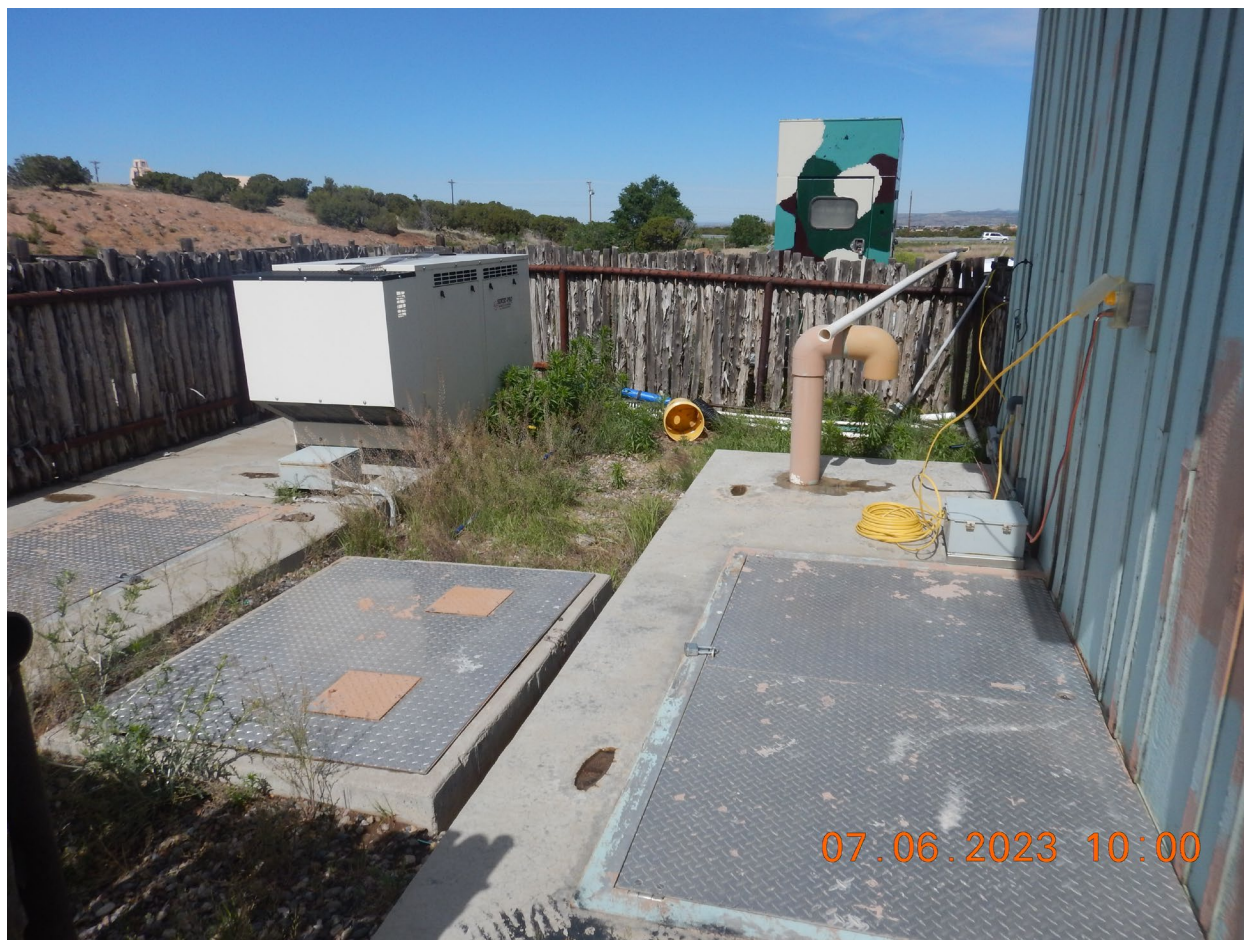
Photo No. 1

- Extensive vegetative overgrowth throughout the facility area was visible, which could potentially attract rodents and/or vermin; thus, causing undermining of the facility structures.
- There are two (2) back-up generator onsite, but their operational status is unknown.
- No facility personnel were onsite and locked doors prevented ready access.

View of the Water Reclamation Facility treatment process equipment located in below ground locked hatchways along the approximate south side of the locked building. Note: the back-up generator, the extensive vegetative overgrowth and inside view of perimeter fencing. (DSCN2540) Photographed by D. Esparza

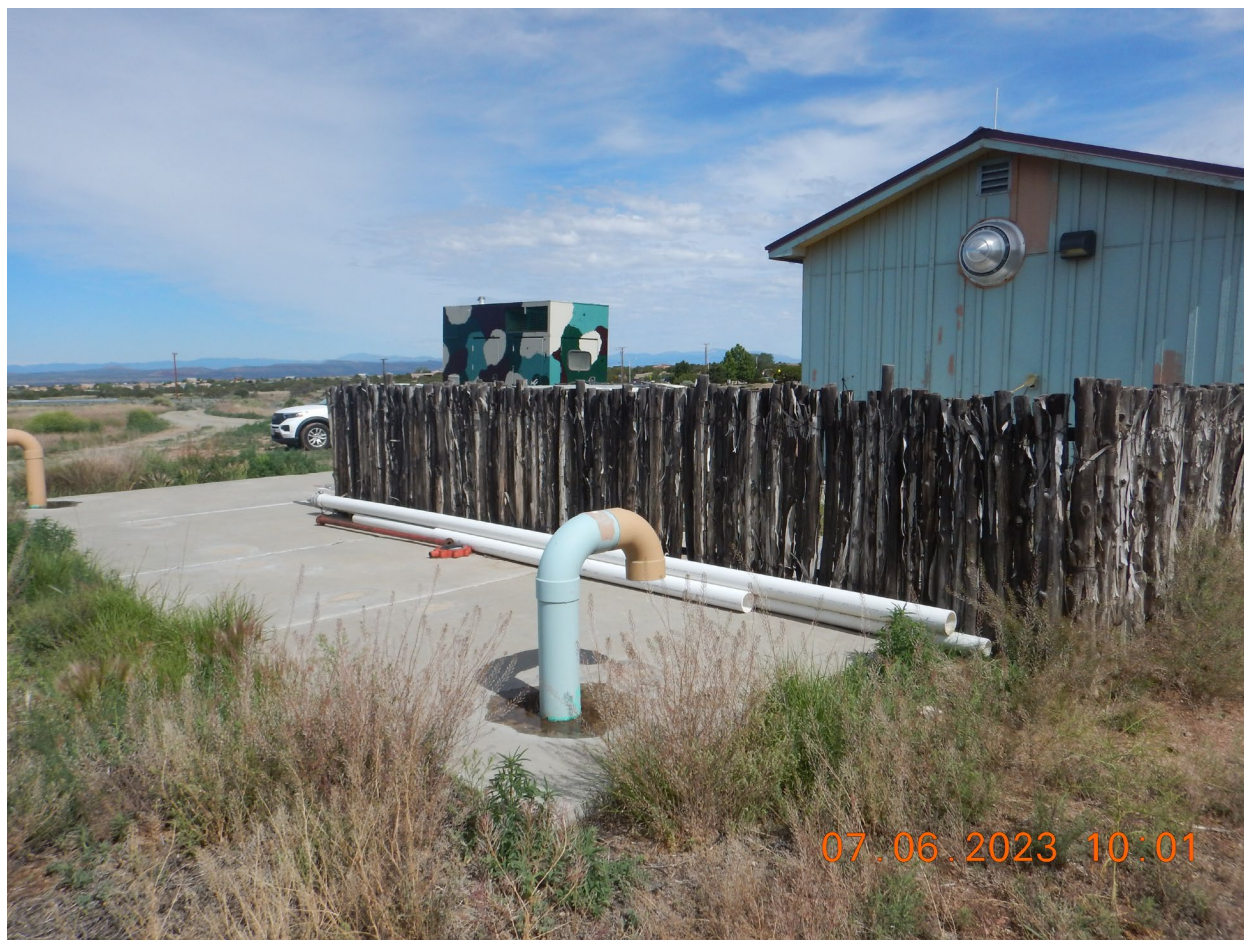
Photo No. 2

Note the additional back-up generator, the extensive vegetative overgrowth and outside view of perimeter fencing looking approximately Northeast. (DSCN2542) Photographed by D. Esparza

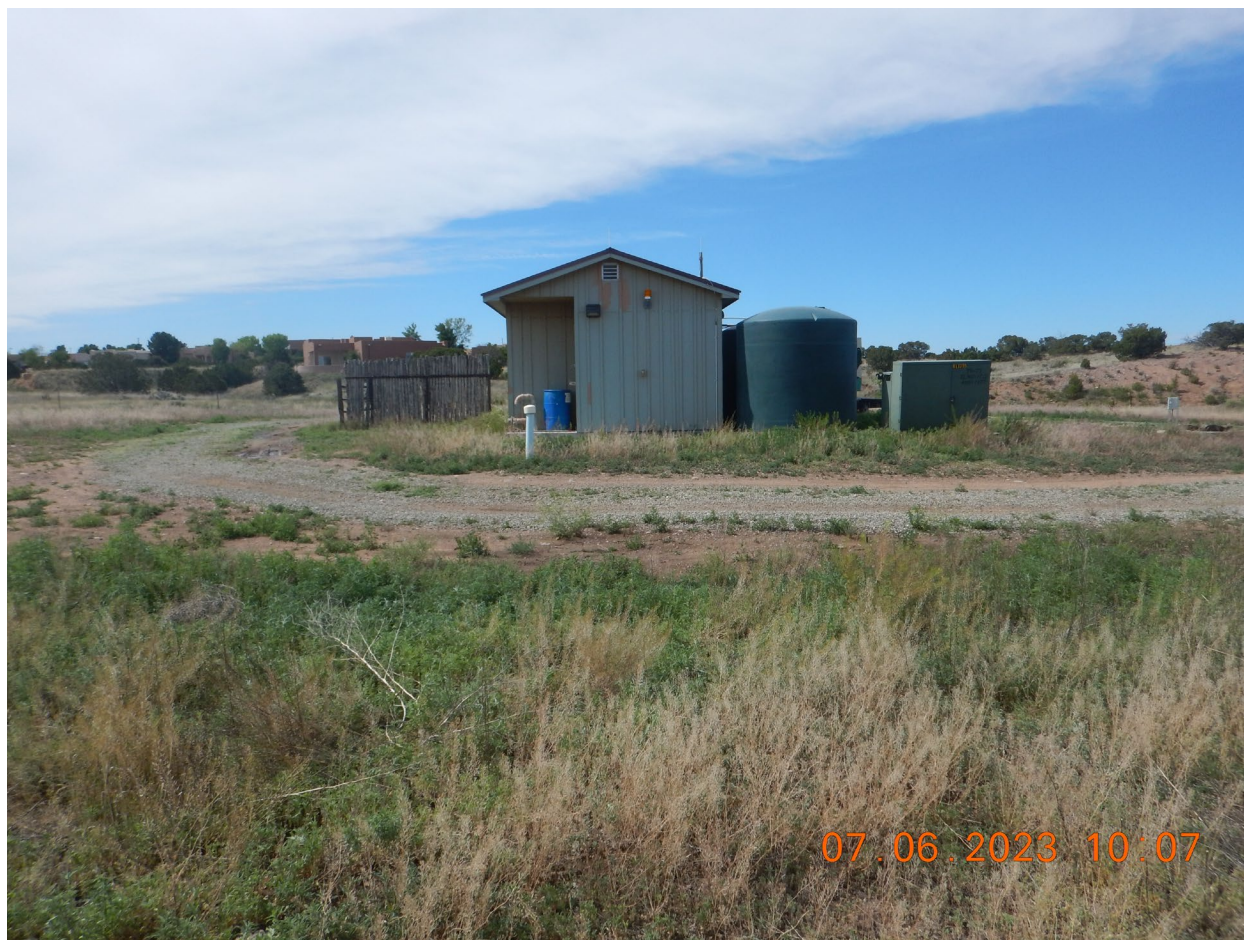
Photo No. 3

View of the Operators Building and electrical transformer looking approximately South and indicated on Frachetti Site Plan (**Appendix 3 Oshara Village Site Plan**). What is not defined or described is the poly-tank. (DSCN2546) Photographed by D. Esparza

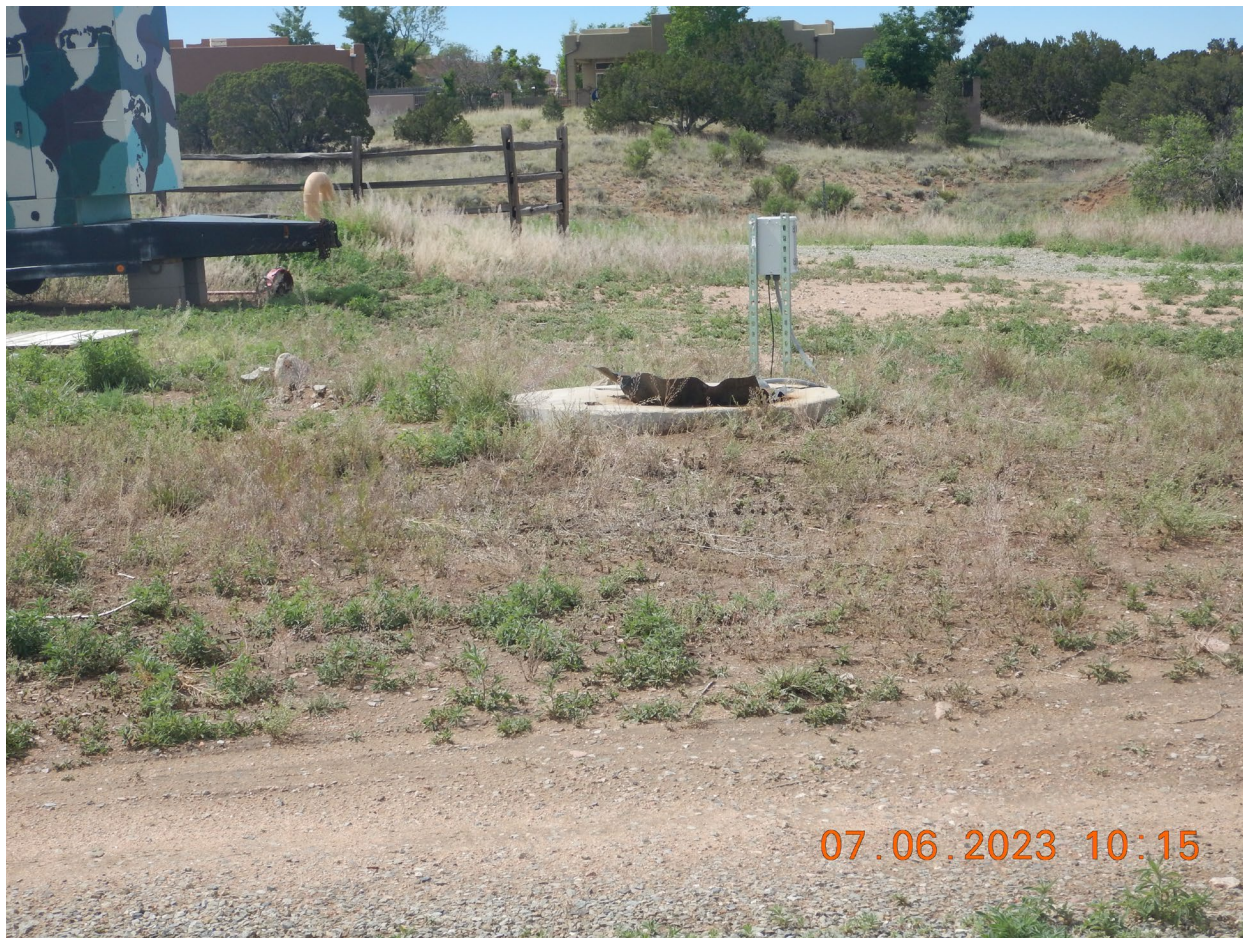
Photo No. 4

View of the adjacent wet well located at the approximate Northwest corner of the Operators Building. Note: the lack of perimeter fencing and vegetative overgrowth. (DSCN2551) Photographed by D. Esparza

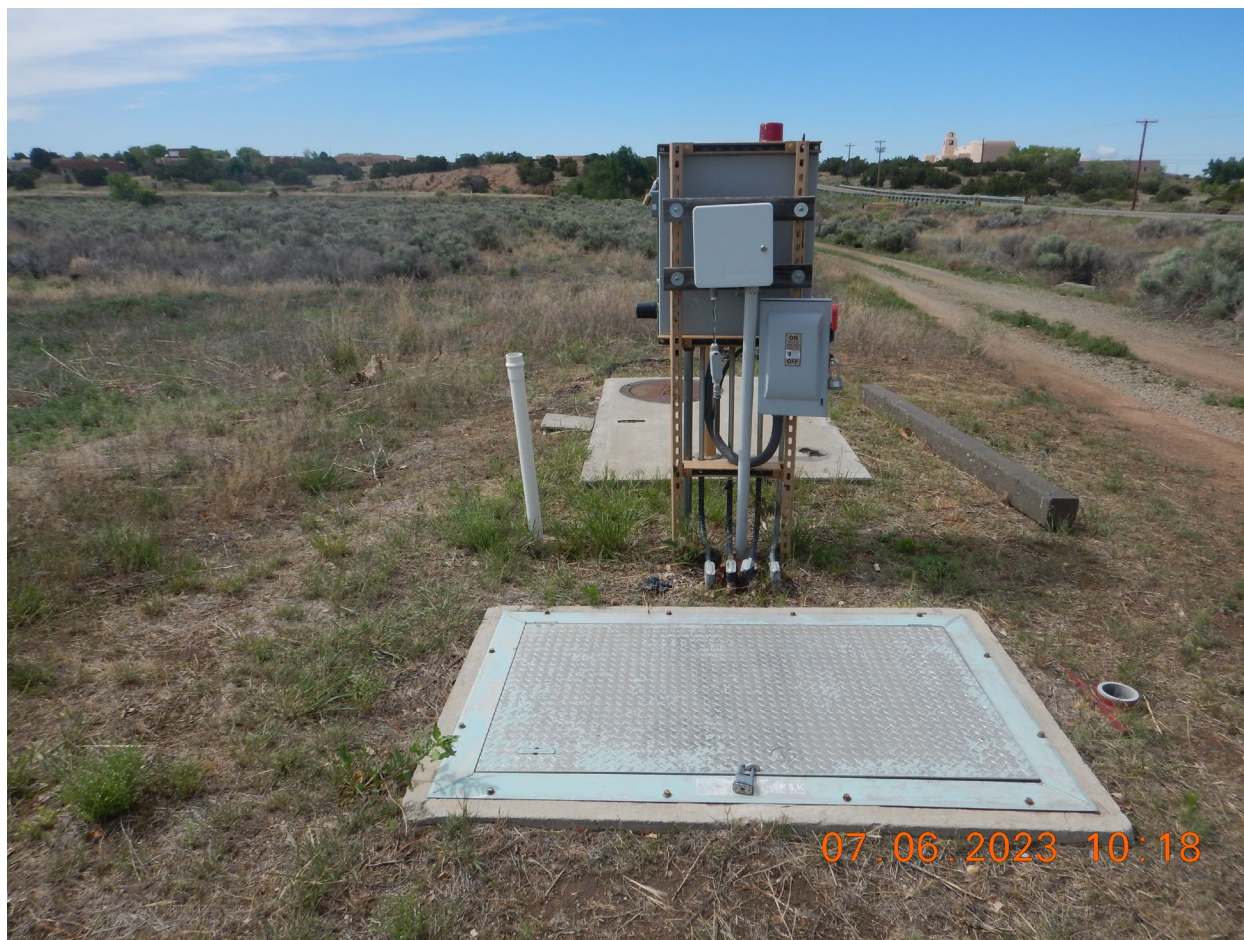
Photo No. 5

View of the Oshara Village WRF individual lift station located approximately 600-feet Northwest the WRF Facility. Note: the lack of perimeter fencing and the locked hatchway. (DSCN2552) Photographed by D. Esparza

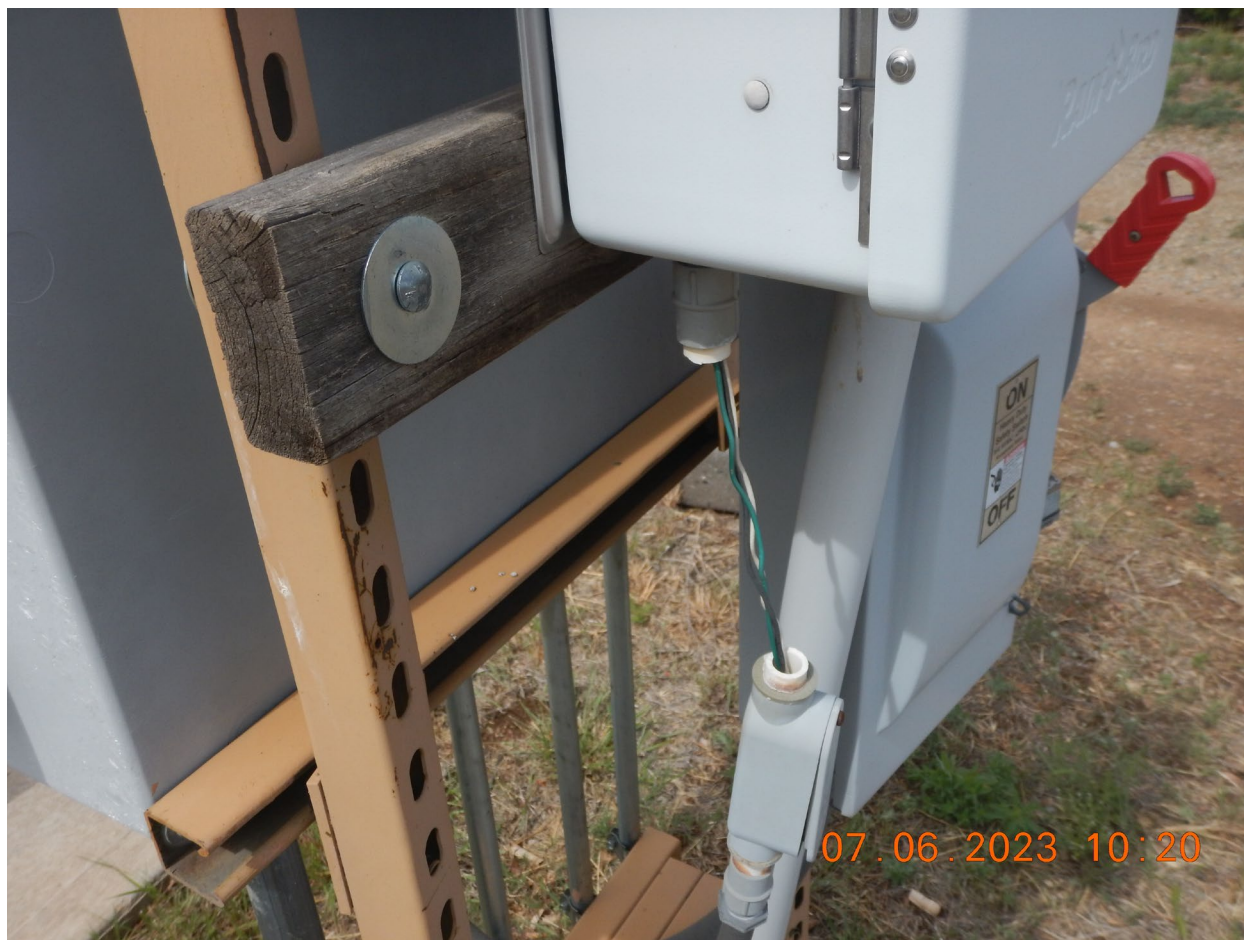
Photo No. 6

View of the Oshara Village WRF individual lift station electrical box. Note: the exposed wiring (no conduit). (DSCN2556) Photographed by D. Esparza
