**Well Inspection**  
**Osage DNR / Environmental Protection Agency**  
**1201 Elm Street, Suite 500**  
**Dallas, Texas 75270**

| <b>Operator Info</b> | Contango Resources, LLC<br>1717 South Boulder, Suite 900<br>Tulsa, OK 74119<br>Phone: 918-392-3396 | <b>Inventory ID</b> | OS2856000 | | |
| | | <b>Well ID</b> | 11W10 | | |
| <b>Inspection Reason</b> | MIT | <b>Responsible Company at Time of Inspection</b> | Contango Resources, LLC | | |

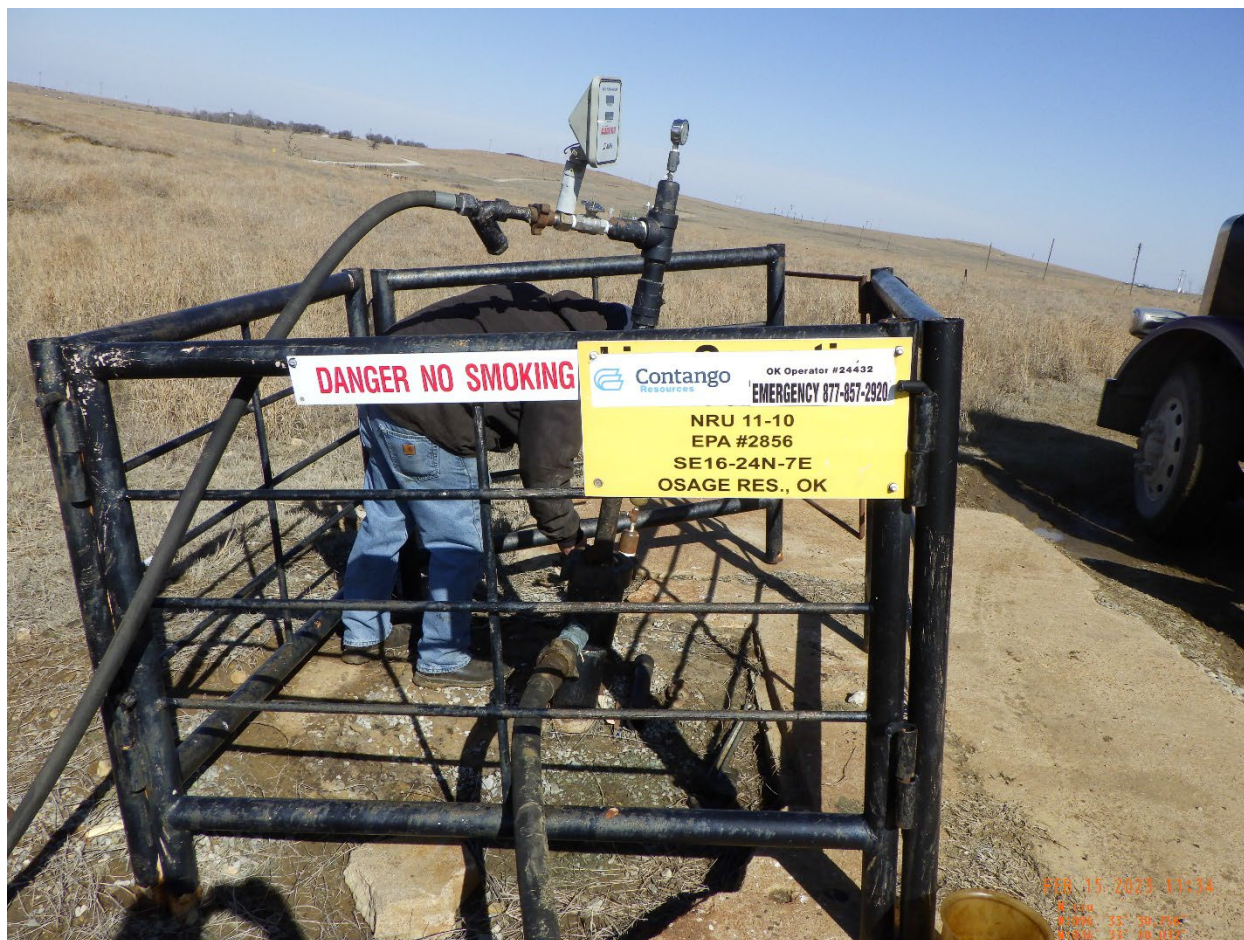
Photo No. 1

**Description:** This was well OS2856000 at the time of the inspection.
