**UNITED STATES ENVIRONMENTAL PROTECTION AGENCY**  
**REGION 10**  
**1200 6<sup>TH</sup> AVENUE**  
**SEATTLE, WASHINGTON 98101**

**SUBJECT:** CLEAN AIR ACT INSPECTION REPORT  
Republic Services Coffin Butte Landfill, Corvallis, OR

**Facility Name:** Republic Services Coffin Butte Landfill

**Date of Inspection:** On Site Inspection: June 23, 2022  
Virtual Conference: July 11, 2022

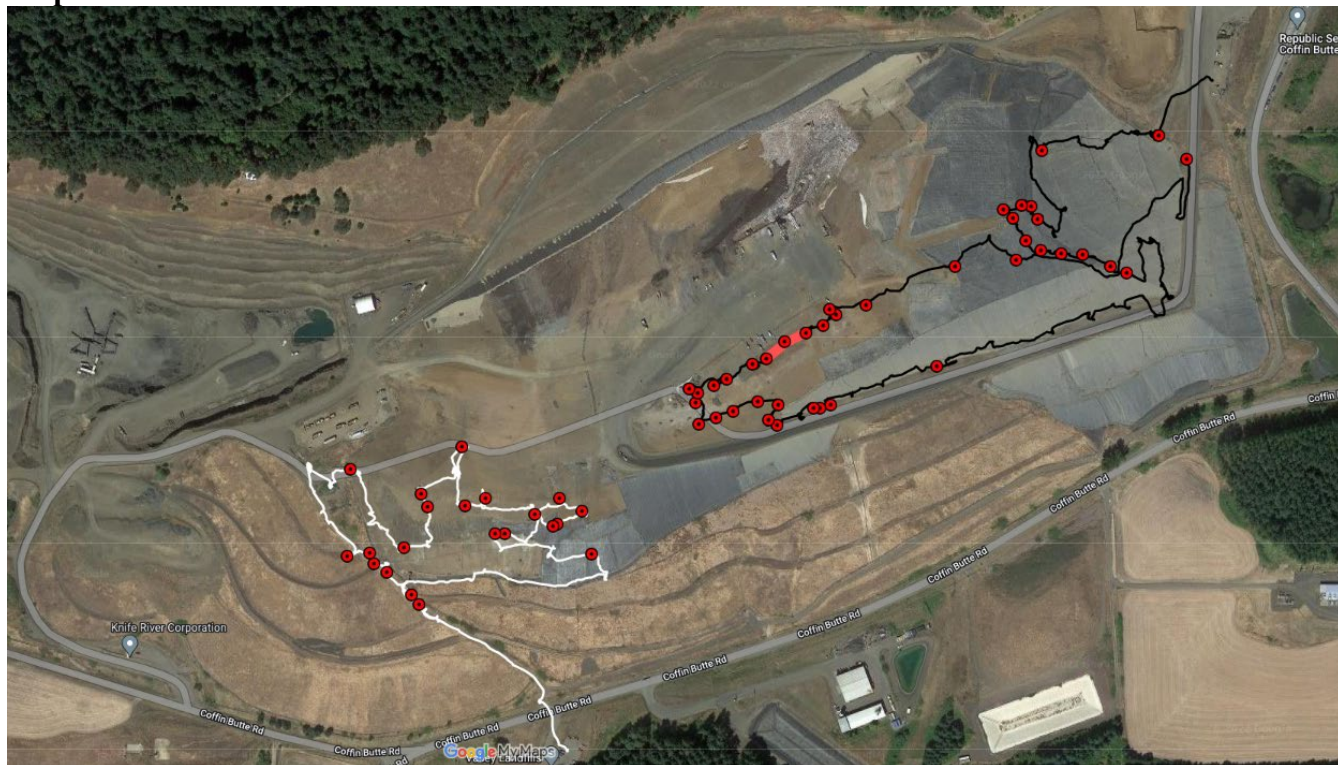
### Map of Detected Exceedances

Flag #51 was by a broad area where the tarp was visibly inflated with gas. The tarp was not moving in the wind, it looked to be being pushed out steadily over a wide area towards the top of the south slope on the central area of the landfill, being held down by straps, cover anchors, and sandbags. Neither Daniel Heins nor Phil Caruso could identify any place where the wind could be lifting under the tarps, as the tarp edges were sandbagged and staked down. Daniel Heins measured a concentration of 2% at flag #51 before pulling away to avoid maxing out his instrument. He measured the methane concentration to be 2000 ppm at 3' in the air at this location, indicating a plume of gas coming out from the inflated tarp area. Along the top of this section of tarp, from flag #52 to #54, every post or tarp hole Daniel Heins monitored exceeded the surface methane standard, with readings of up to 7% shown before the instrument maxed out.

Daniel Heins expressed concerns with the areas of tarp that were inflated with and leaking out landfill gas, as detected during the SEM, noting that in additions to compliance concerns with the surface methane standard that such an accumulation of flammable gas creates a potential safety concern.

SEM exceedance locations plotted over Google Maps satellite imagery. Approximate monitoring paths included, derived from GPS data. Morning path shown in white, afternoon in black. Line of continuous exceedance at every tarp hole between flags 52 and 54 is highlighted in red.
