United States Environmental Protection Agency  
Region 4

## Water Compliance Inspection Report

| Name and Location of Facility Inspected (For industrial users discharging to POTW, also include POTW name and NPDES permit number)<br>Savanna Street WWTP (Sanitary Sewer System)<br>3810 Interstate 55 South and Savanna Street<br>Jackson, Mississippi | Entry Date/Time<br>3/9/2023 8:40 AM<br>Exit Date/Time<br>3/9/2023 3:40 PM | Permit Effective Date<br>7/18/2017<br>Permit Expiration Date<br>6/30/2022 |

### *Section D: Summary of Findings / Comments*

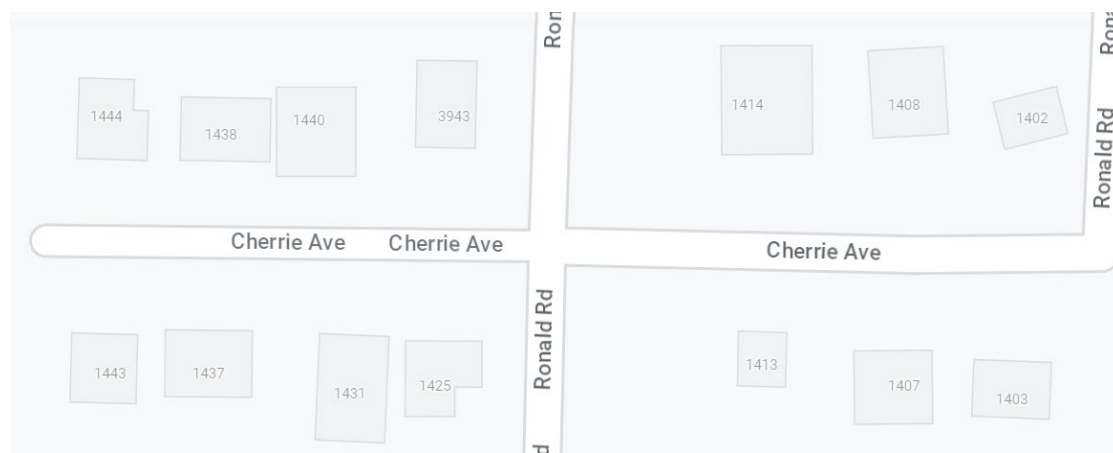
Figure 1. Cherrie Avenue.

1. Cherrie Avenue. Refer to Figure 1 and Photos 1. Inspectors observed sewage debris in the storm water ditch in front of 1444 Cherrie Avenue. The inspector also observed what appeared to be a weep hole (circled in red on Photo 1) that could be a sewage path from the residents lateral at the sewer main. The Inspector also discussed sewage issues with four other residents, not the complainant, that resides on Cherrie Avenue, west of Ronald Road. Each resident described sewage backing up into their homes frequently. Several residents stated that they have had plumbers verify that there are no blockages in their laterals.

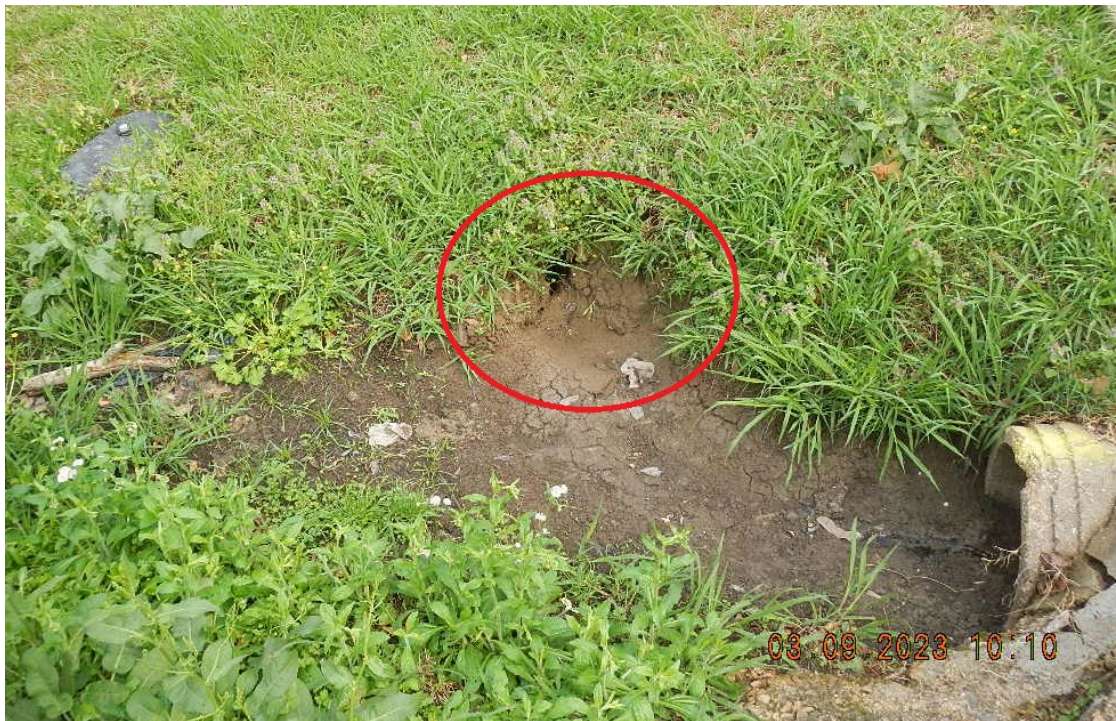
Photo 1. Sewage debris and sewer sludge was observed at the storm water ditch in front of 1444 Cherrie Avenue. Circled in red appears to be a weep hole where sewage is being released into the ditch.

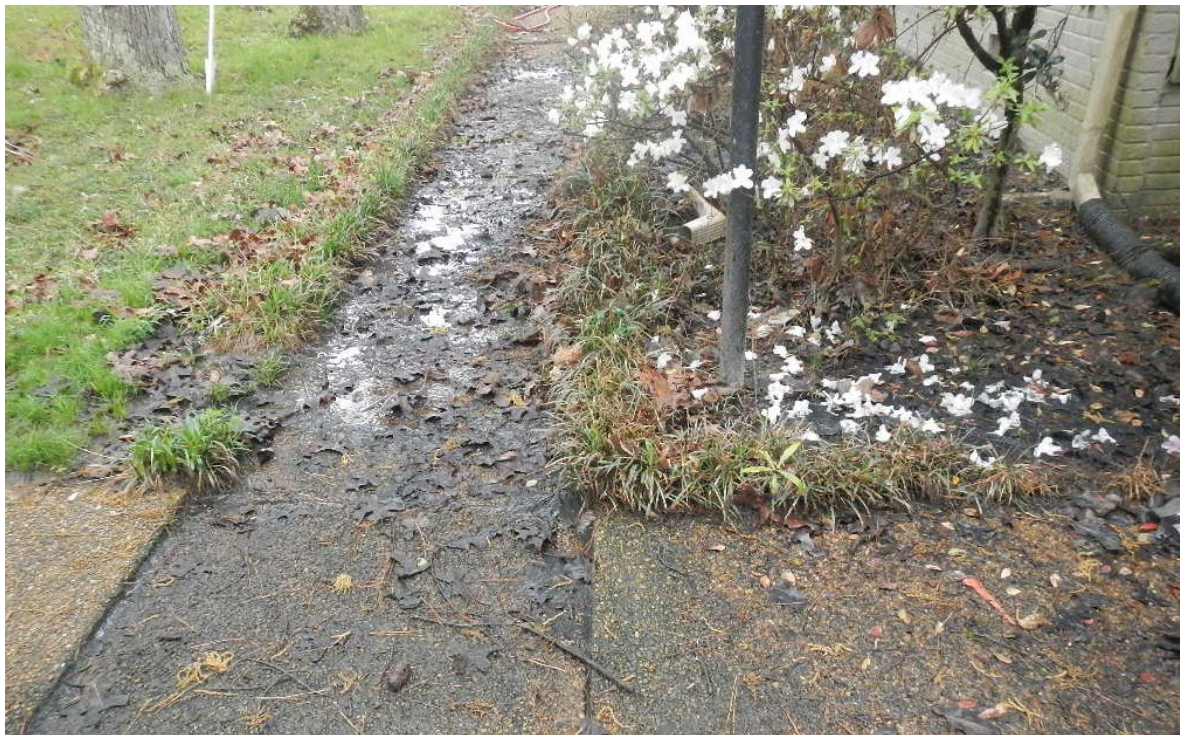
2. 3955 Eastline Drive. Raw sewage and a buildup of sewage sludge was observed in and around the front side of the resident's home, on the walkway, (Photos 2 and 3), and in the storage area for childrens toys (bikes, etc..). A sewage path was also observed traveling across the resident's driveway and into the house next to the driveway on Robert Drive, (Photo 4). Discussions with the resident indicates that they have called plumbers to the residence more than once and have verified that the issue is in the sewer main. Of note, there is too much volume of sewage sludge and sewage runoff on the ground to suggest that it would have originated from the resident's home.

Photo 2. Raw sewage standing in the front walkway.

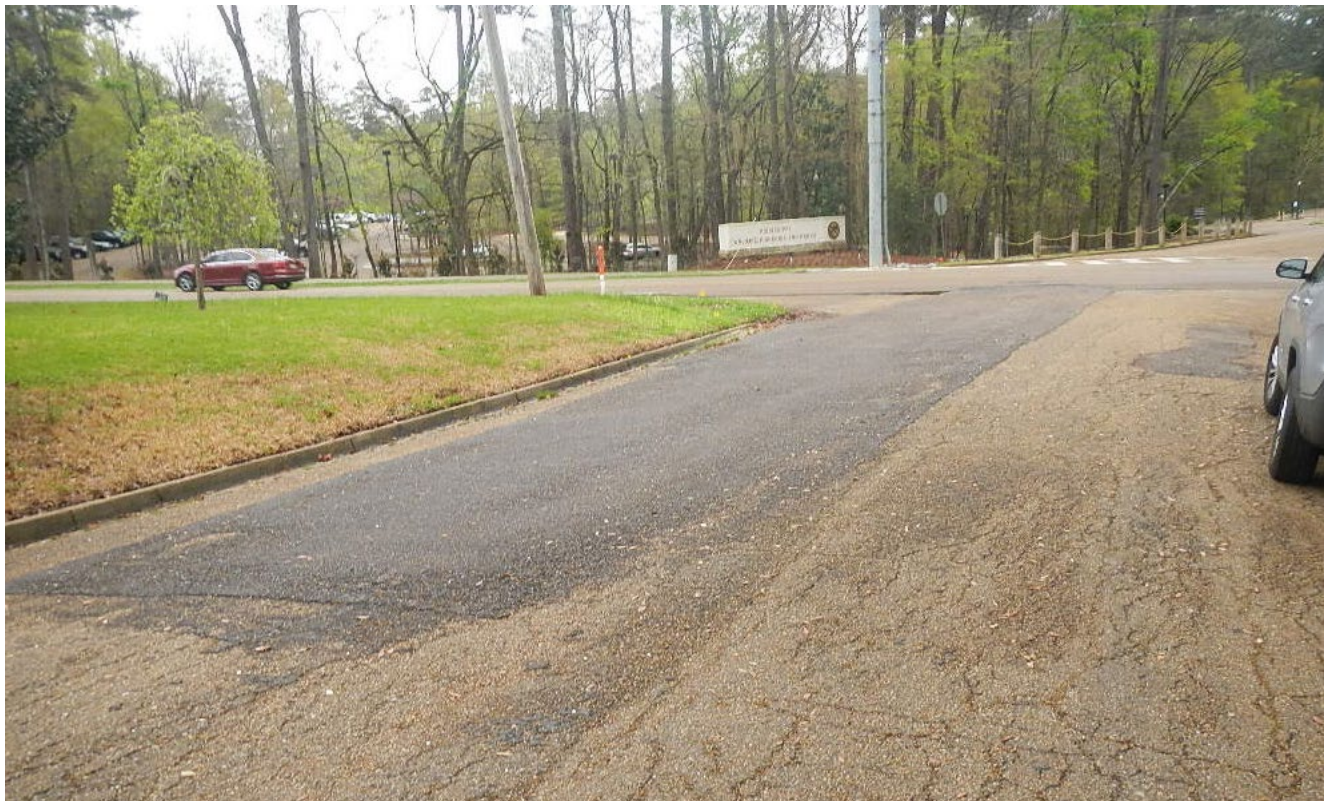
The resident also described point repairs that were made 3 or 4 years ago to the sewer main on Eastline Drive (Photo 5) and that sewage started backing up into his home about 9 months before the inspection. The resident indicated that the City is aware of the problem but has done nothing.

Photo 5. Previous point repair on Eastline Road.

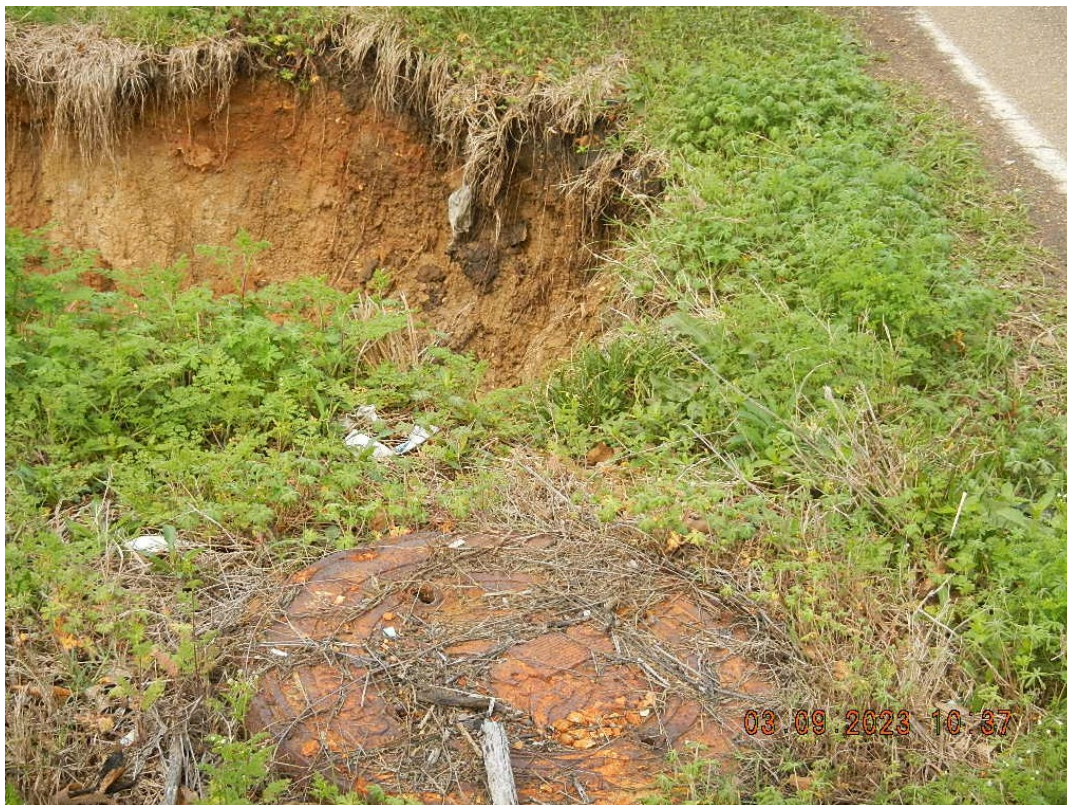
3. McCluer Road. A sink hole located at 1303 McCluer Road was observed next to a sanitary sewer manhole, (Photo 6). The Inspector also notes several weep holes on the opposite side of the sink hole on McCluer Road that smelled of sewage, indicating that sewage may be seeping from the sewer main under, or alongside the road, (Photo 7).

Photo 6: Sink hole likely caused by collapsed sewer main.

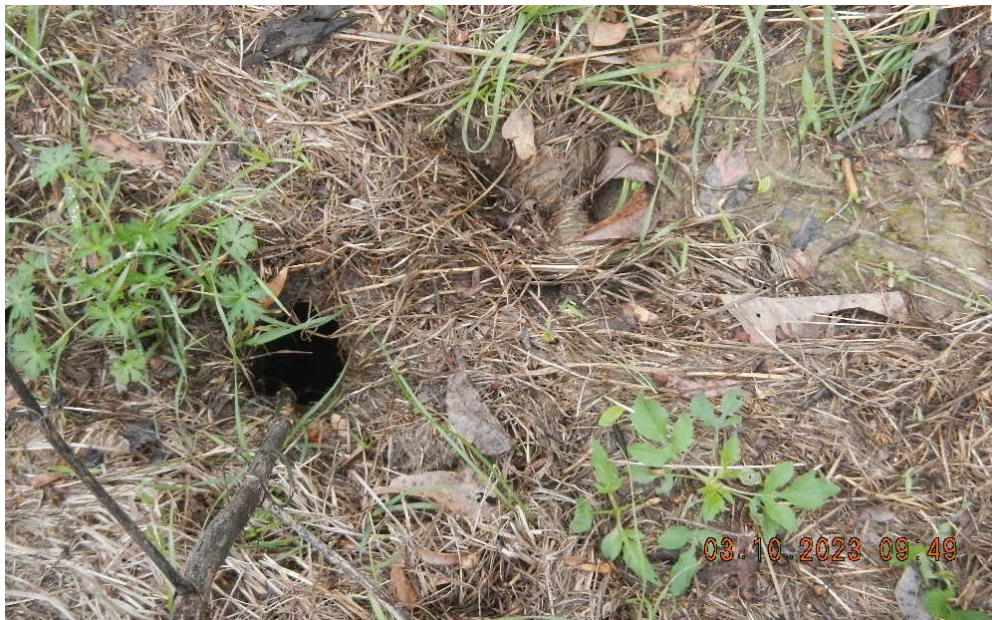
Photo 7: Weep holes smelling of sewage noted on the opposite side of the road where the sink hole was located at 1303 McCluer Road.

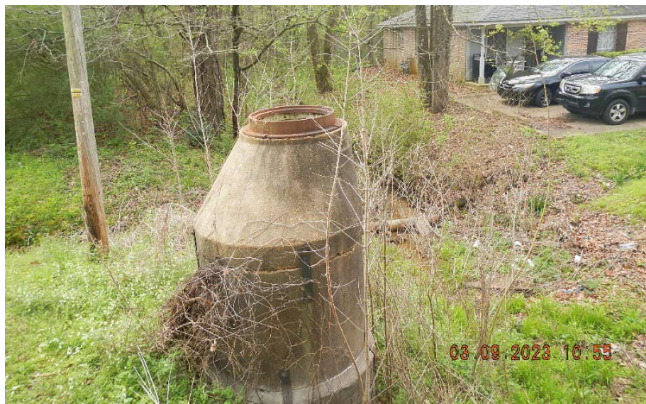
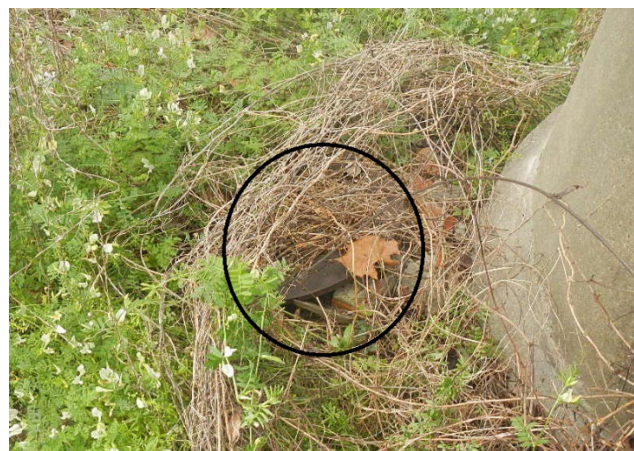
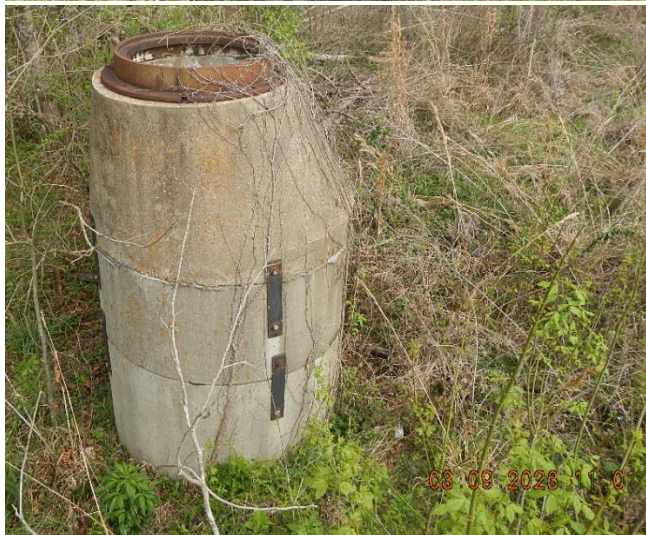
Further east on McCluer Road, the inspector observed two manholes at, or near 193 McCluer Road that were missing the manhole covers, (Photos 8 and 10). The manhole at 193 McCluer Road had its manhole cover laying next to the base of the manhole, (Photo 9). Excessive wet weather inflow can, if enough volume is present at a given time, blow the manhole lid from the top of the manhole.

Photos 8 through 10: Missing manhole covers from two manholes at or near 193 McCluer Road. The black circle indicates where the Inspector observed the missing manhole cover on one of the manholes.
