**Compliance Evaluation Inspection Report**

Shannon Publicly Owned Treatment Works, East  
Shannon Publicly Owned Treatment Works, West

NPDES Permit No. MS0047988

NPDES Permit No. MS0027405

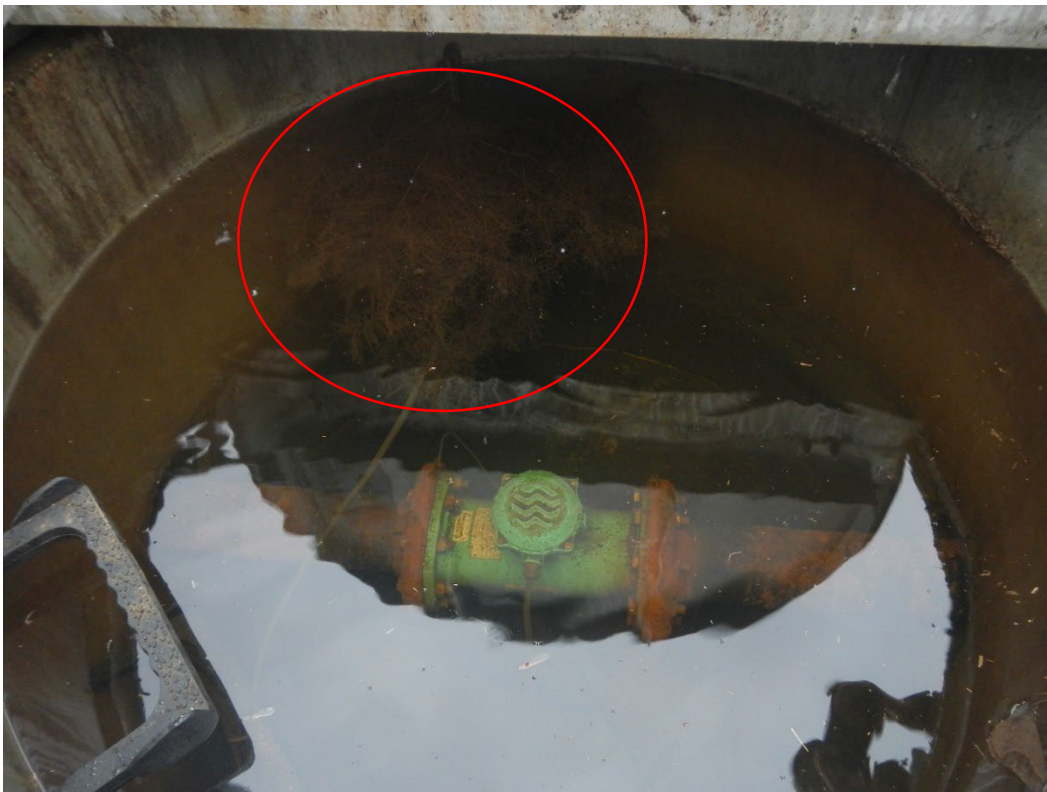
The access structure to the flow meter was flooded with groundwater and roots were seen growing into the structure (Figure 3).

Figure 3: Inline flow meter located between final lagoon and chlorine contact chamber. Flow meter access hole is shown flooded with plant roots growing into chamber.

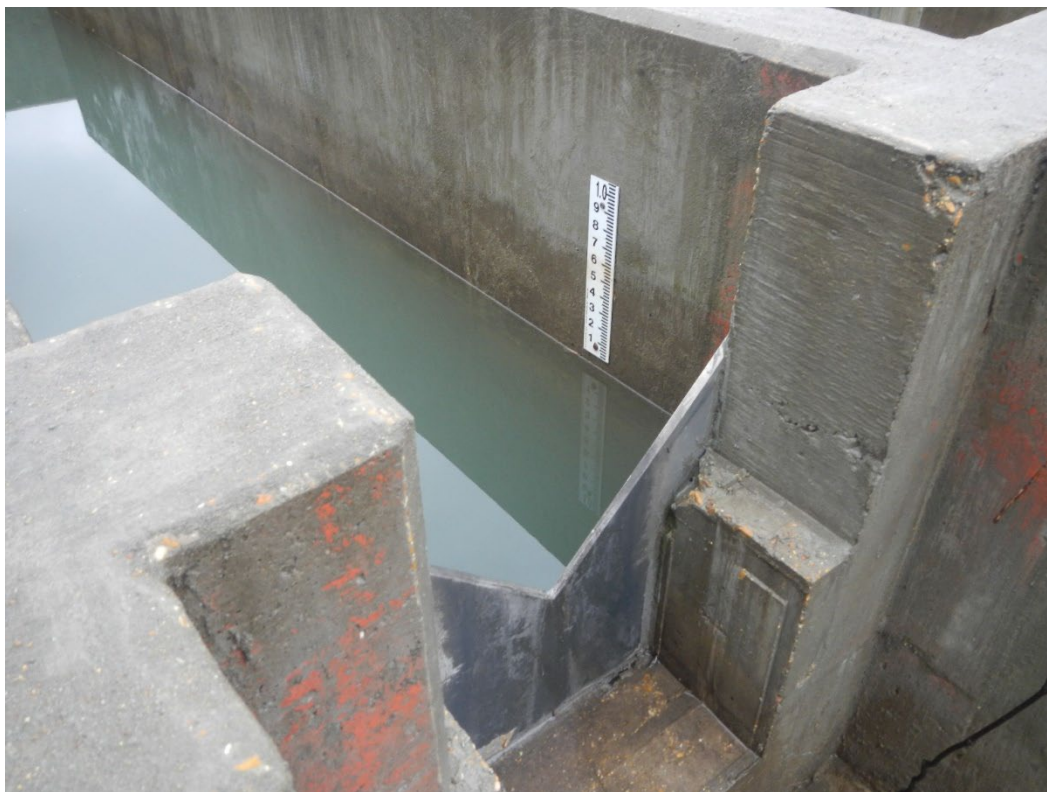
The v-notch weir and staff gauge were in good condition and the staff gauge was clearly legible.

Figure 5: Effluent V-notch weir with staff gauge.

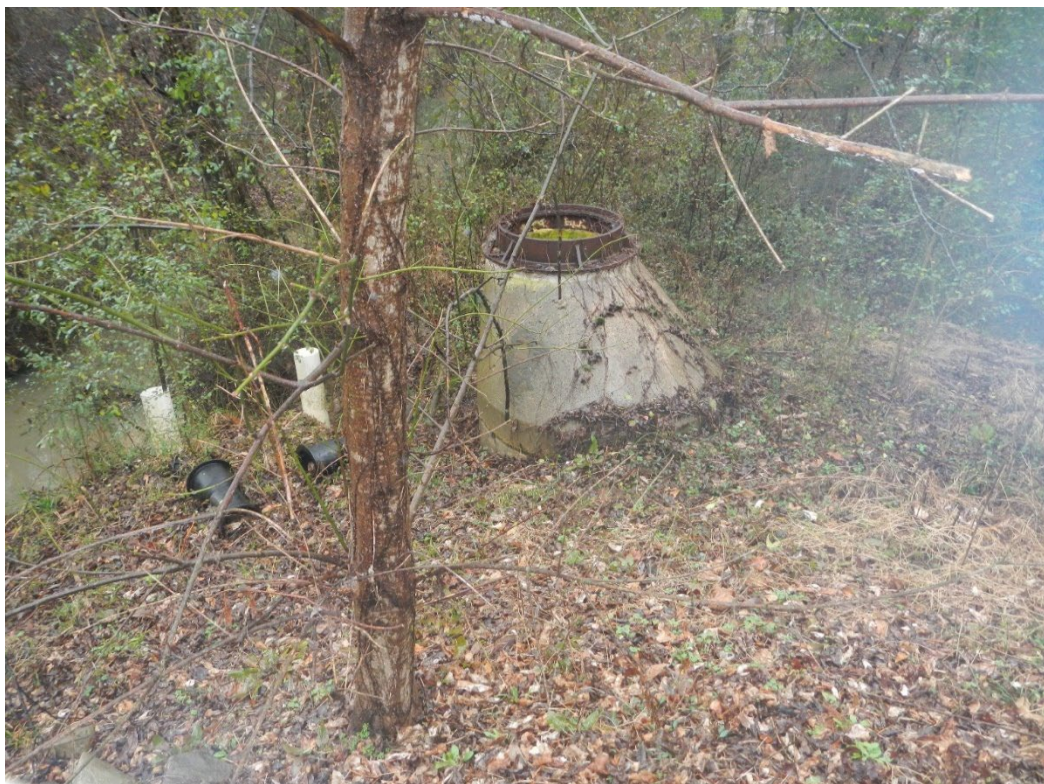
The manhole cover to the influent wet well was missing.

Figure 6: Inlet structure with missing manhole.

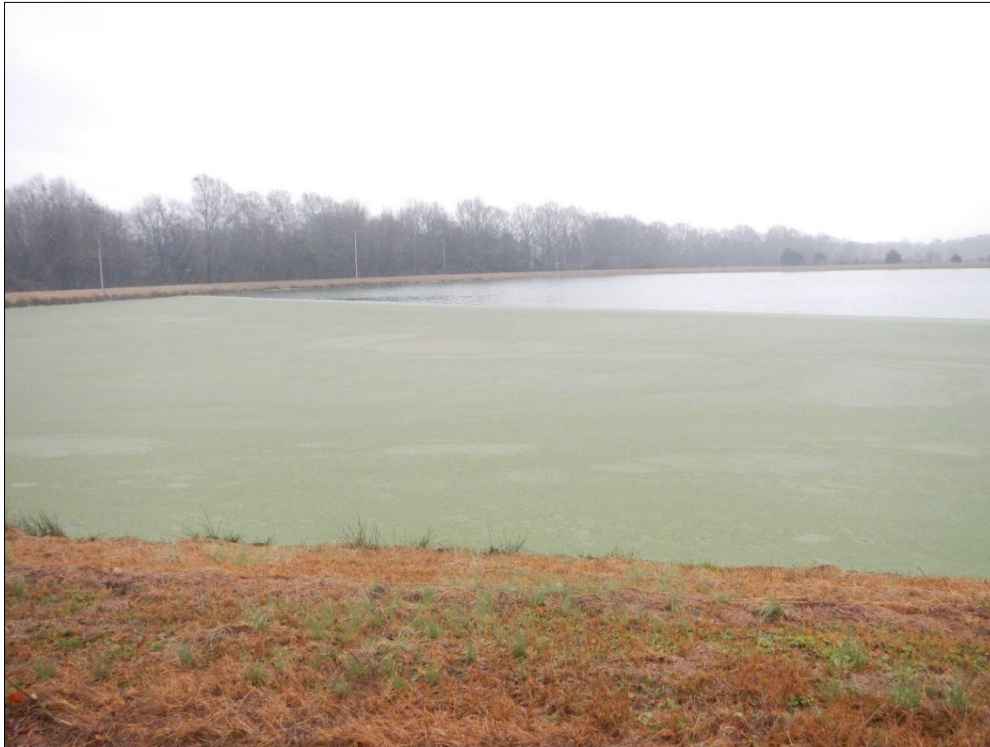
Plant personnel did not know the depth of any of the lagoons as no schematics were available. Town staff stated that they had just recently cleared the facility entrance and the area around the chlorine contact chamber of heavy vegetative growth. Of the three lagoon cells, aeration was operational only in the third cell. Duckweed was observed in the primary lagoon (Figure 11).

Figure 11: Considerable duckweed growing in first lagoon.

The permittee should develop and implement standard operating procedures to effectively operate the lagoon.

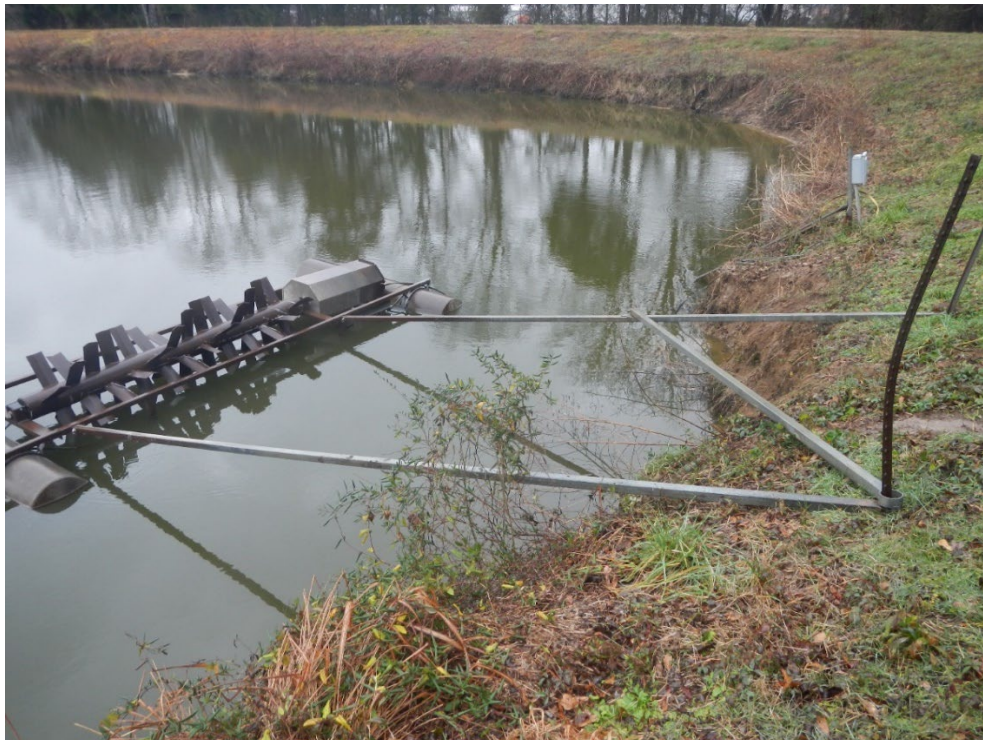
The facility is operated by the same personnel as the POTW East facility. The lagoon had one non-operating aerator (Figure 12). The rest of the lagoon appeared to be in good condition. Facility personnel stated that once the berms dry from recent rainfall they would repair the aerator.

Figure 12: Lagoon aerator was not operational.

- a. Establish Standard Operating Procedures to include procedures for routine operations and maintenance, sampling, and reporting.
- b. Establish record keeping procedures and keep records, as required by its NPDES permit.
- c. Repair aerators.
- d. Promptly secure or remove empty and partially empty chlorine tanks from the elements. Partially filled chlorine gas tanks can present a severe hazard if the tank is dropped or tipped over and damaged.
- e. Cap the POTW West influent manhole.
- f. Drain and clean flow meter chamber of the POTW West.
- g. Submit past due DMRs with available data.
- h. Submit overdue permit renewal applications for both lagoons.

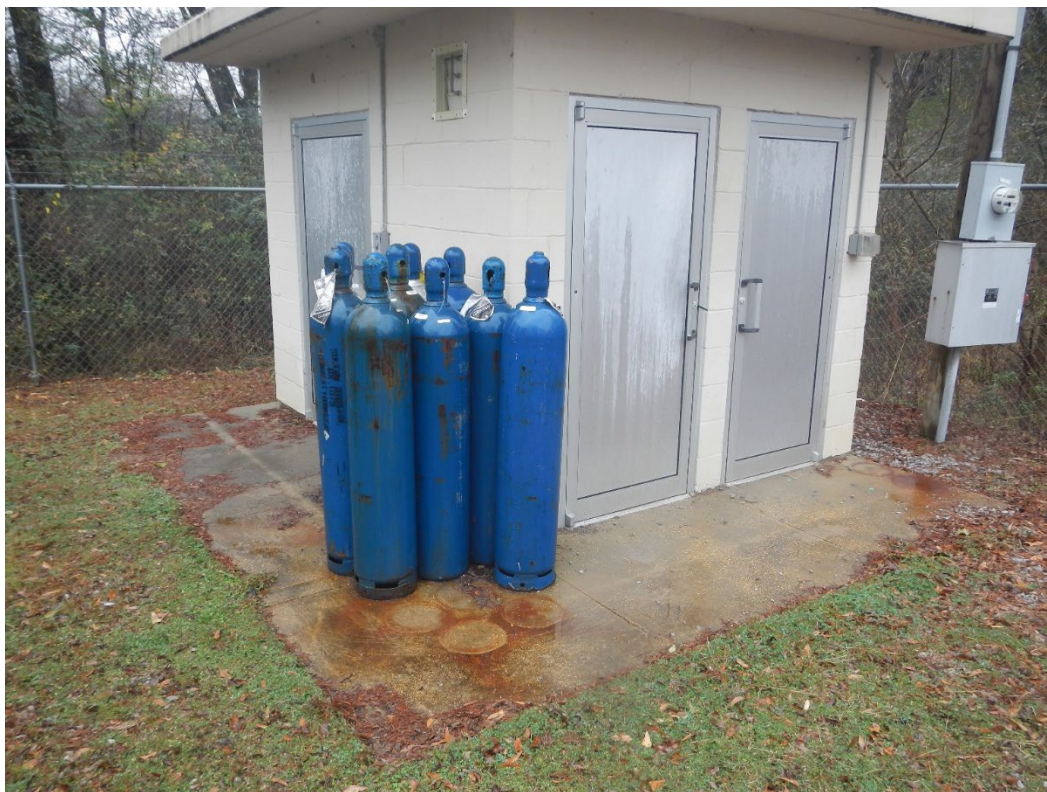
There were numerous empty and partially filled chlorine containers observed outside of the structure that were exposed to weather and showing signs of corrosion (Figure 13).

Figure 13: Empty and partially empty chlorine tanks
