# Photographs for Shell Valley Wasterwater Treatment Lagoons

Inspection Type: Compliance Evaluation Inspection

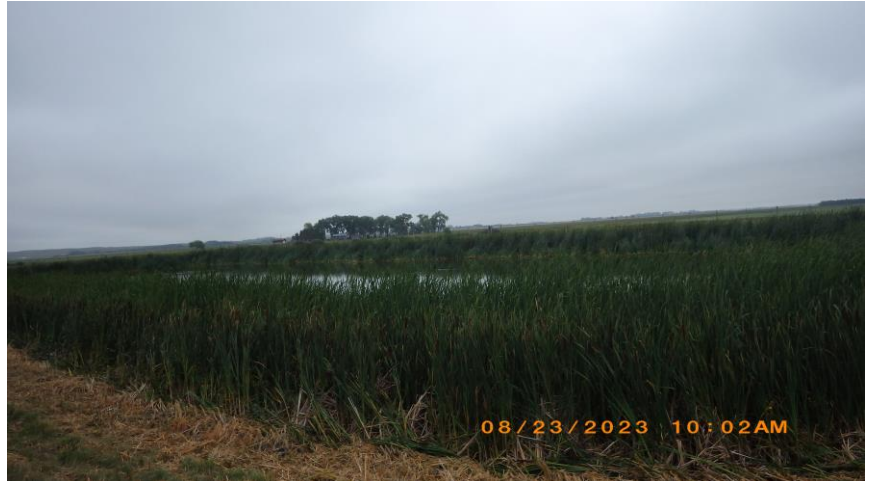
Photo number 502 taken by Akash Johnson on 8/23/2023. The direction of the photo is Southeast.

Overview of Cell 1. Cattails were growing along the interior of the berm.

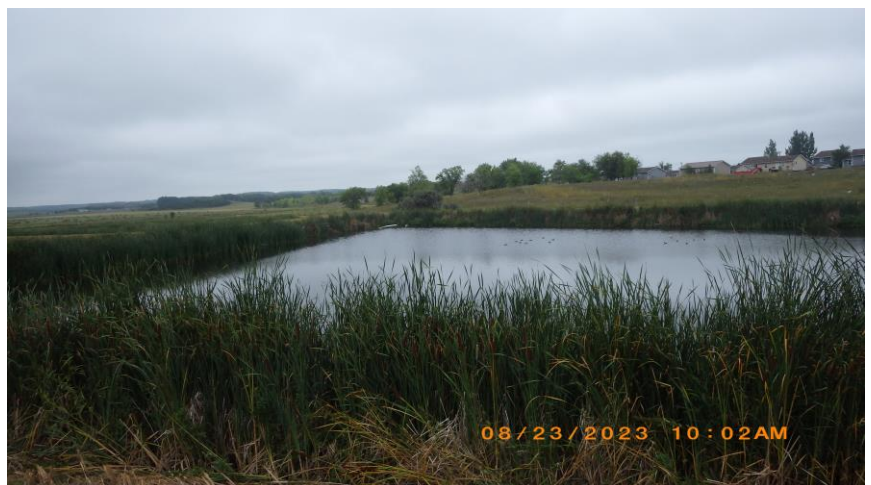
Photo number 503 taken by Akash Johnson on 8/23/2023.

Overview of Cell 2. What was presumed to be transfer piping to Cell 3 is visible in the background (northwest corner of the cell); the transfer piping was elevated several feet above the surface of the water. Cattails were growing along the interior of the berm.

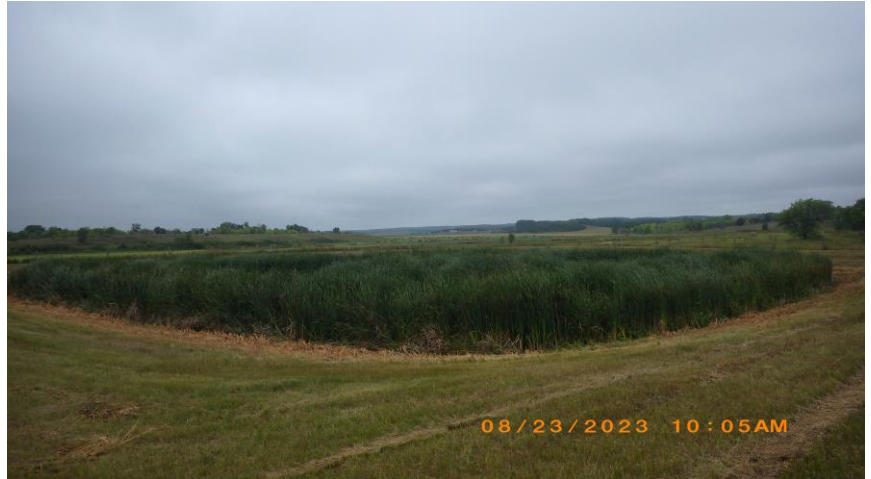
Photo number 504 taken by Akash Johnson on 8/23/2023.

Overview of Cell 3. Little water appeared to be in this cell. Cattails were growing throughout the interior of the cell.

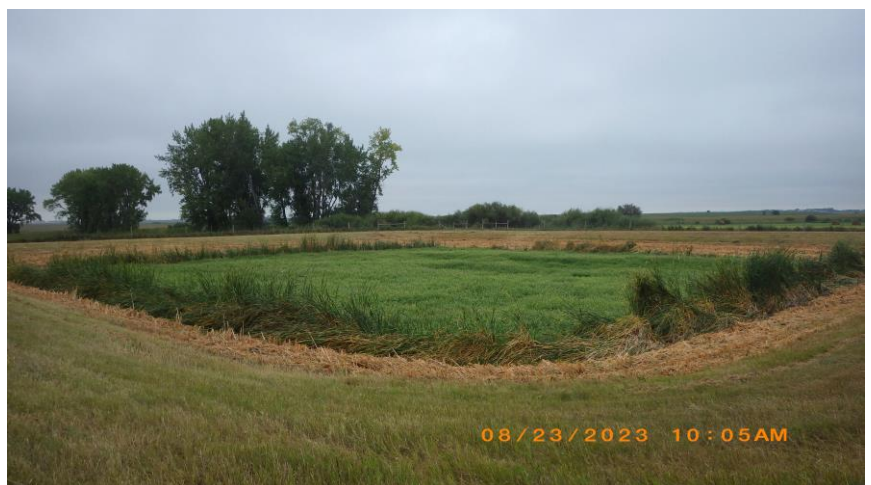
Photo number 505 taken by Akash Johnson on 8/23/2023.

Overview of Cell 4. No water appeared to be in this cell. Cattails were growing along the interior of the berm and vegetation was growing throughout the interior of the cell.
