**UNITED STATES ENVIRONMENTAL PROTECTION AGENCY  
REGION 5  
77 WEST JACKSON BOULEVARD  
CHICAGO, ILLINOIS 60604**

**SUBJECT:** CLEAN AIR ACT INSPECTION REPORT  
Fairborn Cement Company, Xenia, Ohio

**Dates of Inspection:** August 23 and 24, 2022

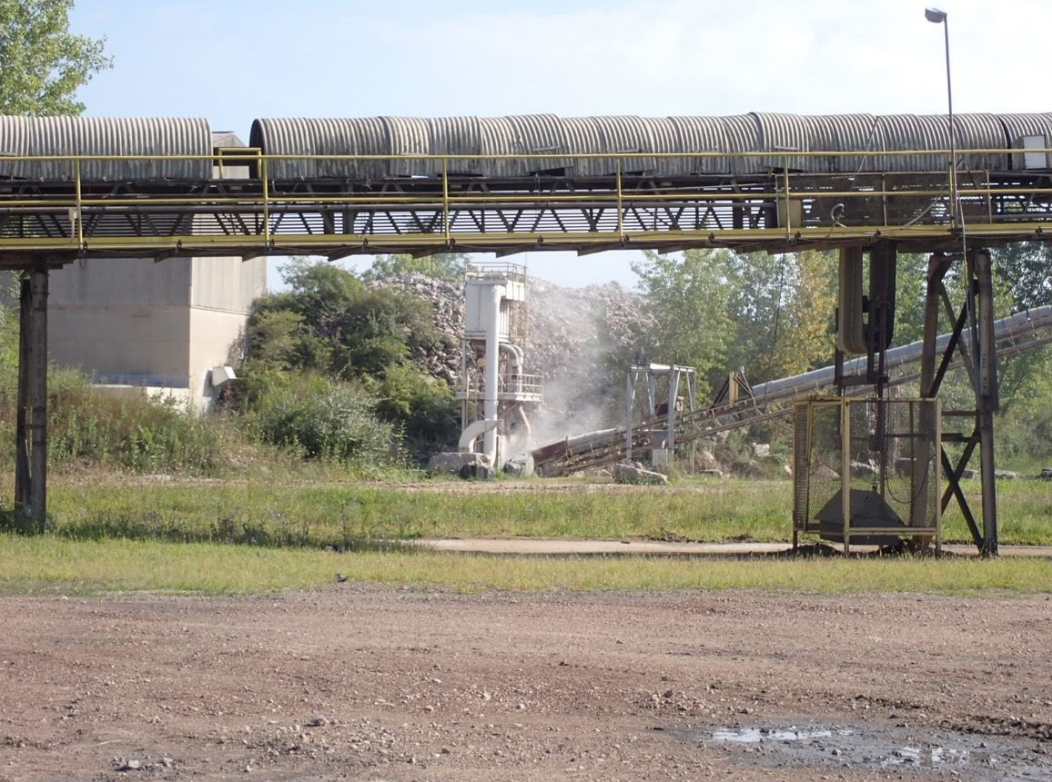
| Image Number | File Name | Date and Time (incl. Time zone and DST) | Description of Image |
|---|---|---|---|
| 3 | P8230007.jpg | 2022:08:23 08:02:40 | Visible Emissions from Limestone Crusher |

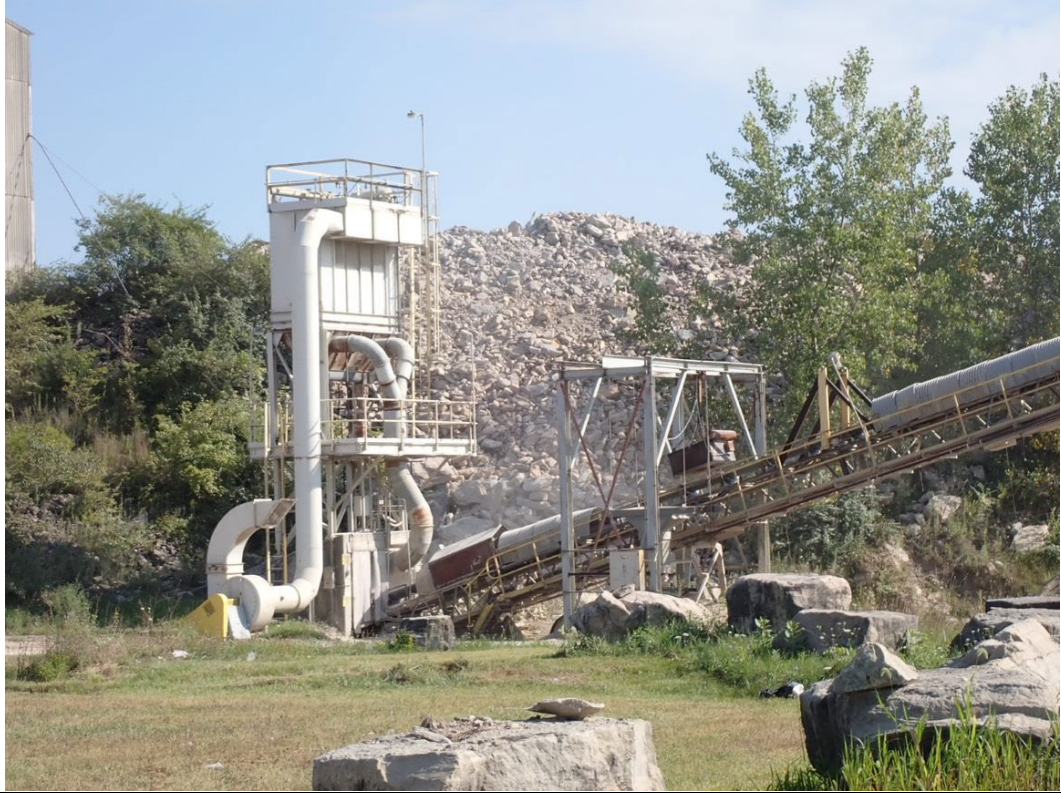
The limestone crushers are inside a building. A horizontal conveyor under the crusher transports the crushed limestone to an inclined conveyor. Fabric filter B10 collects PM from inside the crusher building. Fabric filter B49 collects PM that emits from the inclined conveyor. During the plant tour, the inspectors observed a cloud of PM outside of the crusher building. See pictures 3, 4, and 5 below. Byrne noted that FCC believes B49 is undersized for the crushed and has scheduled its replacement with a fabric filter that will double the volumetric flow rate to 10,000 cubic feet per minute.

| Image Number | File Name | Date and Time (incl. Time zone and DST) | Description of Image |
|---|---|---|---|
| 5 | P8230009.jpg | 2022:08:23 08:08:26 | Visible Emissions from B49 Dust Collector |

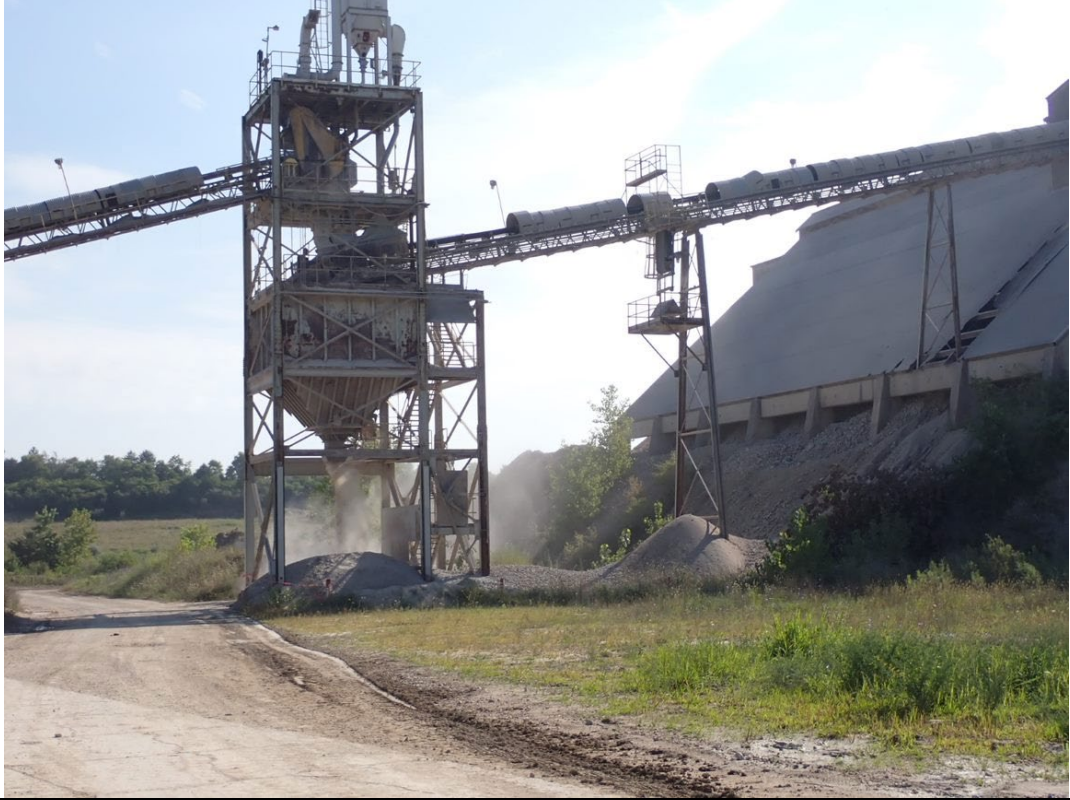
The inspectors observed fugitive dust at the Transfer Tower Hopper (picture 7). Byrne explained that FCC was conducting maintenance to clean the conveyor belt at transfer points. From the top of the pre-heater tower, the inspectors observed PM emitting from the Finish Mill (picture 14). During the second day of the inspection, FCC replaced two leaking bags in the Finish Mill's fabric filter. Byrne provided a copy of the work order. FCC has ordered the bags to replace all 500 bags in the Finish Mill's fabric filter. However, the project has been delayed until February 2023 due to supply chain problems. FCC has a few replacement bags as needed. On the second day of the inspection, Apolinario collected visible emission data for the Finish Mill. The VE data is attached.

| Image Number | File Name | Date and Time (incl. Time zone and DST) | Description of Image |
|---|---|---|---|
| 7 | P8230011.jpg | 2022:08:23 08:13:25 | Transfer Tower Hopper Maintenance Malfunction |

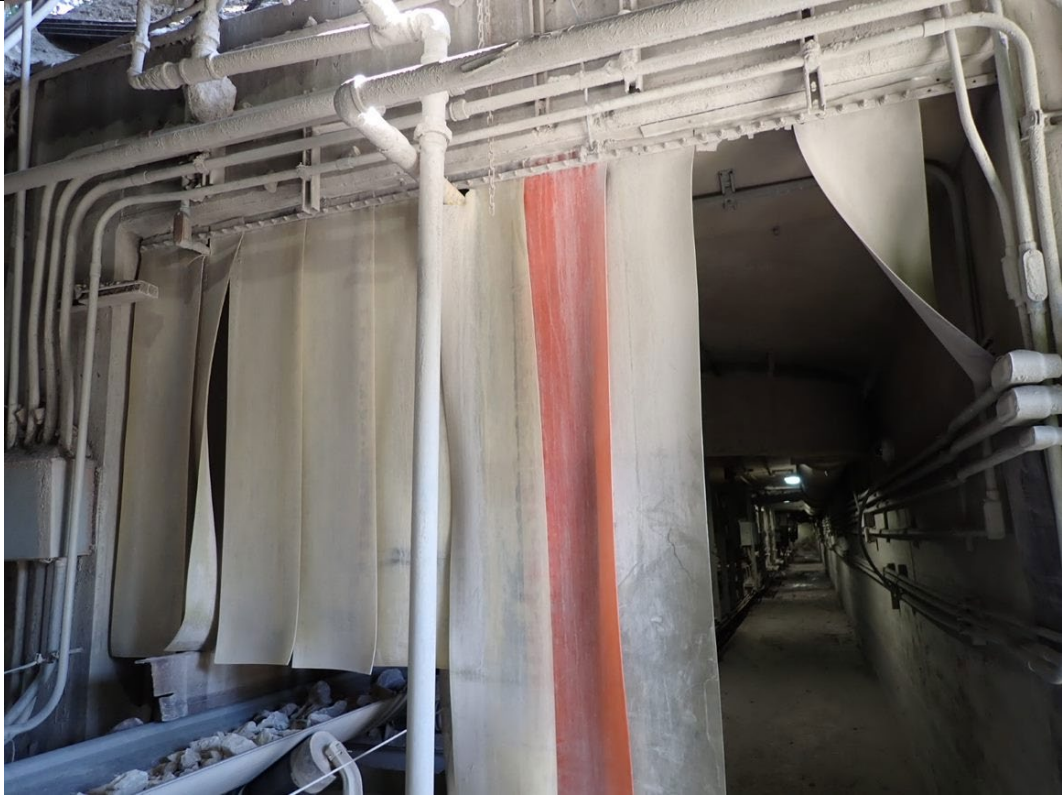
The Title V permit requires FCC to have plastic strip curtains at the tunnel entrance/exit of the limestone crusher which is emission unit P901. The inspectors found them missing.

| Image Number | File Name | Date and Time (incl. Time zone and DST) | Description of Image |
|---|---|---|---|
| 12 | P8230016.jpg | 2022:08:23 08:35:47 | Plastic Strip Curtains at Limestone Crusher |

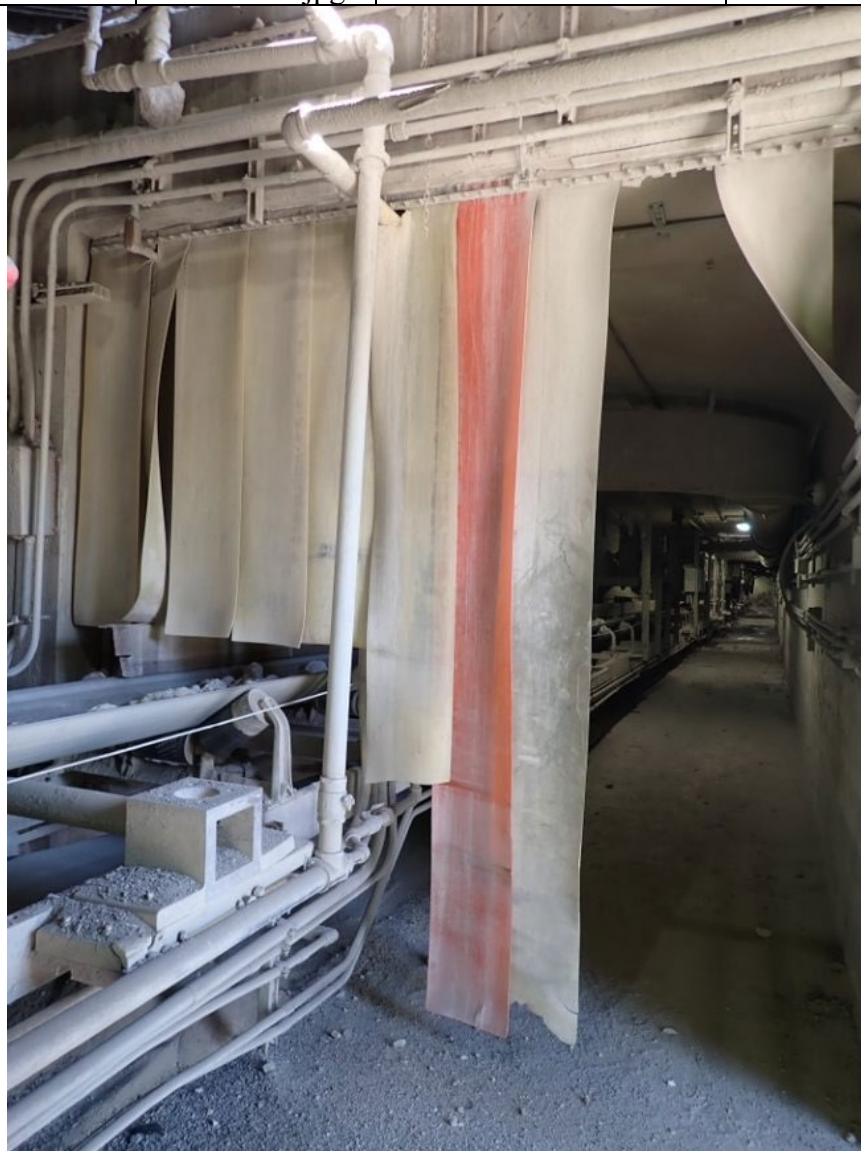
| Image Number | File Name | Date and Time (incl. Time zone and DST) | Description of Image |
|---|---|---|---|
| 13 | P8230017.jpg | 2022:08:23 08:35:56 | Plastic Strip Curtains at Limestone Crusher |

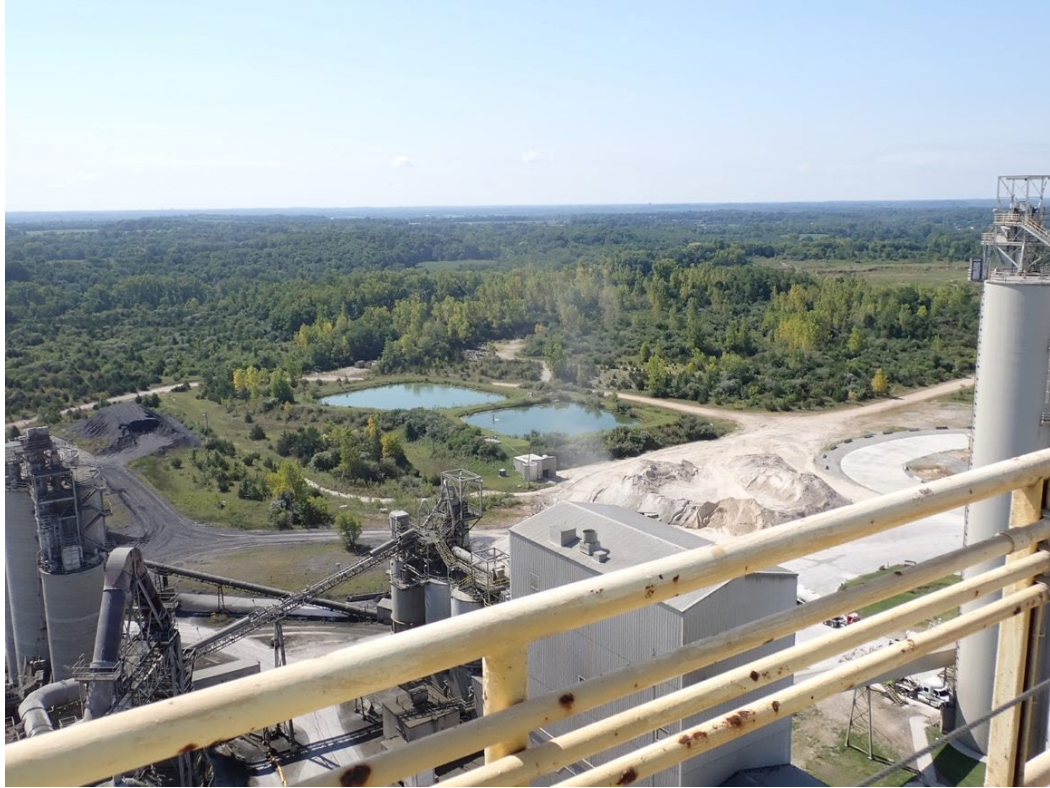
4. Opacity at Finishing Mill was 11.67% (3-minute average).

On August 24, 2022, Apolinario collected visible emission data for the Finishing Mill. The visible emission standard for that source is 10% as 3-minute average. FCC had replaced two bags that morning. The Environmental Manager stated he believes that the collector is still blowing out dust that was in the top plenum.

| Image Number | File Name | Date and Time (incl. Time zone and DST) | Description of Image |
|---|---|---|---|
| 14 | P8230018.jpg | 2022:08:23 09:21:52 | Visible Emissions at Finish Mill |

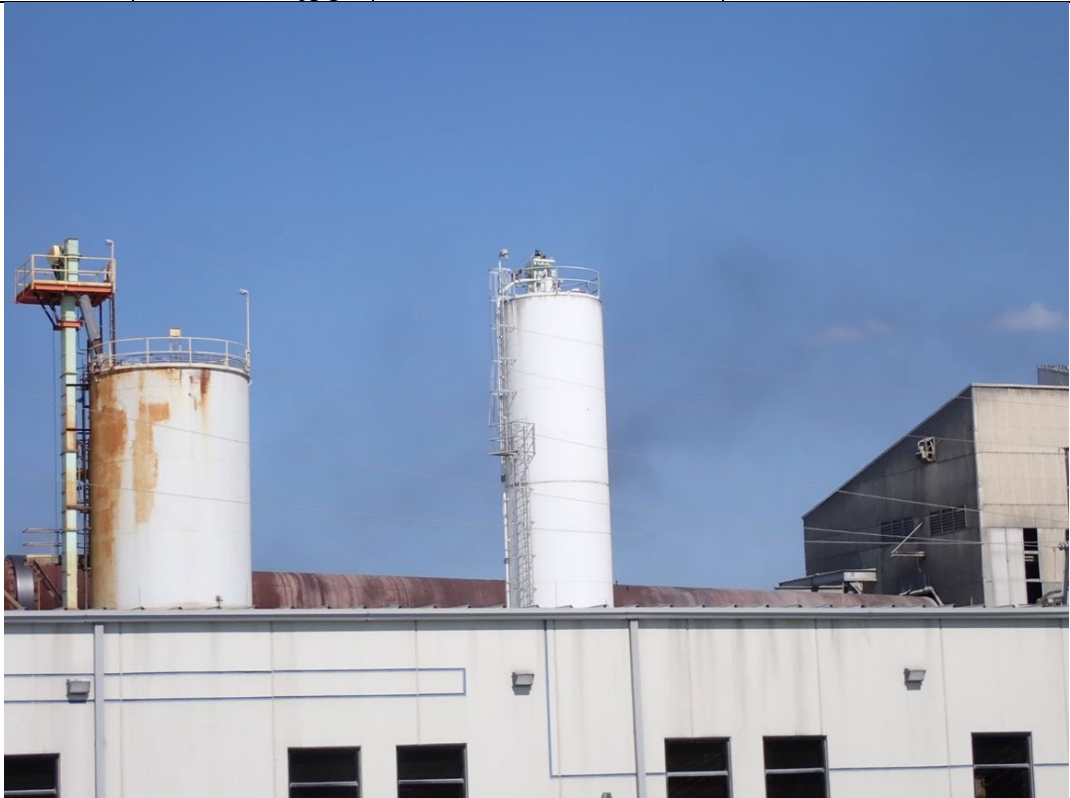
As the inspectors were getting into the car to leave at the end of the first day of the inspection, they observed a plume of black dust above the kiln and followed it back to the carbon injection system where a crew of workers was performing maintenance work. See pictures 16 through 19.

On August 23, 2022, as the inspectors were about to get into the car, Mr. Hall noticed a black dust plume behind the kiln. He followed the plume back to the carbon injection equipment. The inspectors showed the picture to Mr. Byrne and Mr. Miller on August 24, 2022.

| Image Number | File Name | Date and Time (incl. Time zone and DST) | Description of Image |
|---|---|---|---|
| 17 | P8230021.jpg | 2022:08:23 13:37:36 | Activated Carbon Plume |

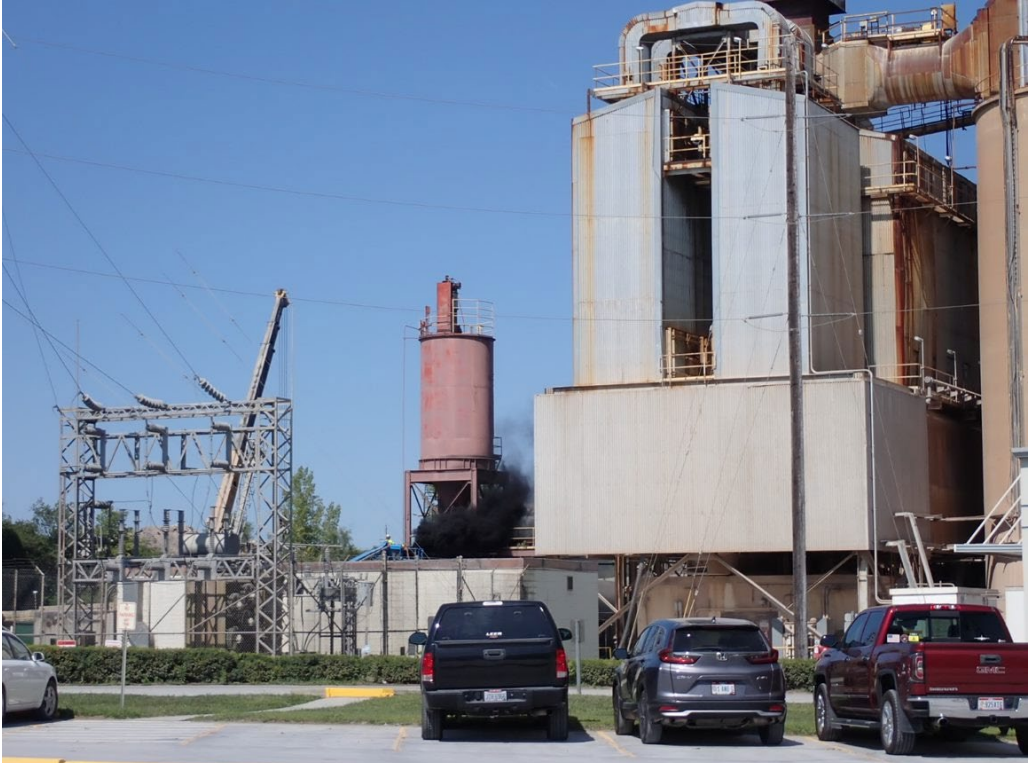
| Image Number | File Name | Date and Time (incl. Time zone and DST) | Description of Image |
|---|---|---|---|
| 18 | P8230022.jpg | 2022:08:23 13:38:09 | Activated Carbon Injection Maintenance |

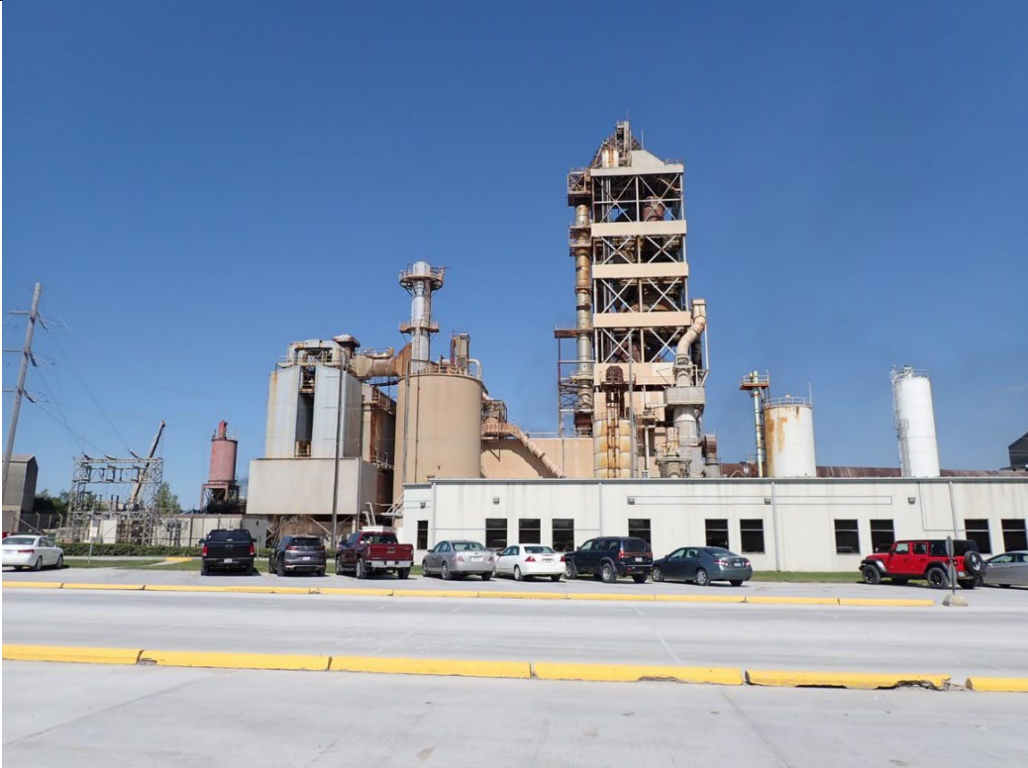
| Image Number | File Name | Date and Time (incl. Time zone and DST) | Description of Image |
|---|---|---|---|
| 19 | P8230023.jpg | 2022:08:23 13:38:14 | Activated Carbon Maintenance, Plant View |
