**UNITED STATES ENVIRONMENTAL PROTECTION AGENCY  
REGION III**

**Report Title:** Clean Water Act, Section 404 Inspection Report for Floyd Johnson Well Pad Site  
**Inspection Date(s):** 05/03/2022  
**Start Time:** 12:10 pm **End Time:** 2:30 pm  
**Regulatory Program(s):** Inspections authorized pursuant to Clean Water Act, Sections 308 and 404 (33 U.S.C. §§ 1318 and 1344)  
**Site Name:** Floyd Johnson Well Pad Site  
**Site Location:** Approximately 1.3 miles south on County Route 89 from the intersection with County Highway 74/2  
New Martinsville, West Virginia 26155  
**Latitude:** 39.7152 N **Longitude:** -80.6071 W  
**County/Parish:** Wetzel County  
**Company:** Chesapeake Appalachia, LLC  
**Mailing Address:** 6100 N. Western Ave.  
Oklahoma City, OK 73118

**Unique Project #:** 3E22WW041A

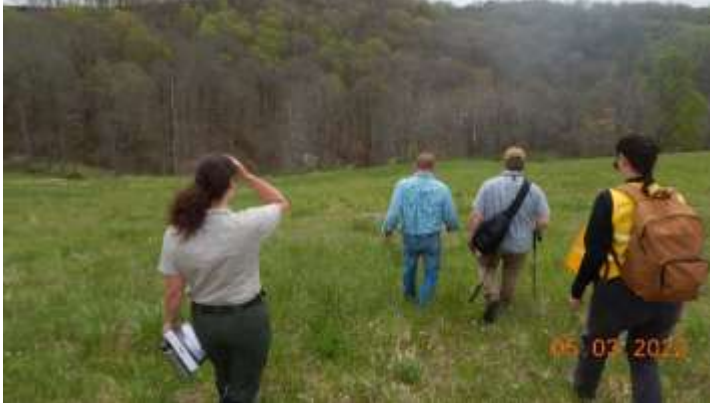
| | <p>Photo ID: DSCN3658.JPG<br/>Date: May 3, 2022</p> <p>Notes: site overview; looking southeast</p> |

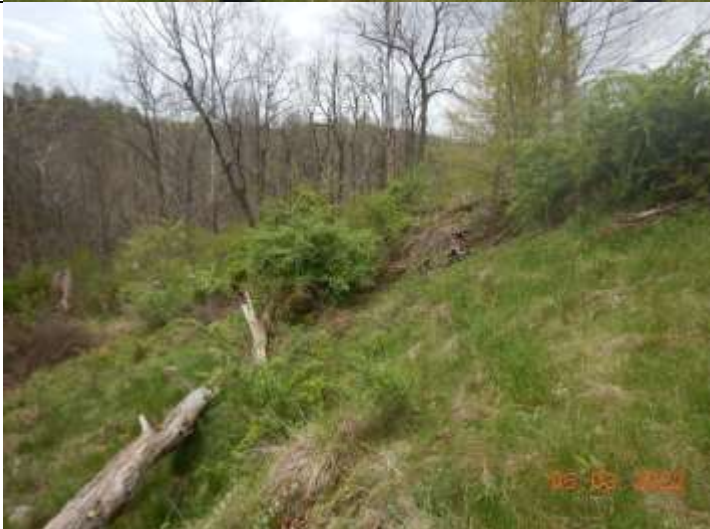
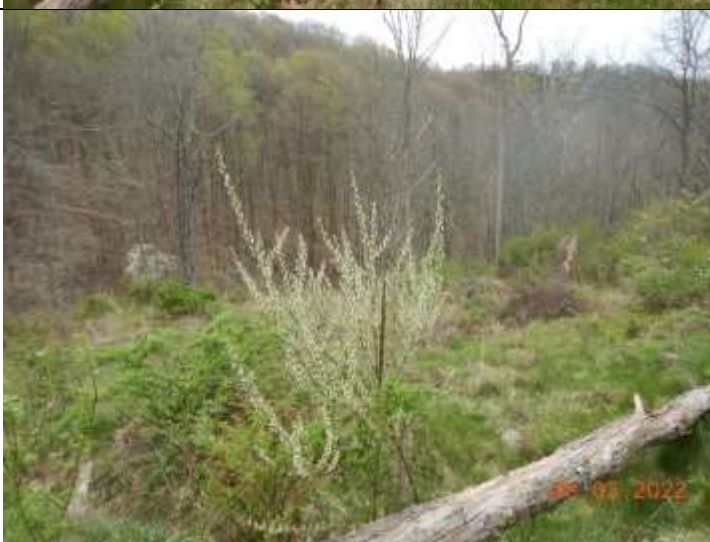
The attendees entered the Site from the north and walked down the hill to the stream reaches. The inspection walkthrough began at the upslope area of the slip along the northwest side of SWV-AMK-003, the mainstem (DSCN3659 and DSCN3660). The top portion of the slip near the upslope portion of the material that had moved was mostly vegetated with some exposed soil cracks (DSCN3661). Those exposed areas had started to re-vegetate. Shrubs have grown in the slip area and appear to be contributing to the slope stability. Relief channels were also present (DSCN3663). The relief channels were observed to have water draining in them. The slip area was not observed to be saturated or ponding/holding water.

| | <p>Photo ID: DSCN3659.JPG<br/>Date: May 3, 2022</p> <p>Notes: top of slip area; looking southwest</p> |
| | <p>Photo ID: DSCN3660.JPG<br/>Date: May 3, 2022</p> <p>Notes: top of slip area; looking south</p> |

- Adaptive management for invasive species control to meet the performance standard of maximum invasive species cover was recommended. ERM stated it would be addressed during the annual monitoring activities.
- The slip area and was observed to be much drier than the previous EPA inspection of the Site (2019). Vegetation was growing on previously exposed soil and the downslope end of the slip was outside of the stream channel.
- The in-stream structure locating in SWV-RDK-003 that was observed in 2019 and identified as an area of a potential head-cut was observed to not have substantially changed in location or condition since then.
- Minor erosion along the bank downstream of this area was observed. ERM discussed the potential placement of additional live stakes in this area to provide additional stability.

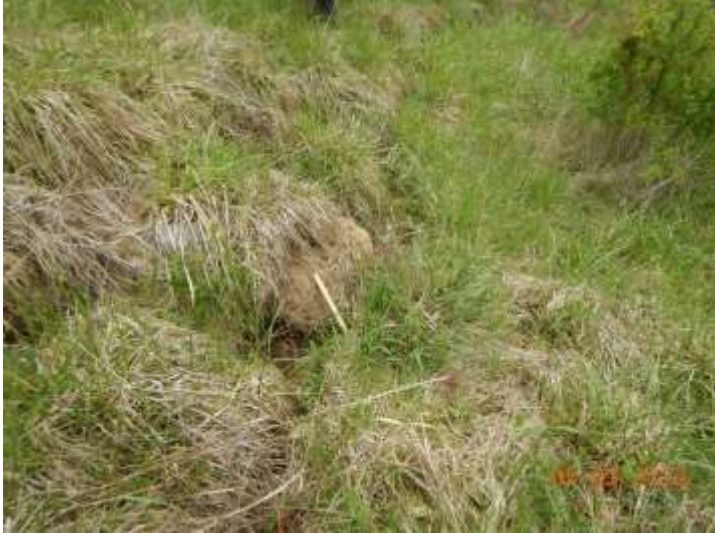
| | <p>Photo ID: DSCN3661.JPG<br/>Date: May 3, 2022</p> <p>Notes: part of the slip with relief/<br/>drainage channel</p> |

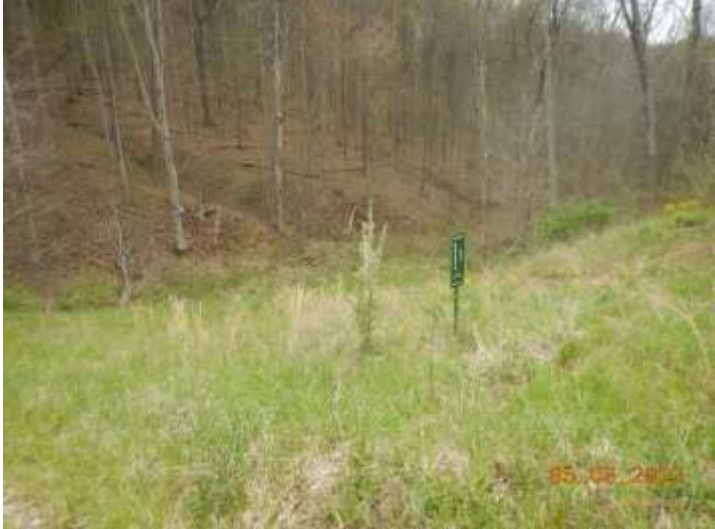
| | <p>Photo ID: DSCN3662.JPG<br/>Date: May 3, 2022</p> <p>Notes: overview of site looking<br/>towards SWV-AMK-003/mainstem;<br/>looking south</p> |

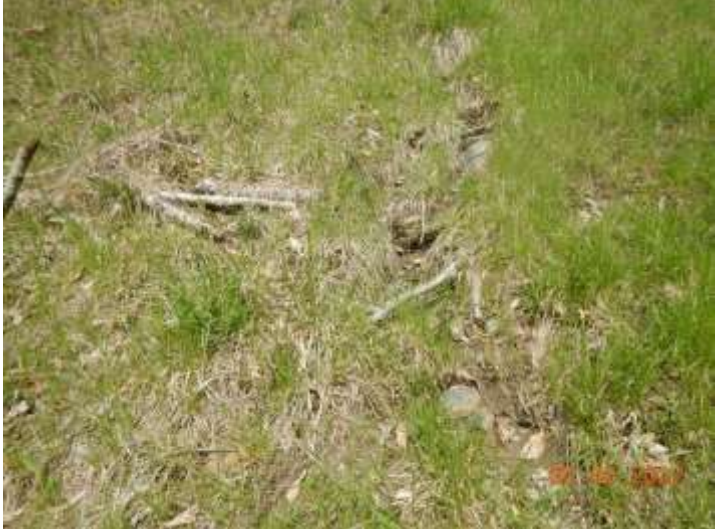
| | <p>Photo ID: DSCN3663.JPG<br/>Date: May 3, 2022</p> <p>Notes: relief/ drainage channel from<br/>the slip area</p> |

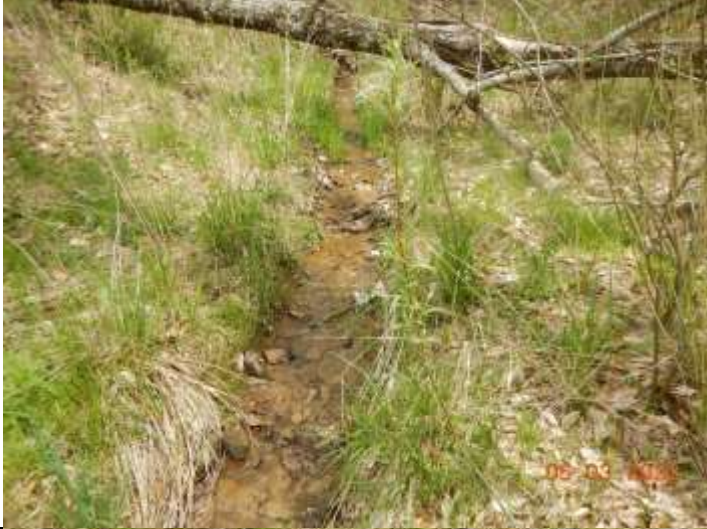
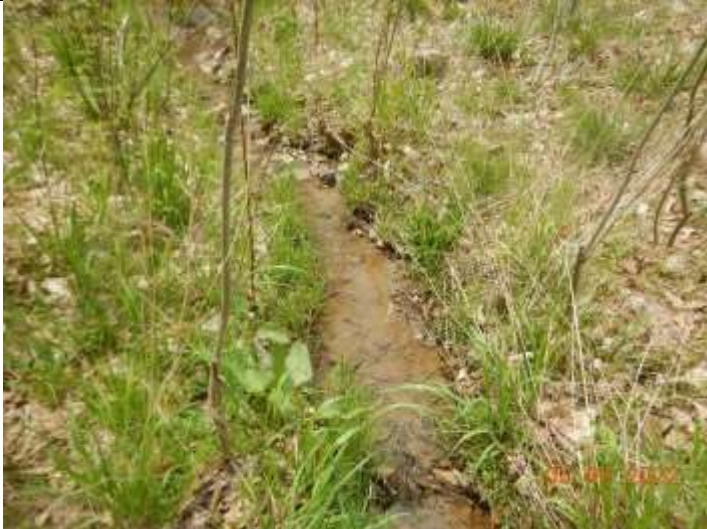
The walkthrough continued downslope to the stream channel for SWV-AMK-003. SWV-AMK-003 was flowing during the time of the inspection and appeared stable (DSCN3664 and DSCN3665). The stream banks were well-vegetated.

| | <p>Photo ID: DSCN3664.JPG<br/>Date: May 3, 2022</p> <p>Notes: SWV-AMK-003; looking north</p> |
| | <p>Photo ID: DSCN3665.JPG<br/>Date: May 3, 2022</p> <p>Notes: SWV-AMK-003; looking south</p> |

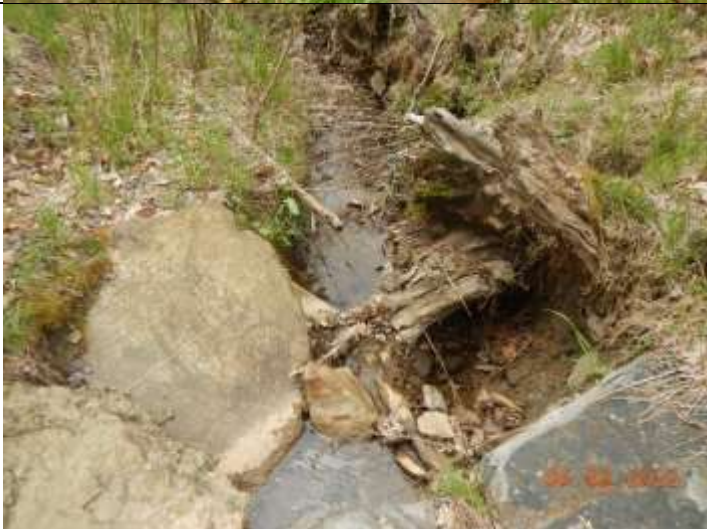
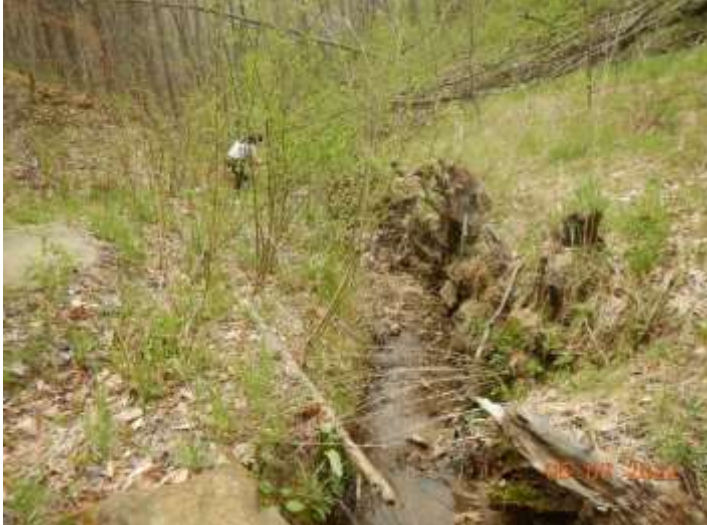
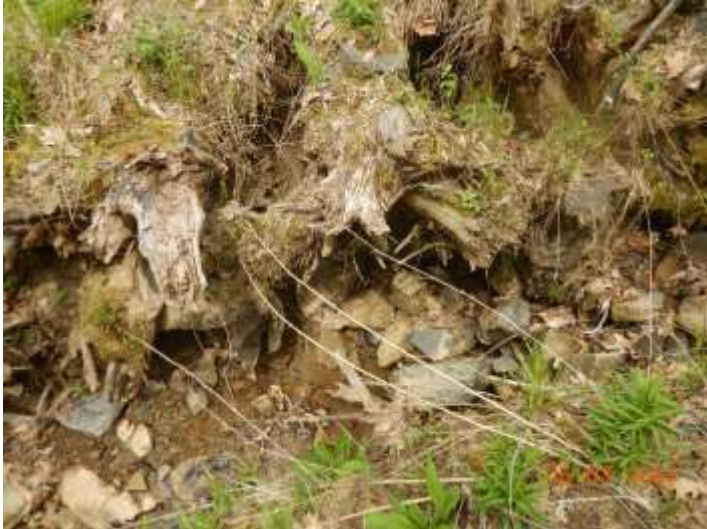
Most of the in-stream structures appeared stable and functioning as designed. One step pool near the central portion of the reach, near the confluence with SWV-DFW-005, was observed to have minor erosion with root wads along the bank being under-cut by the stream flow (DSCN3666 to DSCN3668). The step pool did not appear to be migrating or an active head-cut. The feature was observed to be in the same location and similar condition as was observed during the 2019 inspection by EPA.

| | <p>Photo ID: DSCN3666.JPG<br/>Date: May 3, 2022</p> <p>Notes: SWV-AMK-003; looking south</p> |

| | <p>Photo ID: DSCN3667.JPG<br/>Date: May 3, 2022</p> <p>Notes: SWV-AMK-003; looking south</p> |
| | <p>Photo ID: DSCN3668.JPG<br/>Date: May 3, 2022</p> <p>Notes: SWV-AMK-003</p> |

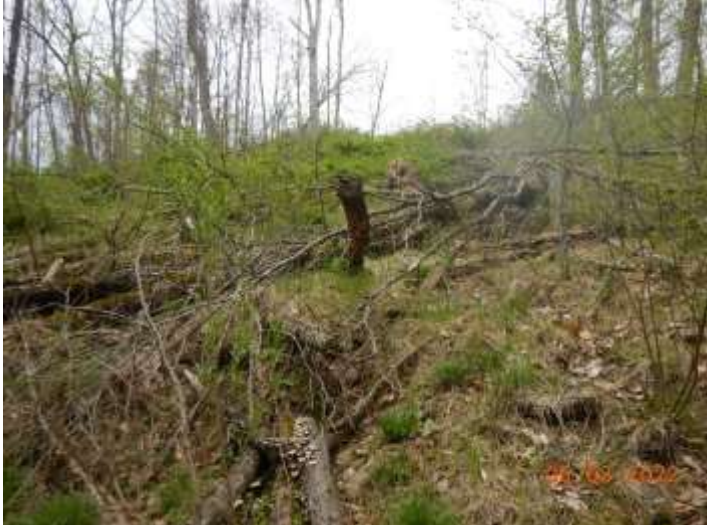
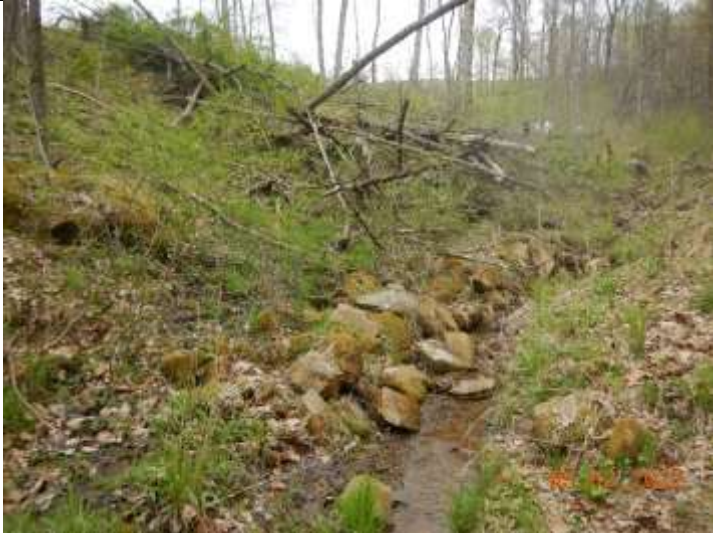
The walkthrough continued downstream along SWV-AMK-003. The base of the slip material near SWV-AMK-003 was observed. The material was observed to be within the riparian buffer zone but outside of the stream itself. Vegetation covered the slip material, and the planted woody stems were not observed to have been covered by any of the material at the time of the inspection (DSCN3669 and DSCN3671).

| | <p>Photo ID: DSCN3669.JPG<br/>Date: May 3, 2022</p> <p>Notes: facing upslope from the base of the slip; looking northwest</p> |

| | <p>Photo ID: DSCN3671.JPG<br/>Date: May 3, 2022</p> <p>Notes: SWV-AMK-003; looking north</p> |

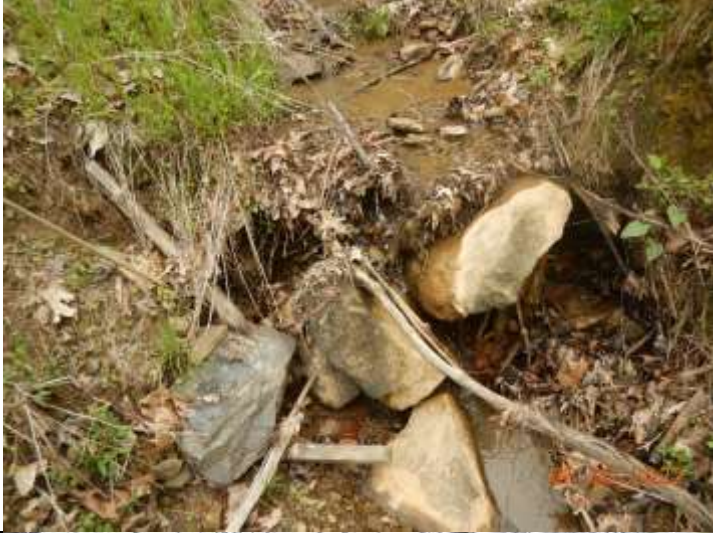
| | <p>Photo ID: DSCN3670.JPG<br/>Date: May 3, 2022</p> <p>Notes: SWV-AMK-003; looking north</p> |

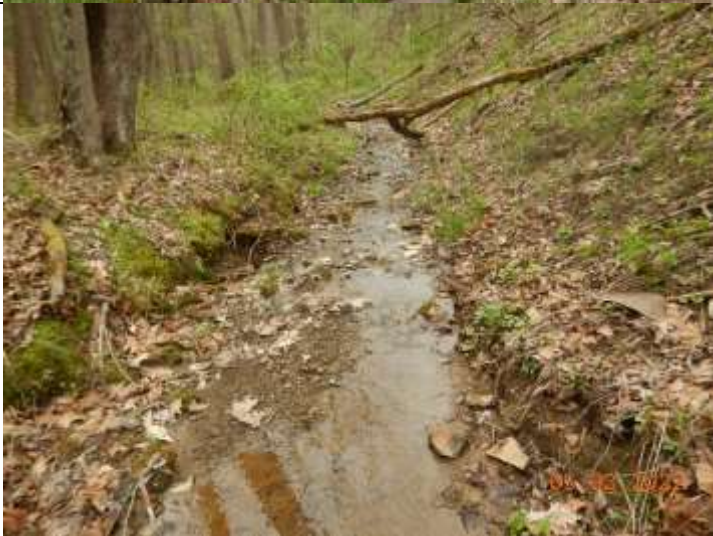
| | <p>Photo ID: DSCN3672.JPG<br/>Date: May 3, 2022</p> <p>Notes: SWV-AMK-003; looking south</p> |
