## Region 6 - Enforcement & Compliance Assurance Division

### INSPECTION REPORT

| Company Name: | <b>SMI Operating Company, LLC</b> | |
| Facility Name: | <b>Gregory, JD (B-5) SWD Tank Battery</b> | |

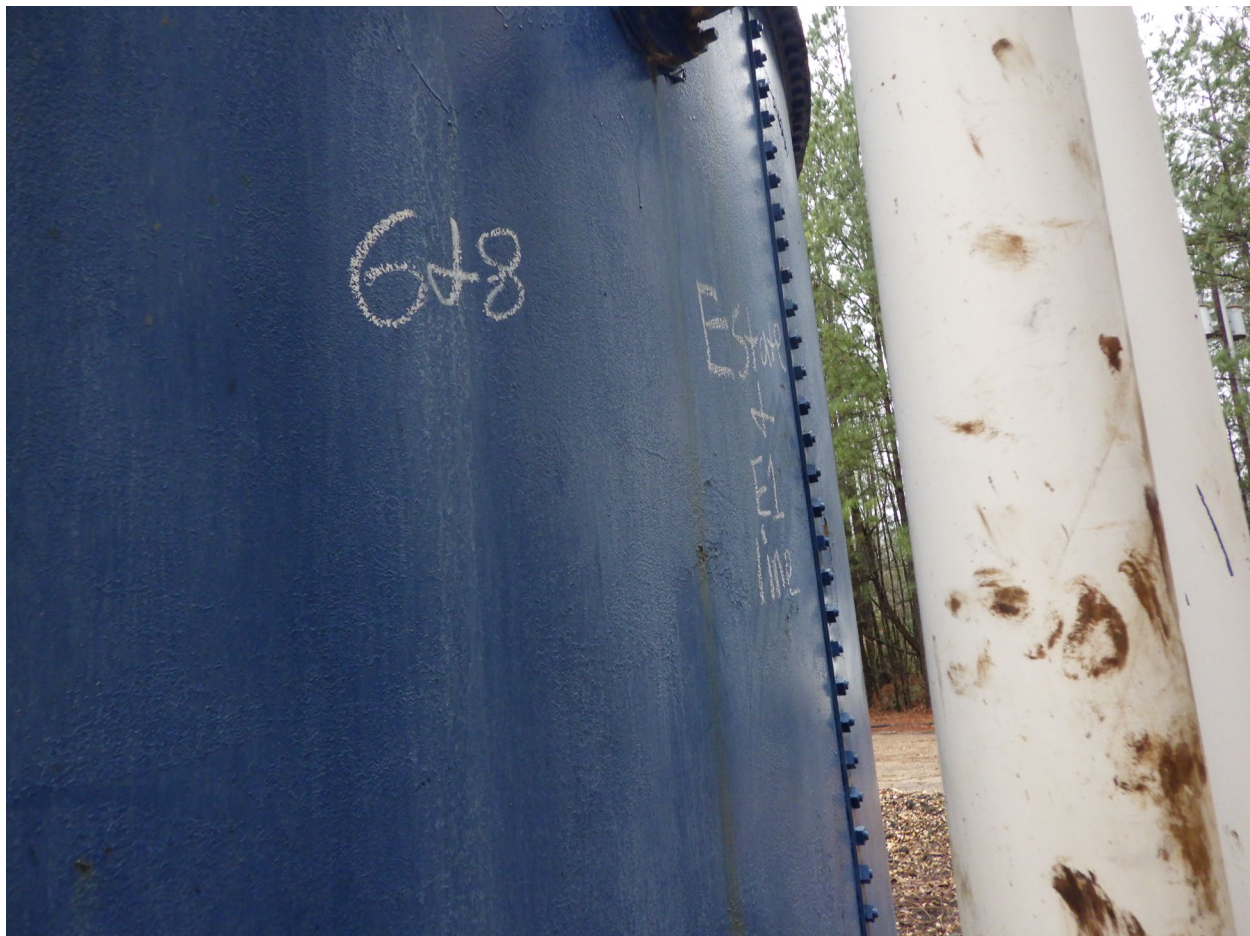
Photo No. 1

**Description:** Looking SSW, this photo shows basic identification on the saltwater storage tank.

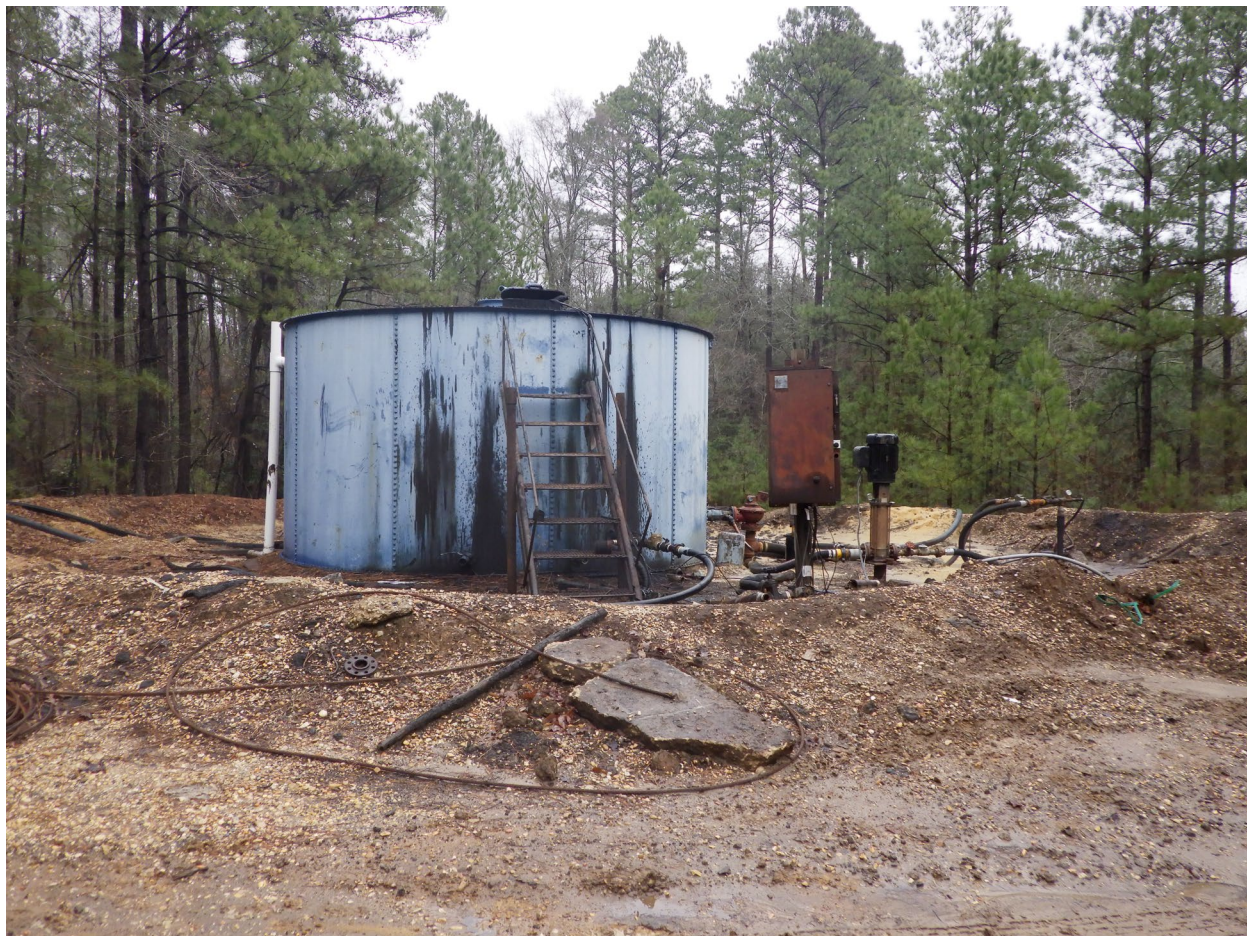
Photo No. 2

**Description:** Looking ENE, this photo shows an overview of the facility.

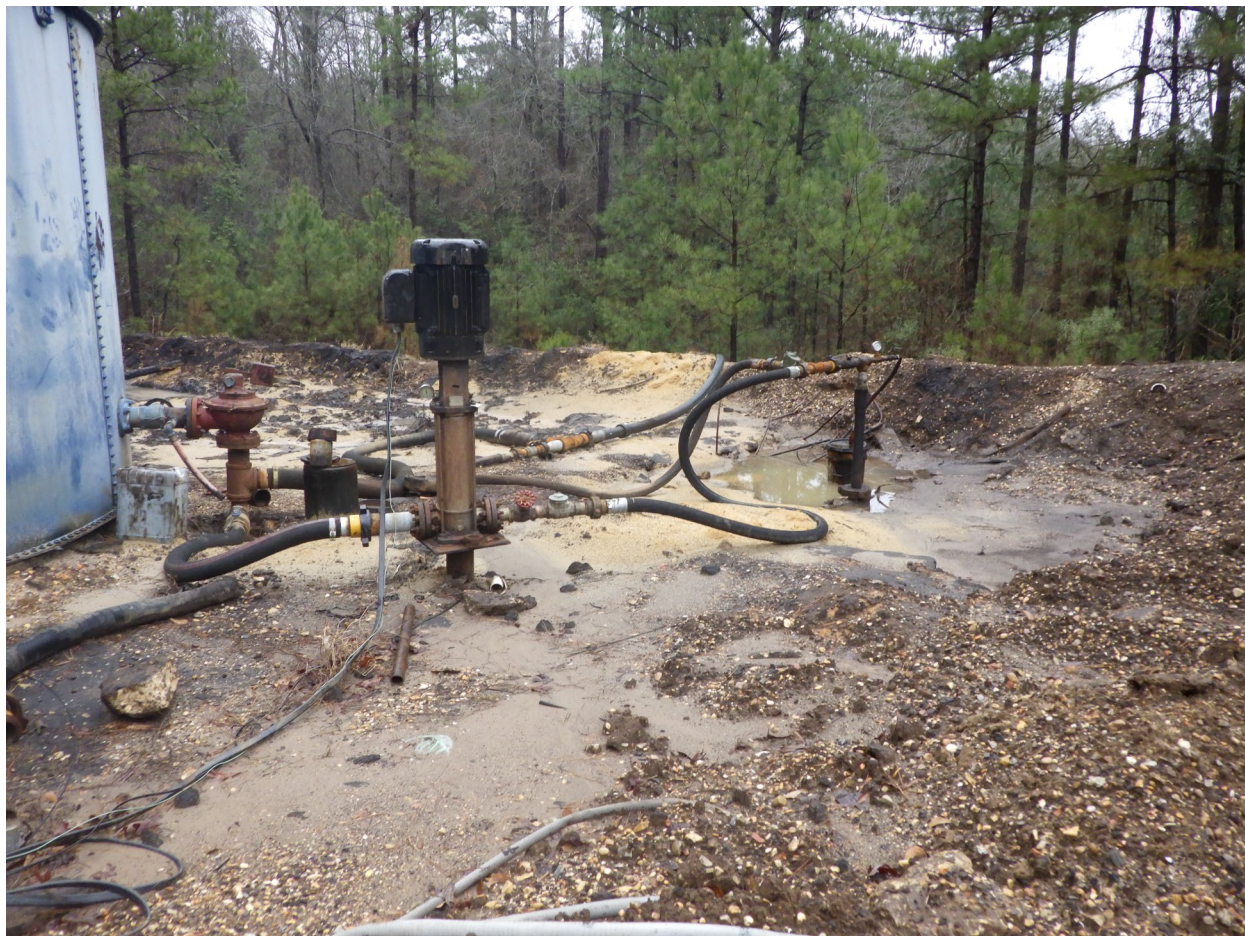
Photo No. 3

**Description:** Looking NE, this photo shows the Class II saltwater disposal (SWD) injection well and pump.

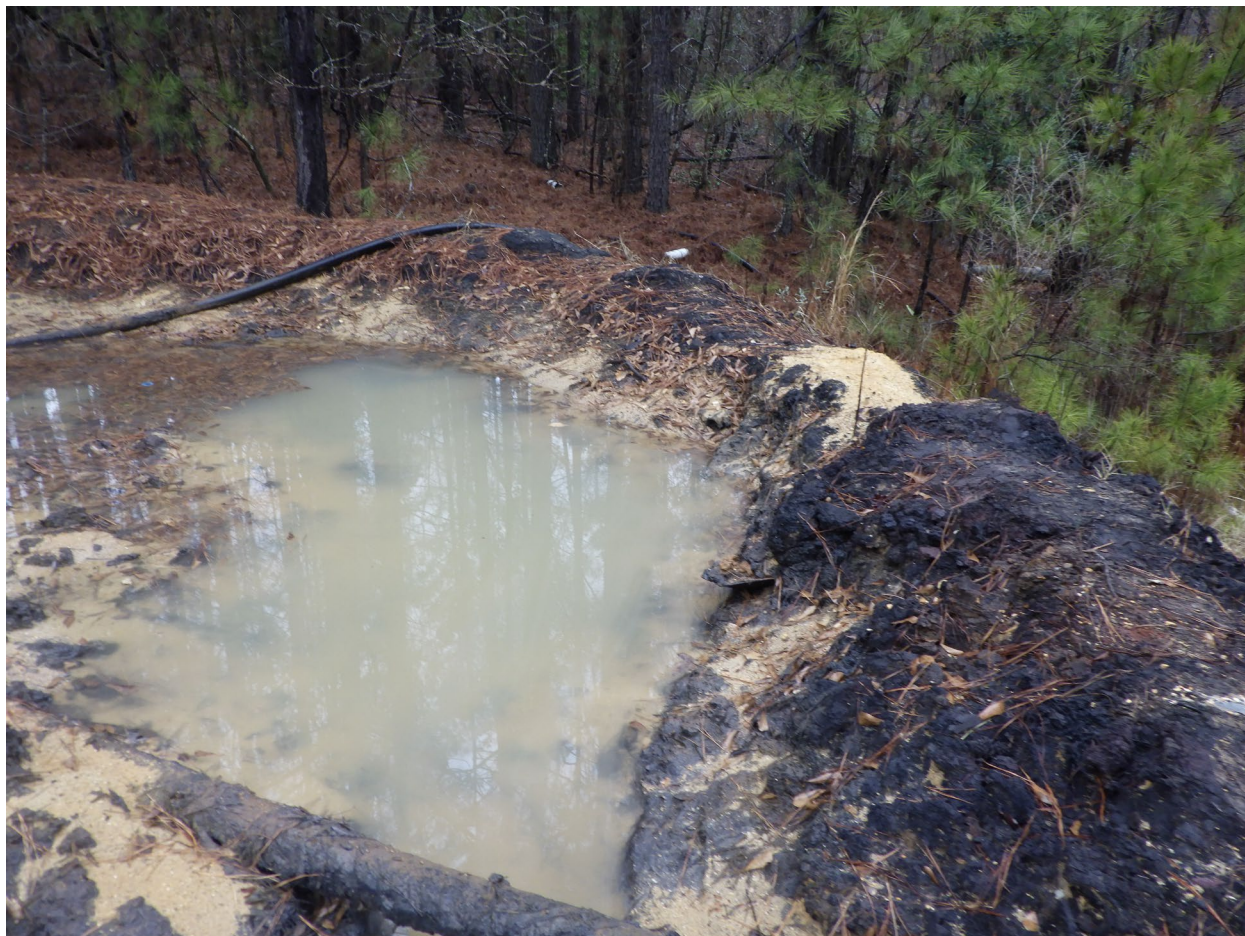
Photo No. 4

I observed the sump area of the secondary containment, see Photos No. 4 and No. 5.

**Description:** Looking NNE, this photo shows the sump area of the secondary containment with tank bottom applied to the berm.

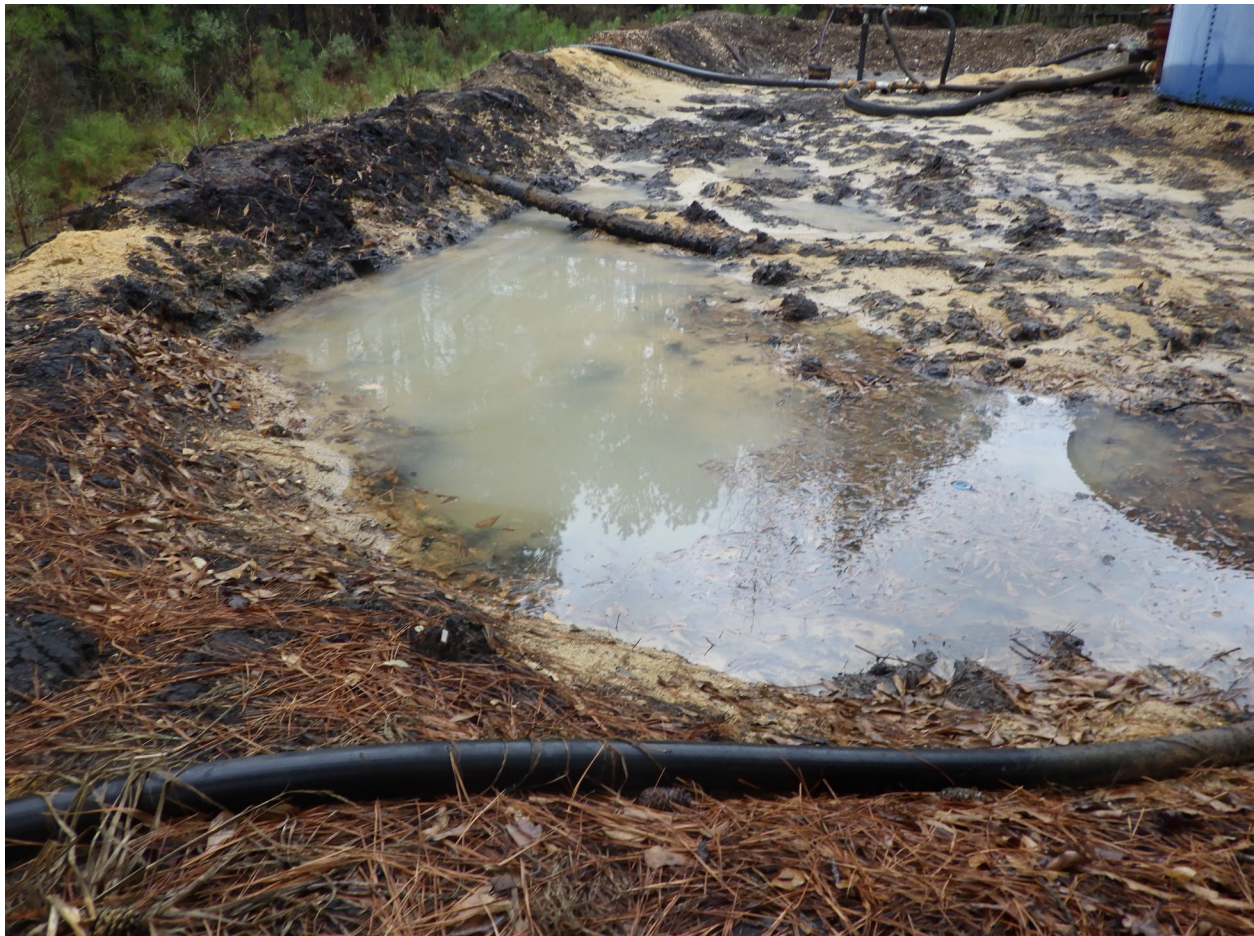
Photo No. 5

**Description:** Looking ESE, this photo shows an additional view of the sump area of the secondary containment.

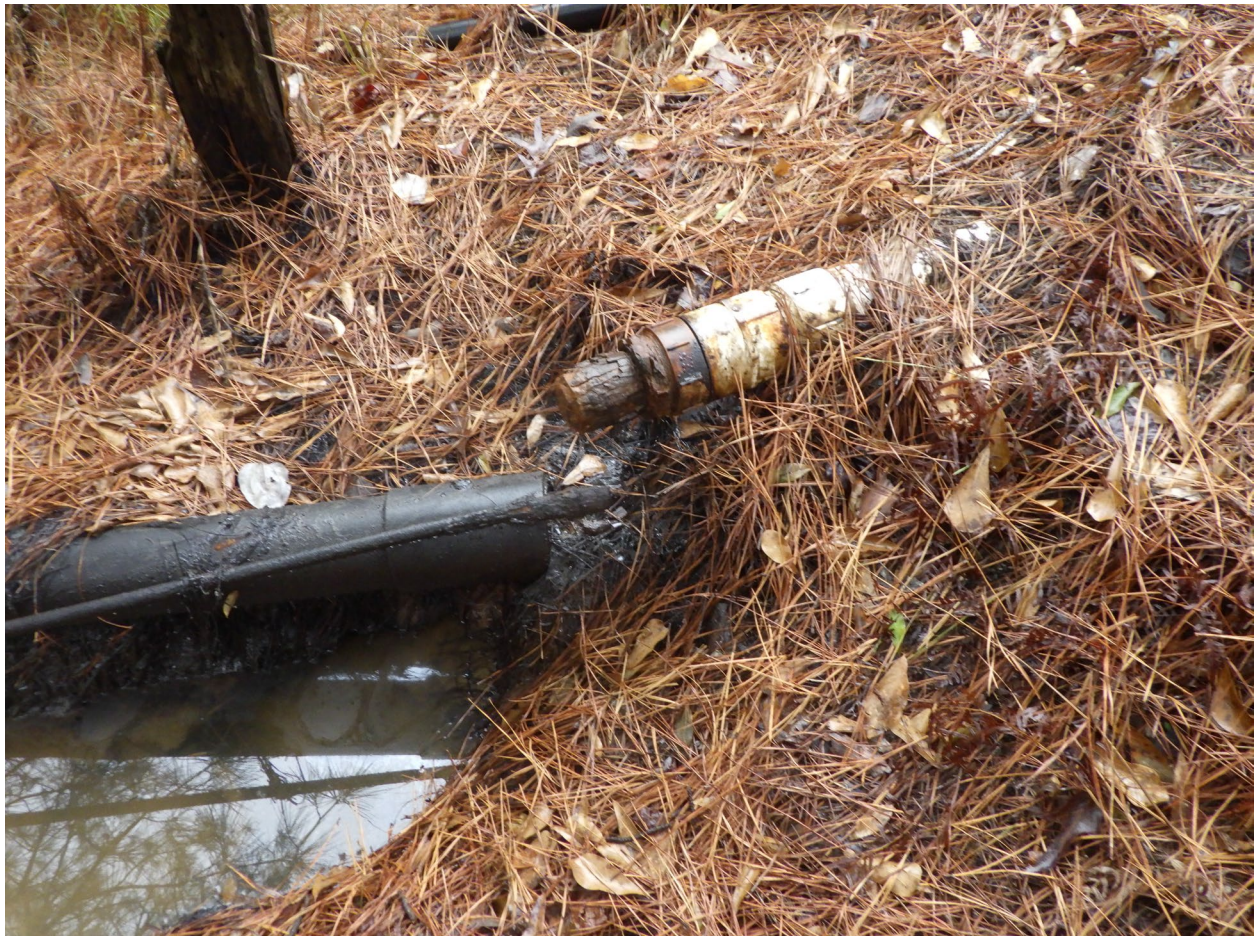
Photo No. 6

I observed the drainpipe and cap for the secondary containment, see Photos No. 6 and No. 7.

**Description:** Looking ENE, this photo shows the drainpipe for the secondary containment with a pool of water below the pipe. A sheen and rusty color were noted in the pool.

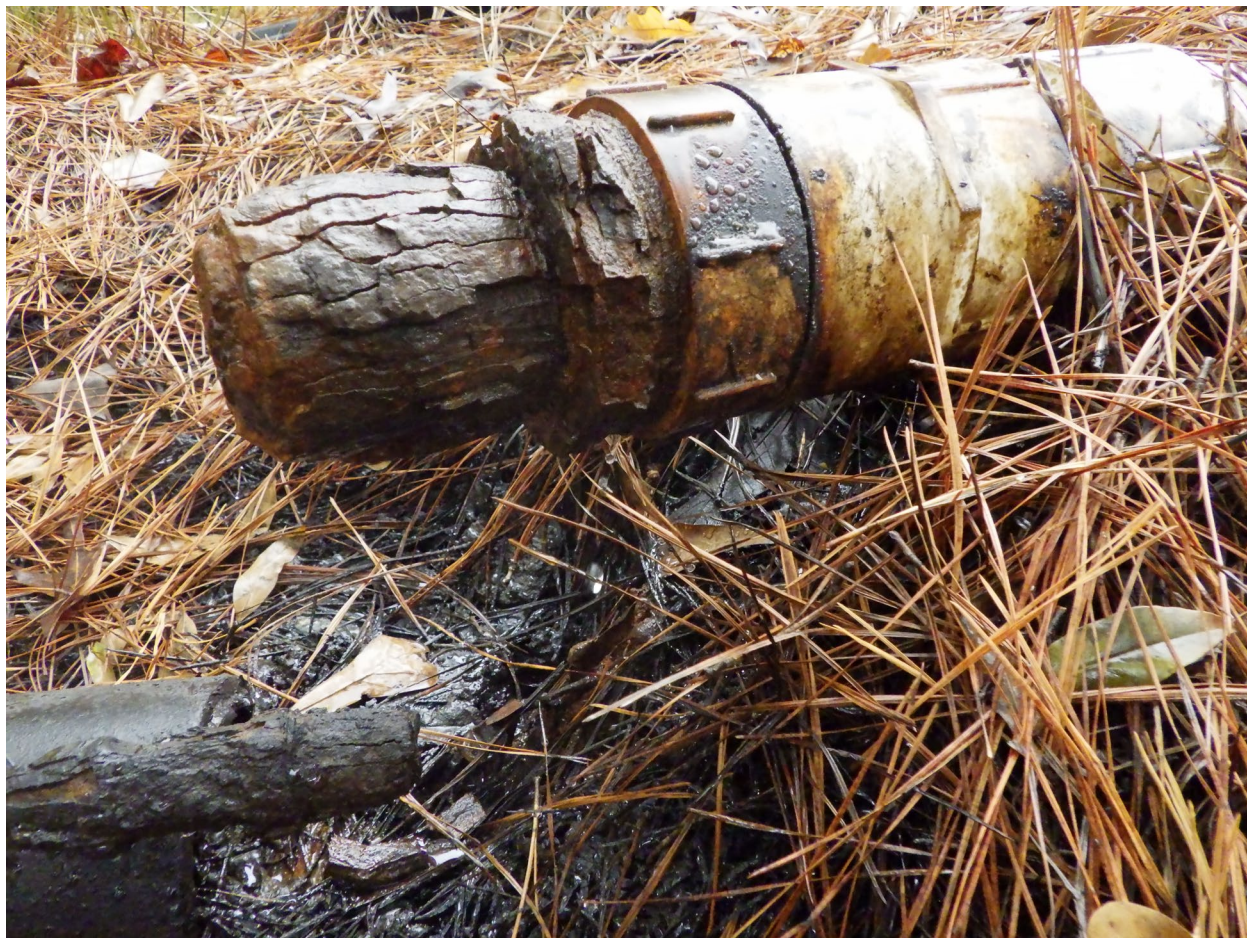
Photo No. 7

- No updated signage at the facility,
- Active leak from the drainpipe due to broken/worn cap,
- Residual or historic loose crude oil along discharge flowpath, and
- Elevated TDS readings along the discharge flowpath into an ephemeral conveyance and wetlands.

**Description:** Looking E, this photo shows a closeup of the worn drainpipe cap that was actively leaking during the inspection.

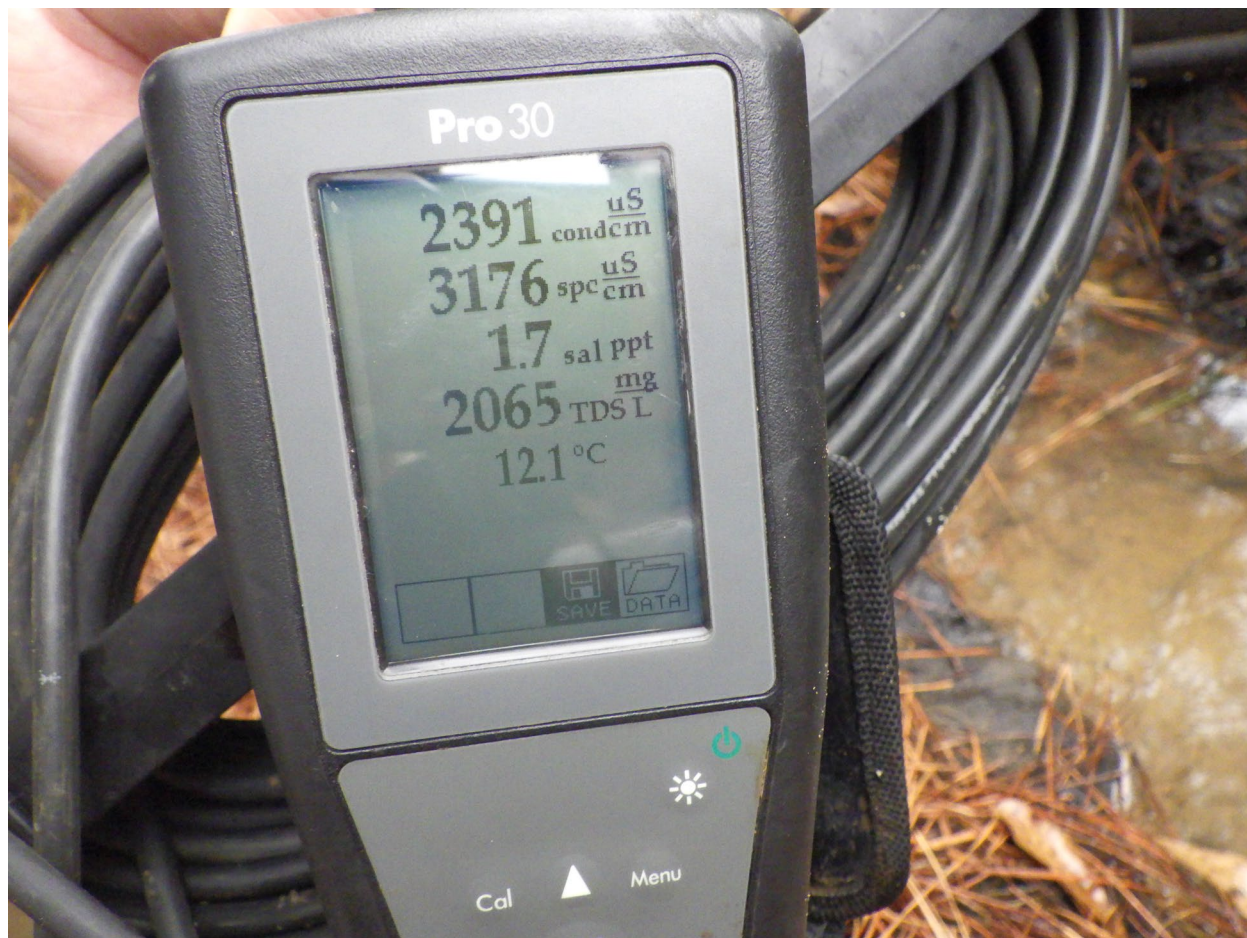
Photo No. 8

I observed an elevated total dissolved solid (TDS) reading of **2,065 mg/L** (initial) in a pool of water downstream of the secondary containment drainpipe, see Photo No. 8.

Description: Looking N, this photo shows an elevated Total Dissolved Solid (TDS) reading of 2,065 mg/L (initial) in a pool of water downstream of the drainpipe.

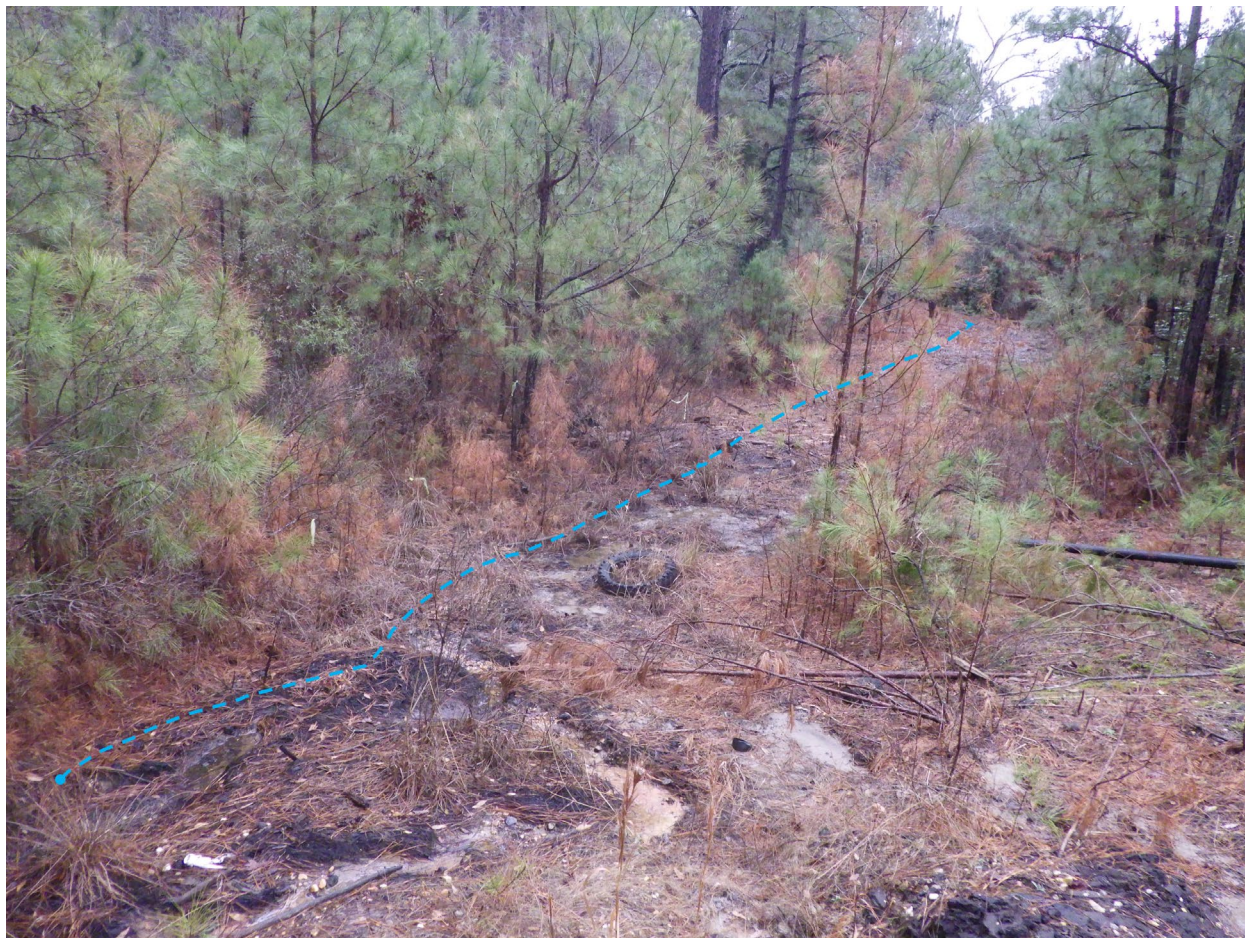
Photo No. 9

I observed dead vegetation downstream of the TDS reading from Photo No. 8, see Photos No. 9 and No. 10.

**Description:** Looking ENE, this photo shows the flowpath for the drainpipe and downstream of the TDS reading referenced in No. 8. Directional arrows added for clarity.

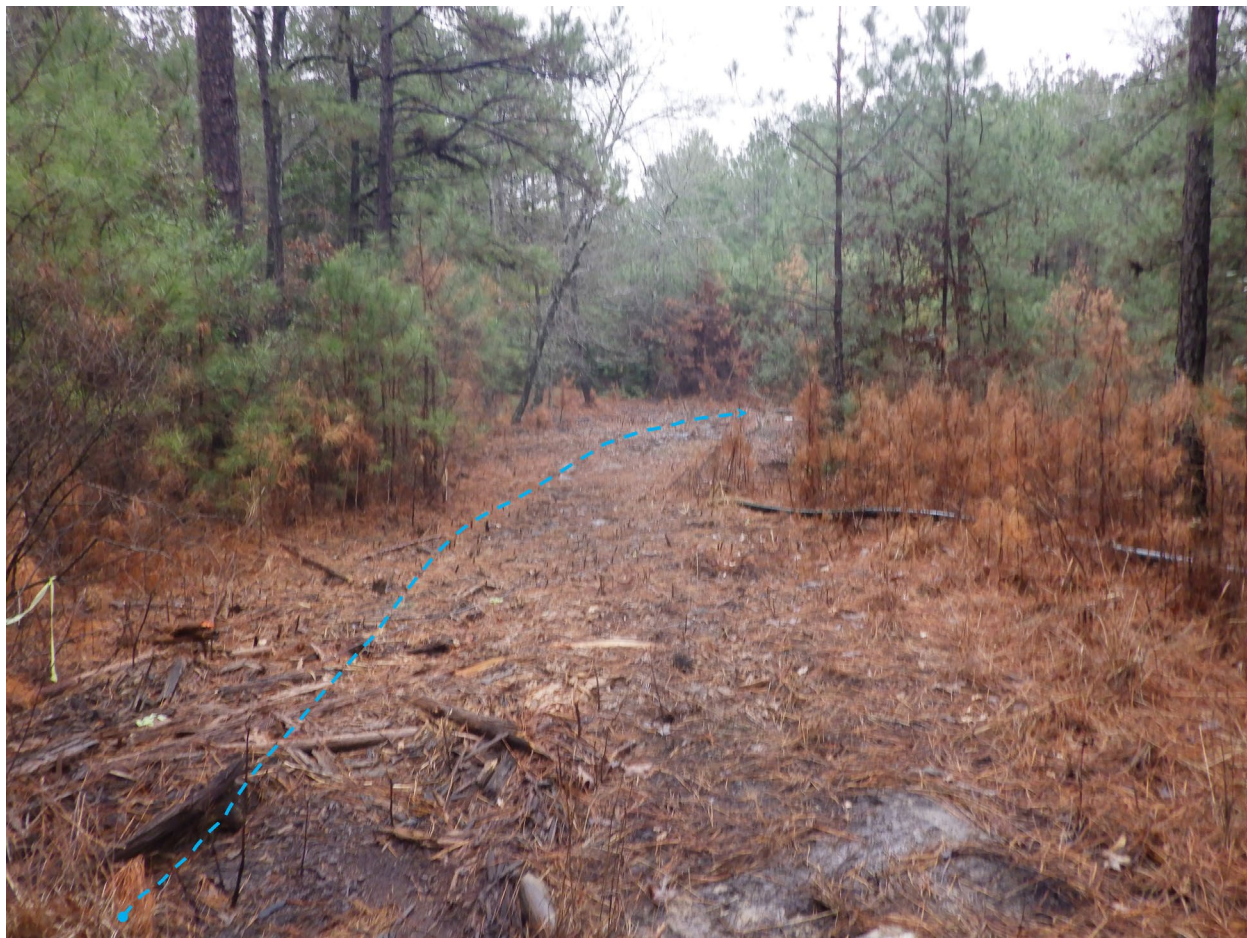
Photo No. 10

**Description:** Looking E, this photo shows an additional view of the flowpath from the drainpipe. Dead vegetation was noted along the flowpath. Directional arrows added for clarity.

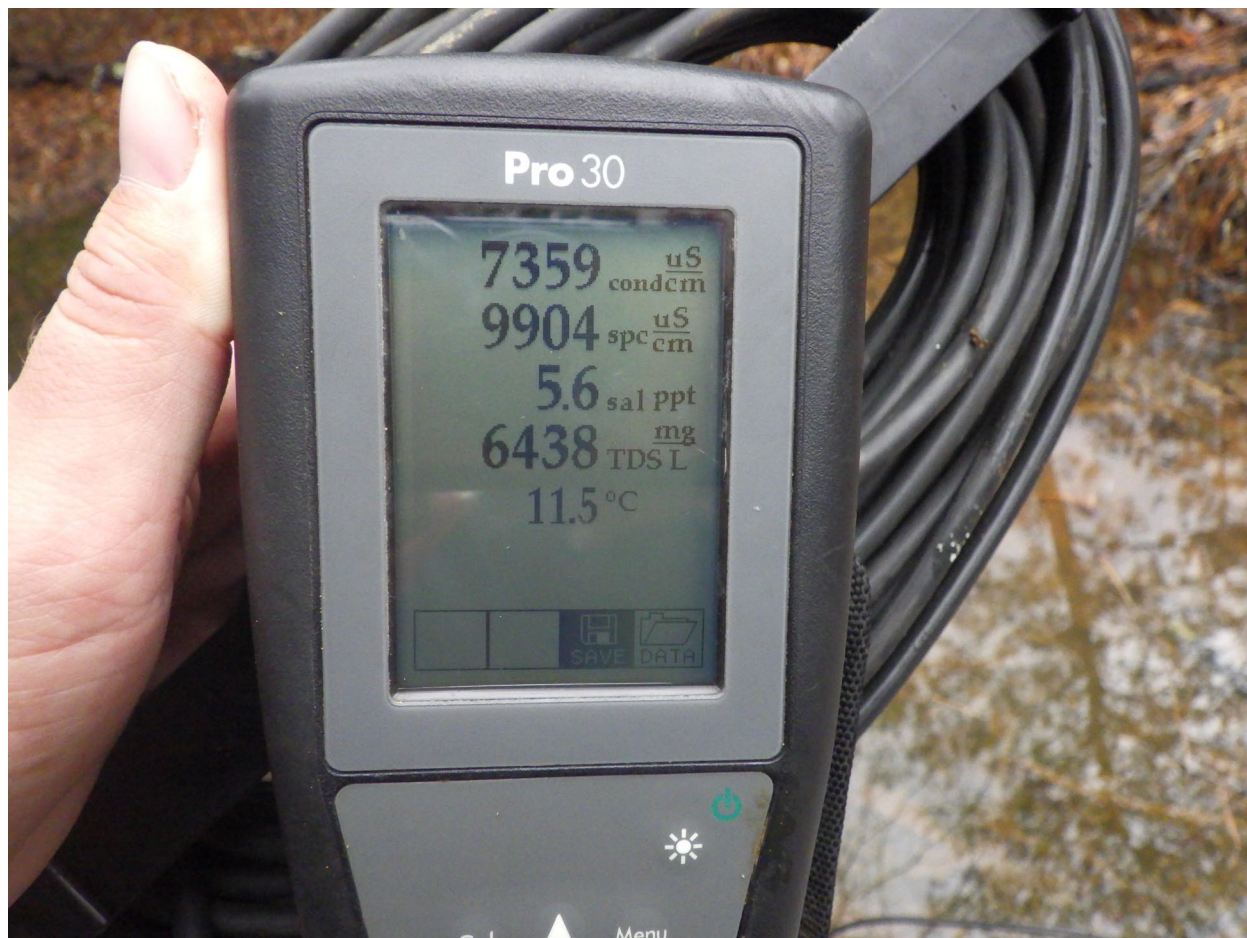
Photo No. 11

I observed an elevated TDS reading of **6,438 mg/L** at the point of entry (POE) into a wetland, see Photo No. 11.

**Description:** Looking NNE, this photo shows an elevated TDS reading of 6,438 mg/L at the point of entry (POE) into a wetland.

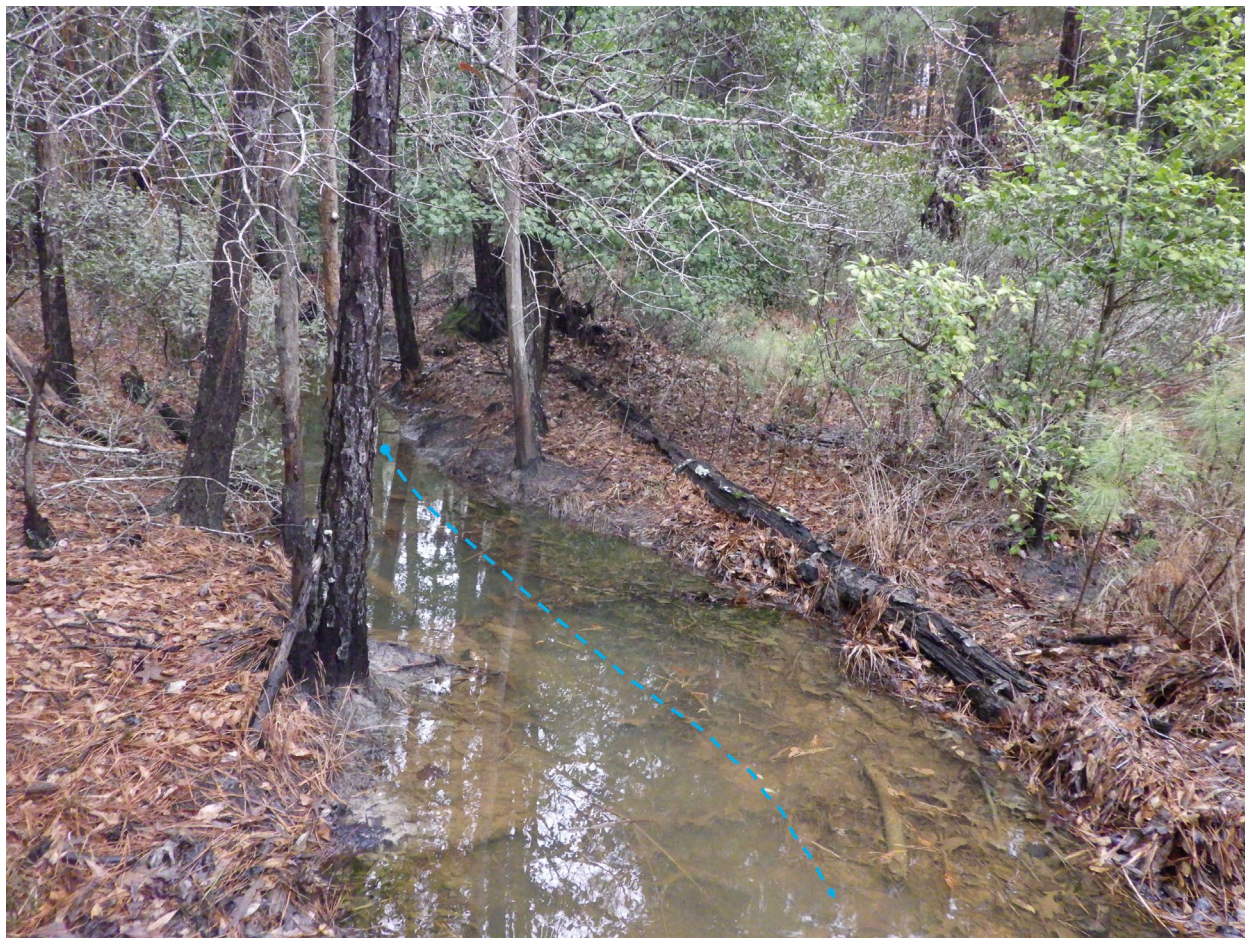
Photo No. 12

**Description:** Looking NE, this photo shows the upstream characteristics of the ephemeral conveyance from Photo No. 11. Directional arrows added for clarity.

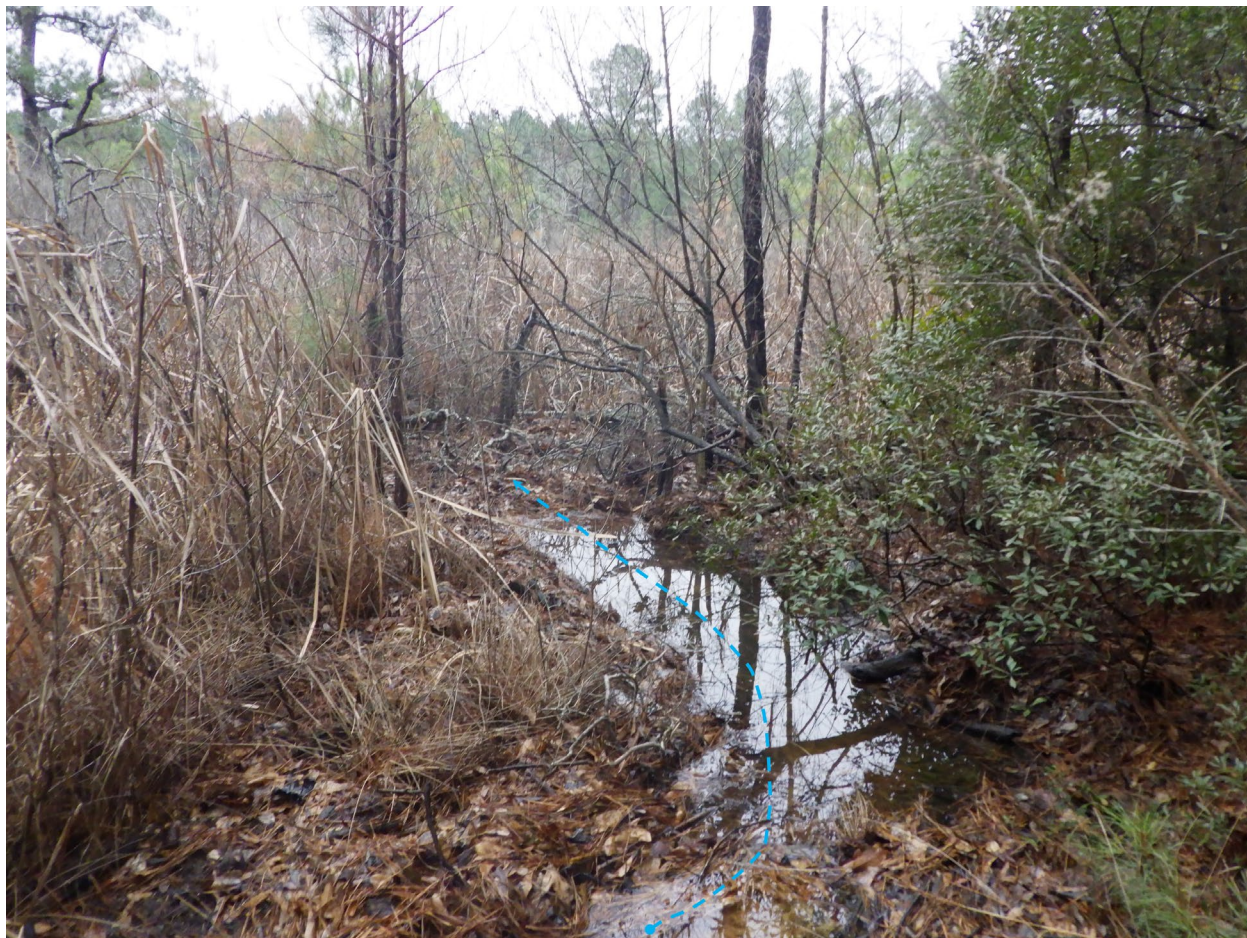
Photo No. 13

**Description:** Looking SE, this photo shows the downstream characteristics of the ephemeral conveyance from Photo No. 11. Directional arrows added for clarity.

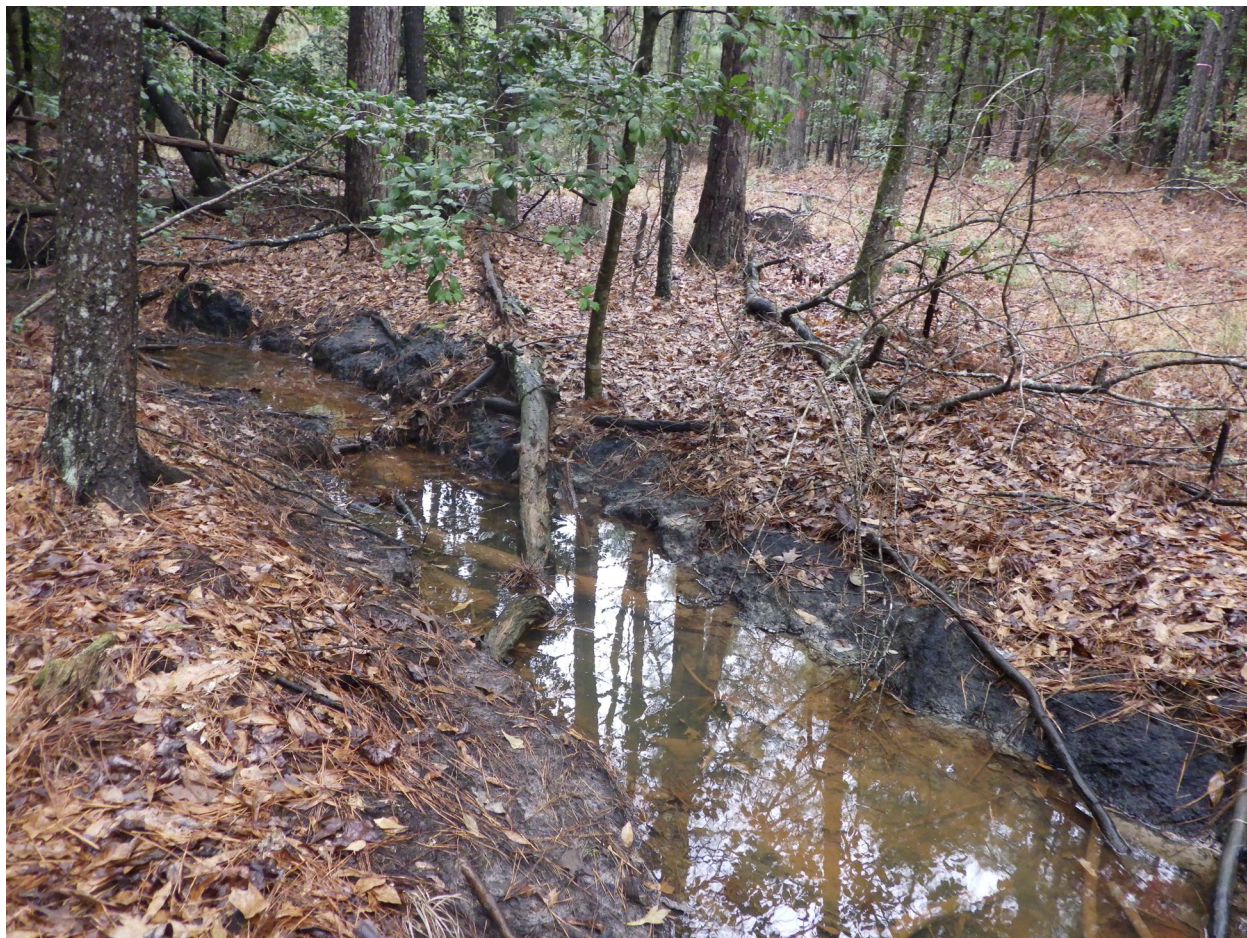
Photo No. 14

I observed residual or historic loose crude oil along the banks of the ephemeral conveyance leading to the wetland, see Photo No. 14.

**Description:** Looking NE, this photo shows residual or historic loose crude oil along the banks of the ephemeral conveyance.

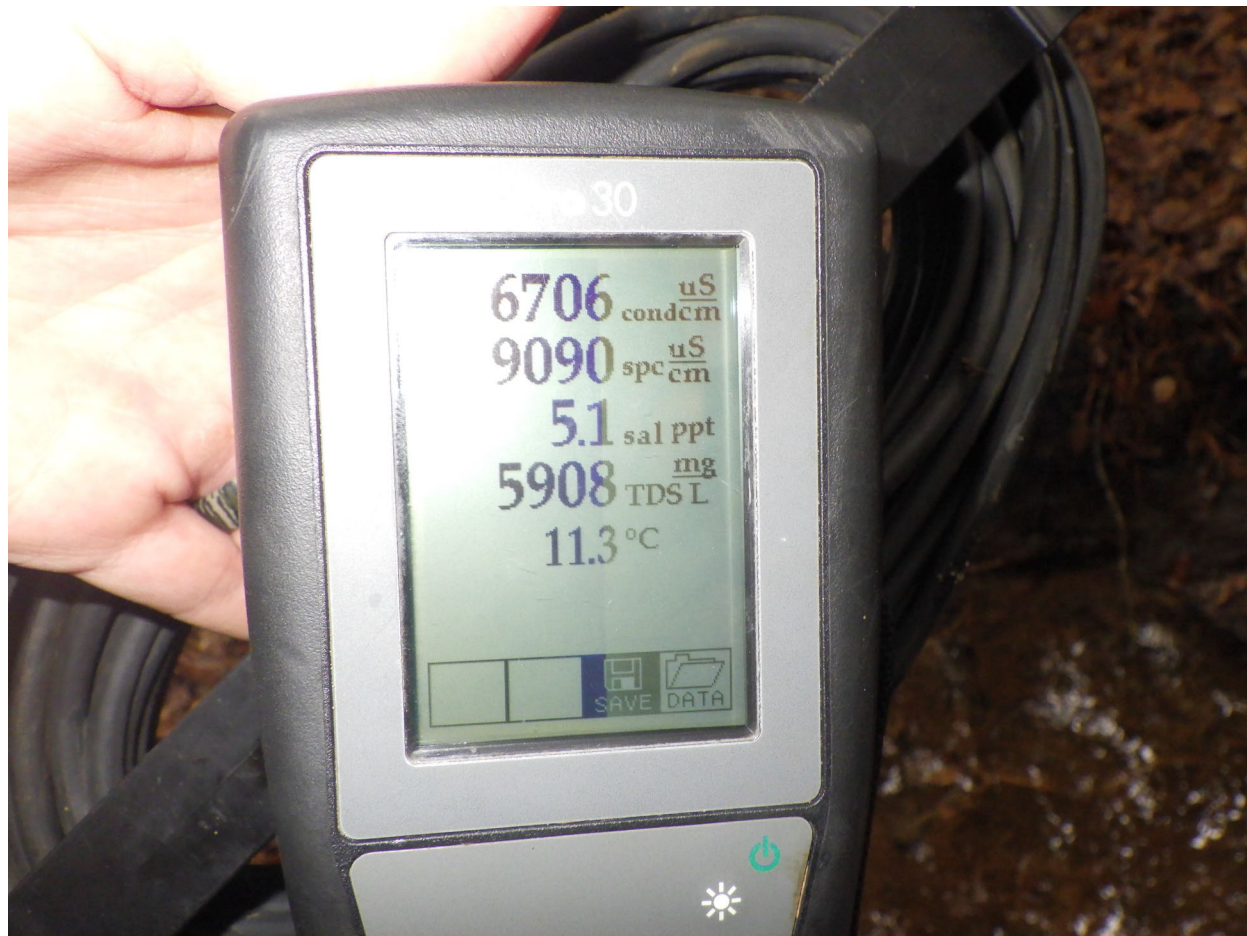
Photo No. 15

I observed an elevated TDS reading of **5,908 mg/L** (mid-stream) in the ephemeral conveyance upstream of the wetland, see Photo No. 15.

**Description:** Looking NE, this photo shows an elevated TDS reading of 5,908 mg/L (mid-stream) for the ephemeral conveyance.

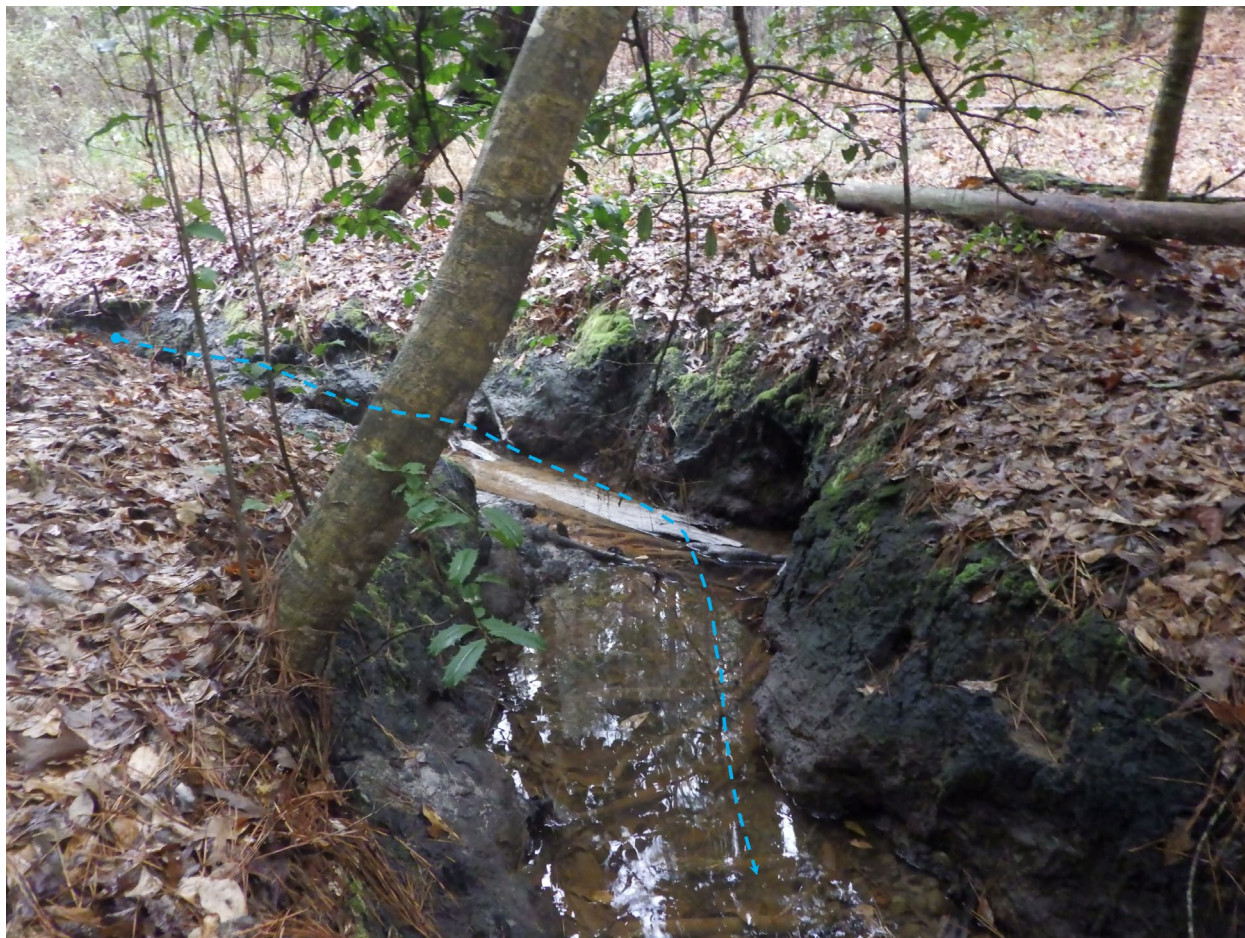
Photo No. 16

**Description:** Looking ENE, this photo shows the upstream characteristics of the ephemeral conveyance from Photo No. 15. Directional arrows added for clarity.

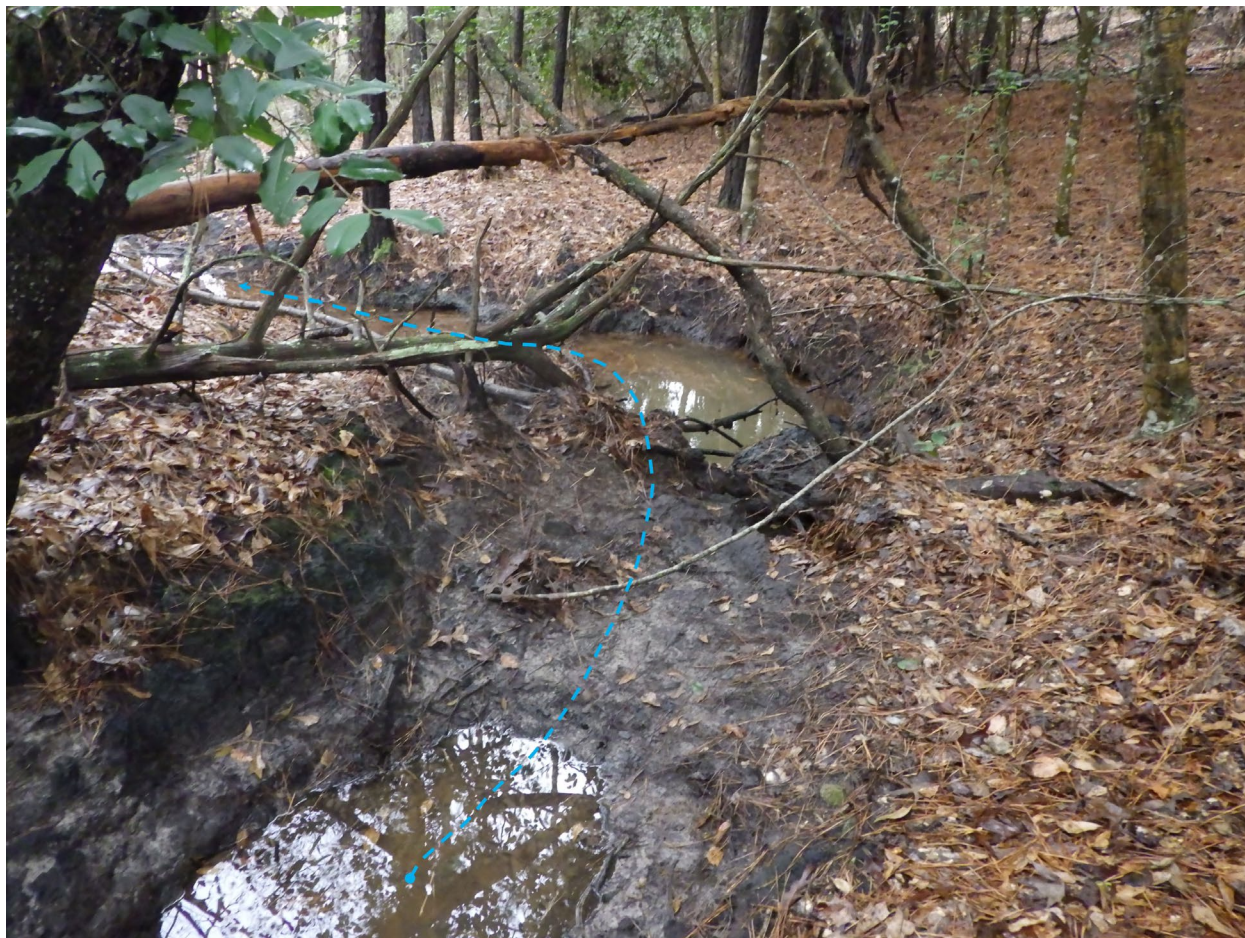
Photo No. 17

**Description:** Looking SSE, this photo shows the downstream characteristics of the ephemeral conveyance from Photo No. 15. Directional arrows added for clarity.

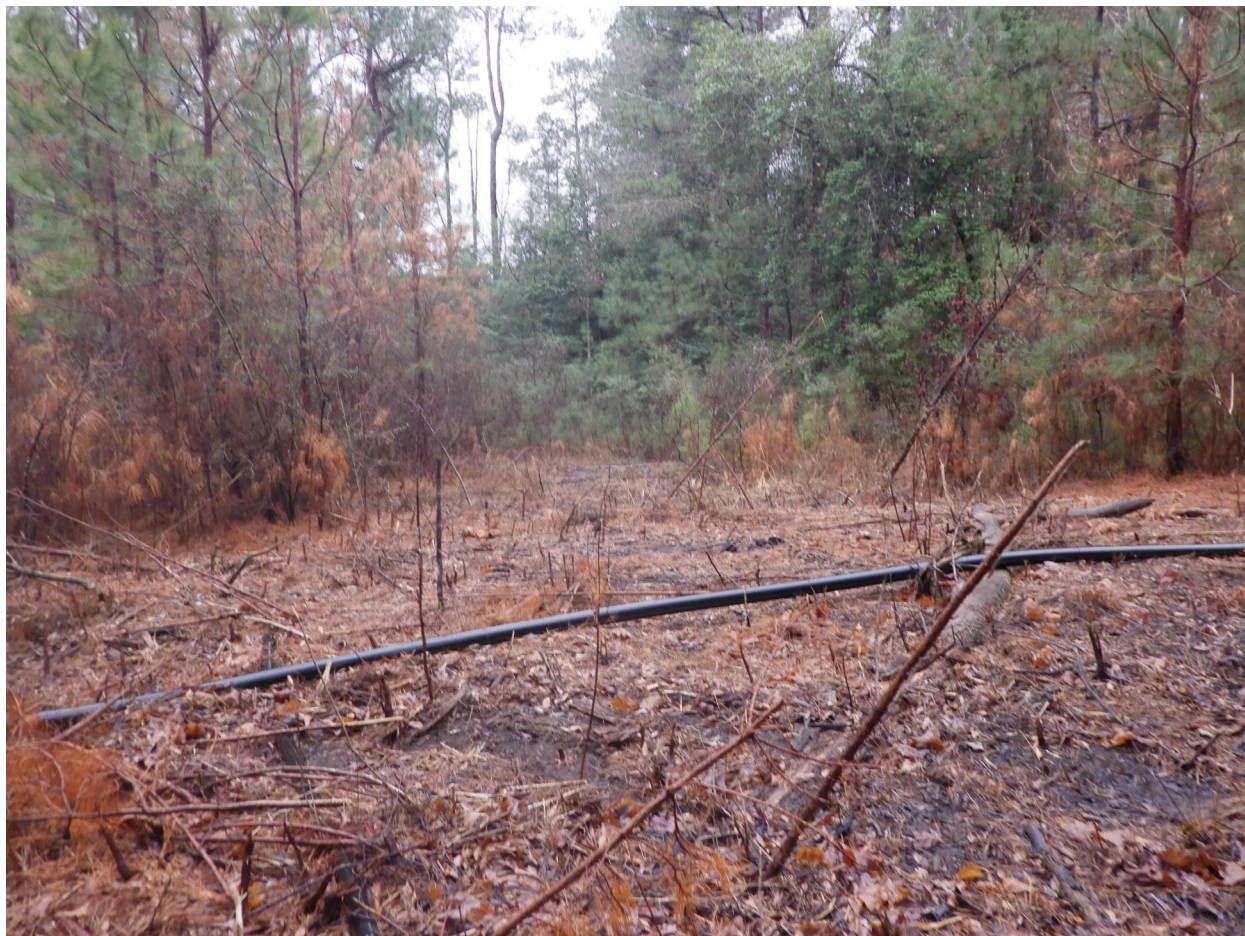
Photo No. 18

I observed a new flowline along the discharge flowline with dead vegetation within the area, see Photos No. 18 through No. 20.

**Description:** Looking SSE, this photo shows a large area of dead vegetation with a new flowline within the area.
