## Region 6 - Enforcement & Compliance Assurance Division

### INSPECTION REPORT

| Company Name: | <b>SMI Operating Company, LLC</b> | |
| Facility Name: | <b>Gregory, JD (B-5) SWD Tank Battery</b> | |

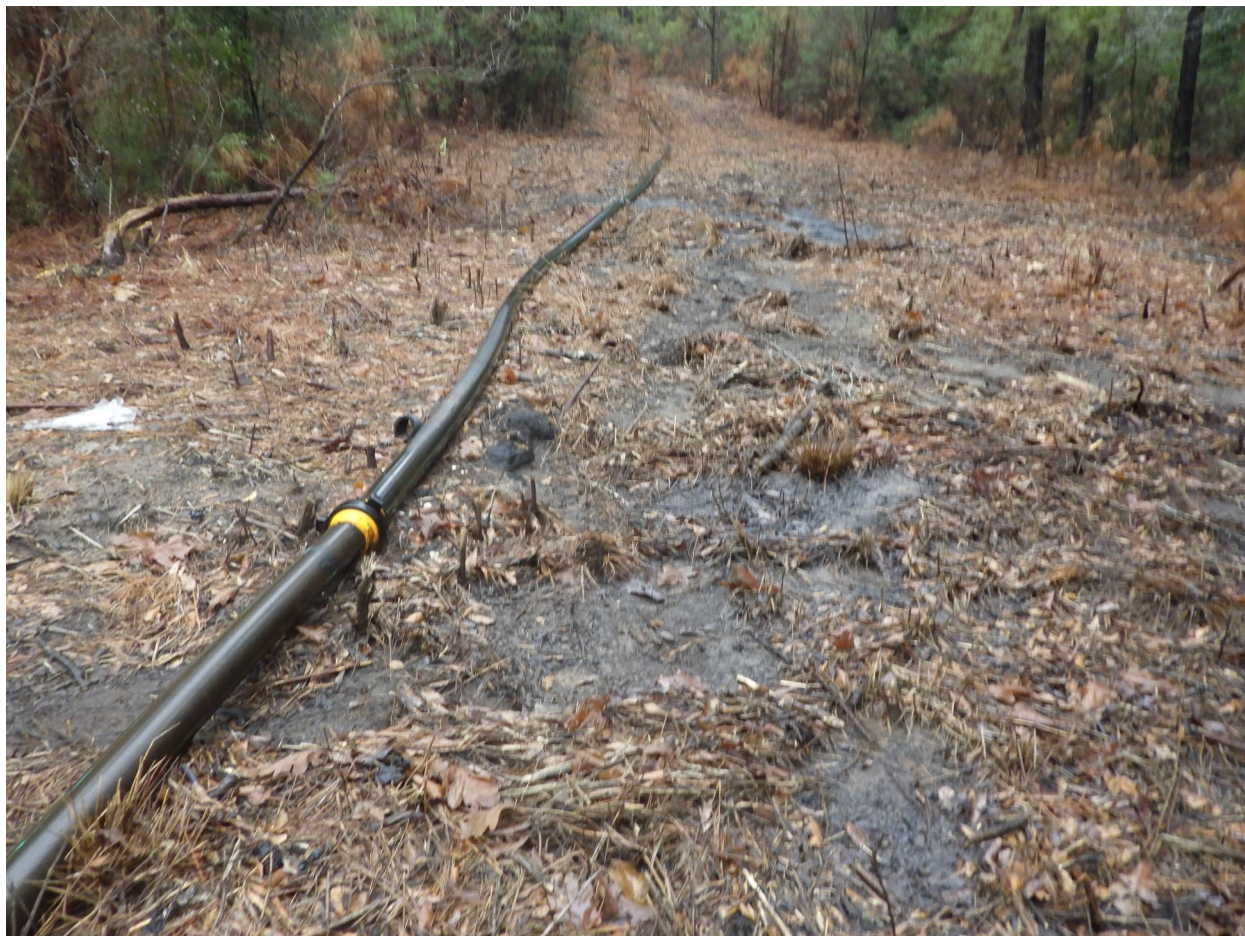
Photo No. 19

**Description:** Looking NNW, this photo shows an additional view of the flowline in Photo No. 18.

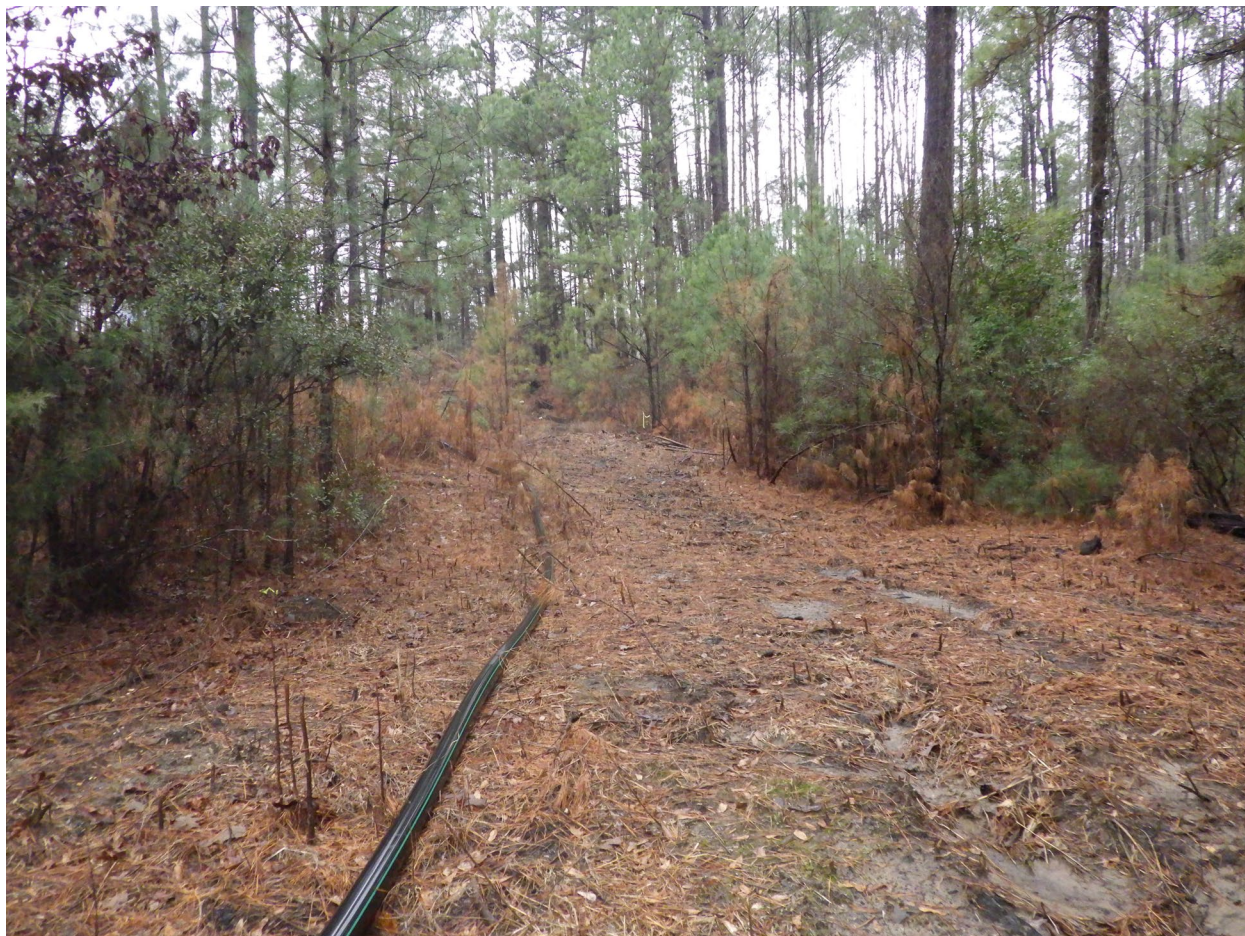
Photo No. 20

**Description:** Looking WNW, this photo shows an additional view of the flowline in Photo No. 18.

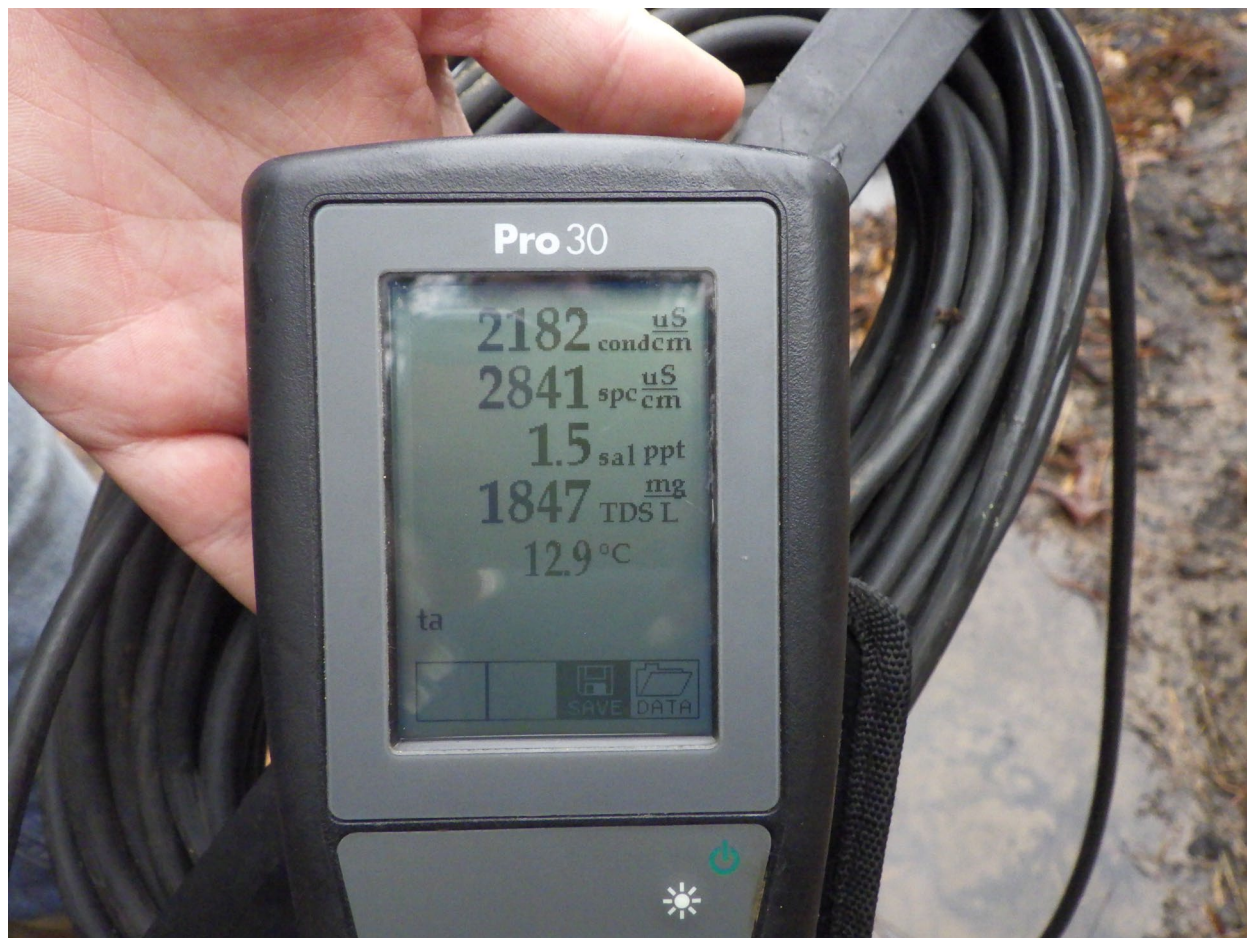
Photo No. 21

I observed an elevated TDS reading of **1,847 mg/L** (upstream) in a pool of water in the flowpath of the flowline, see Photo No. 21.

Description: Looking ENE, this photo shows an elevated TDS reading of 1,847 mg/L from a pool of water located within the flowpath.

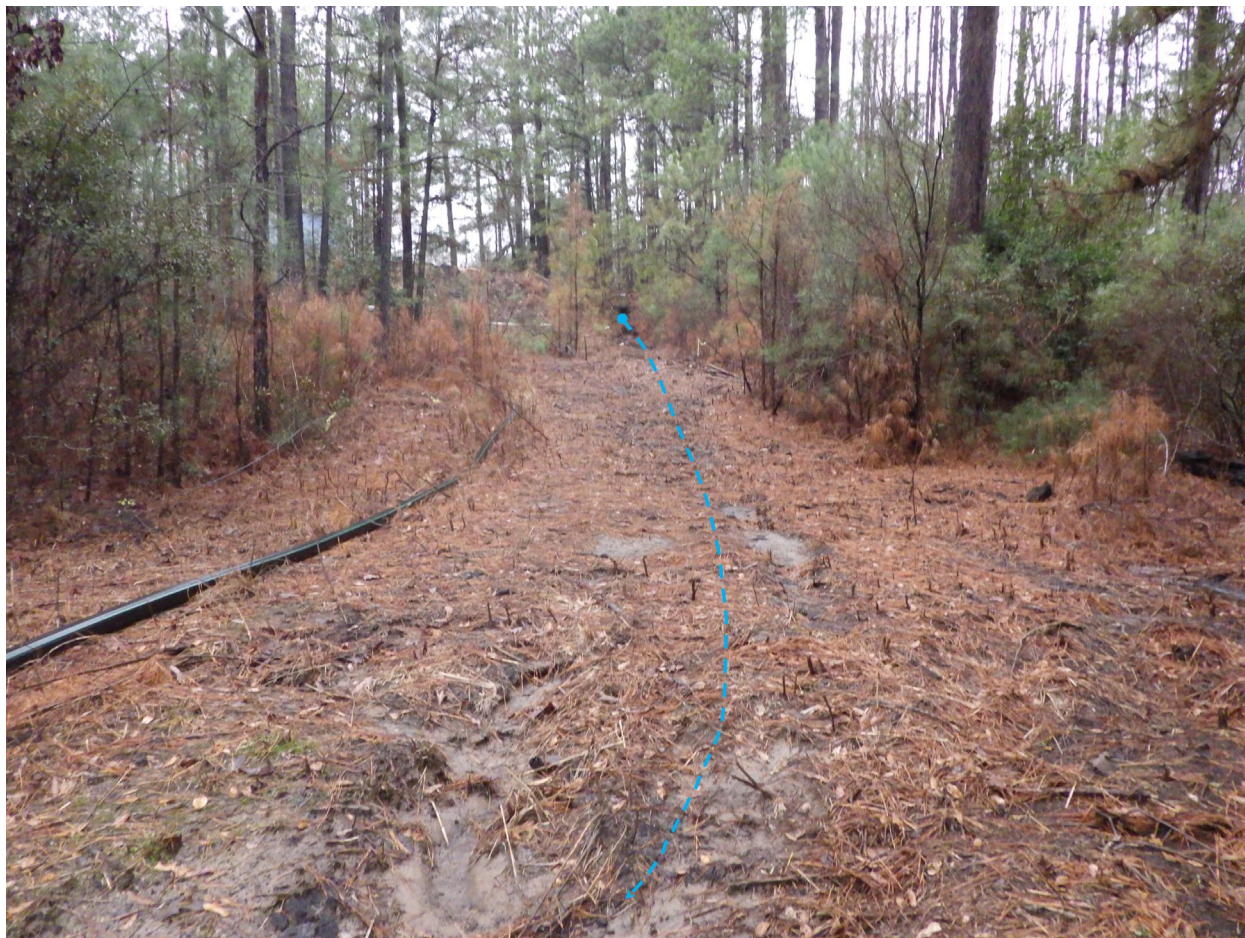
Photo No. 22

**Description:** Looking WNW, this photo shows the upstream characteristics of the flowpath from Photo No. 21. Directional arrows added for clarity.

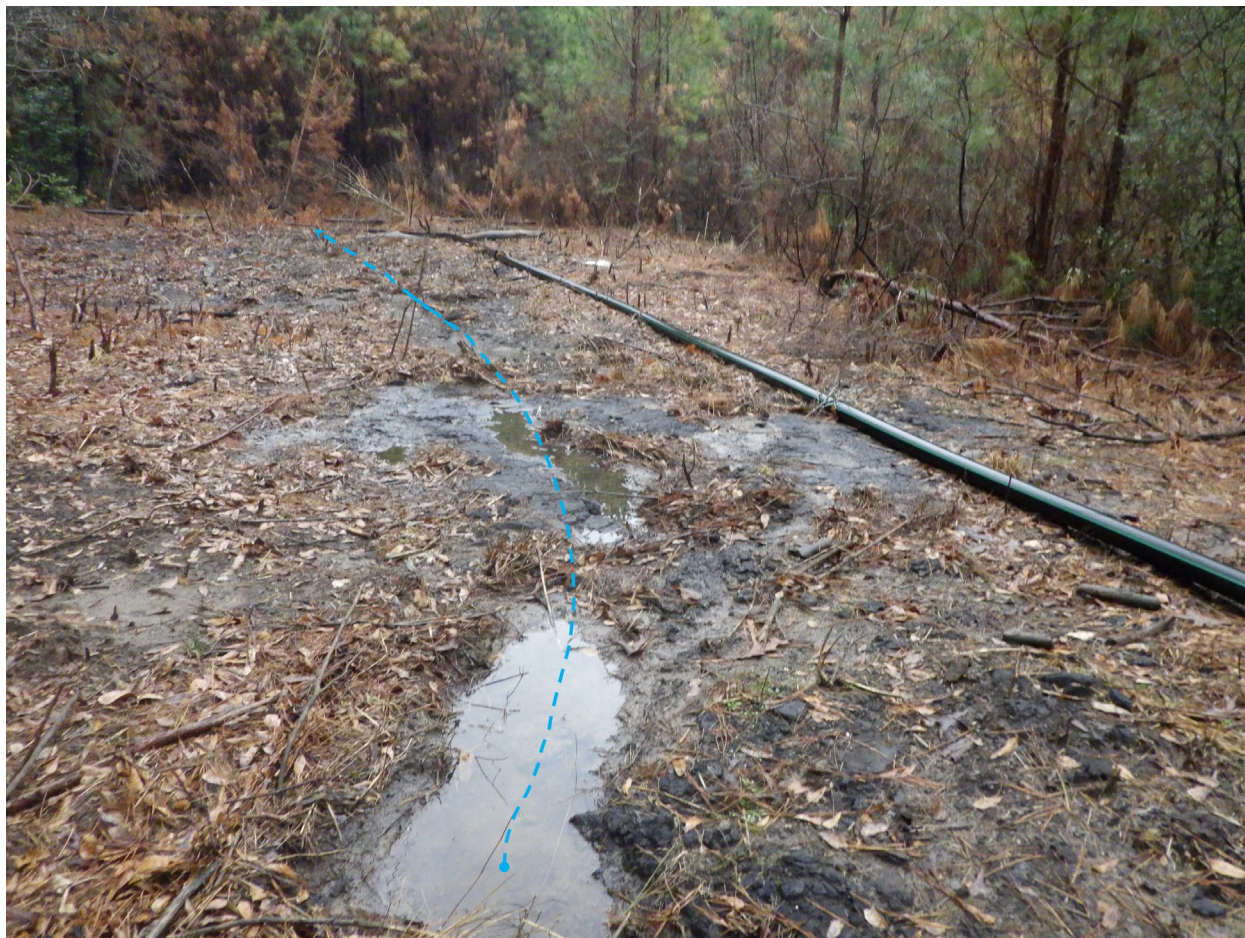
Photo No. 23

**Description:** Looking E, this photo shows the downstream characteristics of the flowpath from Photo No. 21. Directional arrows added for clarity.

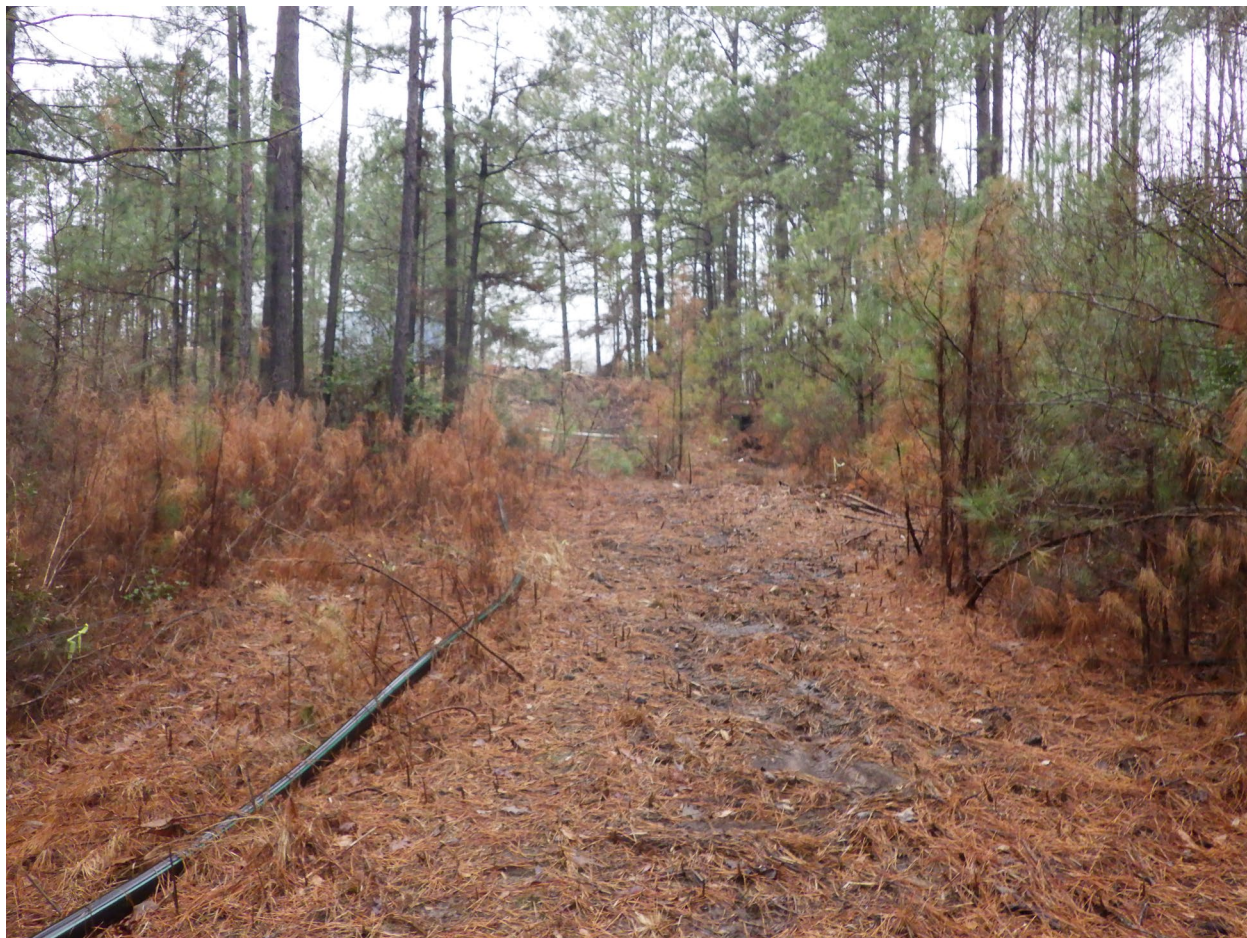
Photo No. 24

I observed dead vegetation along the flowpath leading up to the facility, see Photos No. 24 and 25.

**Description:** Looking W, this photo shows the new flowline and dead vegetation along the flowpath near the facility.

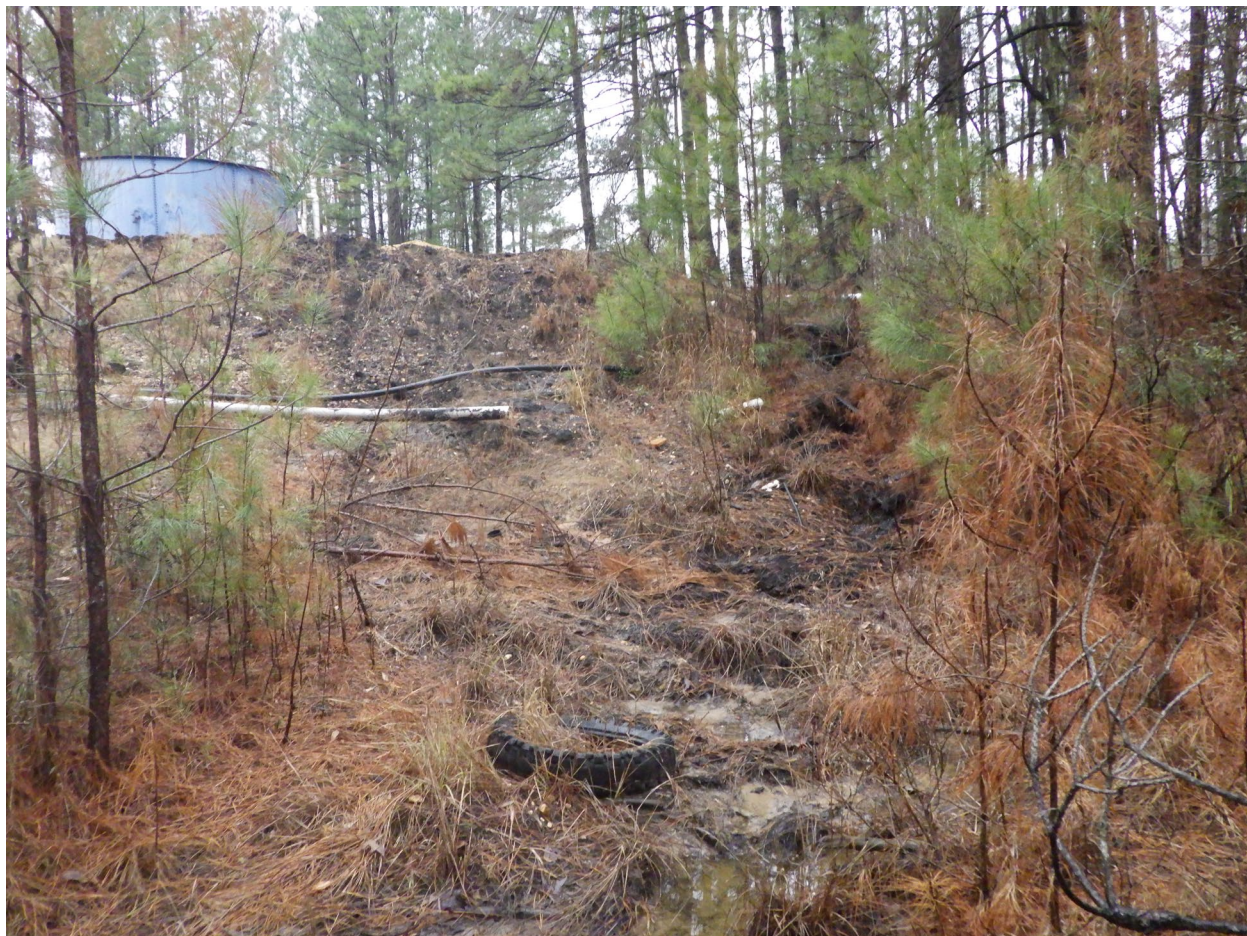
Photo No. 25

**Description:** Looking W, this photo shows the drainpipe and dead vegetation near the facility.

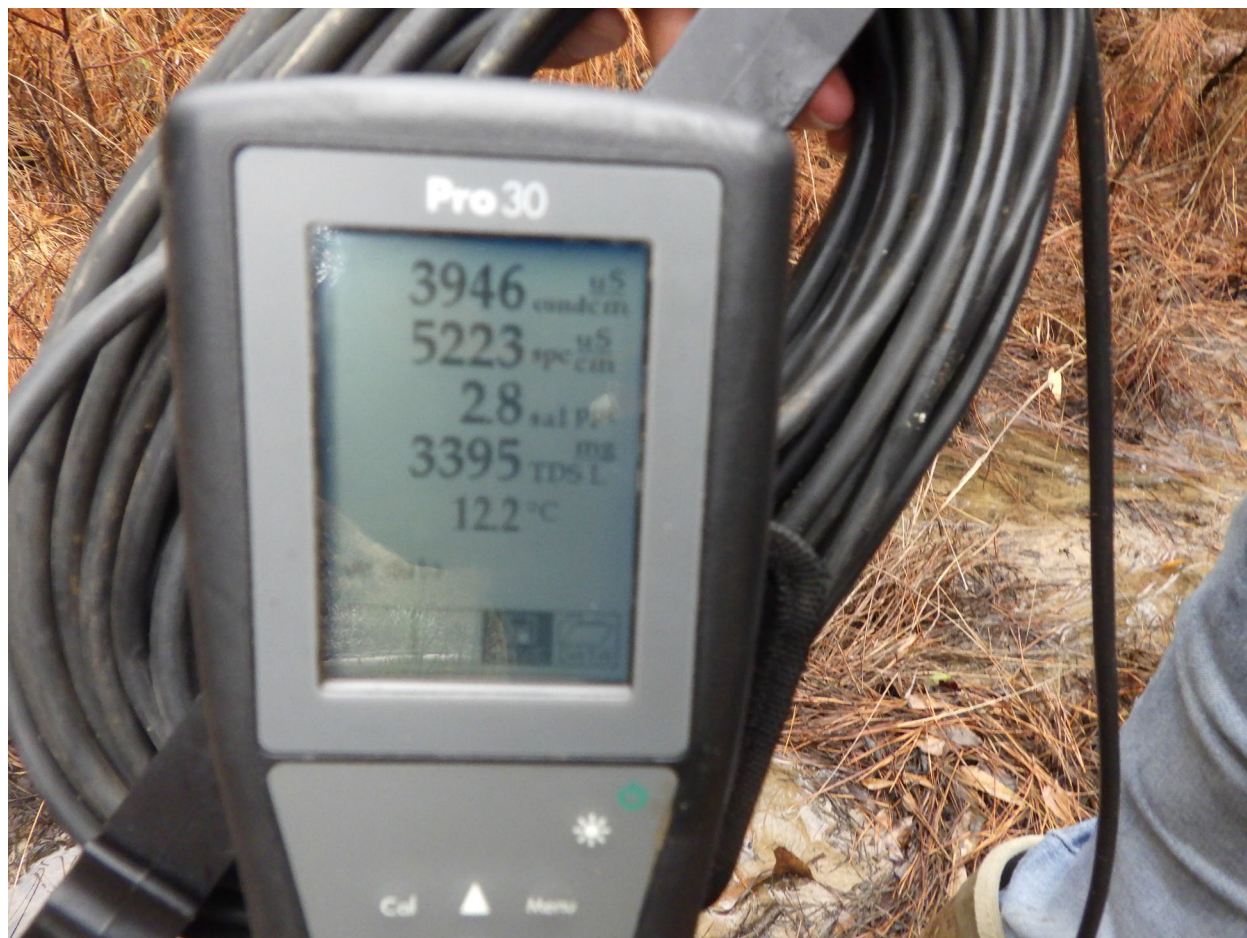
Photo No. 26

I observed an elevated TDS reading of **3,395 mg/L** in a pool of water in the vicinity of the facility, see Photo No. 26.

**Description:** Looking NE, this photo shows an elevated TDS reading of 3,395 mg/L in a pool of water directly downstream of the facility.

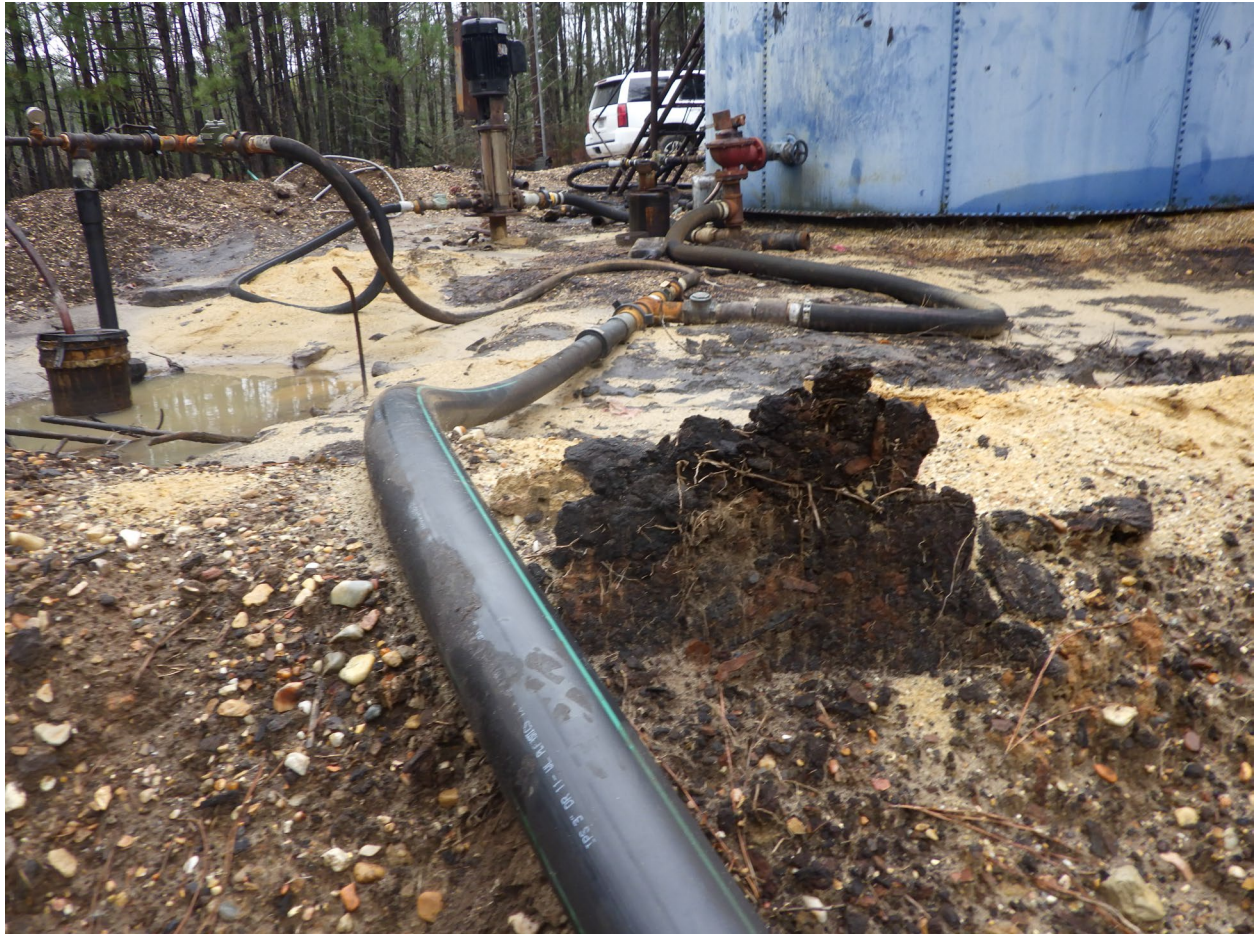
I observed the new flowline connected to the pump for the SWD injection well, see Photo No. 29.
