**Well Inspection**  
**Osage DNR / Environmental Protection Agency**  
**1201 Elm Street, Suite 500**  
**Dallas, Texas 75270**

| <b>Operator Info</b> | CapturePoint, LLC (formerly Perdure Petroleum, LLC)<br>1101 Central Expwy S., Suite 150<br>Allen, TX 75013<br>Phone: 832-300-8221 | <b>Inventory ID</b> | OS0517000 | | |
| | | <b>Well ID</b> | 84-W3 | | |
| <b>Inspection Reason</b> | MIT | <b>Responsible Company at Time of Inspection</b> | CapturePoint, LLC | | |

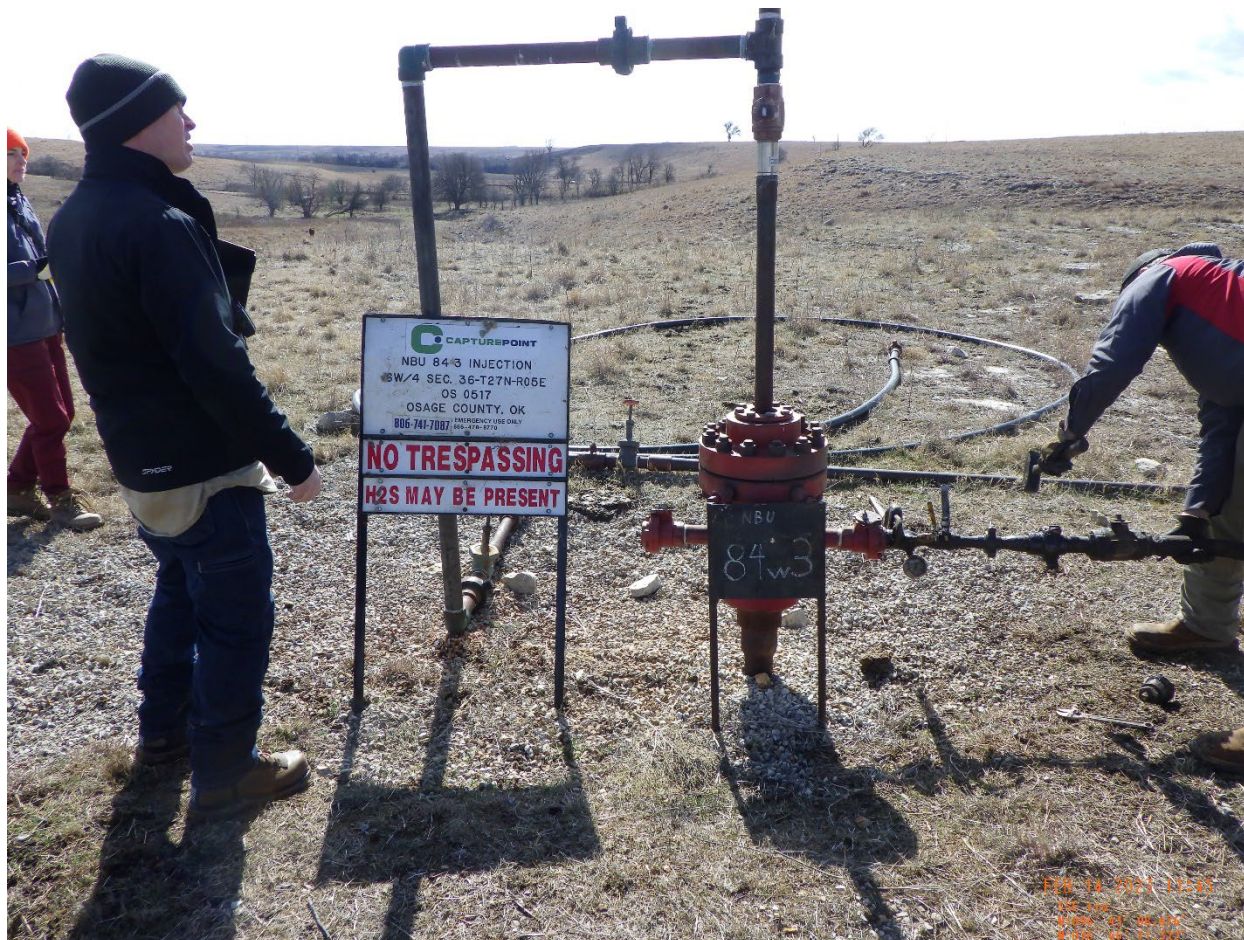
Photo No. 1

**Description:** This was well OS0517000 at the time of the inspection.
