## RCRA Compliance Branch INSPECTION REPORT

| <b>Inspection Date(s):</b> | 11/13/2023 | <b>Inspection Announced:</b> No |
| <b>Facility or Site Name:</b> | George Industries LLC | |
| <b>Facility/Site Physical Location:</b> | 1 S. Page Avenue | |

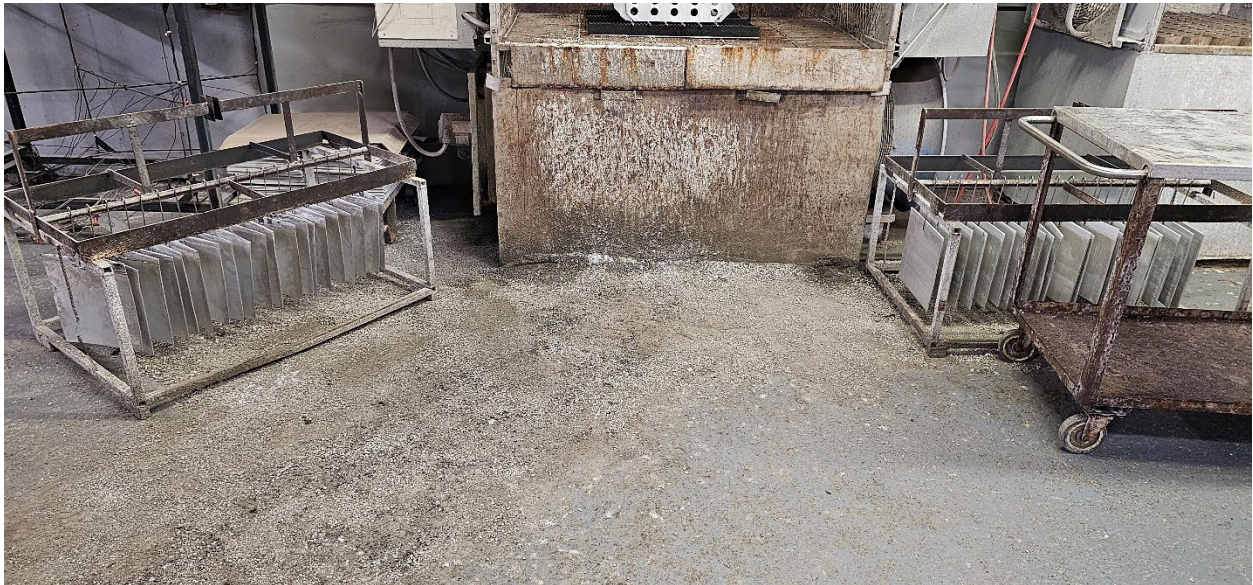
This area is used to dip products into a salt bath, the dipped products are immediately brought to cool in a nearby area. When the product is conveyed to the cooling area hazardous waste salts are dripped along the floor in this area. The hazardous waste drips are collected in speedy dry, however the hazardous waste mixed-speedy dry was observed scattered across the entire dip brazing pot area. The hazardous waste mixed speedy dry material was also observed outside the dip brazing area most likely from foot traffic in this area. The facility representative said there is not sump or collection system in place to collect the hazardous waste and move it to a proper hazardous waste storage container. (Figure 1)

- b. At the time of the inspection, hazardous waste mixed-speedy dry was observed scattered across the entire dip brazing pot area. The hazardous waste mixed speedy dry material was also observed outside the dip brazing area most likely from foot traffic in this area. The facility representative said there is no sump or collection system in place to collect and transport the hazardous waste to a proper hazardous waste storage container. and move it to a proper hazardous waste storage container.

Figure 1: This figure shows the hazardous waste mixed-speedy dry that was observed scattered across the entire dip brazing pot area. The hazardous waste mixed speedy dry material was also observed outside the dip brazing area most likely from foot traffic in this area. The facility representative said there is no sump or collection system in place to collect the hazardous waste and move it to a proper hazardous waste storage container.

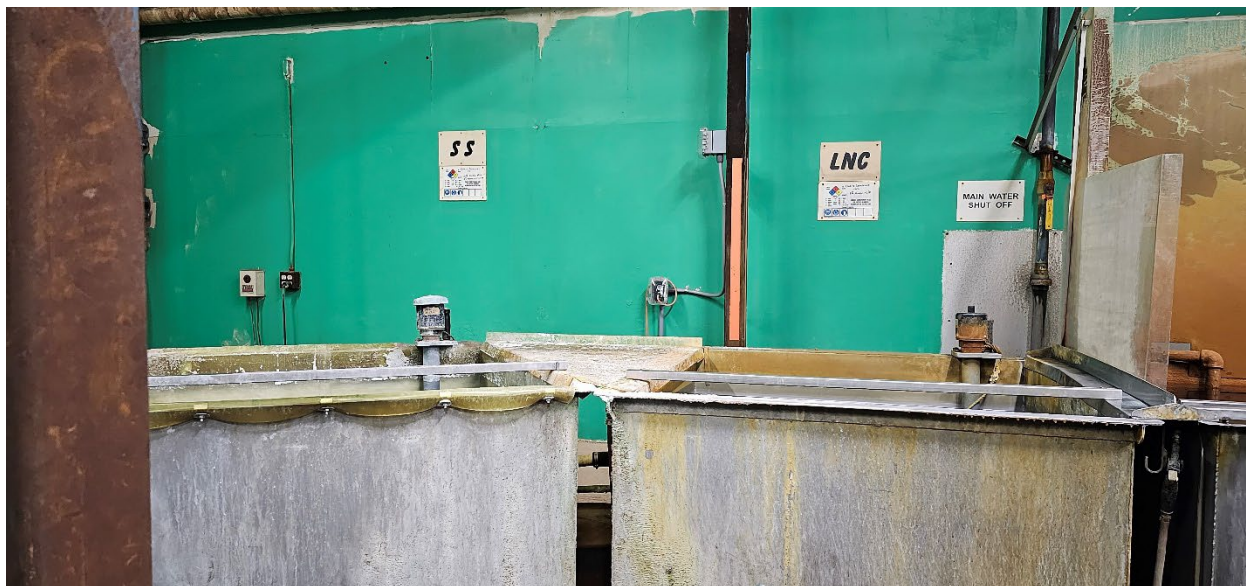
The chem-line area is used to clean parts for processing. The area contained soap tanks, rinse tanks, and 2 acid tanks. The 2 acid tanks were approximately 300-gallons each and contained solutions of: one 10% nitric acid, and one 2% nitric acid. Hazardous waste acid was observed on the floor of this area at the time of the inspection, and obvious signs of corrosion of the surrounding concrete and structural supports were observed. The facility does not have a sump system in place to collect the acid waste and convey it to a proper hazardous waste storage container. (Figure 2 and 3)

Figure 2: This figure shows the two nitric acid tanks located in the chem-line area. Apparent spill staining observed on the cross platform between the tanks as well as the sides of the tanks.

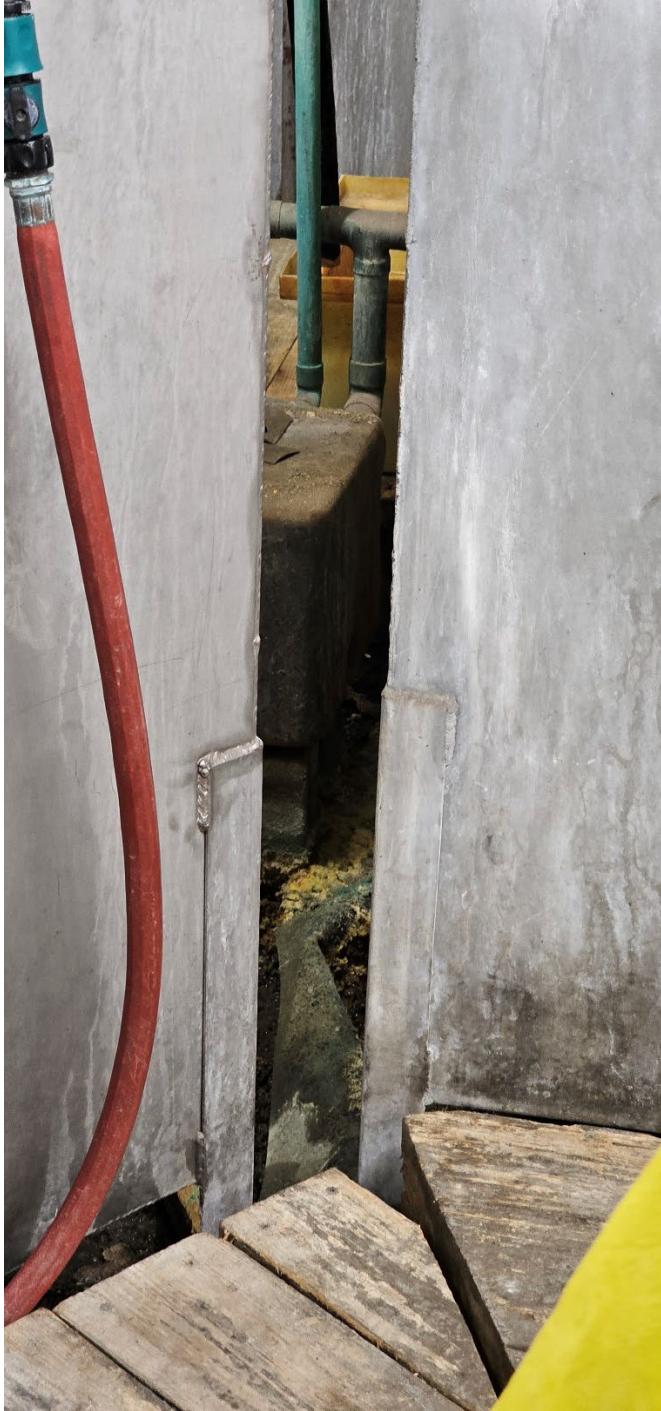
- c. At the time of the inspection, hazardous waste acid was observed on the floor of this area, and obvious signs of corrosion of the surrounding concrete and structural supports were observed. The facility does not have a sump system in place to collect the acid waste to convey it to a proper hazardous waste storage container.

Figure 3: This figure shows hazardous waste acid observed on the floor of this area at the time of the inspection, and obvious signs of corrosion of the surrounding concrete and structural supports were observed.

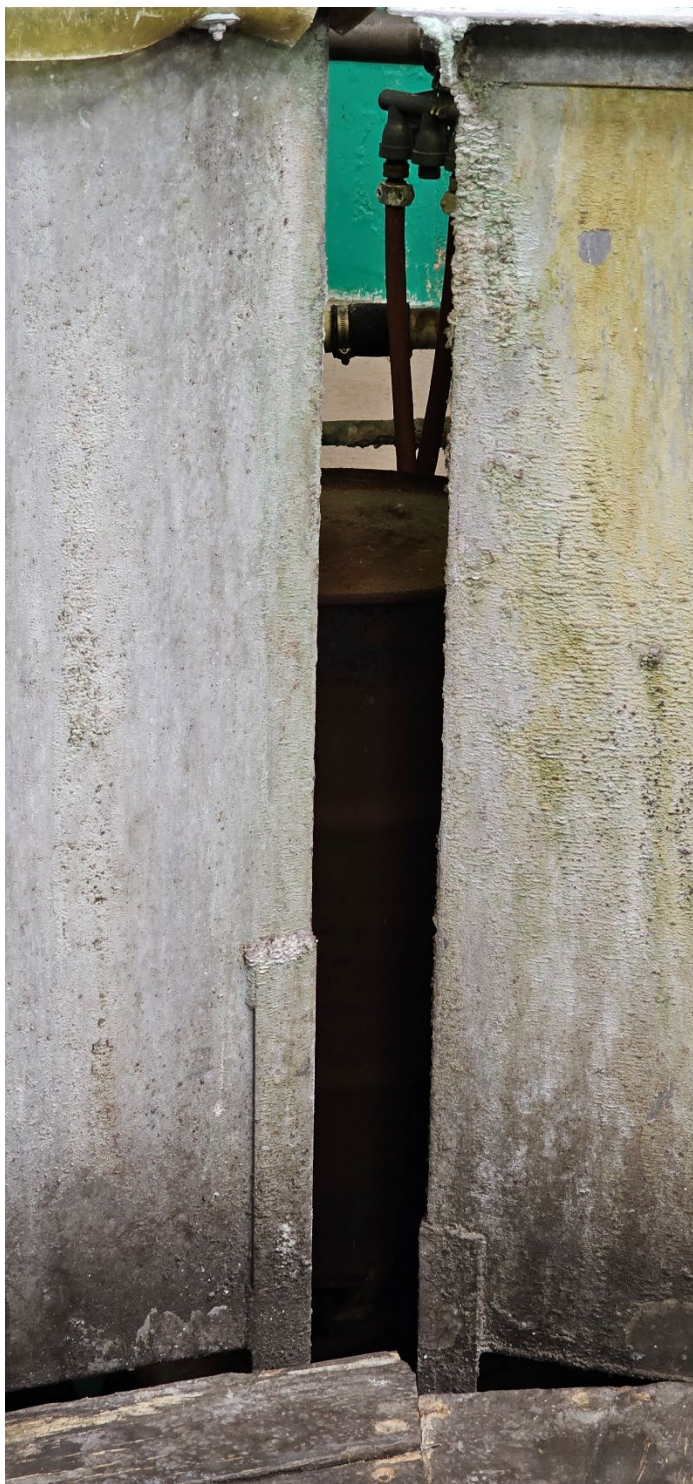
Figure 4: Another photo showing the corrosion and pitting from the acid exposure. A 55-gallon drum was observed severely corroded between the 2 tanks. The facility representative was unsure of the material in the drum or its quantity.
