ES SILO  
8-18-1972

L. B. Willett      January 1973

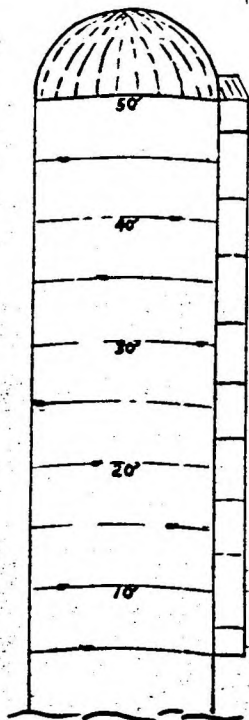
1. Silo was built and coated with a material that contained PCBs in 1957.

2. The silo cleaned with a wire brush, coating was Thoroseal<sub>R</sub> hydraulic cement with an Acryl-60<sub>R</sub> bonder on 6-5-72. - Standard Dry Wall Inc., Miami, Florida

3. The silo was filled with chopped grass 6-17-72 and opened 6-24-72

4. The silo was refilled with chopped corn in late October 1972.

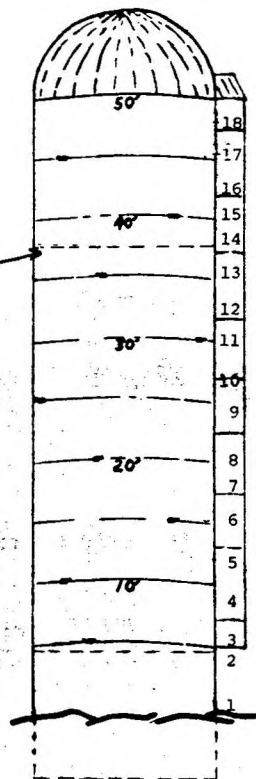
1. Silo was built and coated with a material that contained PCBs in 1954.

2. In 1966 lower 8 feet and the pit were coated with Silenzcrete, Universal Cooperatives, Alliance, Ohio.

3. On 9-16-72 the silo was cleaned and recoated with Water based Epoxy - Action! Plastic, Inc. Charlotte, Michigan; from the base of the pit to 37 feet above ground level.

4. The silo was filled with chopped corn 10-5-72 and was opened 10-30-72

5. The silo was filled with corn silage from stack silo 2-9-73.
