**Region 6 - Enforcement & Compliance Assurance Division**  
**INSPECTION REPORT**

| Regulatory Program(s) | Clean Water Act – National Pollution Discharge Elimination System (NPDES) – Brine Program | |
| Company Name: | <b>Citation Oil &amp; Gas Corp.</b> | |
| Facility Name: | <b>Healdton IV Unit</b> | |

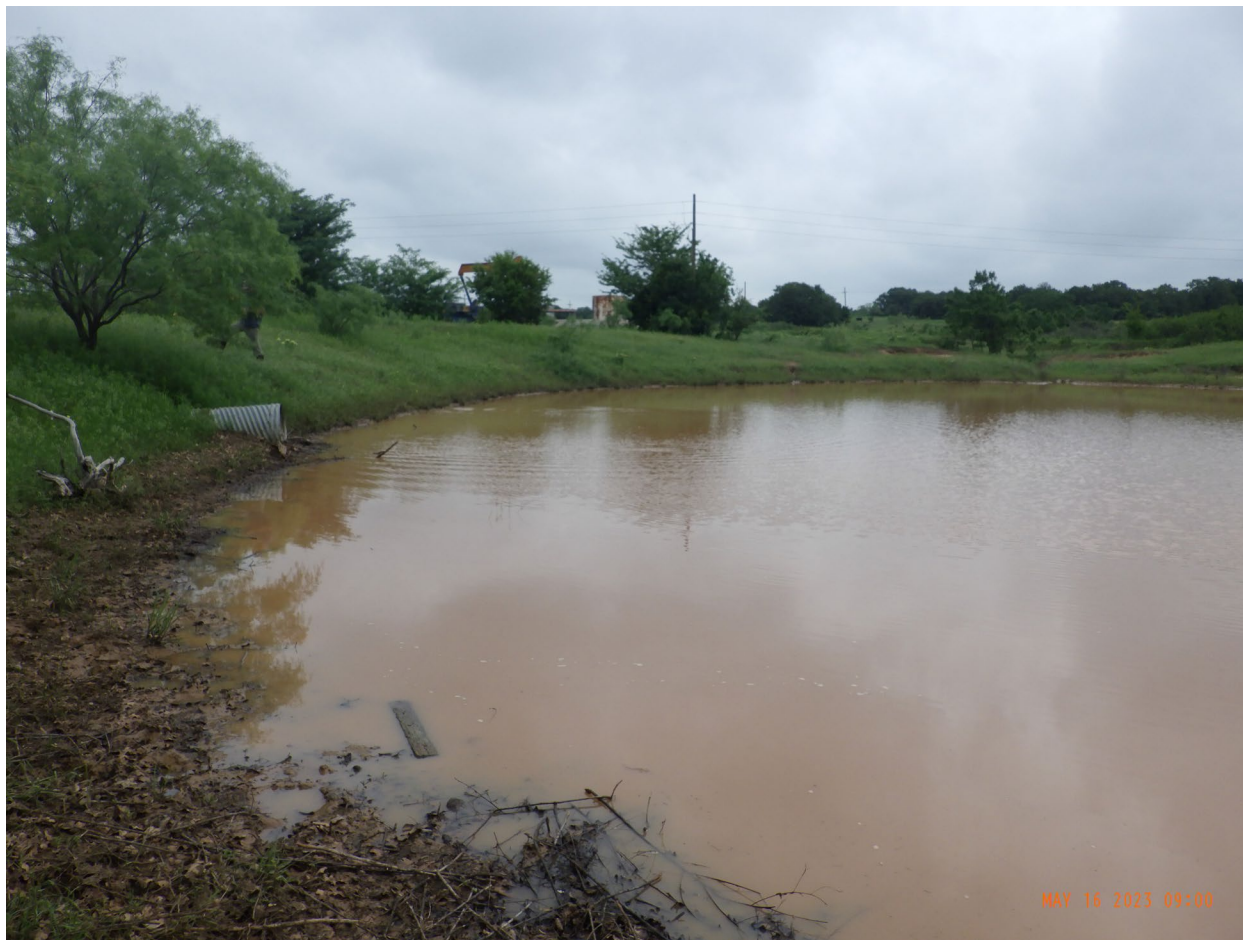
**Description:** This was a pond observed along an intermittent tributary. The pond had a large culvert associated with the spill way of the pond on the west side of this pond (or the left side of this photo).

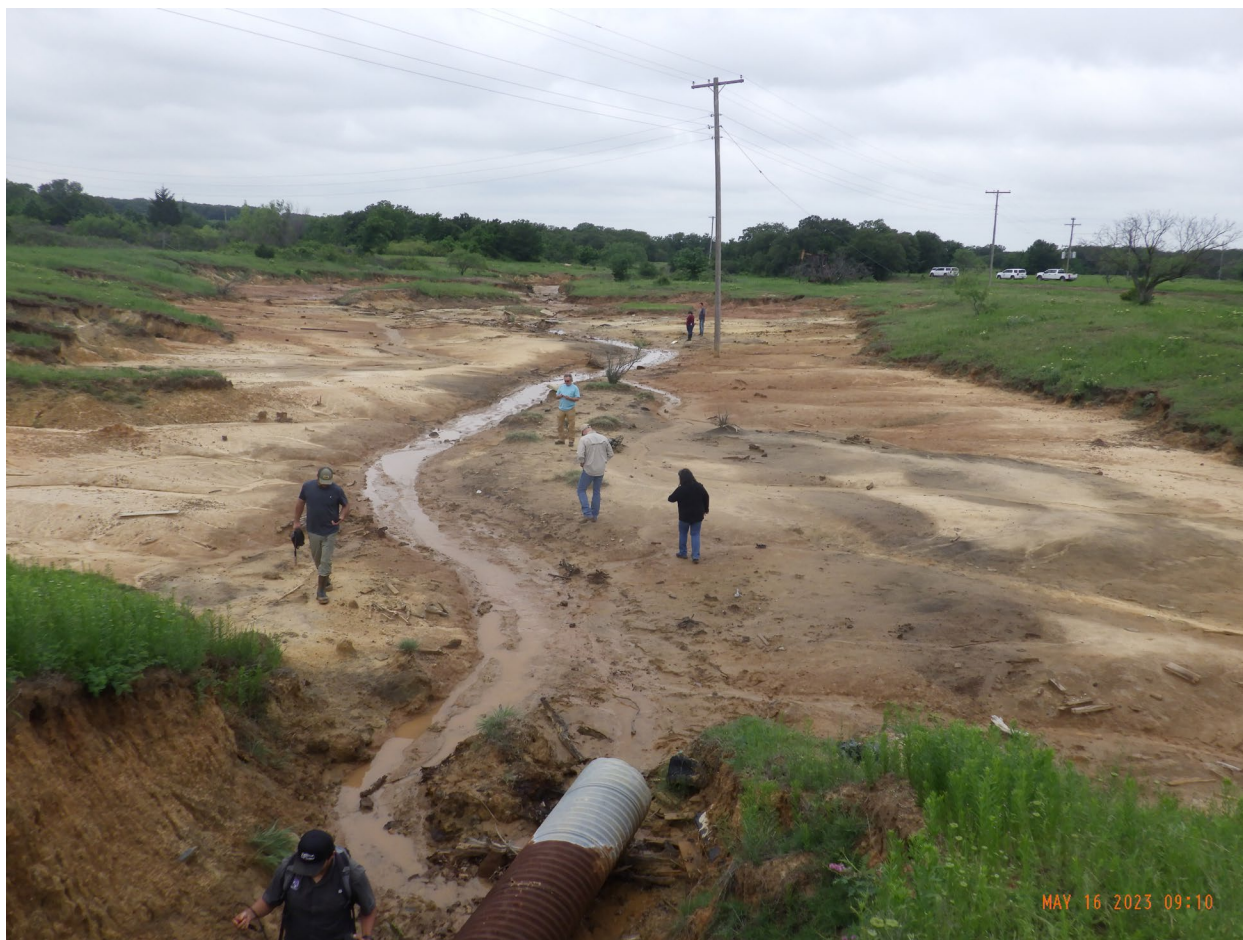
**Description:** This photo shows a downstream view of the tributary of Post Oak Creek from the spill way of the dam of the pond seen in Photo No. 2 of this Appendix. Significant erosion and lack of vegetation were observed throughout this area of the tributary.

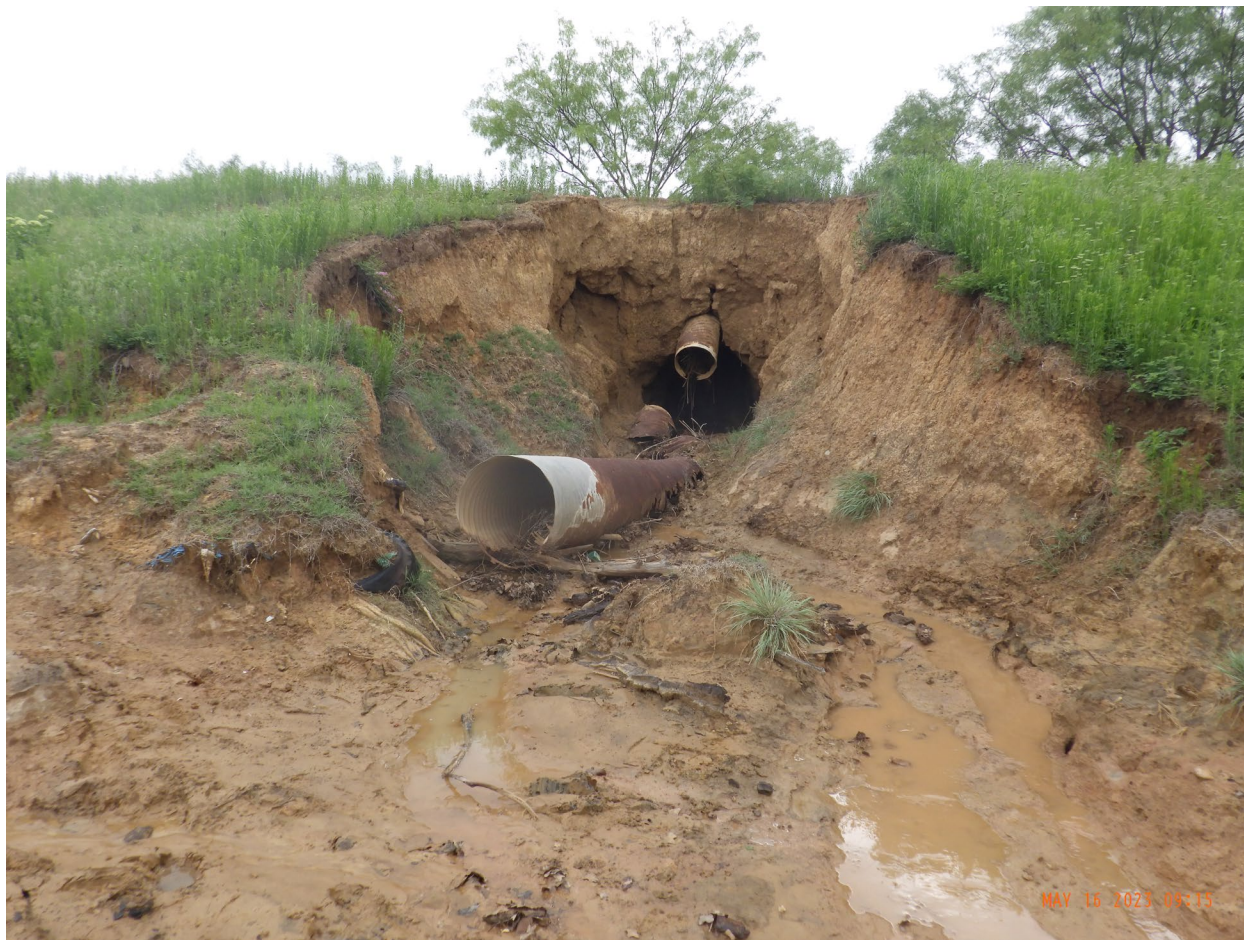
**Description:** This photo shows an upstream view of the tributary of Post Oak Creek below the spill way of the dam of the pond seen in Photo No. 2 of this Appendix. Significant erosion and lack of vegetation were observed throughout this area of the tributary. Fluids appeared to be leeching through a corroded culvert and significant erosion under the dam road were also observed. Some black staining was observed along the fluids in the area from the northern bank of the tributary, which was flowing at the time of the inspection. There was some sheen observed in this location of the tributary as well.

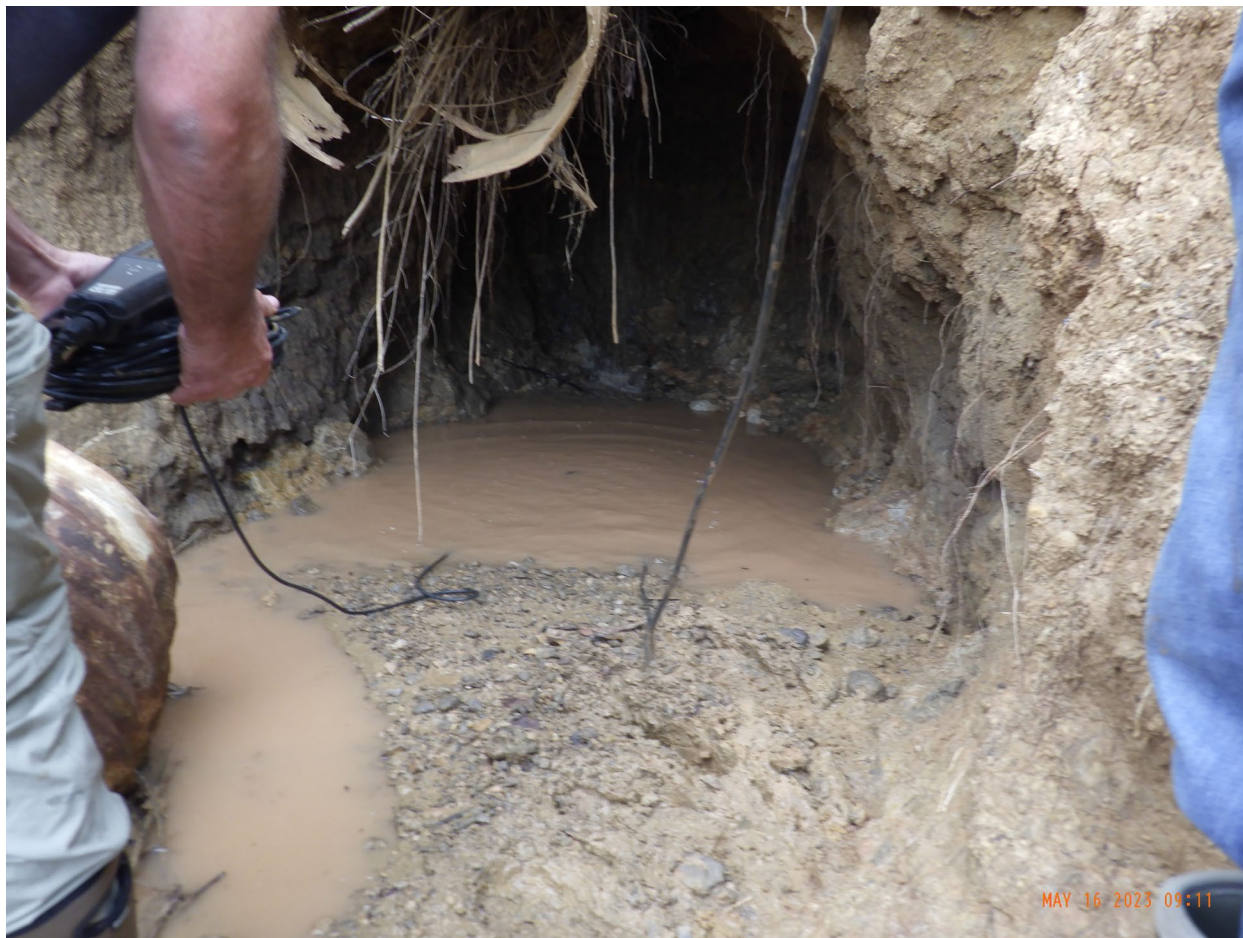
**Description:** This photo shows an upstream view of the tributary of Post Oak Creek below the spill way of the dam of the pond seen in Photo No. 2 of this Appendix. Significant erosion and lack of vegetation were observed throughout this area of the tributary. Fluids appeared to be leeching through a corroded culvert and significant erosion under the dam road were also observed. A TDS reading was taken at this location.

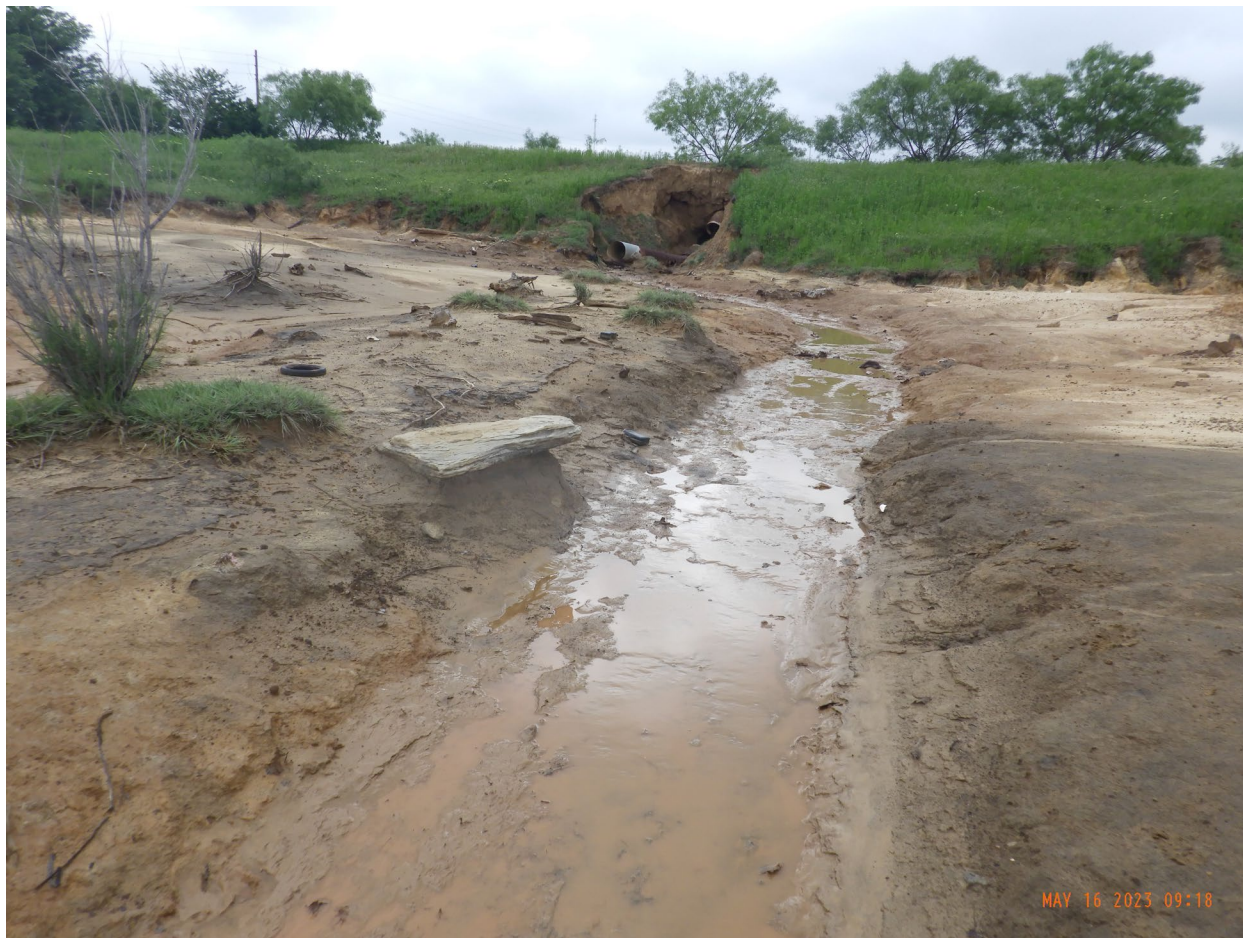
**Description:** This photo shows an upstream view of the tributary located below the spill way of the pond. The tributary was flowing at this location. Some black and darker discoloration of the soil along the immediate banks of the tributary was observed at this location.

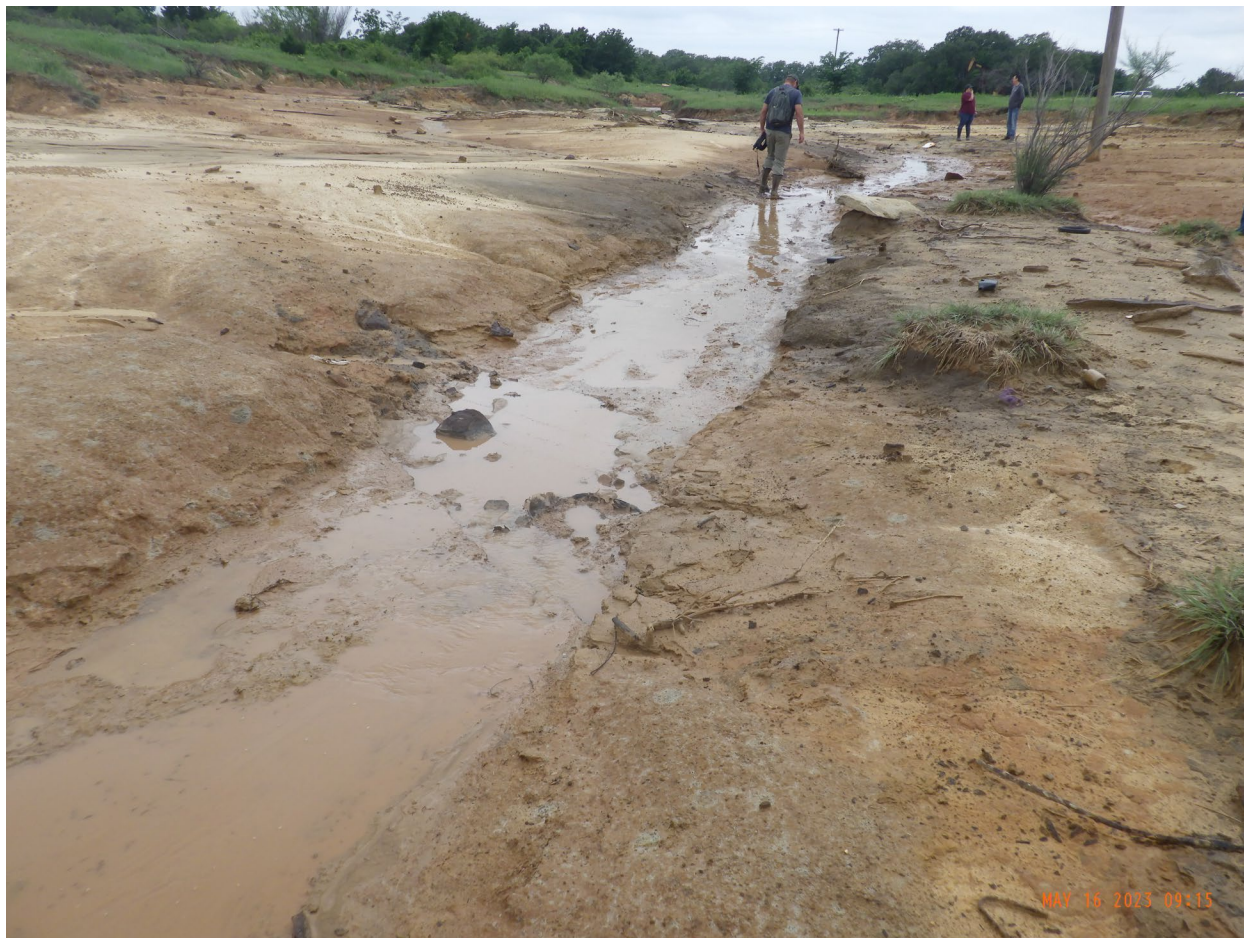
**Description:** This photo shows a downstream view of the tributary located below the spill way of the pond. The tributary was flowing at this location. Some black and darker discoloration of the soil along the immediate banks of the tributary was observed at this location.

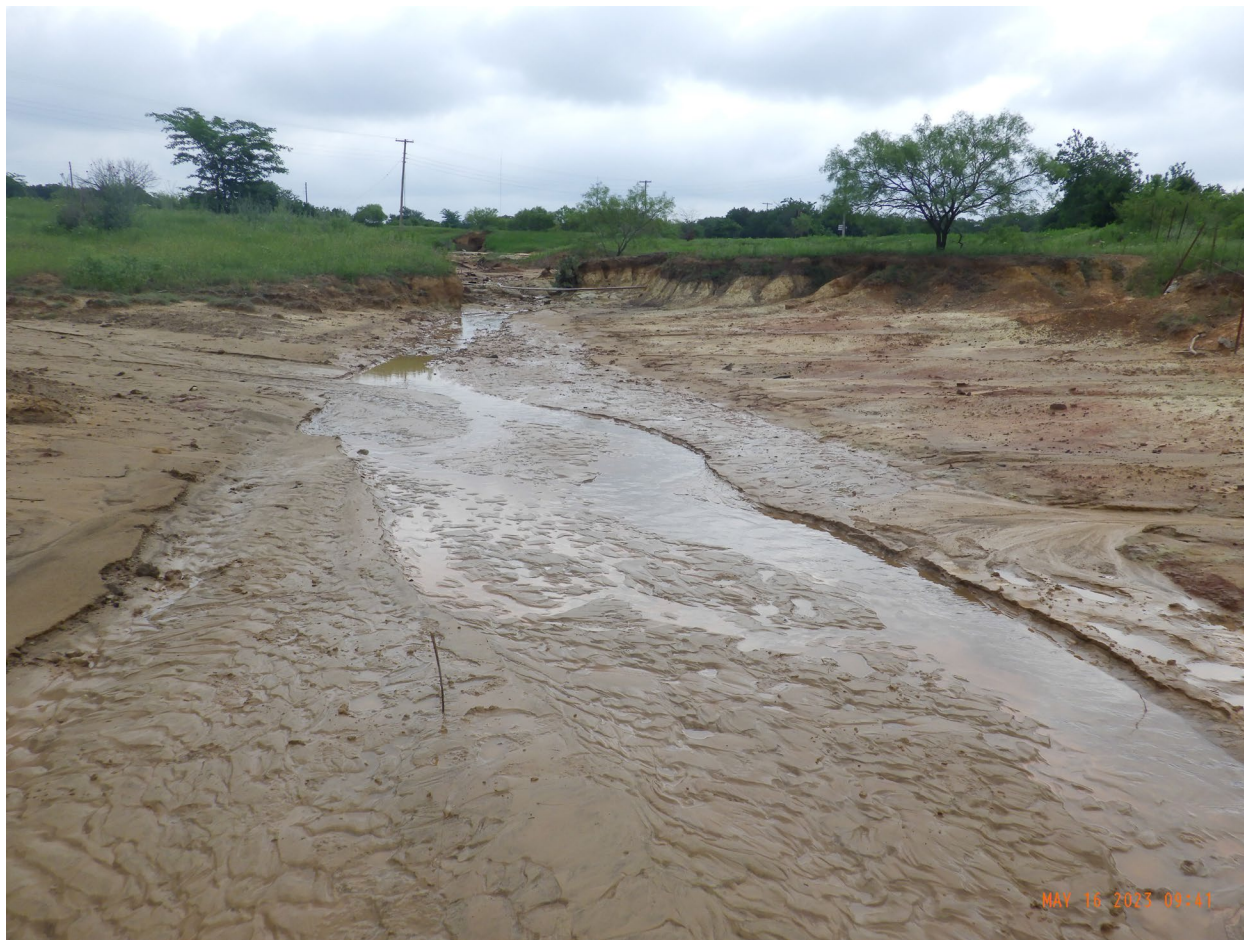
**Description:** This photo was taken over 600 feet downstream from the pond in Photo No. 2 of this Appendix. This is an upstream view of the tributary during the inspection. The tributary was flowing during this inspection and had bank like features observed. Several production flow lines from the oil and gas lease were also observed crossing over the tributary throughout out this area.

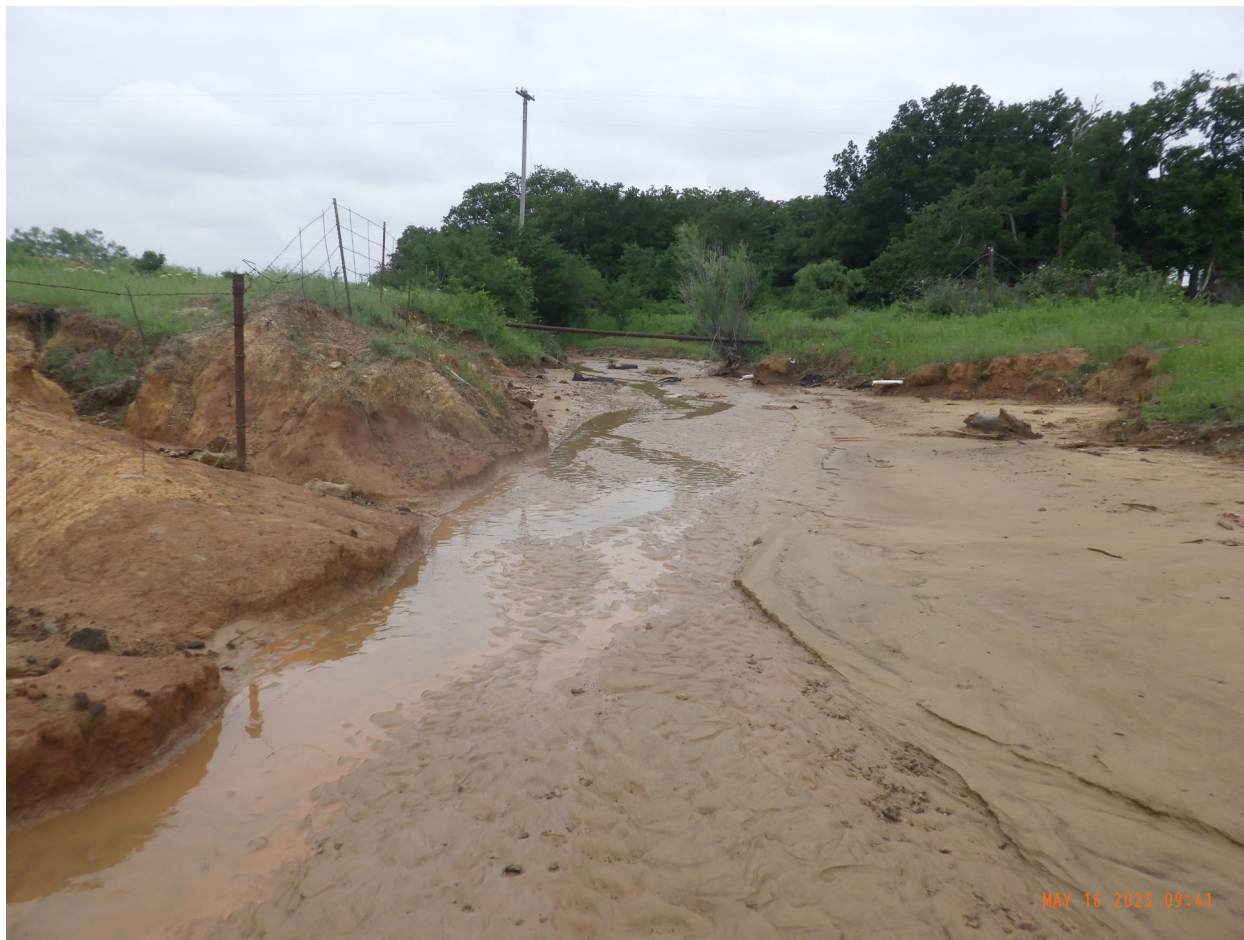
**Description:** This photo was taken over 600 feet downstream from the pond in Photo No. 2 of this Appendix. This is a downstream view of the tributary during the inspection. The tributary was flowing during this inspection and had bank like features observed. Several production flow lines from the oil and gas lease were also observed crossing over the tributary throughout out this area.

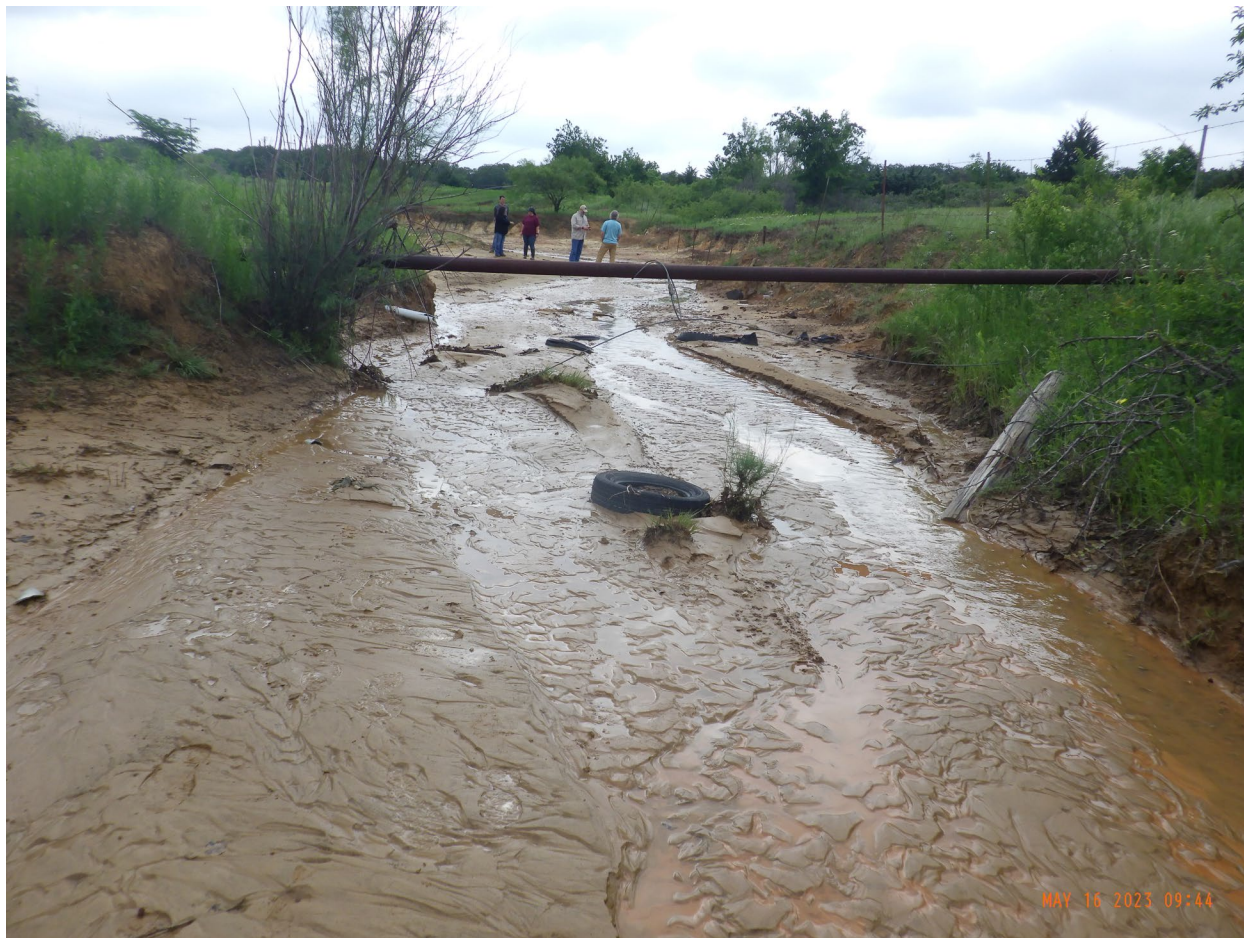
**Description:** This photo was taken over 720 feet downstream from the pond in Photo No. 2 of this Appendix. This was an upstream view of the tributary at this location. The tributary was flowing during this inspection and had bank like features observed. Several production flow lines from the oil and gas lease were also observed crossing over the tributary throughout out this area. Some debris, like old tires, were also observed in the tributary during the inspection.

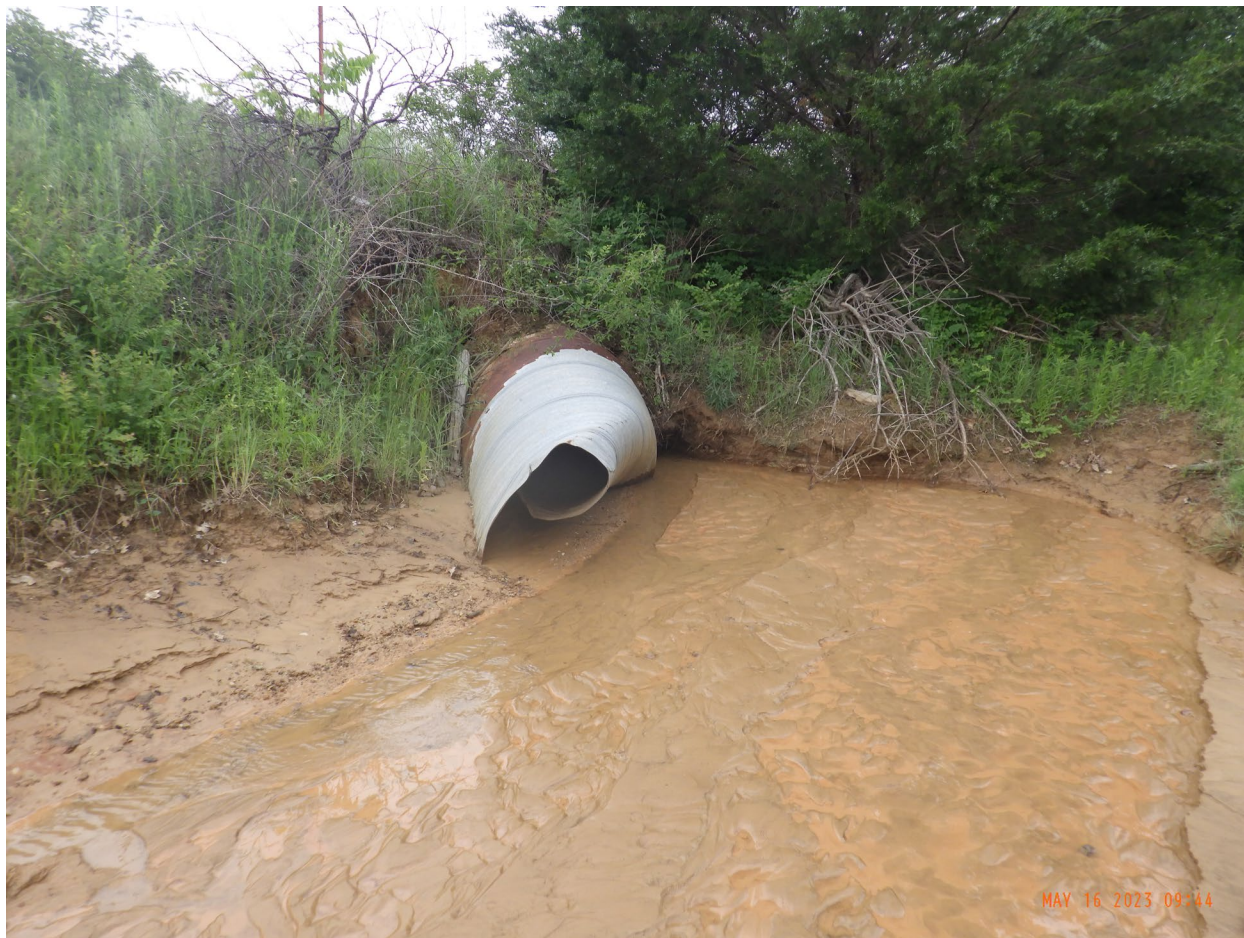
**Description:** This photo was taken over 720 feet downstream from the pond in Photo No. 2 of this Appendix. This was a downstream view of the tributary at this location. The tributary was flowing during this inspection and had bank like features observed. Several production flow lines from the oil and gas lease were also observed crossing over the tributary throughout out this area. Some debris, like old tires, were also observed in the tributary during the inspection.

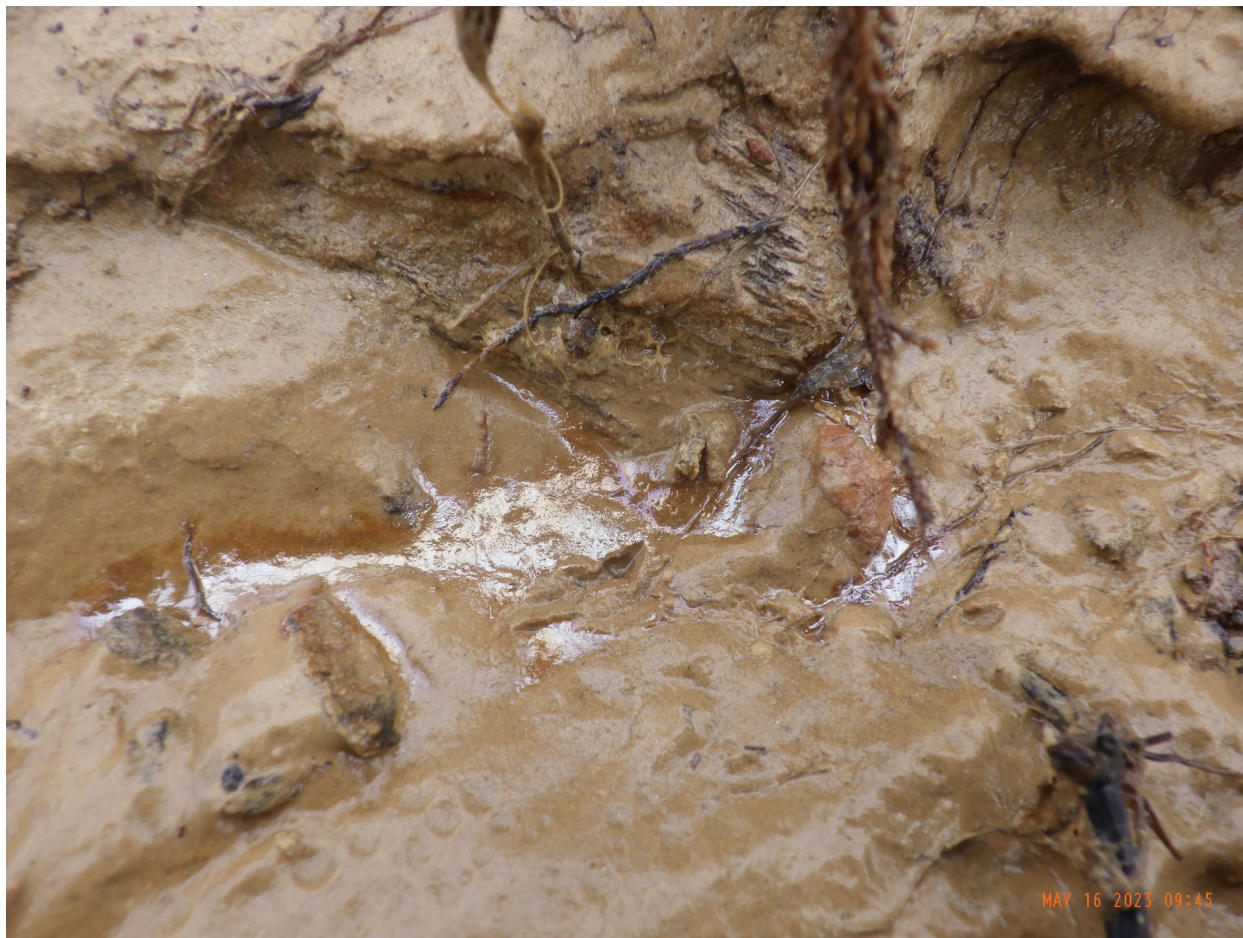
**Description:** This photo was taken over 720 feet downstream from the pond in Photo No. 2 of this Appendix. On the northern bank of the tributary during the inspection, an oil or petroleum like sheen was observed seeping into the tributary, as seen in this photo.

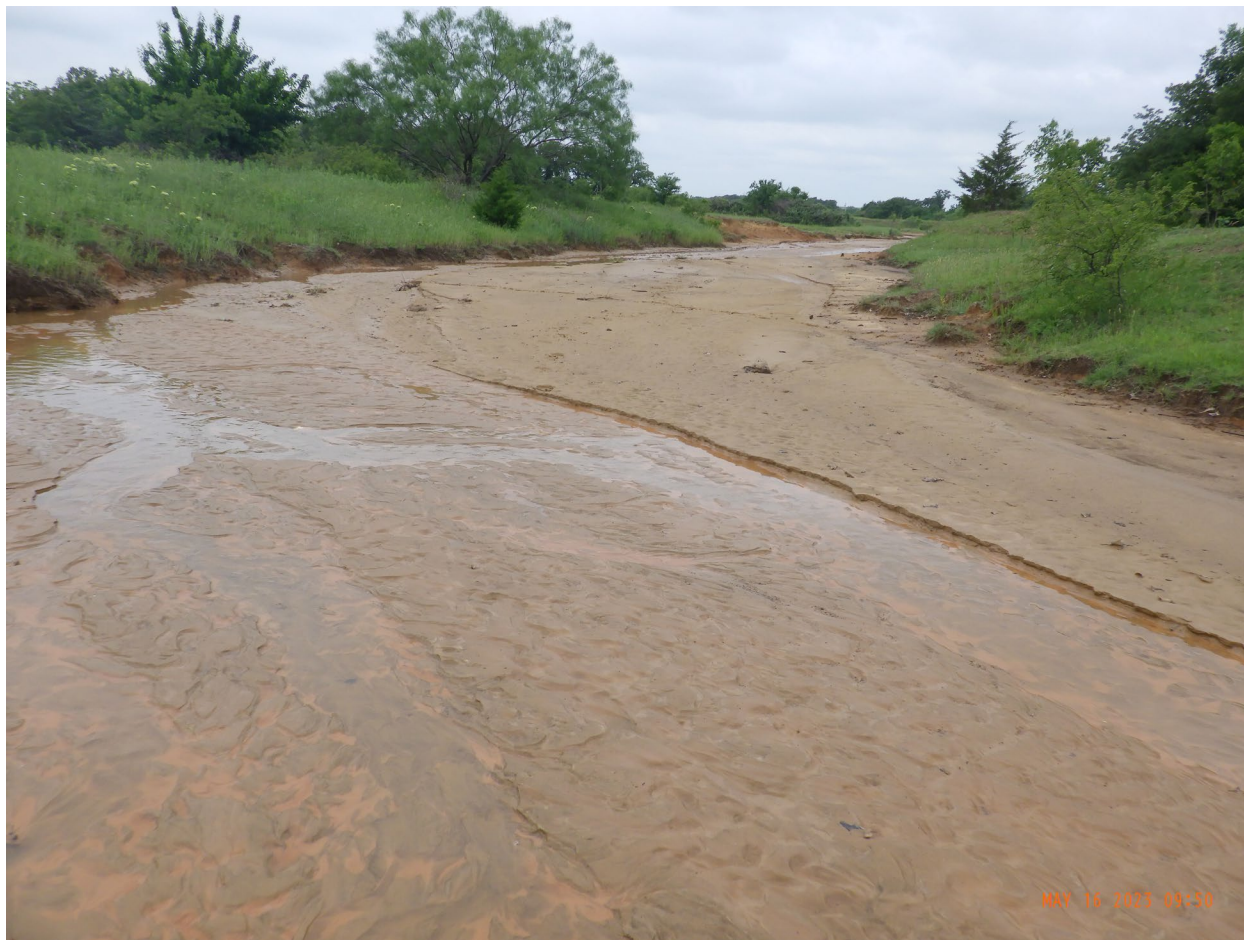
**Description:** This photo was approximately 900 feet downstream from the pond in Photo No. 2 of this Appendix. This is a downstream view of the tributary of Post Oak Creek. Tributary features including banks, some bed, and flowing water were observed during the inspection.

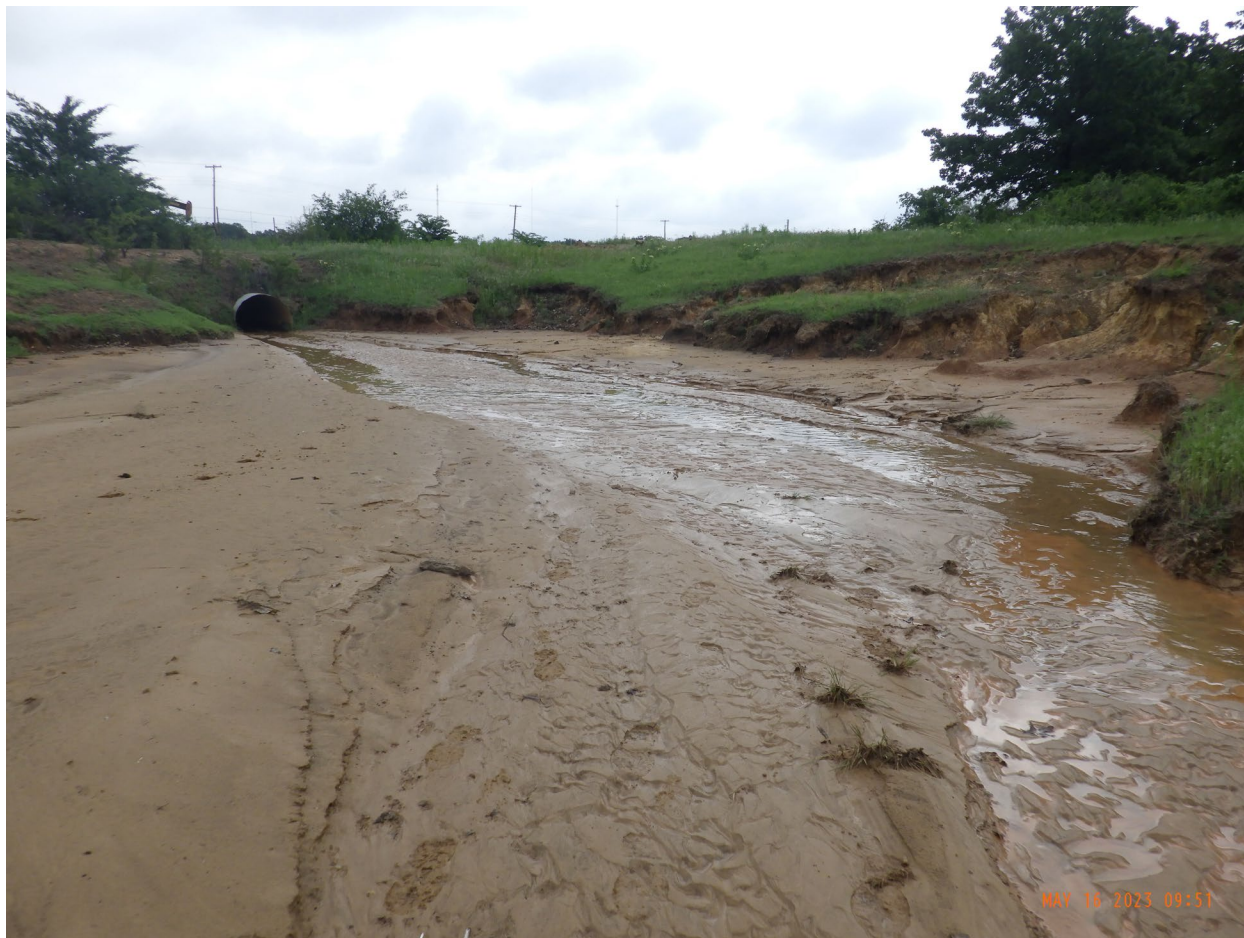
**Description:** This photo was approximately 900 feet downstream from the pond in Photo No. 2 of this Appendix. This is an upstream view of the tributary of Post Oak Creek. Tributary features including banks, some bed, and flowing water were observed during the inspection. Additionally, a culvert was placed in stream to assist with flow from the tributary.

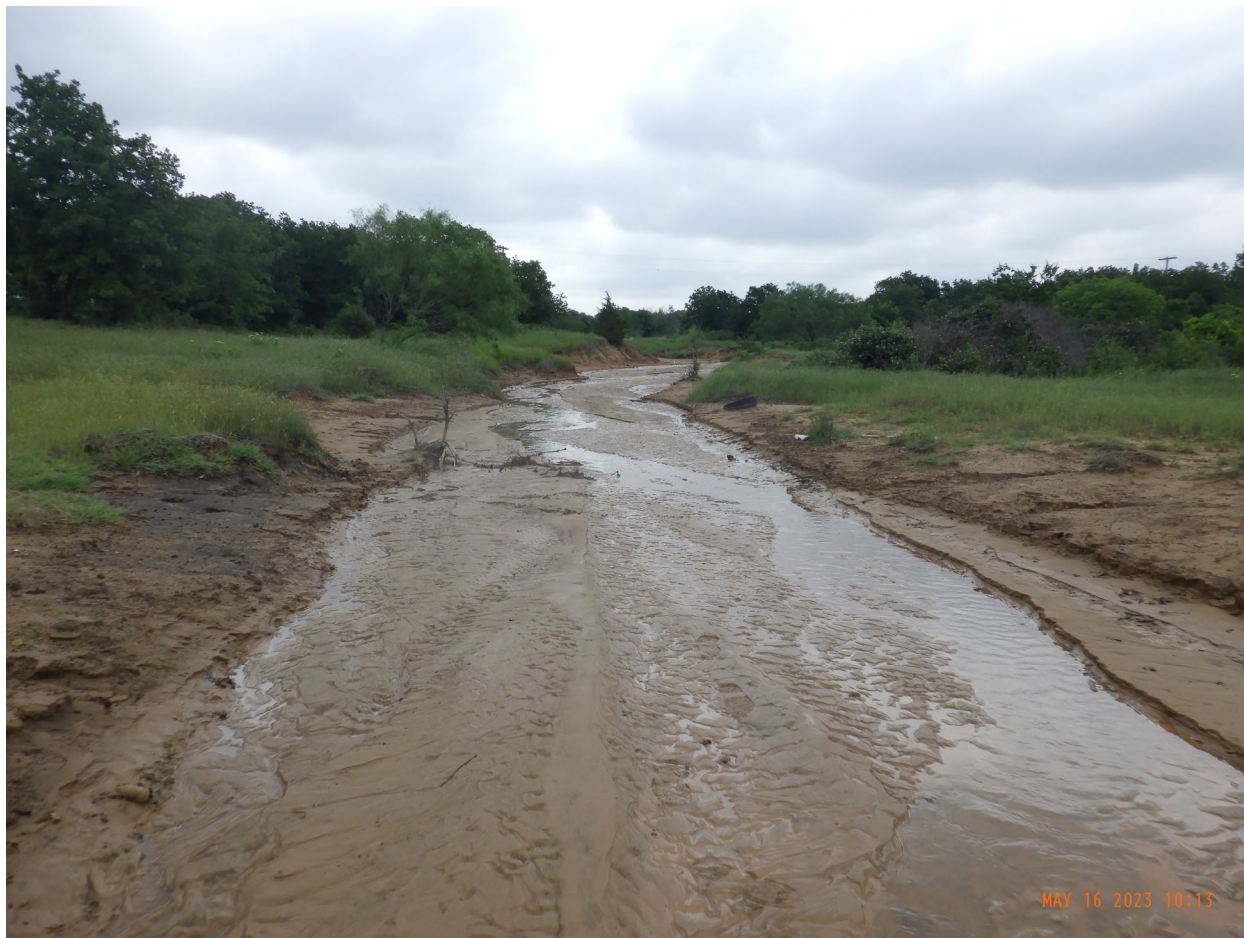
**Description:** This photo was over 1,280 feet downstream from the pond in Photo No. 2 of this Appendix. This is an upstream view of the tributary of Post Oak Creek. Tributary features including banks, some bed, and flowing water were observed during the inspection.

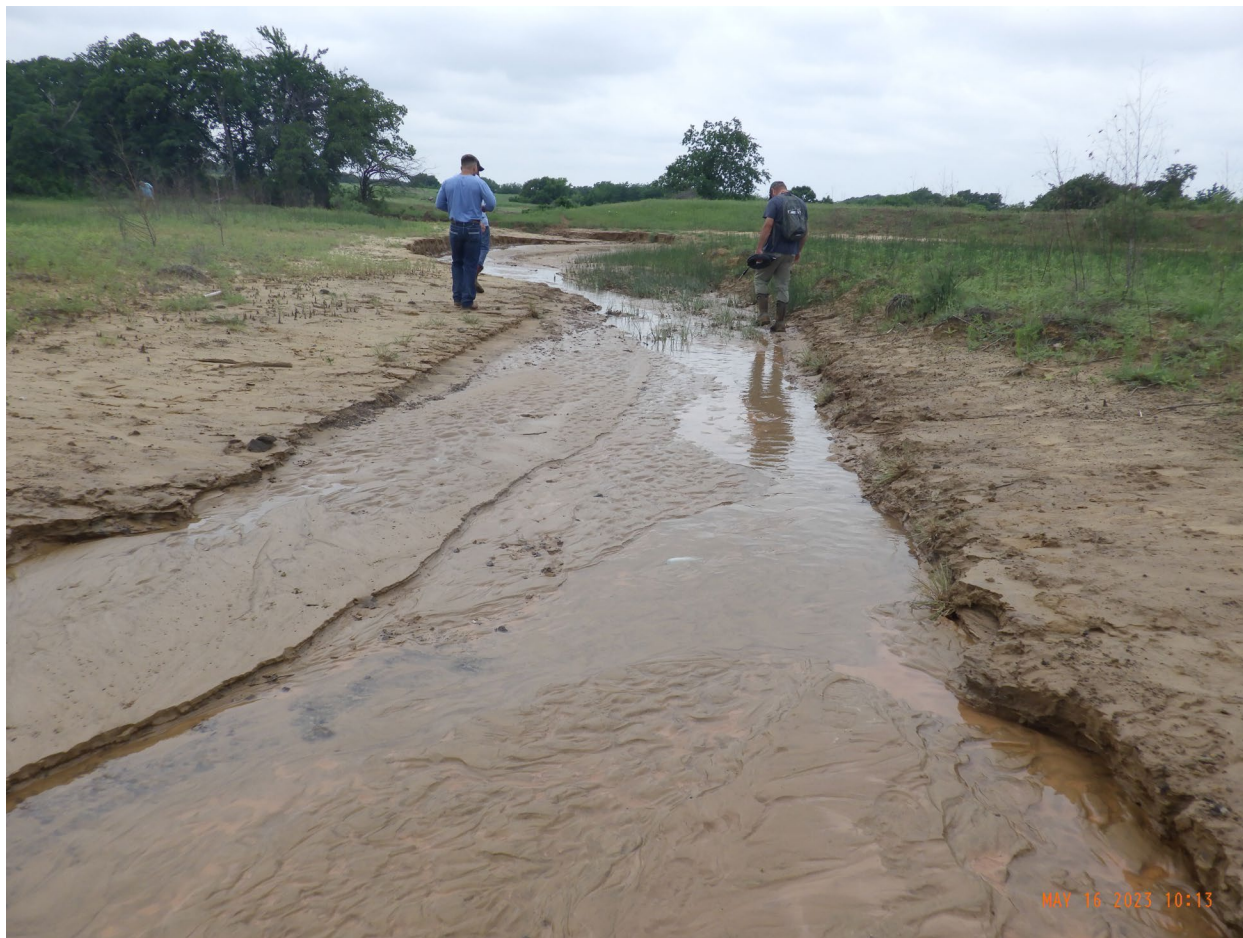
**Description:** This photo was over 1,280 feet downstream from the pond in Photo No. 2 of this Appendix. This is a downstream view of the tributary of Post Oak Creek. Tributary features including banks, some bed, and flowing water were observed during the inspection.

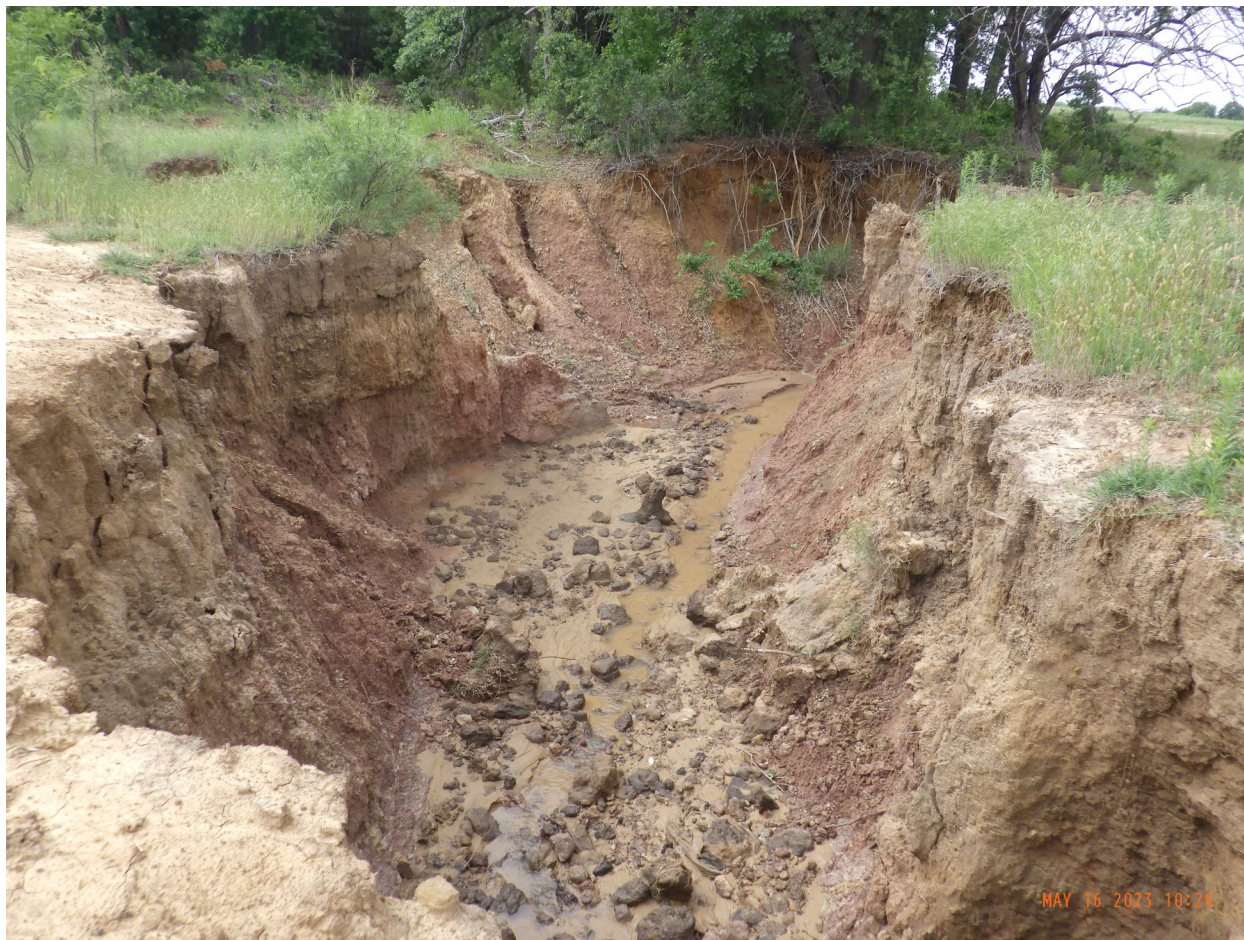
**Description:** This photo was approximately 0.28 miles downstream from the pond in Photo No. 2 of this Appendix. This is a downstream view of the tributary of Post Oak Creek. Tributary features including banks, some bed rock, and flowing water were observed during the inspection. Significant erosion was also observed in this part of the tributary.

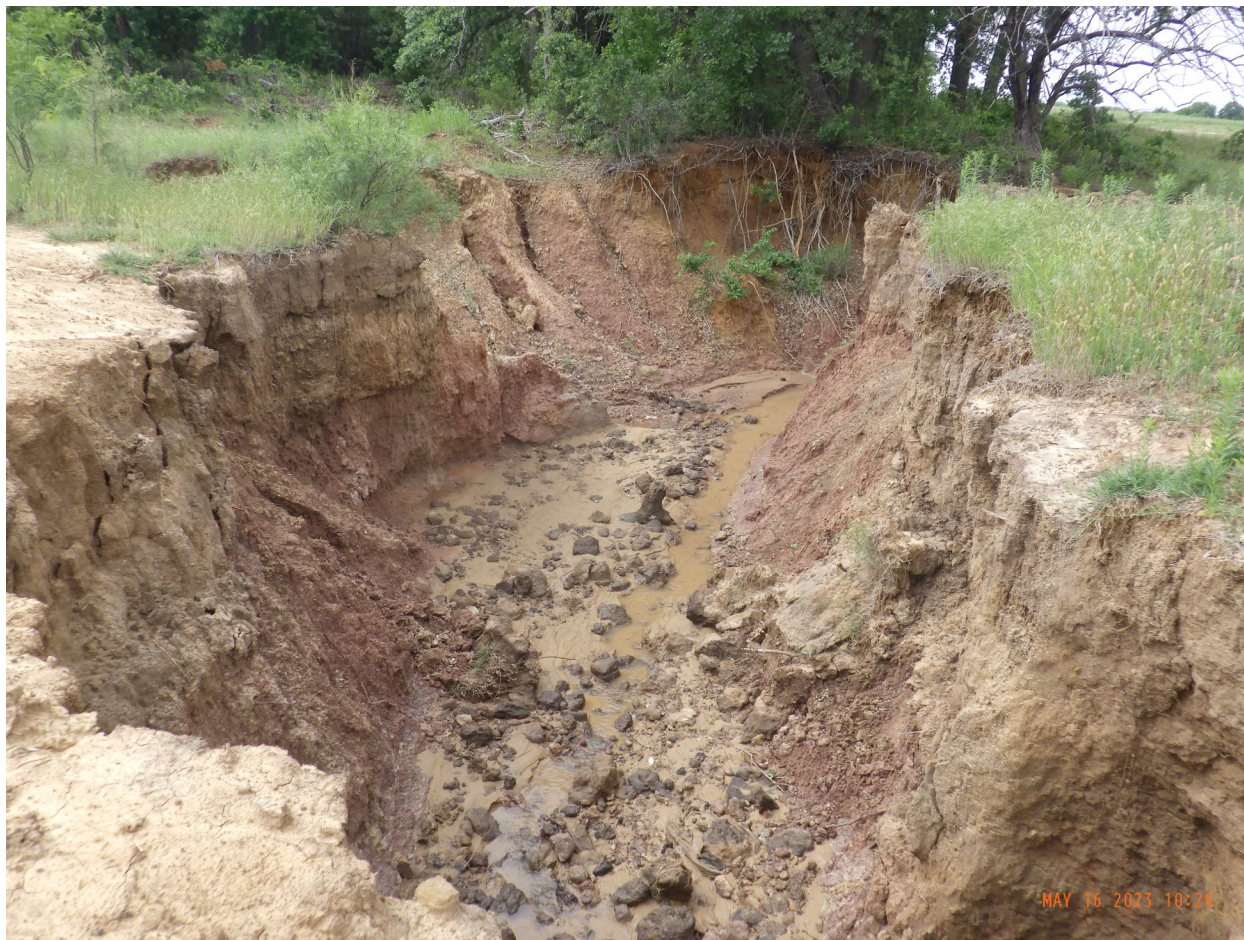
**Description:** This photo was approximately 0.28 miles downstream from the pond in Photo No. 2 of this Appendix. This is a downstream view of the tributary of Post Oak Creek. Tributary features including banks, some bed rock, and flowing water were observed during the inspection. Significant erosion was also observed in this part of the tributary.

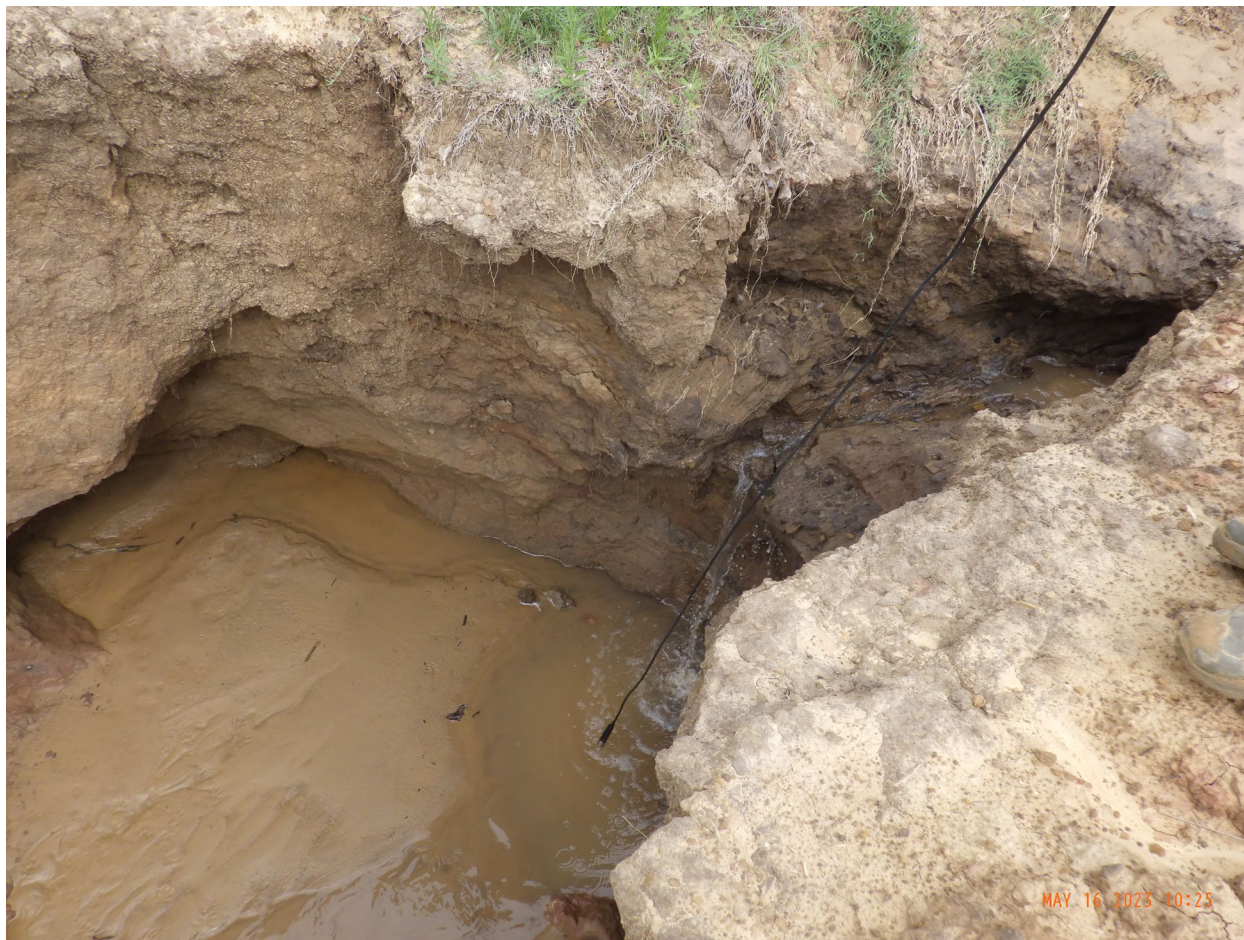
**Description:** This photo was approximately 0.28 miles downstream from the pond in Photo No. 2 of this Appendix. This is a view of the stream column of the tributary of Post Oak Creek at this location. Tributary features including banks, some bed rock, and flowing water were observed during the inspection. Significant erosion was also observed in this part of the tributary. Some bank discoloration, including darker and black looking soil, were observed here. A meter reading was taken here at this location which was a deep drop off point in the tributary.
