**Region 6 - Enforcement & Compliance Assurance Division**  
**INSPECTION REPORT**

| Regulatory Program(s) | Clean Water Act – National Pollution Discharge Elimination System (NPDES) – Brine Program | |
| Company Name: | <b>Citation Oil &amp; Gas Corp.</b> | |
| Facility Name: | <b>Healdton IV Unit</b> | |

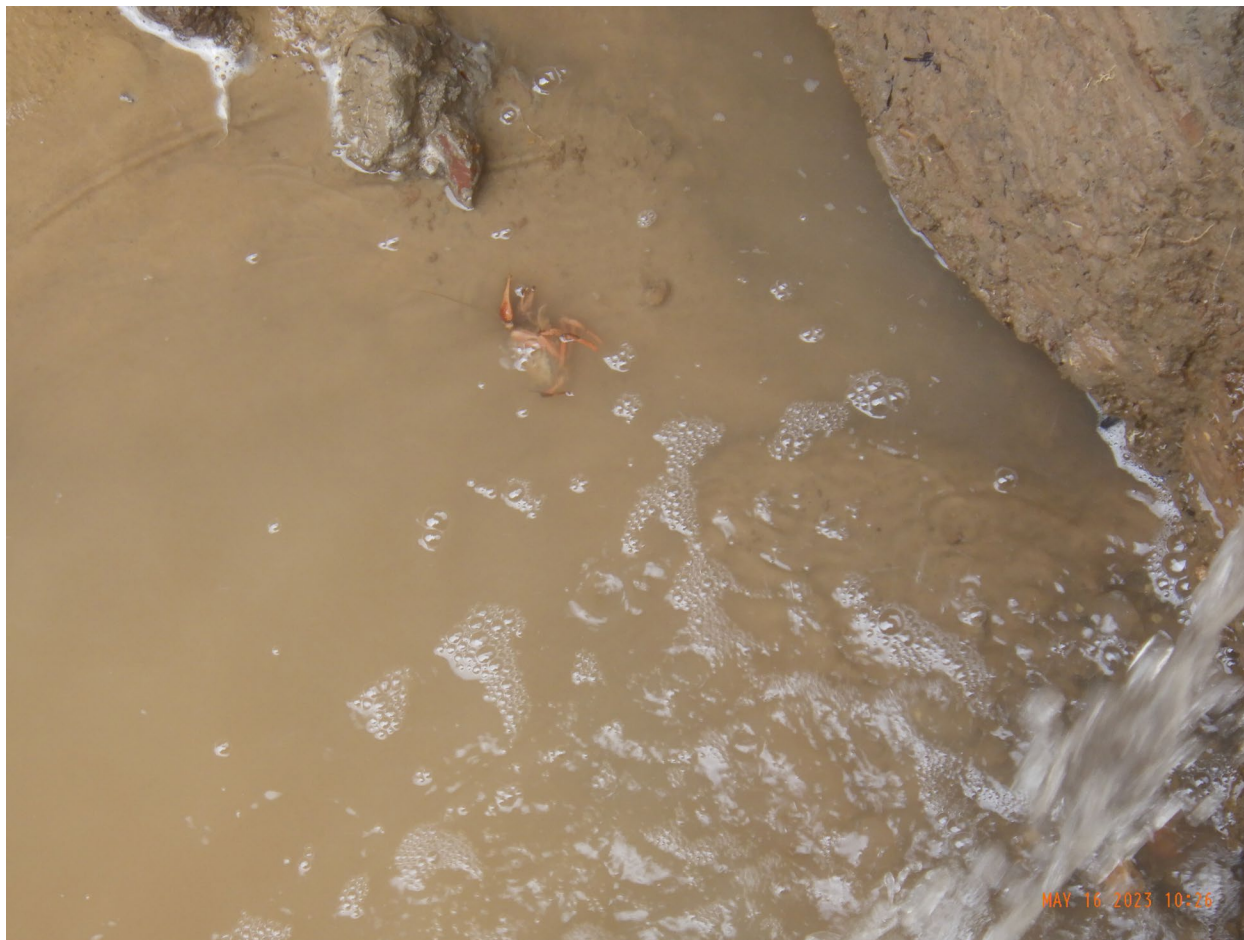
**Description:** This photo was approximately 0.28 miles downstream from the pond in Photo No. 2 of this Appendix. This is a view of the stream column of the tributary of Post Oak Creek at this location. This is a zoomed in photo at the same spot as Photo No. 27 in this Appendix. I observed one dead crawfish, as seen in this photo.

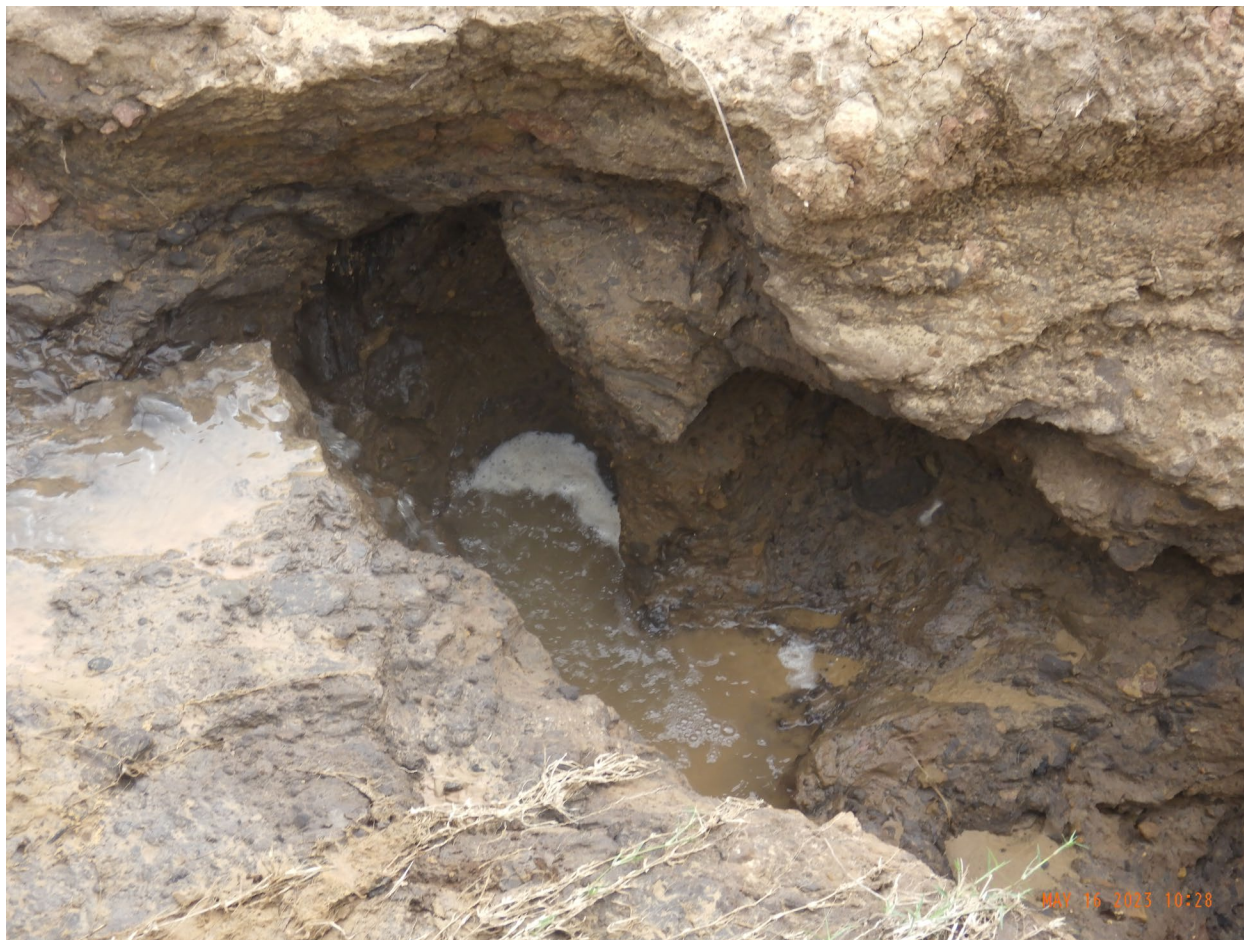
**Description:** This photo was approximately 0.28 miles downstream from the pond in Photo No. 2 of this Appendix. This is a view of the stream column of the tributary of Post Oak Creek at this location. This is a zoomed in photo at the same spot as Photo No. 27 in this Appendix. I observed foam in the tributary, as seen in this photo.

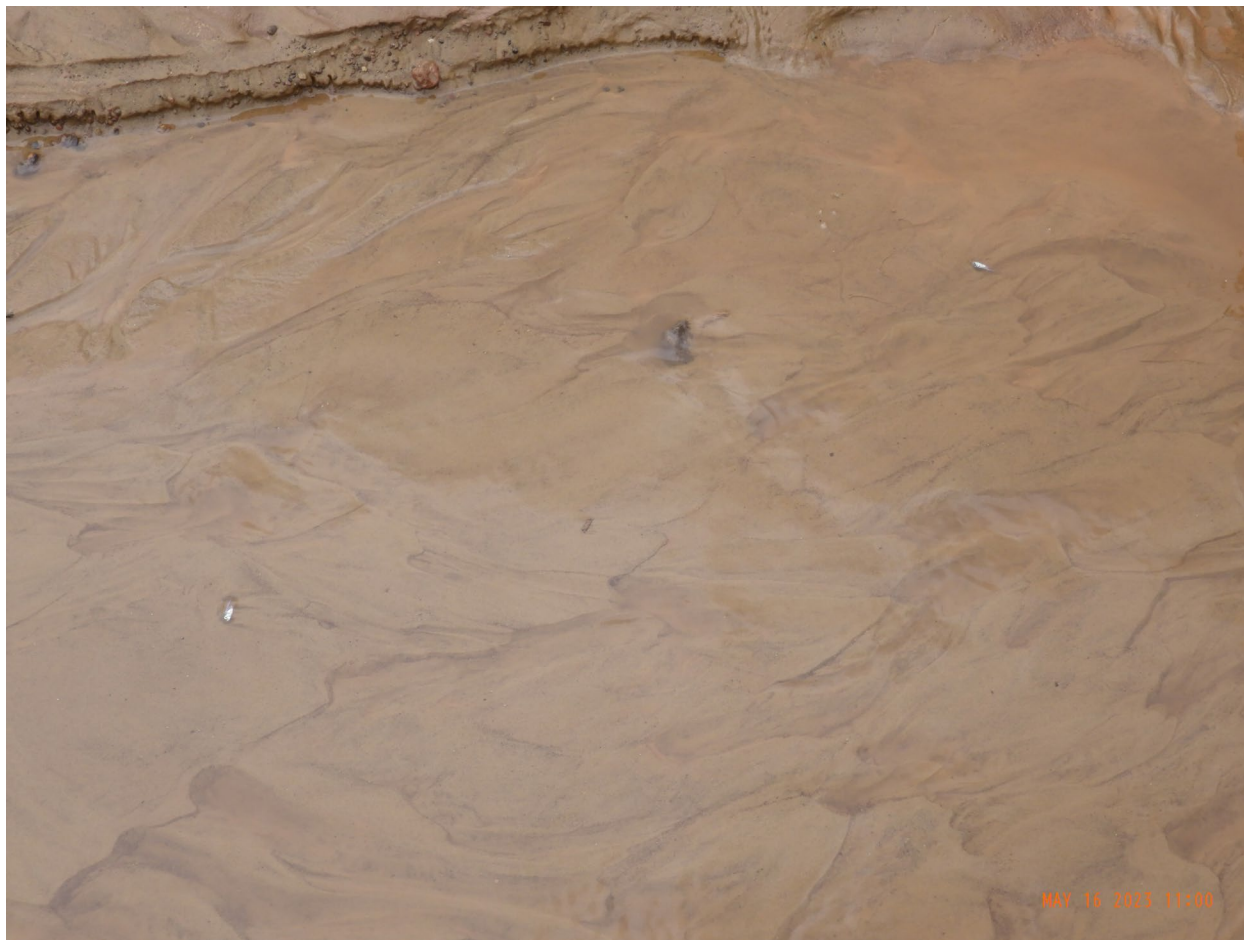
**Description:** This photo was approximately 0.43 miles downstream from the pond in Photo No. 2 of this Appendix. Two dead minnows (silver) and one crawfish that was alive were observed in the tributary at this location.

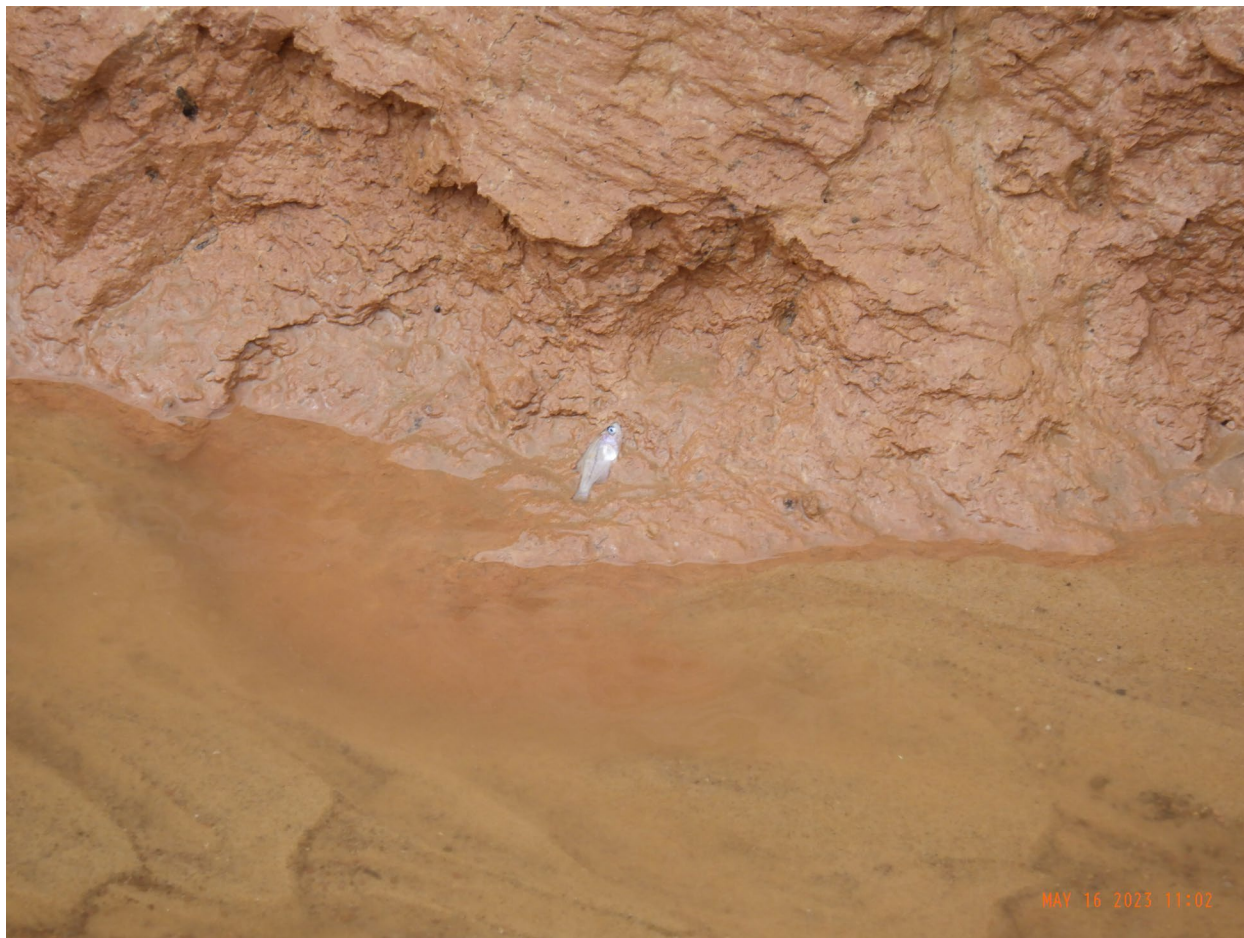
**Description:** This photo was approximately 0.48 miles downstream from the pond in Photo No. 2 of this Appendix. An additional dead minnow (silver) was observed in the tributary at this location.

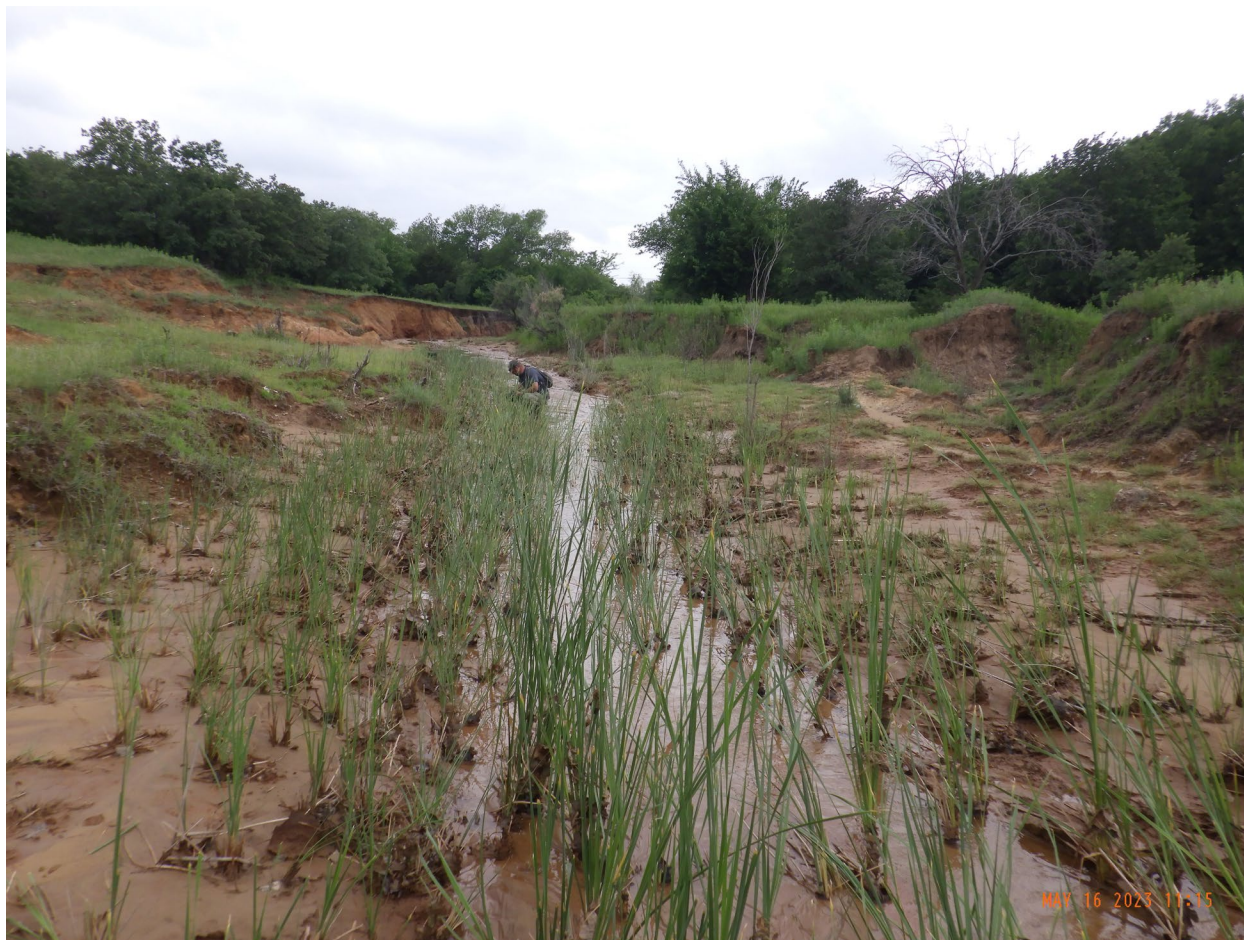
**Description:** This photo was approximately 0.48 miles downstream from the pond in Photo No. 2 of this Appendix. Bed, bank, and riparian vegetation (*e.g.*, cattails) were observed at this location. The tributary was flowing during the inspection.

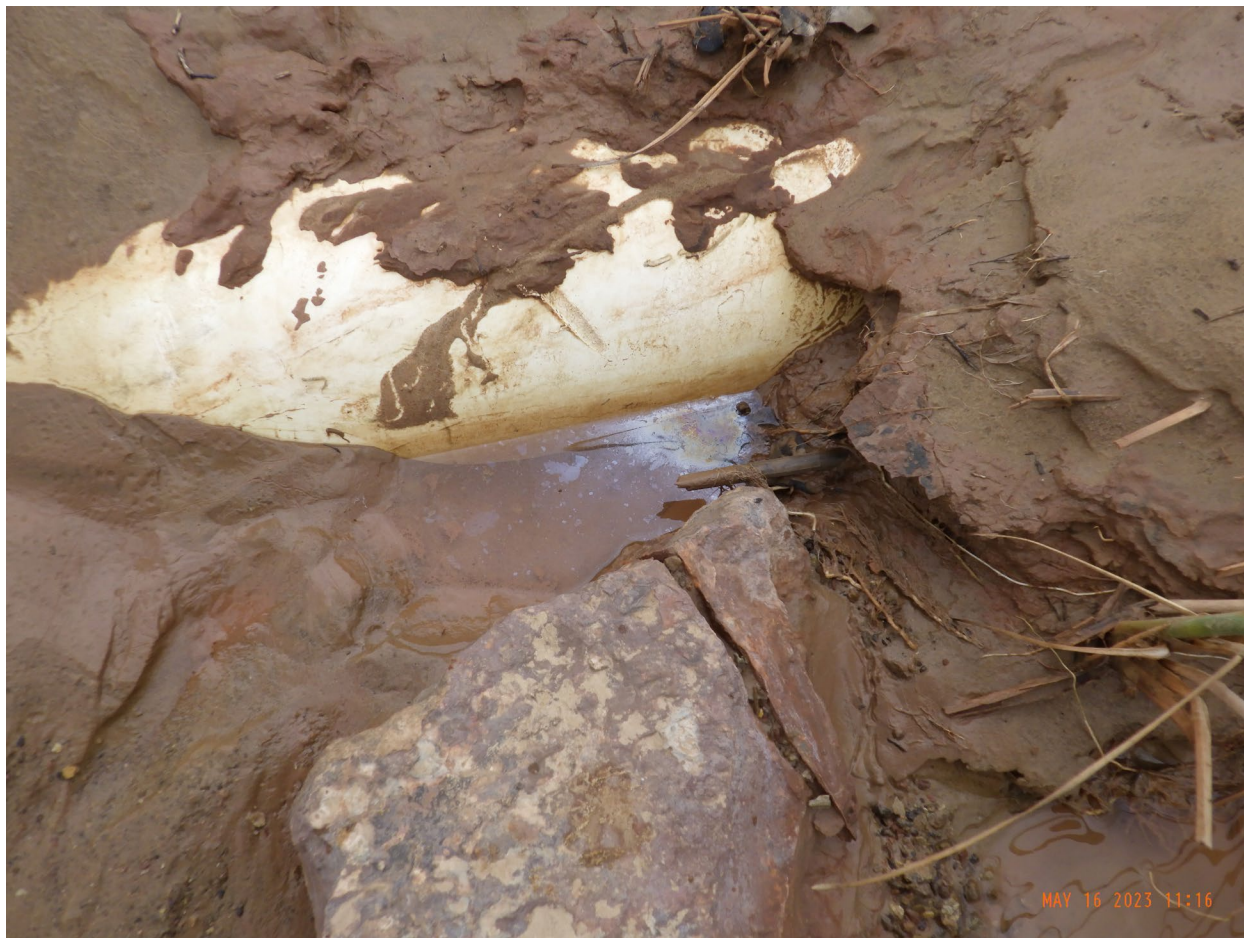
**Description:** This photo was approximately 0.48 miles downstream from the pond in Photo No. 2 of this Appendix. A part of a PVC pipe was observed in the tributary. Additionally, some oil sheen was observed at this location during the inspection.

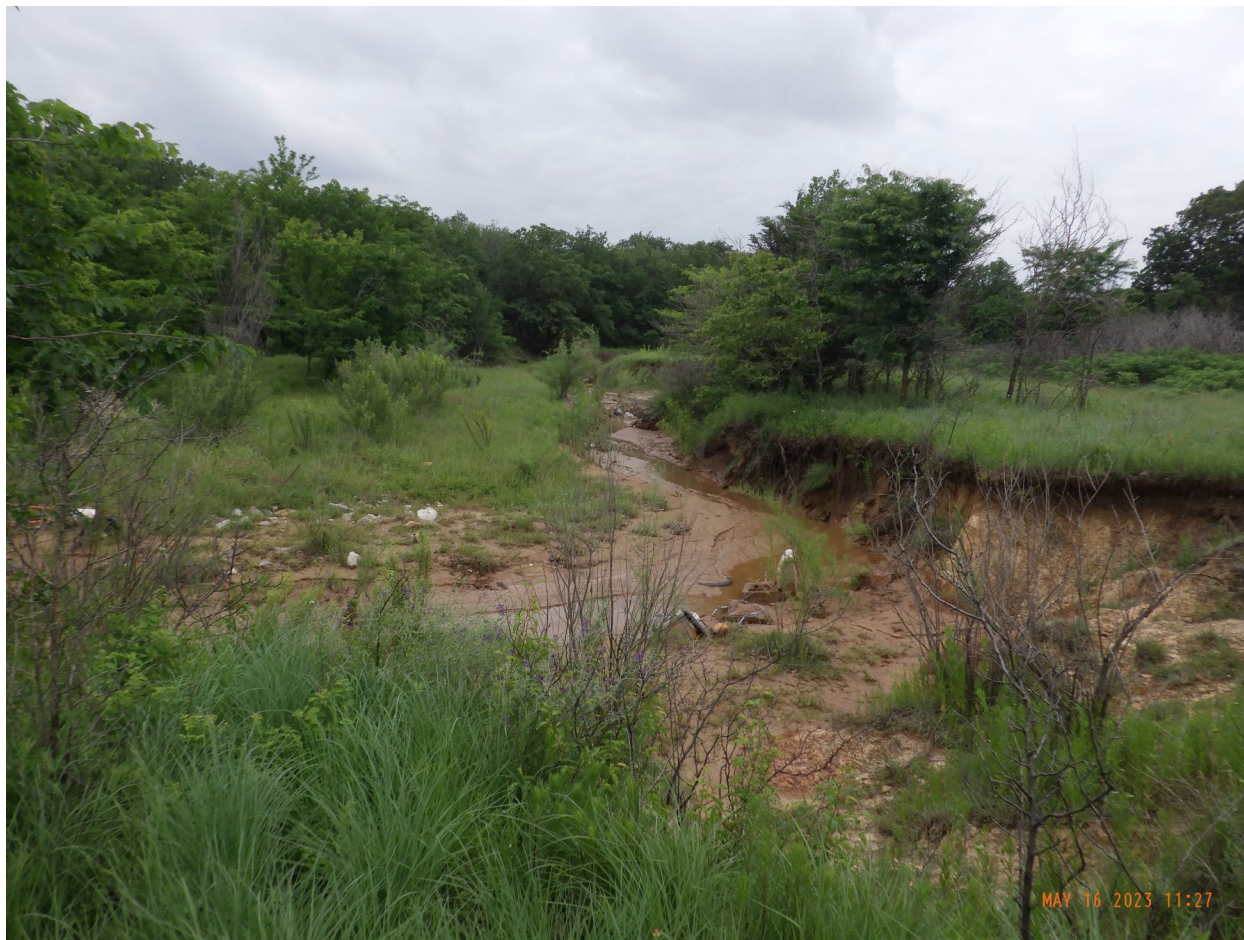
**Description:** This photo was approximately 0.57 miles downstream from the pond in Photo No. 2 of this Appendix. This photo shows a downstream view of the tributary to Post Oak Creek, where bed, bank, and other tributary characteristics were observed near the Wildflower Rd. Bridge crossing. There was also a significant quantity of larger debris in this part of the creek likely due to dumping of trash into this tributary. The debris was a separate concern from my observations associated with elevated TDS levels in the tributary.

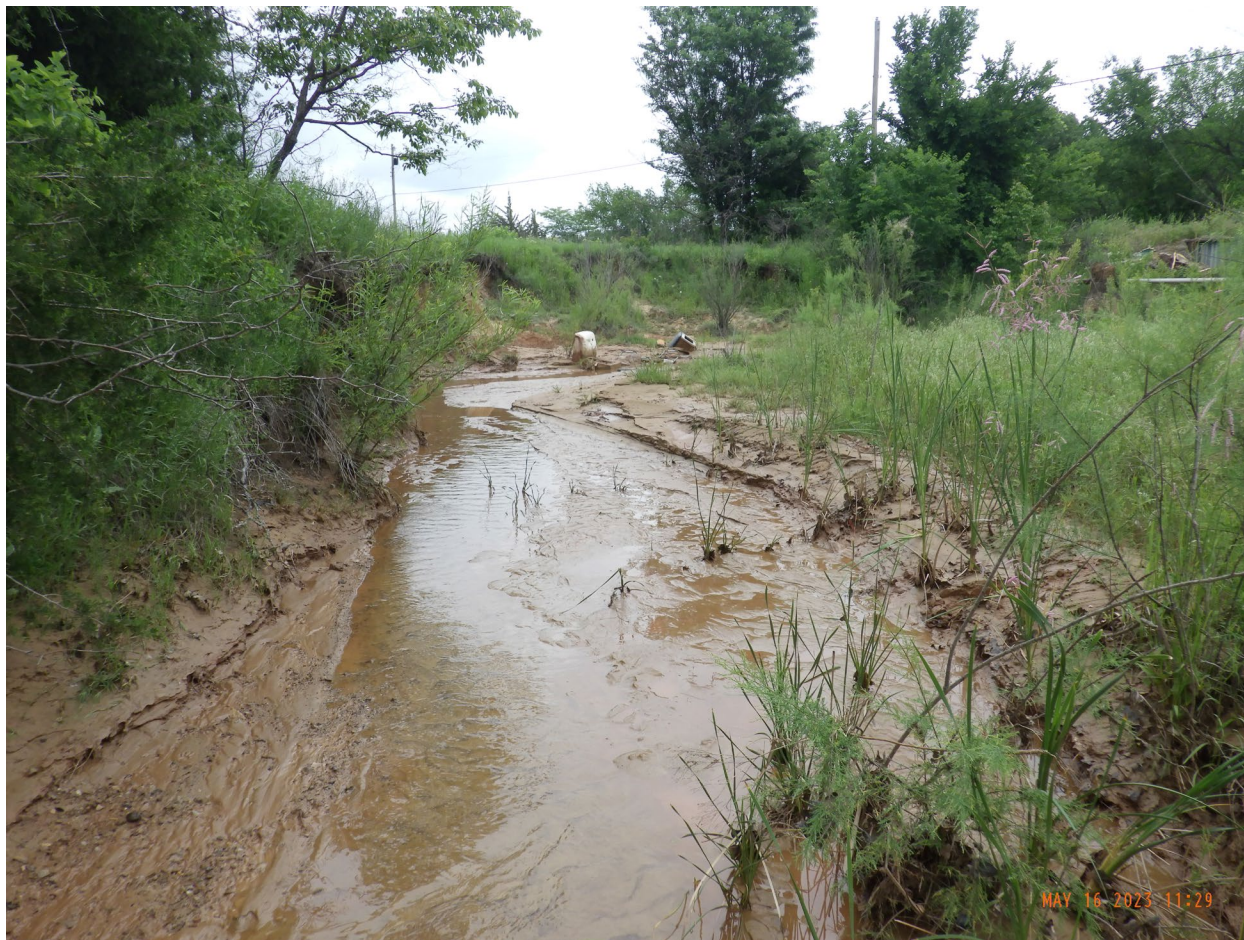
**Description:** This photo was approximately 0.57 miles downstream from the pond in Photo No. 2 of this Appendix. This photo shows an upstream view of the tributary to Post Oak Creek, where bed, bank, and other tributary characteristics were observed near the Wildflower Rd. Bridge crossing. There was also a significant quantity of larger debris in this part of the creek likely due to dumping of trash into this tributary. The debris was a separate concern from my observations associated with elevated TDS levels in the tributary.

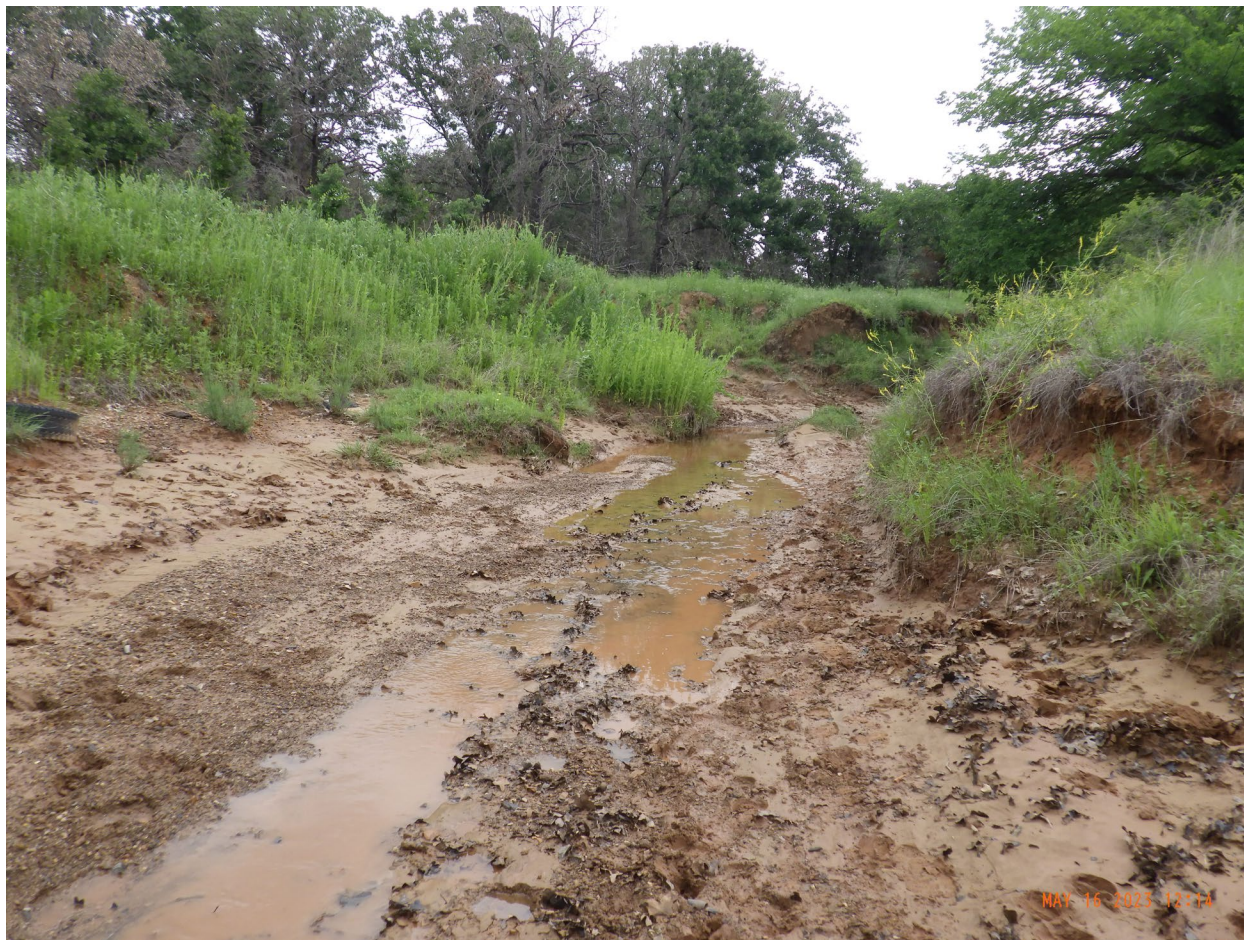
**Description:** This photo was approximately 1.16 miles downstream from the pond in Photo No. 2 of this Appendix. This photo shows an upstream view of the tributary, where bed, bank, and some riparian vegetation were observed.

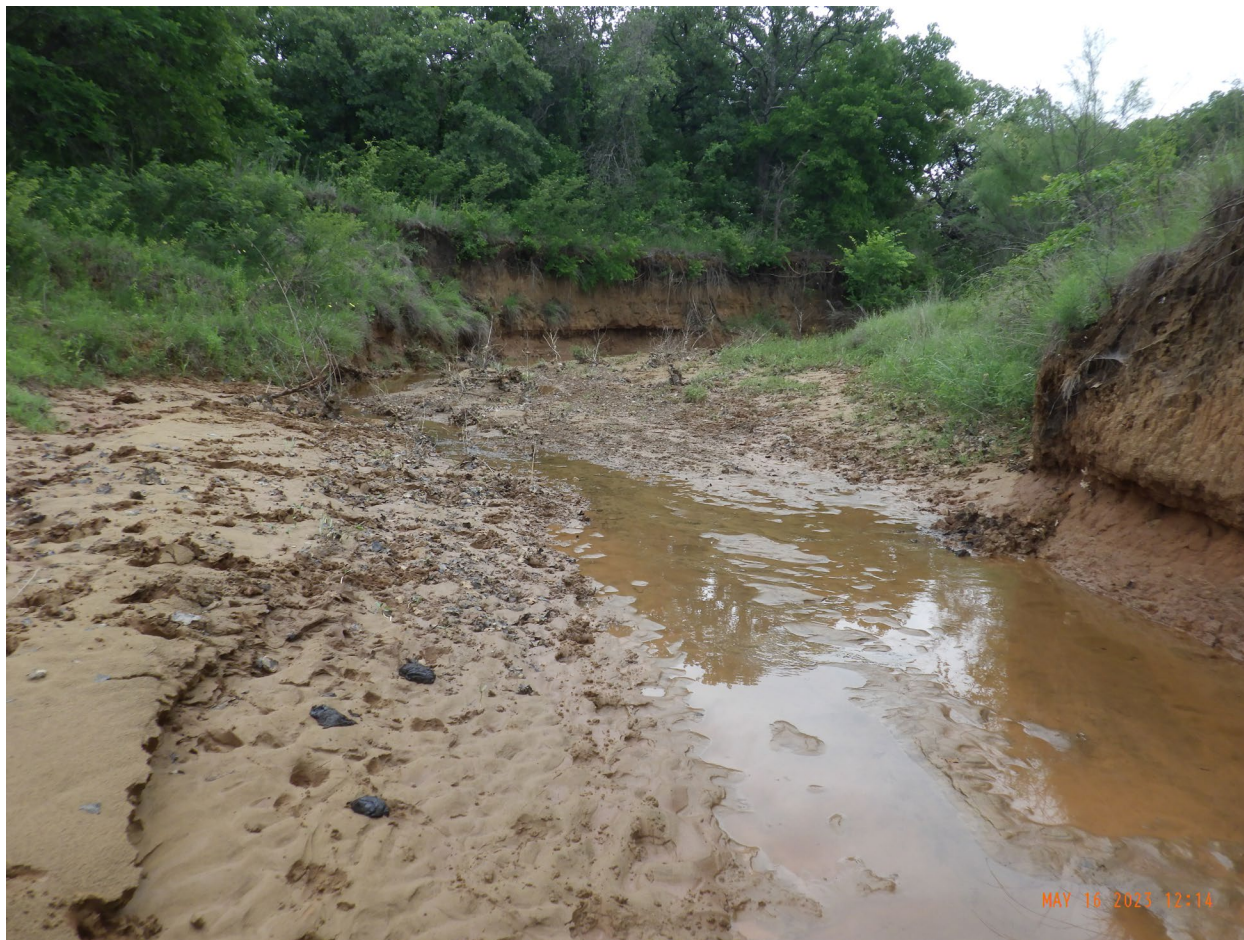
**Description:** This photo was approximately 1.16 miles downstream from the pond in Photo No. 2 of this Appendix. This photo shows a downstream view of the tributary, where bed, bank, and some riparian vegetation were observed.
