**Well Inspection**  
**Osage DNR / Environmental Protection Agency**  
**1201 Elm Street, Suite 500**  
**Dallas, Texas 75270**

| | | <b>Well ID</b> | 4W6 | | |
| <b>Inspection Reason</b> | Plugging Witnessed | <b>Responsible Company at Time of Inspection</b> | Contango Resources, LLC | | |

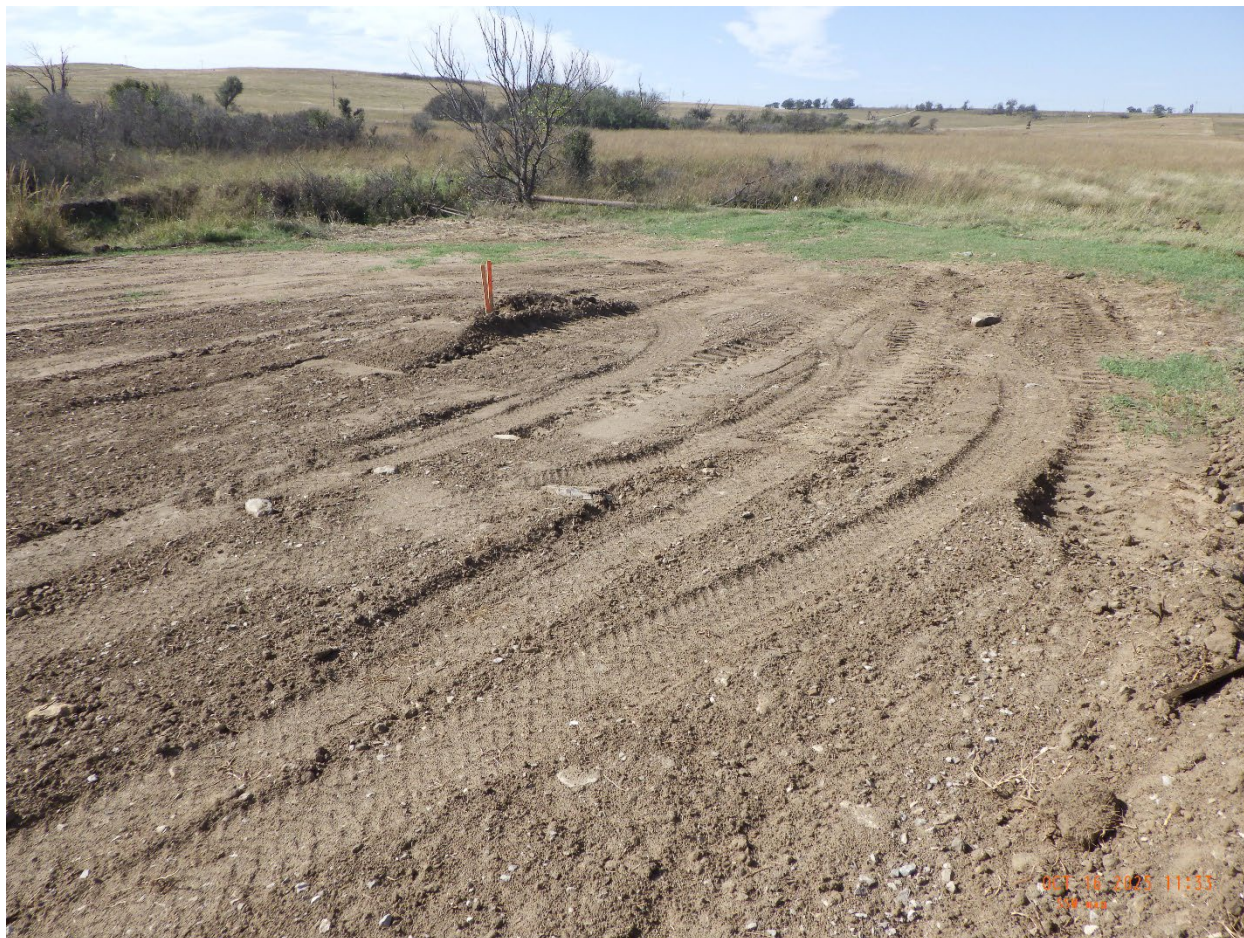
Photo No. 1

**Description:** This was the location of well OS2836000, surface restoration was complete.
