U.S. Environmental Protection Agency, Region 4  
61 Forsyth Street SW, Atlanta, GA 30303  
**Water Compliance Inspection Checklist**

| <b>Facility Name:</b> Sardine Pit North | | <b>SIC Code:</b> 1442 |

## ALG850000 – Alabama NPDES General Permit for Non-Coal/Non-Metallic Aggregate Mining Worksheet

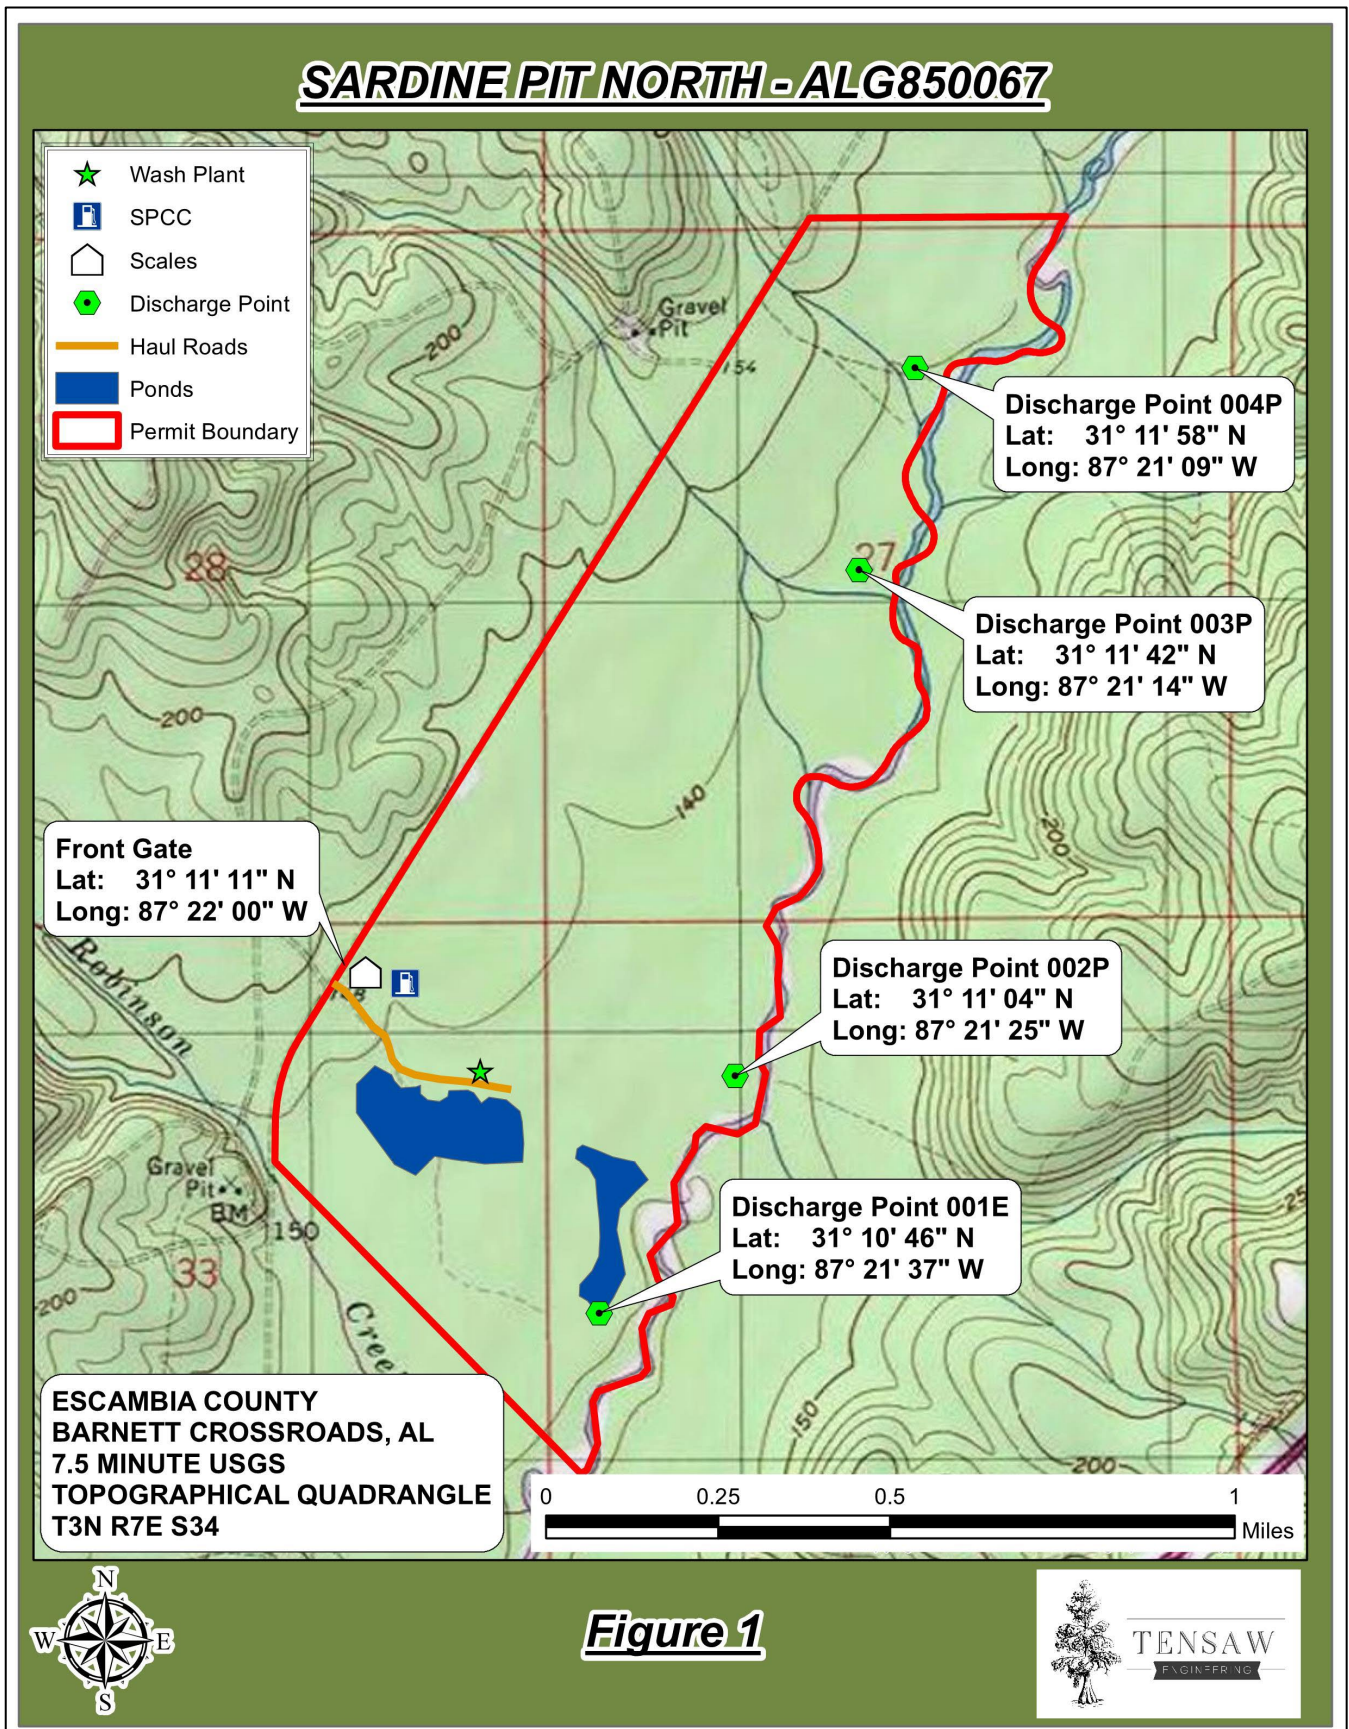
Image 1

Sardine Pit North (the Facility) is a sand and gravel mine operated by South Alabama Materials. The Facility is bordered by Big Escambia Creek to the East and Robinson Creek to the south (refer to [Image 1](#), below). The Facility is approximately 550 acres in total size with approximately 50 acres of disturbed area at any time. Sardine Pit South and Sardine Pit North comprise the entire 550 acres owned by South Alabama Materials. The Facility originally obtained NPDES permit coverage in 2014 and the permit was renewed in 2017. The Facility’s 2017 permit coverage expired on March 31, 2022, and was not renewed until December 4, 2023.

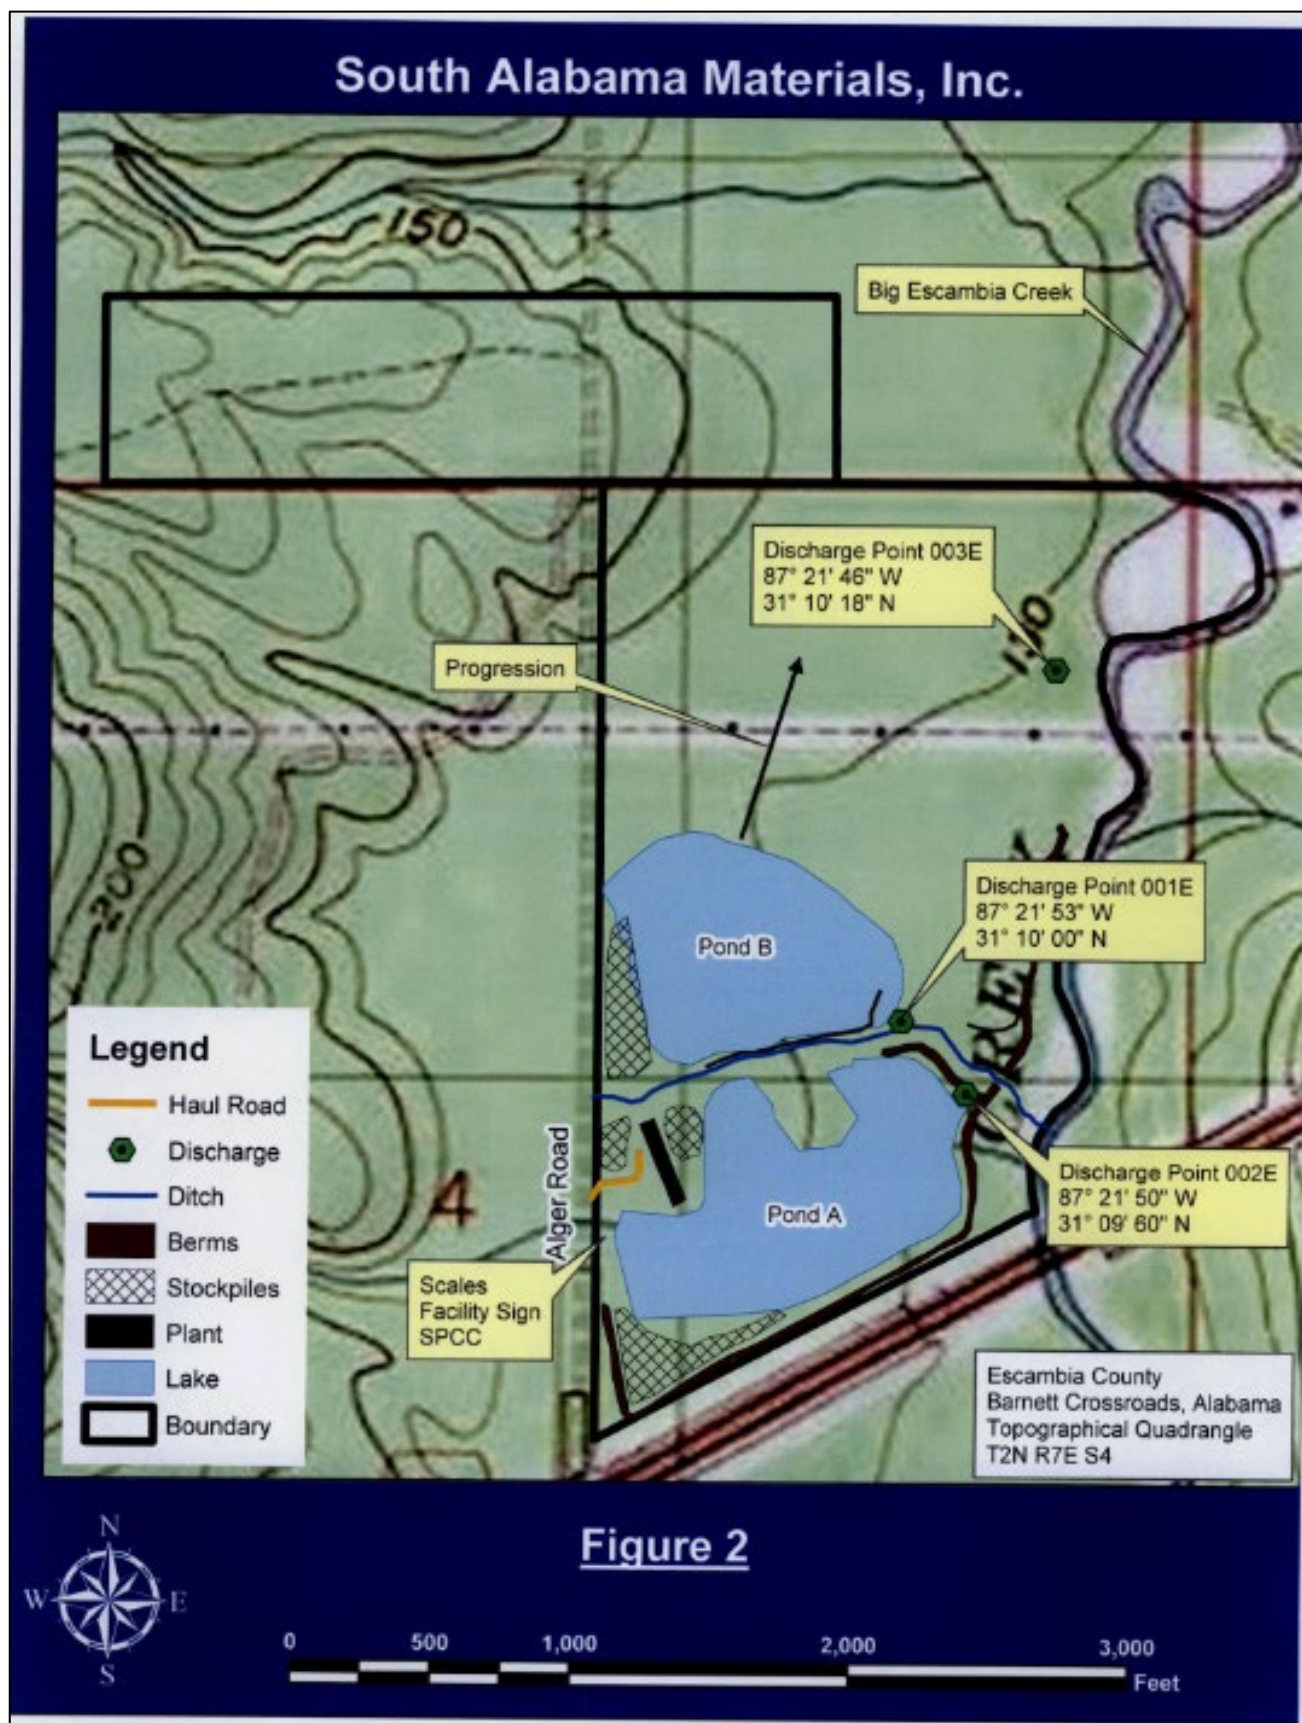
Image 2

The permittee started Facility mining operations in Sardine Pit South (Permit # AL850066), located south of Robinson Creek (refer to [Image 2](#), below). Mining operations in Sardine Pit South began in approximately 2003 and ceased in 2015, according to the Facility representatives. Following mining operations, the Sardine Pit South was reportedly reclaimed through revegetation. Although operations ceased at Sardine Pit South in 2015, the operator submitted discharge monitoring reports (DMRs) for three outfalls through June 2022, reporting no discharge on all DMRs during this period. Alabama Department of Environmental Management (ADEM) administratively closed out the operations at Sardine Pit South site on July 12, 2022.
