**Region 6 - Enforcement & Compliance Assurance Division**  
**INSPECTION REPORT**

| Company Name: | <b>CLH20, LLC (Centre Living Homes)</b> | |
| Facility Name: | <b>Painted Tree Lakeside District West Phase 2</b> | |
| Identification/Permit Number: | TXR1593PA | |

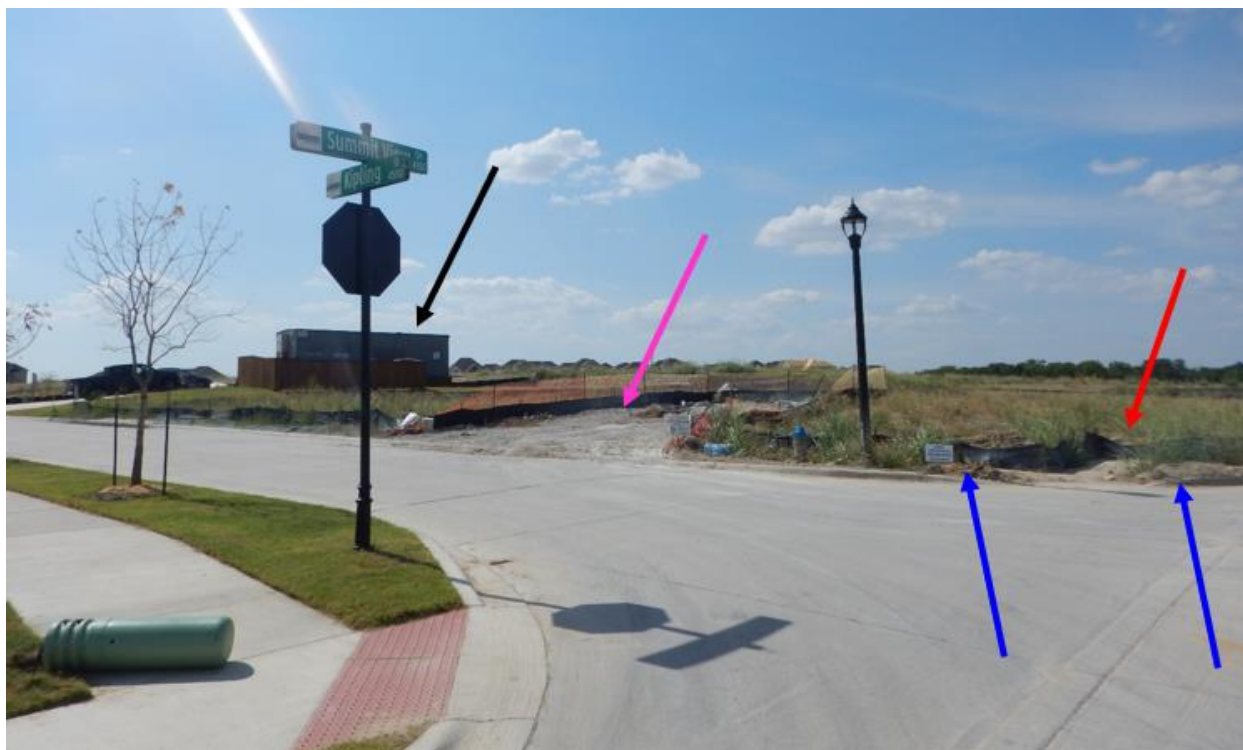
Photo No. 1

Description: Corner view, of the intersection of Kipling St. and Summit View Dr., with view of construction trailer in the background (black arrow). Ineffective BMPs indicated by red arrow (i.e., damaged silt fencing). Damaged erosion blankets, accumulated sediment and sediment carryover observed on the sidewalk(s), curb(s), and into the access streets from the construction area (blue arrows). The site's concrete washout pad was also located on Kipling St. (pink arrow). Closer views provided in following photos.

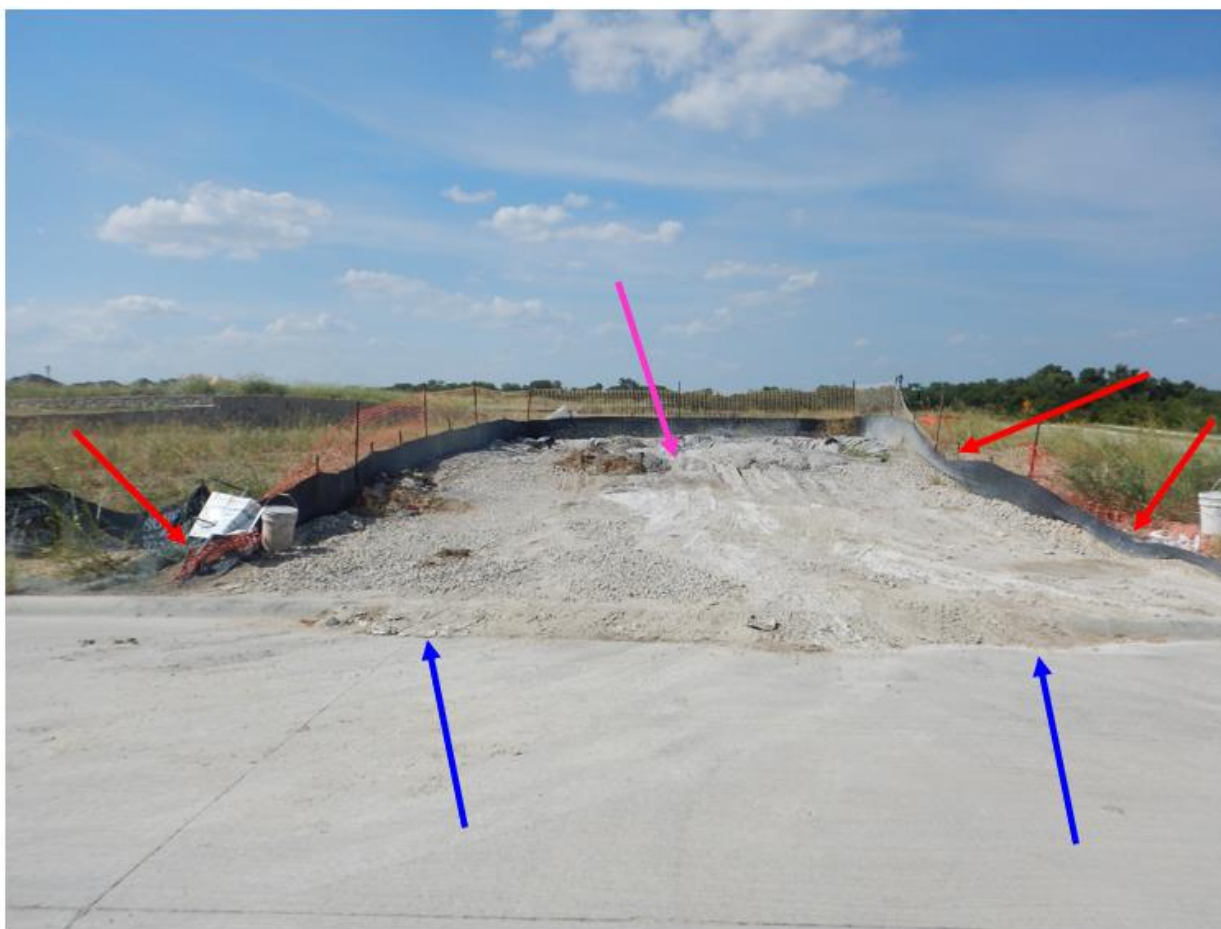
Photo No. 2

Description: Closer view, of the site's concrete washout pad (pink arrow). Note: The area is sloped towards Kipling St. with concrete dust/material and sediment carryover in the access street (blue arrow) and the silt fence bordering the concrete washout pad was also damaged in some areas.

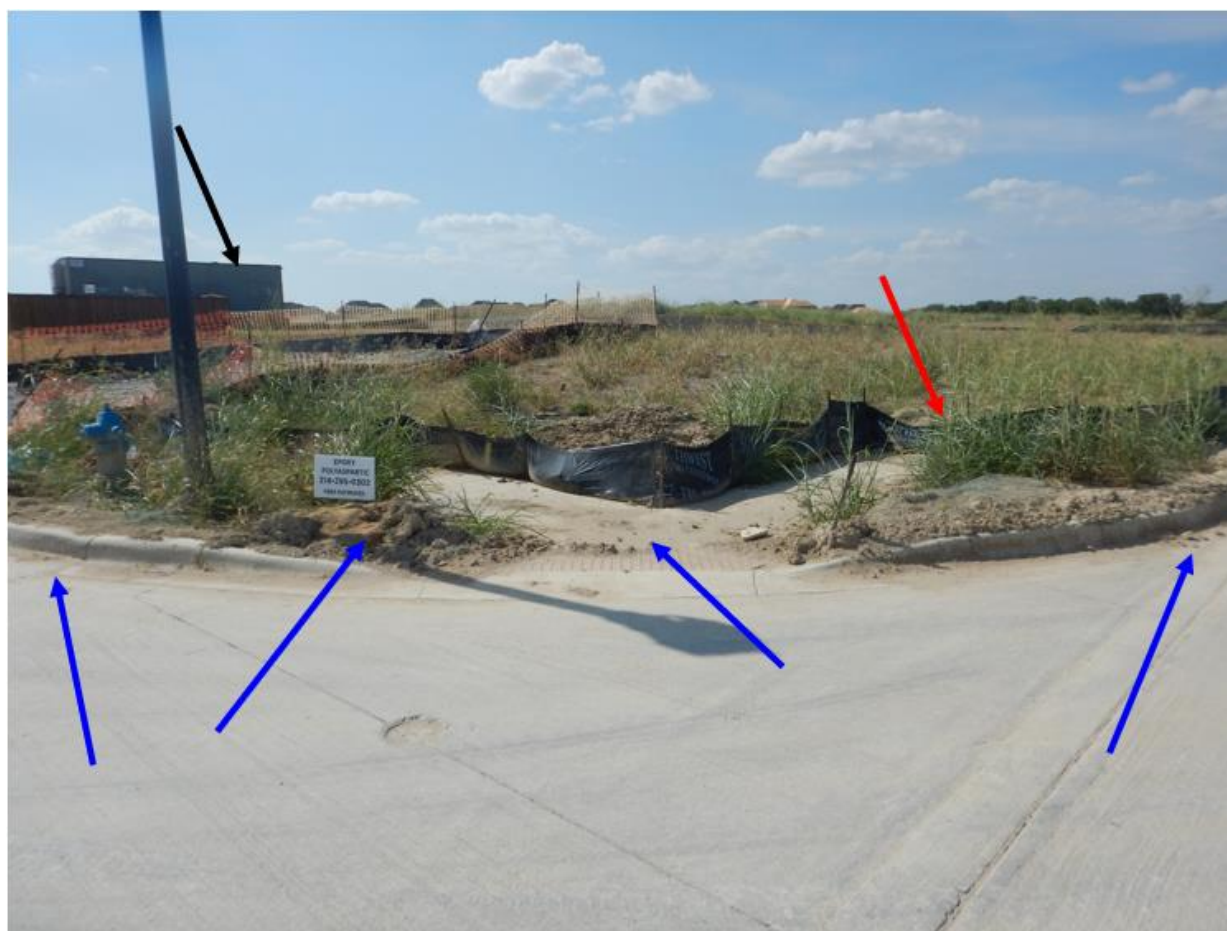
Photo No. 3

Description: Closer view, of the intersection of Kipling St and Summit View Dr with view of construction trailer in the background (black arrow). Ineffective BMPs indicated by red arrow (i.e., damaged silt fencing). Damaged erosion blankets, accumulated sediment and sediment carryover observed on the sidewalk(s), curb(s), and into the access streets from the construction area (blue arrows).

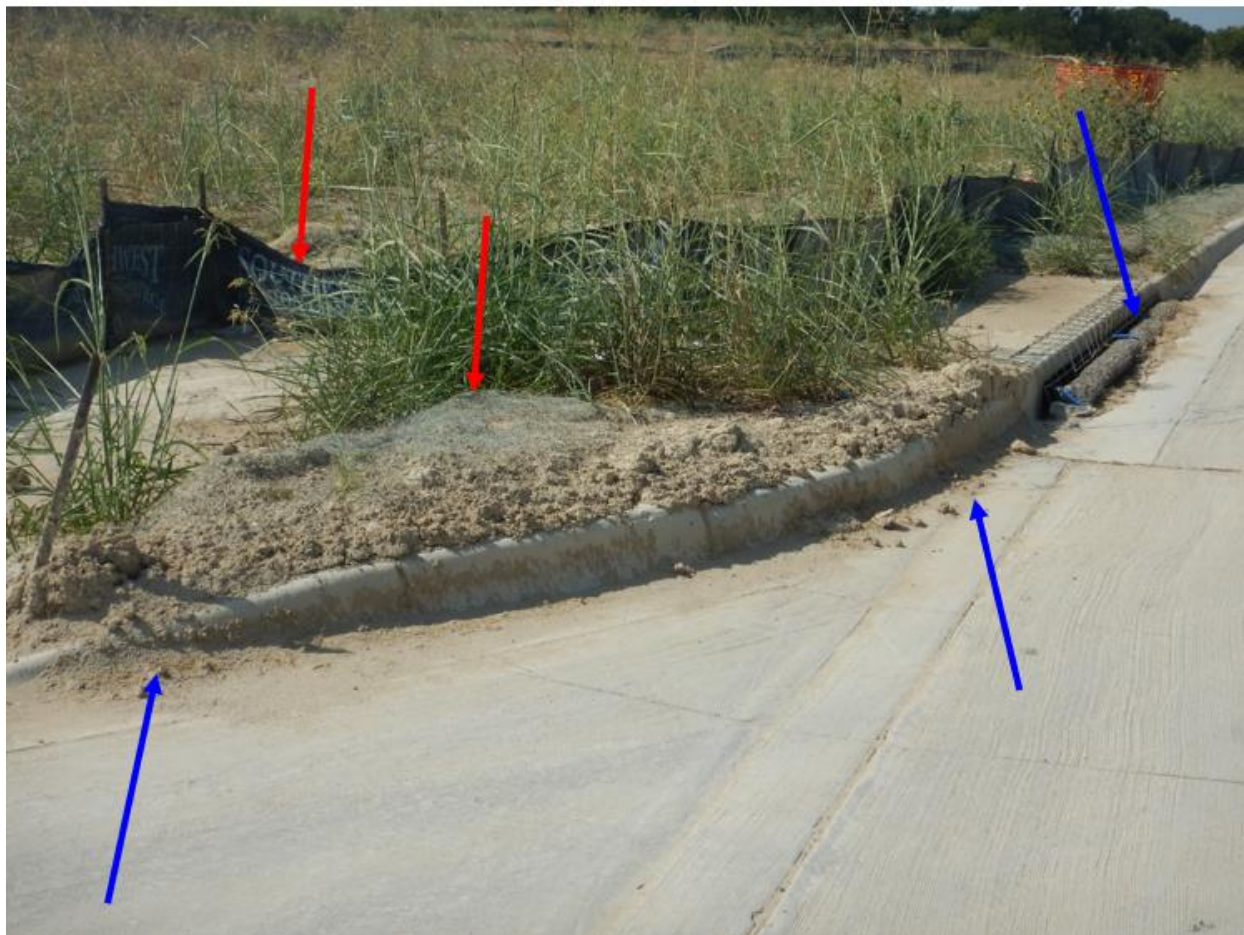
Photo No. 4

Description: Closer view, of corner area at the intersection of Kipling St. and Summit View Dr., with view of ineffective BMPs indicated by red arrow (i.e., damaged silt fencing and erosion blanket), accumulated sediment and sediment carryover observed on the sidewalk(s), curb(s), and into the access streets from the construction area (blue arrows). Note: Sediment carryover into the access street leading to the inlet protection. Closer picture of inlet protection provided in Photos #5 and #6.

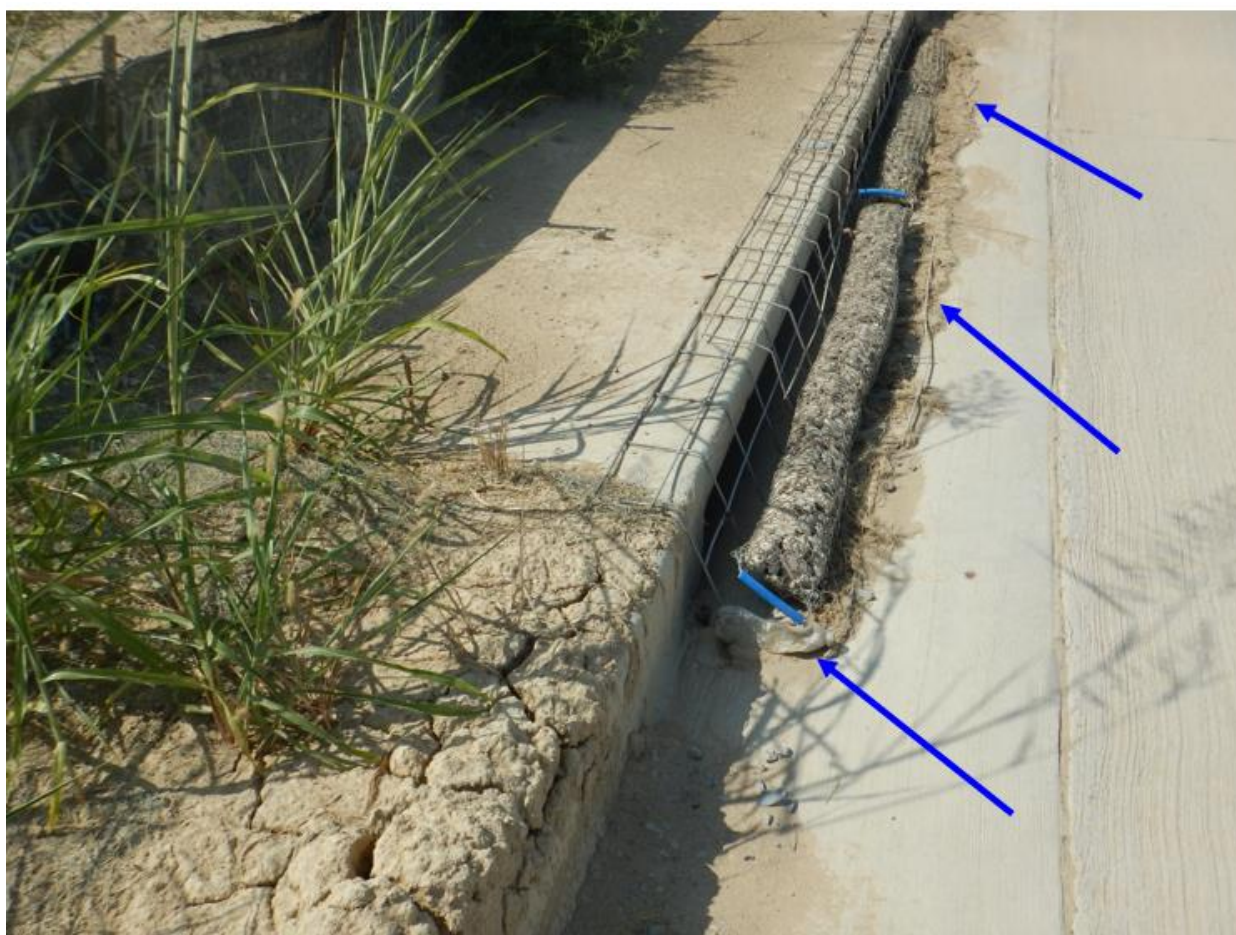
Photo No. 5

Description: View, of inlet protection on Summit View Dr., not maintained in an effective operating condition (e.g., inlet protection surrounded with sediment, dead vegetation, and other debris).

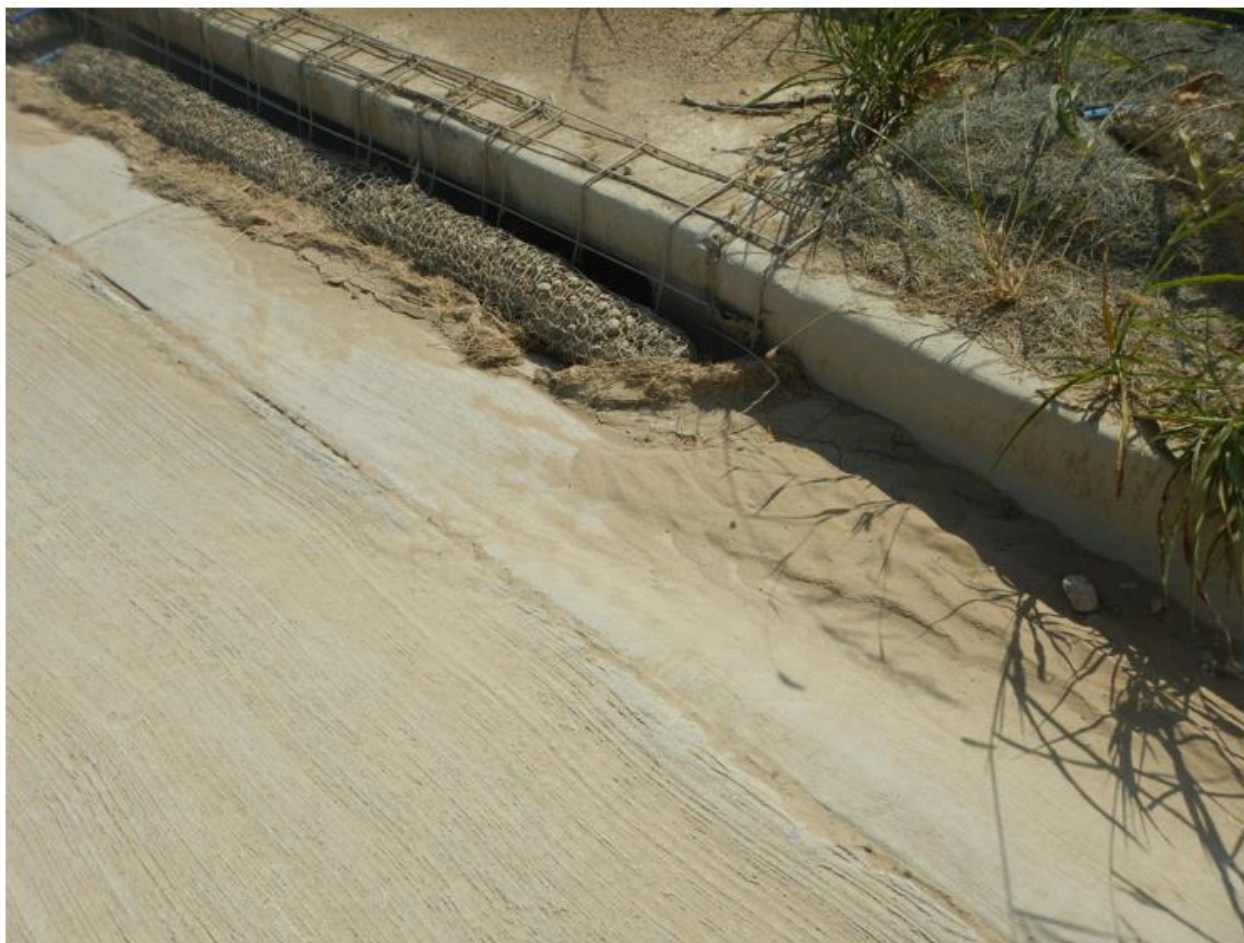
Photo No. 6

Description: Closer view, of inlet protection on Summit View Dr., not maintained in an effective operating condition (e.g., inlet protection surrounded with sediment and dead vegetation).

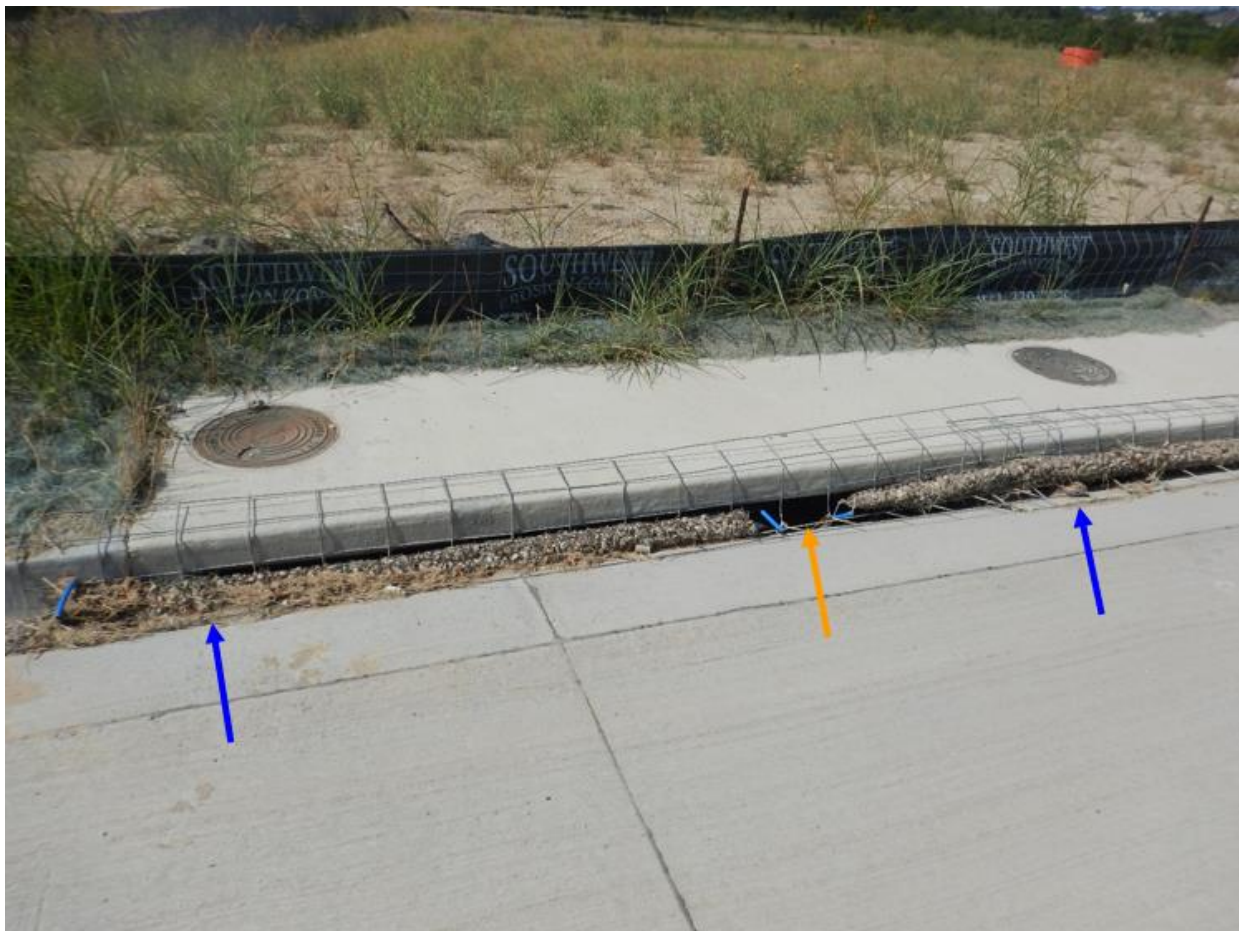
Photo No. 7

Description: View, of inlet protection on Summit View Dr., not maintained in an effective operating condition (e.g., debris, silt, and dead vegetation) was observed surrounded and/or trapped in the device. In addition, there was a gap in the middle of the two (2) structures, which could potentially allow debris, silt and/or dead vegetation to enter the drain (orange arrow).

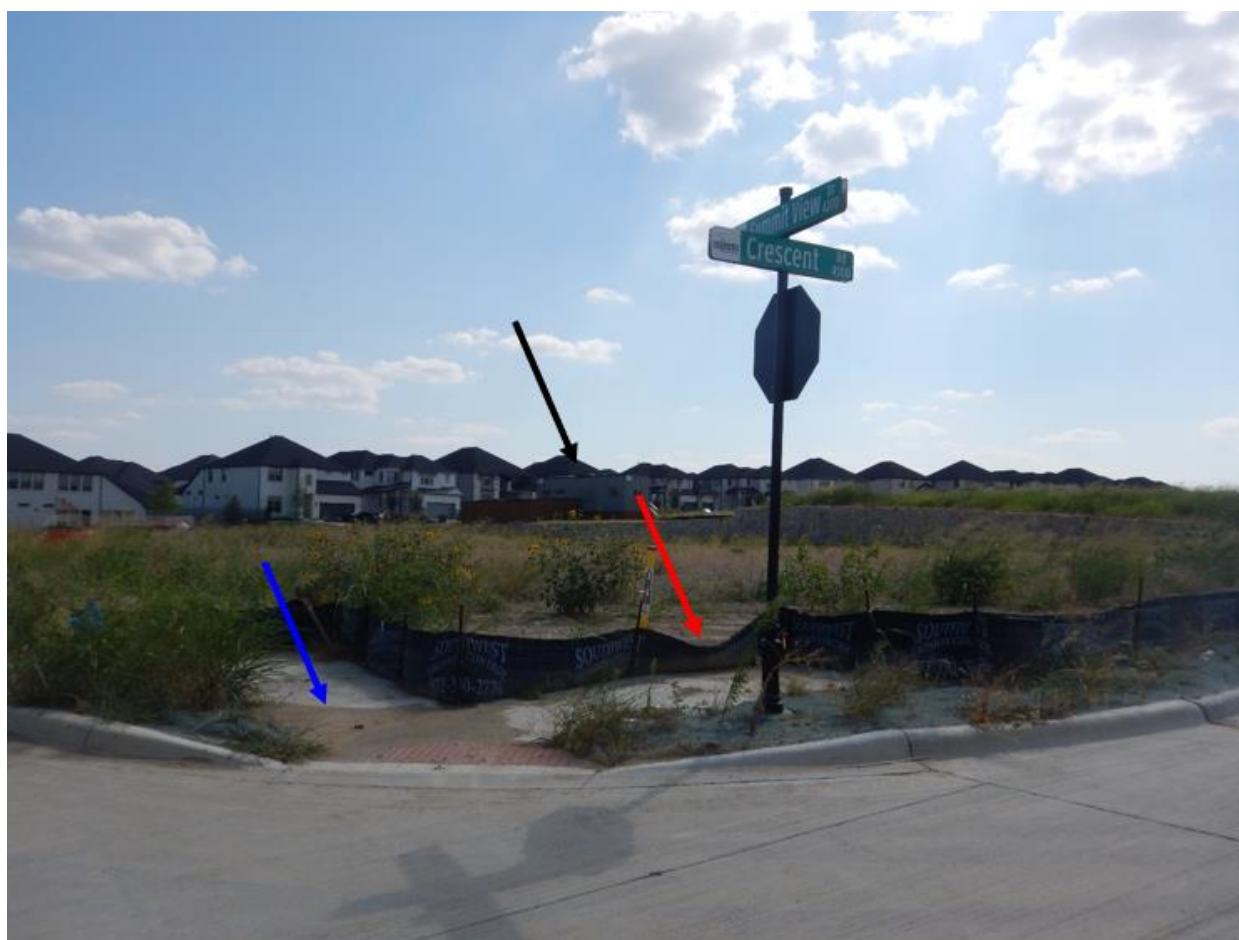
Photo No. 8

Description: View, of intersection of Summit View Dr. and Crecent Rd., with view of construction trailer in the background on Kipling St (black arrow). Ineffective BMPs indicated by red arrow (i.e., damaged silt fencing). Sediment carryover observed on the sidewalk from the construction area (blue arrow).

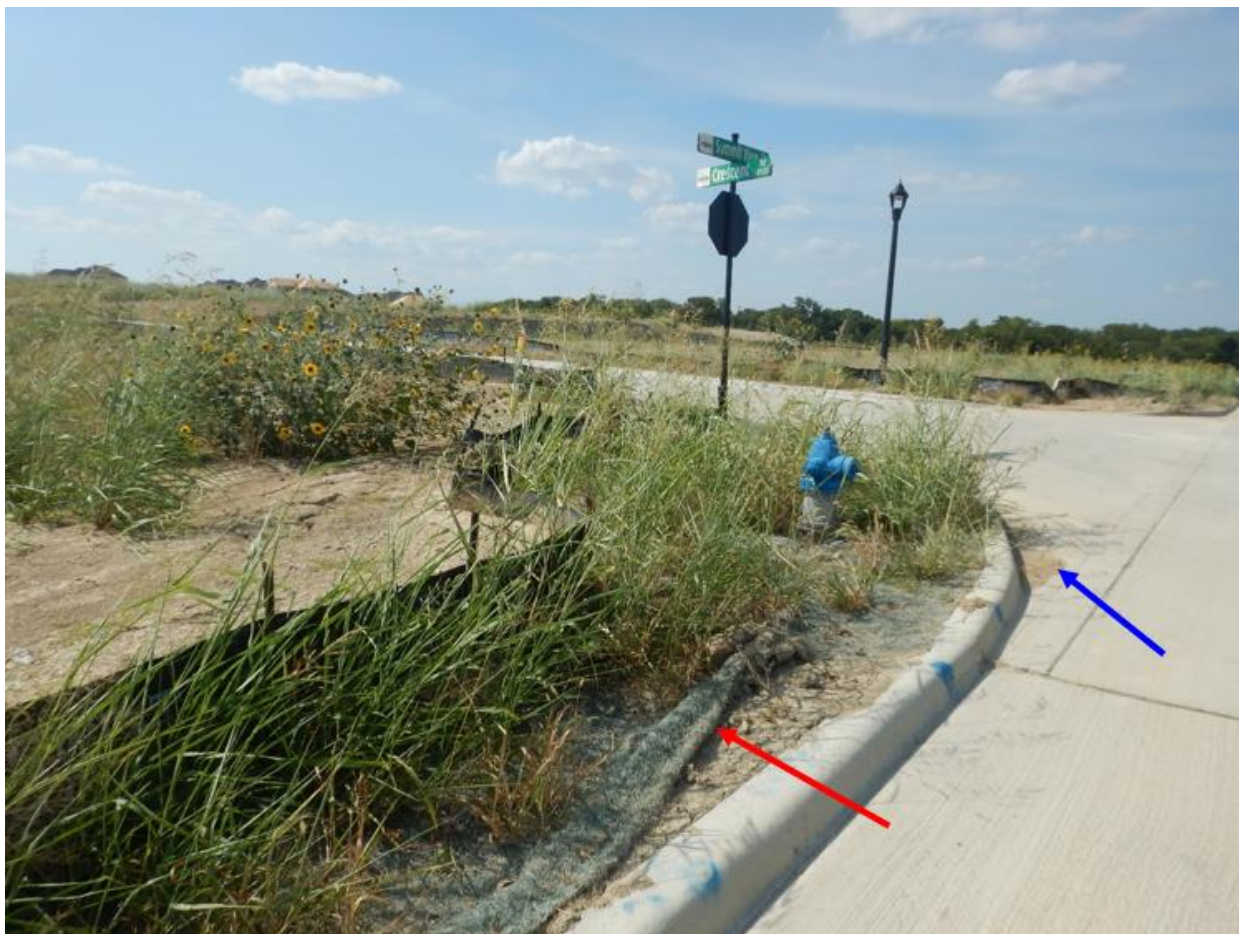
Photo No. 9

Description: An additional view, of the intersection of Summit View Dr. and Crecent Rd., with view of ineffective BMPs indicated by red arrow (i.e., damaged erosion blankets). Sediment carryover into the access street was also observed (blue arrows).

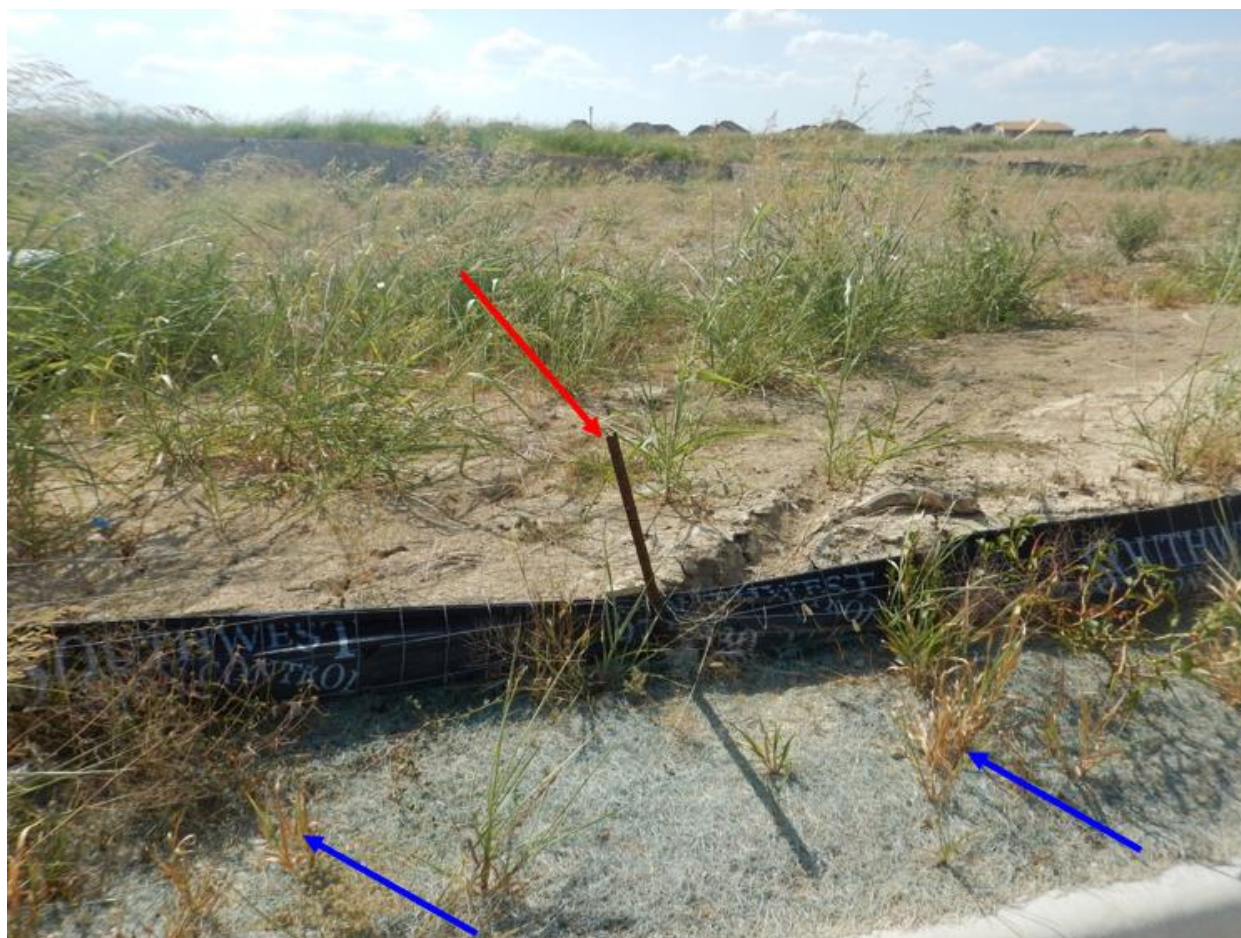
Photo No. 10

Description: View, of ineffective BMPs indicated by red and blue arrows (i.e., damaged silt fencing and erosion blanket filled with vegetive growth).

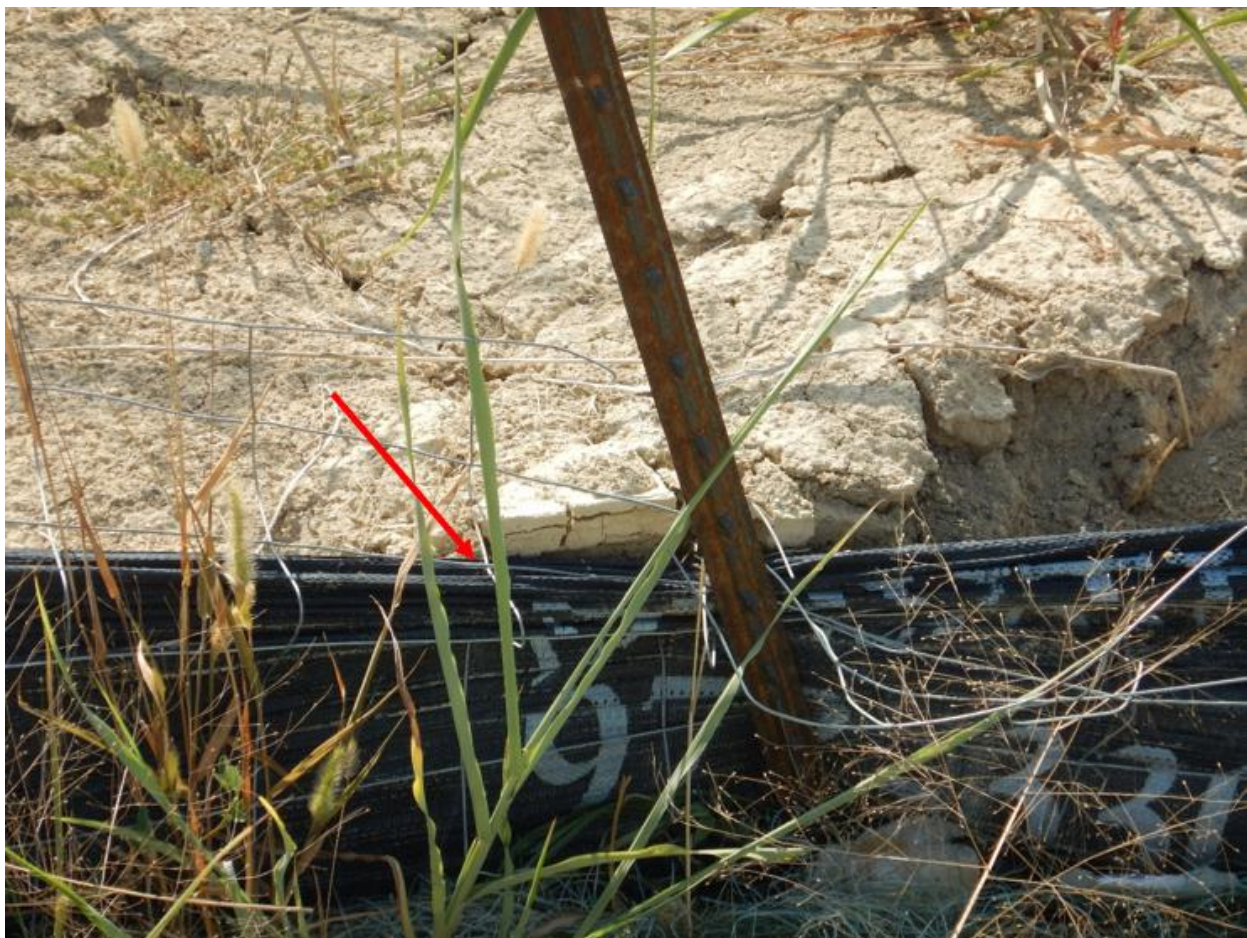
Photo No. 11

Description: Closer view, of ineffective BMPs indicated by red arrow (i.e., damaged silt fencing). It was also observed that the silt fencing had recessed towards the ground and dirt/sediment buildup was now leveled with the top of the silt fence.

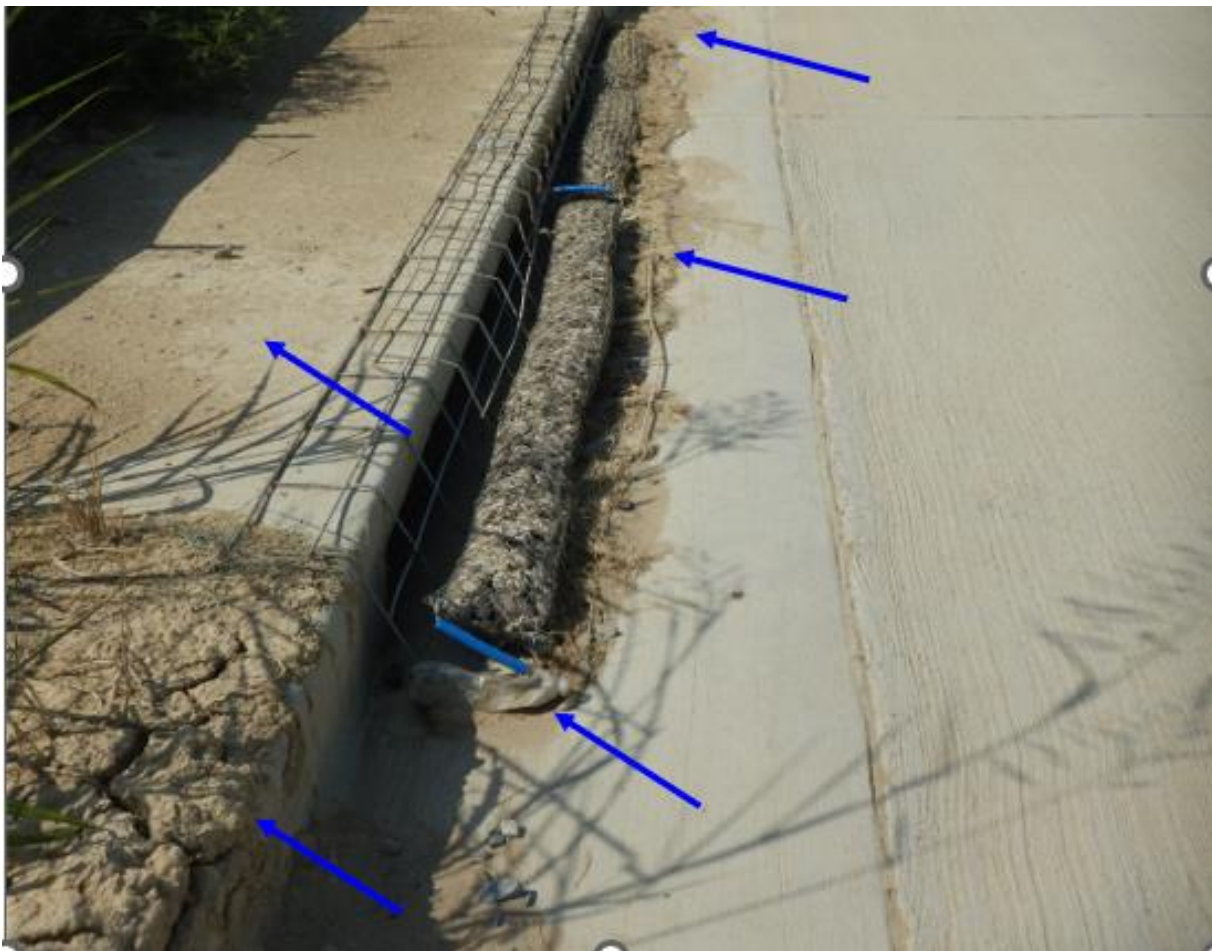
Photo No. 12

Description: View, of inlet protection on Summit View Dr., not maintained in an effective operating condition (e.g., inlet protection filled with sediment and surrounded by dead vegetation, trash, and debris). Closer view of inlet captured in Photo #13. Sediment carryover onto the sidewalk, curb, and into the access street was also observed.

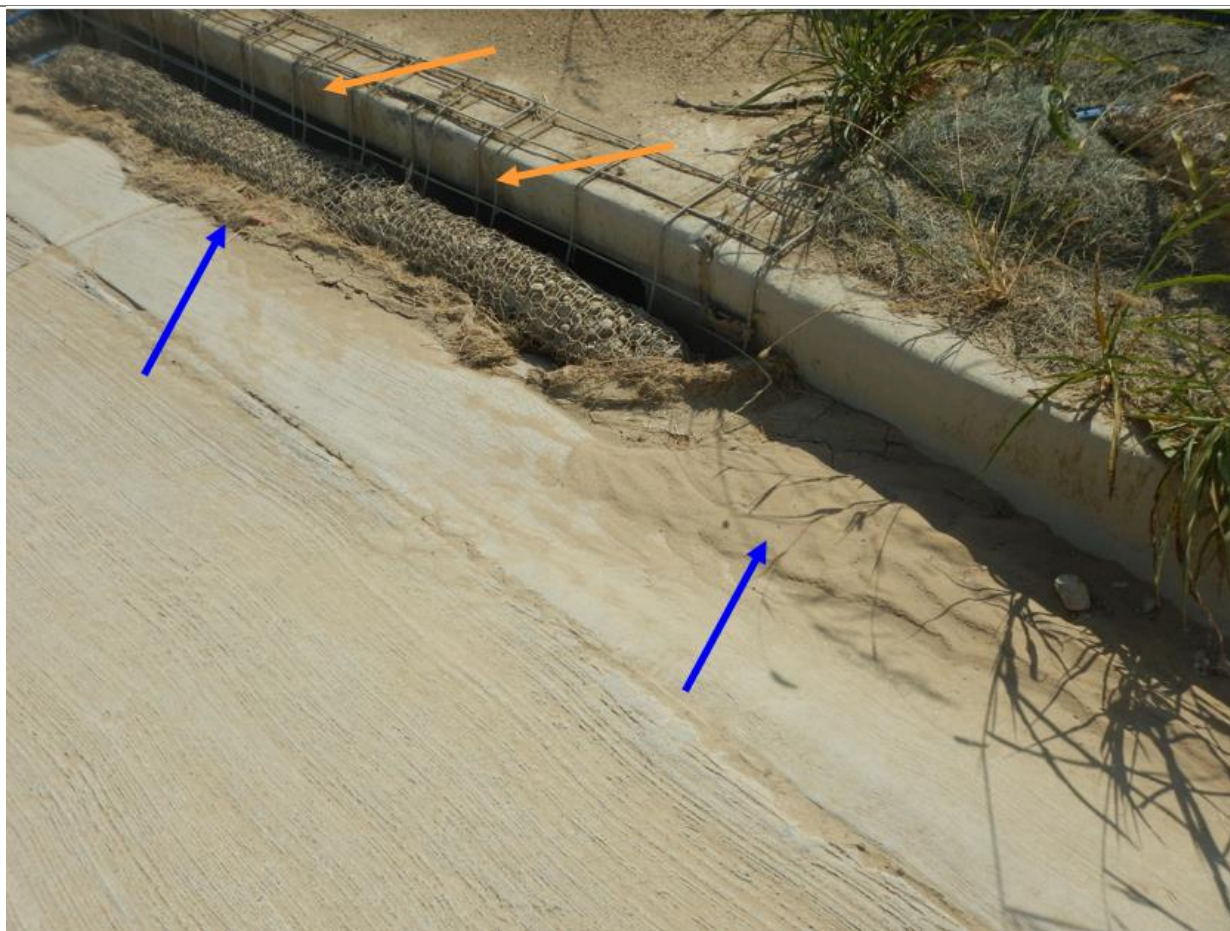
Photo No. 13

Description: Closer view, of inlet protection on Summer View Dr., not maintained in an effective operating condition (e.g., inlet protection surrounded with sediment and dead vegetation). There was sediment accumulation on the sides leading to the inlet protection. In addition, there was sediment staining (orange arrows) observed just above the inlet protection, leading from the sidewalk and curb, which indicated the potential of impacted stormwater directly into the drainage system.

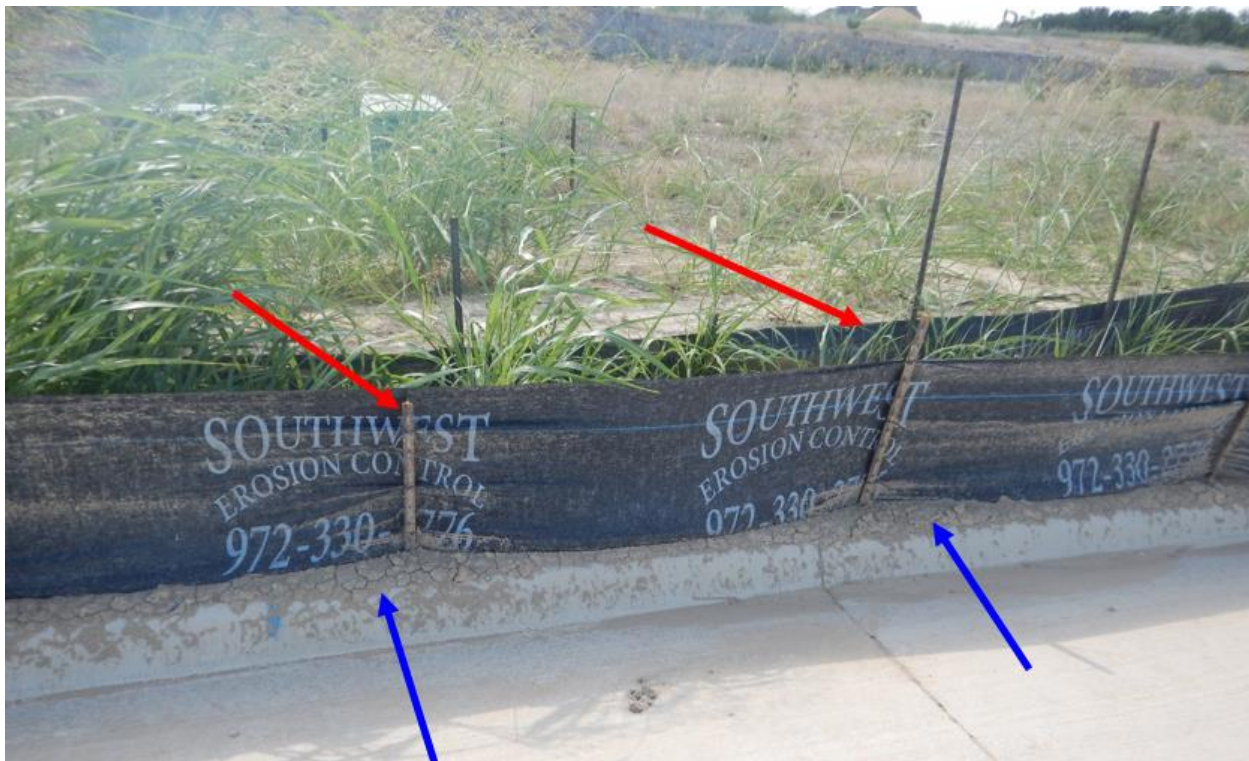
Photo No. 14

Description: View, of ineffective BMPs indicated by red arrows. Specifically, the silt fencing installed failed to prevent sediment carryover from exiting the construction area and accumulating on the curb and carrying over in the access road on Summit View Dr (blue arrows).

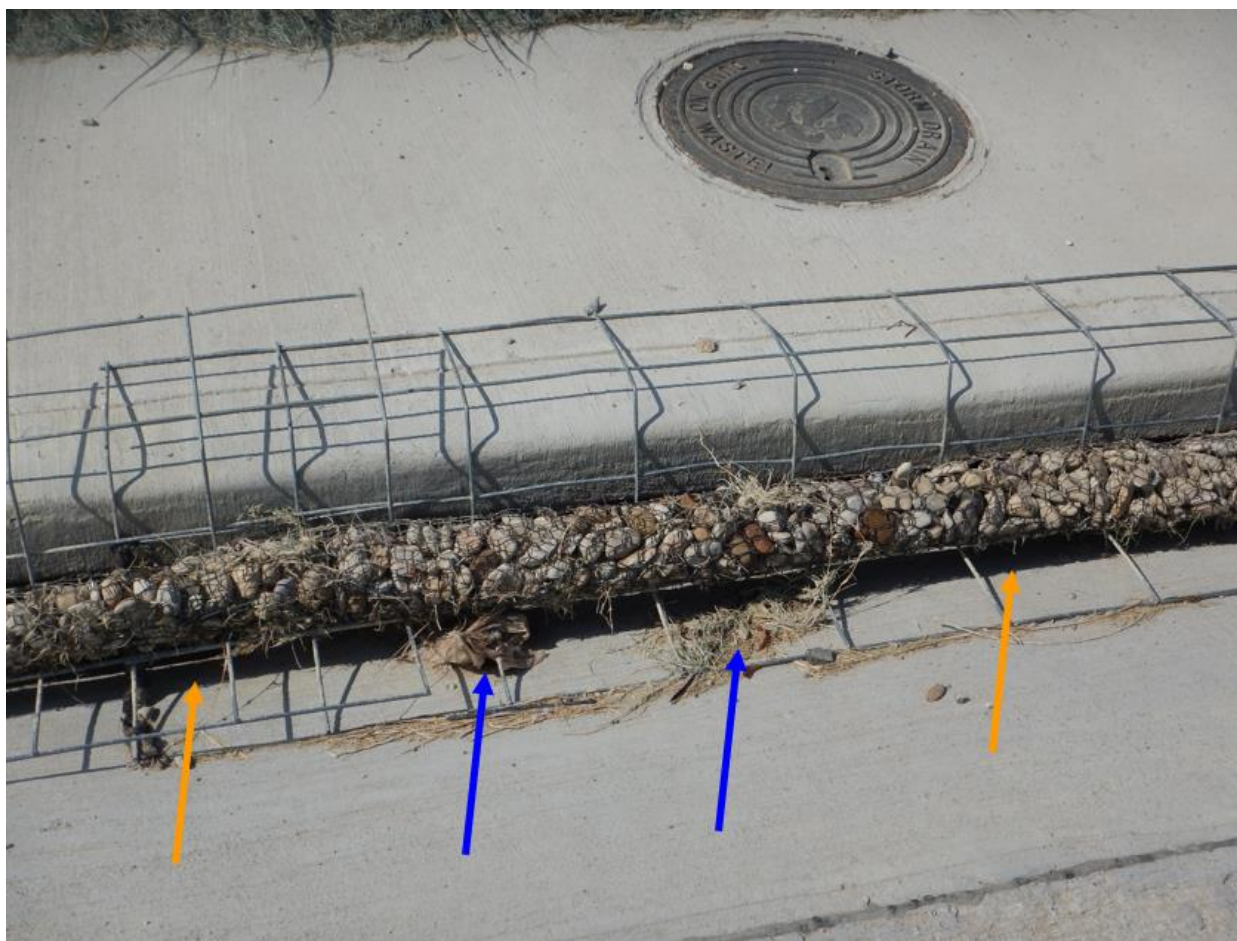
Photo No. 15

Description: View, of inlet protection on Crescent St., not maintained in an effective operating condition. Note: Other trash/debris (e.g., plastic bag and dead vegetation) was observed (blue arrows). Also, the inlet was installed at a height that contained space between the inlet protection and the ground, which allowed sediment and other debris to enter the stormwater drain underneath the inlet protection (as reflected by orange arrows).

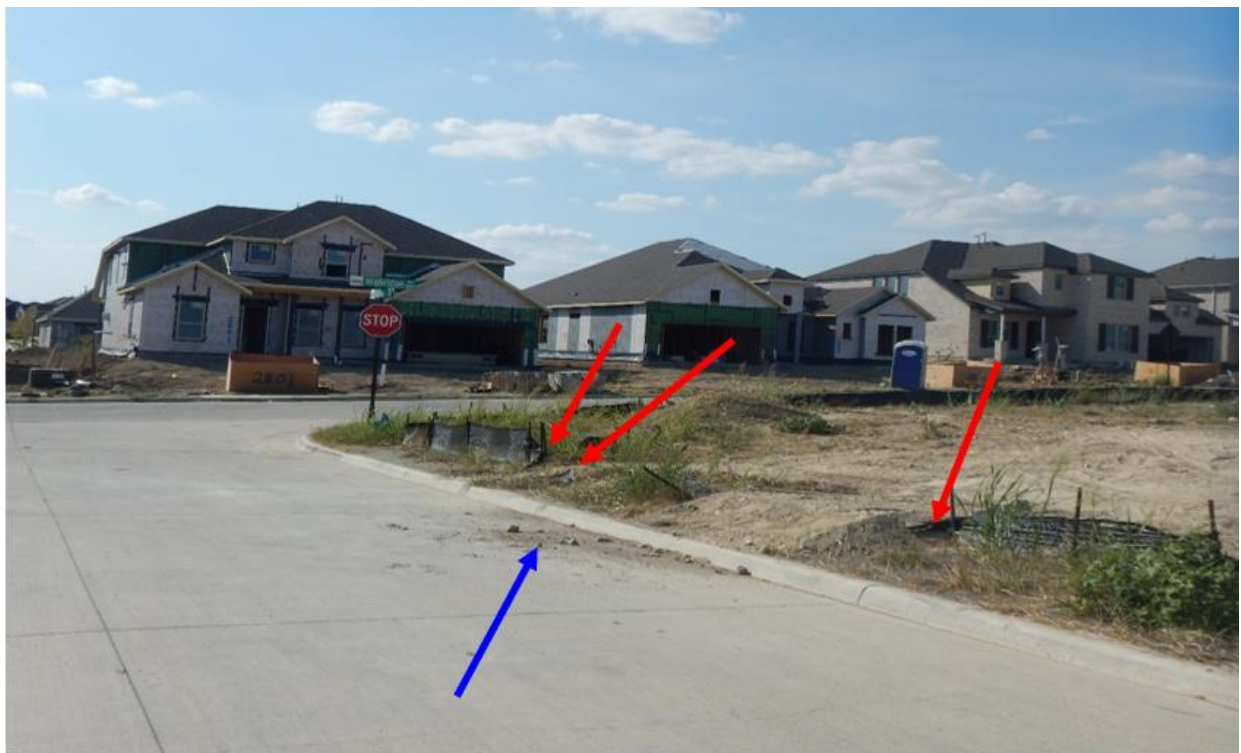
Photo No. 16

Description: View, near the intersection of Kipling St. and Highridge Dr., ineffective BMPs indicated by red arrows. Specifically, the silt fencing was damaged and/or not present, and the installed failed to prevent sediment carryover from the construction area and accumulating in the access road on Kipling St. (blue arrow).

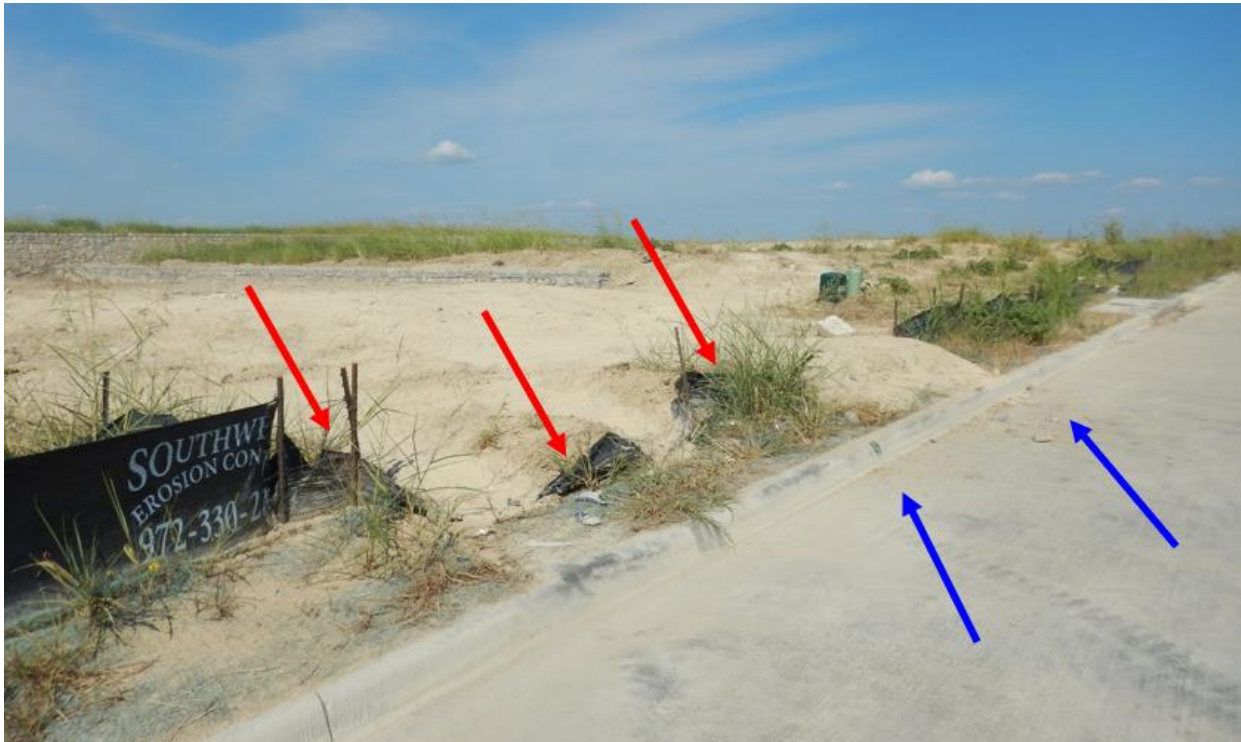
Photo No. 17

Description: Closer view, of construction area on Kipling St. (near the intersection of Highridge Dr.), ineffective BMPs indicated by red arrow. Specifically, the silt fencing was damaged and/or not present, and the installed failed to prevent sediment carryover from exiting the construction area and accumulating in the access road on Kipling St (blue arrow).

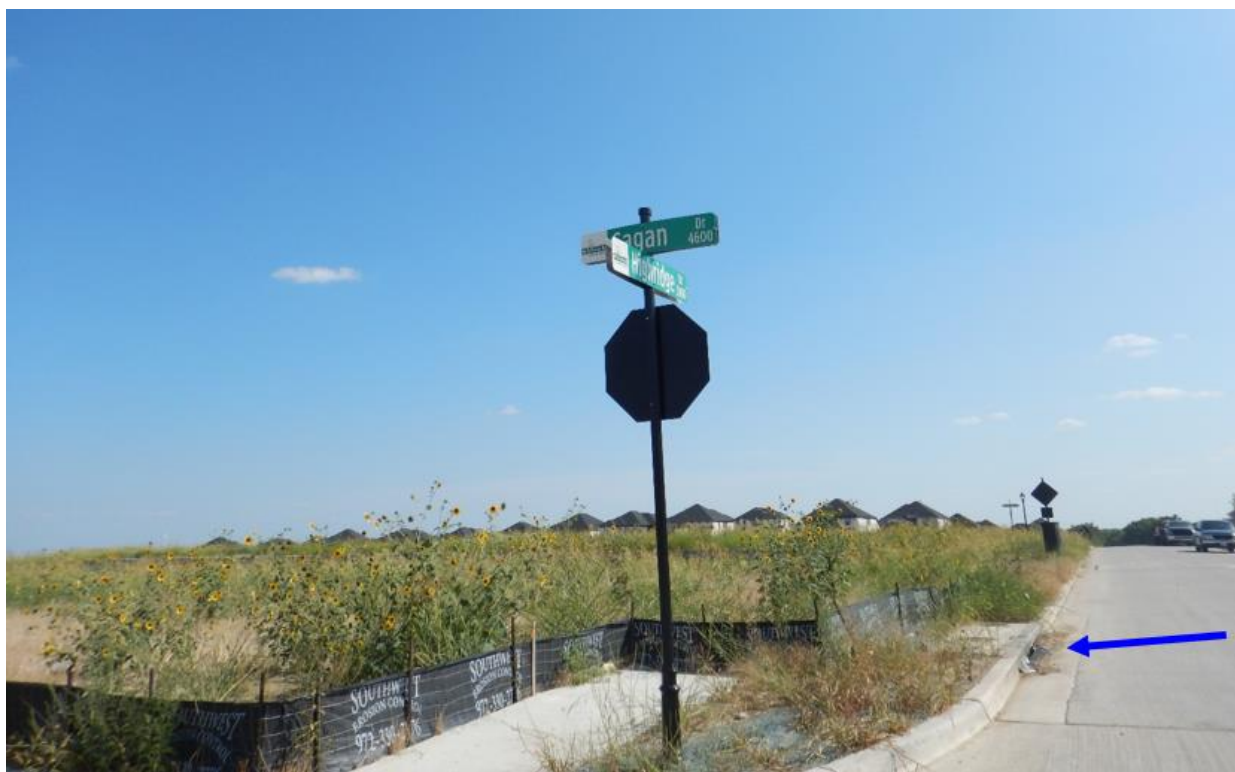
Photo No. 18

Description: Corner view, of the intersection of Sagan Dr. and Highridge Dr., with view of an inlet protection not maintained in an effective operating condition (blue arrow) (e.g., inlet protection surrounded by dead vegetation, sediment, trash, and debris). Closer views provided in following photos.

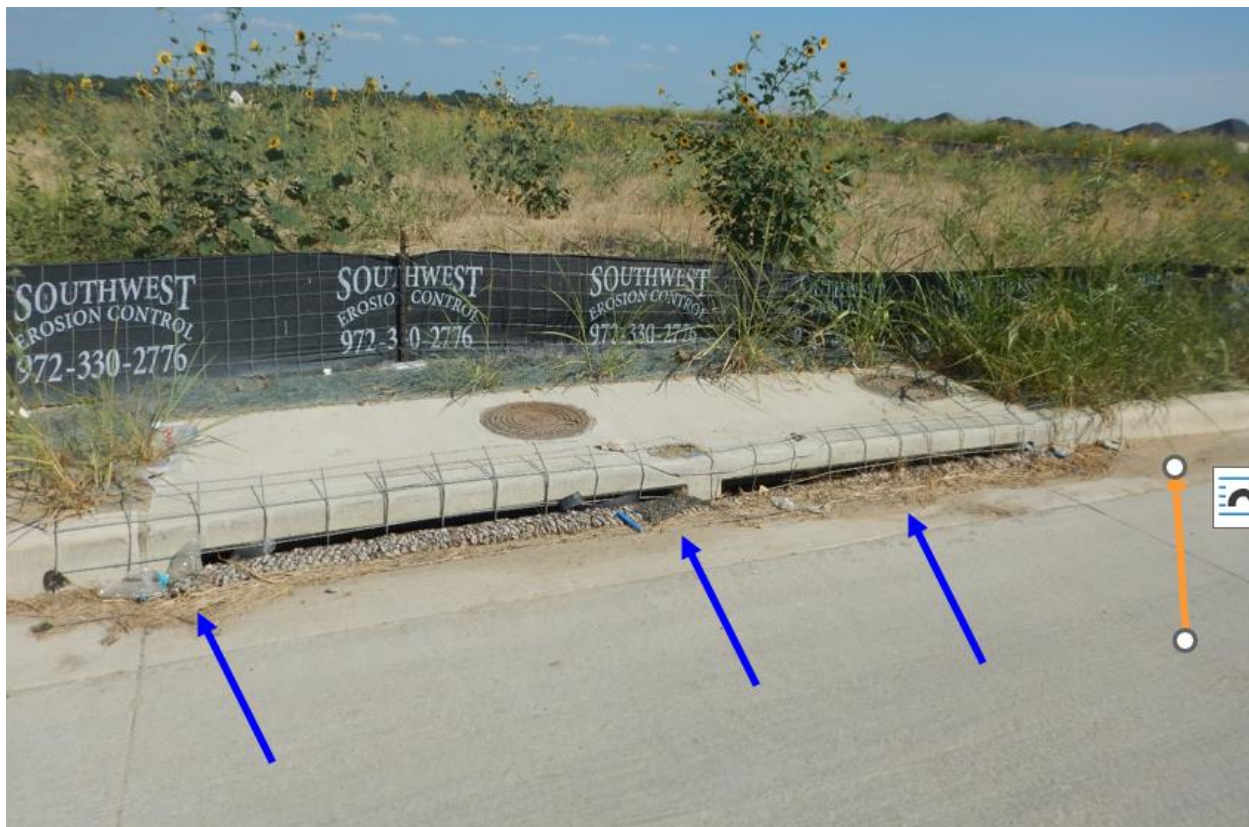
Photo No. 19

Description: Closer view, of an inlet protection on Highridge Dr., not maintained in an effective operating condition indicated by blue arrows (e.g., inlet protection surrounded by dead vegetation, sediment, trash, and debris). In addition, sediment carryover accumulated in the access road (orange arrow).
