**Region 6 - Enforcement & Compliance Assurance Division**  
**INSPECTION REPORT**

| Company Name: | <b>CLH20, LLC (Centre Living Homes)</b> | |
| Facility Name: | <b>Painted Tree Lakeside District West Phase 2</b> | |
| Identification/Permit Number: | TXR1593PA | |

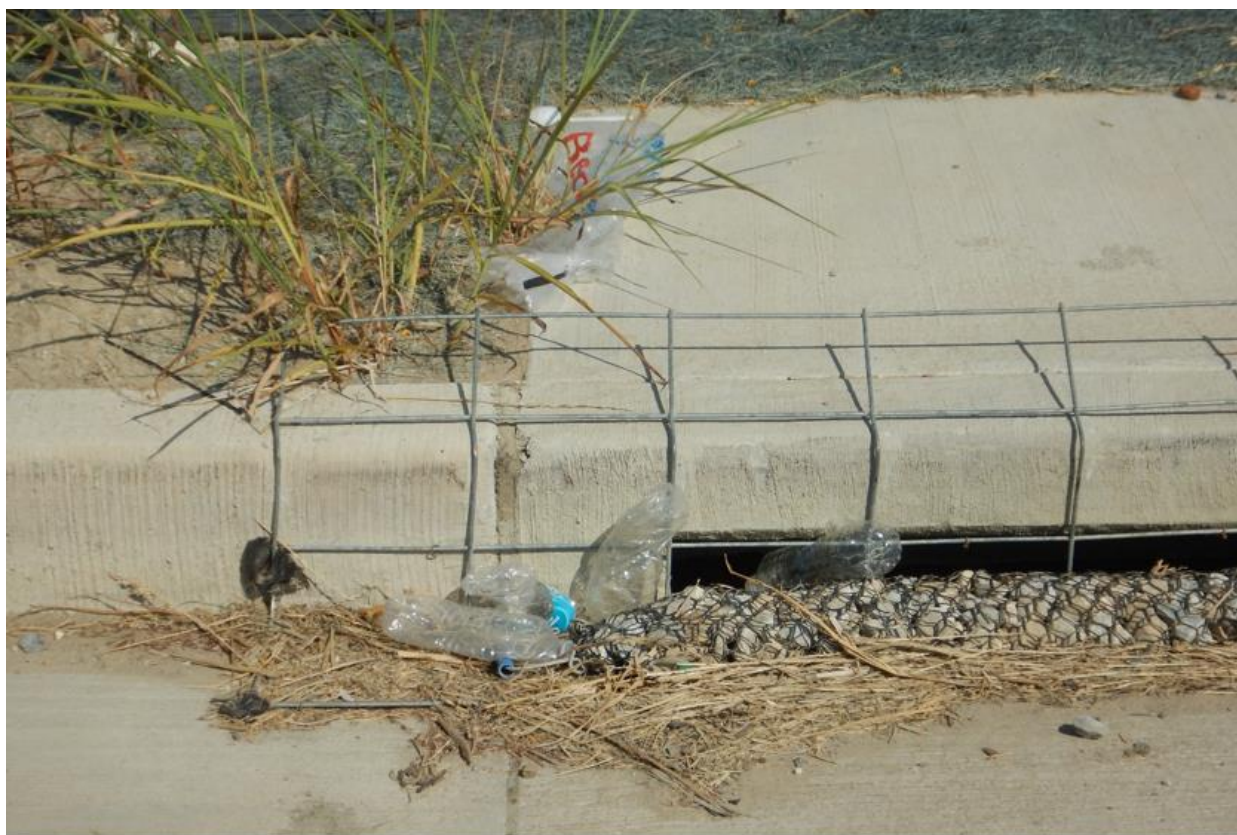
Photo No. 20

Description: Closer view, of an inlet protection on Highridge Dr., not maintained in an effective operating condition (e.g., inlet protection surrounded by dead vegetation, sediment, trash, and debris).

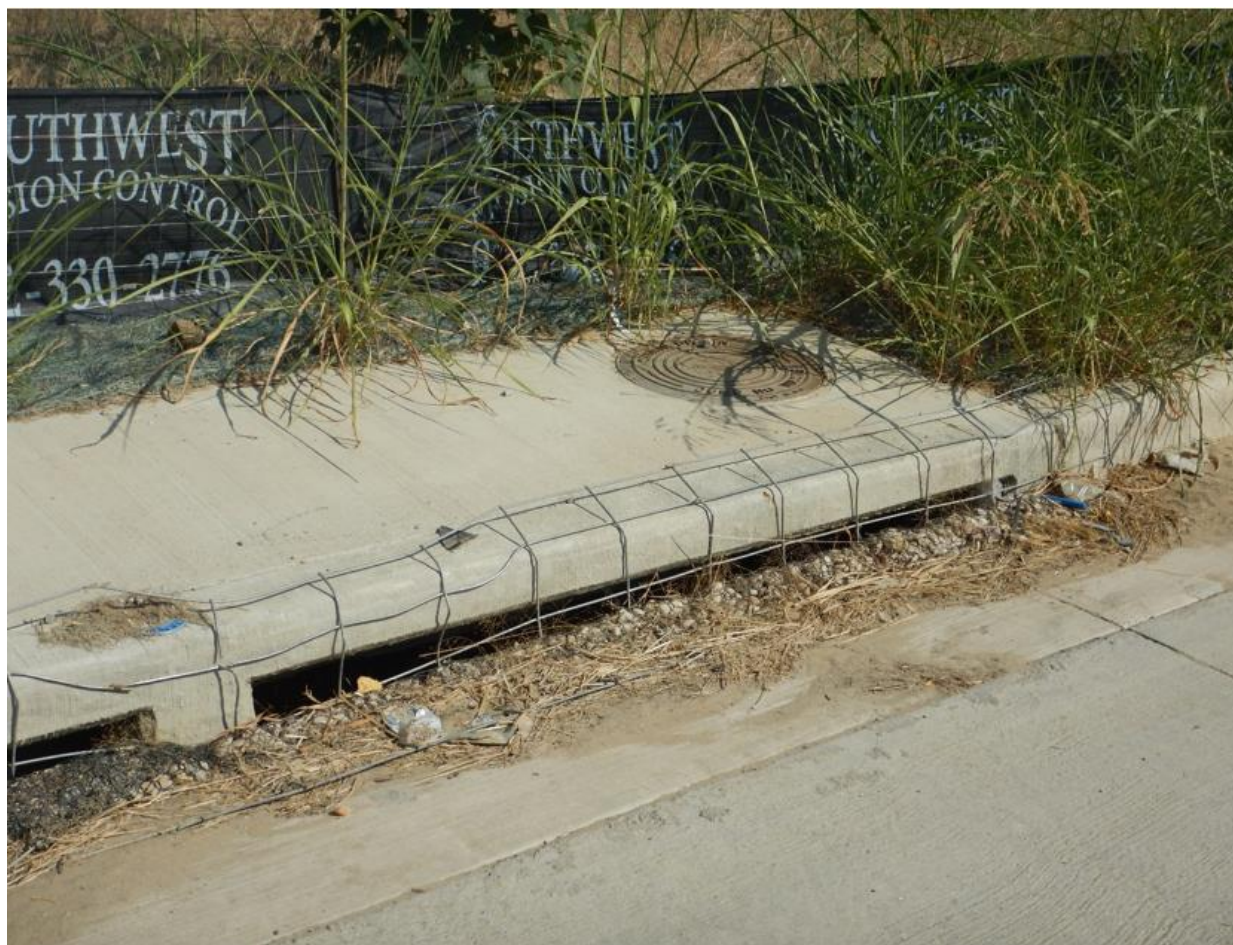
Photo No. 21

Description: Closer view, of an inlet protection on Highridge Dr., not maintained in an effective operating condition (e.g., inlet protection surrounded by dead vegetation, sediment, trash, and debris).

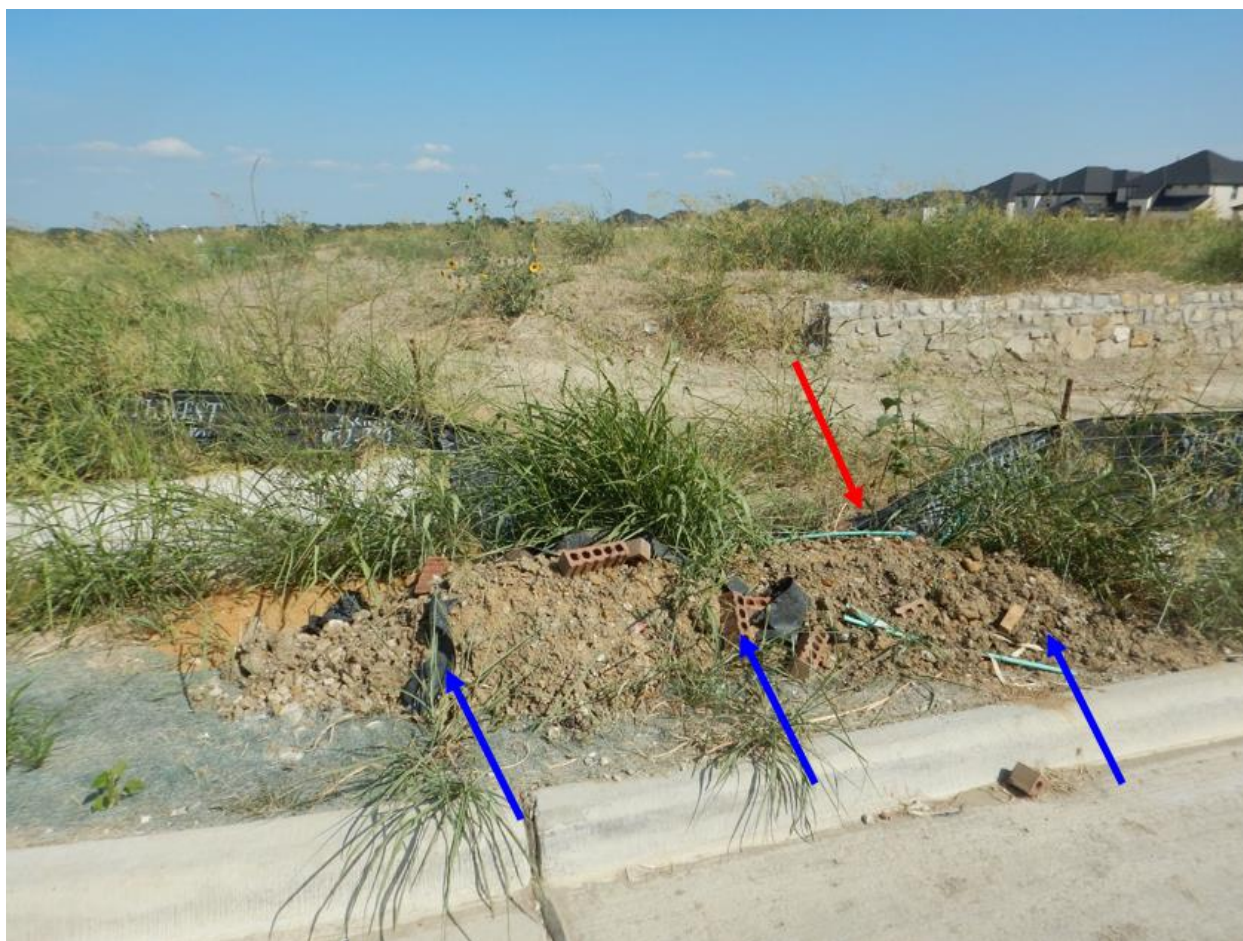
Description: View, of construction area on Highridge Dr. (near the intersection of Sagan Dr.), ineffective BMPs indicated by red arrow. Specifically, the silt fencing was damaged. In addition, on top of the sidewalk's erosion blanket, there was a mound of sediment, bricks, and other construction debris located outside of the damaged silt fence area (blue arrows).

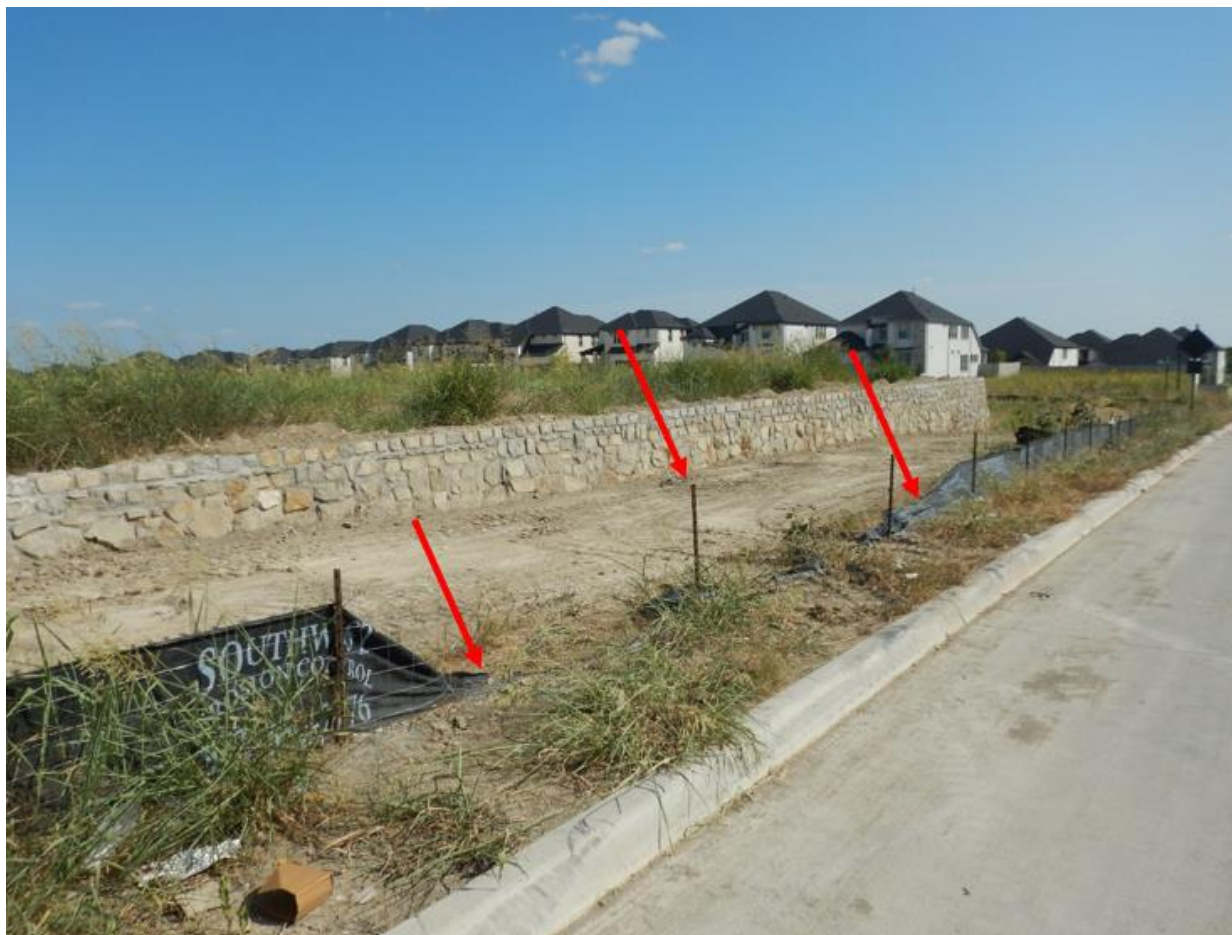
Description: View, of construction area on Highridge Dr. (bordered between Sagan Dr. and Kipling St.), ineffective BMPs indicated by red arrows. Specifically, the silt fencing was noticeably damaged.

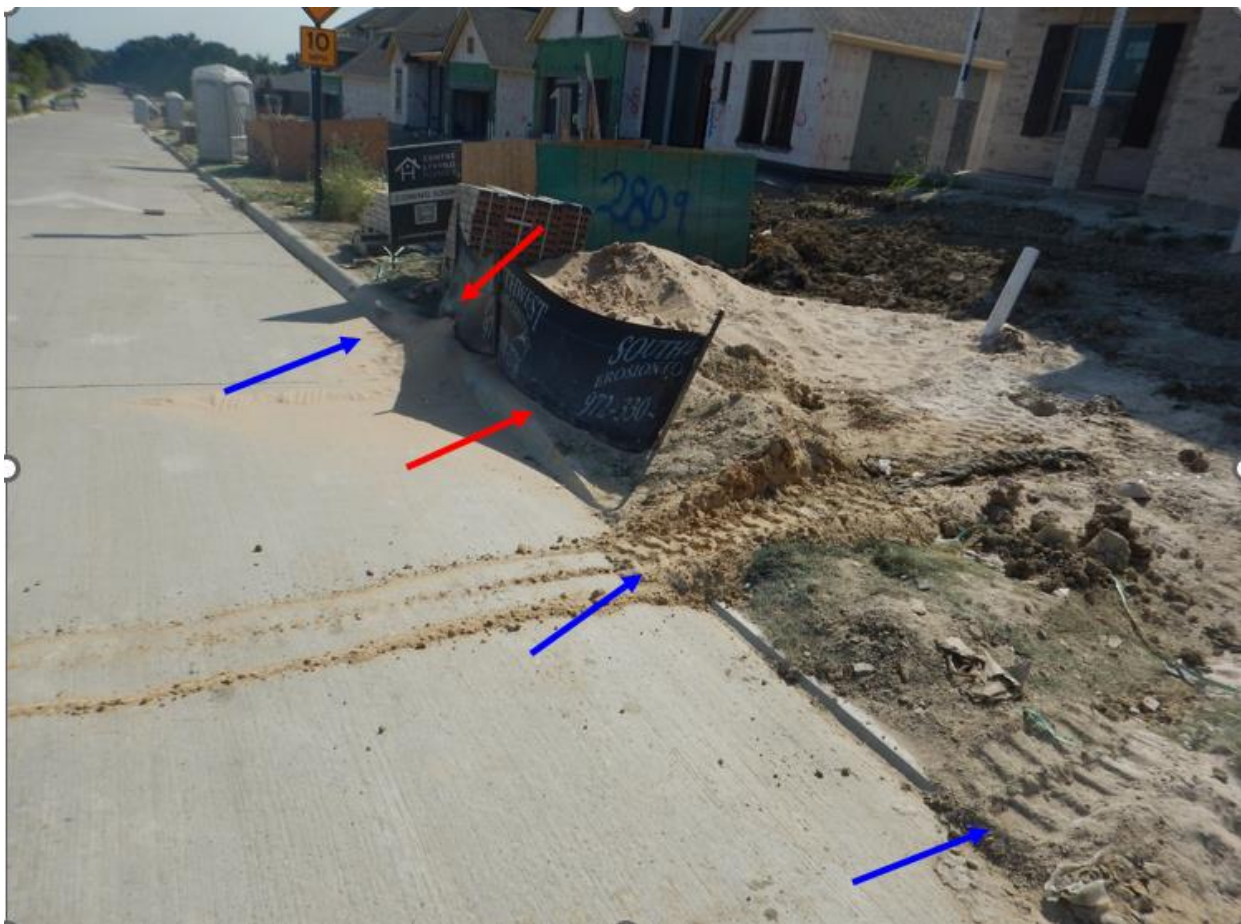
Description: View, of ineffective BMPs and sediment carryover accumulated in the access road. Specifically, the improperly installed silt fence allowed sediment to carry over into the access road (red arrows). In addition, there were tire tracks extending from the construction area at 2809 Highridge Dr. with additional sediment carryover into the access road (blue arrows).

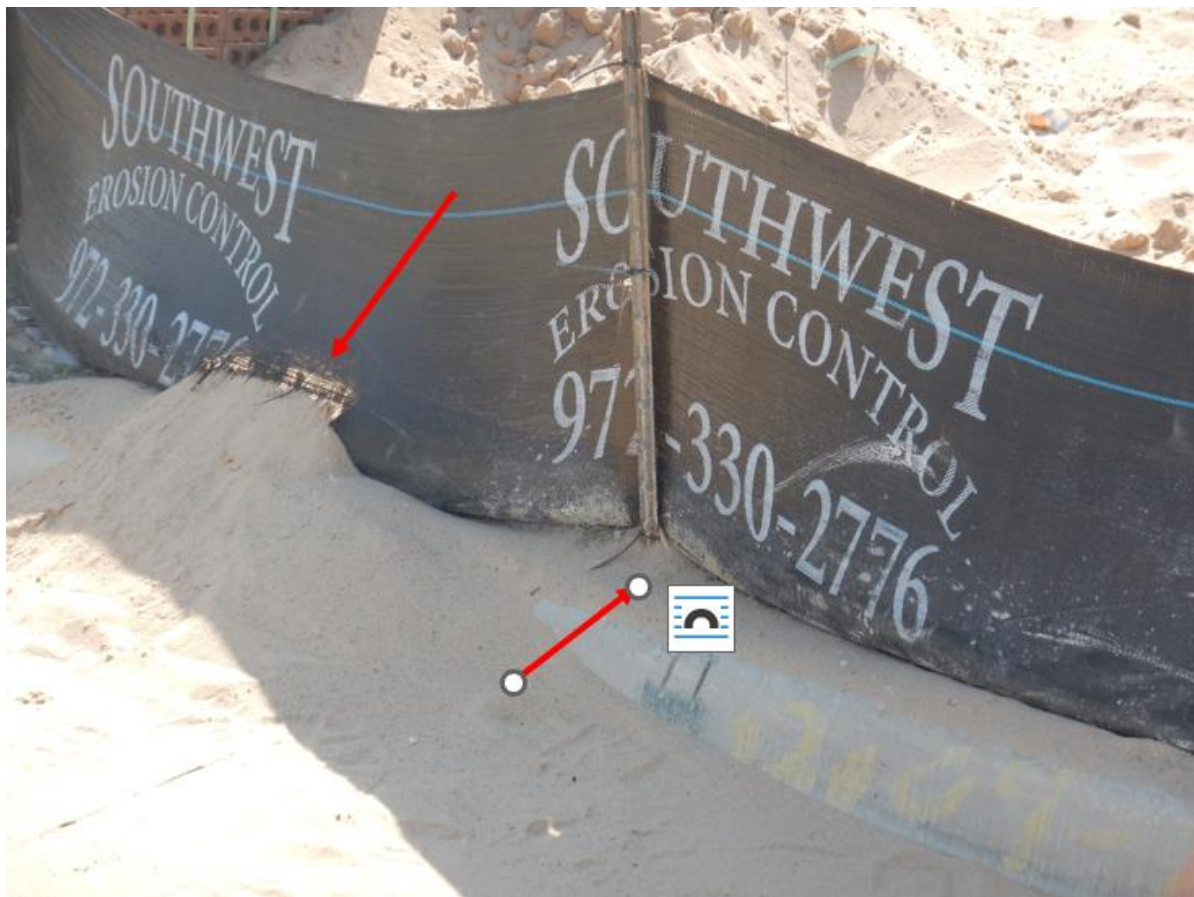
Description: Closer view, of ineffective BMPs and sediment carryover accumulated in the access road.

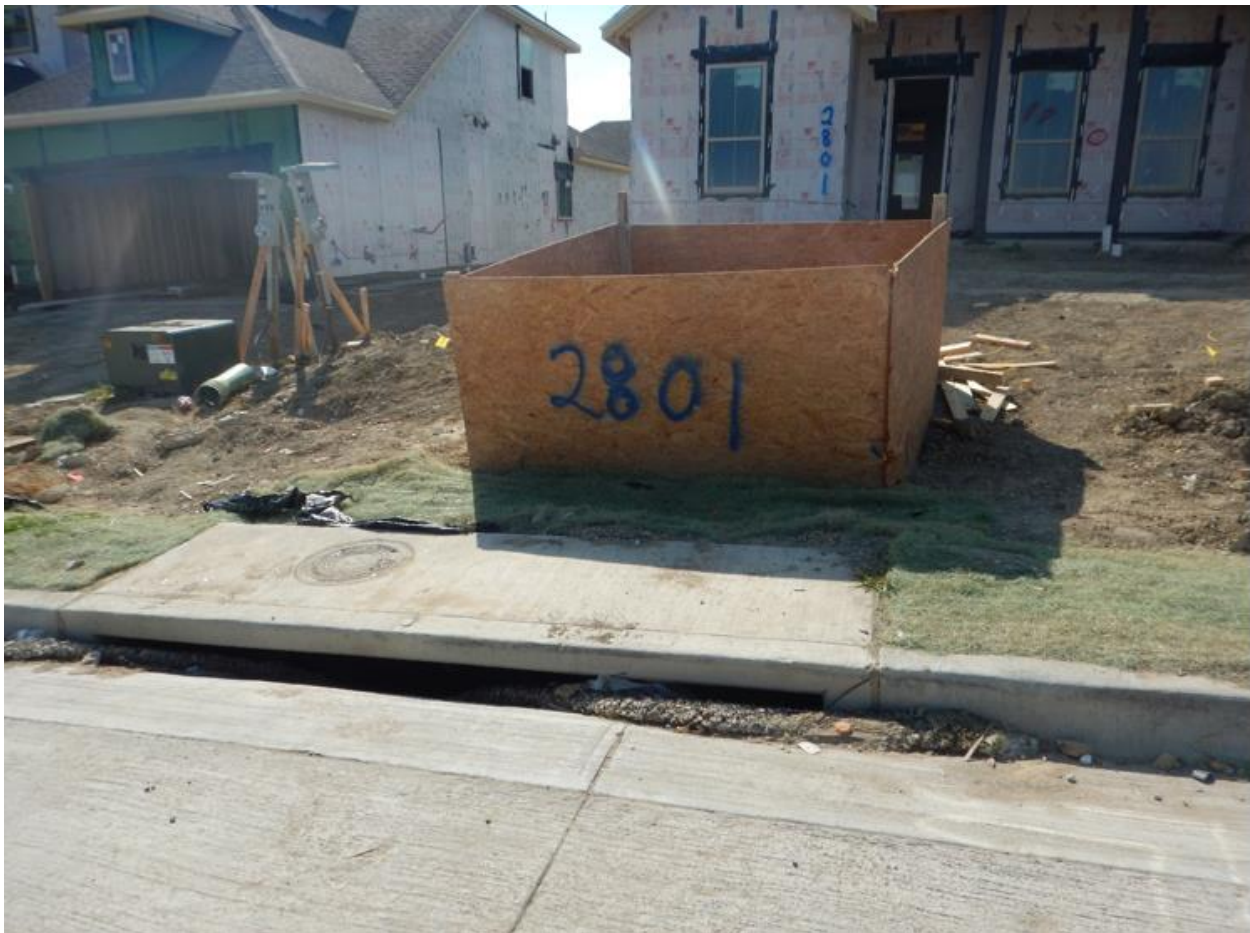
Description: View, of an inlet protection at 2801 Highridge Dr., not maintained in an effective operating condition (e.g., inlet protection surrounded by dead vegetation, sediment, trash, and debris). In addition, greater than half of the inlet protection has fallen into the storm strain, thus allowing potential for observed sediment, trash, other debris, etc., to enter and impact the stormwater drainage system.
