## Region 6 - Enforcement & Compliance Assurance Division

### INSPECTION REPORT

| Inspection Date(s): | February 26, 2026 | |
| Facility Name: | <b>Rosamond Crossing Southeast Corner Phase 1 – Kroger 651</b> | |

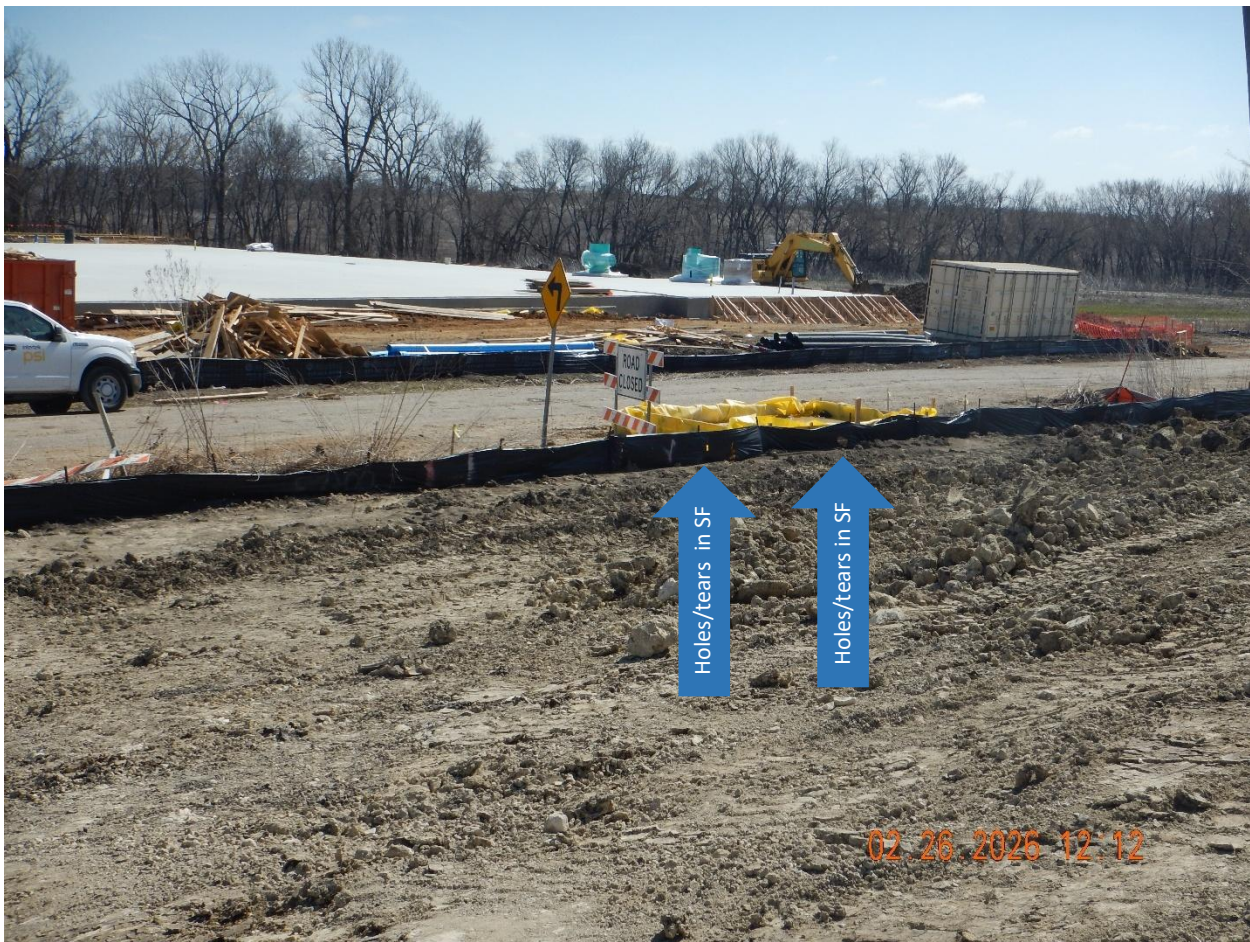
Photo no. 1

- The site was in the land development phase of construction, consisting mostly of exposed sediment.
- Silt fence was installed along the eastern and southern perimeters of the site (**Appendix 1, Photos 1-2**). The silt fence along the northern perimeter of the site had recently been removed with the stakes still in place (**Appendix 1, Photo 3**). Mr. Kirby advised that they were grading and the silt fence would be re-installed by the following Friday (March 6, 2026).

Description: Silt fence (SF) installed along the eastern perimeter of the site. The silt fence had holes/tears in multiple areas.

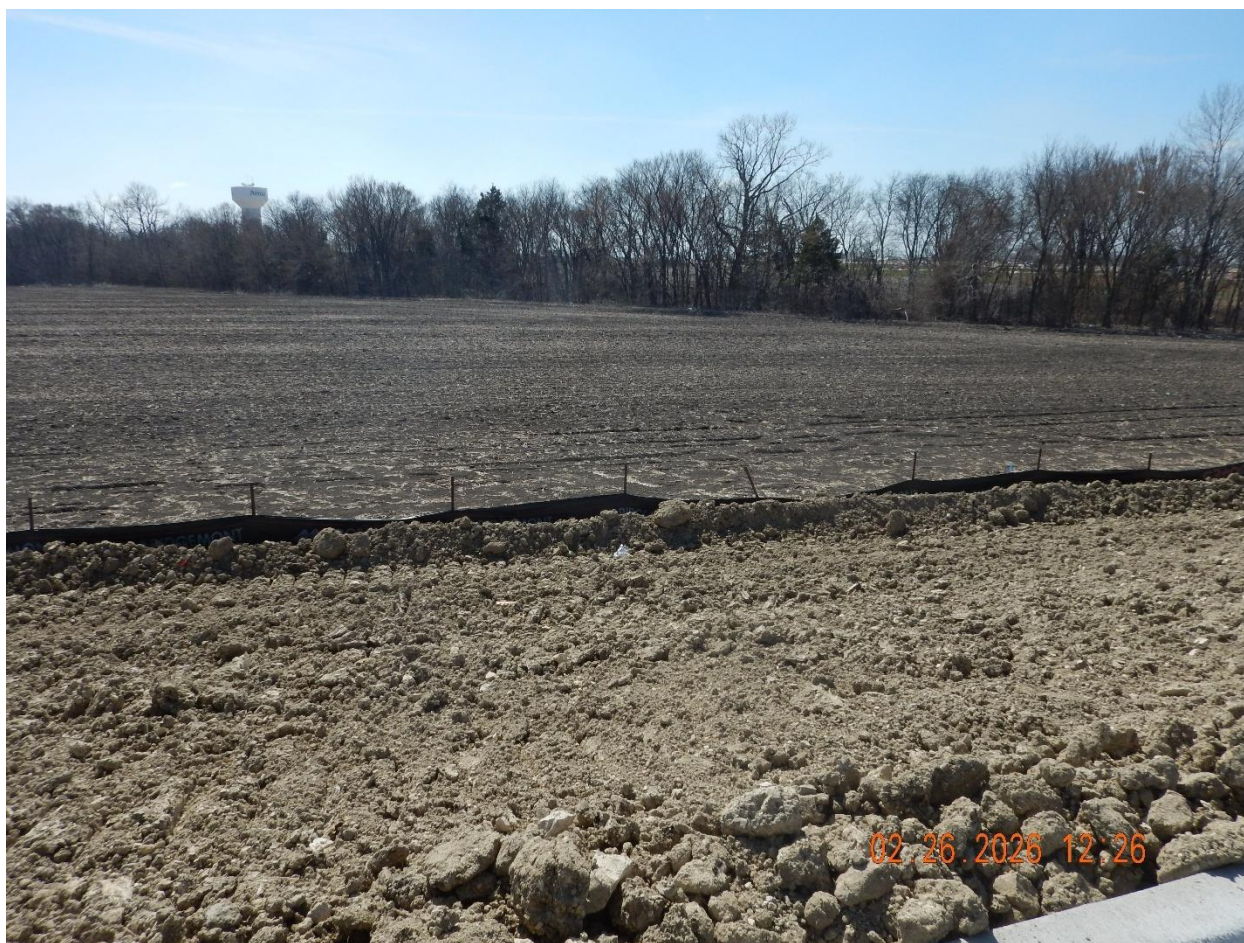
Photo no. 2

Description: Silt fence installed along the southern perimeter of the site. Sediment buildup (in excess of 50%) was observed along the silt fence.

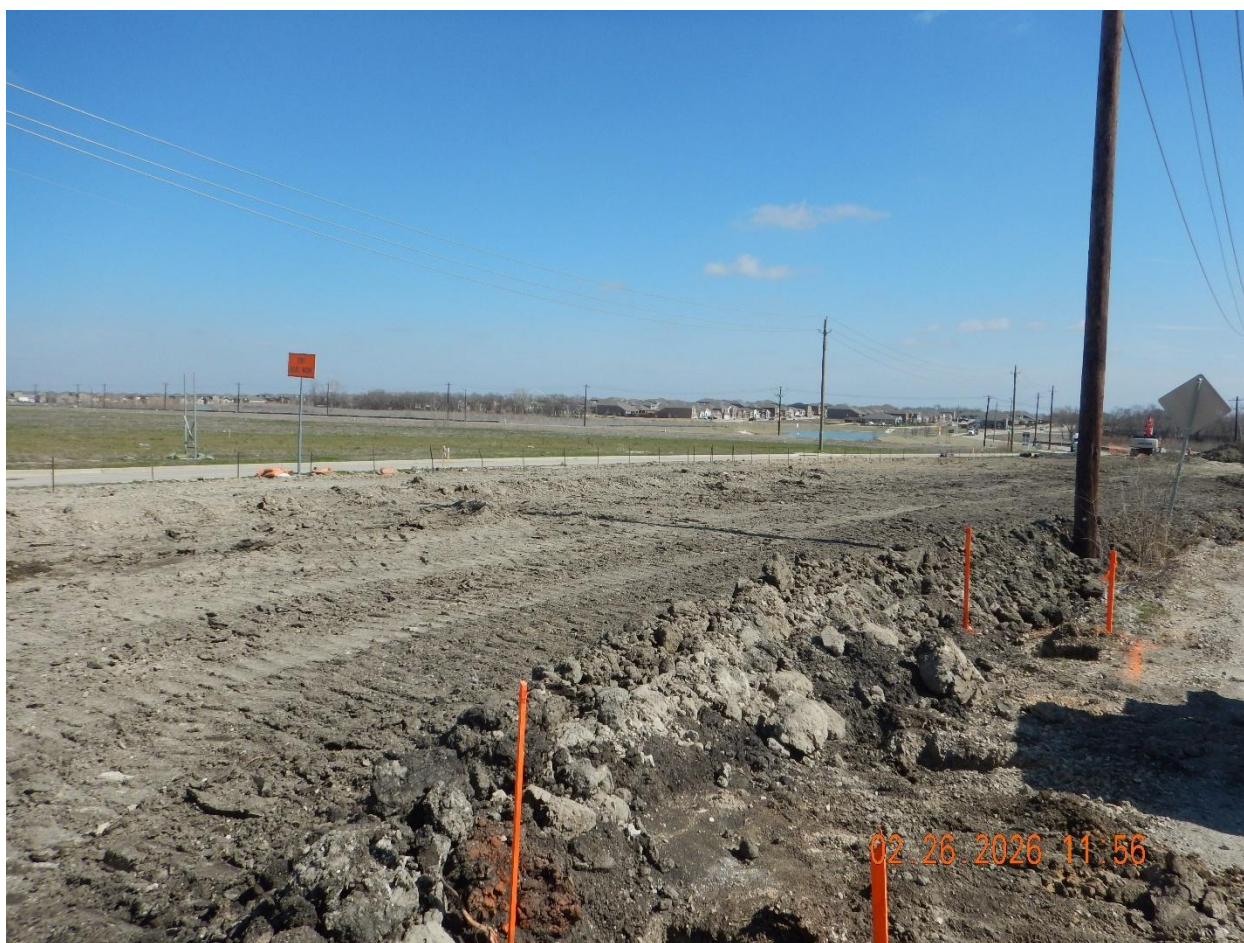
Photo no. 3

Description: The northern perimeter of the site. No silt fence is present and black stakes are still installed along the road.

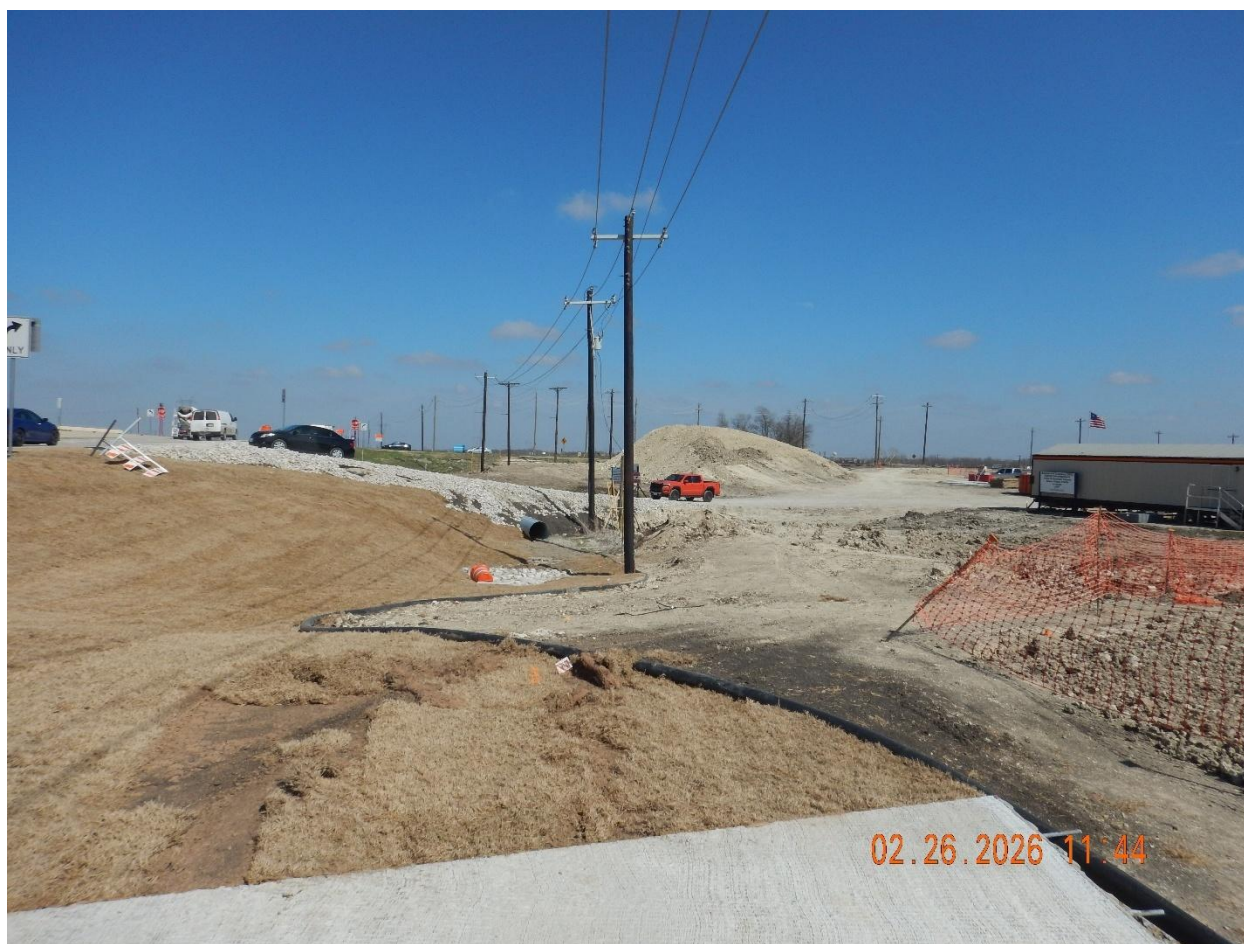
Photo no. 4

- The western perimeter was stabilized by vegetation/sod, a rock/gravel construction entrance, and was sloped towards the interior of the site (**Appendix 1, Photo 4**). Rock check dams were observed along the western perimeter ditch (**Appendix 1, Photo 5**).

Description: The western perimeter stabilized by vegetation/sod, a rock/gravel construction entrance, and sloped towards the interior of the site

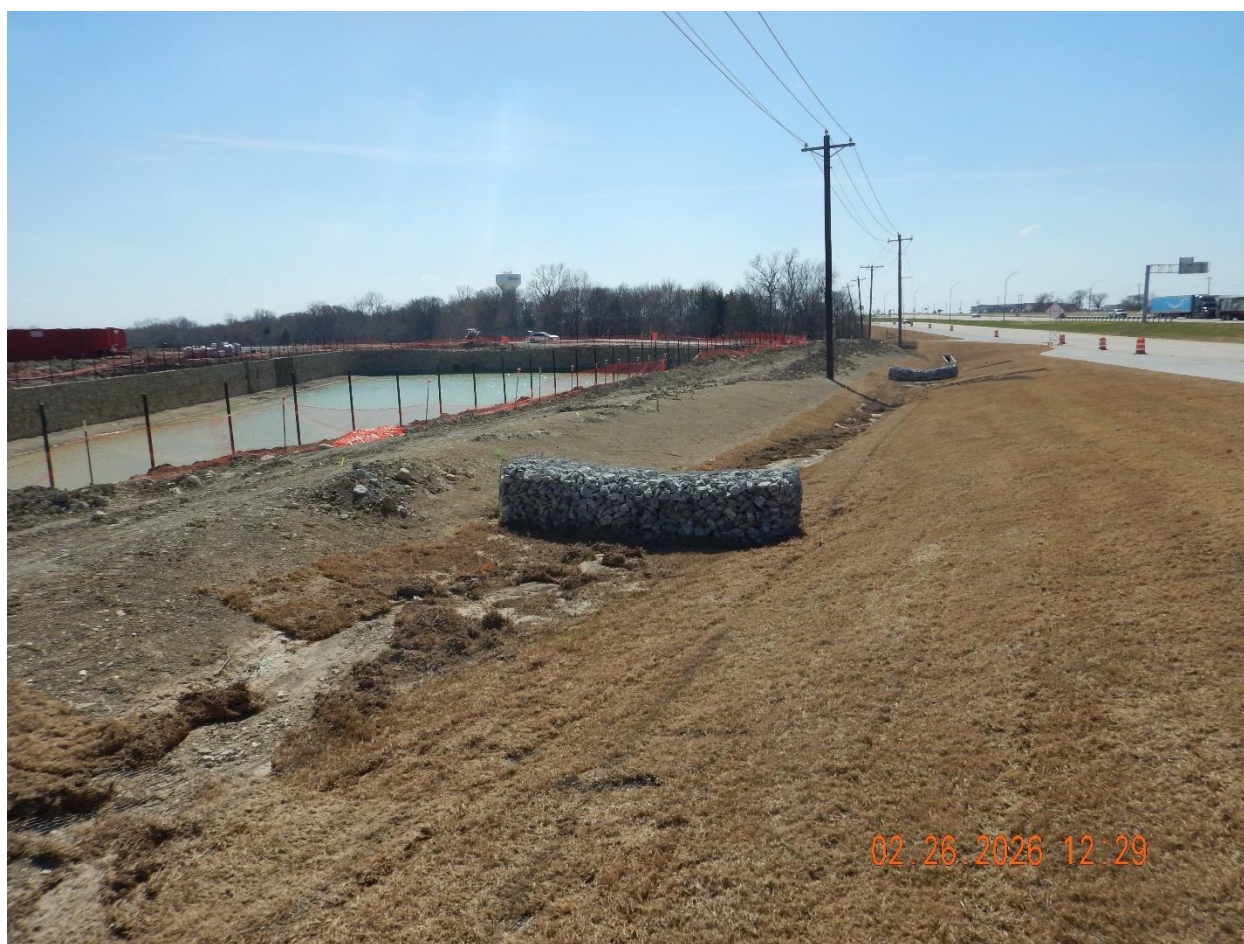
Photo no. 5

- Two (2) permanent sedimentation basins (ponds) were observed on-site. One sediment basin was located near the west perimeter of the property (**Appendix 1, Photo 5**) and receives water from the area drains (as the site progresses most inlets will tie into this pond). The second sediment basin was observed along the southeast perimeter (**Appendix 1, Photo 6**) of the site and primarily collects surface water.

Description: Rock check dams along the western perimeter ditch. Also pictured is a sediment basin (pond) that receives water from the site's area drains.

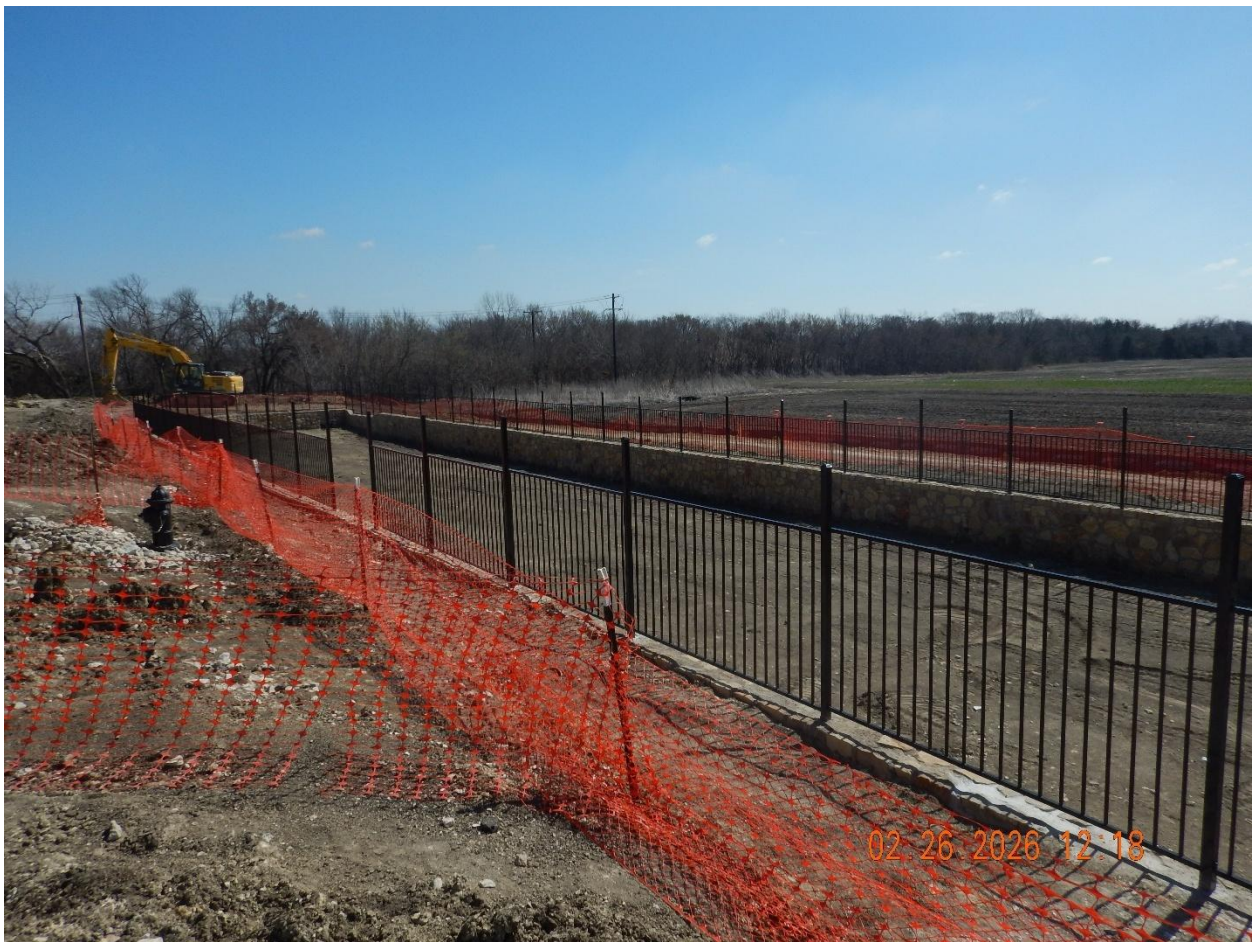
Photo no. 6

Description: The second sediment basin observed on-site near the southeast perimeter that primarily collects surface water.

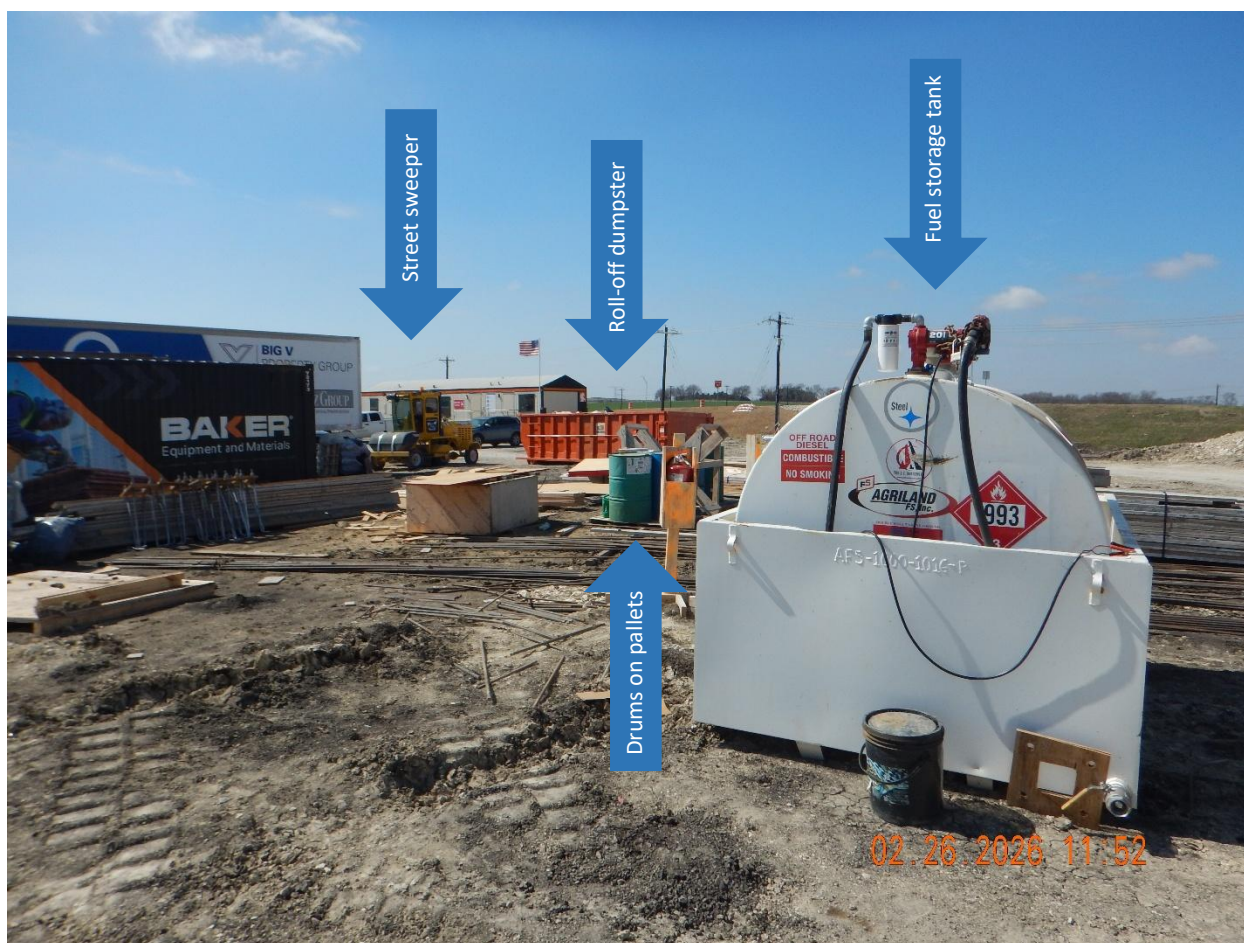
Photo no. 7

- A material storage area, roll-off dumpster, street sweeper, two (2) fuel storage containers, and one (1) concrete washout was observed on-site (**Appendix 1, Photos 7-8 and 10**). Potential pollutants in the material storage area were mostly stored off the ground on pallets. There was no evidence of spillage or leakage near the fuel storage containers or the concrete washout area.

Description: A material storage area, roll-off dumpster, street sweeper, and a double walled fuel storage container located east of the construction trailer. Potential pollutants (drums) were stored off the ground on pallets. There were no signs of spillage or leakage near the fuel storage tank.

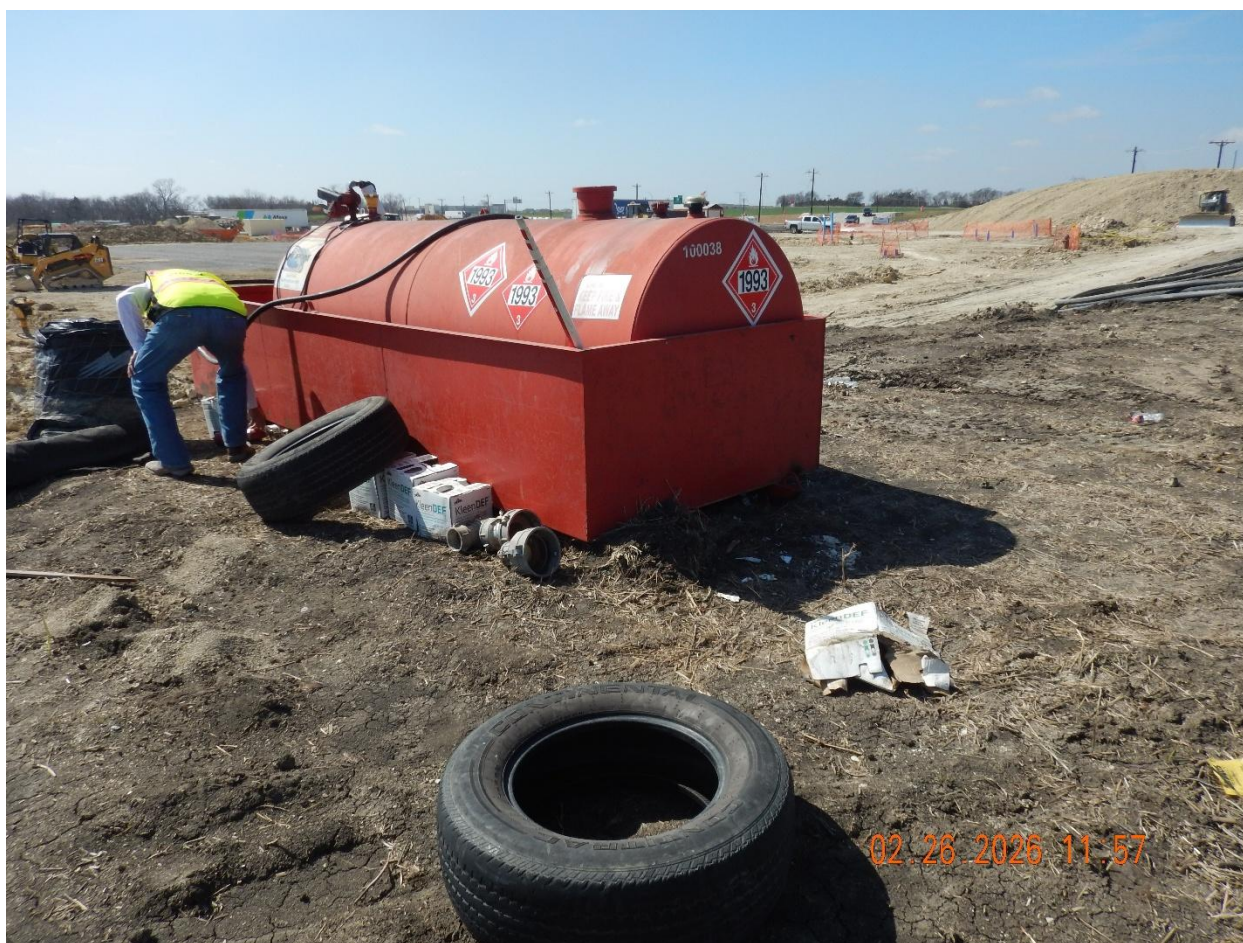
Photo no. 8

Description: A second fuel storage container located near the north perimeter of the site with KleenDef stored on the ground directly next to it. No evidence of spillage/leakage was observed near the tank.

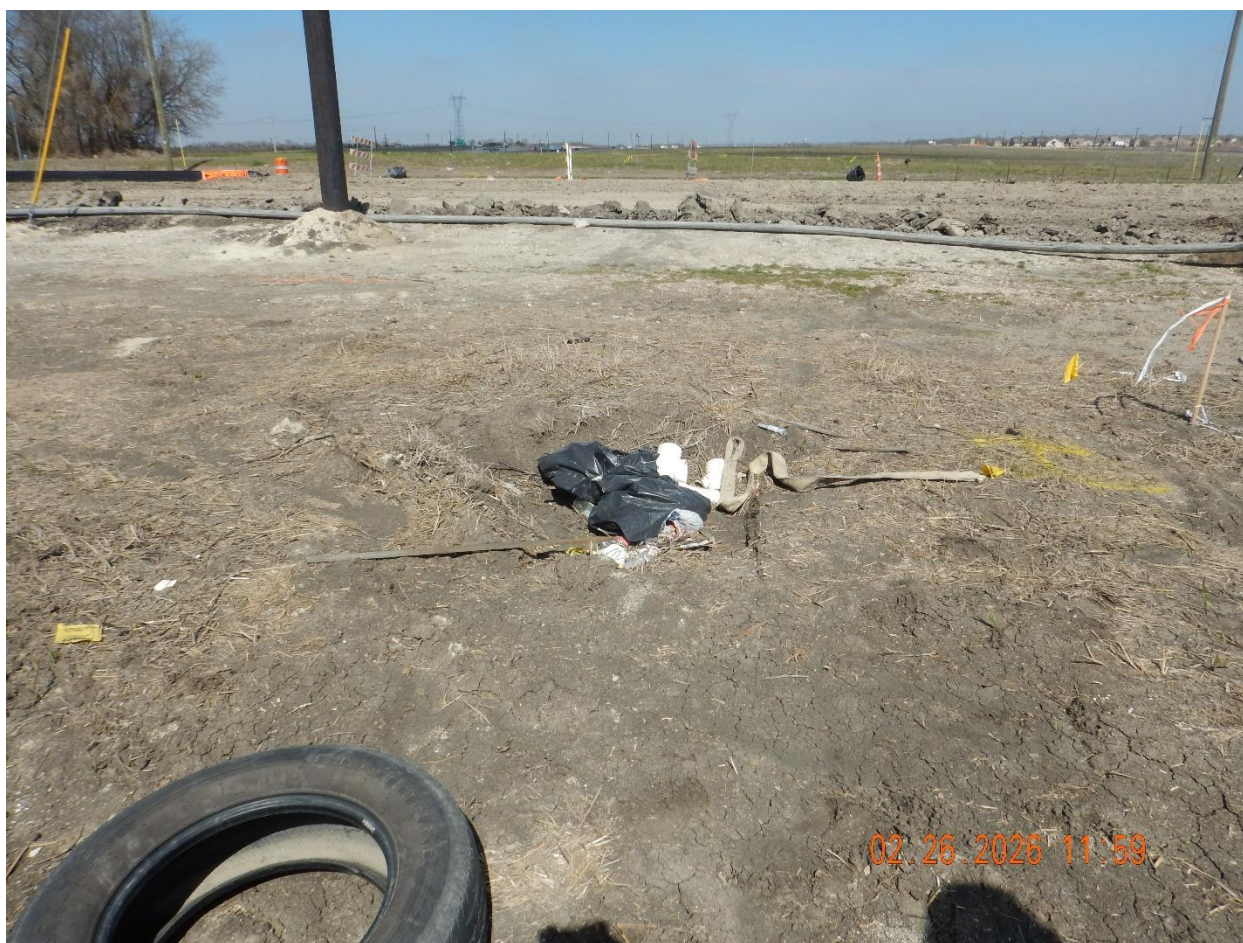
Photo no. 9

Description: Blowable trash observed in a pile near the fuel storage container near the north perimeter of the site.

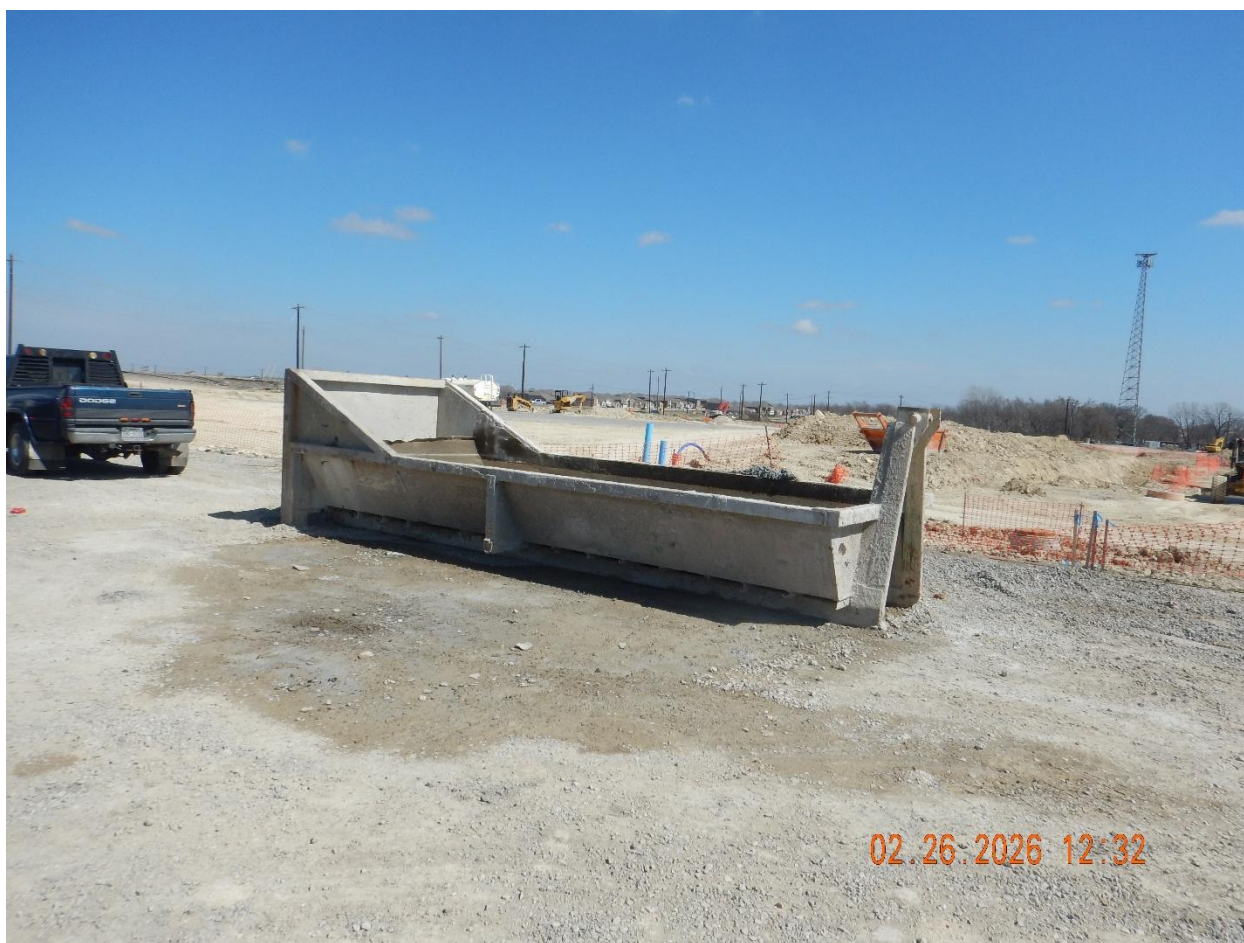
Photo no. 10

Description: Concrete washout located east of the construction trailer. No evidence of leakage/spillage was observed.

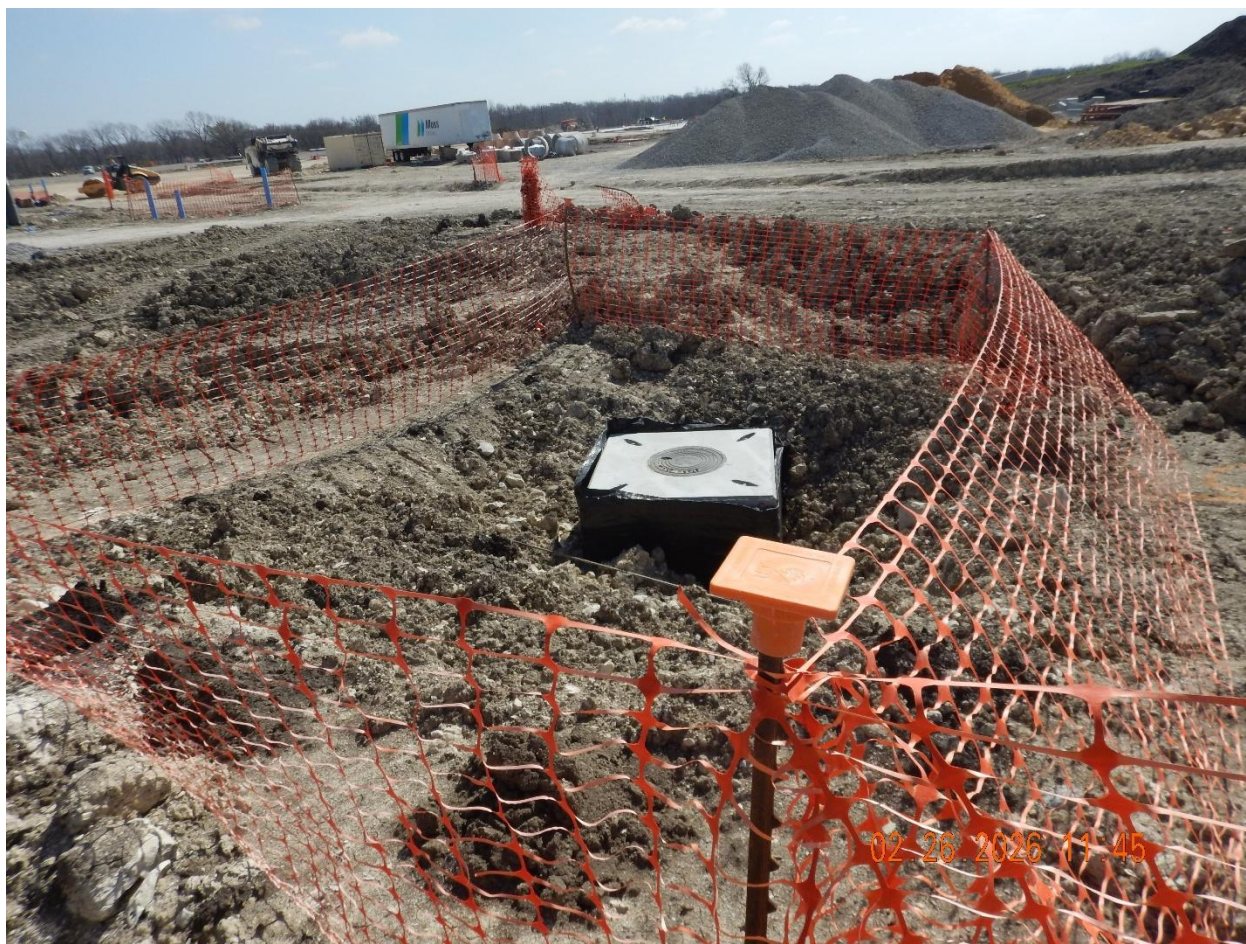
Photo no. 11

- Inlet protection was observed on the inlets throughout the site (**Appendix 1, Photo 11**).

Description: Inlet protection installed around one of the interior inlets.

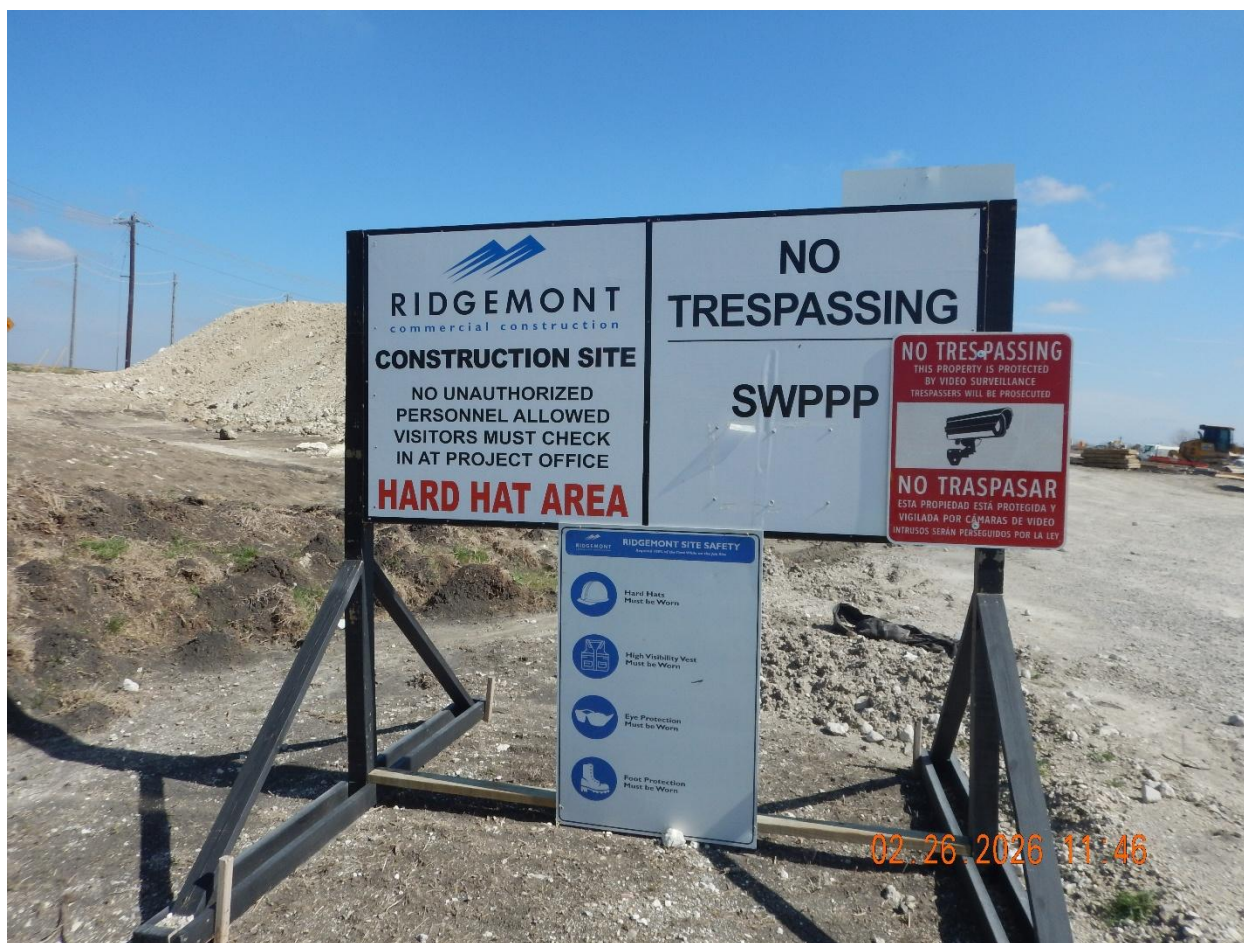
Photo no. 12

1. The Construction Site Notices (CSNs) were not posted on-site at the time of the inspection (**Appendix 1, Photo 12**).
2. Silt fence along the east perimeter of the site had sediment buildup (in excess of 50%), was not properly installed (not trenched), and was damaged with holes and tears in multiple areas (**Appendix 1, Photos 1 and 13-14**).
3. Sediment buildup (in excess of 50%) was observed along the southern perimeter silt fence near the southwest corner of the site (**Appendix 1, Photo 2**).
4. Slurry was observed discarded directly on the sediment where piers had recently been poured (**Appendix 1, Photo 15**).
5. KleenDef was stored directly on the ground near the fuel storage containment (near the northern perimeter of the site) and trash was discarded in a pile nearby (**Appendix 1, Photos 8-9**).

Description: Missing CSNs near the construction entrance off of North Central Expressway.

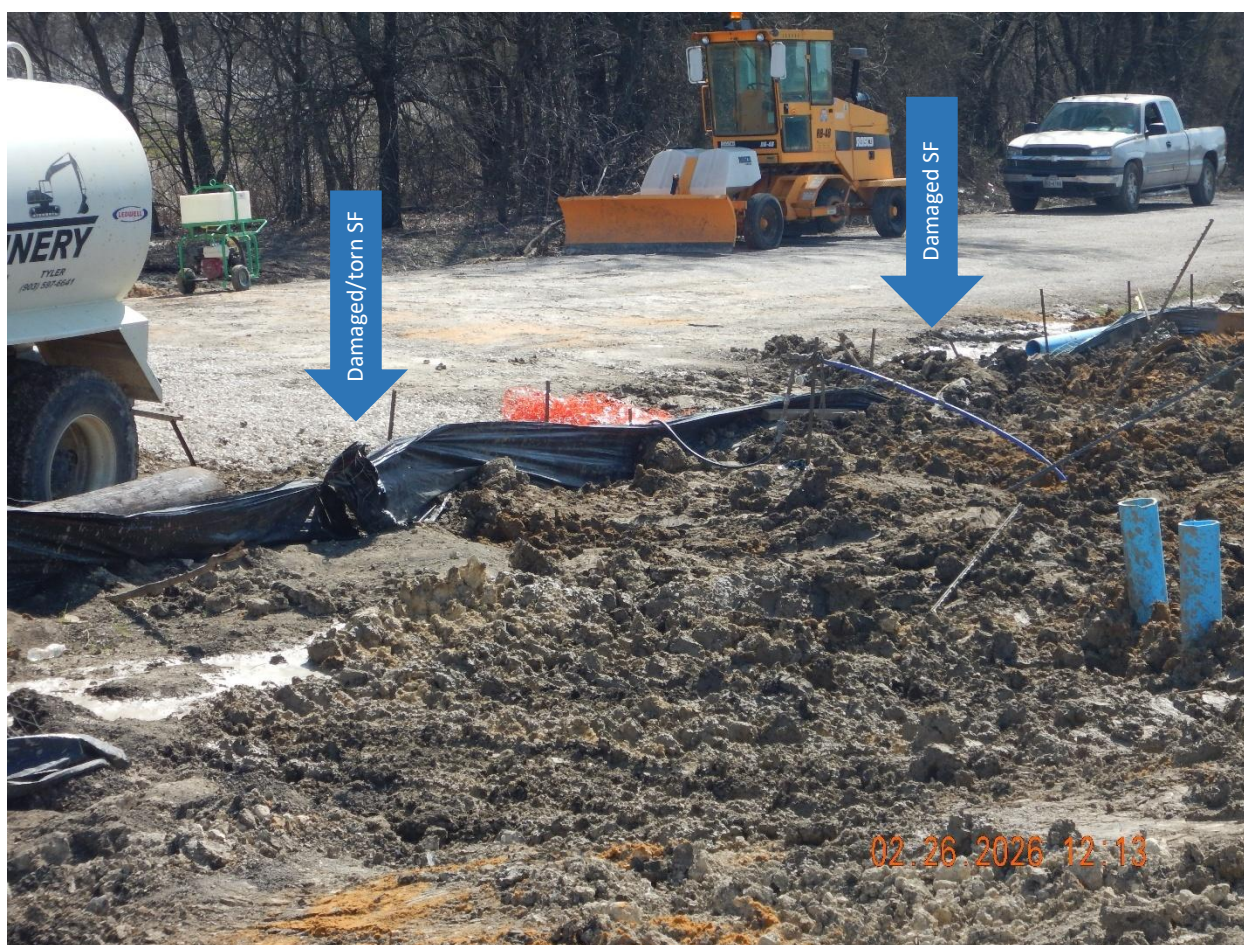
Photo no. 13

Description: Damaged silt fence (SF) with areas of sediment buildup (in excess of 50%) and holes/tears along the eastern perimeter of the site.

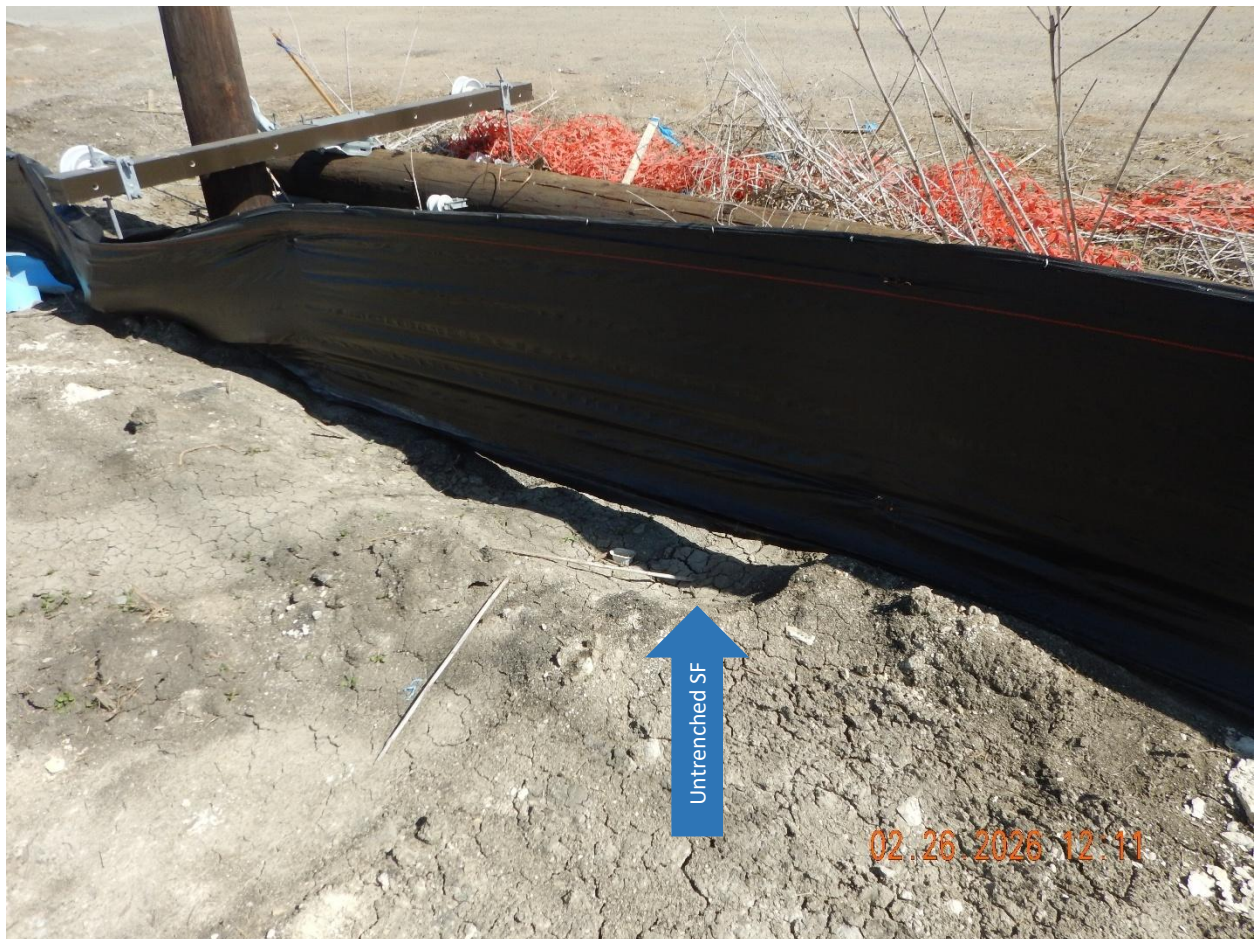
Photo no. 14

Description: Improperly installed (not trenched) silt fence (SF) along the eastern perimeter of the site.

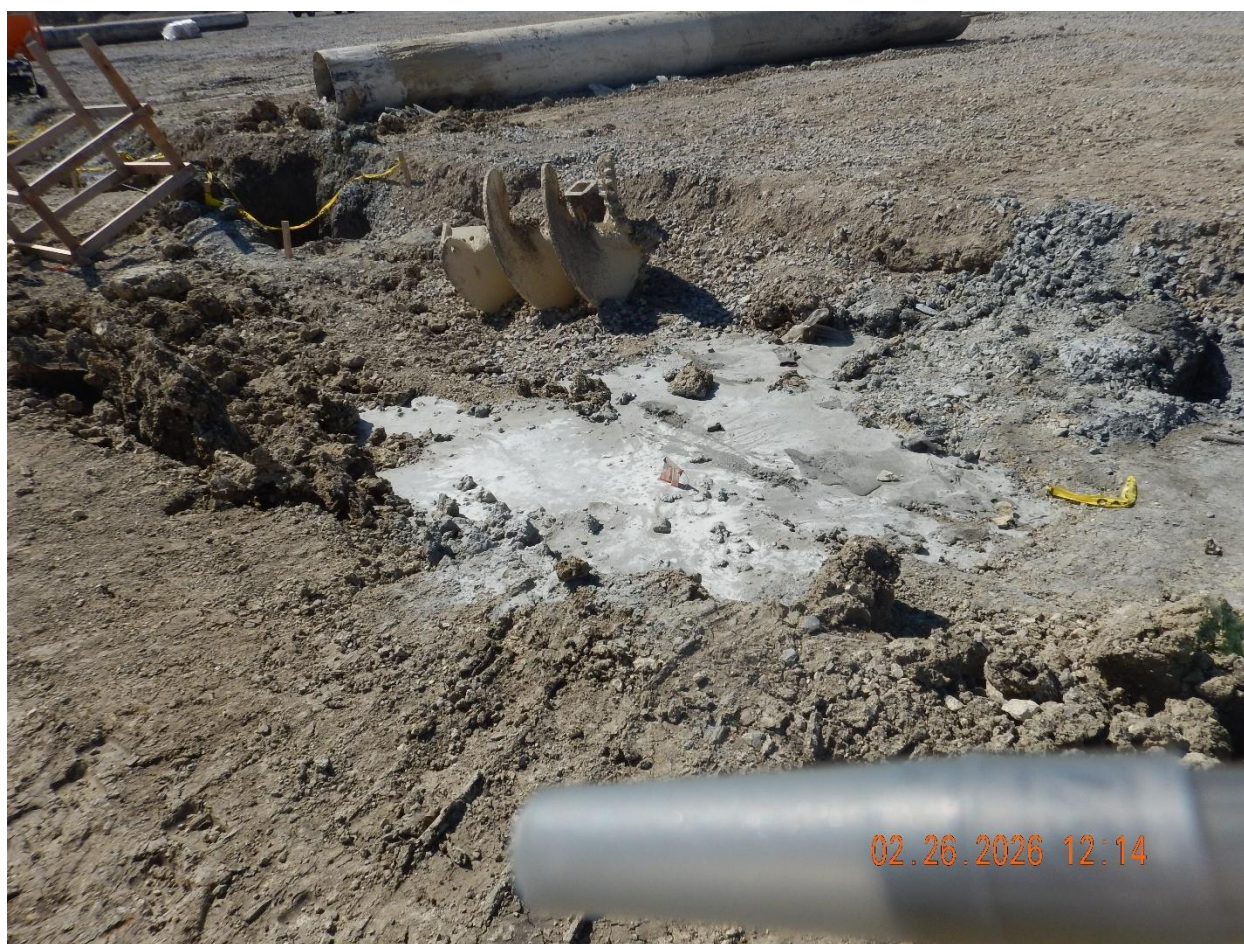
Photo no. 15

Description: Slurry discarded directly onto the sediment where piers had recently been poured on-site.
