**Well Inspection**  
**Osage DNR / Environmental Protection Agency**  
**1201 Elm Street, Suite 500**  
**Dallas, Texas 75270**

| <b>Operator Info</b> | McCann Resources, Inc<br>1613 West 6th Street<br>Bartlesville, OK 740033404<br>Phone: 918-337-4747 | <b>Inventory ID</b> | OS2222000 | | |
| | | <b>Well ID</b> | W-83 | | |

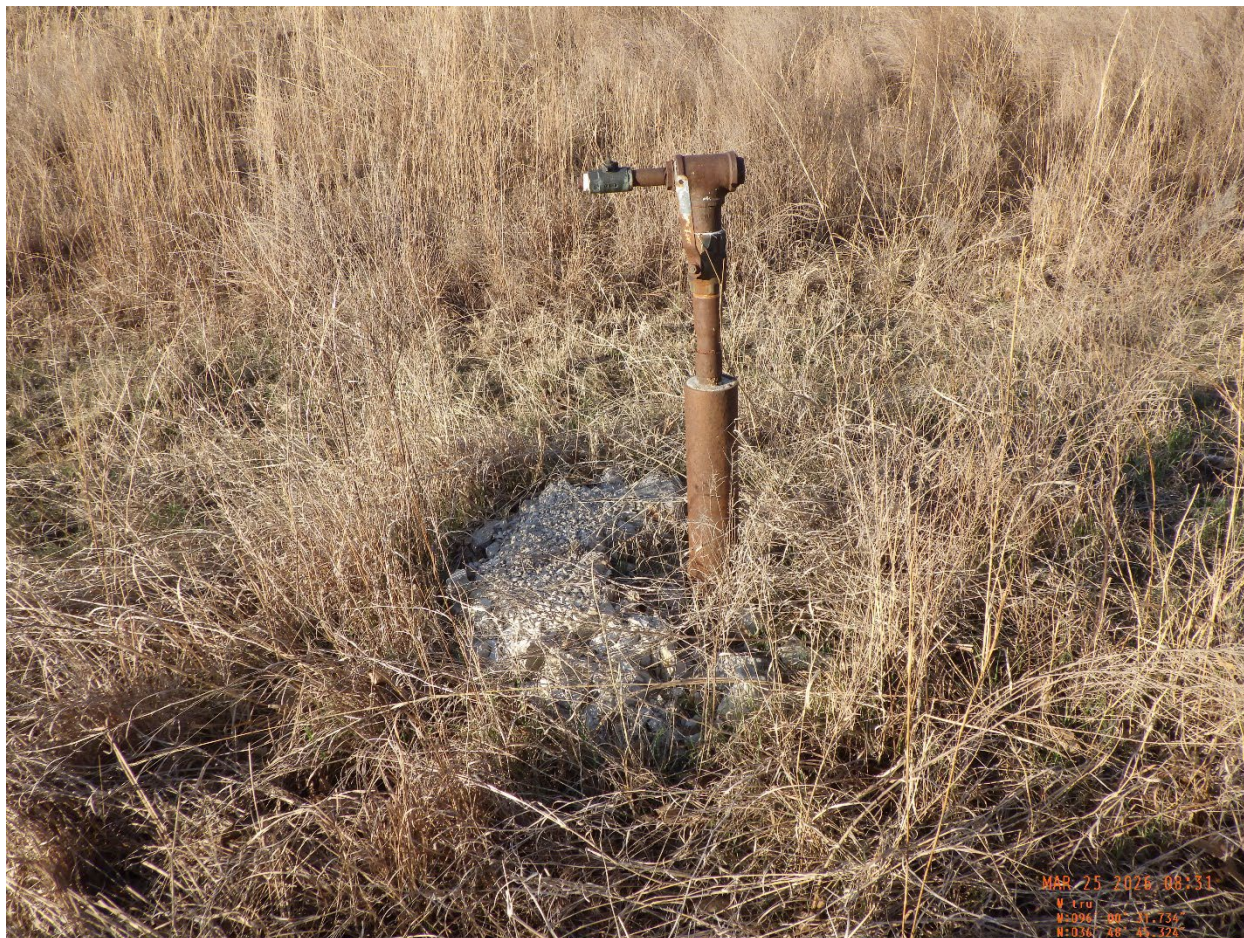
Photo No. 1

| <b>Inspection Comments</b> | Well, OS2222000 appeared to be 4" casing with 2 1/16" tubing cemented to surface. The well was reduced to a 1" ball valve. Well fittings were tight and prevented observance of fluid level and pressure readings. The well was disconnected and not injecting. The well was overdue for MIT at the time of the inspection. | | | | |

**Description:** This was well OS2222000 at the time of the inspection. At the time of the inspection, the well was disconnected and was not injecting. The well was overdue for MIT.
