**Region 6 - Enforcement & Compliance Assurance Division**  
**INSPECTION REPORT**

| Inspection Date(s): | 05/02/2023 | |
| Company Name: | <b>Calgary Energy, LLC</b> | |
| Facility Name: | <b>Tidal Osage</b> | |

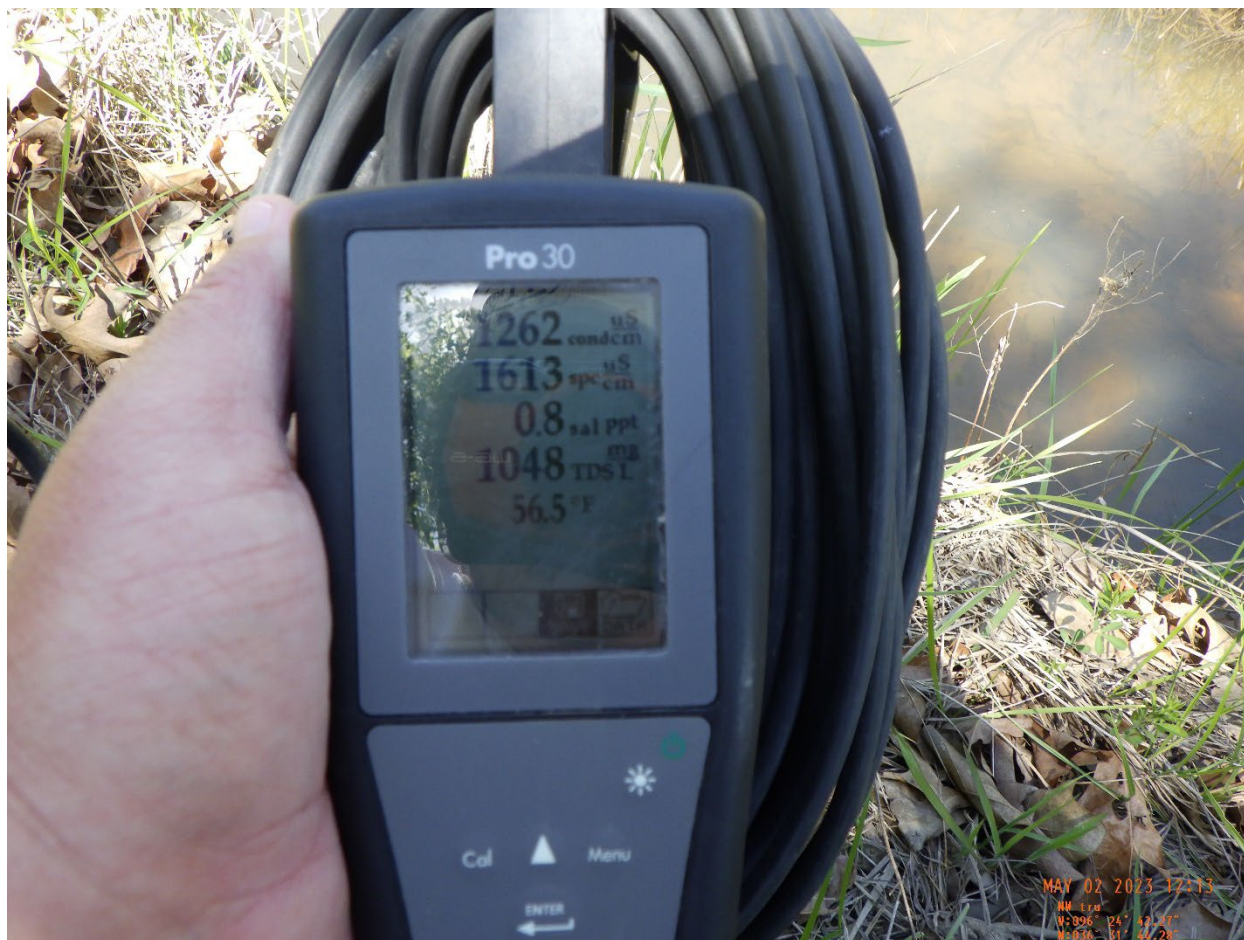
Photo No. 1

I observed a “background” TDS field reading of 1,048 mg/L taken in the main channel of the impacted tributary of Little Hominy Creek, upstream from the Point of Entry (POE). This field reading was taken in a pool of water which had NOT been impacted by the spill. See photo No. 1 of Appendix 1 (photo log) included with this report. GPS location information for each observation is recorded with each photo in the photo log. All TDS field readings observed during the inspection were taken with an EPA cataloged, properly calibrated YSI Pro 30 conductivity meter.

**Description:** TDS field reading of 1048 mg/L taken upstream from the Point of Entry (POE). This reading was taken in an area which was NOT impacted by the spill. This field reading should be used when assessing "background" TDS levels for the area.

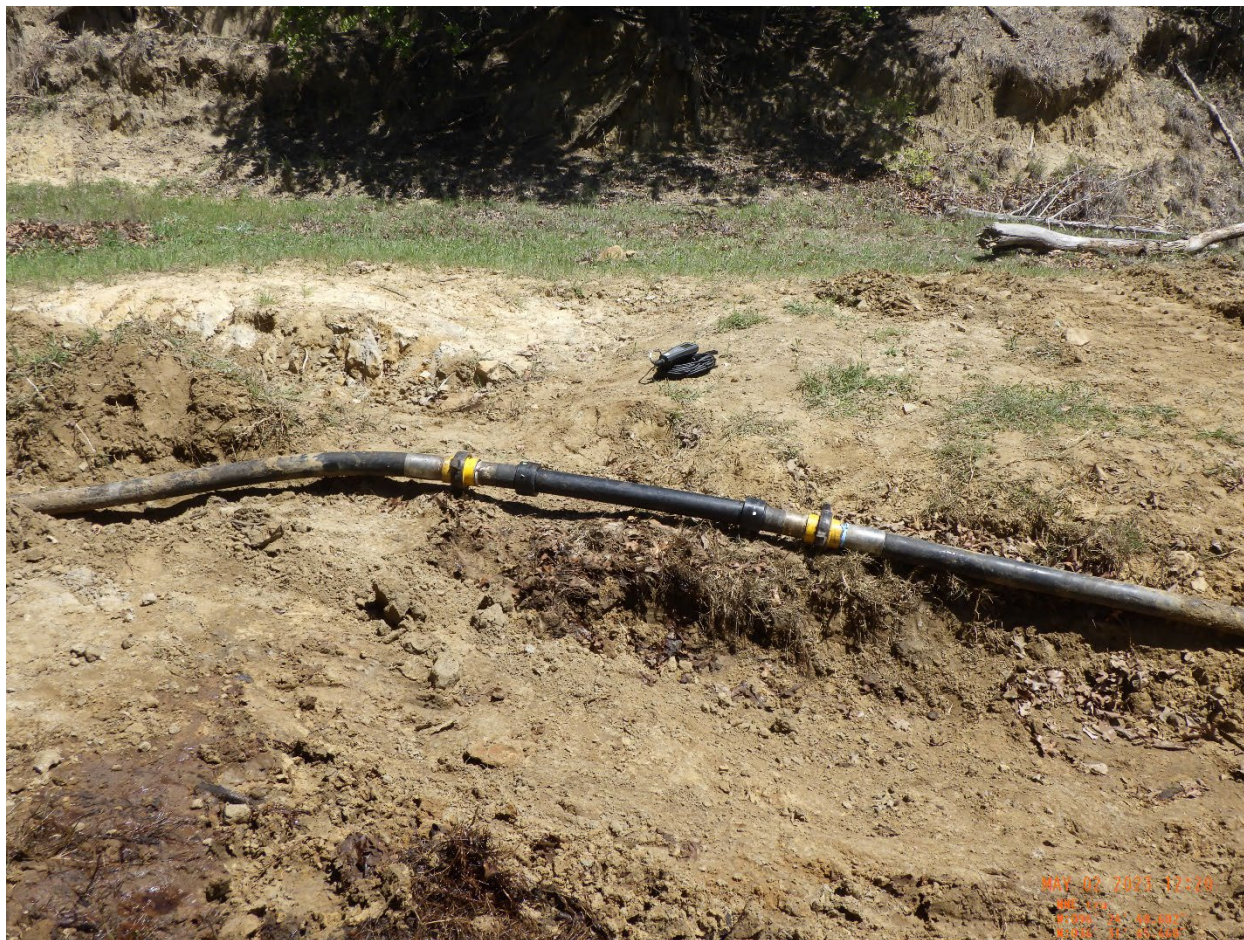
Photo No. 2

EPA conducted an initial spill inspection on the Tidal Osage II Lease, where a 3-inch diameter poly flowline ruptured at a “butt weld”, releasing a company reported volume of 300 barrels oilfield brine and 1 barrel of crude oil onto the land which migrated downgradient approximately 35 feet where it entered into a tributary of Little Hominy Creek. The pipeline failure occurred on a main “trunk line” which was carrying produced water and oil to the Tidal Osage II tank battery.

I observed the repaired section of 3-inch poly flowline which had ruptured. This section of repaired flowline was the Release Point of the spill. Oil staining and brine impacts were observed near the release point. See photo No. 2 and 3.

**Description:** This was the repaired section of 3-inch diameter poly flowline where the spill originated (release point). The operator stated there was a poly "butt weld" exposed, which developed a crack, causing the oil and brine to be released.

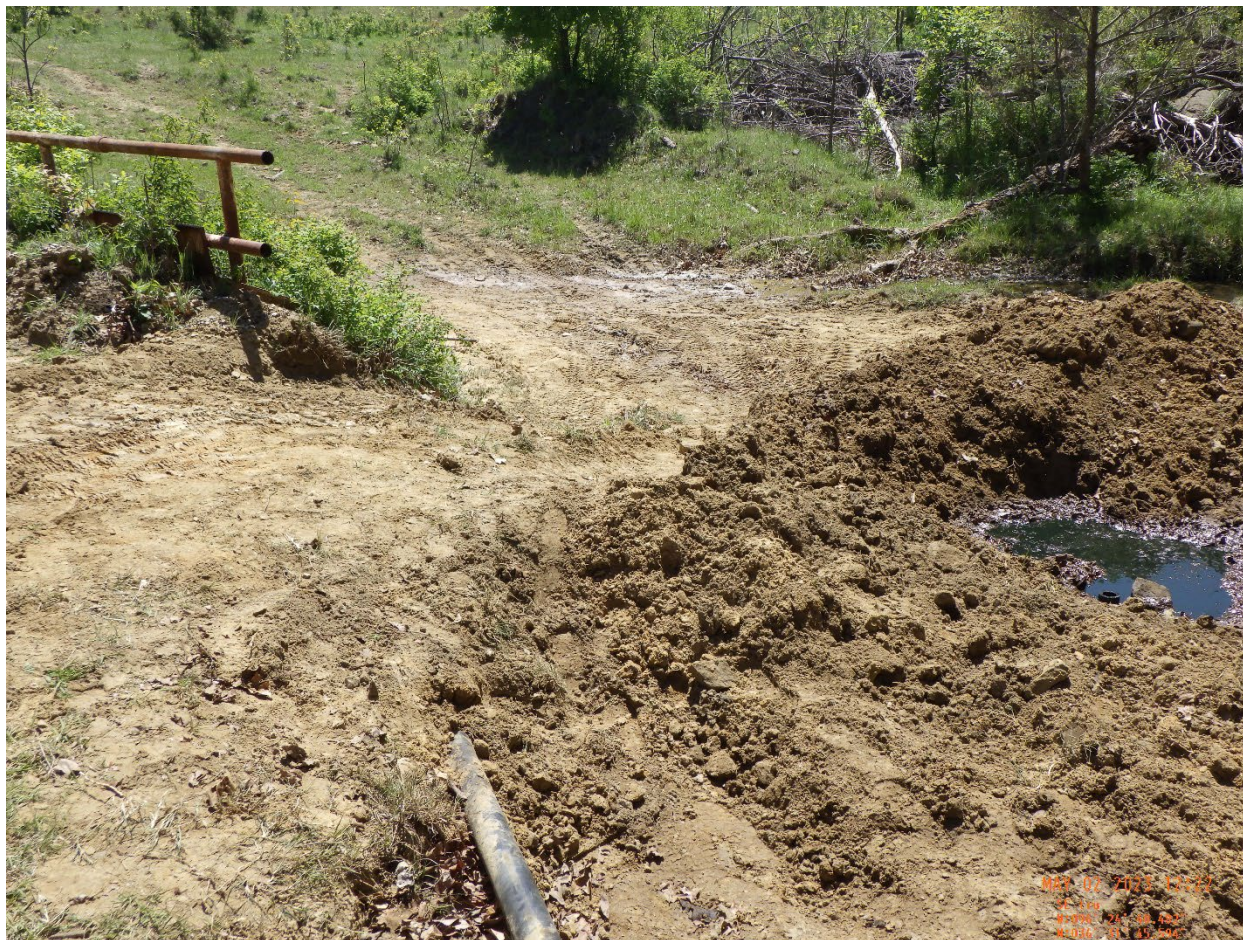
Photo No. 3

I observed the flowpath from the release point to the POE. Oil and brine staining were observed along the flowpath. The overland flowpath was approximately 35 feet from the release point to the point of entry into the impacted tributary. See photo No. 3.

**Description:** This was a photo standing at the release point, with a view to the south toward the POE into the tributary of Little Hominy Creek. The spill traveled downgrade approximately 35 feet from the release point to the POE.

With these concerns, I recommend that the operator remediate the overland flowpath from the release point to the point of entry into the impacted tributary. I also recommend that special care should be applied to this spill to ensure impacts are not migrated further downstream by upcoming rainfall events,

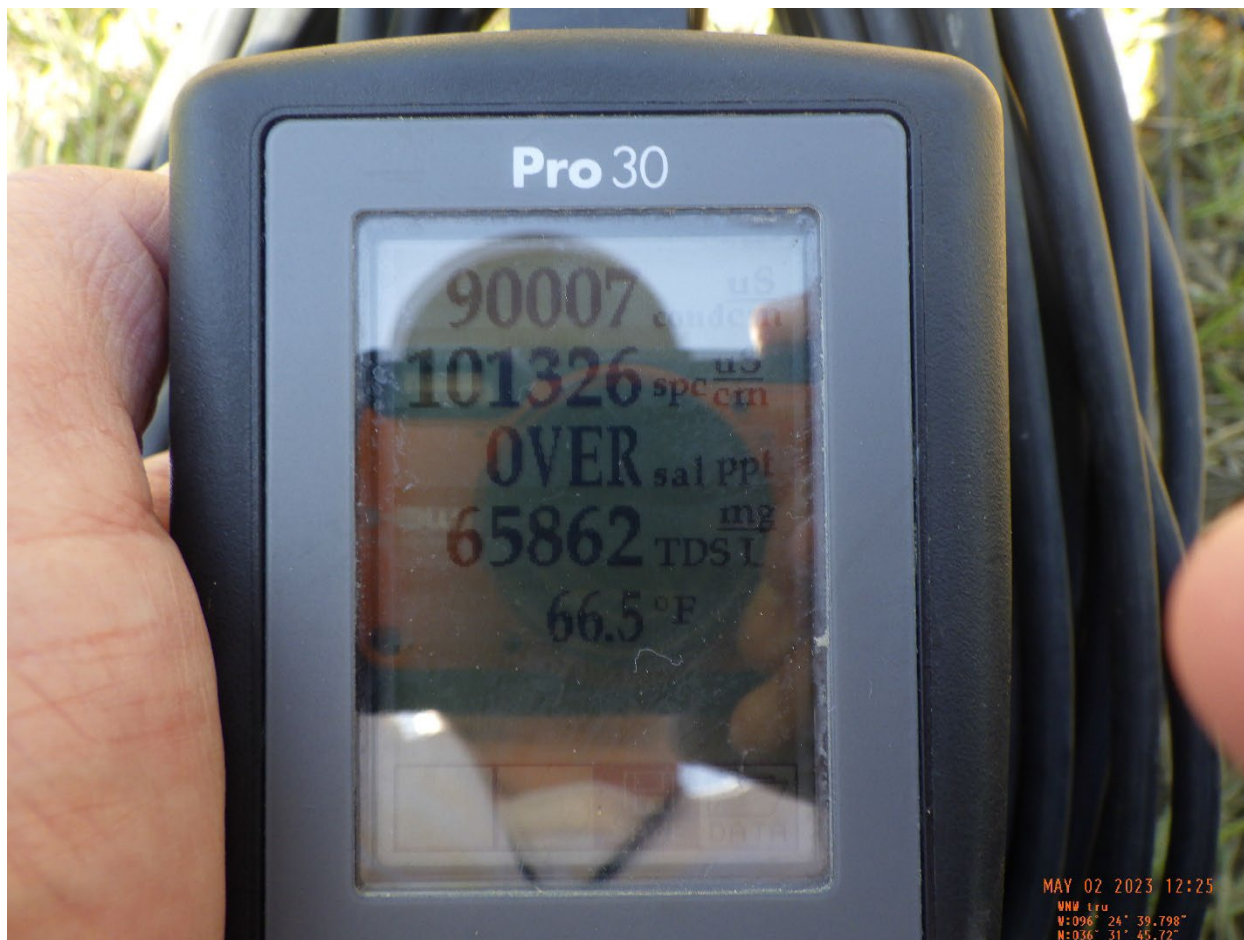
Photo No. 4

I observed an elevated TDS field reading of 65,862 mg/L in the main channel of the impacted tributary at the POE. This was the highest observed TDS field reading of the inspection. I also observed the downstream and upstream bed and bank features of the tributary from the POE. See photos No. 4, 5 and 6.

**Description:** This was an elevated TDS field reading of 65,862 mg/L taken at the POE into the impacted tributary of Little Hominy Creek. This was the highest TDS level observed during the inspection.

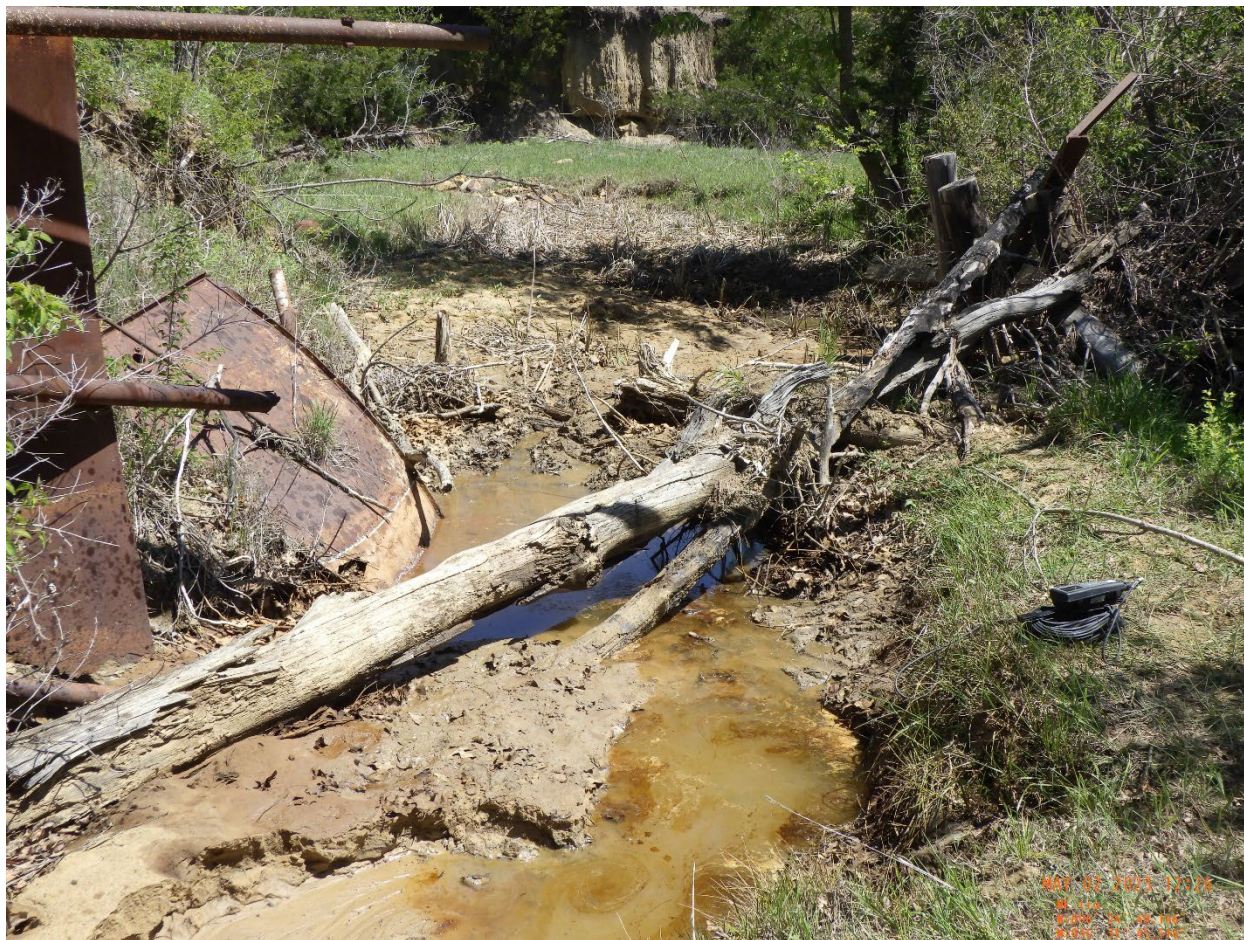
Photo No. 5

**Description:** This was the pool of water where the elevated TDS of 65,862 mg/L measurement was taken at the POE, with a view looking downstream. Oil was also present at the POE.

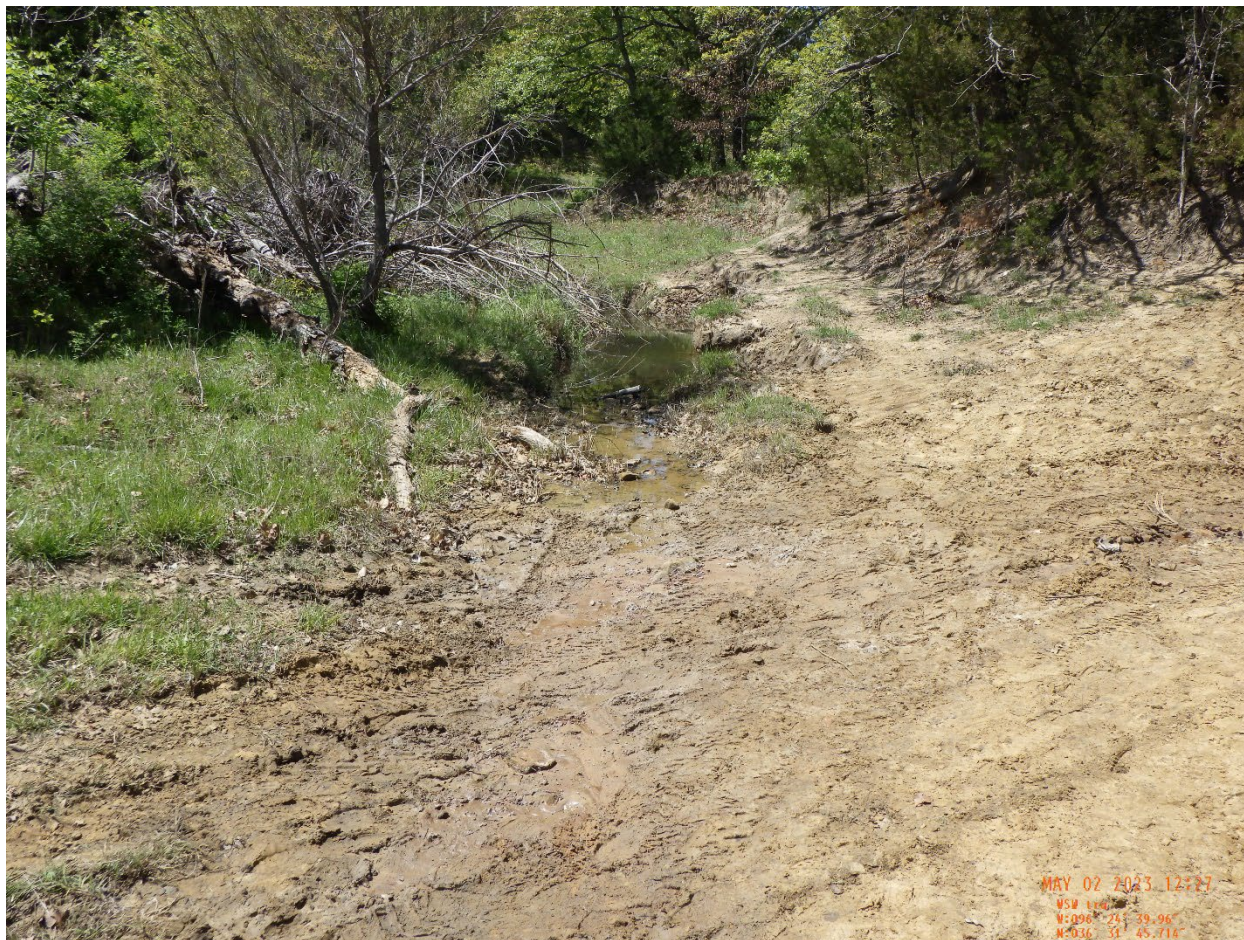
Photo No. 6

**Description:** This was a photo standing at the POE with a view to the SW or upstream.

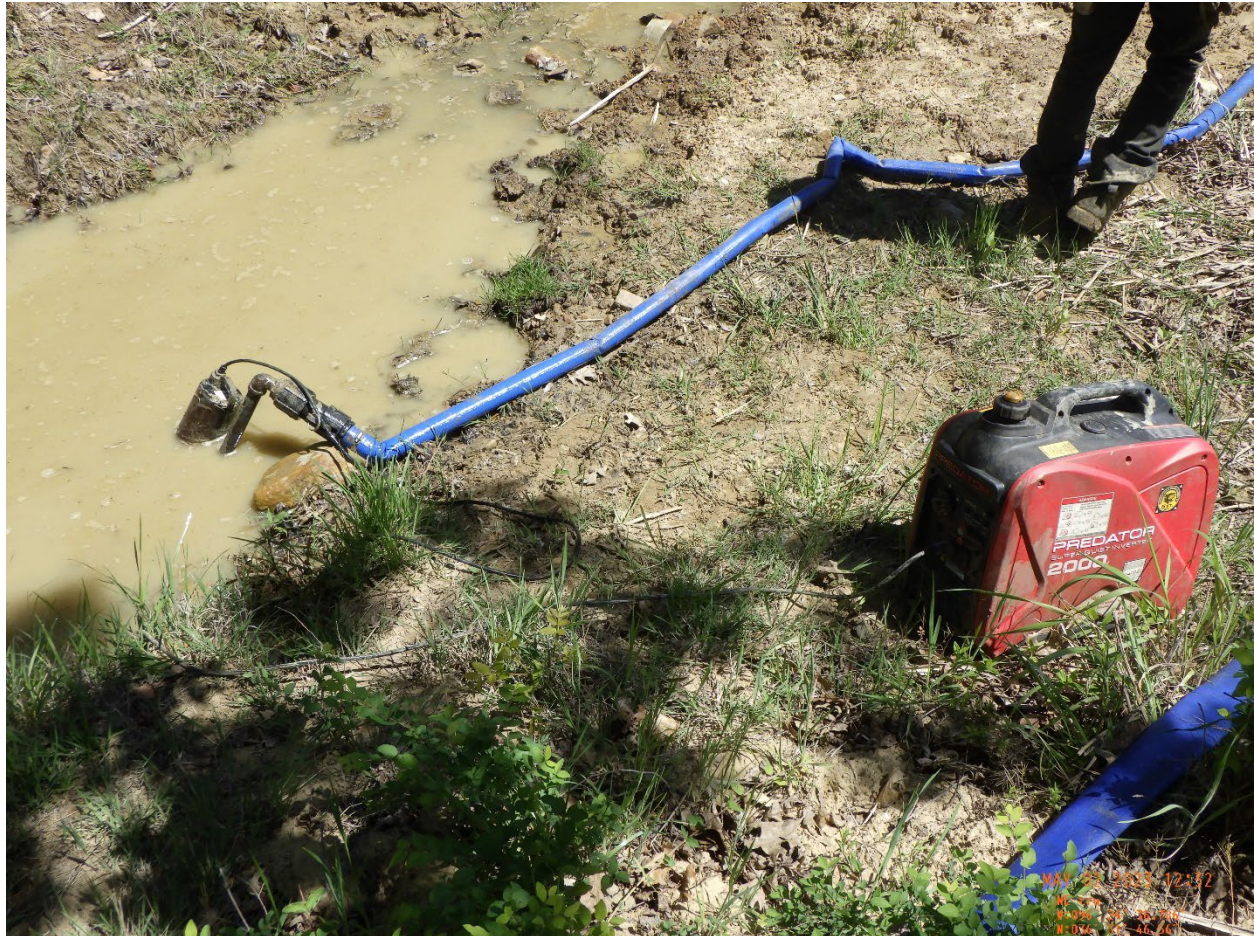
Photo No. 7

I observed Calgary Energy, LLC employees working with transfer pumps along the impacted tributary to “sweep” or pump impacted waters downstream to awaiting vacuum trucks where the water was being removed and taken for proper disposal. See photo No. 7.

**Description:** This was a photo taken downstream from the POE. Workers and equipment "sweeping" or emptying the brine from one hole of water downstream to the next hole of water, progressively moving the water toward vacuum trucks stationed downstream which were removing impacted water from the tributary.

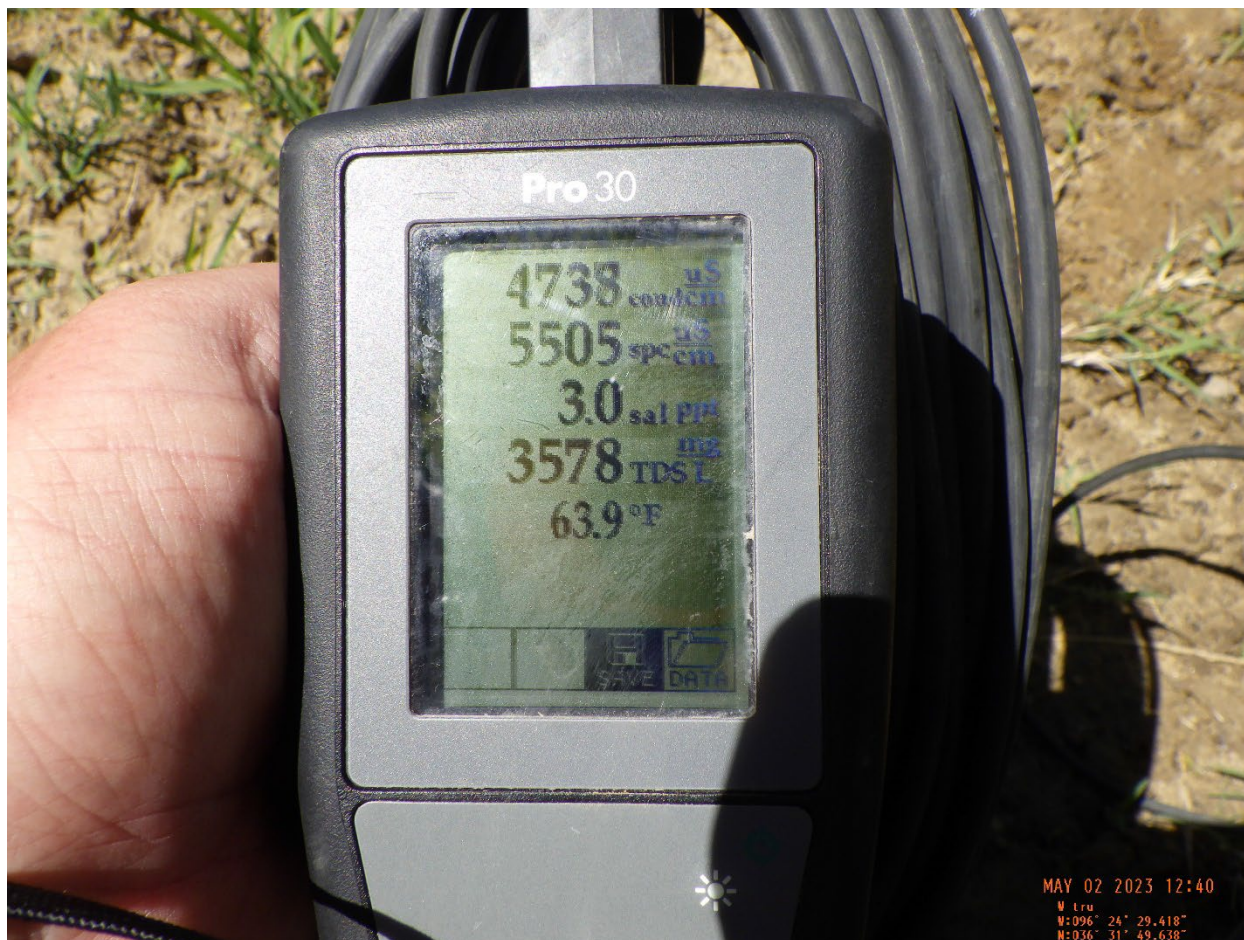
Photo No. 8

Progressing downstream, I observed an elevated TDS field reading of 3,578 mg/L as well as the bed and bank features of the impacted tributary at the location. These observations and GPS locations are detailed in photos No. 8, 9 and 10 of the photo log.

**Description:** This was an elevated TDS field reading of 3,578 mg/L taken downstream from the POE.

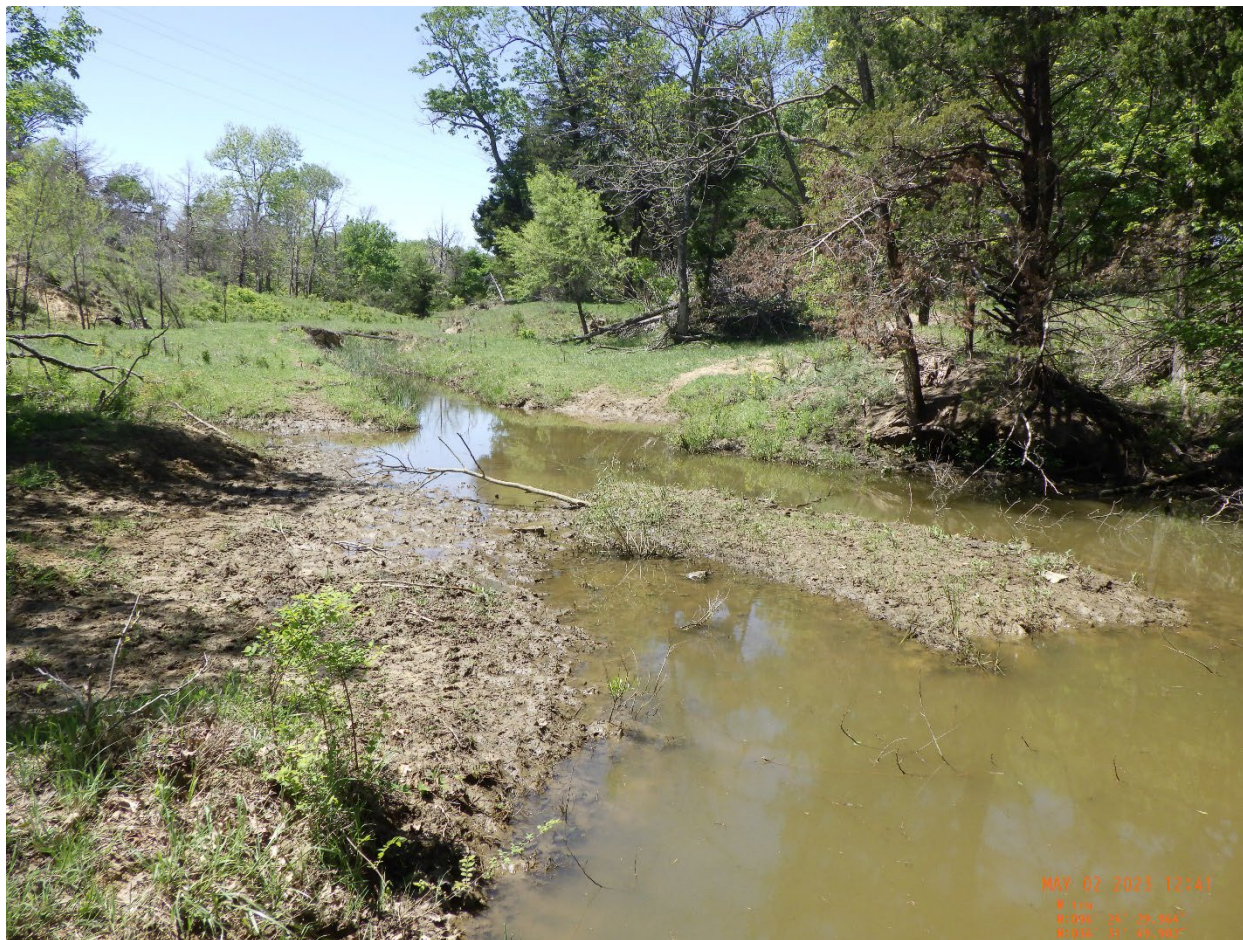
Photo No. 9

**Description:** This was a photo taken at the same location as Photo No. 8 on the previous page. This is a view looking SW or upstream, this photo shows the bed and bank features of the impacted tributary.

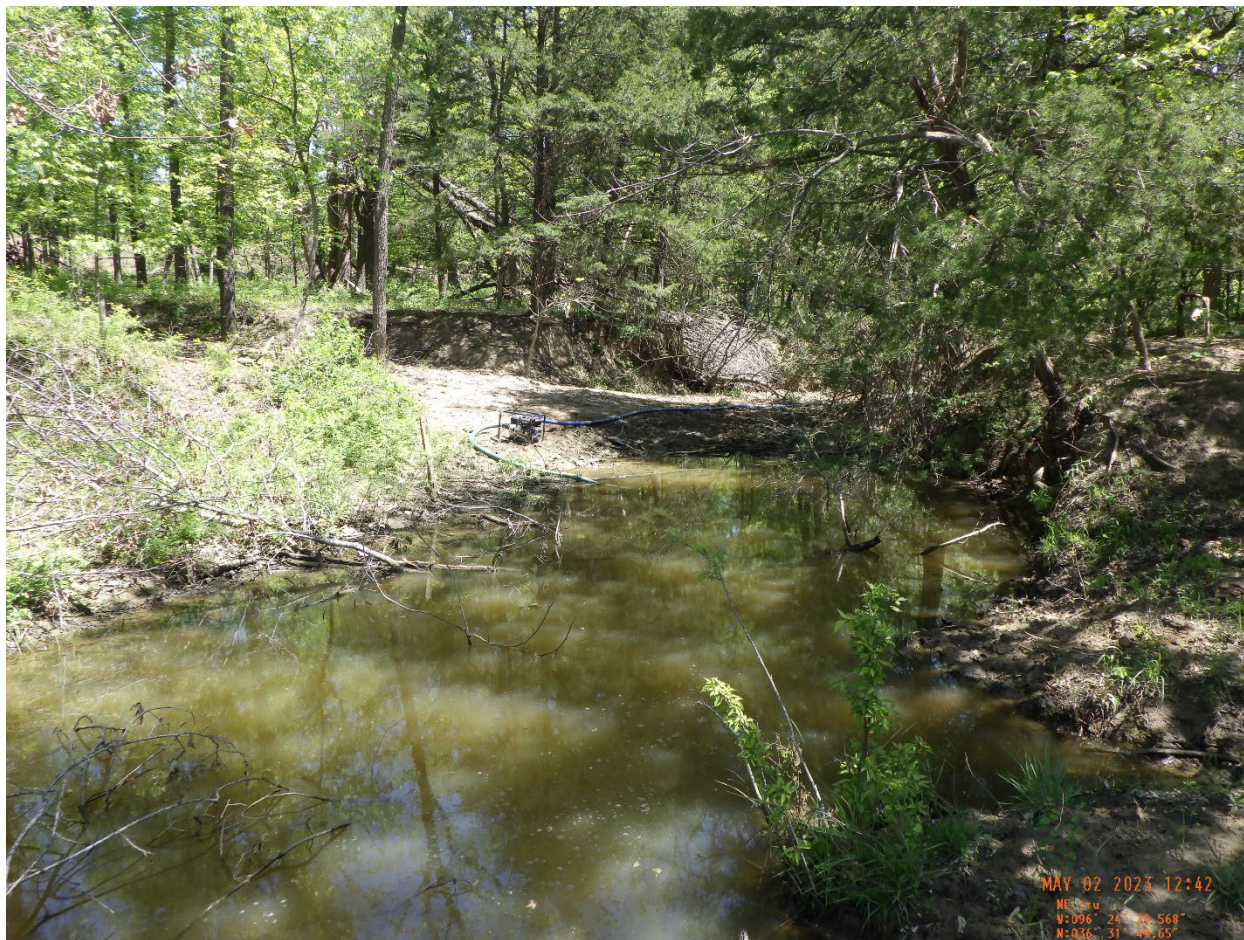
Photo No. 10

**Description:** This was a photo taken from the same location as photos No. 8 and 9. This was a photo with a NE or downstream view, showing the bed and bank features of the impacted tributary. There was a transfer pump moving impacted water downstream toward the vacuum trucks.

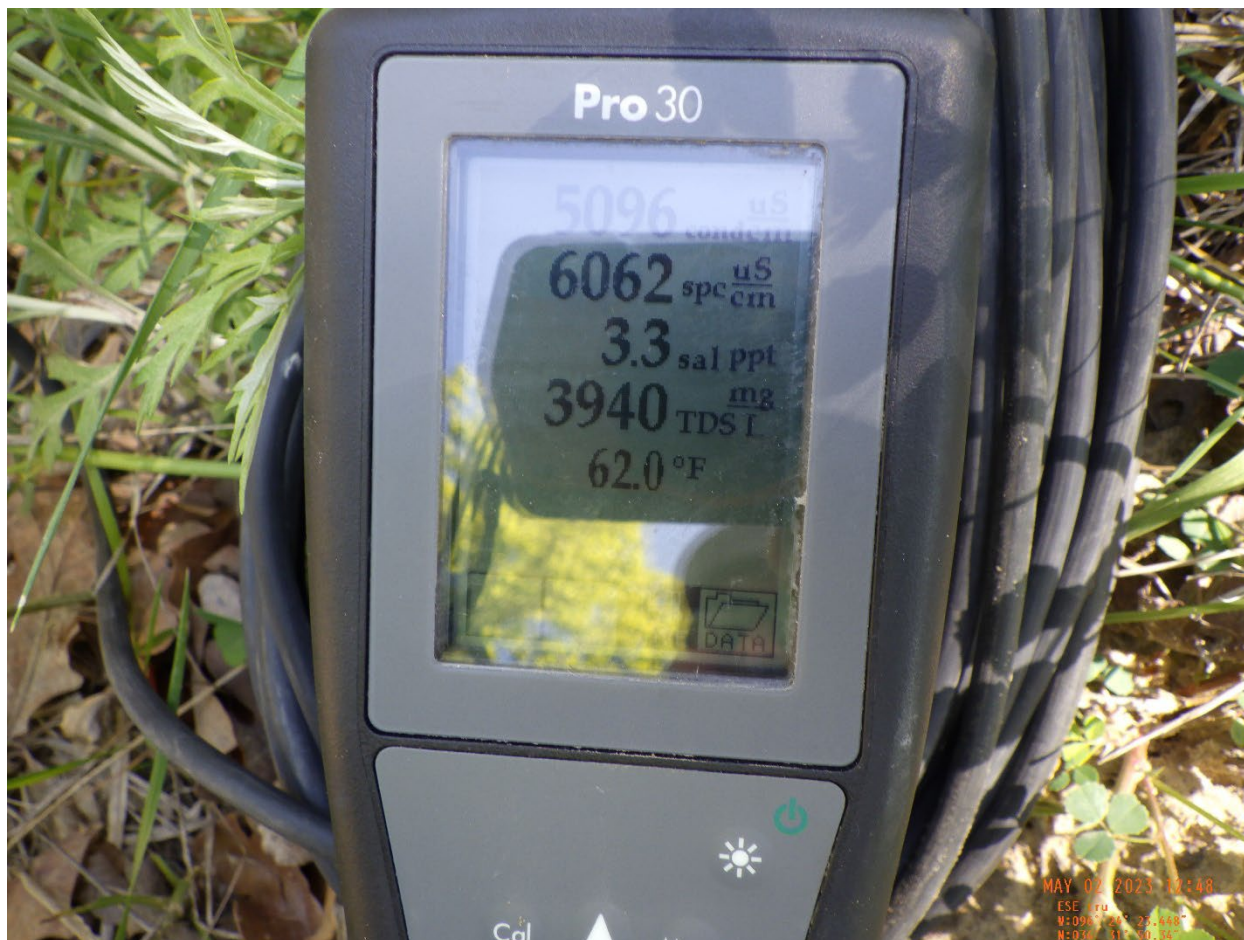
Photo No. 11

I observed an additional elevated TDS field reading of 3,940 mg/L as I tracked spill impacts downstream. See photo No. 11. I observed the bed and bank features of the impacted tributary at the same location. The bed and bank observations can be seen in Photos No. 12 and 13 of the photo log.

**Description:** This was an elevated TDS field reading of 3,940 mg/L taken downstream from the POE along the main channel of the impacted tributary.

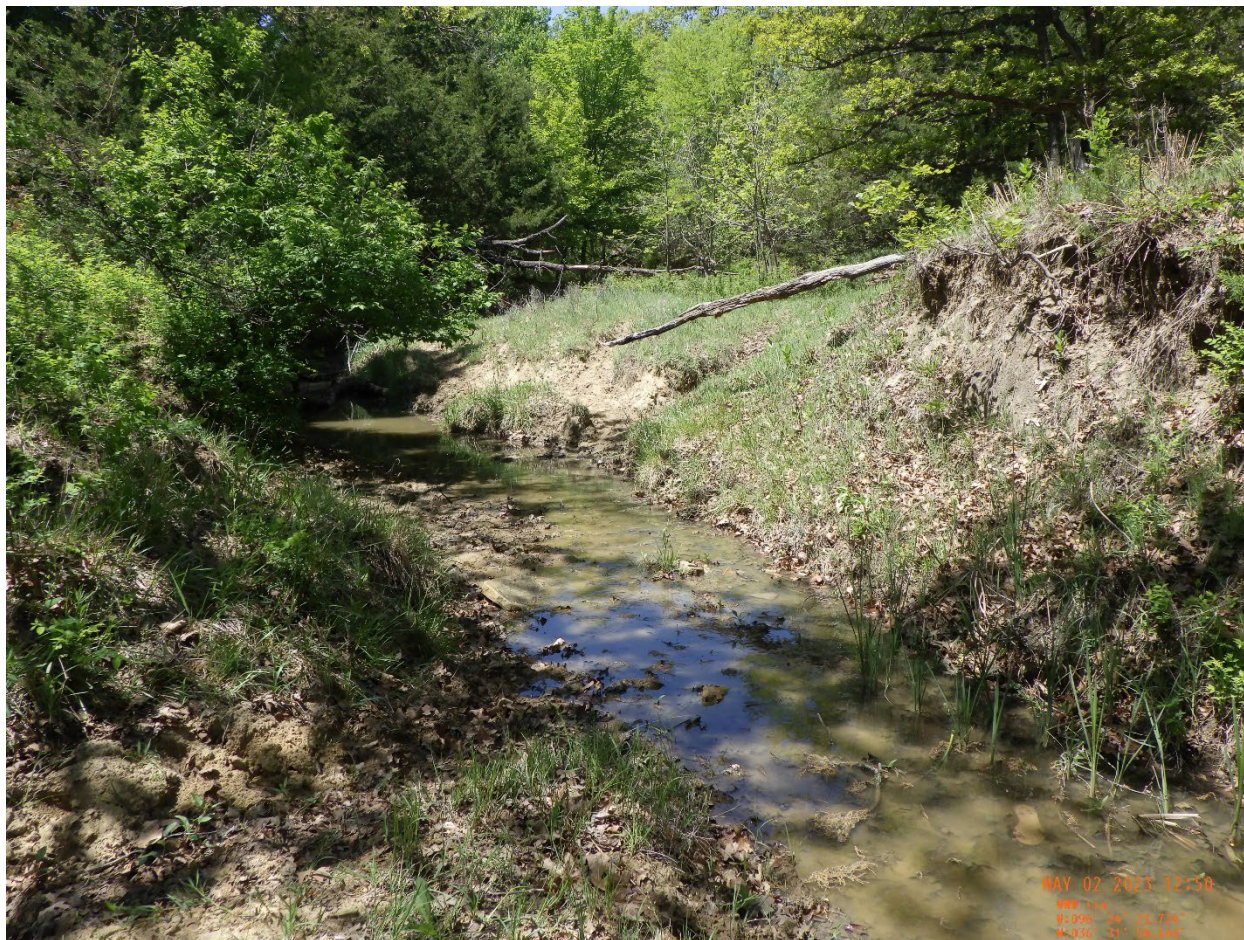
Photo No. 12

**Description:** This was a photo taken from the same location as Photo No. 11. This was a view looking SW or upstream showing the bed and bank features of the impacted tributary.

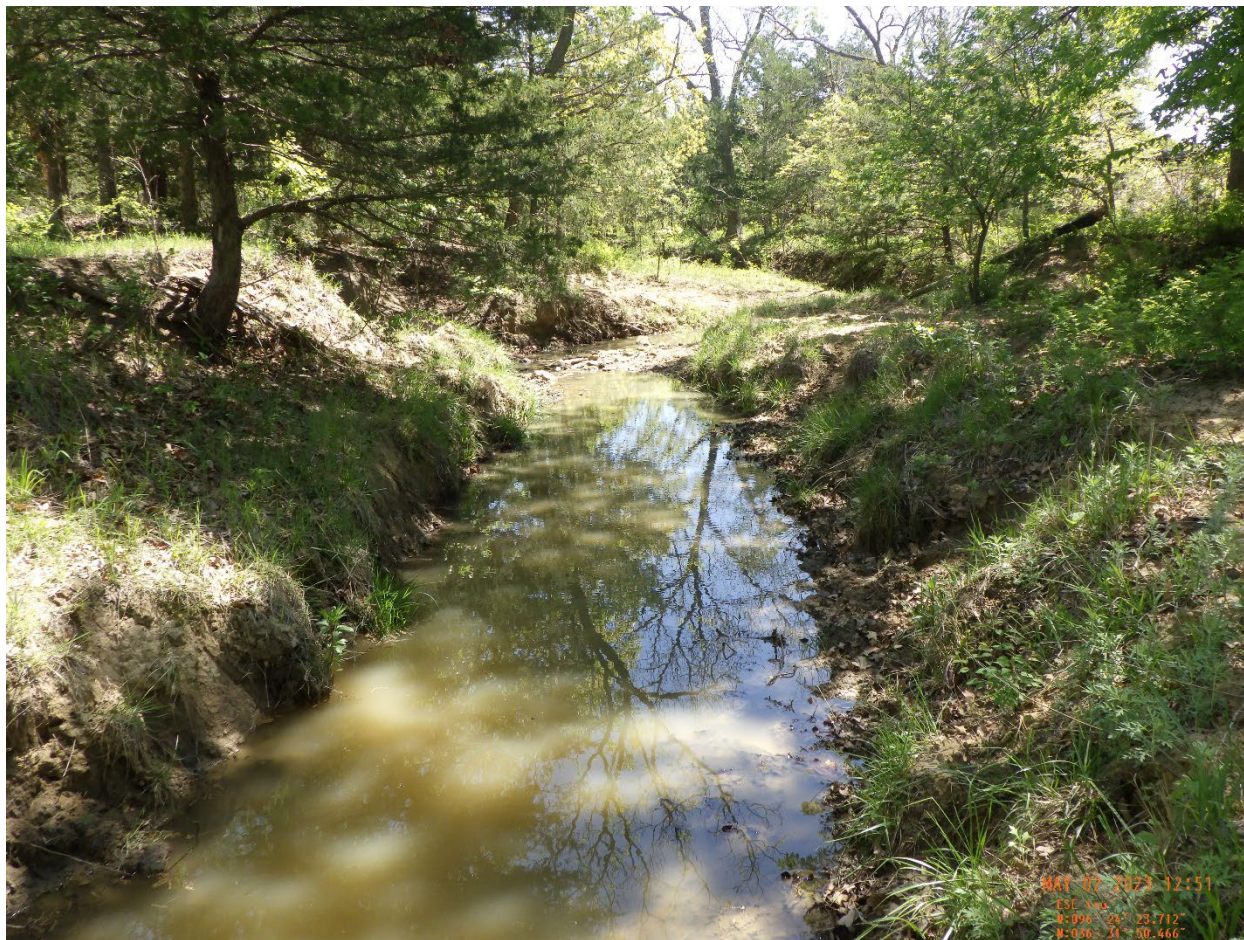
Photo No. 13

**Description:** This was a photo taken from the same location as Photos No. 11 and 12. This was a view looking NE or downstream showing the bed and bank features of the impacted tributary.

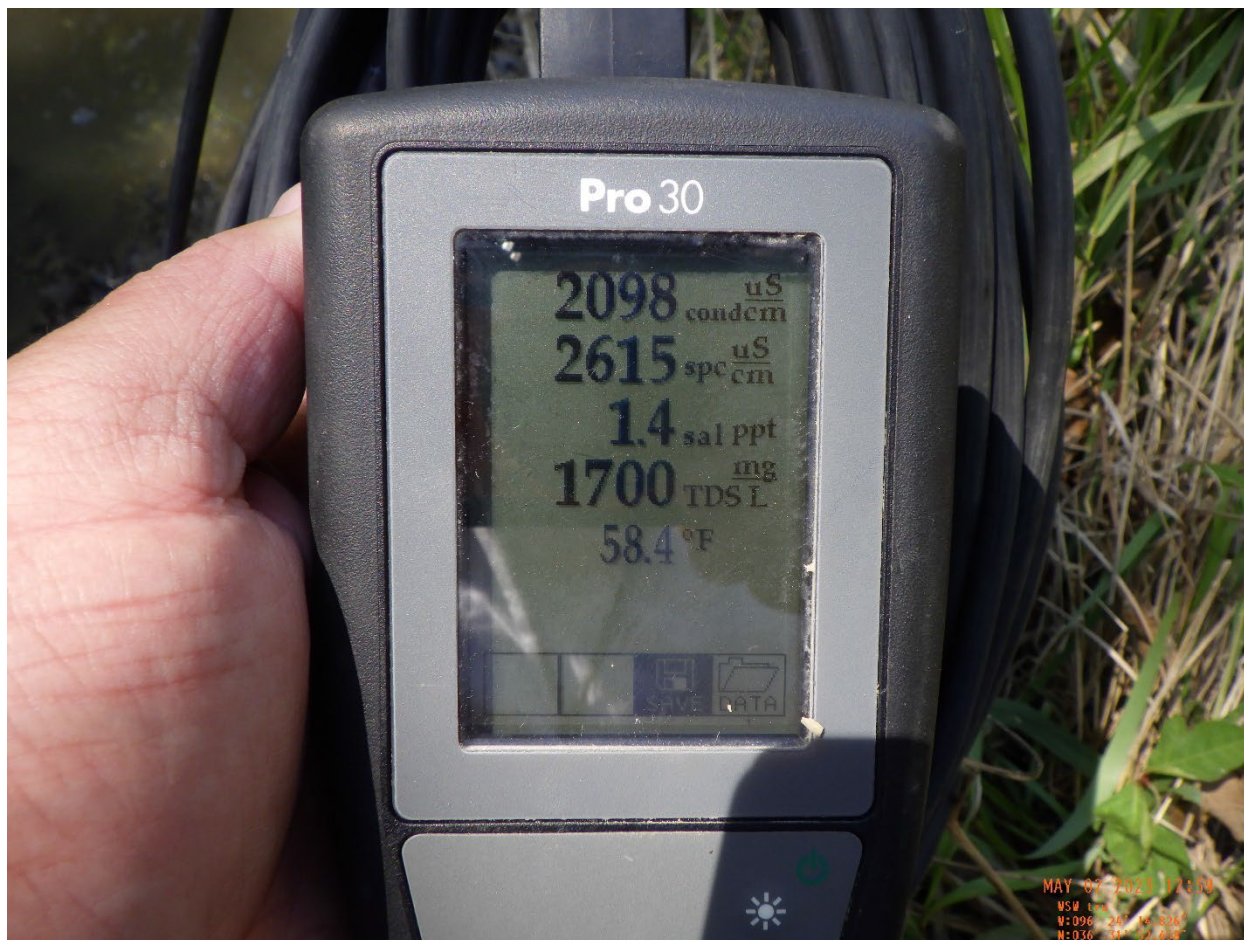
Photo No. 14

I observed an elevated TDS field reading of 1,700 mg/L in the pool immediately above (upstream) the lowermost, temporary containment dam which had been placed by the operator to prevent downstream migration of impacted waters. See photo No 14.

**Description:** This was an elevated TDS field reading of 1,700 mg/L taken in the lowermost impacted pool of the impacted tributary. This field reading was taken in the pool of water immediately upstream from the lower, temporary containment dam which had been placed by the operator to prevent further downstream migration of impacted waters.

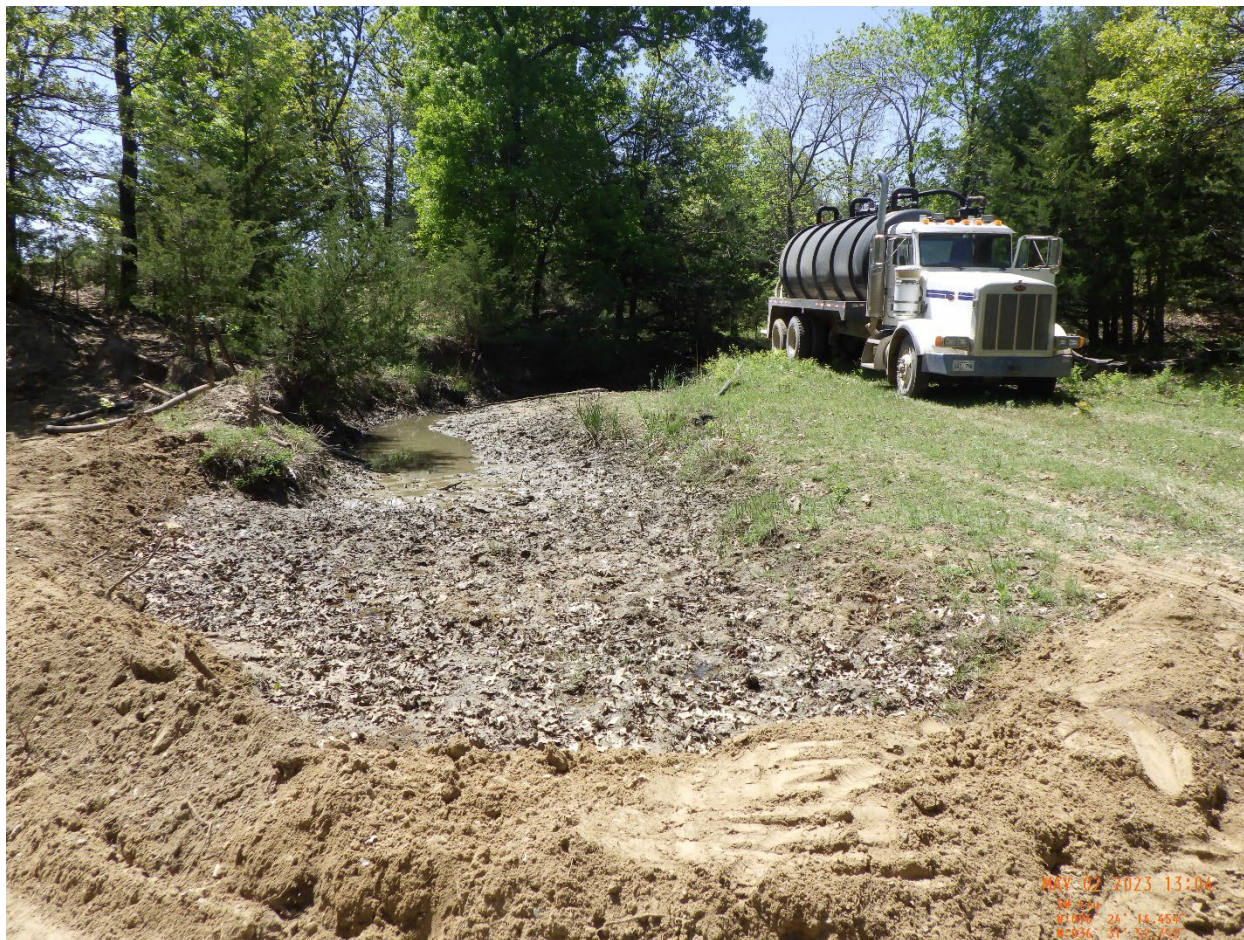
Photo No. 15

I observed the temporary, lowermost containment dam, as well as vacuum trucks removing elevated TDS waters from the impacted tributary. See photo No. 15 for GPS location information. This was also the last point where I observed spill impacts at the time of the inspection.

**Description:** This is the lowermost, temporary containment dam, placed by the operator to prevent further downstream migration of brine impacted waters. The dam was placed in an appropriate location, as evidence of spill impacts were not observed as the inspection continued downstream.

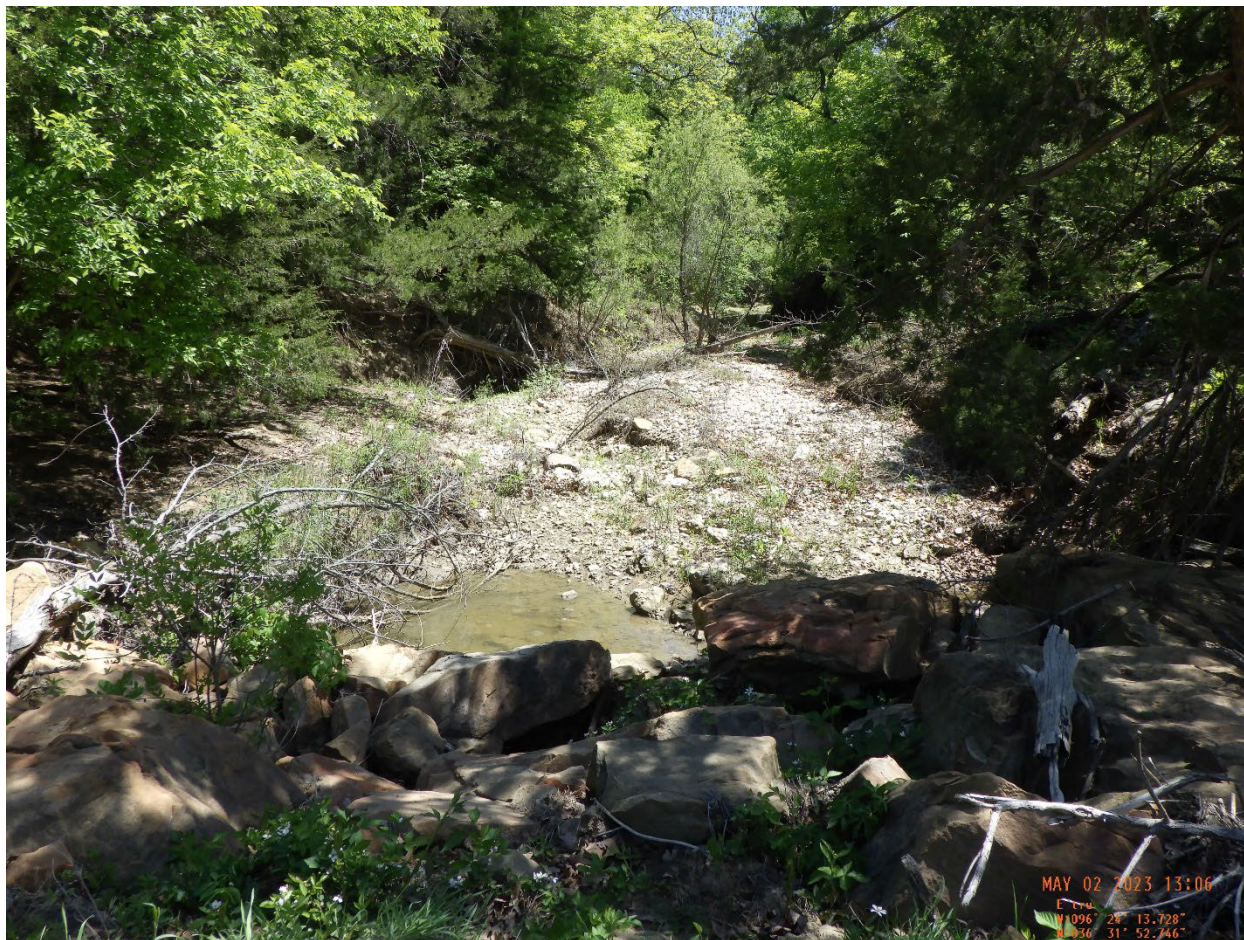
Photo No. 16

**Description:** This was a photo taken from the same location as photo No. 15. This is a downstream view toward the east. I did not observe spill impacts at any point downstream from the temporary containment dam at the time of the inspection.

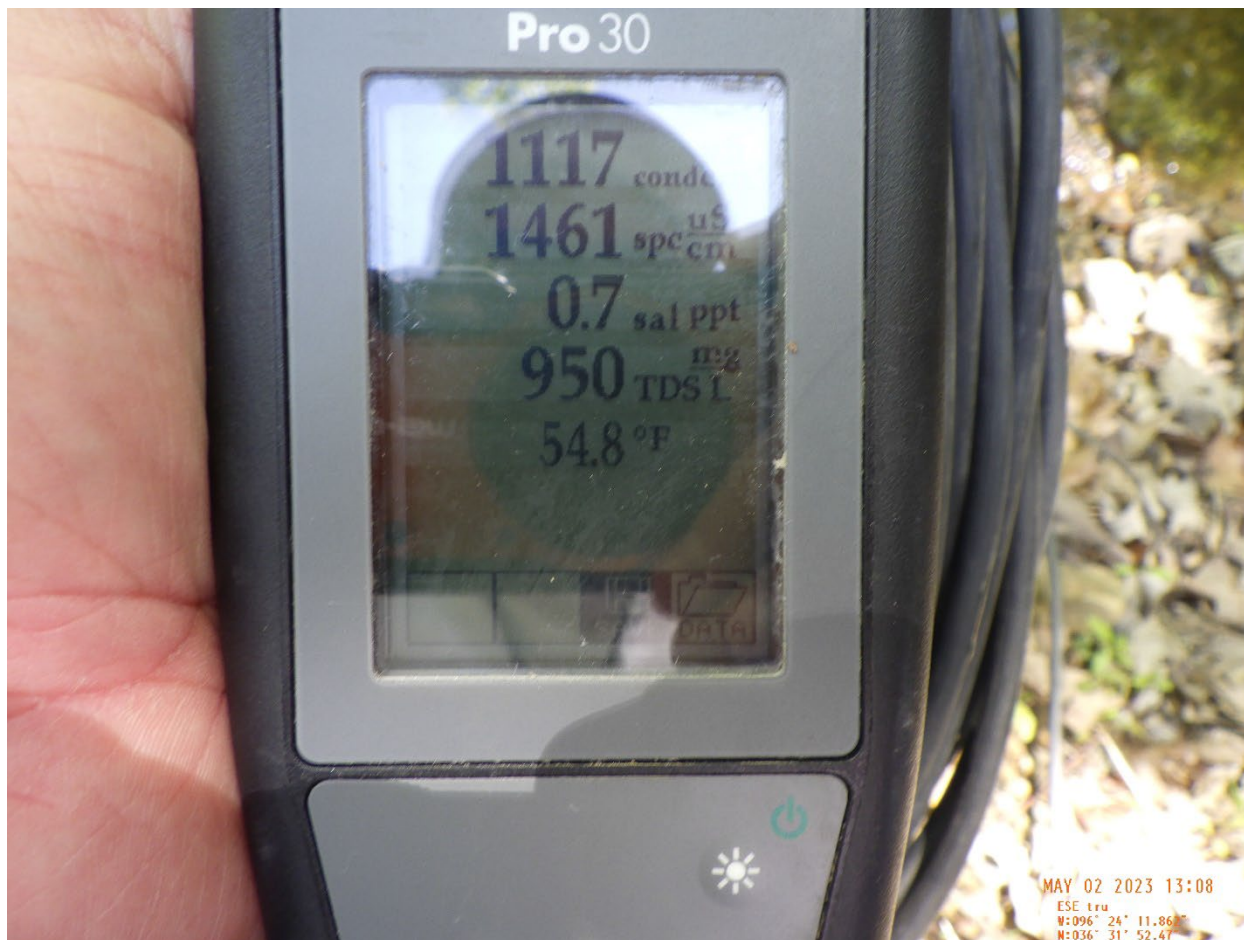
Photo No. 17

I continued the inspection downstream, beyond the temporary containment dam, and observed a TDS field reading of 950 mg/L in a deep pool in the main channel of the tributary. This TDS field reading was below the upstream “background” reading observed at the beginning of the inspection and provided evidence that the containment dam had been appropriately placed. This TDS field reading should also be used when assessing background TDS levels for the area. See photos No. 17 and 18.

**Description:** This was a TDS field reading of 950 mg/L observed in a deep hole downstream from the last recorded spill impacts. This TDS field reading was lower than the upstream background reading observed at the beginning of the inspection and should also be used when considering “background” TDS levels for the area.
