**Region 6 - Enforcement & Compliance Assurance Division**  
**INSPECTION REPORT**

| Inspection Date(s): | 05/02/2023 | |
| Company Name: | <b>Calgary Energy, LLC</b> | |
| Facility Name: | <b>Tidal Osage</b> | |

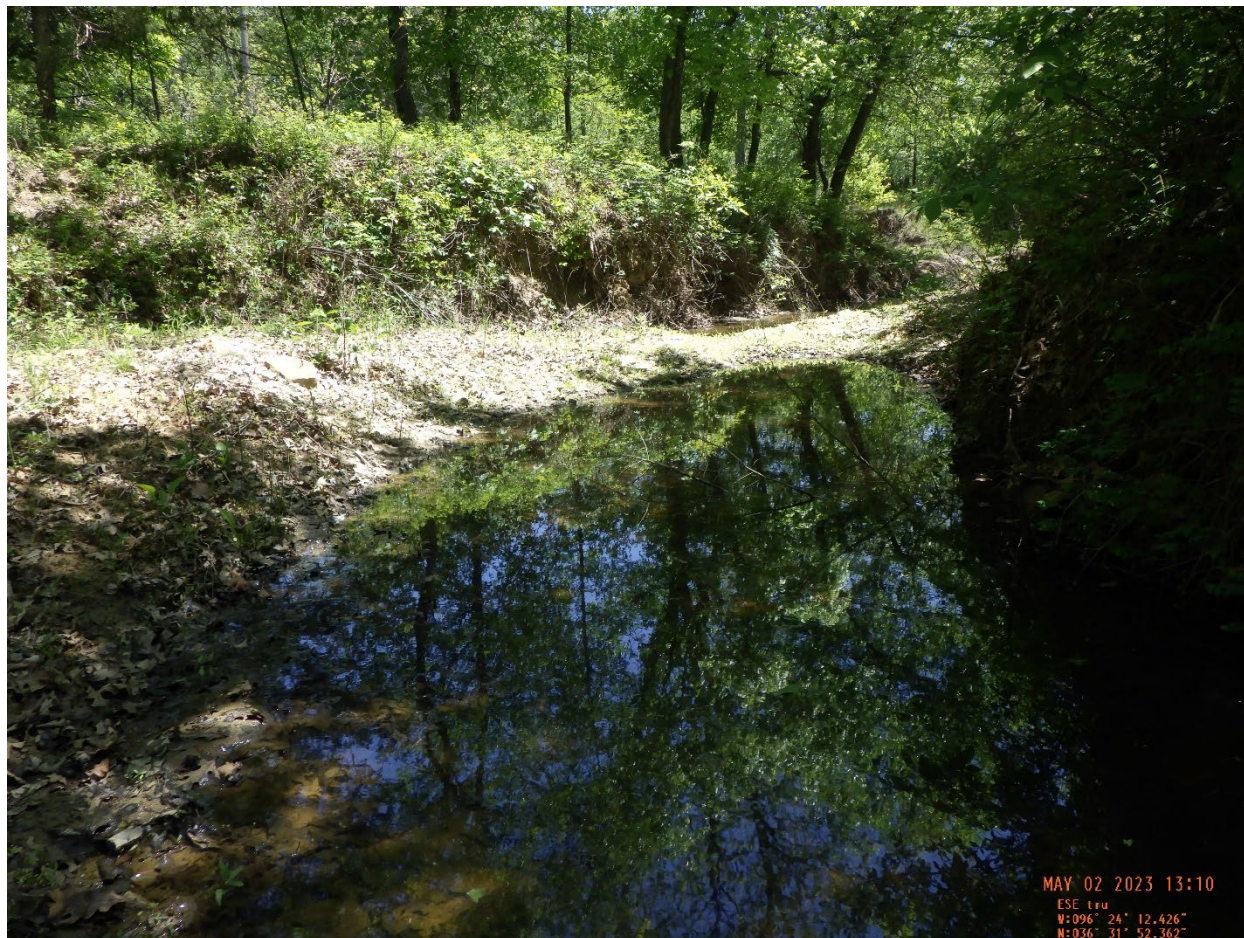
Photo No. 18

**Description:** This was the deep pool where the TDS field reading from photo No. 17 was observed. At the time of the inspection, there was no evidence of spill impacts at this location, or at any point further downstream.
