Clean Water Act (CWA) Inspection Report

| <b>Type of Inspection</b> | CEI - Compliance Evaluation Inspection | | | |
| <b>Project or Site Name</b> | Fagerlie Subdivision | | | |
| <b>Permit Number</b> | WAR312688 | | | |

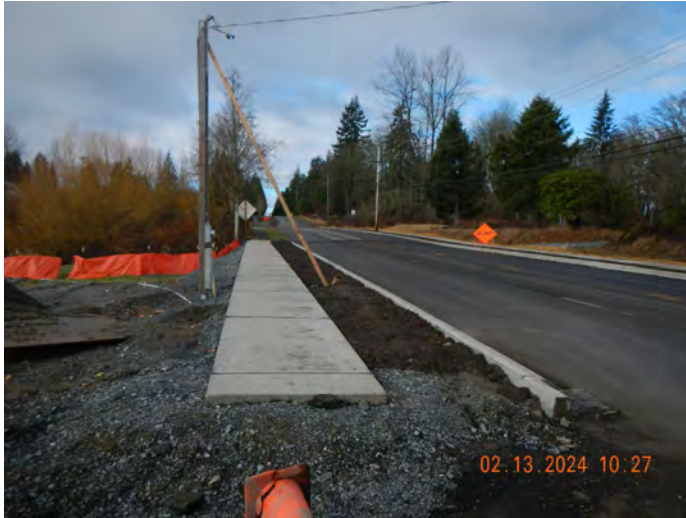
Photo #:01 (DSCN3573)

Description: Facing west along 20<sup>th</sup> Street SE, photo of installed sidewalk and frontage area just west of the construction entrance. "Witches hat" installed in roadside catch basin.

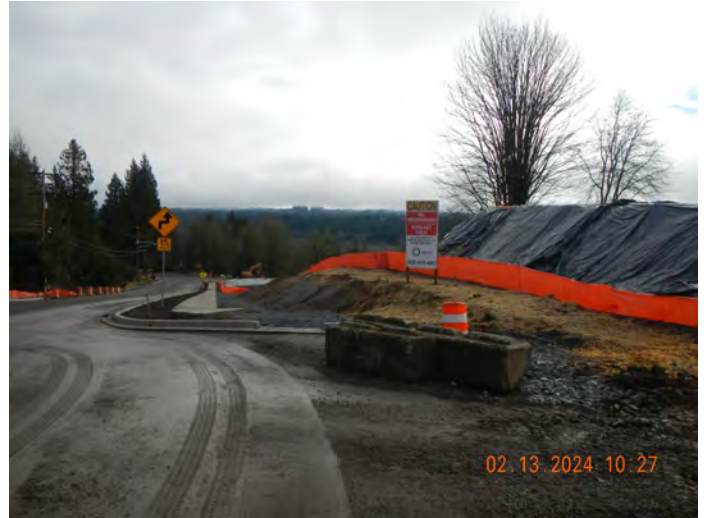
Photo #:02 (DSCN3574)

Description: Facing east along 20<sup>th</sup> Street SE, photo of installed sidewalk and frontage area east of the construction entrance.

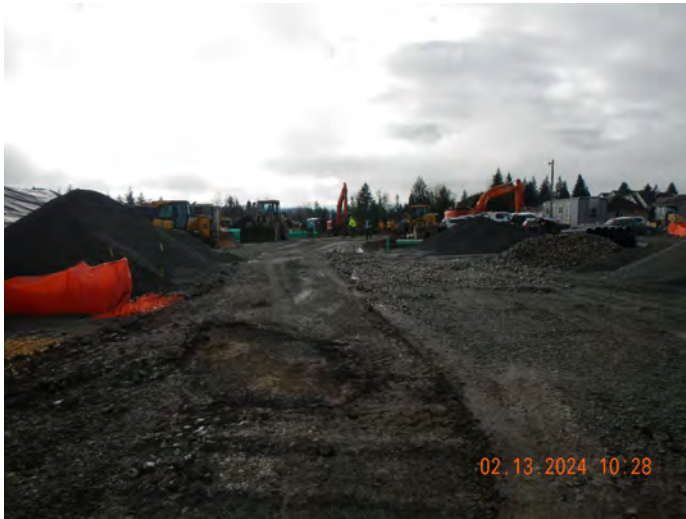
Photo #:03 (DSCN3575)

Description: Facing south from 20<sup>th</sup> Street SE, photo of primary construction entrance. Entrance was just graded to allow for street sweeper to access.

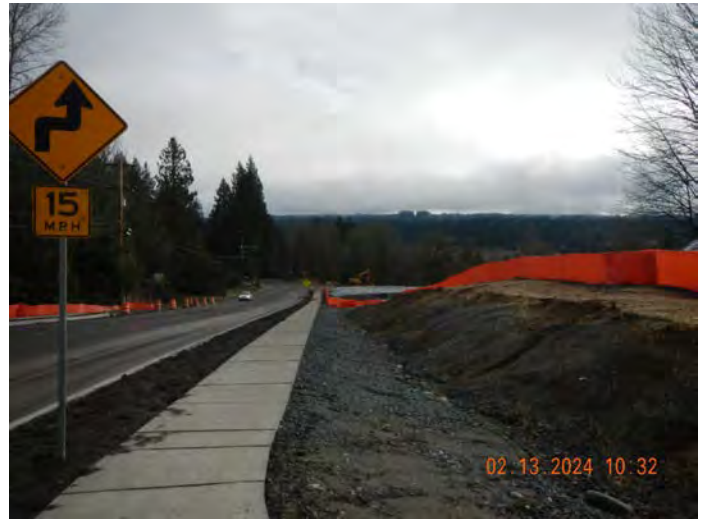
Photo #:04 (DSCN3576)

We continued east along the new frontage areas of 20<sup>th</sup> Street SE (**Photo 4**) and observed additional frontage landscape areas under construction. BMPs observed included silt fencing, straw application and plastic tarps used for covering exposed slopes and stockpiles (**Photo 5**). We observed one roadside catch basin that was being piped to discharge on-site rather than tied into the stormwater pond. Mr. Villwock discussed the piping was a temporary measure to promote on-site infiltration rather than contribute additional stormwater to the infiltration/detention pond (**Photo 6 & Photo 7**). It was discussed that additional BMPs could be used at the catch basin pipe's discharge location to minimize contact with exposed soils, including an unstabilized stockpile.

Description: Facing east along 20<sup>th</sup> Street SE, photo of installed sidewalk and frontage area east of the construction entrance.

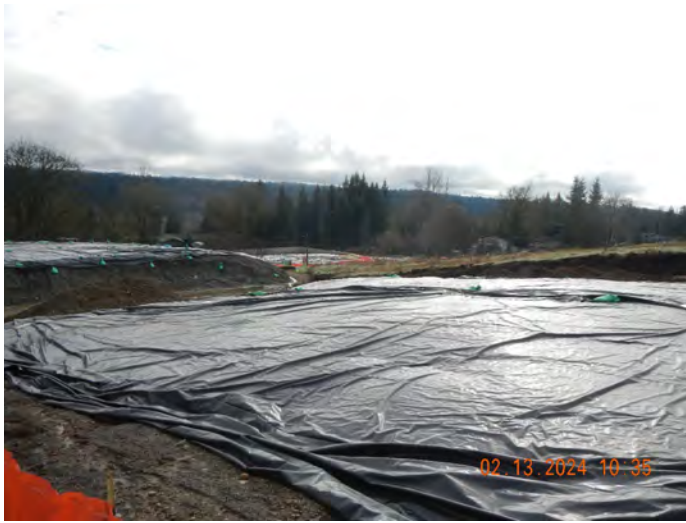
Photo #:05 (DSCN3577)

Description: Facing southeast, photo of plastic covering used as a BMP for a graded area south of 20<sup>th</sup> Street SE.

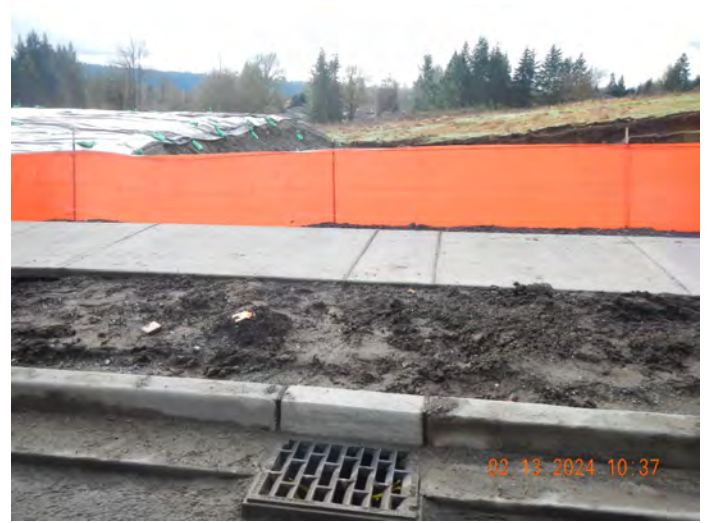
Photo #:06 (DSCN3578)

Description: Facing south along 20<sup>th</sup> Street SE, photo of roadside catch basin and perimeter silt fencing. Topsoil installed within frontage area to begin landscaping. "Witches hat" installed within catch basin.

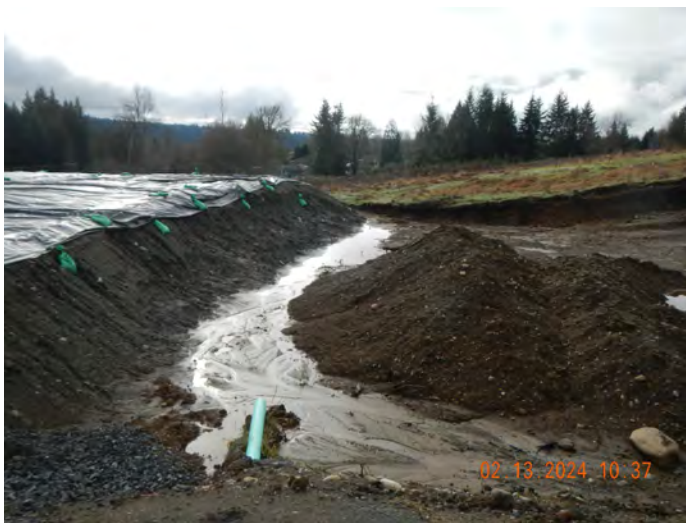
Photo #:07 (DSCN3579)

Description: Facing south along 20<sup>th</sup> Street SE, photo of drainage pipe connected to roadside catch basin pictured in Photo #06. Water entering the catch basin is designed to infiltrate within vegetated area, instead of discharging to stormwater pond. Uncovered stockpile within area.

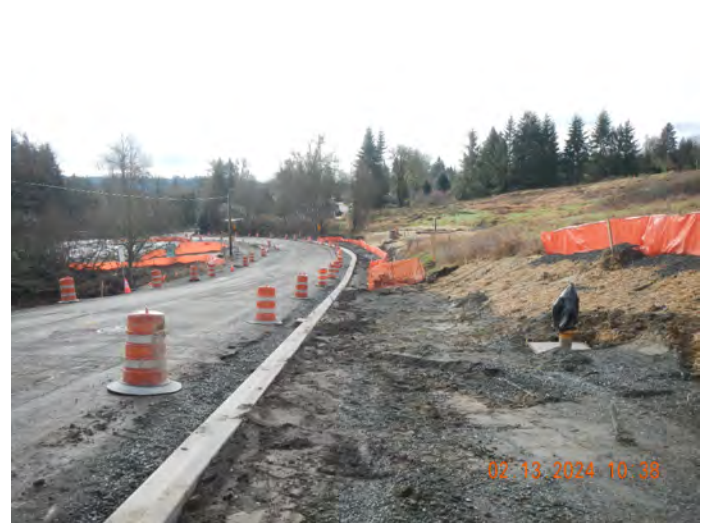
Photo #:08 (DSCN3580)

Description: Facing south along Williams Road. Photo of project's northeast perimeter. Eastern side of project generally left undisturbed during current phase.

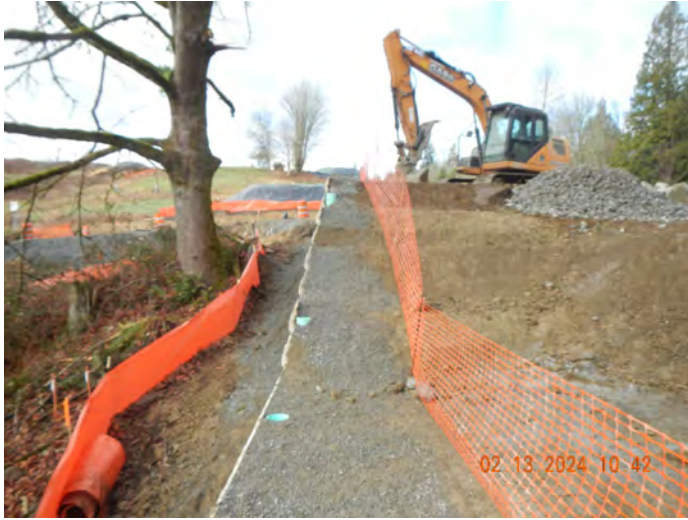
Photo #:09 (DSCN3581)  
Description: Facing west at “Lot 50” (Lot 52 on map). Area was prepped/work the day prior to the inspection.

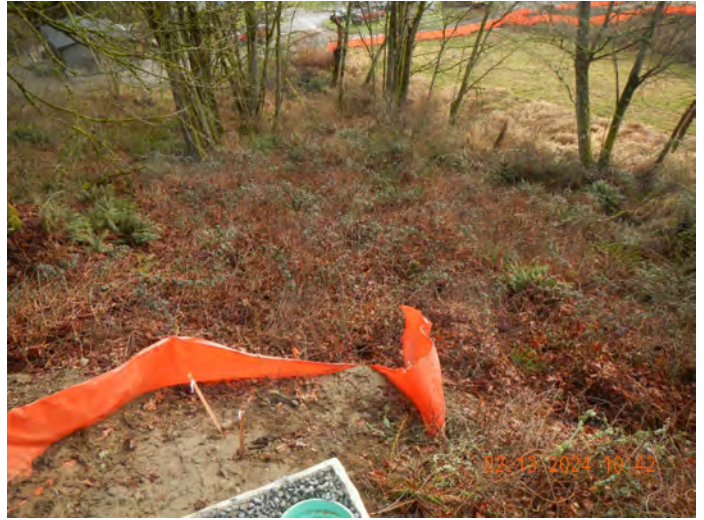
| <p>AOC: As discussed earlier within this report, during the site walk-through we observed three separate sections of silt fence in need of maintenance (<b>Photo 10, Photo 11 &amp; Photo 17</b>). We also observed an exposed and unworked stockpile near the diverted drainage channel from a 20<sup>th</sup> Street SE roadside catch basin (<b>Photo 7</b>).</p> <p>The concern is the observed BMP in need of maintenance based upon the written standard, and the exposed/unworked stockpile near the diverted drainage channel from the 20<sup>th</sup> Street SE roadside catch basin.</p> <p>Post-inspection on February 21, 2024, Mr. Villwock provided photographs via email of the maintenance performed in response to the inspection, including the identified areas of silt fencing and the covering of the identified stockpile (<b>Attachment F</b>).</p> | |

Photo #:10 (DSCN3582)  
Description: Facing east, photo of silt fencing in need of maintenance (southeast corner of “lot 50”).

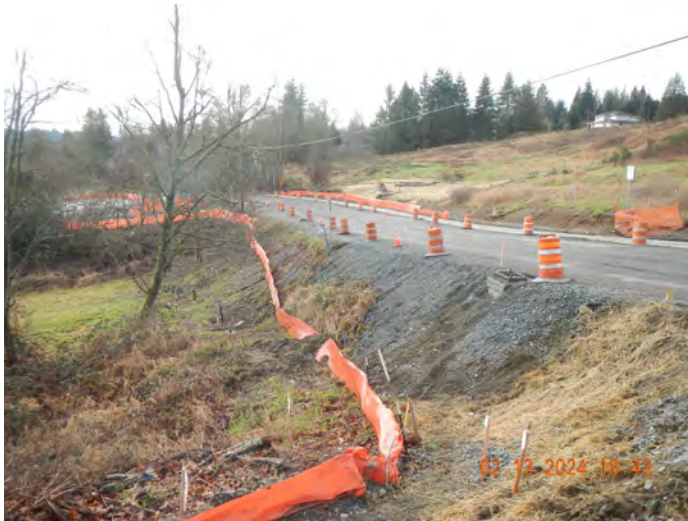
Photo #:11 (DSCN3583)  
Description: Facing south, photo from “Lot 50” of silt fencing in need of maintenance. Area is east of Williams Road. City of Lake Stevens recently in the area doing some water main work.

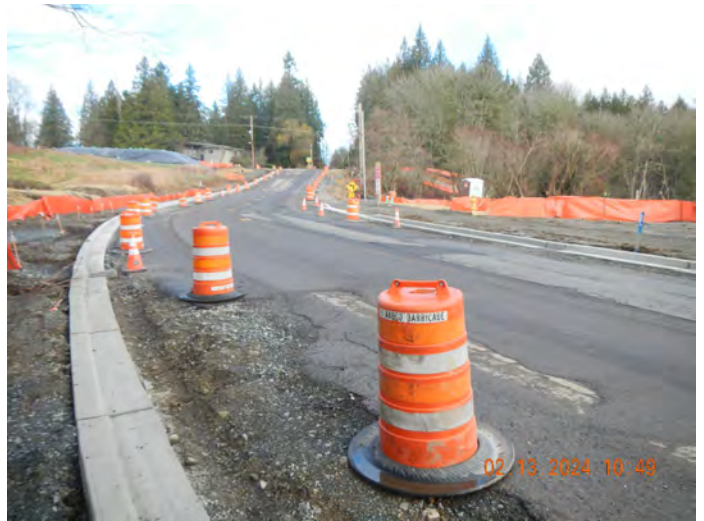
Photo #:12 (DSCN3584)  
Description: Facing north along Williams Road, photo of frontage area and two roadside catch basins (background) designed to discharge to the roadside ditch south of Williams Road.

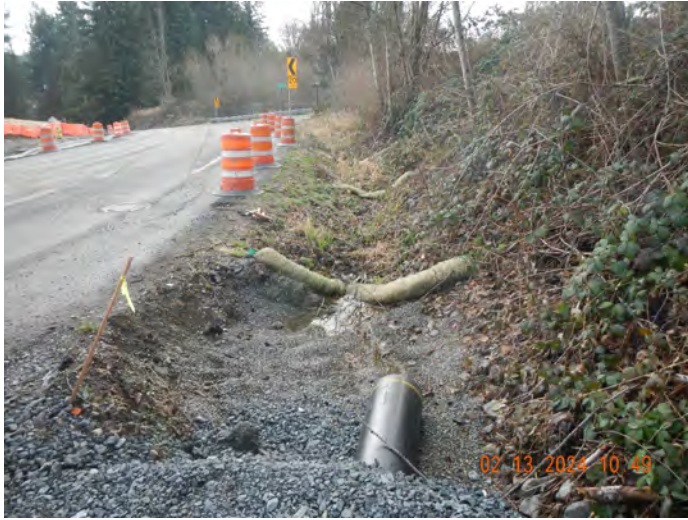
Photo #:13 (DSCN3585)

Description: Facing south along Williams Road, photo of discharge to roadside ditch. Discharge consists of two roadside catch basins shown in Photo #12.

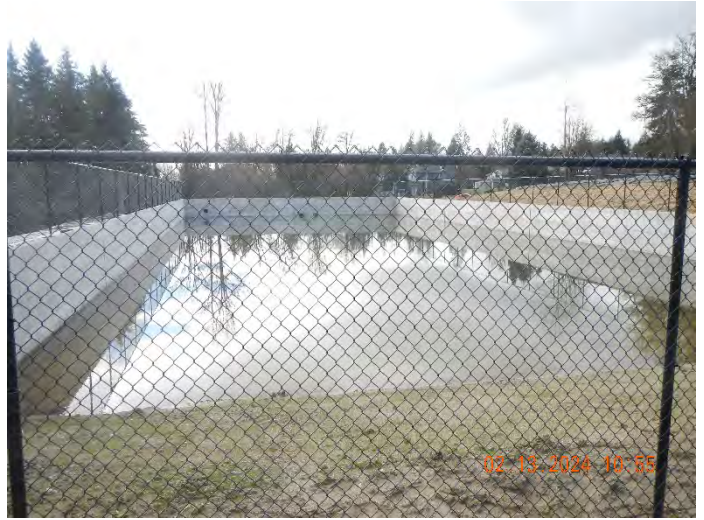
Photo #:14 (DSCN3586)

Description: Facing south, photo of stormwater pond.

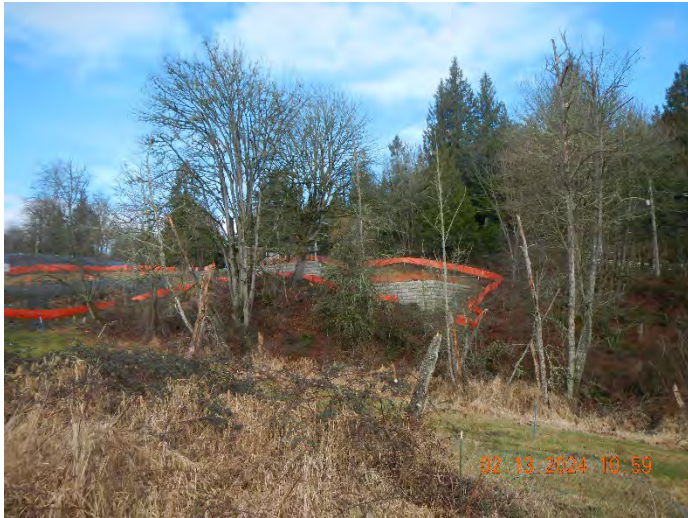
Photo #:15 (DSCN3587)

Description: Facing north from stormwater pond, photo looking back toward "Lot 50."

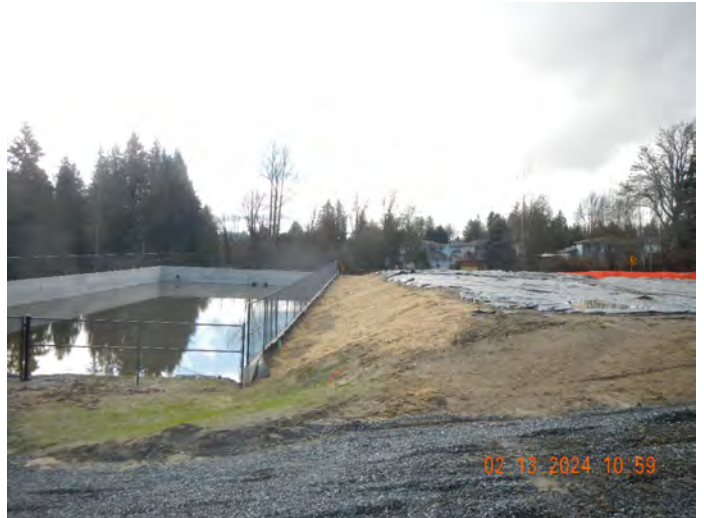
Photo #:16 (DSCN3588)

Description: Facing south, photo of stormwater pond and plastic covering unstabilized area to the west of the pond.

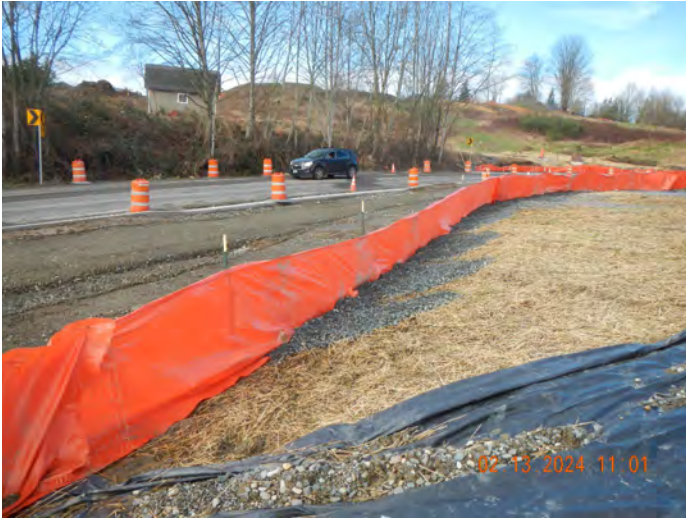
Photo #:17 (DSCN3589)

We again crossed Williams Road and observed the project’s stormwater pond. It was discussed that the pond’s overflow/discharge structure was yet to be completed, we observed perimeter silt fencing installed around the pond as well as permanent chain-link fencing (**Photo 14**). The Project’s “Lot 50” is located north of the pond, beyond a vegetated area outside the Project’s boundary (**Photo 15**). Additional BMPs observed near the pond included plastic sheeting for large unstabilized areas, established hydro-seeding, and straw covering (**Photo 16**). One area of perimeter silt fencing was observed to be in need of maintenance (**Photo 17**).

Description: Facing west, photo of portion of silt fence in need of maintenance. Area of silt fence not trenched in.

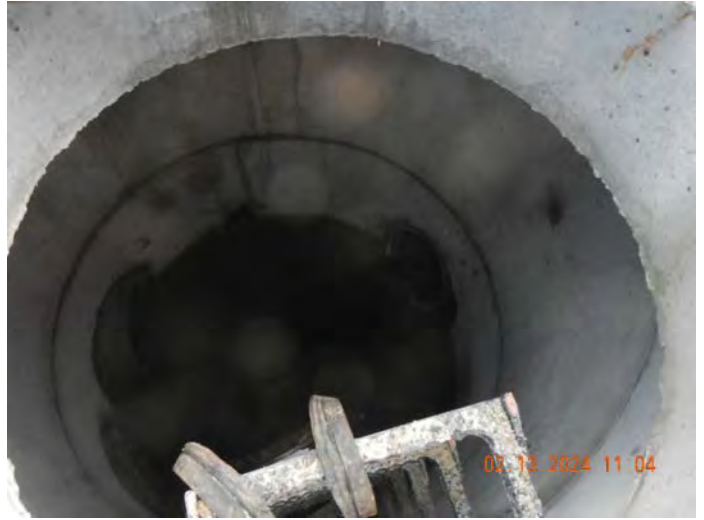
Photo #:18 (DSCN3590)

Description: Photo within stormwater pond outfall vault. Water observed to be flowing/discharging from within the vault.

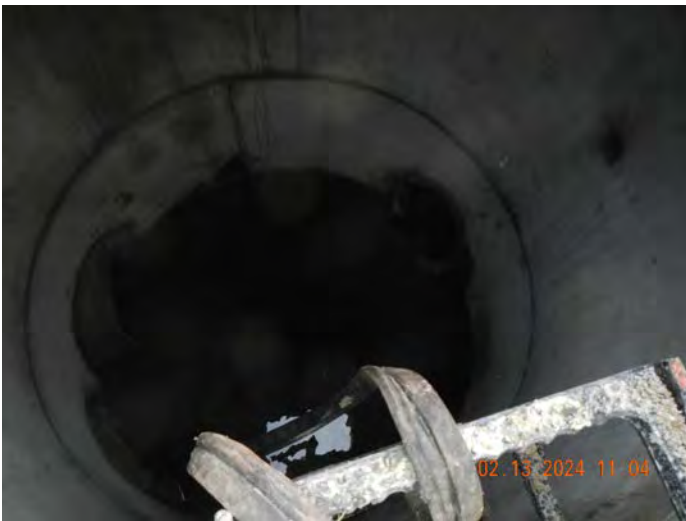
Photo #:19 (DSCN3591)

Description: Photo within stormwater pond outfall vault. Water observed to be flowing/discharging from within the vault.

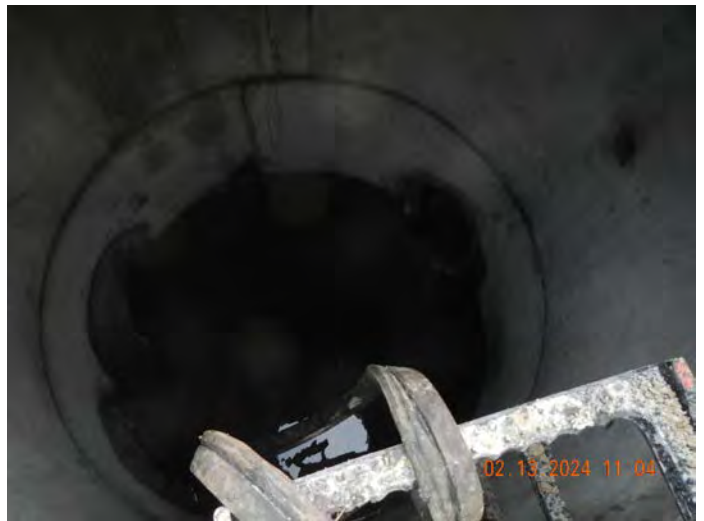
Photo #:20 (DSCN3592)

Description: Photo within stormwater pond outfall vault. Water observed to be flowing/discharging from within the vault.

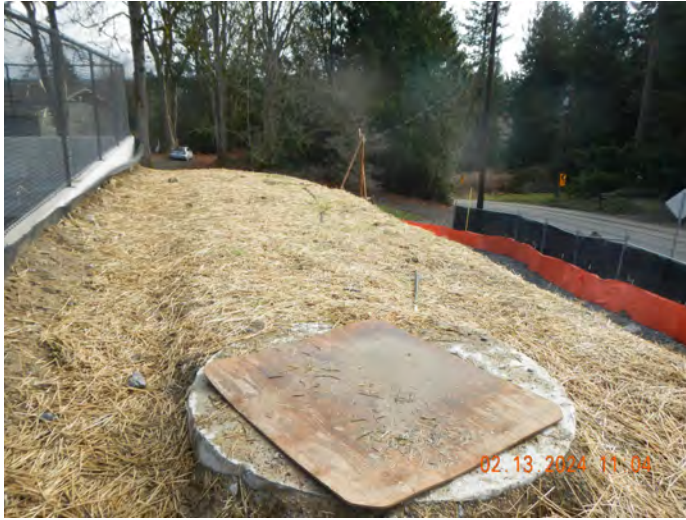
Photo #:21 (DSCN3593)

Description: Facing east, photo of stormwater pond outfall vault. Future work will include installing discharge piping to the roadside ditch, north side of Williams Road.

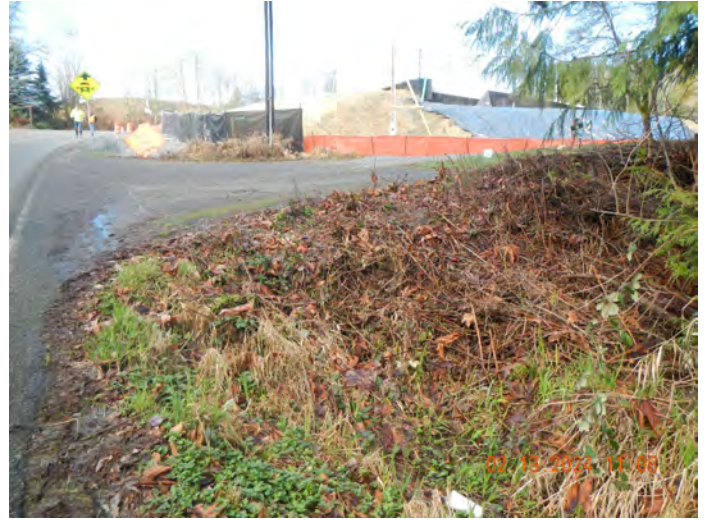
Photo #:22 (DSCN3595)

We observed the pond’s partially completed overflow vault. The vaults opening was covered by sheet of plywood at the time of inspection. Upon removing the plywood and viewing inside the vault, we observed stormwater to be flowing from the pond through the vault (**Photo 18 – Photo 21**). It was discussed that as outfall piping had yet to be constructed, stormwater discharging from the pond is believed to be infiltrating within a rock area subsurface near the vault. The infiltration area would be occurring south of the pond and northwest of the Williams Road ditch. No stormwater was observed within the north Williams Road ditch (**Photo 22**).

Description: Description: Facing west, photo from the north side of Williams Road, viewing roadside ditch. Potential/future location of stormwater pond overflow discharge from the pond's outfall vault.

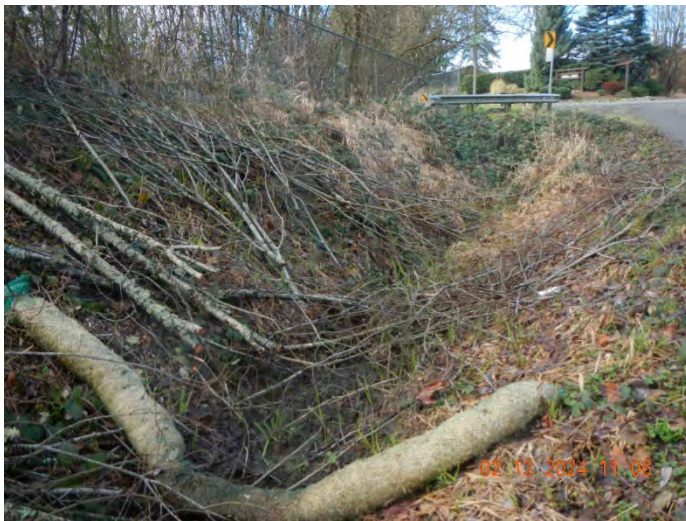
Photo #:23 (DSCN3594)

Facing west, photo from the south side of Williams Road showing roadside ditch. Location of catch basin discharge from the two catch basins along Williams Road.

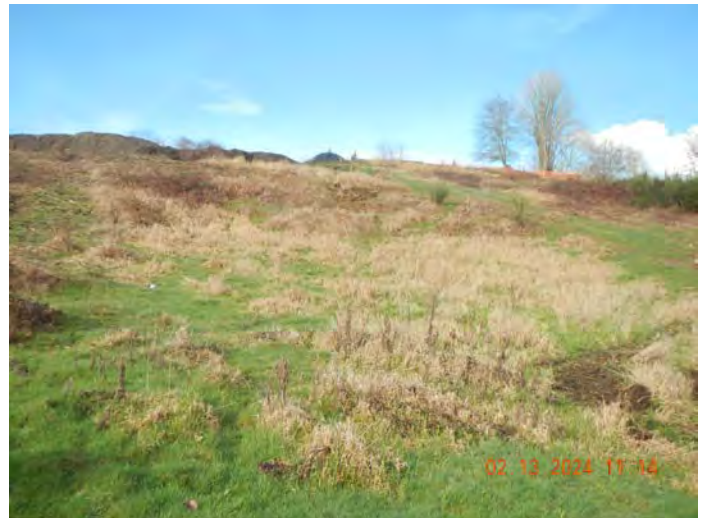
Photo #:24 (DSCN3596)

Description: Facing west, photo of vegetative area located on the eastern side of the project, west of Williams Road. Area had yet to be cleared to prevent any erosion during wet season.

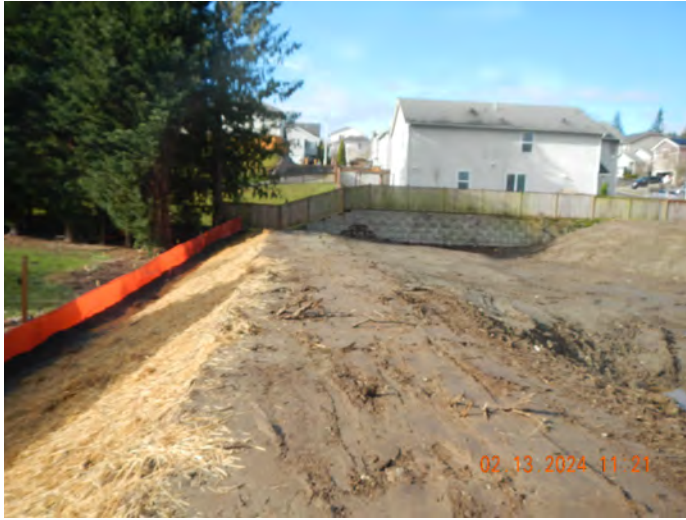
Photo #:25 (DSCN3597)

Description: Facing west, photo of the project's southern perimeter. Facility maintains existing berm, straw coverage, and perimeter silt fencing.

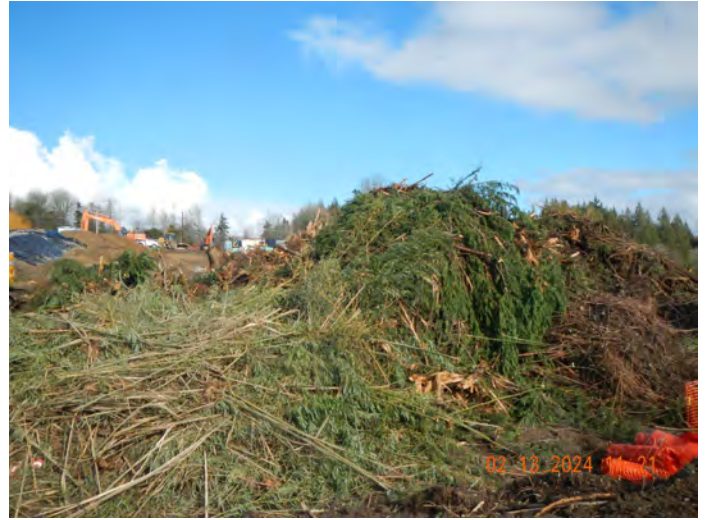
Photo #:26 (DSCN3598)

Description: Facing north, photo of wooded debris cleared the previous day.

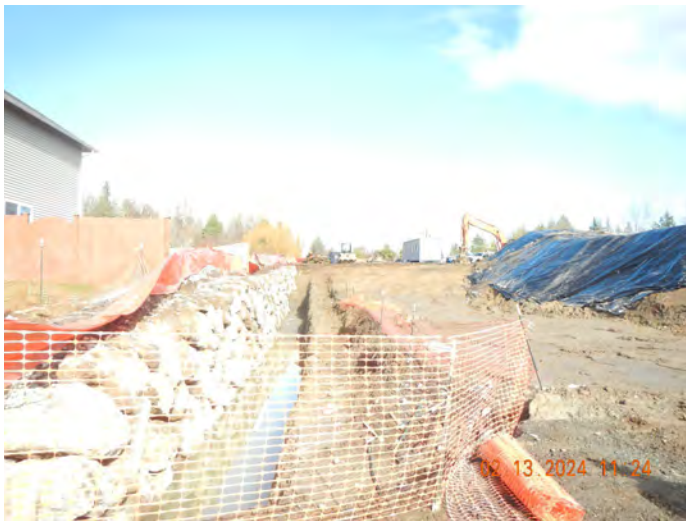
Photo #:27 (DSCN3599)

Description: Facing north, photo of western perimeter. Rock wall constructed with only trench to avoid further disturbance.

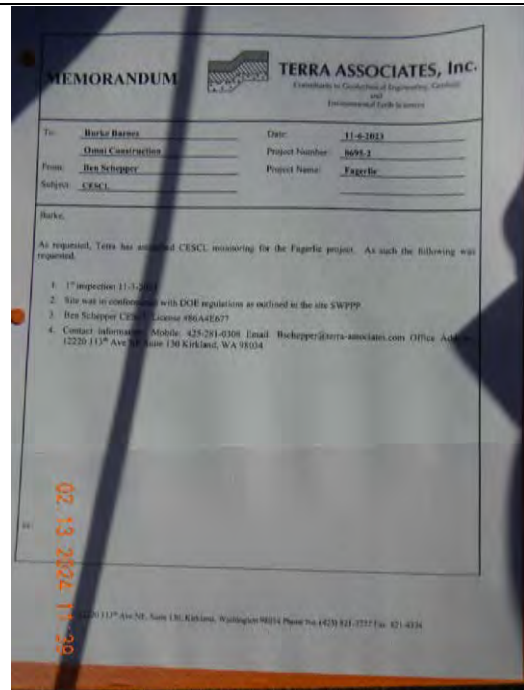
Photo #:28 (DSCN3600)

Description: Photo of initial CESCL memo for the project by current contractor and Terra Associates, Inc.

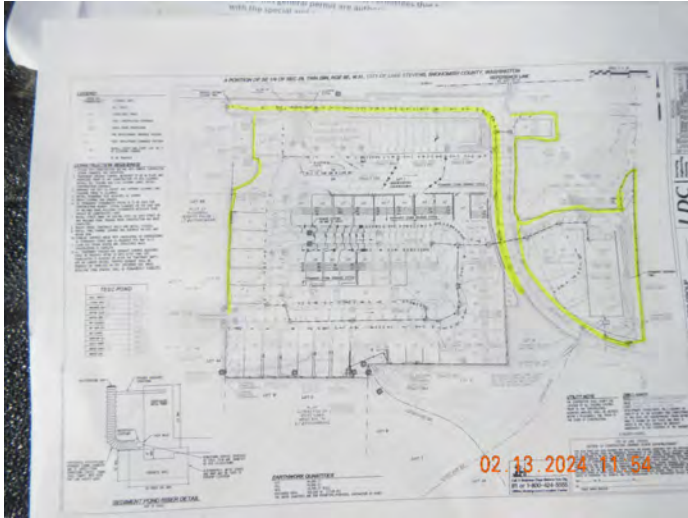
Photo #:29 (DSCN3601)

The Project's Site Map was located within the SWPPP binder. The only BMP outlined on the Site Map was the perimeter silt fencing **(Photo 29)**. Mr. Mausser discussed that he was behind in updating the Site Map contained within the SWPPP. It was also noted that the sampling/monitoring location(s) were not identified within the Site Map. We discussed the permit required contents of the Site Map and the tracking of BMP implementation and maintenance.

was behind in updating the Site Map. It was also noted that the discharge/monitoring location(s) were not identified within the Site Map. Additionally, at the time of inspection during the site walk-through near the stormwater pond, Omni Construction, LLC staff were unsure of the current discharge/monitoring location.

Description: Photo of Site Map contained within the SWPPP binder.
