Clean Water Act (CWA) Inspection Report

| <b>Type of Inspection</b> | CEI - Compliance Evaluation Inspection | | | |
| <b>Project or Site Name</b> | Fagerlie Subdivision | | | |
| <b>Permit Number</b> | WAR312688 | | | |

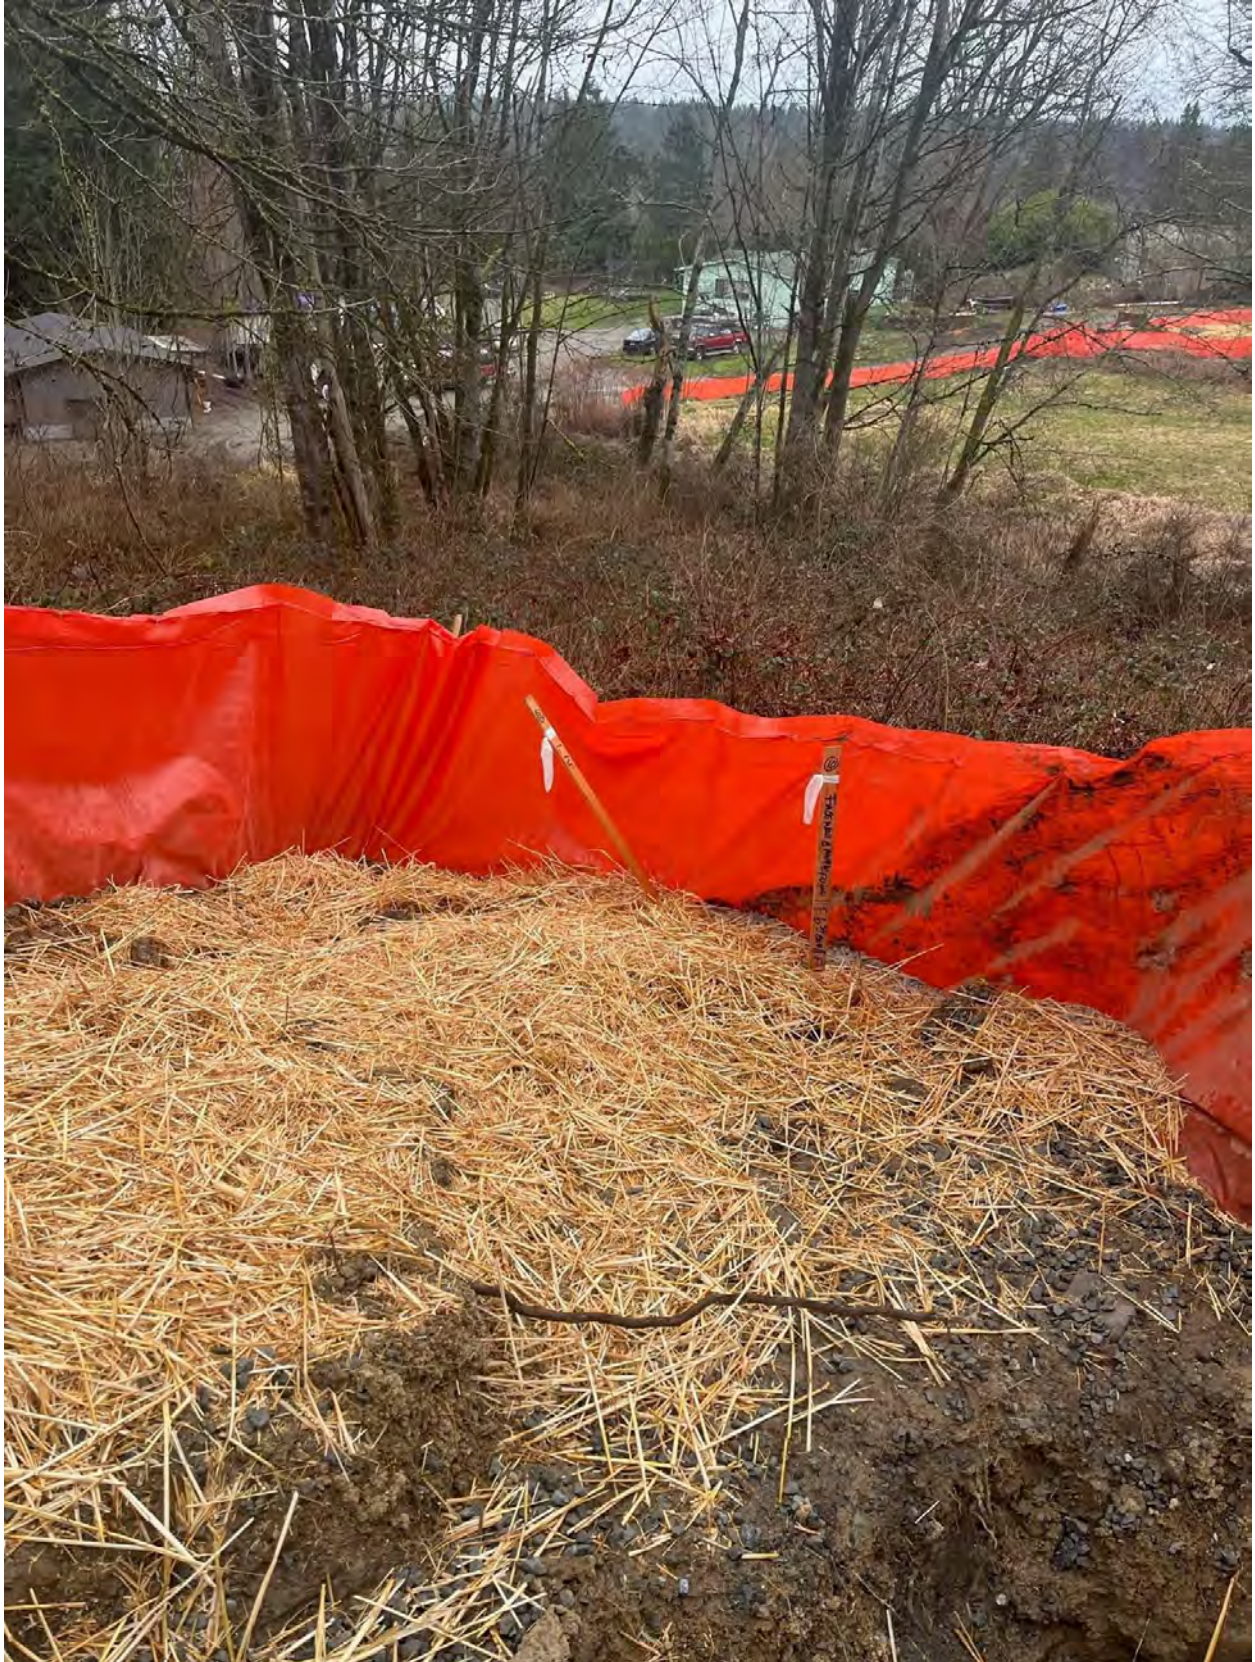
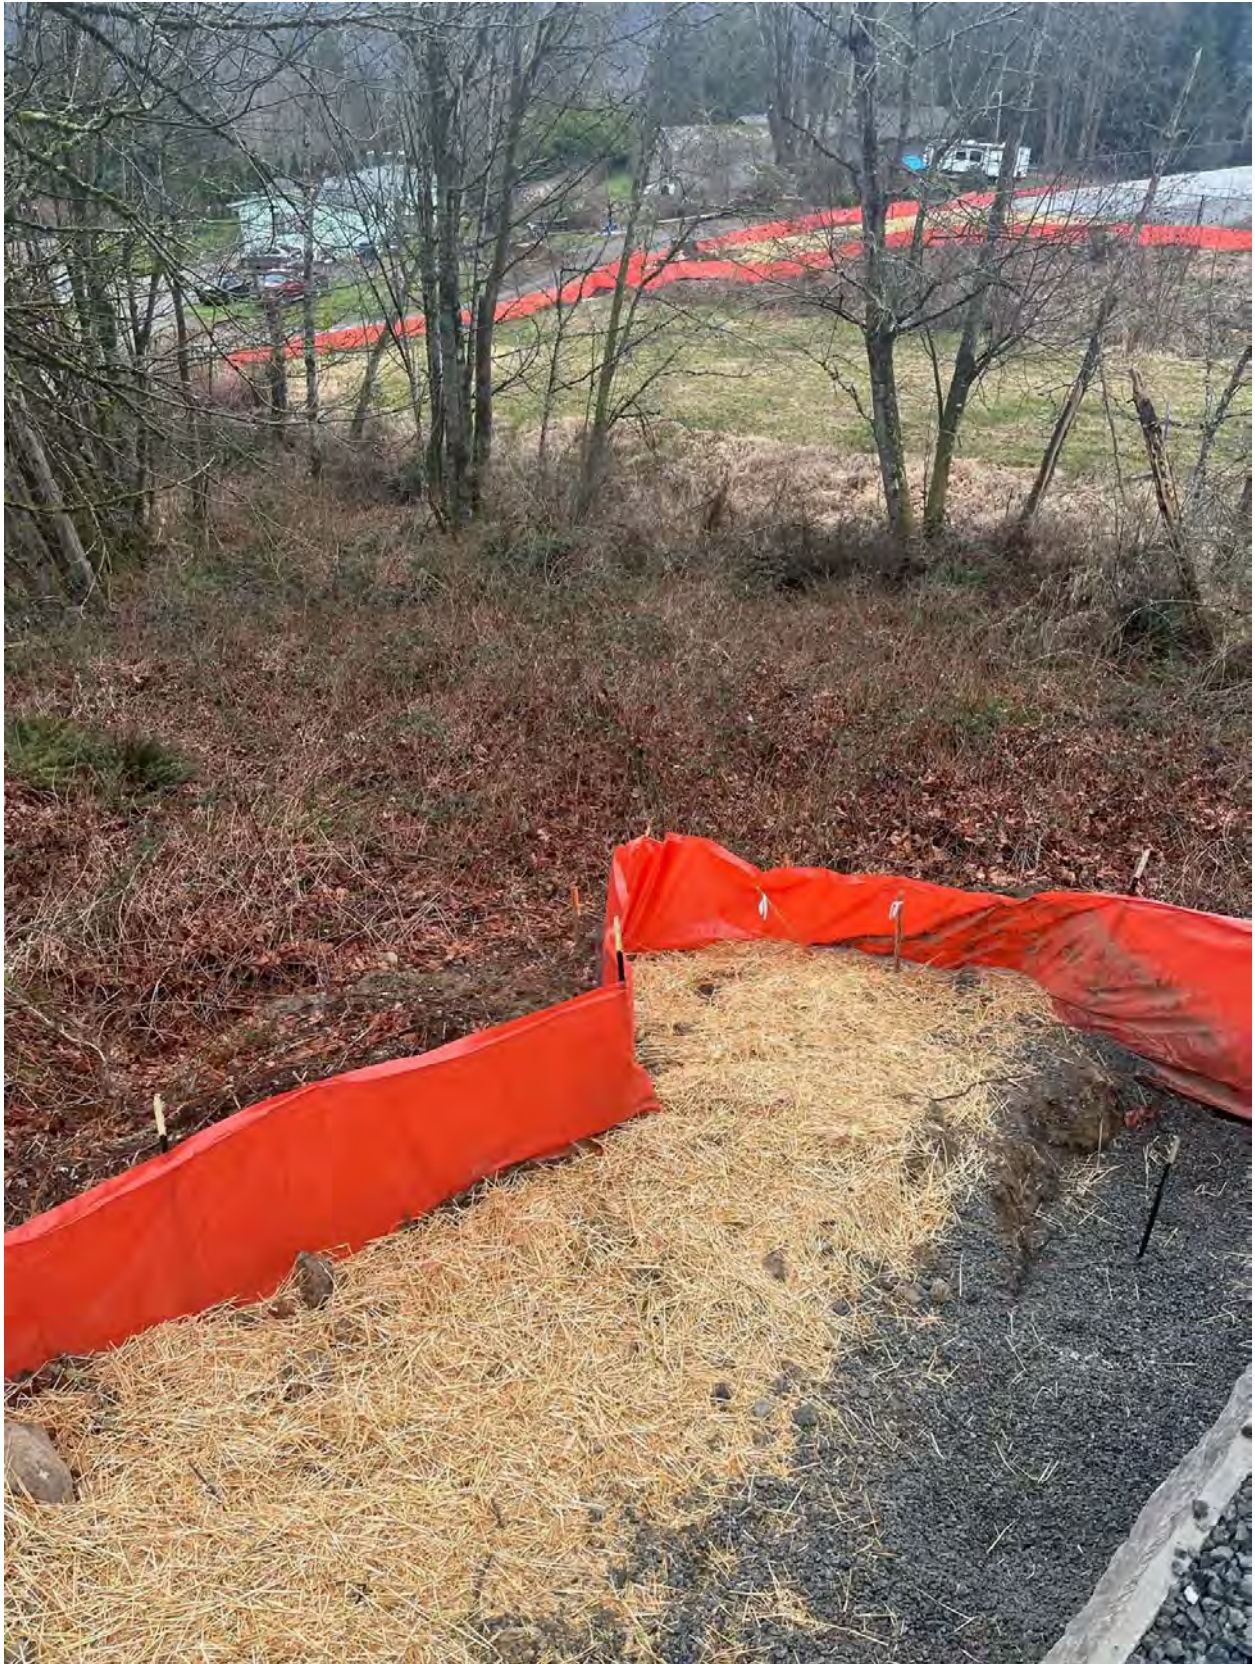
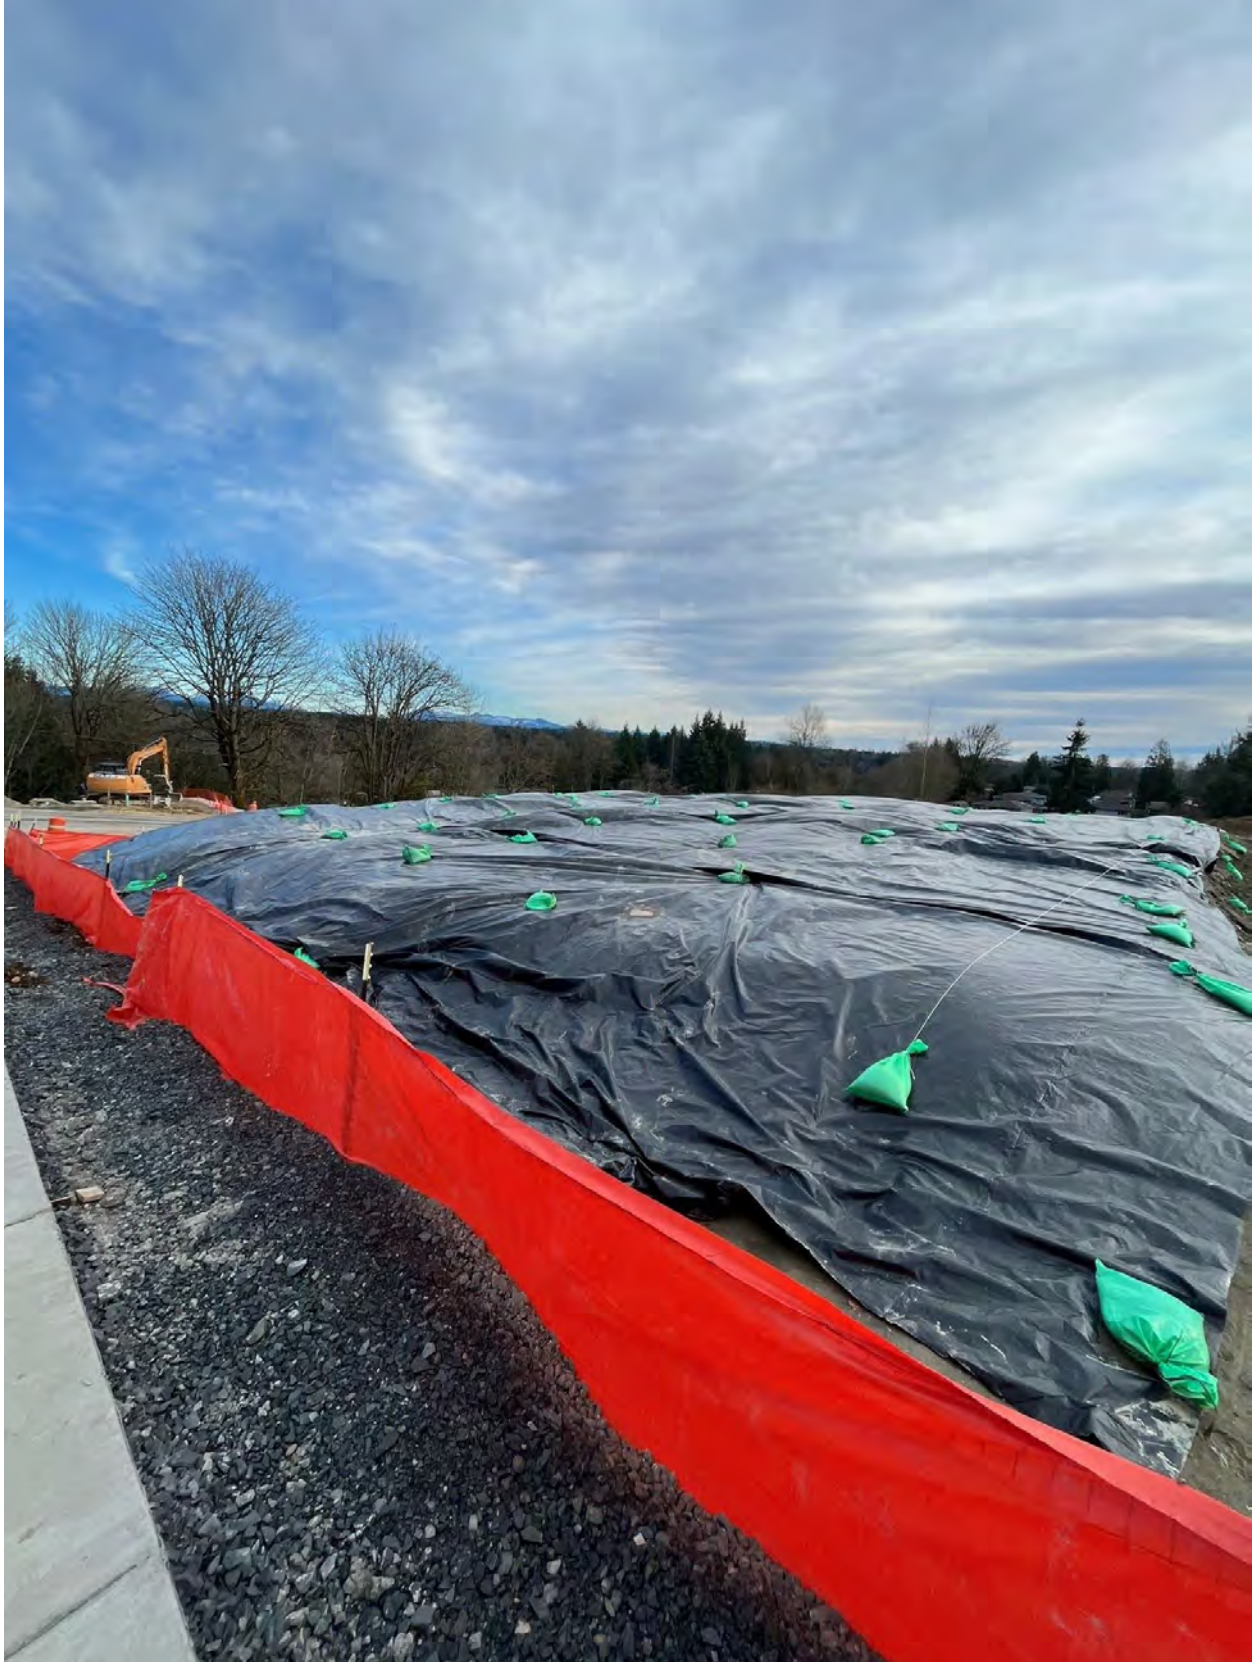
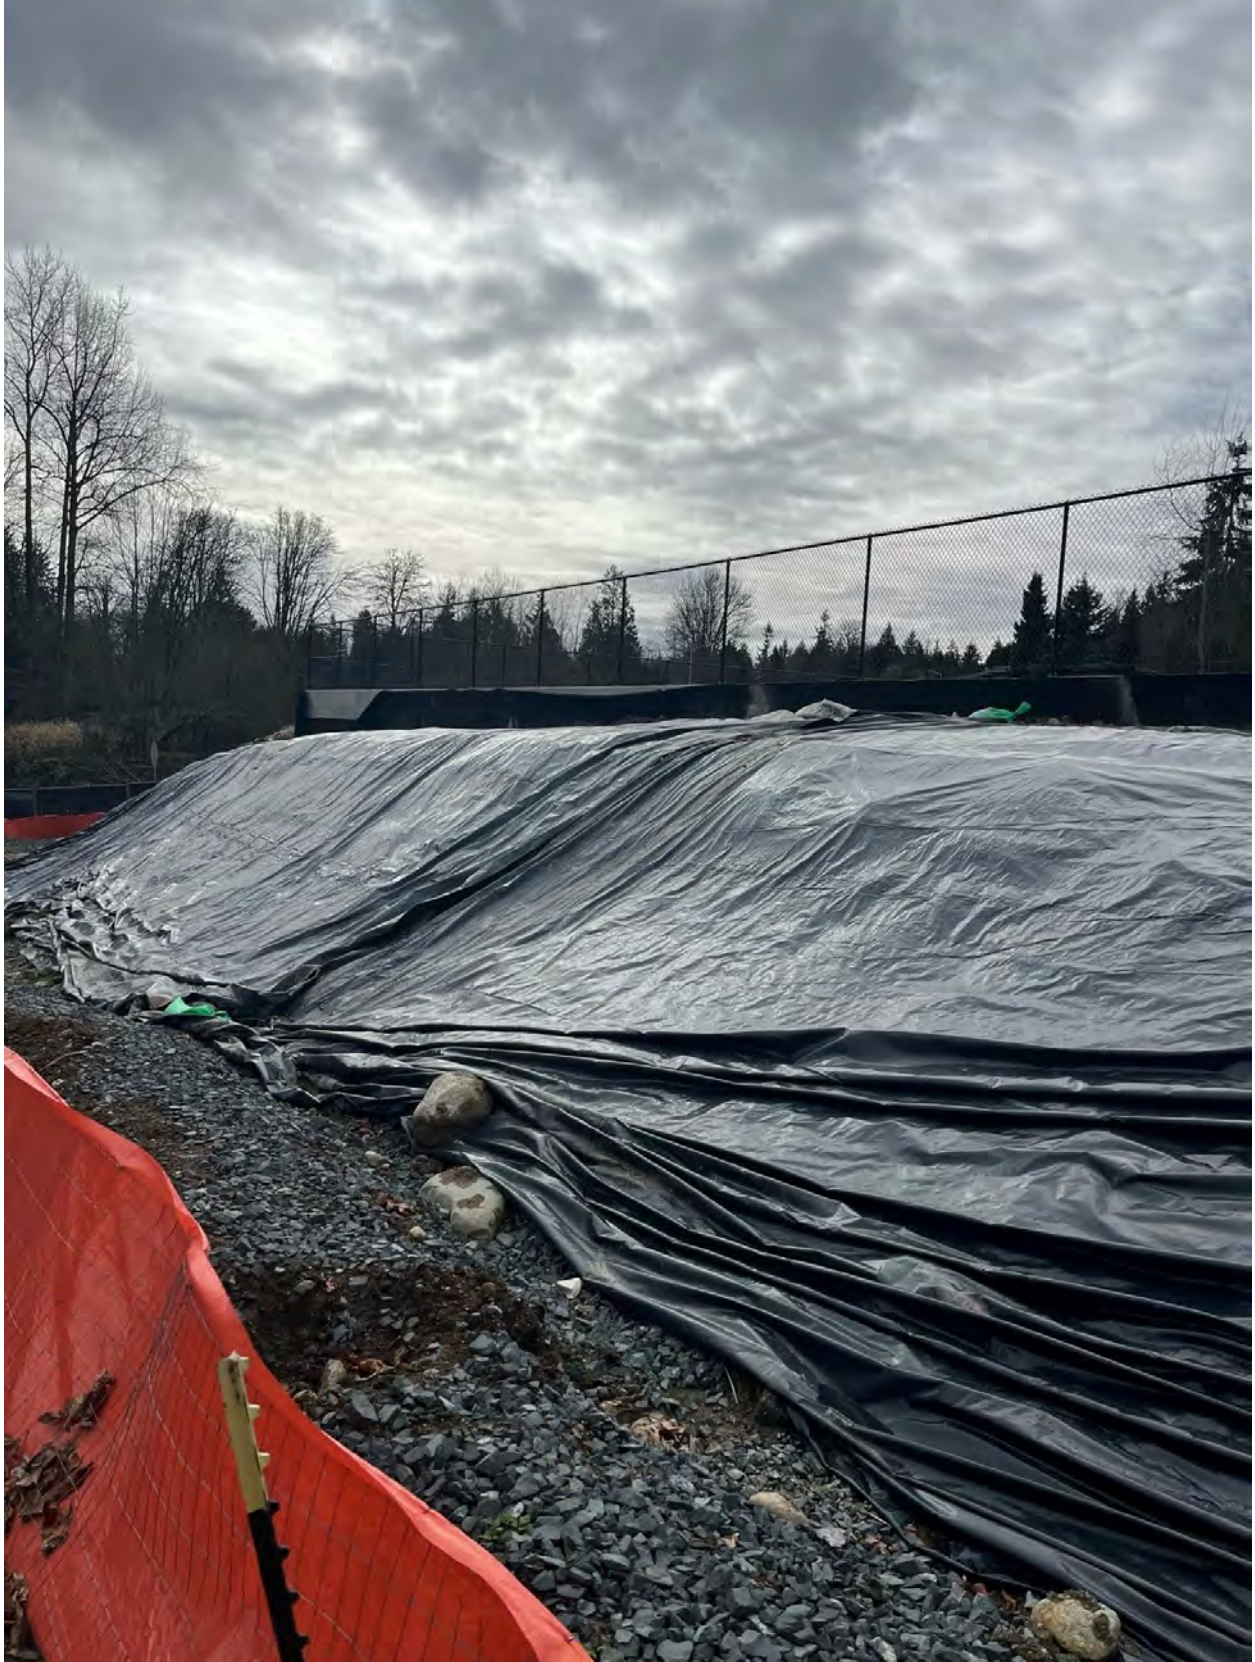
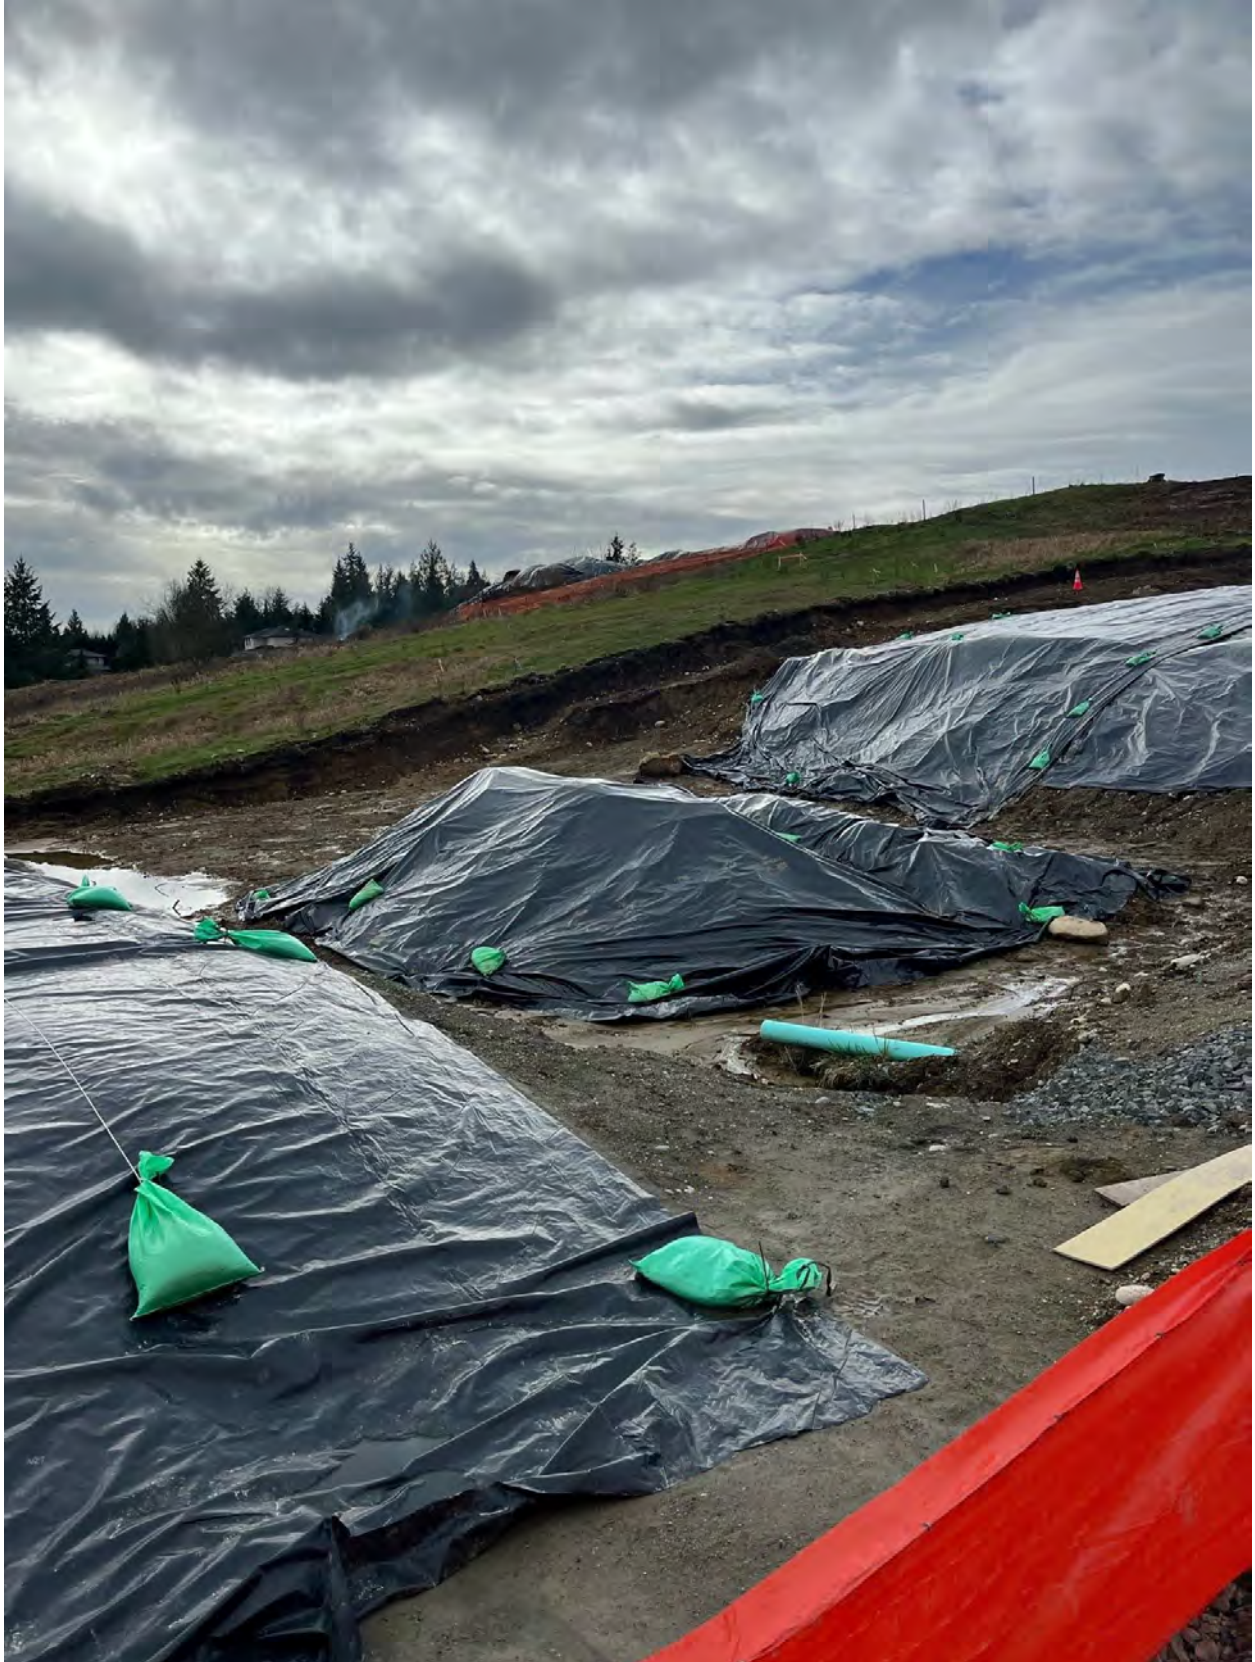
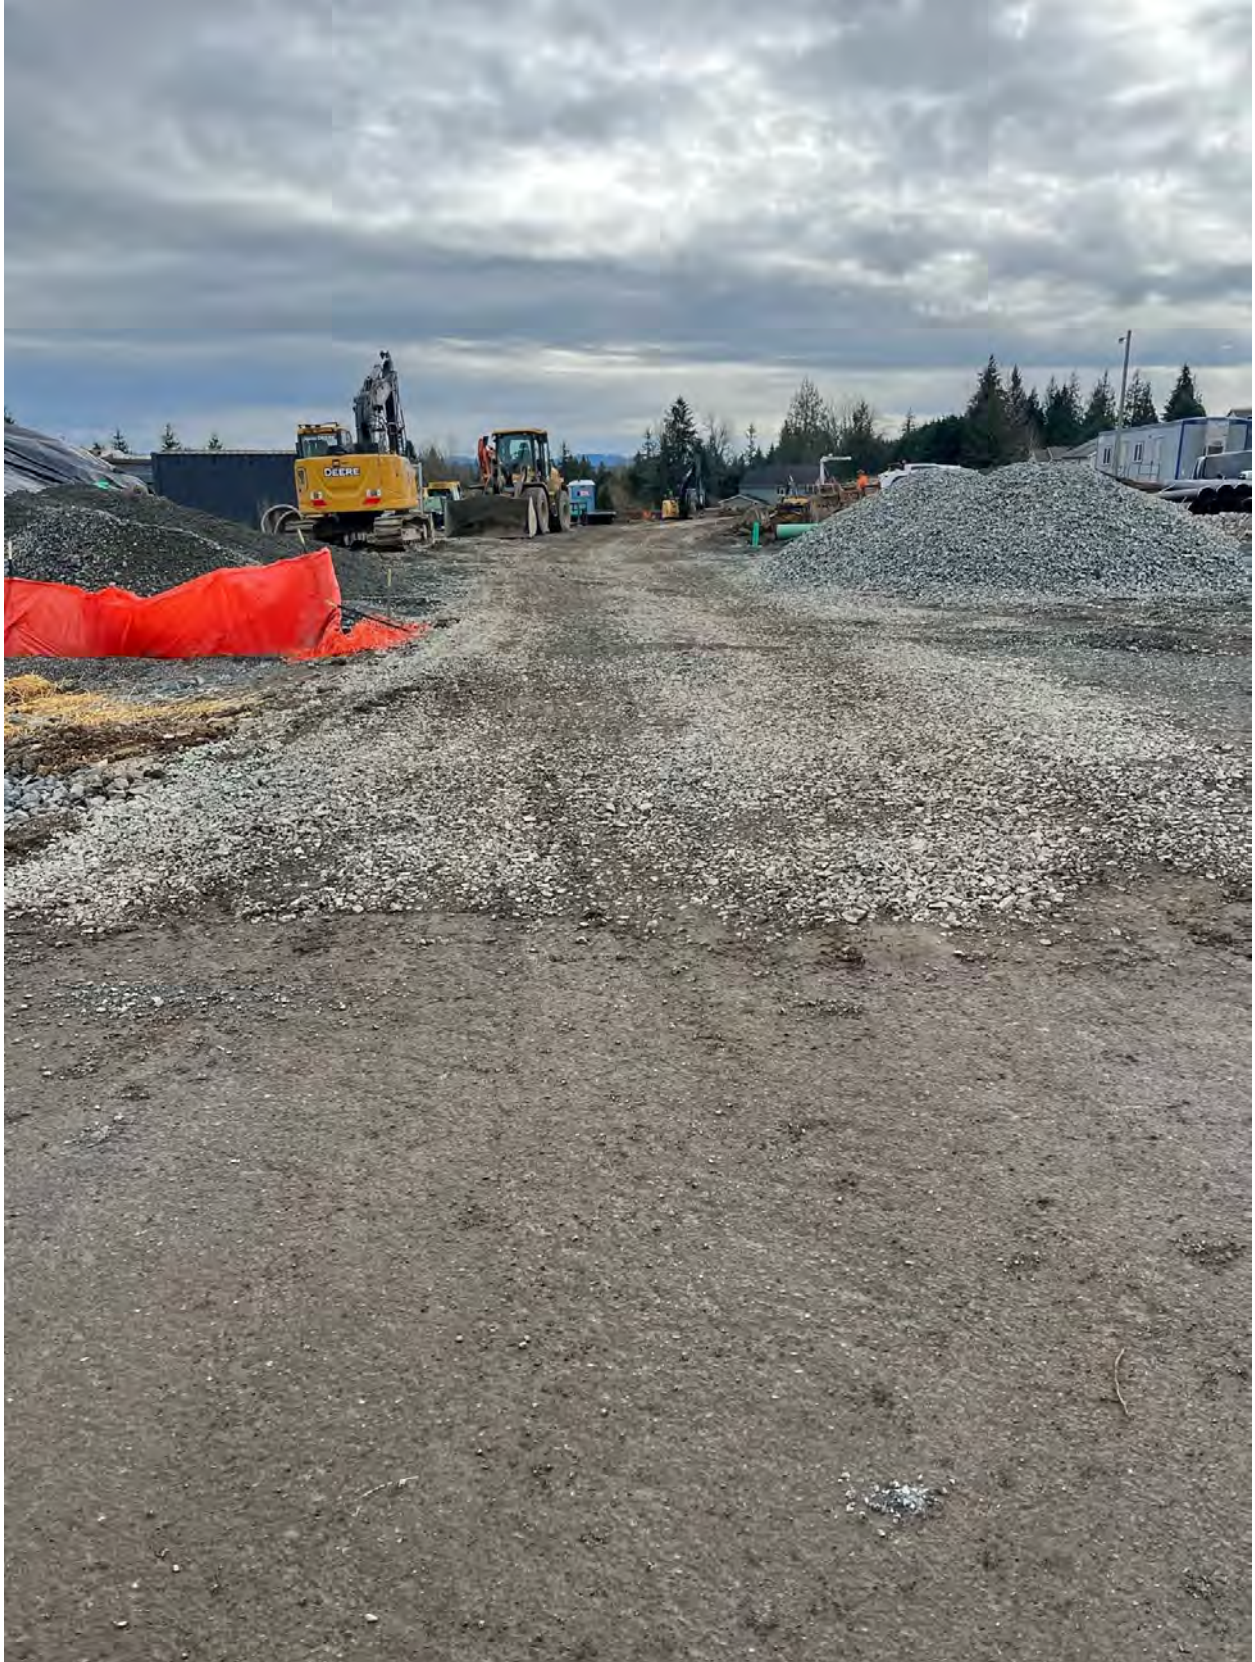
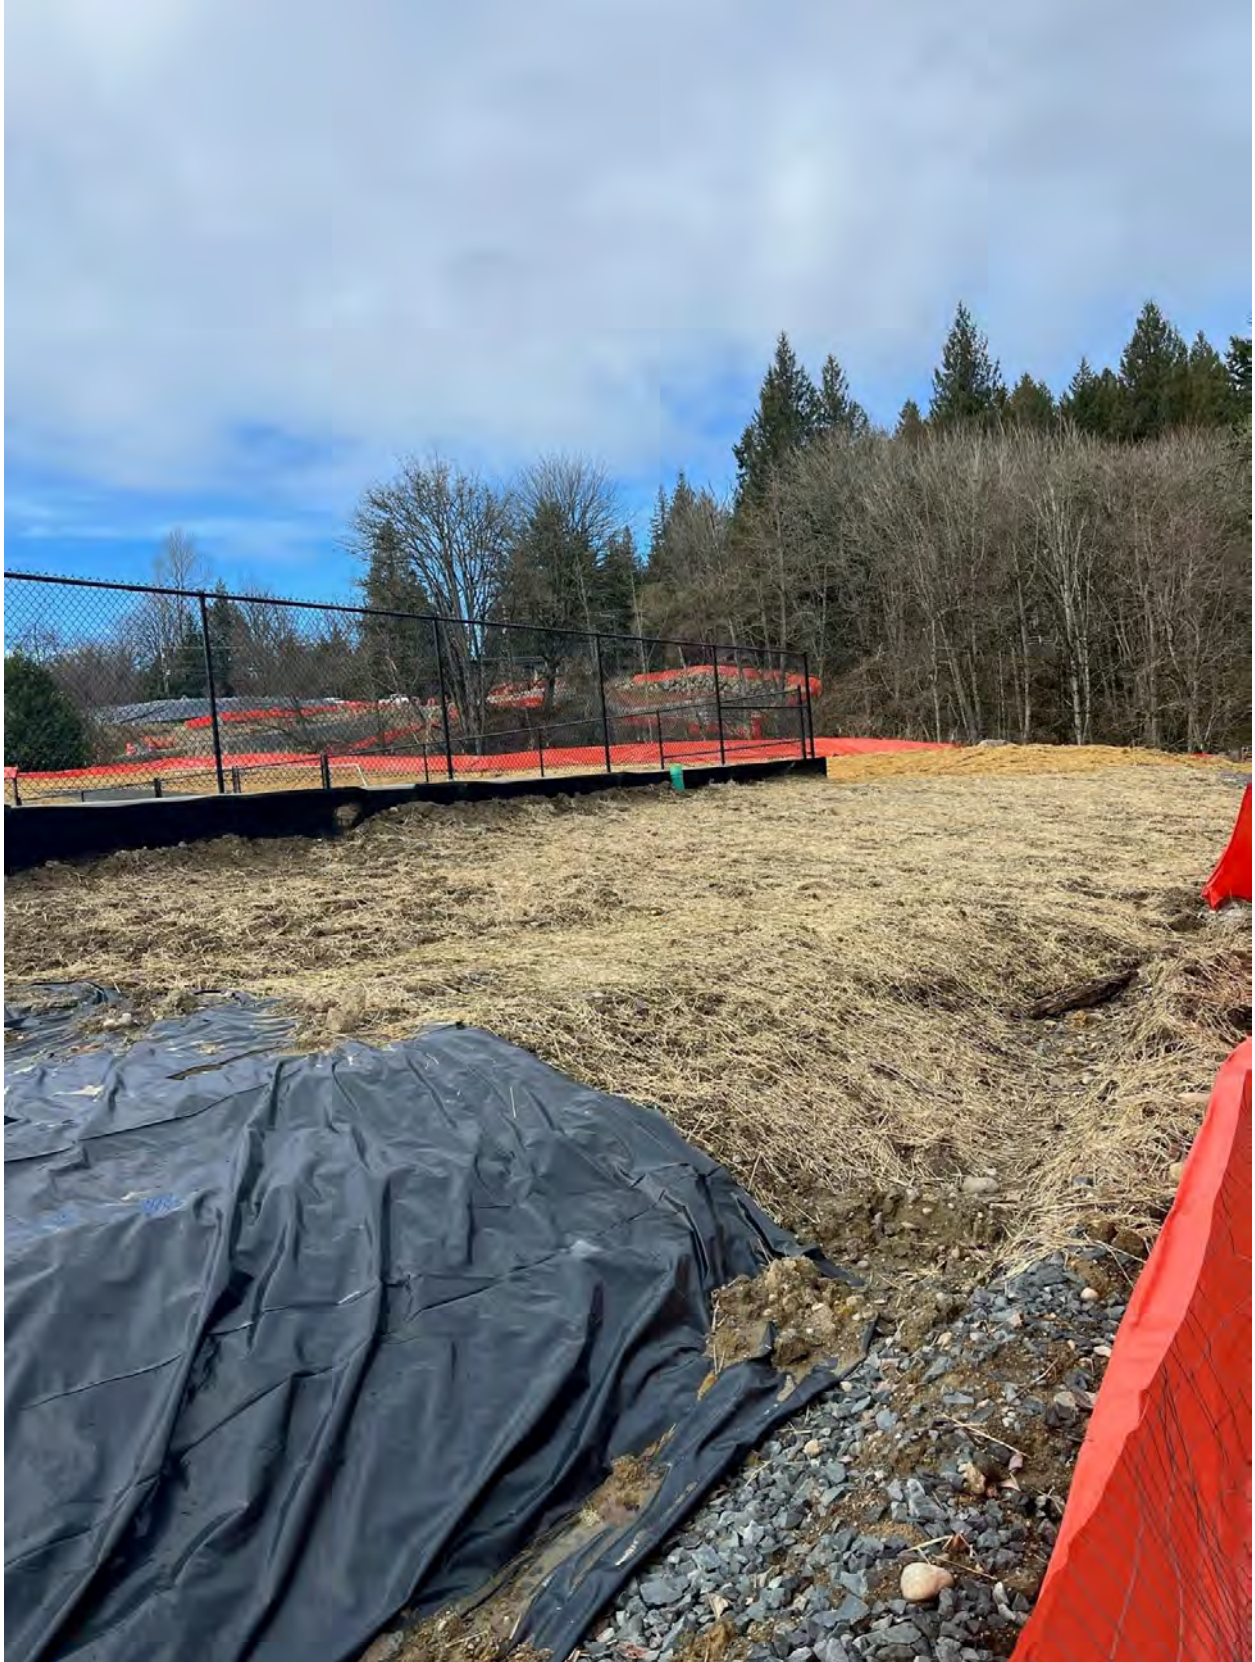
## **Attachment F**

### **Post-Inspection Photographs of BMP Maintenance Performed in Response to the Inspection**

| <p>AOC: As discussed earlier within this report, during the site walk-through we observed three separate sections of silt fence in need of maintenance (<b>Photo 10, Photo 11 &amp; Photo 17</b>). We also observed an exposed and unworked stockpile near the diverted drainage channel from a 20<sup>th</sup> Street SE roadside catch basin (<b>Photo 7</b>).</p> <p>The concern is the observed BMP in need of maintenance based upon the written standard, and the exposed/unworked stockpile near the diverted drainage channel from the 20<sup>th</sup> Street SE roadside catch basin.</p> <p>Post-inspection on February 21, 2024, Mr. Villwock provided photographs via email of the maintenance performed in response to the inspection, including the identified areas of silt fencing and the covering of the identified stockpile (<b>Attachment F</b>).</p> | |
