**Region 6 - Enforcement & Compliance Assurance Division**  
**INSPECTION REPORT**

| Media Program: | Water, Clean Water Act (Brine) | |
| Company Name: | CapturePoint, LLC | |
| Facility Name: | Dye Lease | |

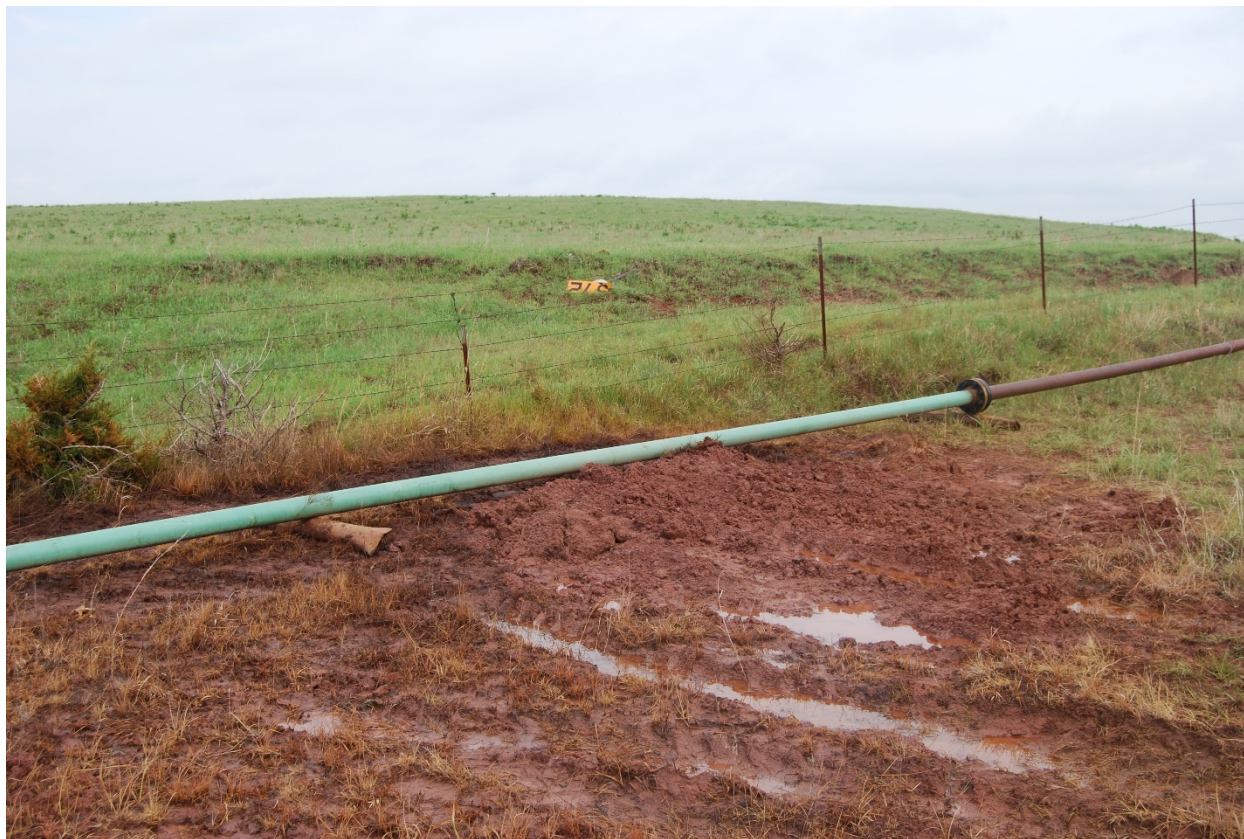
Upon arrival at the Release Point of the spill, I observed a section of 4-inch diameter steel pipeline which had recently been installed to replace the failed section of pipeline according to Juan Tejada, this repaired section of pipeline can be seen in Photo No. 1 of Appendix 1 (Photo Log) included with this report. I was unable to observe the failed section of pipeline as it was already removed from the location. I also observed an area of produced water impacted soil and vegetation surrounding the pipeline at the release point. The land impacted area varied in width between 3 feet and 30 feet and continued downgradient approximately 100 feet where the produced water entered a small unnamed stream, a portion of these land impacts can also be seen in Photo No. 1. I followed the flowpath of the spill to the Point of Entry (POE) and moved approximately 20 feet upstream in the receiving stream to take a “background” Total Dissolved Solids (TDS) field reading with a properly calibrated YSI Pro 30 conductivity meter, which measured 410.0 mg/L TDS which can be seen in Photo No. 2. I observed the POE into the stream and noticed a light sheen of oil on the surface of the water, the POE and the oil sheen can be seen in Photo No. 3. I collected a field TDS reading of 33,570 mg/L, which is depicted in Photo No. 4. I observed a moderate amount of instream flow at the POE, Juan Tejada stated this was caused by “flushing” operations which had been taking place prior to my arrival. From the POE location,

**Description:** A green, 4-inch diameter, plastic lined, steel flowline repair joint. This repair joint was installed by the operator prior to my arrival. The ruptured section of flowline was not available for observation at the time of inspection. The area pictured above was the Release Point of the spill.

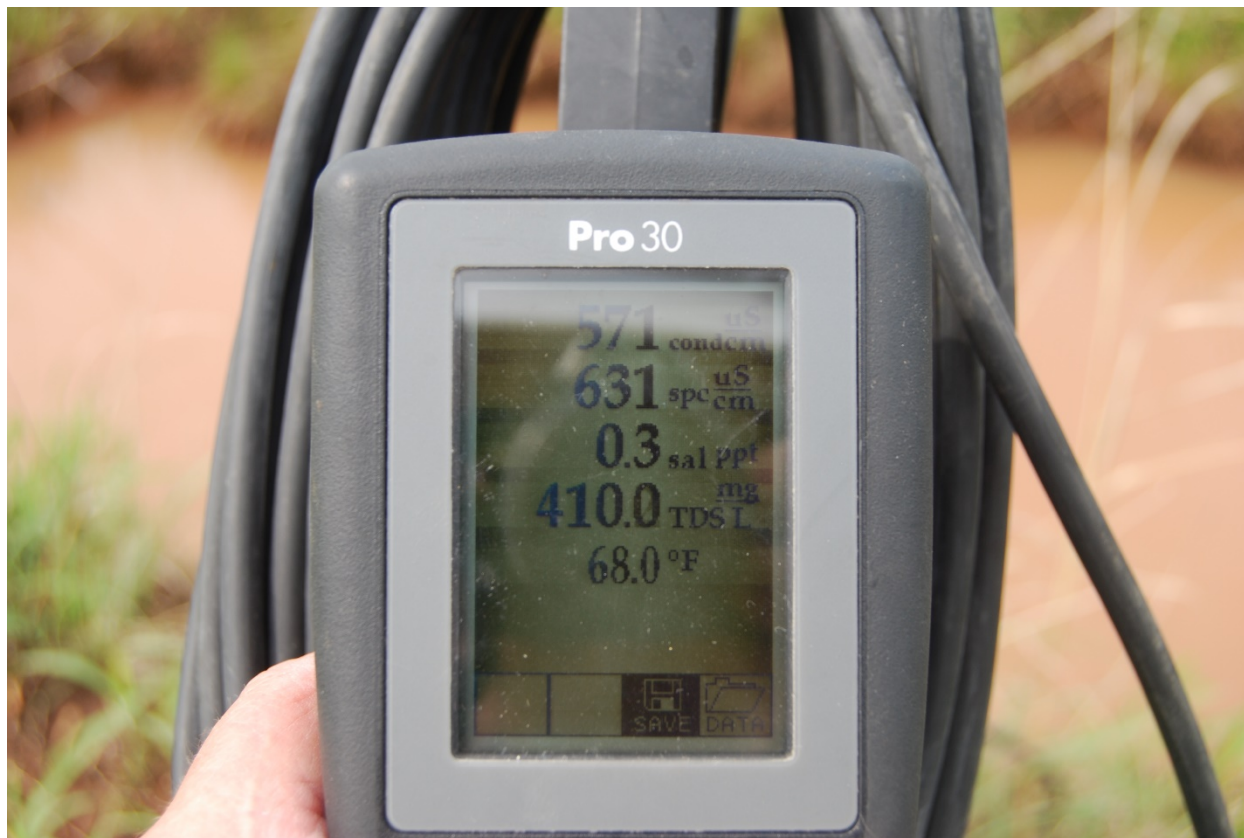
Photo No. 2

**Description:** This field reading of 410.0 mg/L TDS was taken upstream from the Point of Entry (POE) in the receiving stream. This reading should be used to establish "background" TDS levels for the impacted stream.

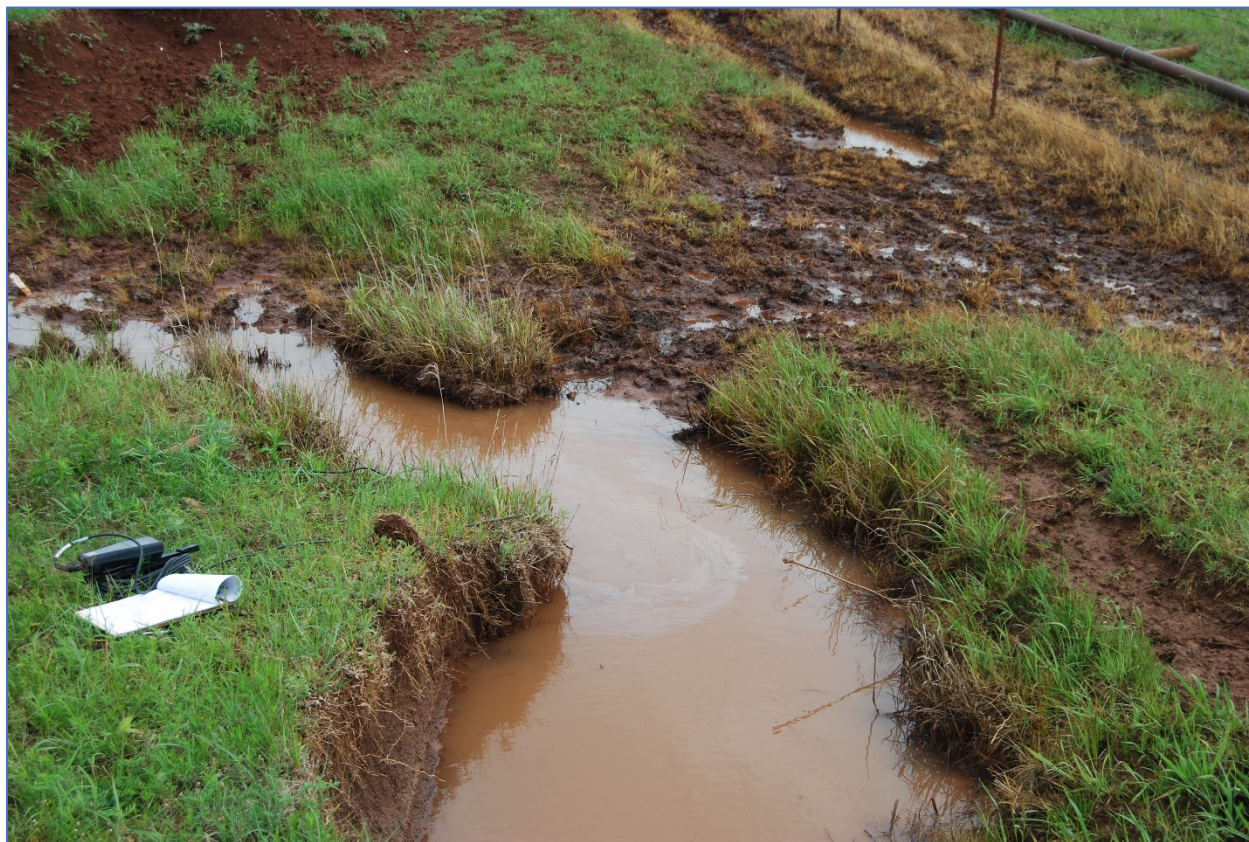
Photo No. 3

**Description:** This was the location of the POE in the main channel, where produced water containing elevated TDS and small amounts of crude oil entered the stream.

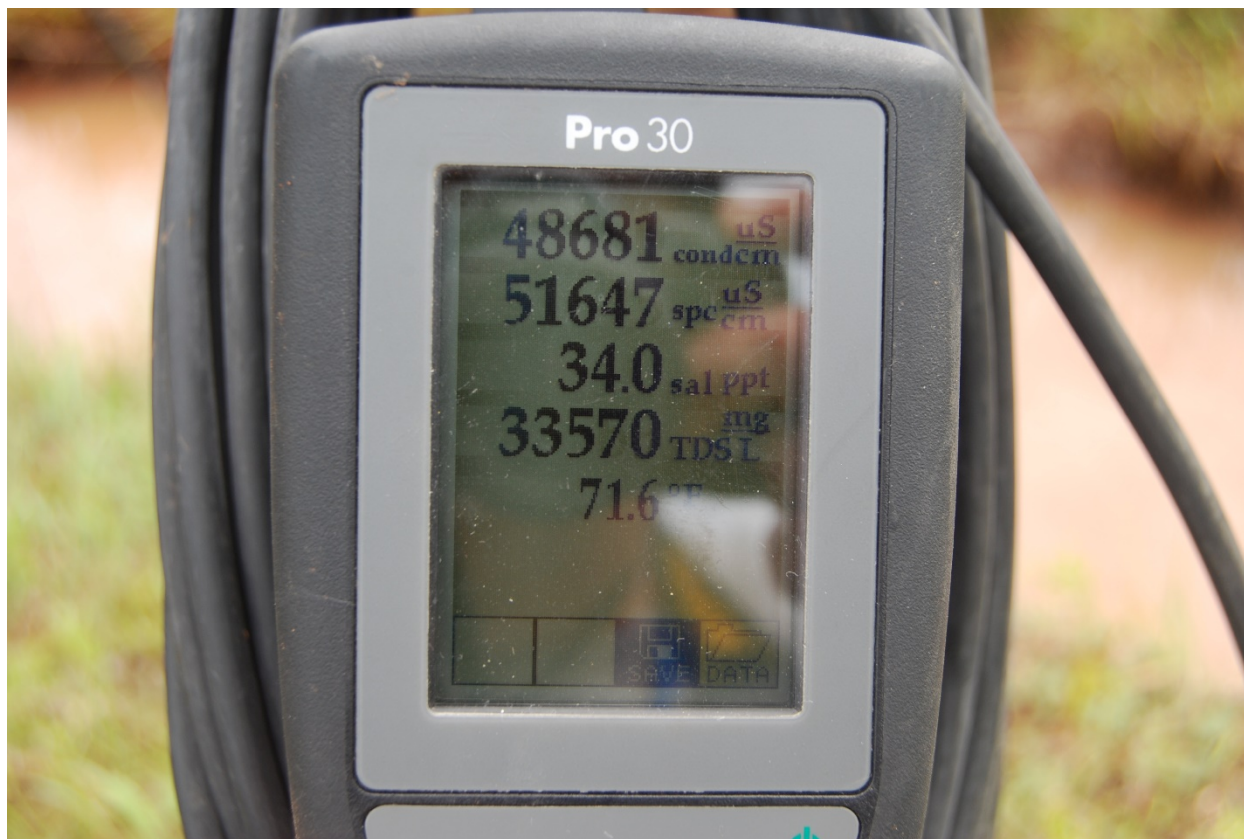
Photo No. 4

**Description:** This was an elevated TDS field reading taken at the POE into the impacted stream measuring 33,570 mg/L.

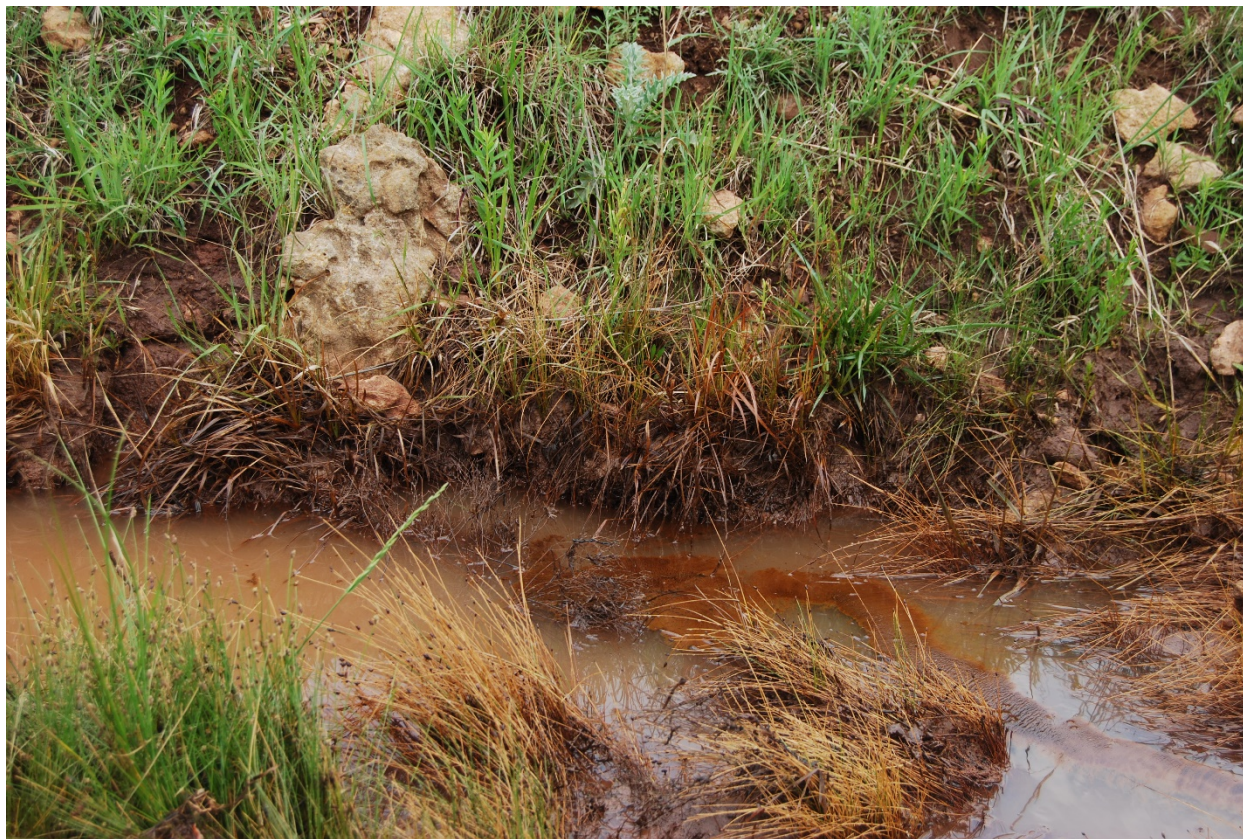
Photo No. 5

**Description:** Small amounts of crude oil were floating on the surface of the impacted stream at the time of inspection. Oil-stained grass was present on the stream bank, the stained grass appeared dark brown in the photo. Brine impacted grass was present in the flowpath of the stream, these impacted grasses appeared light brown/yellow in the photo. This photo was taken approximately 150 feet downstream from the POE.

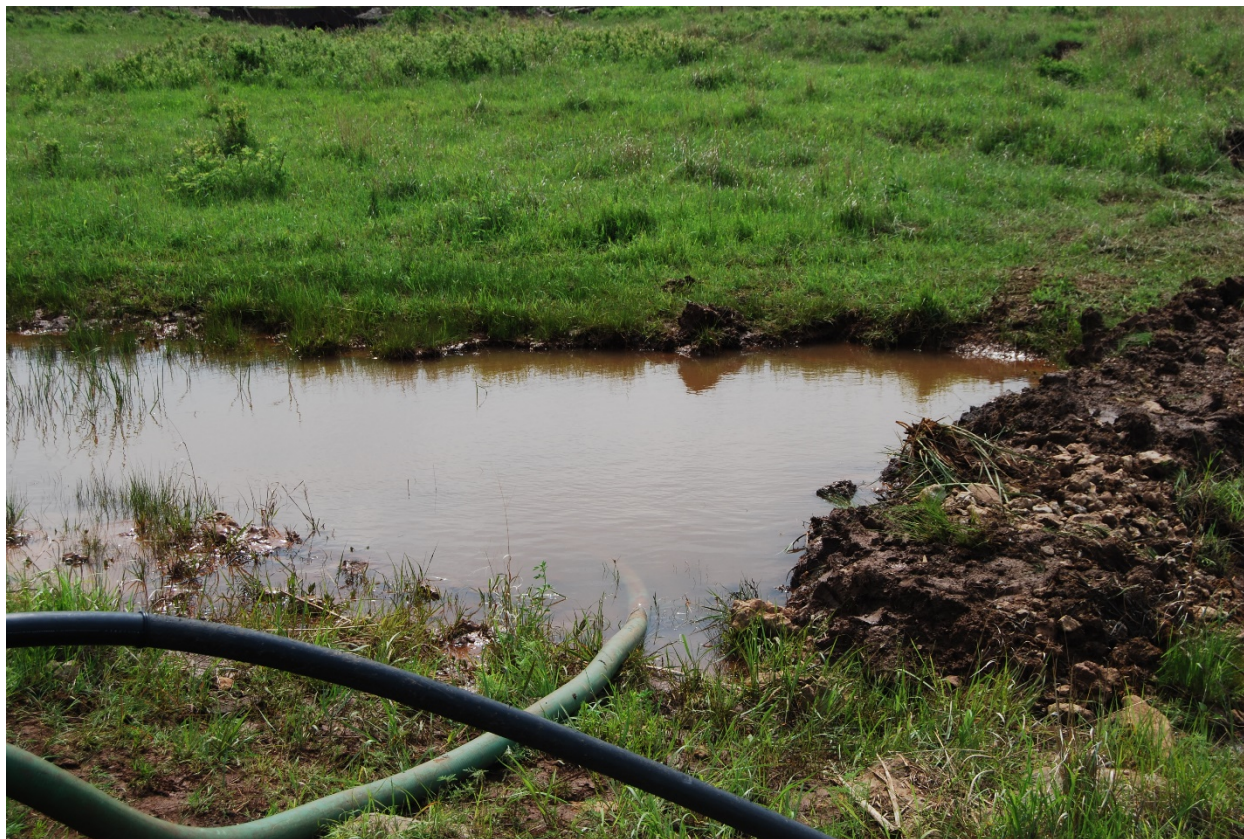
Photo No. 6

**Description:** The 1<sup>st</sup> temporary dam was located approximately ½ mile downstream from the POE. This site was being used to capture elevated TDS waters and a pump was being used to transport water through a flowline to a nearby tank battery for disposal through the underground injection system associated with the facility operations.

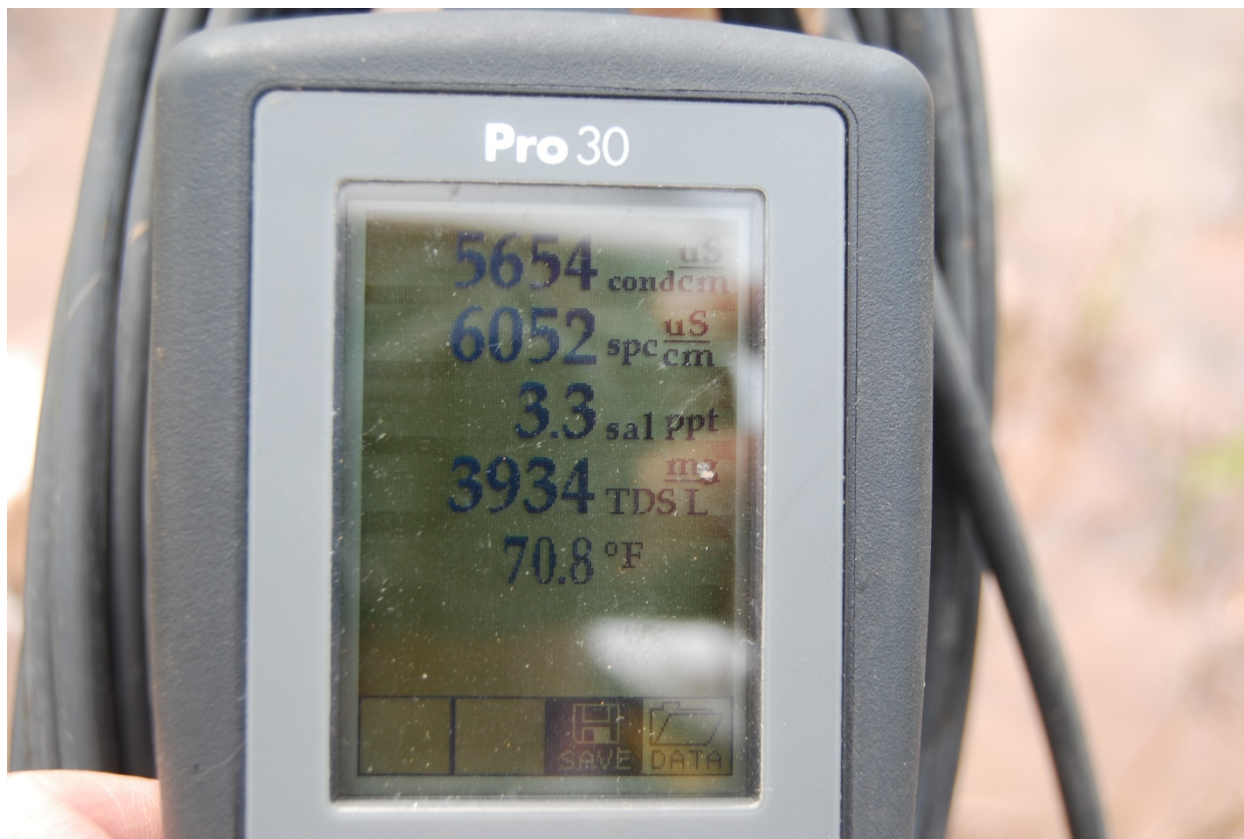
Photo No. 7

**Description:** This elevated TDS field reading was taken in the upstream pool at the 1<sup>st</sup> temporary downstream dam along the impacted stream.

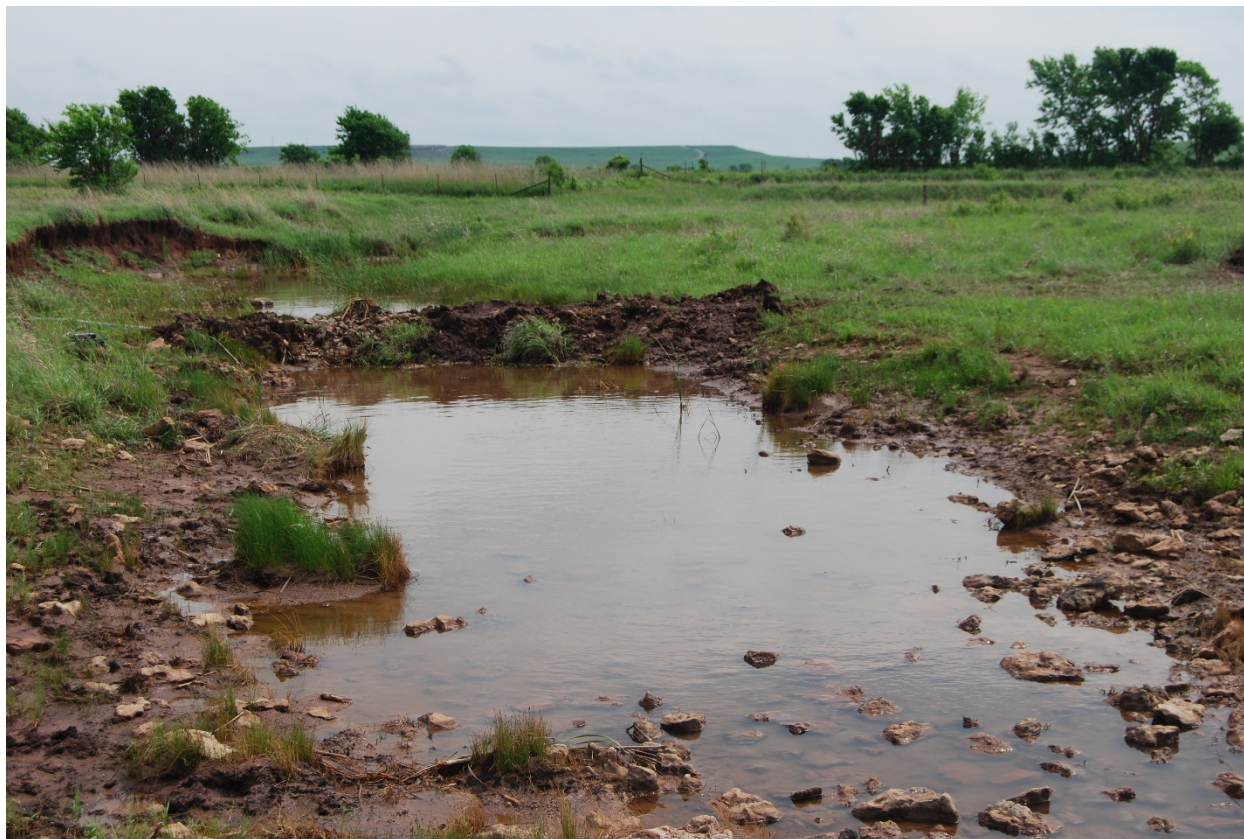
Photo No. 8

**Description:** This photo was taken from the downstream side of the 1<sup>st</sup> temporary dam, the view looked upstream to the dam.

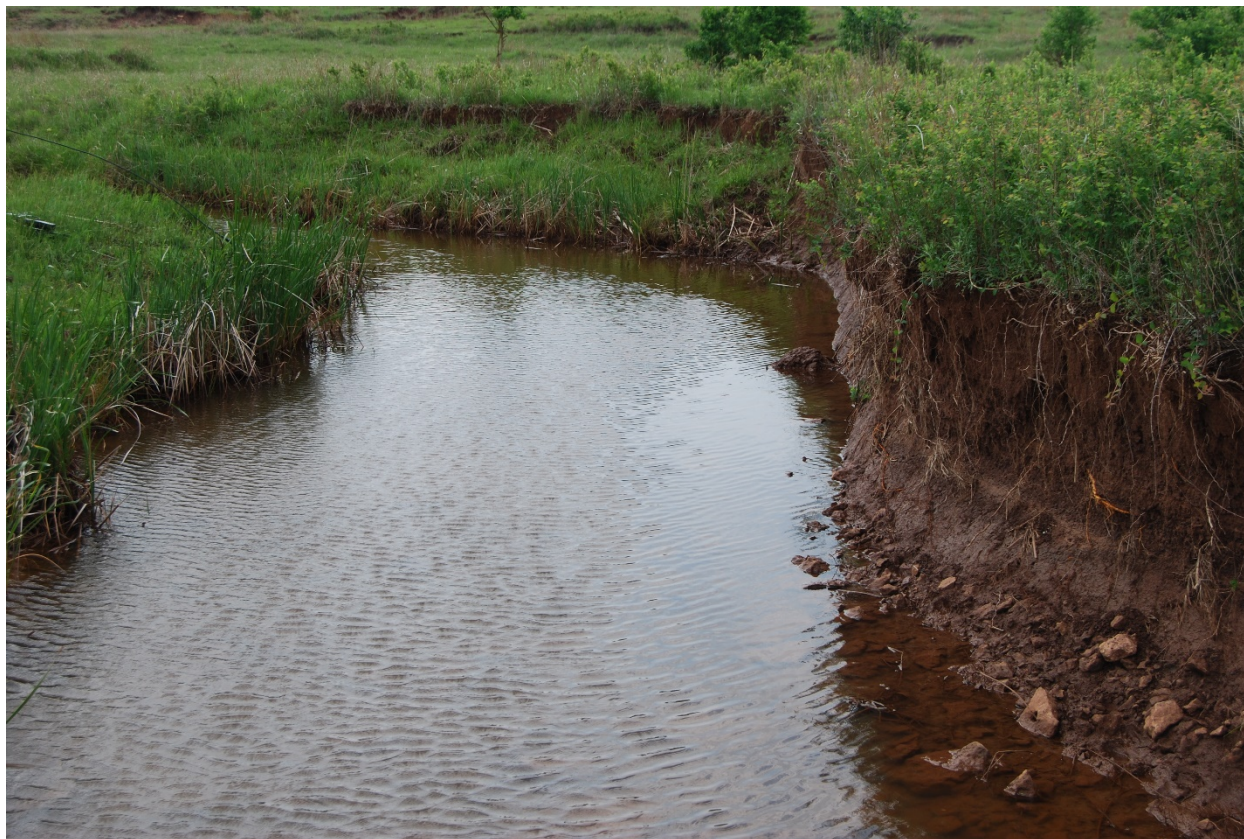
Photo No. 9

**Description:** This photo captured the more pronounced bed and bank features of the stream, as the spill impacts were tracked further downstream. An elevated TDS field reading of 37,918 mg/L was also taken at this location.

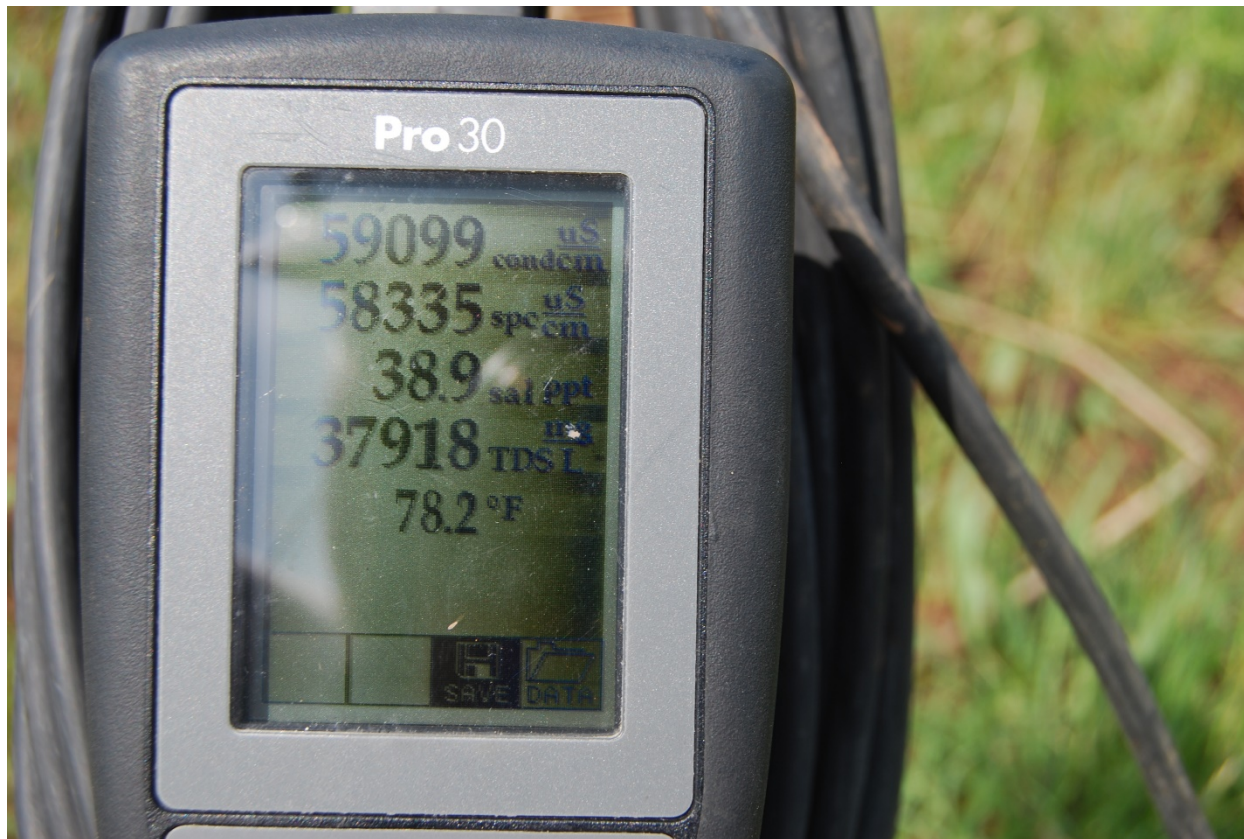
Photo No. 10

**Description:** Elevated TDS field reading of 37,918 mg/L which was taken in the pool of water shown in Photo No. 9 of this photo log.

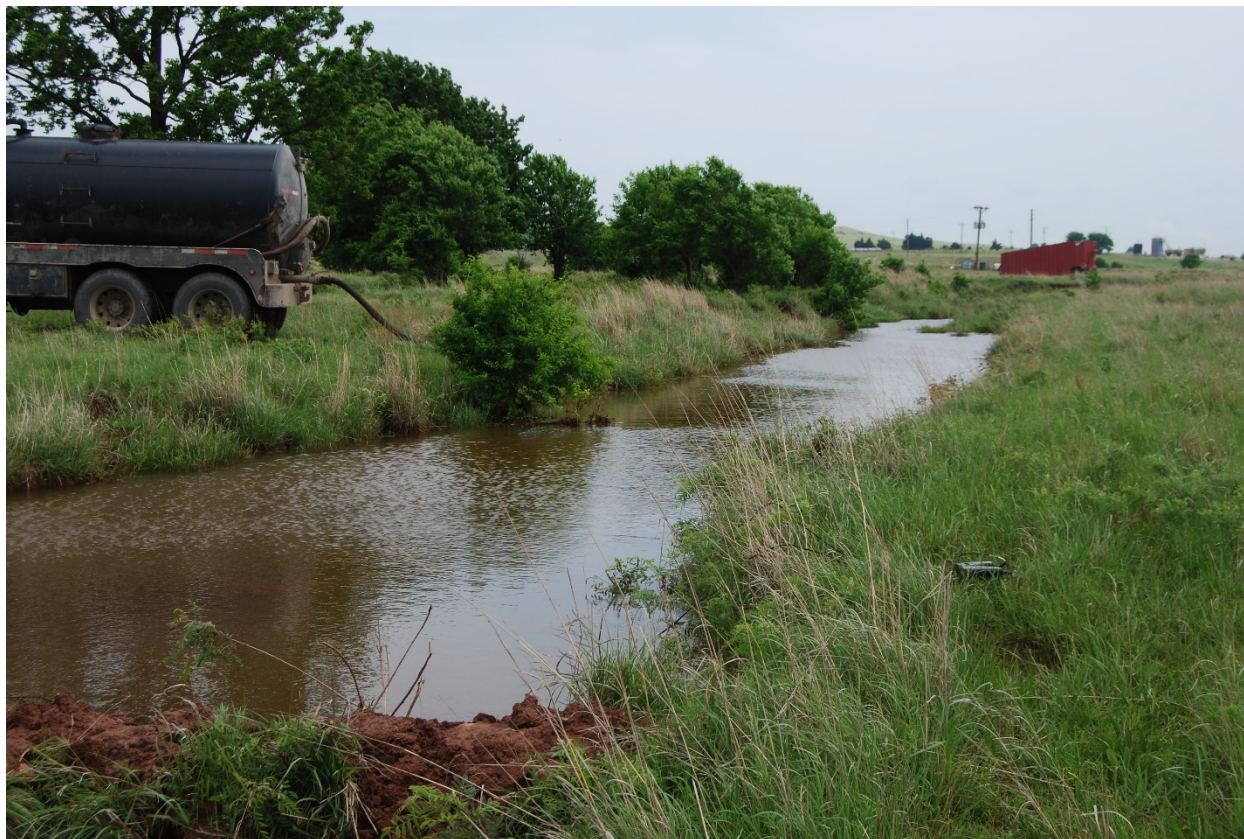
Photo No. 12

Throughout the inspection I witnessed multiple vacuum/tank trucks actively removing impacted waters from the stream. At the 2<sup>nd</sup> temporary containment dam (Photo No. 12) I was able to view a truck working as well as one of the frac tanks which was placed for use during the cleanup efforts. I observed an elevated field reading of 42,300 mg/L TDS in the pool immediately upstream from the 2<sup>nd</sup> dam (see Photo No. 13). I observed the highest elevated TDS field reading of the inspection which measured 48,263 mg/L TDS on the downstream side of the 2<sup>nd</sup> containment dam as seen in Photo No. 15. I observed the 3<sup>rd</sup> and 4<sup>th</sup> temporary containment dams which can be seen in Photo No. 16 and No. 19 of the photo log, respectively. I observed the 5<sup>th</sup> and final and lowermost temporary containment dam (seen in Photo No. 20). This final dam's location was where access and the stream size reasonably allowed for the construction of a temporary containment dam; however, this dam did not completely prevent further downstream migration of waters with elevated TDS. I took an elevated TDS field reading in the pool of water immediately upstream from the 5<sup>th</sup> dam, which measured 21,578 mg/L TDS, this reading can be seen in Photo No. 21. I observed spill impacts continuing downstream beyond the final/lowermost containment dam as evidenced by an elevated TDS field reading of 1,968 mg/L taken approximately 200 yards downstream from the lowermost dam. This field reading can be seen in Photo No. 24. The location of the 1,968 mg/L field reading is documented in Photo No. 23, this location represented the first field reading taken at a point where the impacted stream gained a continuous surface water connection to the waters of Kaw Lake.

**Description:** Bottom left corner of the picture showed the 2nd downstream temporary containment dam. The large pool of water was on the upstream side of the dam. The vacuum truck was actively removing elevated TDS waters from the stream during the inspection.

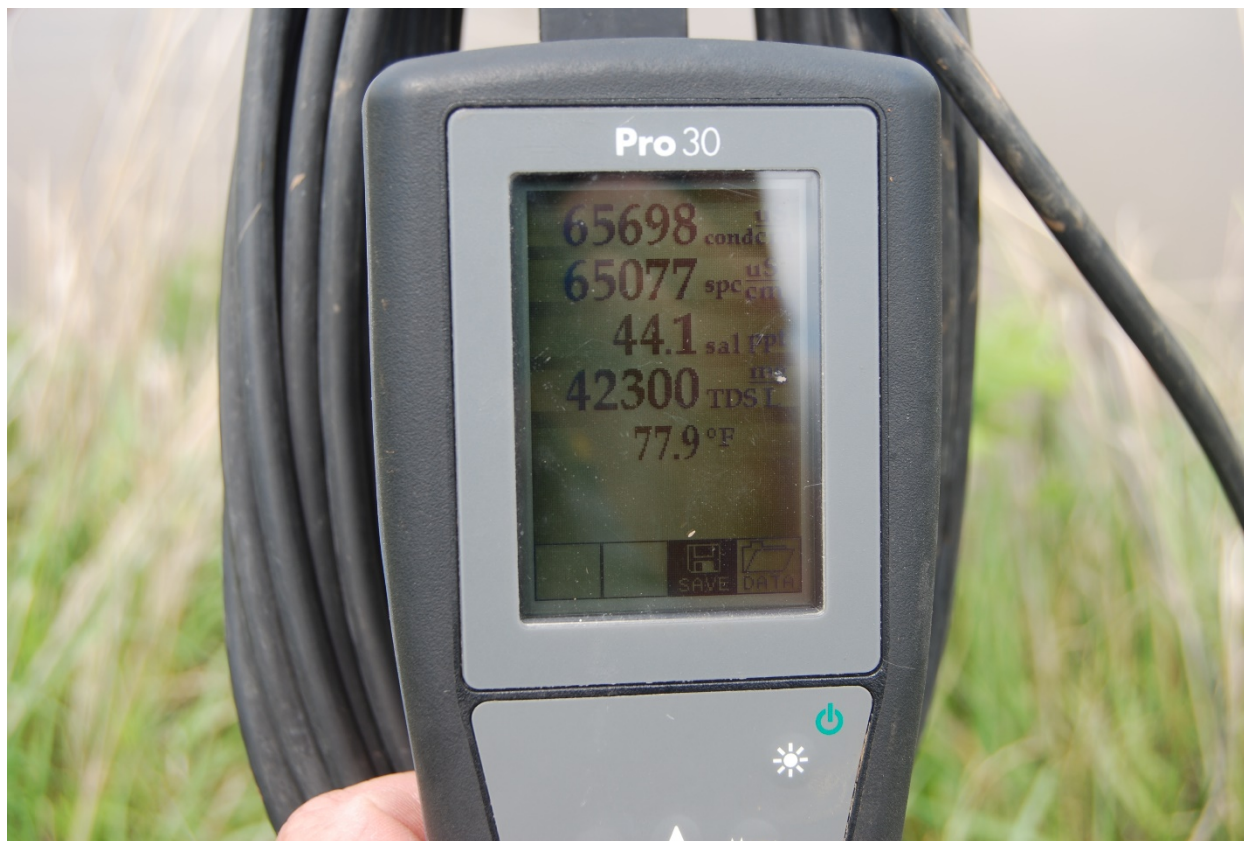
Photo No. 13

**Description:** Elevated TDS field reading of 42,300 mg/L was taken in the upstream pool at the 2<sup>nd</sup> temporary containment dam.

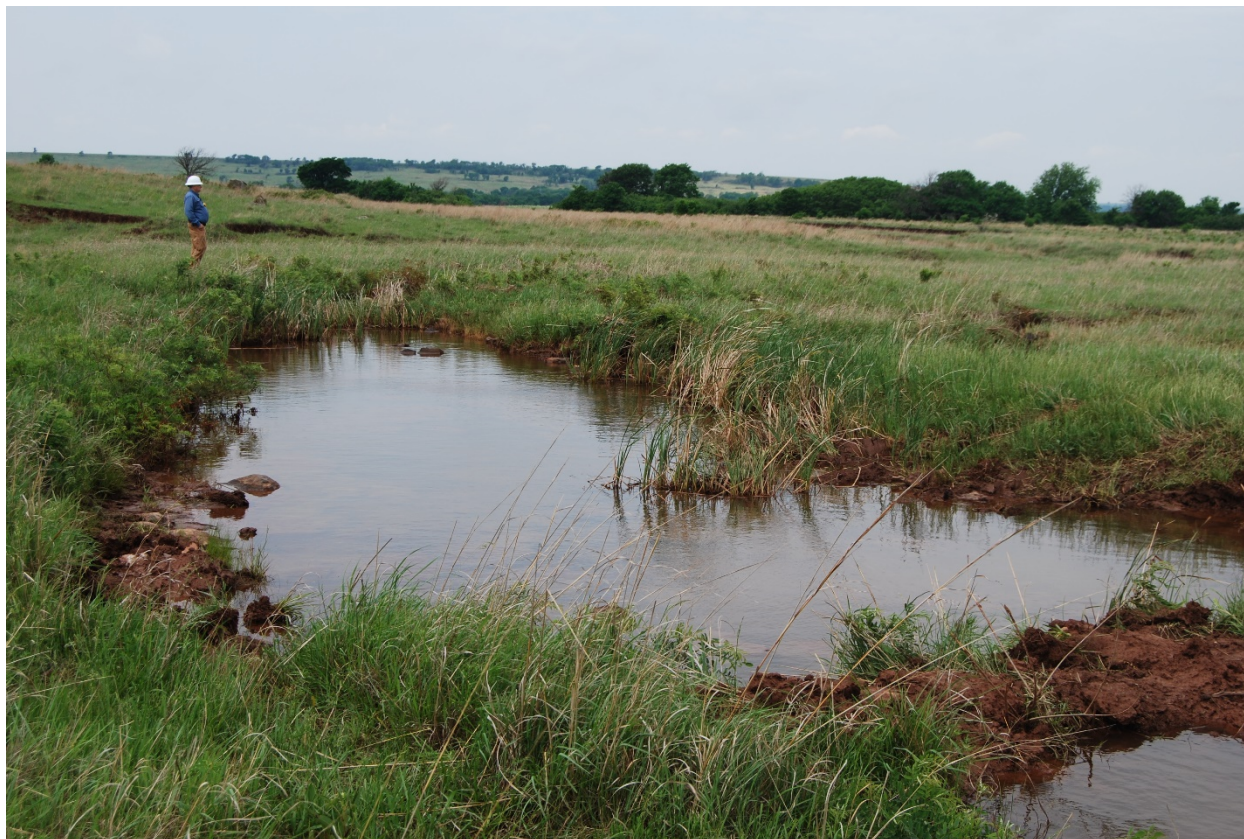
Photo No. 14

**Description:** This photo was taken from the 2<sup>nd</sup> containment dam with a view downstream. An elevated TDS field reading of 48,263 mg/L was taken from the downstream pool pictured above. This reading was the highest observed during the inspection.

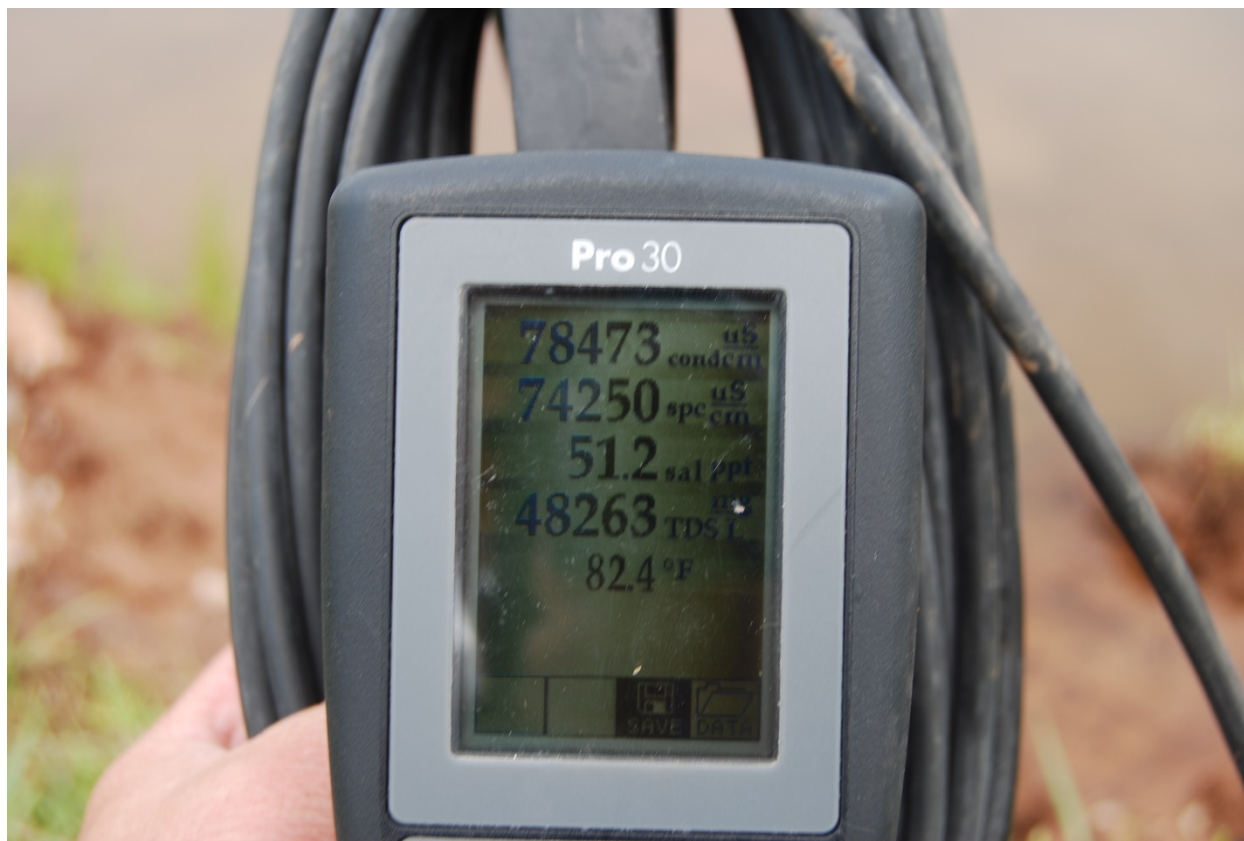
Photo No. 15

**Description:** This was an elevated TDS field reading of 48,263 mg/L, taken in the pool of water immediately below the 2<sup>nd</sup> temporary containment dam.

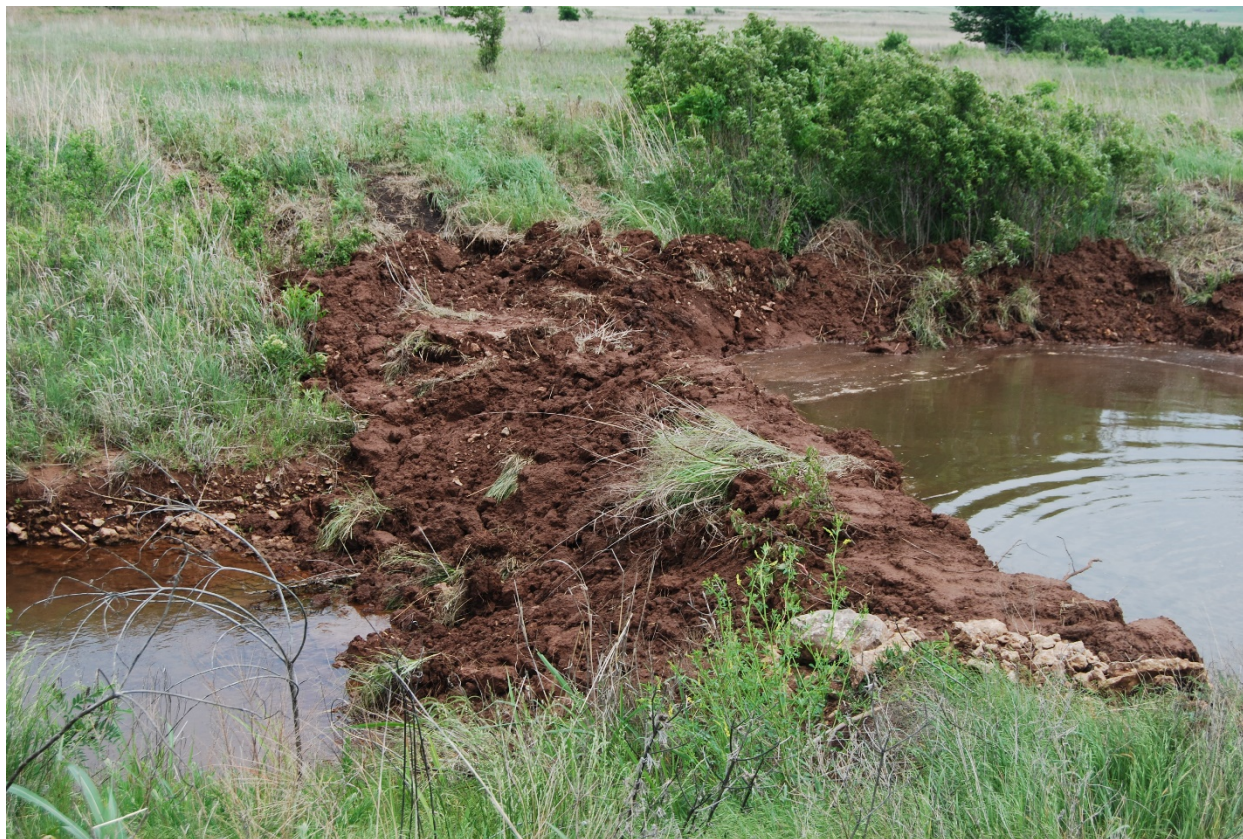
Photo No. 16

**Description:** This was a photo of the 3<sup>rd</sup> downstream temporary containment dam placed by the operator.

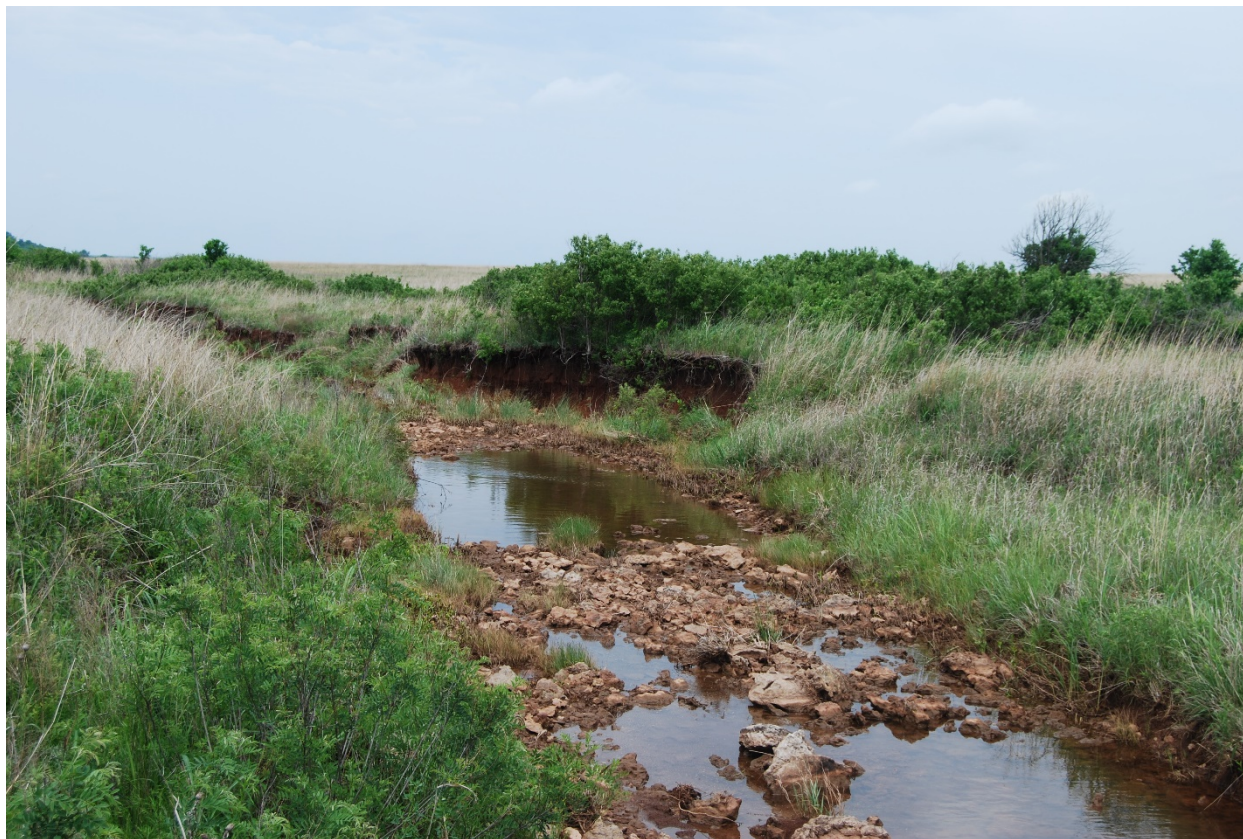
Photo No. 17

**Description:** This photo was taken from the 3<sup>rd</sup> downstream temporary containment dam; this was a view looking downstream and was an accurate representation of the stream bed and banks as spill impacts were tracked downstream.

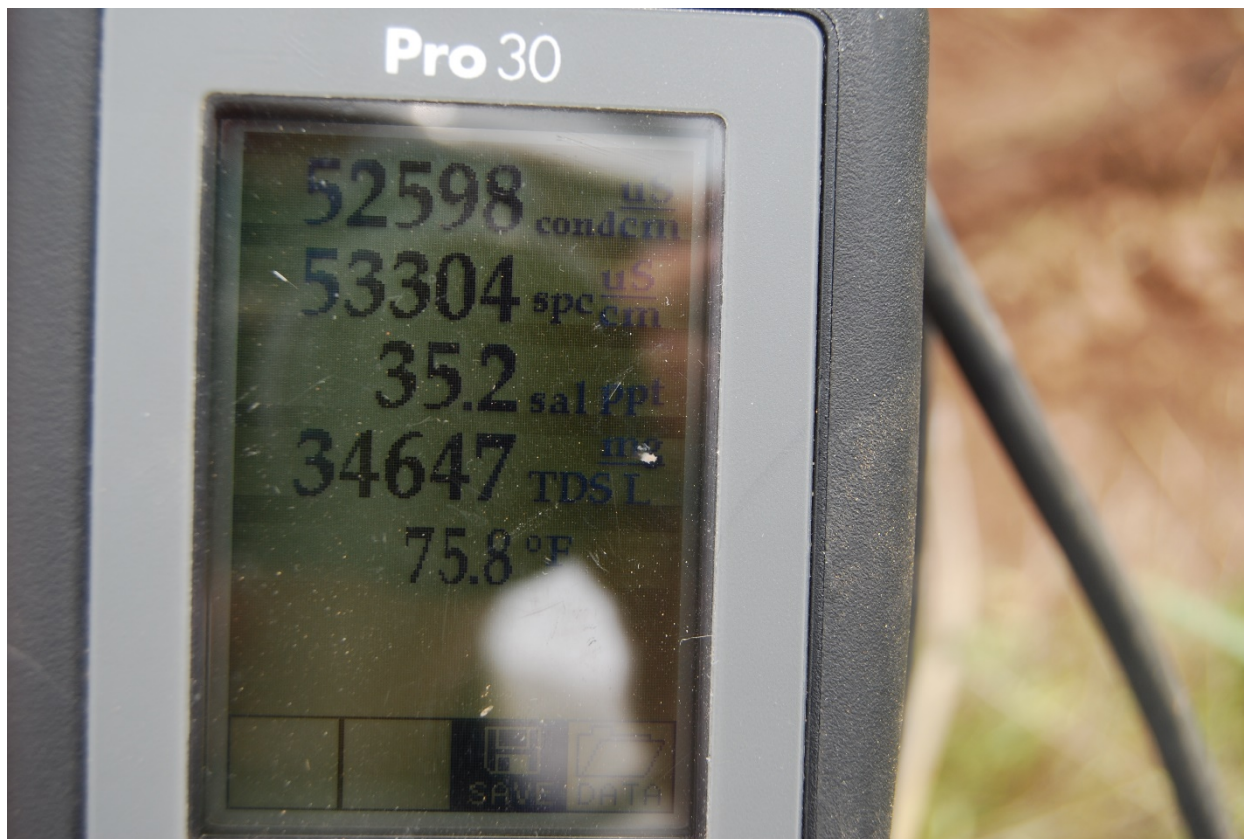
Photo No. 18

**Description:** This was an elevated TDS field reading of 34,647 mg/L, taken at the 3<sup>rd</sup> temporary containment dam.

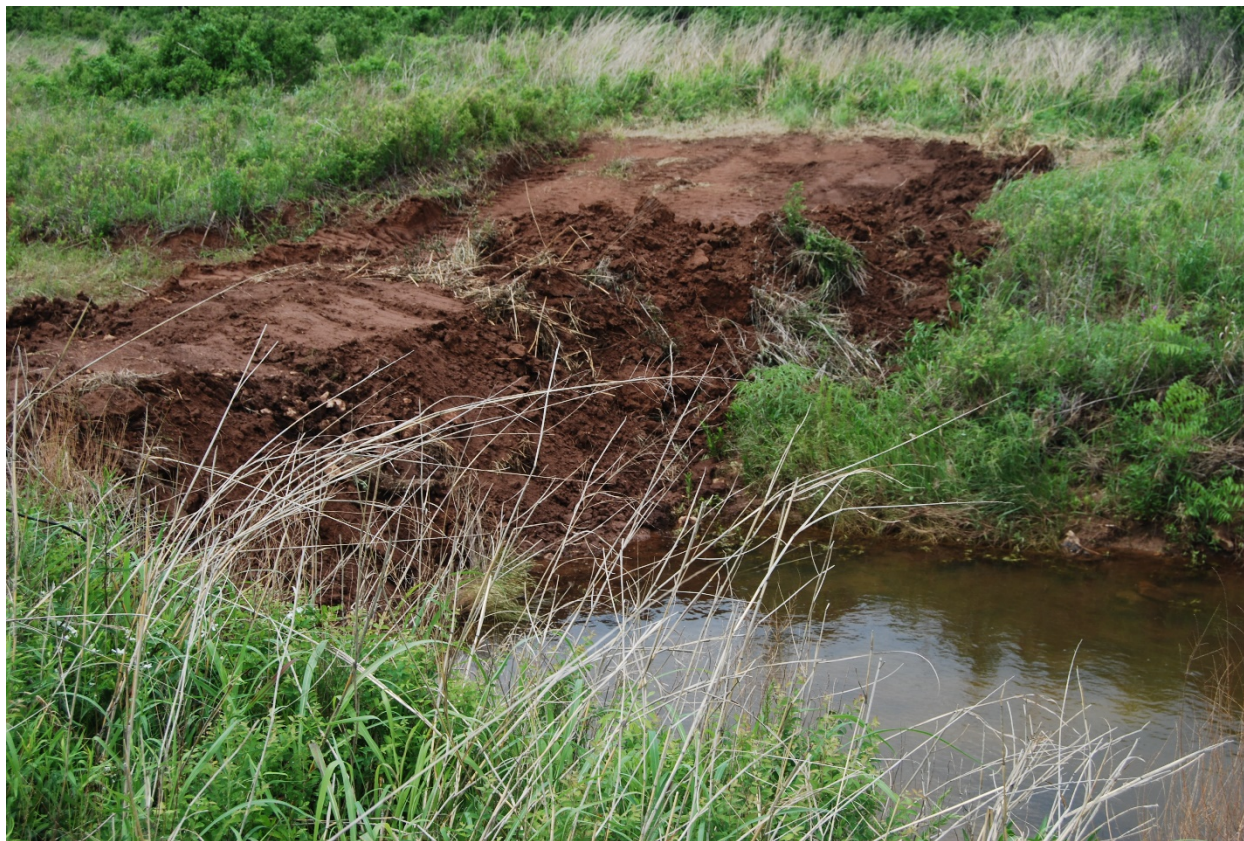
Photo No. 19

**Description:** This was the 4<sup>th</sup> downstream temporary containment dam placed by the operator.

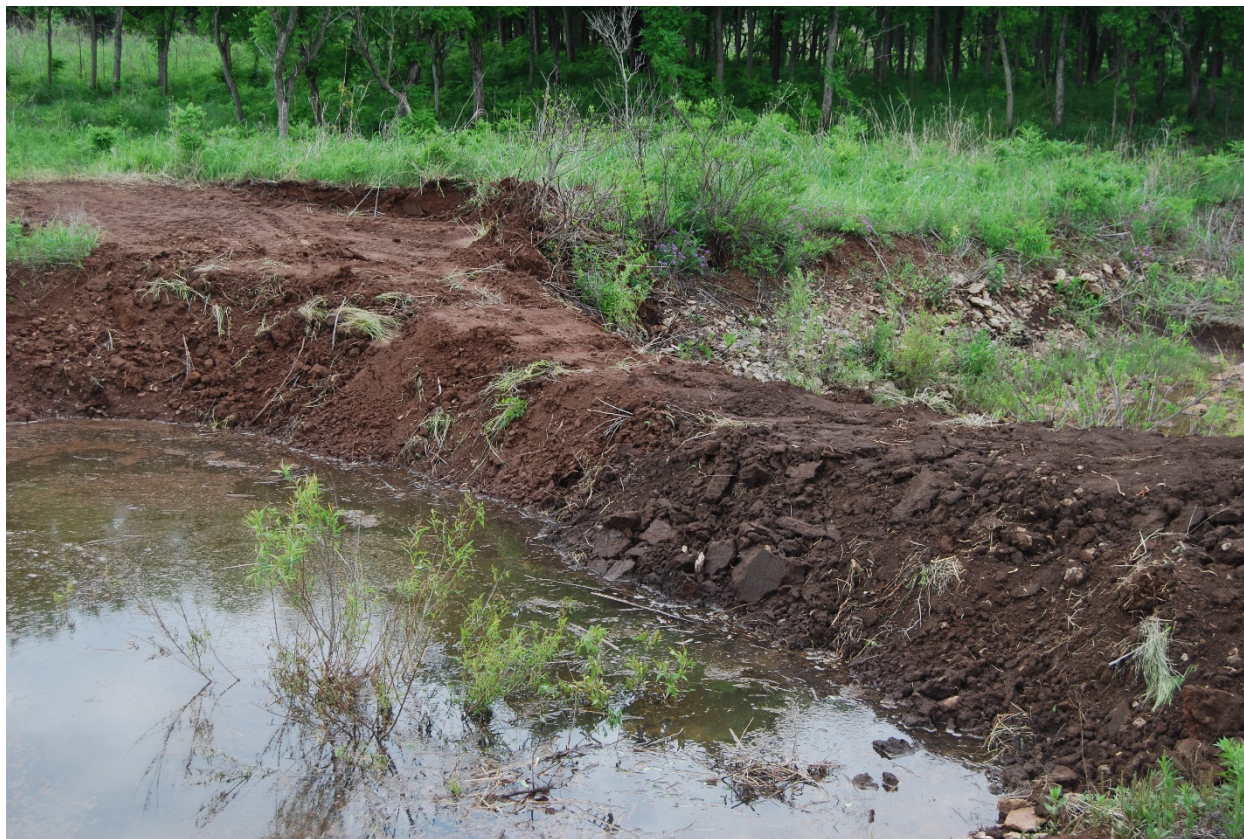
Photo No. 20

**Description:** This was the 5<sup>th</sup> and final downstream temporary containment dam constructed by the operator. While this dam did not completely prevent further downstream migration of waters with elevated TDS, this was the last location where access and stream size reasonably allowed for the construction of a temporary dam.

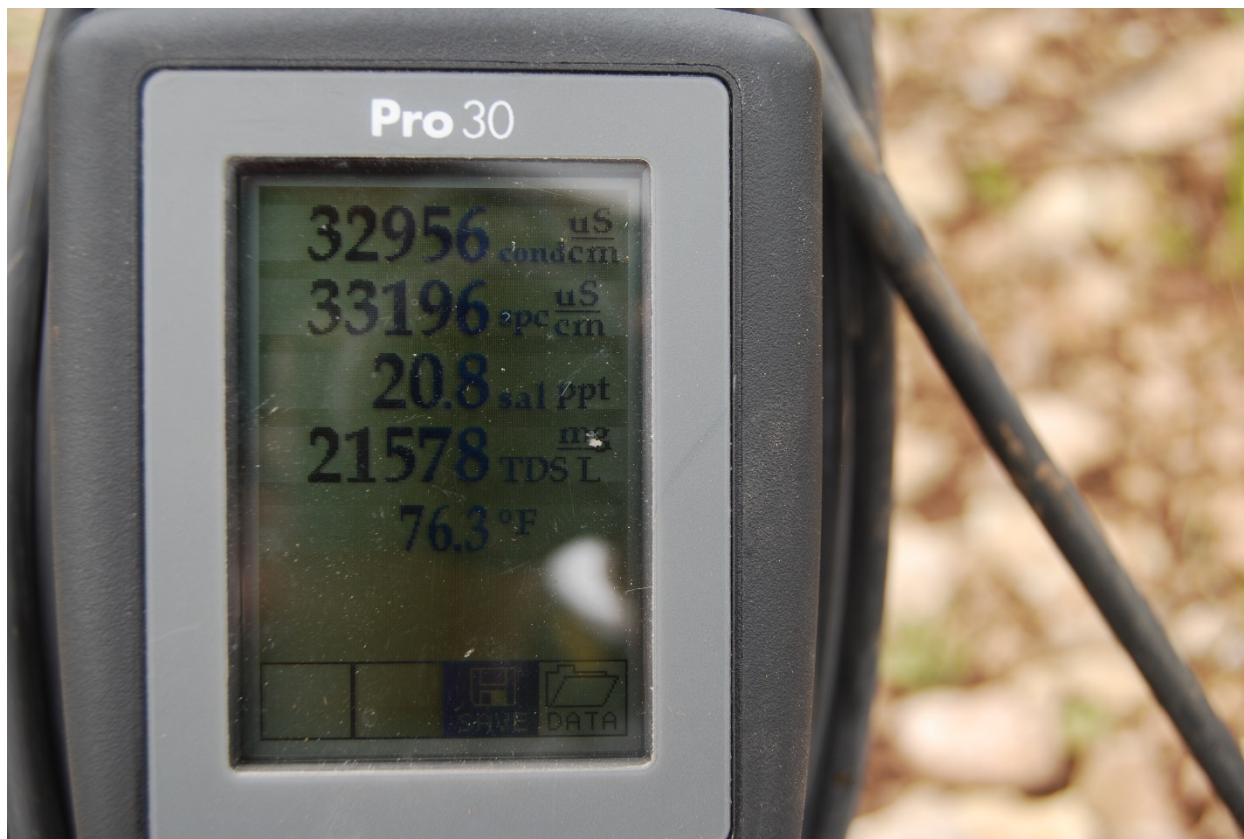
Photo No. 21

**Description:** This was an elevated TDS field reading of 21,578 mg/L taken in the upstream pool at the lowermost downstream temporary containment dam.
