**Region 6 - Enforcement & Compliance Assurance Division**  
**INSPECTION REPORT**

| Media Program: | Water, Clean Water Act (Brine) | |
| Company Name: | CapturePoint, LLC | |
| Facility Name: | Dye Lease | |

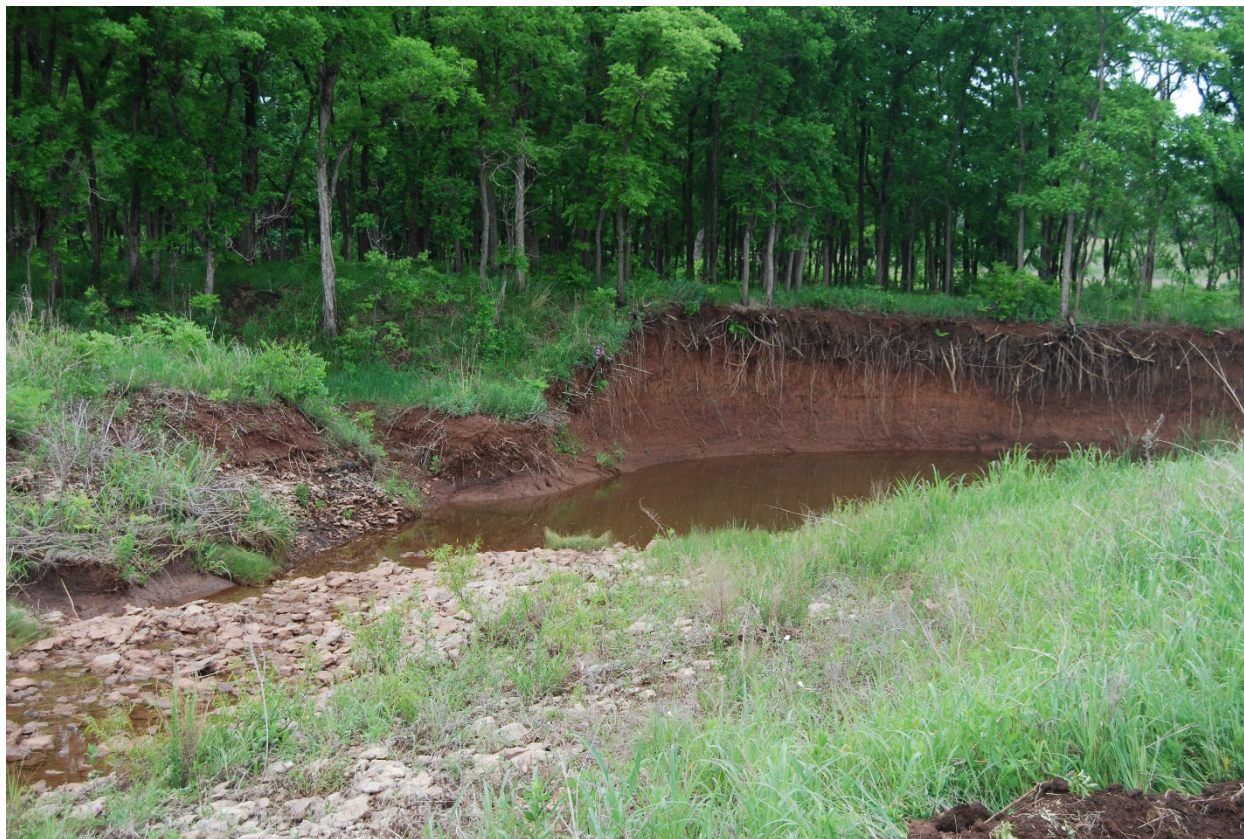
Photo No. 22

**Description:** This photo was taken standing at the last downstream containment dam, with a view looking further downstream. This photograph has a good representation of the sharply defined streambed and streambanks as spill impacts continued beyond all containment structures.

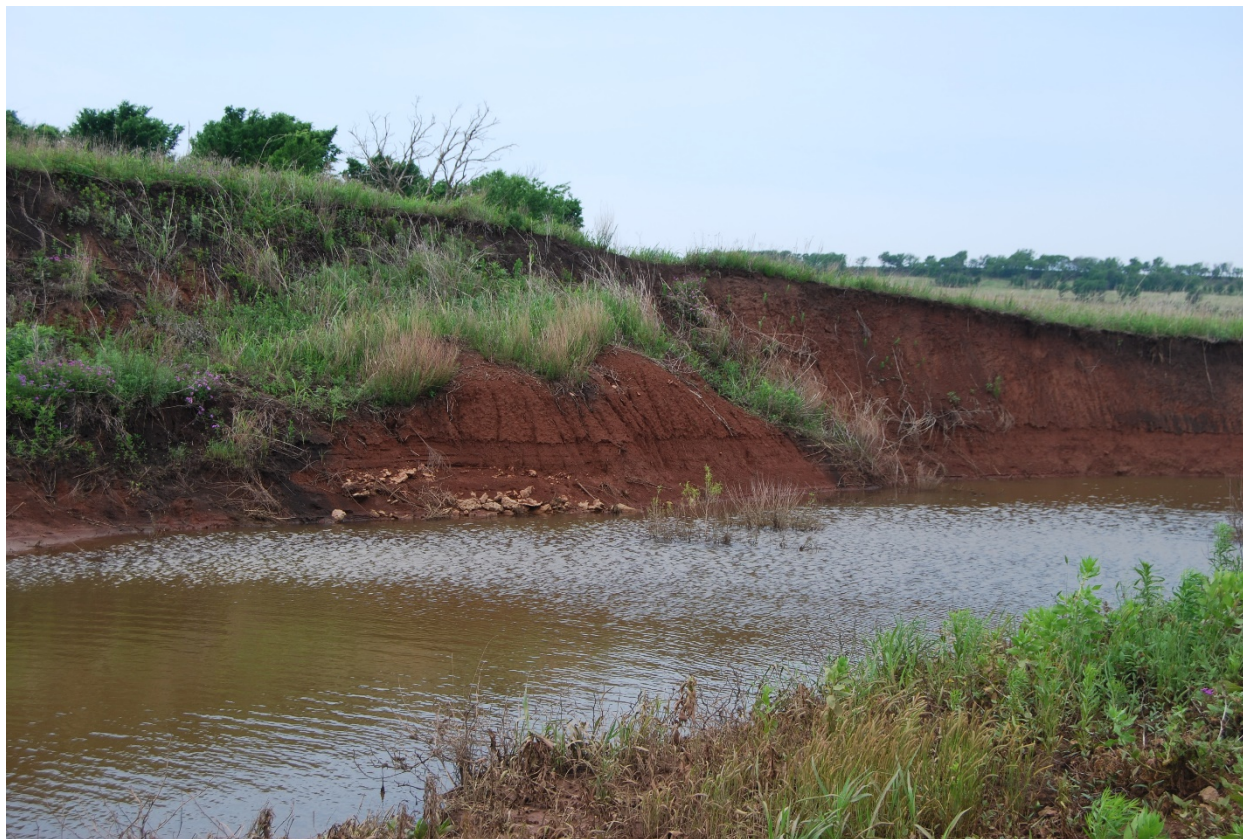
Photo No. 23

**Description:** This photo represented the location where the impacted stream achieved a continuous surface water connection to the waters of Kaw Lake. This location was approximately 200 yards downstream from the lowermost containment dam. An elevated TDS field reading of 1,986 mg/L was taken at this location. Note the well-defined bed and bank features of the stream. Due to recent heavy rainfall events, the water level in Kaw Lake was elevated above normal at the time of this inspection.

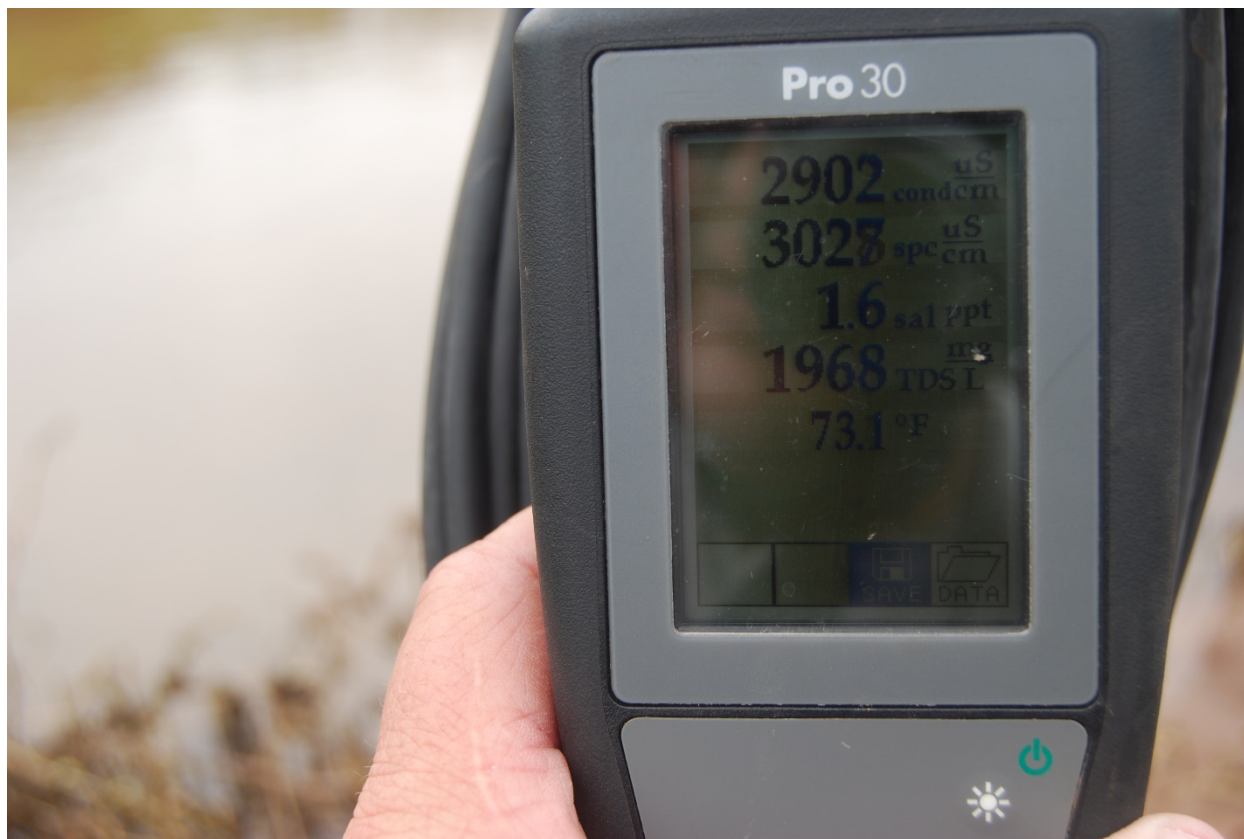
Photo No. 24

**Description:** Elevated TDS field reading of 1,968 mg/L taken at the point where the impacted stream achieved a continuous surface connection with the waters of Kaw Lake.

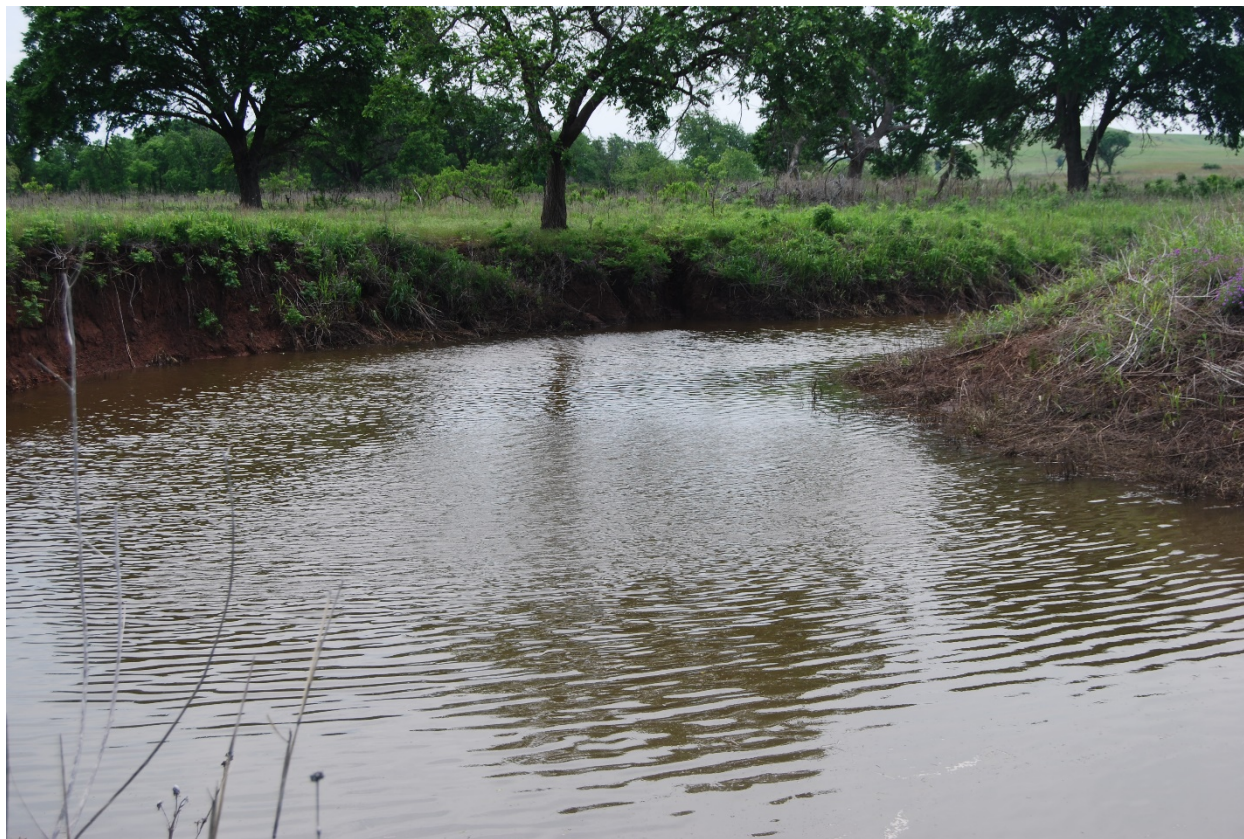
Photo No. 25

**Description:** This photo showed the increased size of the lower portion of the stream as it nears the open waters of Kaw Lake. This photo was taken at the GPS coordinates listed above and the view was looking upstream. An elevated TDS field reading of 954 mg/L was taken at this location at the time of the inspection.

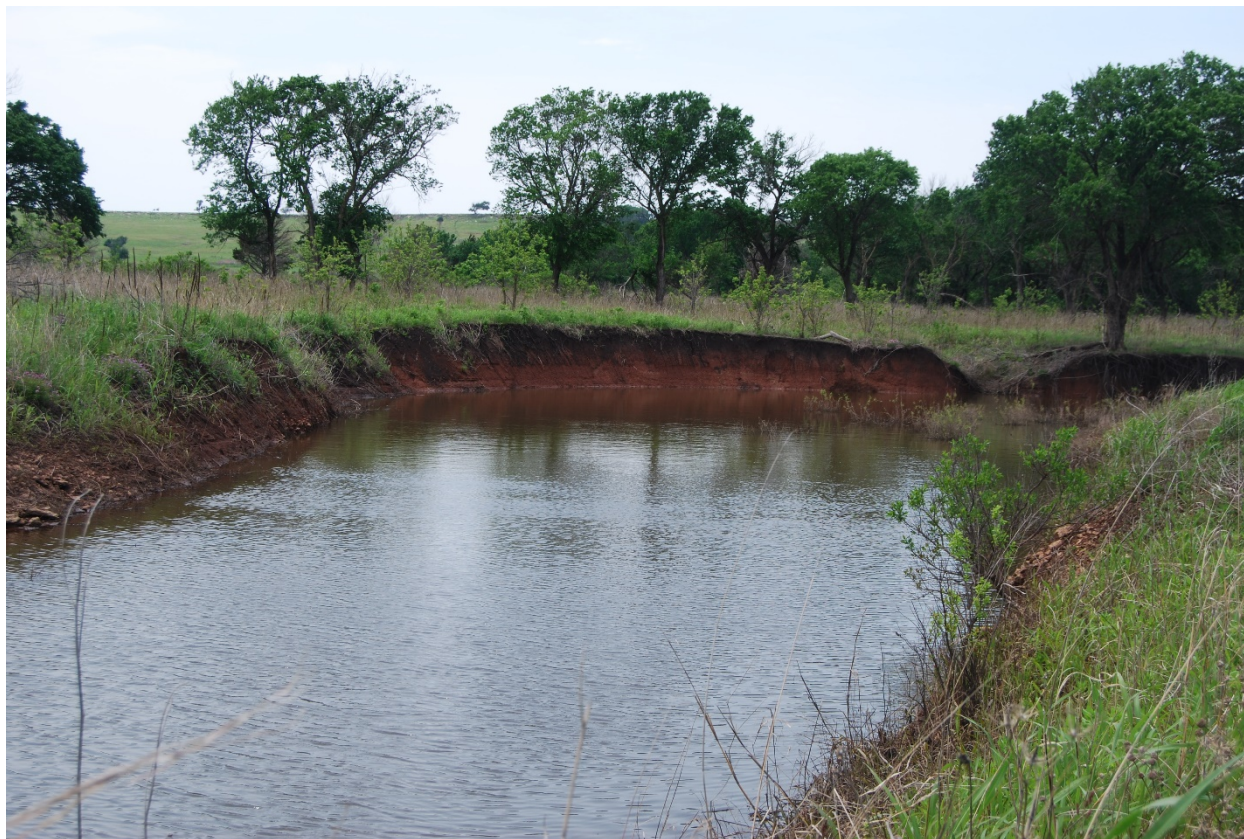
Photo No. 26

**Description:** This photo showed the increased size of the lower portion of the stream as it nears the open waters of Kaw Lake. This photo was taken at the GPS coordinates listed above and the view was looking downstream. An elevated TDS field reading of 954 mg/L was taken at this location at the time of the inspection.

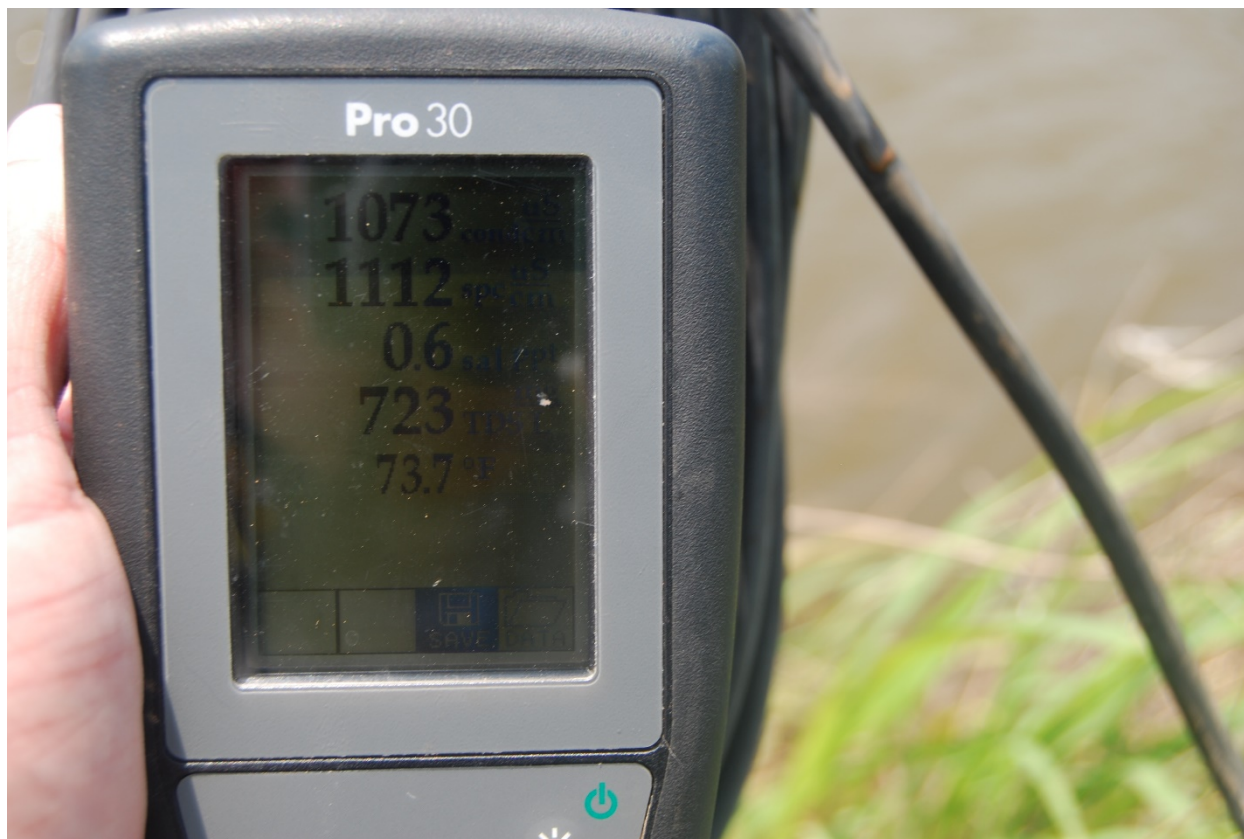
Photo No. 27

The final or furthest downstream measurement which documented elevated levels of TDS in the impacted stream displayed a measurement of 723 mg/L TDS and can be seen in Photo No. 27. The GPS location of 36.810412, -96.784332 was the furthest point I was able to observe spill impacts along the stream, the inspection could not continue downstream as our path was impeded by water which was too deep to cross.

**Description:** This was an elevated TDS field reading of 723 mg/L taken during the inspection. This location and field reading represented the furthest point downstream which spill impacts were documented on the day of the inspection. Due to high water levels in Kaw Lake, backed up lake waters prevented further downstream tracking of spill impacts.
