**Region 6 Compliance Assurance and Enforcement Division  
INSPECTION REPORT**

| Company Name: | <b>Migwis Operating, LLC</b> | | |
| Facility Name: | <b>Bowen</b> | | |
| Identification/Permit Number: | OKU000865 | | |

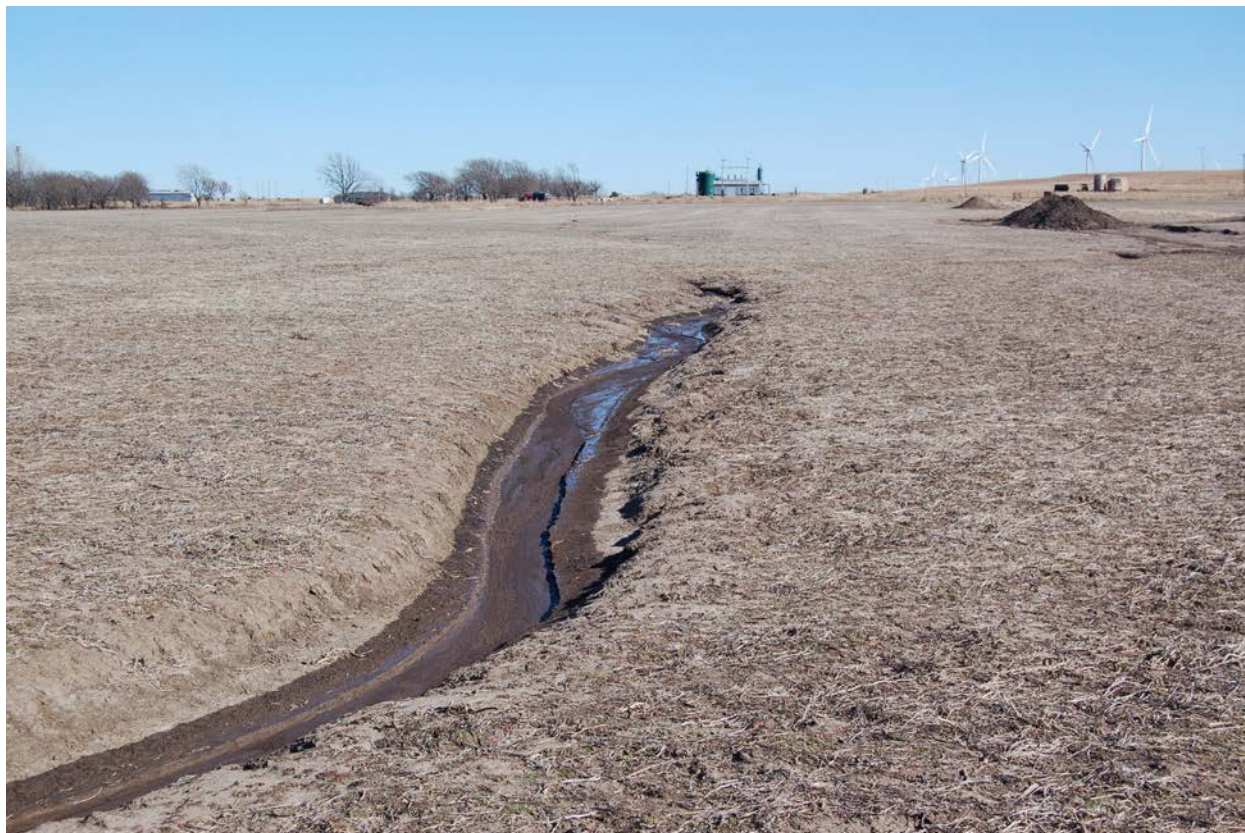
Photo No. 1

Description: This image shows produced water that was discharged from the Migwis Operating, LLC – Bowen facility. The Bowen tank battery can be seen in the background of this photo. The discharged fluids flowed west from the tank battery toward the tributary of Salt Creek.

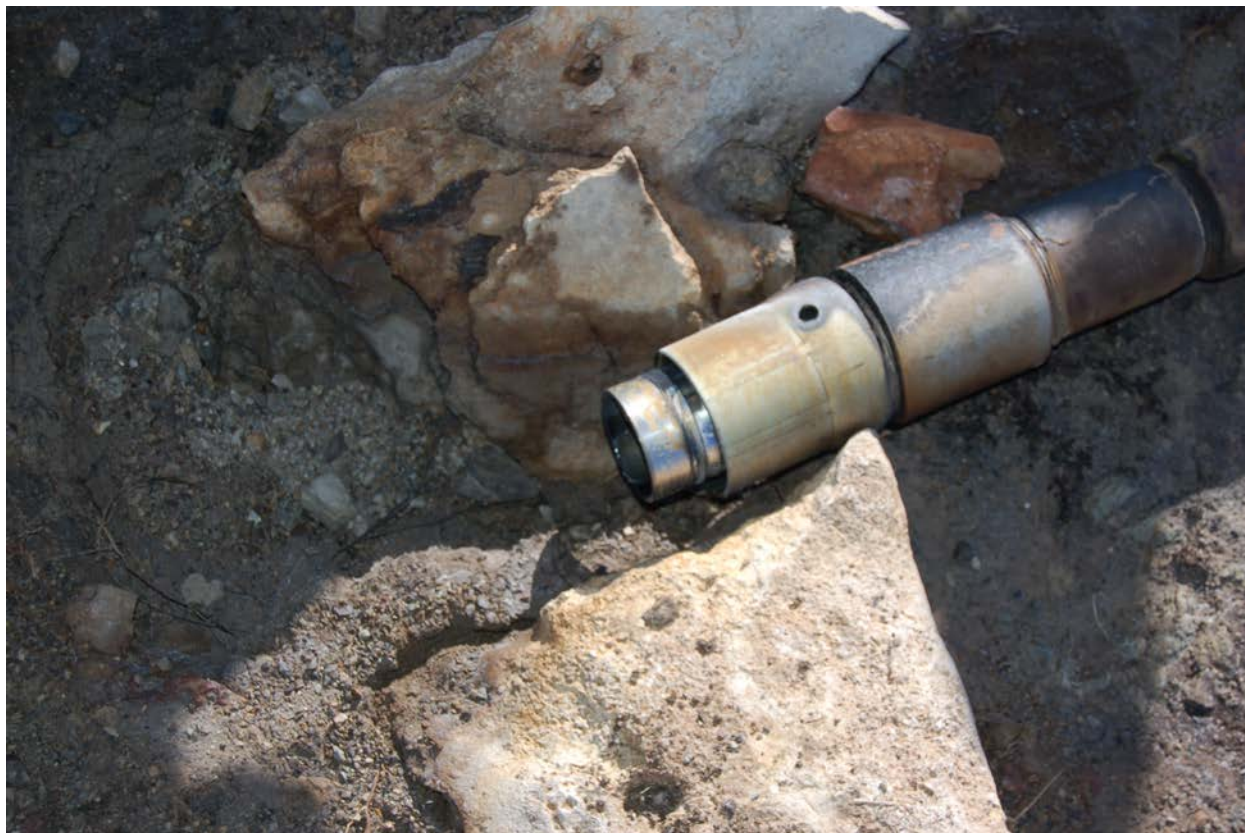
Photo No. 2

The origination point of discharge was the Bowen tank battery located east of the point of entry of discharged fluids into the tributary of Salt Creek. There are several wells on the site associated with the Bowen lease. A hose on the discharge side of the injection pump parted and caused brine to discharge westward from the injection line break across a plowed field to the tributary of Salt Creek.

Description: The discharge of fluids originated from a broken injection line associated with the injection operations at the Bowen tank battery. The injection line parted as shown here and allowed brine to flow into the field to the west of the tank battery and to the tributary of Salt Creek.

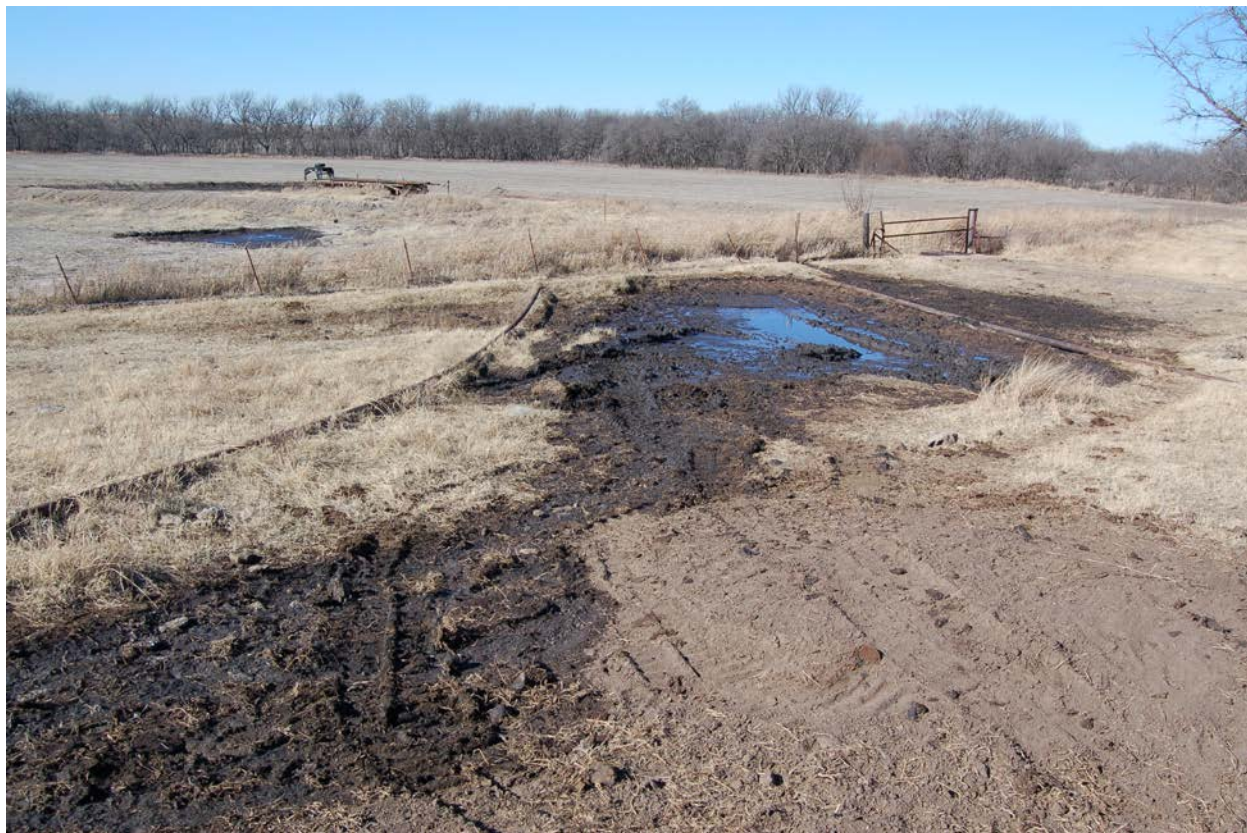
Photo No. 3

Description: Discharged fluids, including brine, flowed from the parted line and ran northwest through a plowed field and into the tributary of Salt Creek. The injection well is shown here towards the upper left portion of this photo.

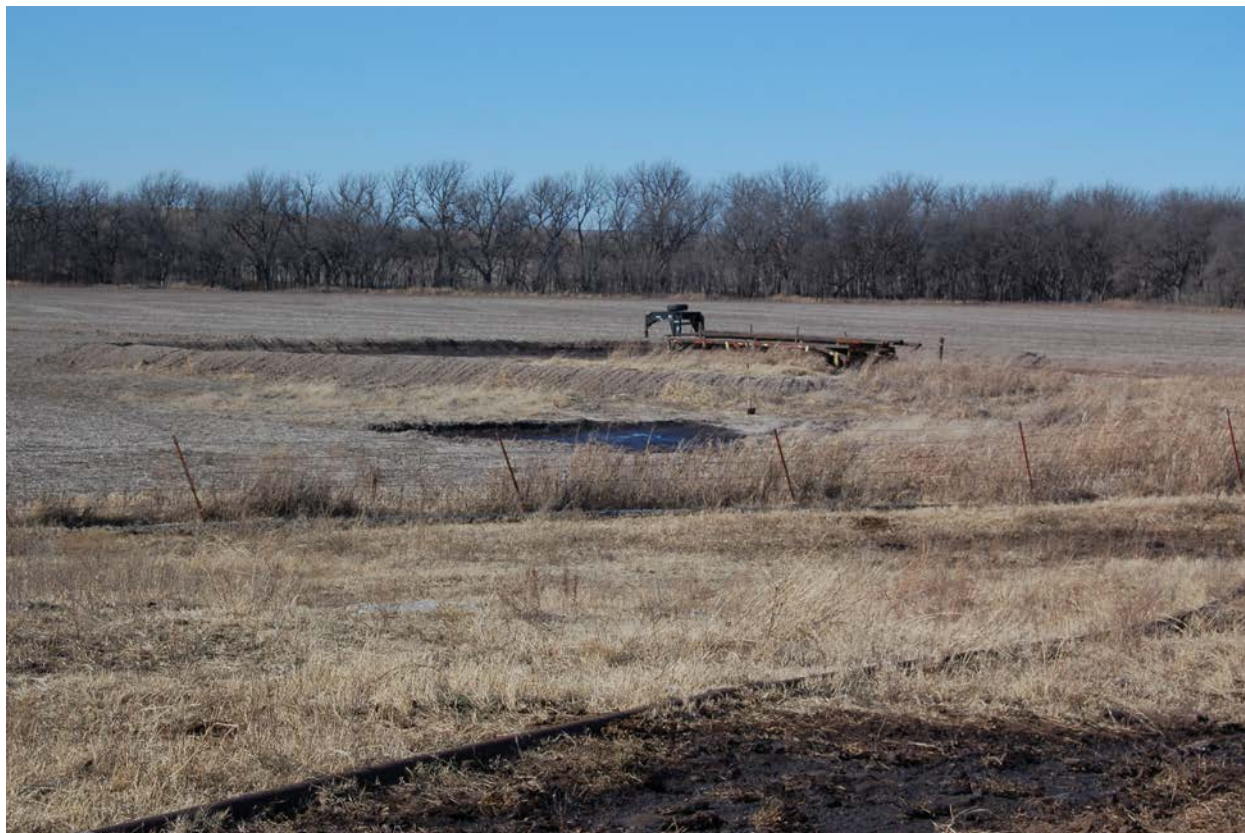
Photo No. 4

Description: I observed that the discharged brine pooled up in the field before running west across the field to the tributary of Salt Creek.

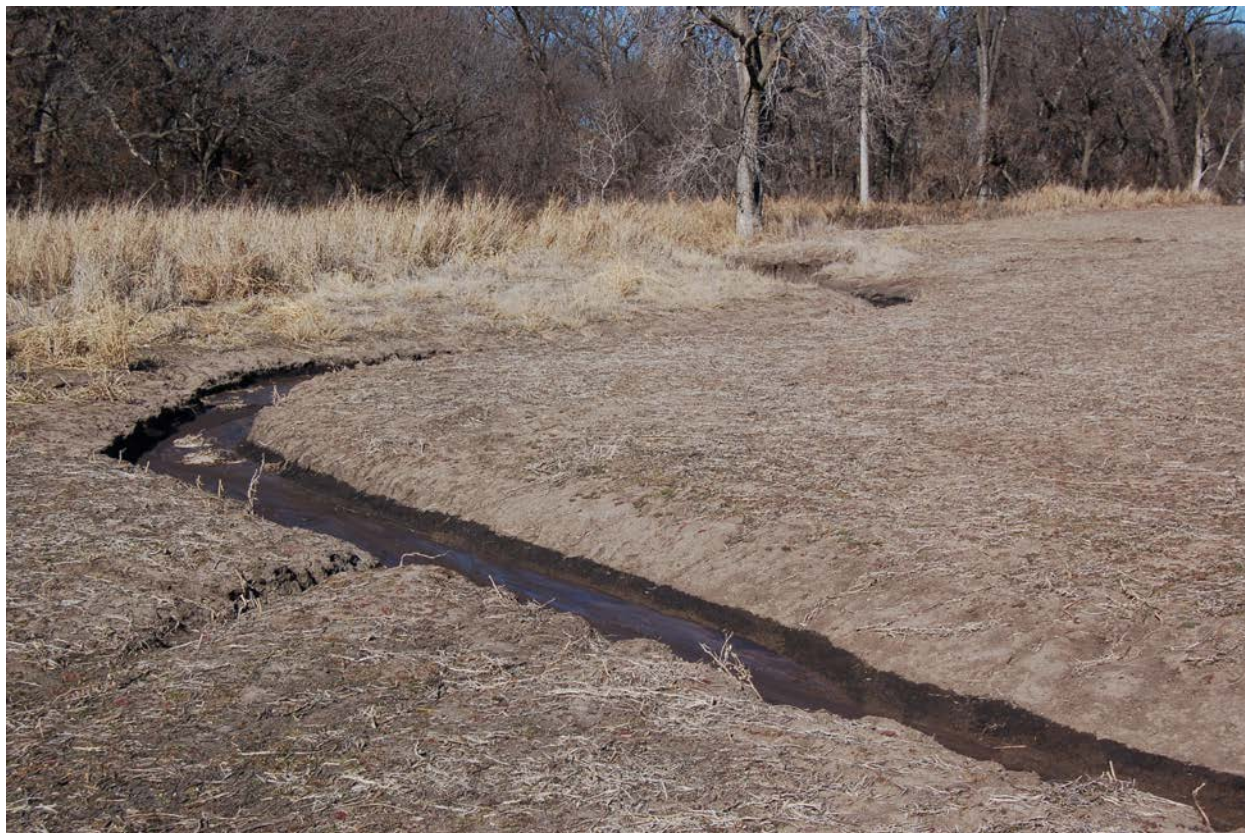
Photo No. 5

Description: The flow path of discharged fluids, like brine, entered a wooded area here just east of the tributary of Salt Creek.

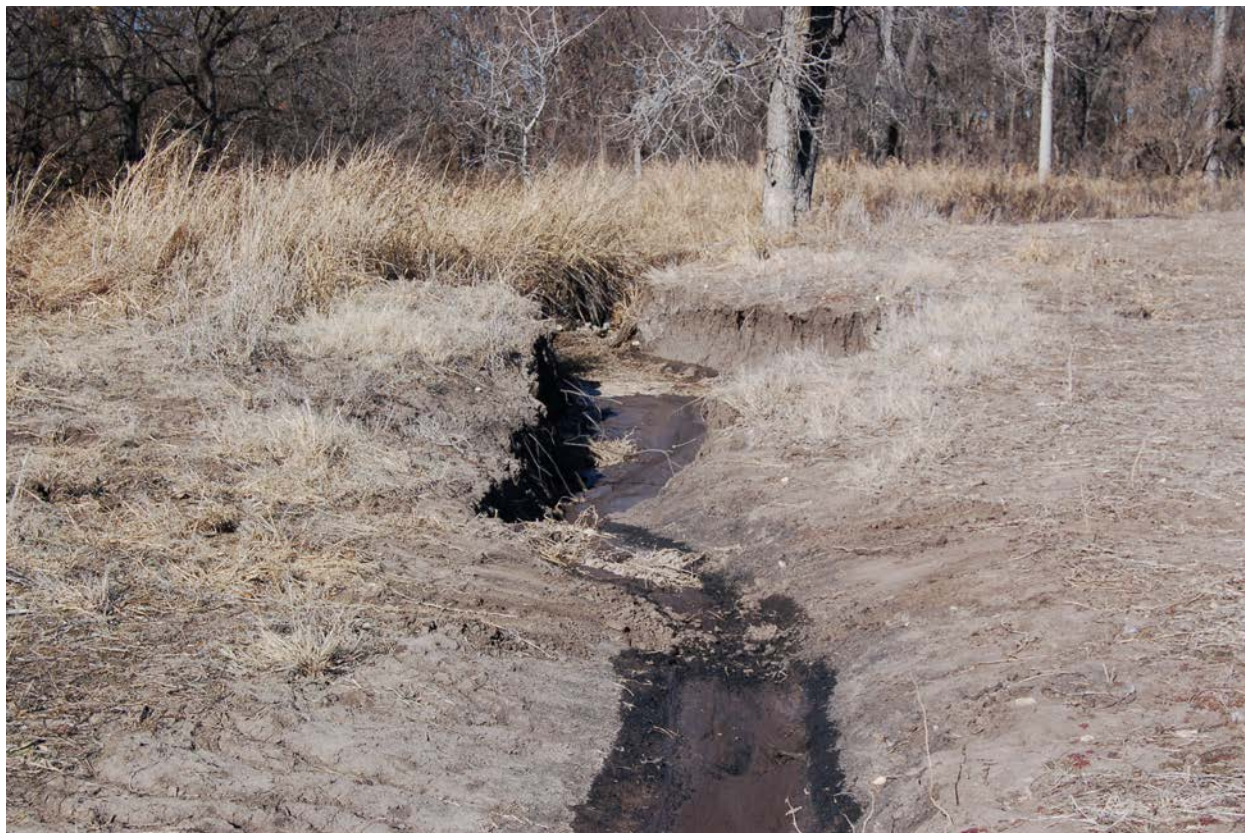
Photo No. 6

Description: The flow path had brine and fluids flowing west down a bank towards the tributary of Salt Creek.

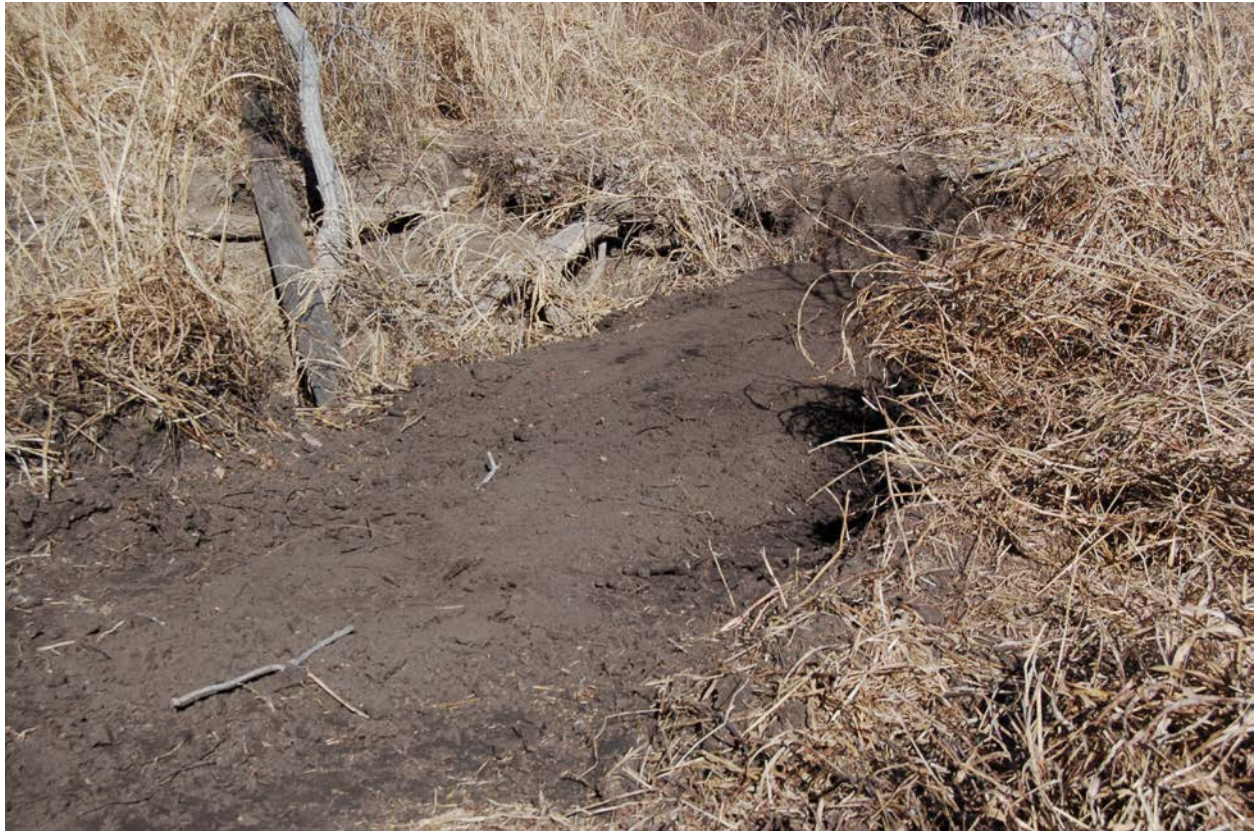
Photo No. 7

Description: I observed a temporary dam in place, seen in the above photo, that was built at the point of entry to the tributary of Salt Creek.

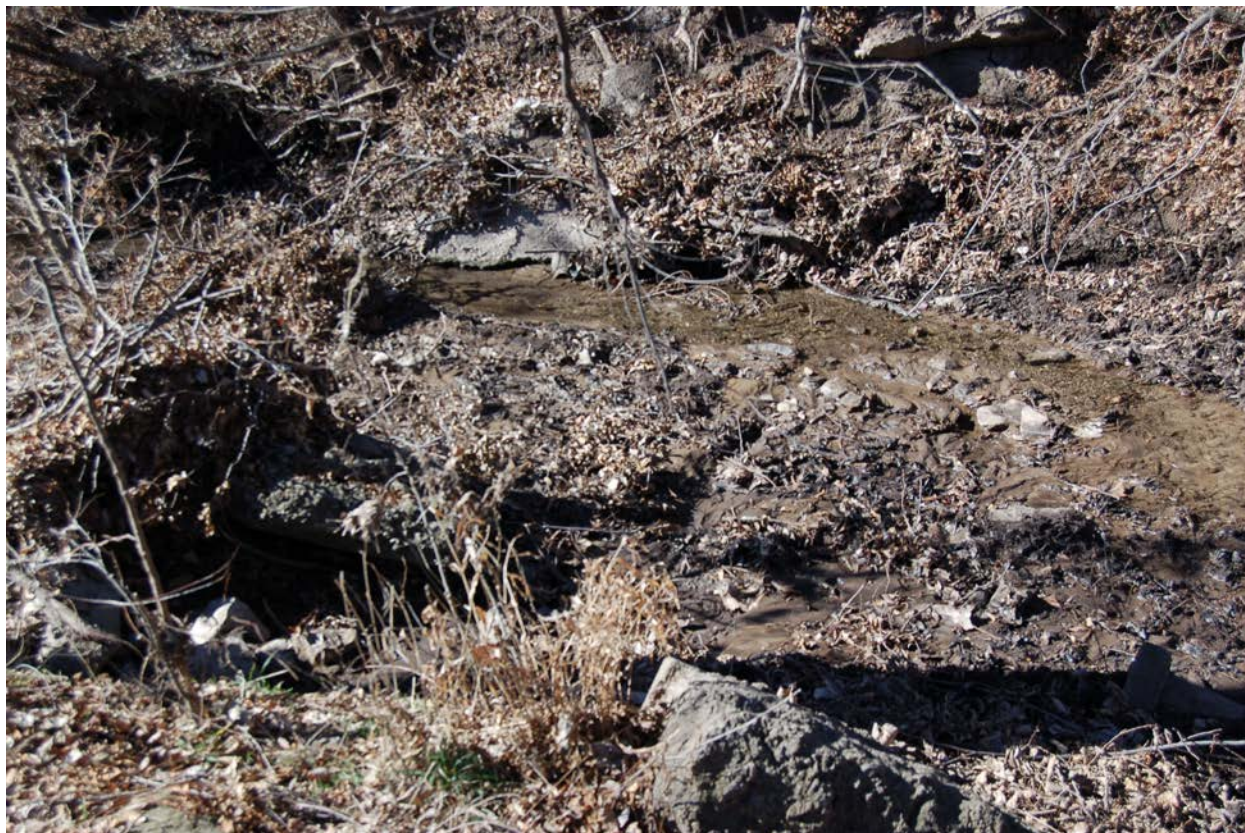
Photo No. 8

Description: This was the point of entry to the tributary of Salt Creek from the discharged fluids, including brine from the Migwis Operating, LLC – Bowen facility.

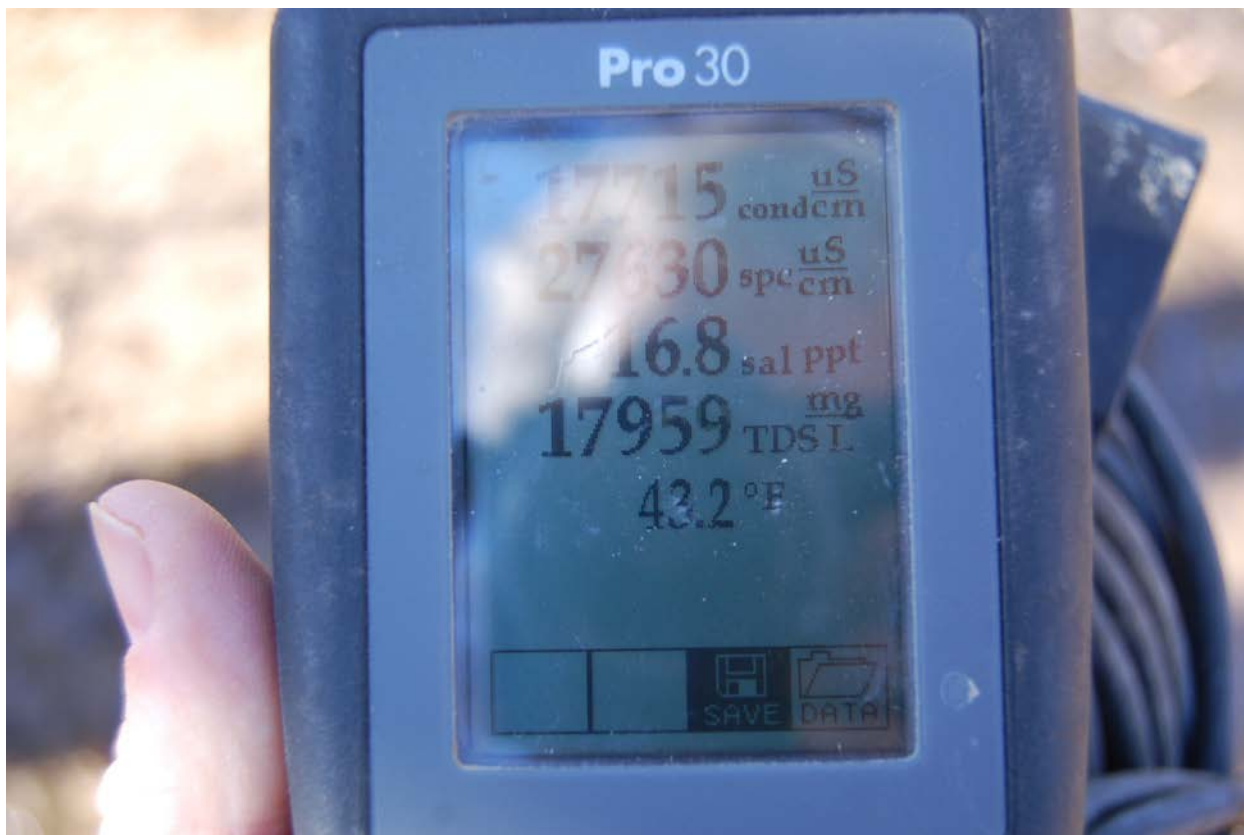
Photo No. 9

Description: The Total Dissolved Solids (TDS) of the tributary of Salt Creek at the point of entry was 17,959 mg/L. The TDS was taken with a calibrated YSI 30 Pro Conductivity meter.

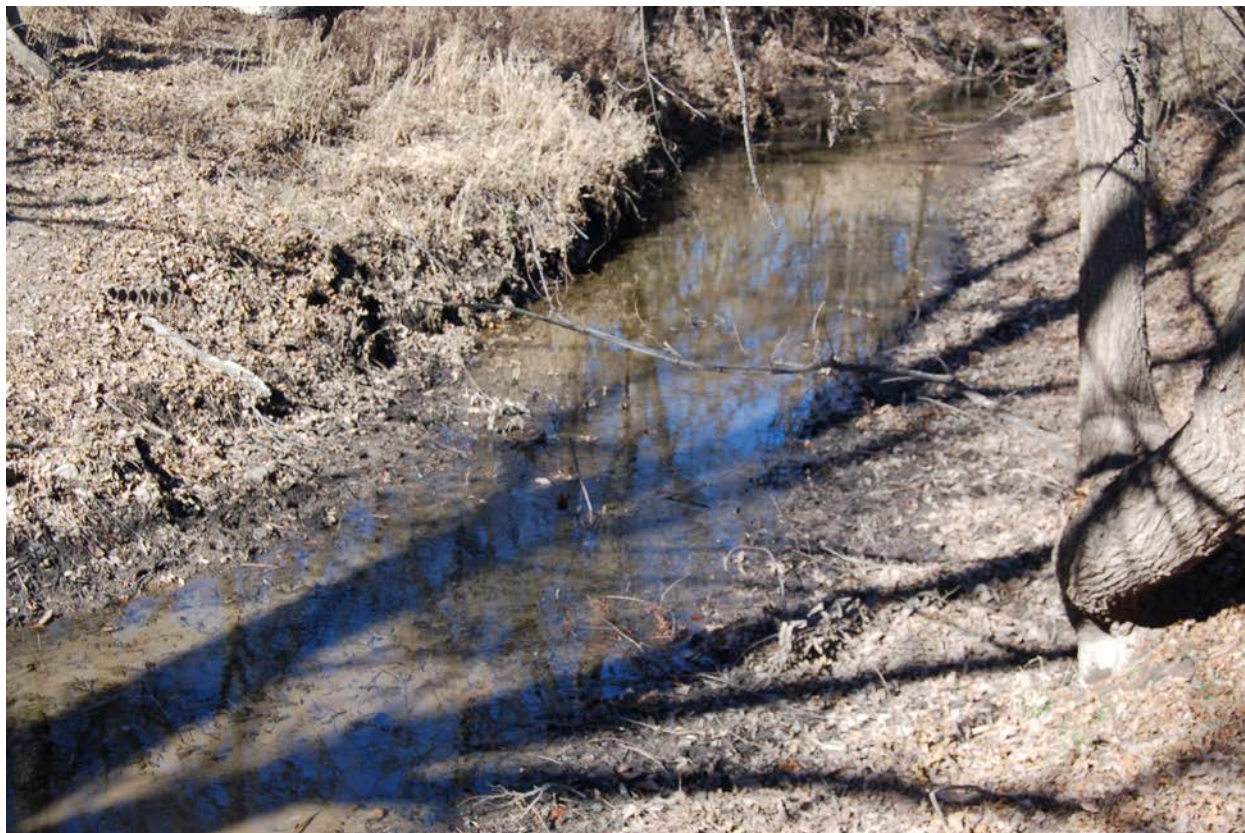
Photo No. 10

Description: The tributary of Salt Creek was flowing during the time of the inspection, and this image shows a view of the tributary upstream from the point of entry.

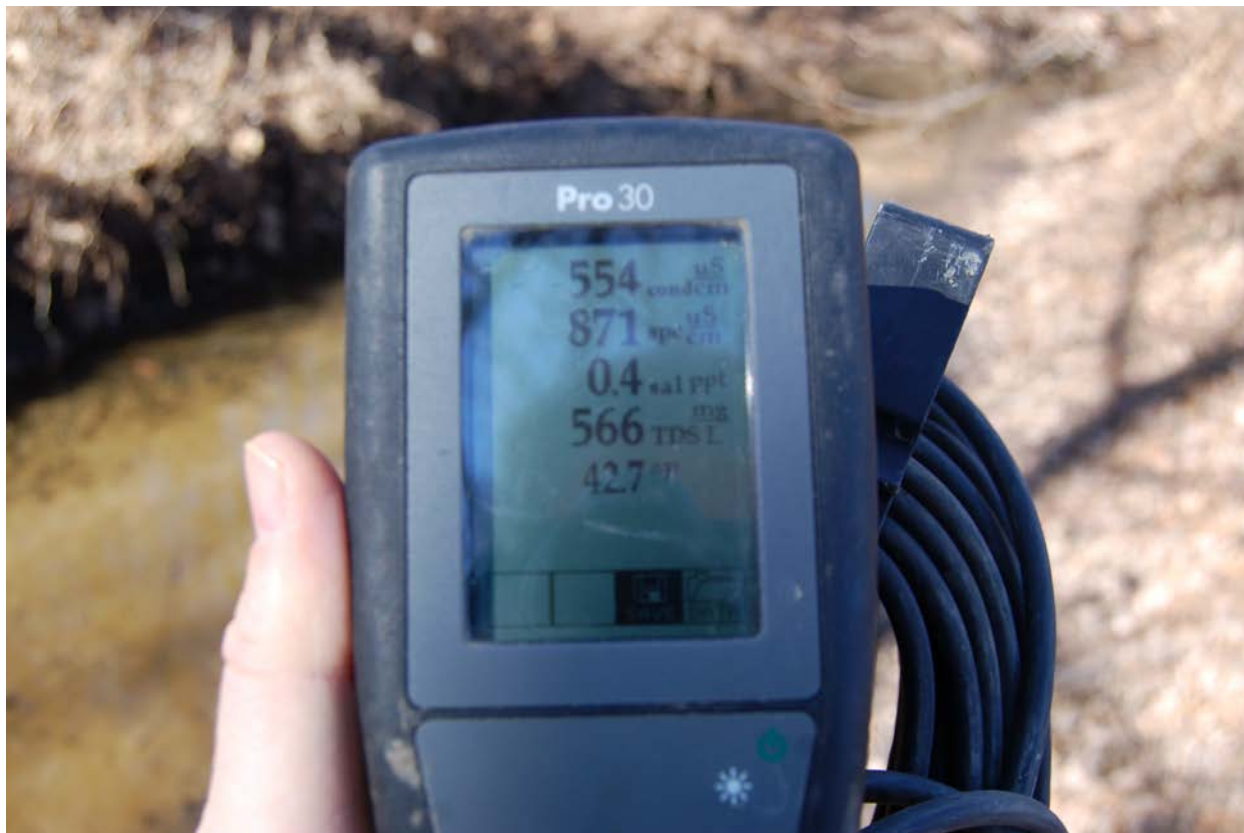
Photo No. 11

Description: TDS of the tributary upstream was 566 mg/L.

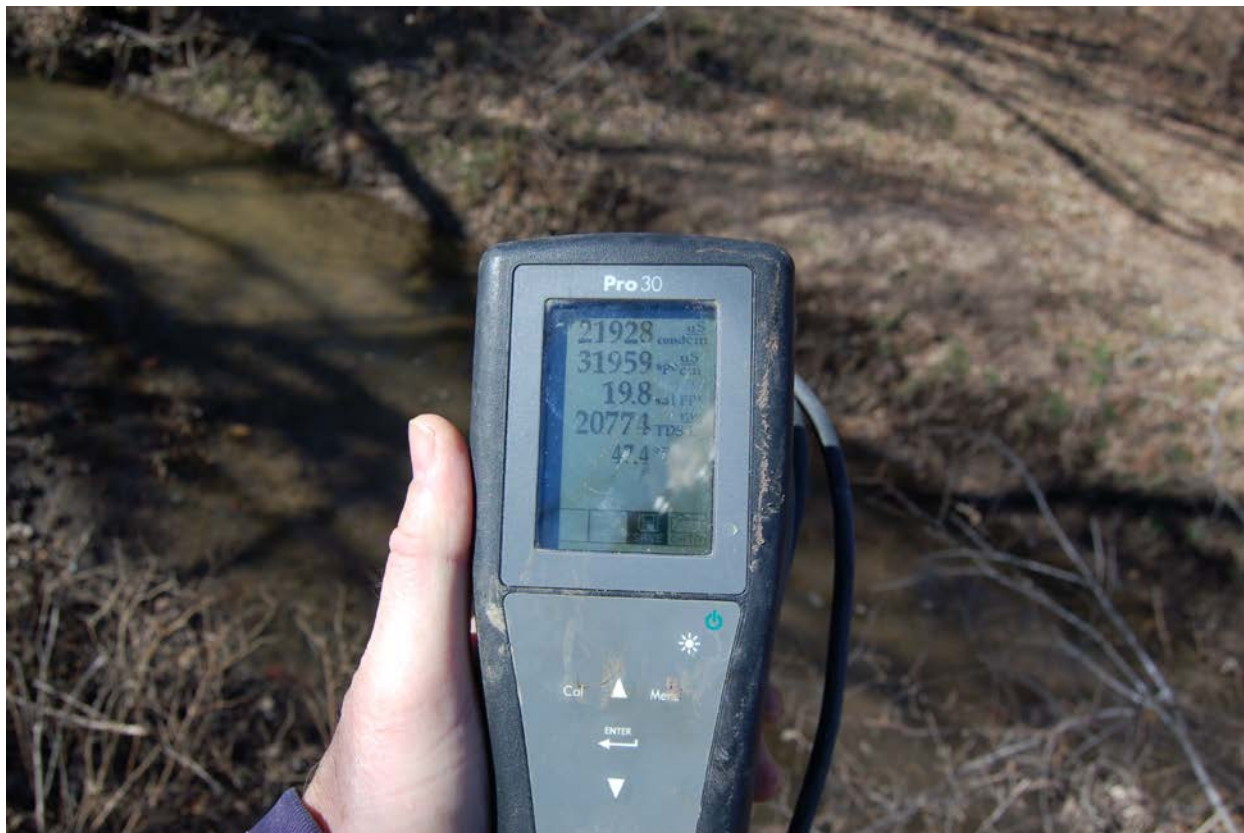
Photo No. 12

Description: A TDS reading was taken downstream from the point of entry in the tributary of Salt Creek entry and was 20,774 mg/L. This location was approximately 150 feet downstream from the point of entry into the tributary.

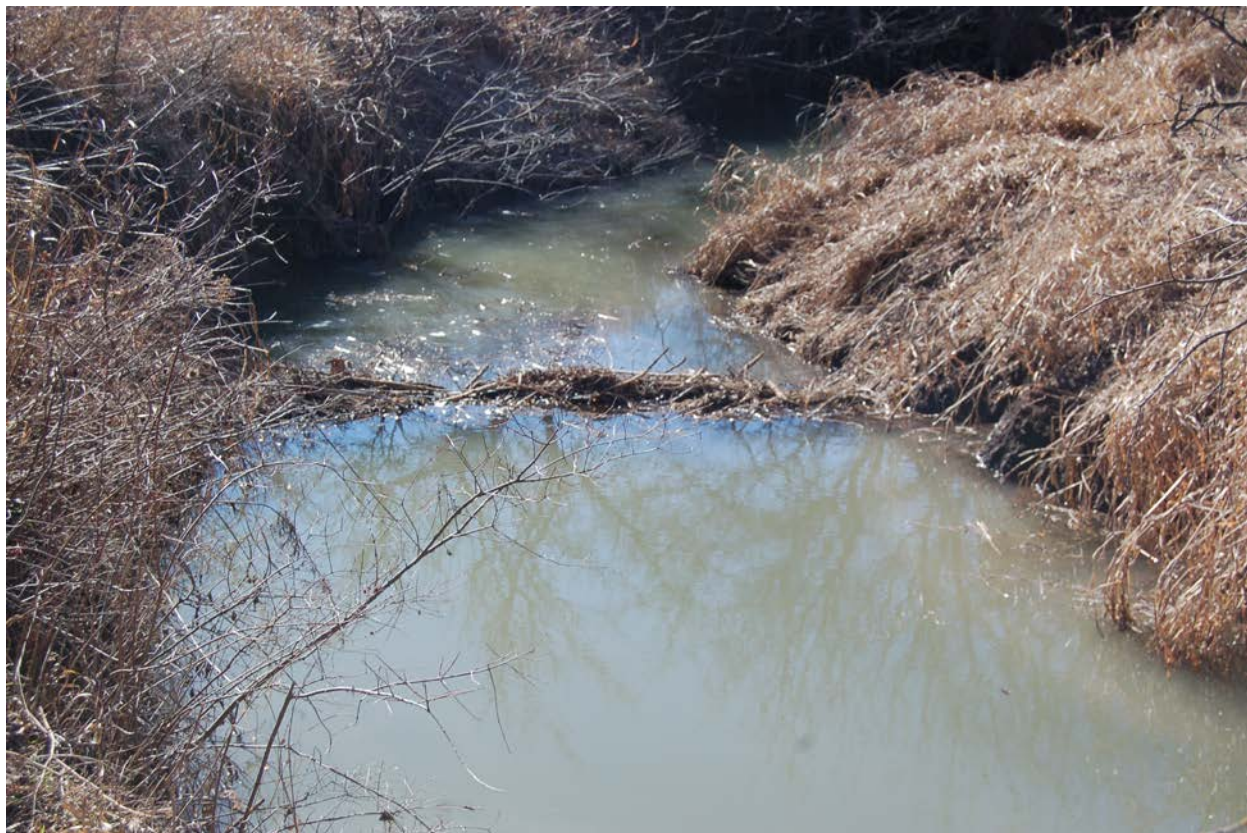
Photo No. 13

Description: This figure shows the tributary farther downstream from the point of entry. A beaver dam was constructed within the tributary, and contained a large portion of the discharge fluids, like brine, from flowing further downstream. This beaver dam was approximately 0.2 miles downstream from the point of entry on the tributary of Salt Creek.

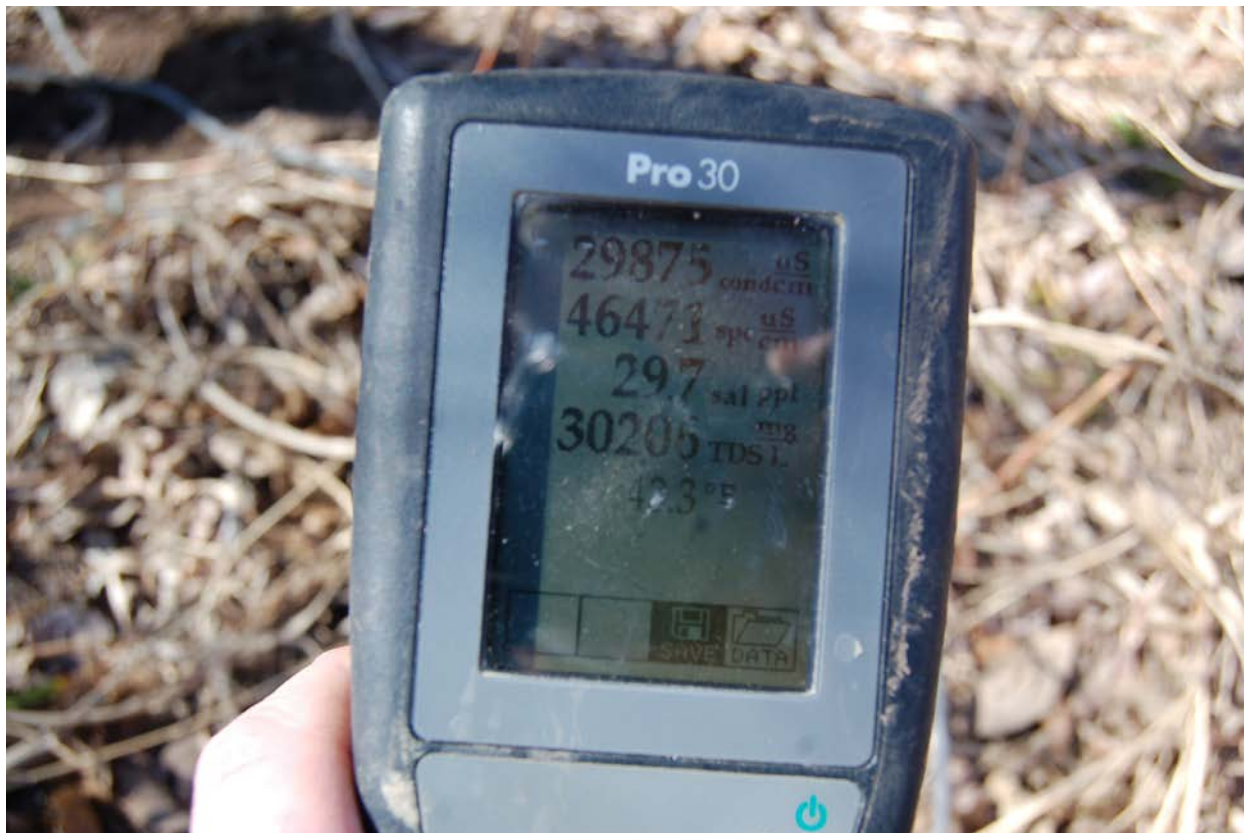
Photo No. 14

Description: The TDS reading upstream of the beaver dam on the tributary of Salt Creek was 30,206 mg/L. The TDS reading of 2,500 mg/L was flowing over the top of the beaver dam.

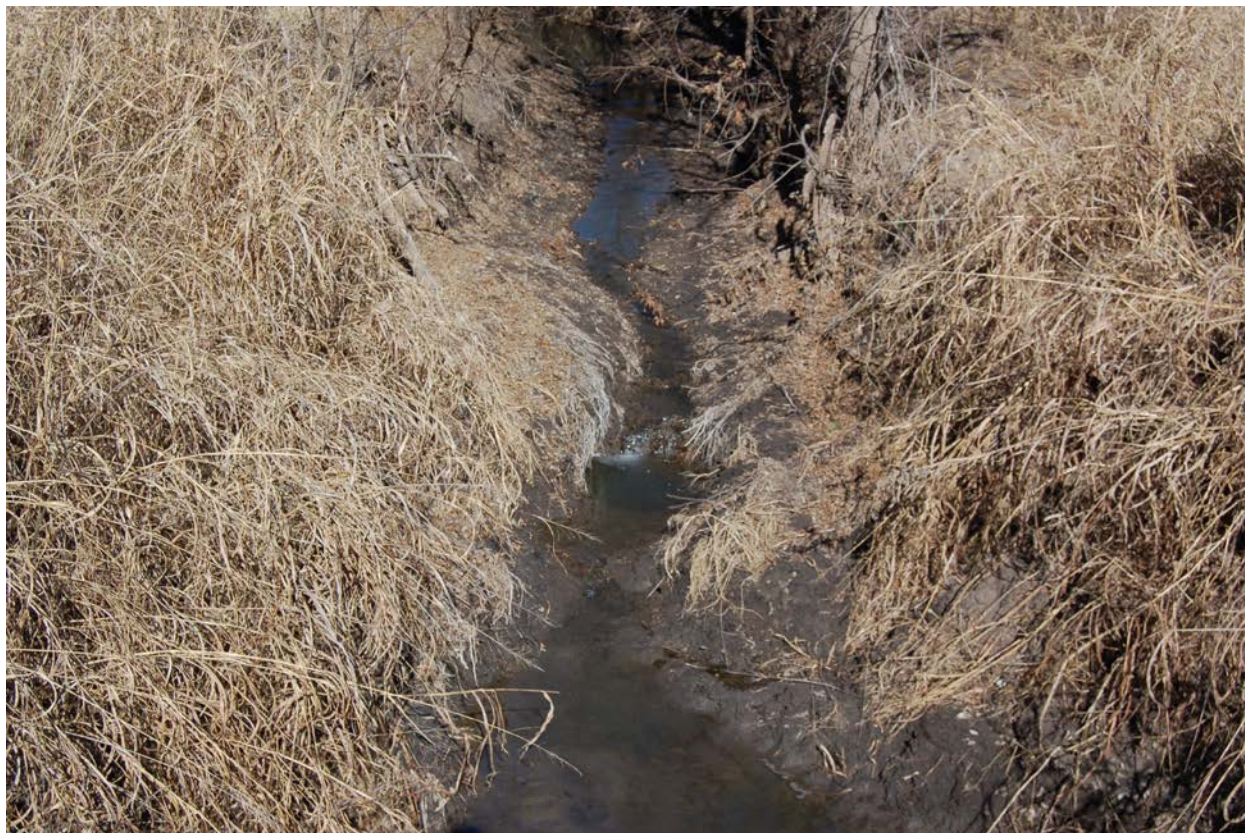
Photo No. 15

Description: This was a view of the tributary of Salt Creek from a small bridge southwest of the point of entry. The tributary was flowing southwest. There were two beaver dams between this point on the tributary of Salt Creek and the point of entry. The northern most beaver dam was shown in photo 13. This location is approximately 0.3 miles downstream from the point of entry on the tributary of Salt Creek. This location is downstream from the second beaver dam and shows continued downstream flow from the second beaver dam.

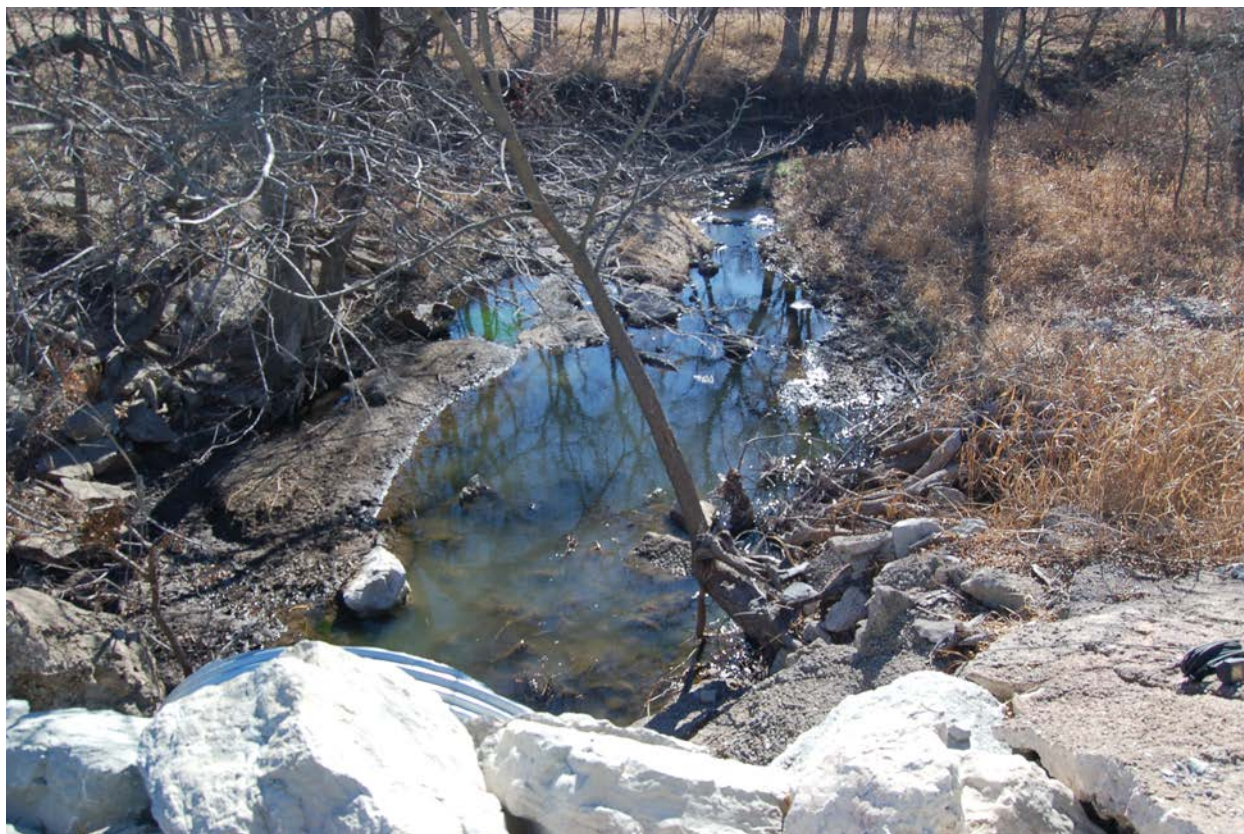
Photo No. 16

Description: This image shows a view downstream from the bridge on the tributary of Salt Creek.

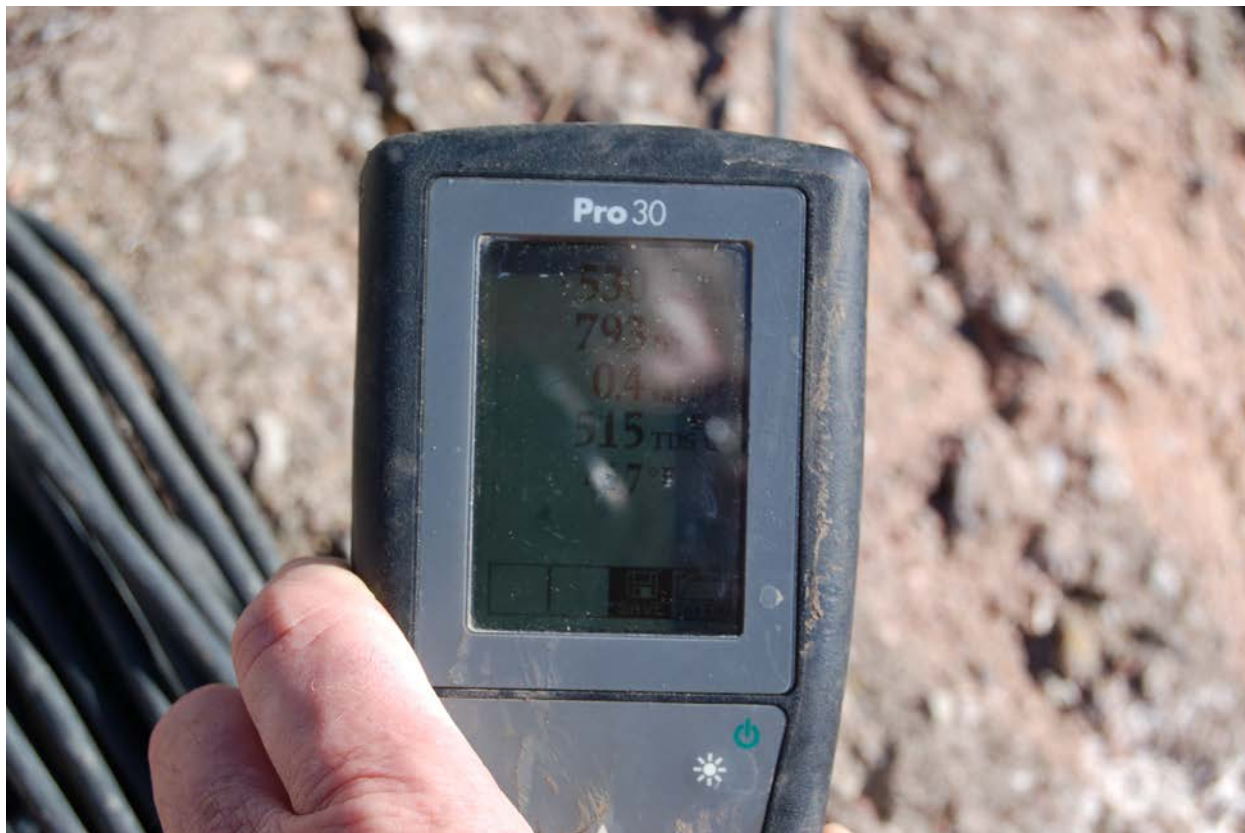
Photo No. 17

Description: A TDS reading of the tributary of Salt Creek that was downstream of the bridge, shown in Photo 16 was 515 mg/L.
